Detecting and Eliminating Illicit Discharges to Improve Water Quality in the Lamoille River Basin

Final Report

Issued: January 31, 2014

Prepared for:	Prepared by:
Jim Pease	Dave Braun
VT Department of Environmental Conservation	Stone Environmental, Inc.
1 National Life Drive, Main Building, 2nd Floor Montpelier, VT 05620-3522	535 Stone Cutters Way Montpelier, VT 05602
Tel. / (802) 490-6116	Tel. / 802-229-5379
E-Mail / Jim.Pease@state.vt.us	E-Mail / dbraun@stone-env.com

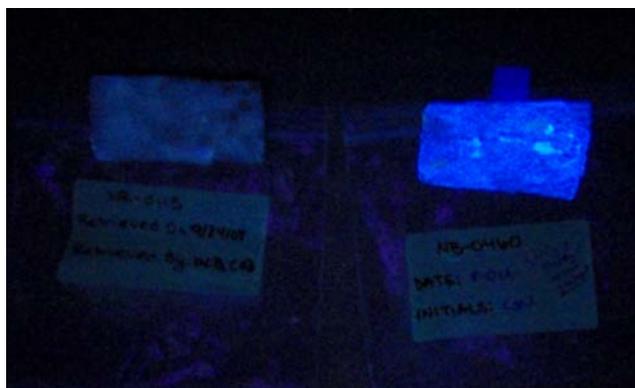
Figure 1. Optical brightener monitoring pads under UV light

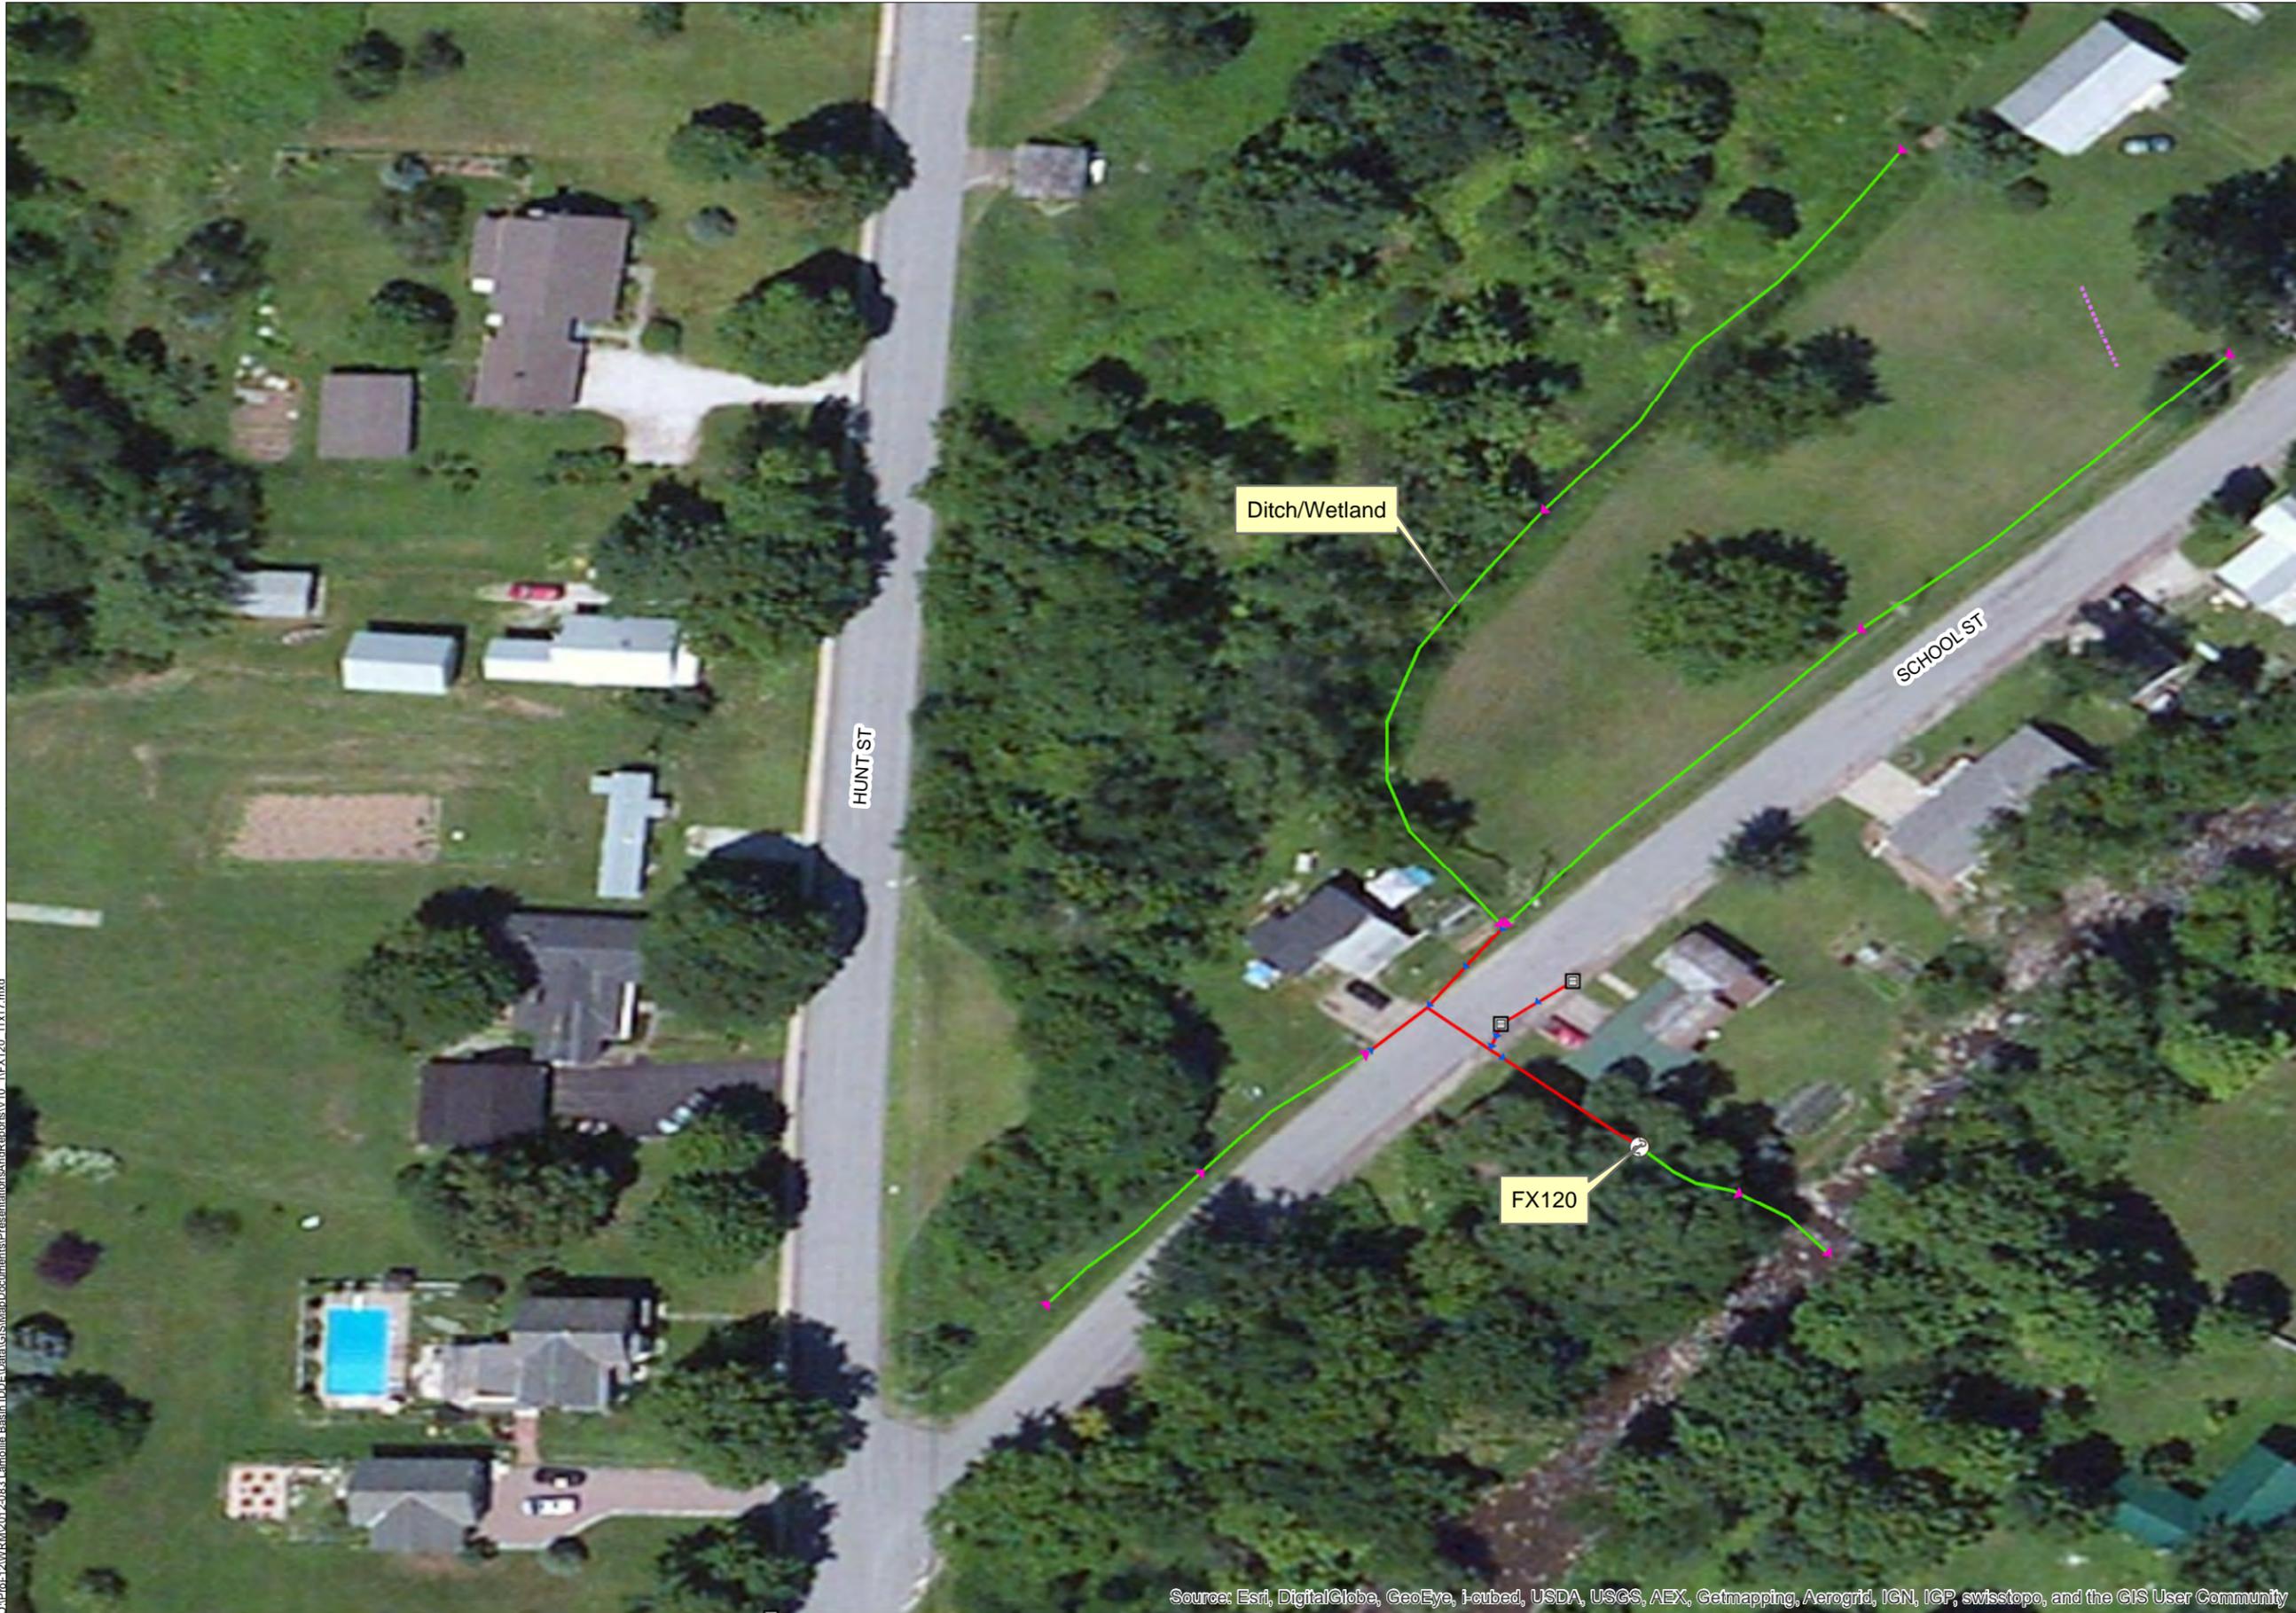
Map 3. System FX120
Lamoille River Basin IDDE
 Fairfax, VT

The FX120 outfall is a 15-in. corrugated metal pipe. This system discharges on the southeast side of School Street (Appendix C, Map 3). The outfall pipe was dripping and had a musty odor and iron staining at the time of the initial assessment. Water quality data for this outfall are presented in Table 7. Moderate concentrations of ammonia (0.5-1.0 mg/L) were measured at the outfall on August 2 and 14; however, no ammonia was detected when the outfall was resampled on September 20, 2012. Low chlorine concentrations were measured on all three sampling dates. Due to detection of ammonia at the outfall, follow-up sampling was conducted on September 20, 2012 for total phosphorus and *E. coli* analysis. The flow rate was moderate (0.14 L/s) and the concentrations of total phosphorus (31.6 µg/L) and *E. coli* (74 MPN/100 mL) were low.

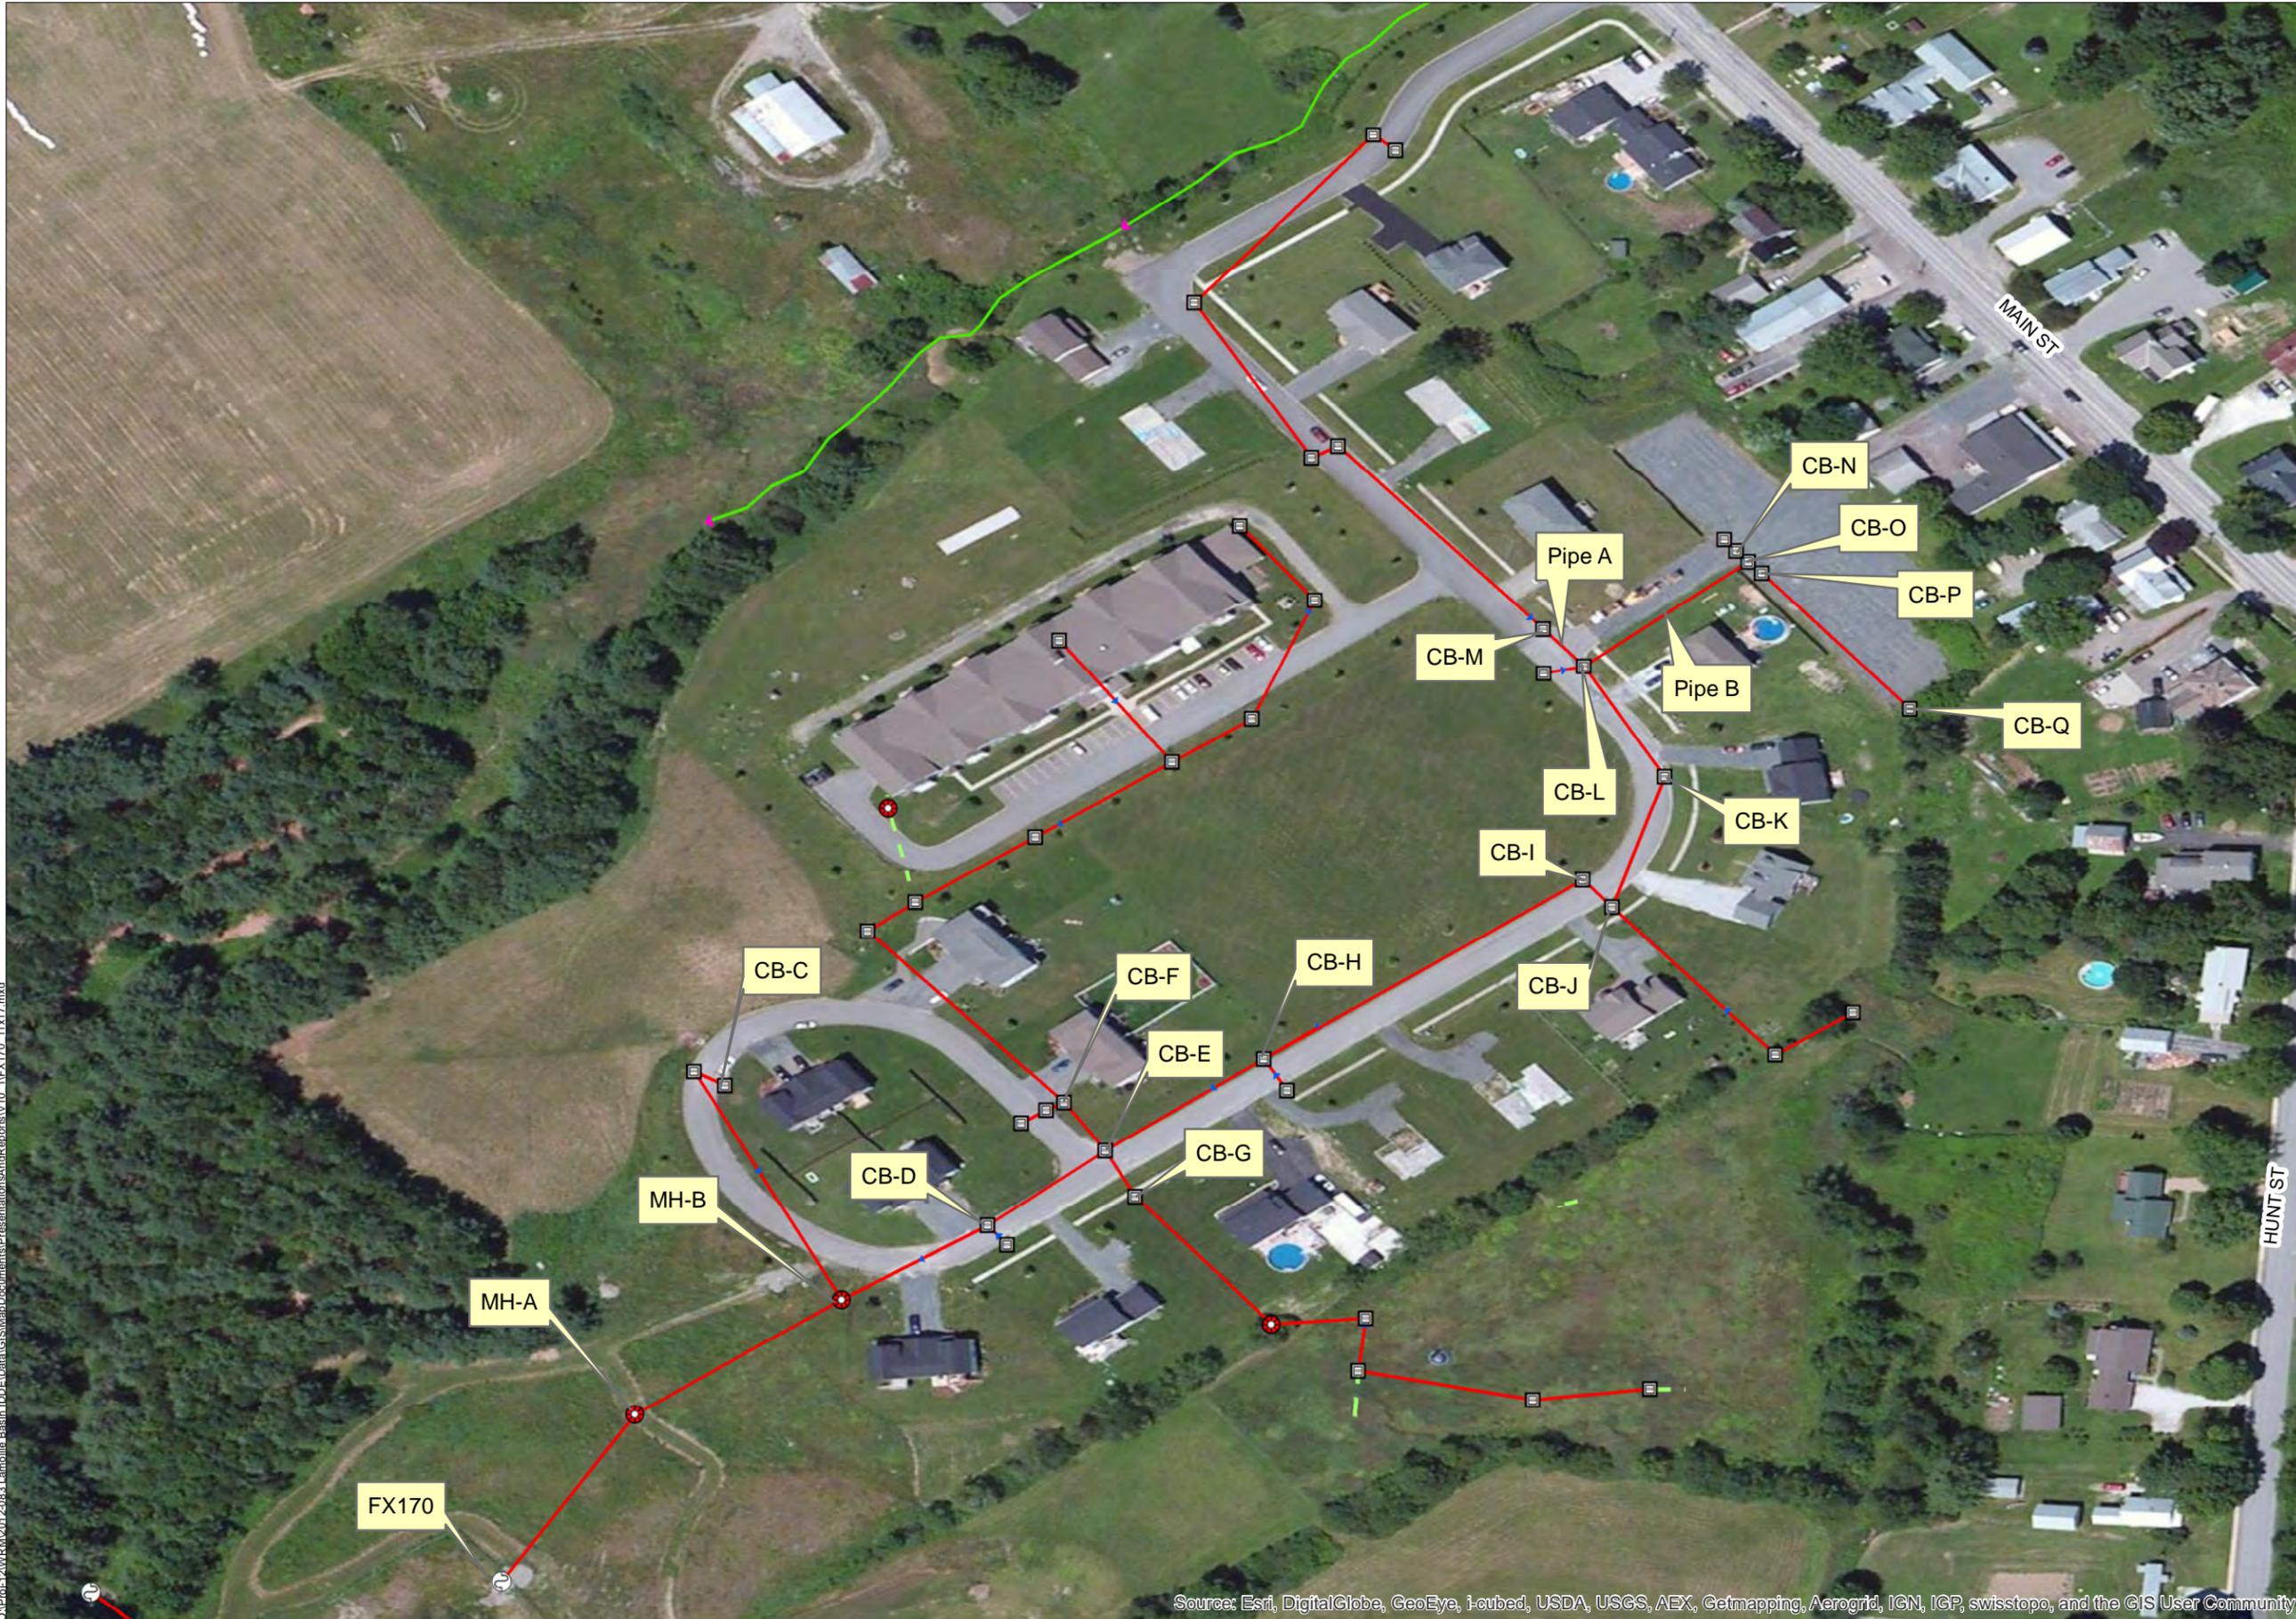
Map 4. System FX170
Lamoille River Basin IDDE
 Fairfax, VT

On August 13, 2013, this system was visited with Randy Devine of the Town of Fairfax. We confirmed significant flows of chlorinated water entering catchbasin CB-L from both Pipe A and Pipe B. It is unclear whether the source is the municipally-owned water main or a privately owned lateral. **We have recommended that the Town perform leak detection on the municipal water line along Old Academy Street and on the line from Old Academy Street back to Main Street.**

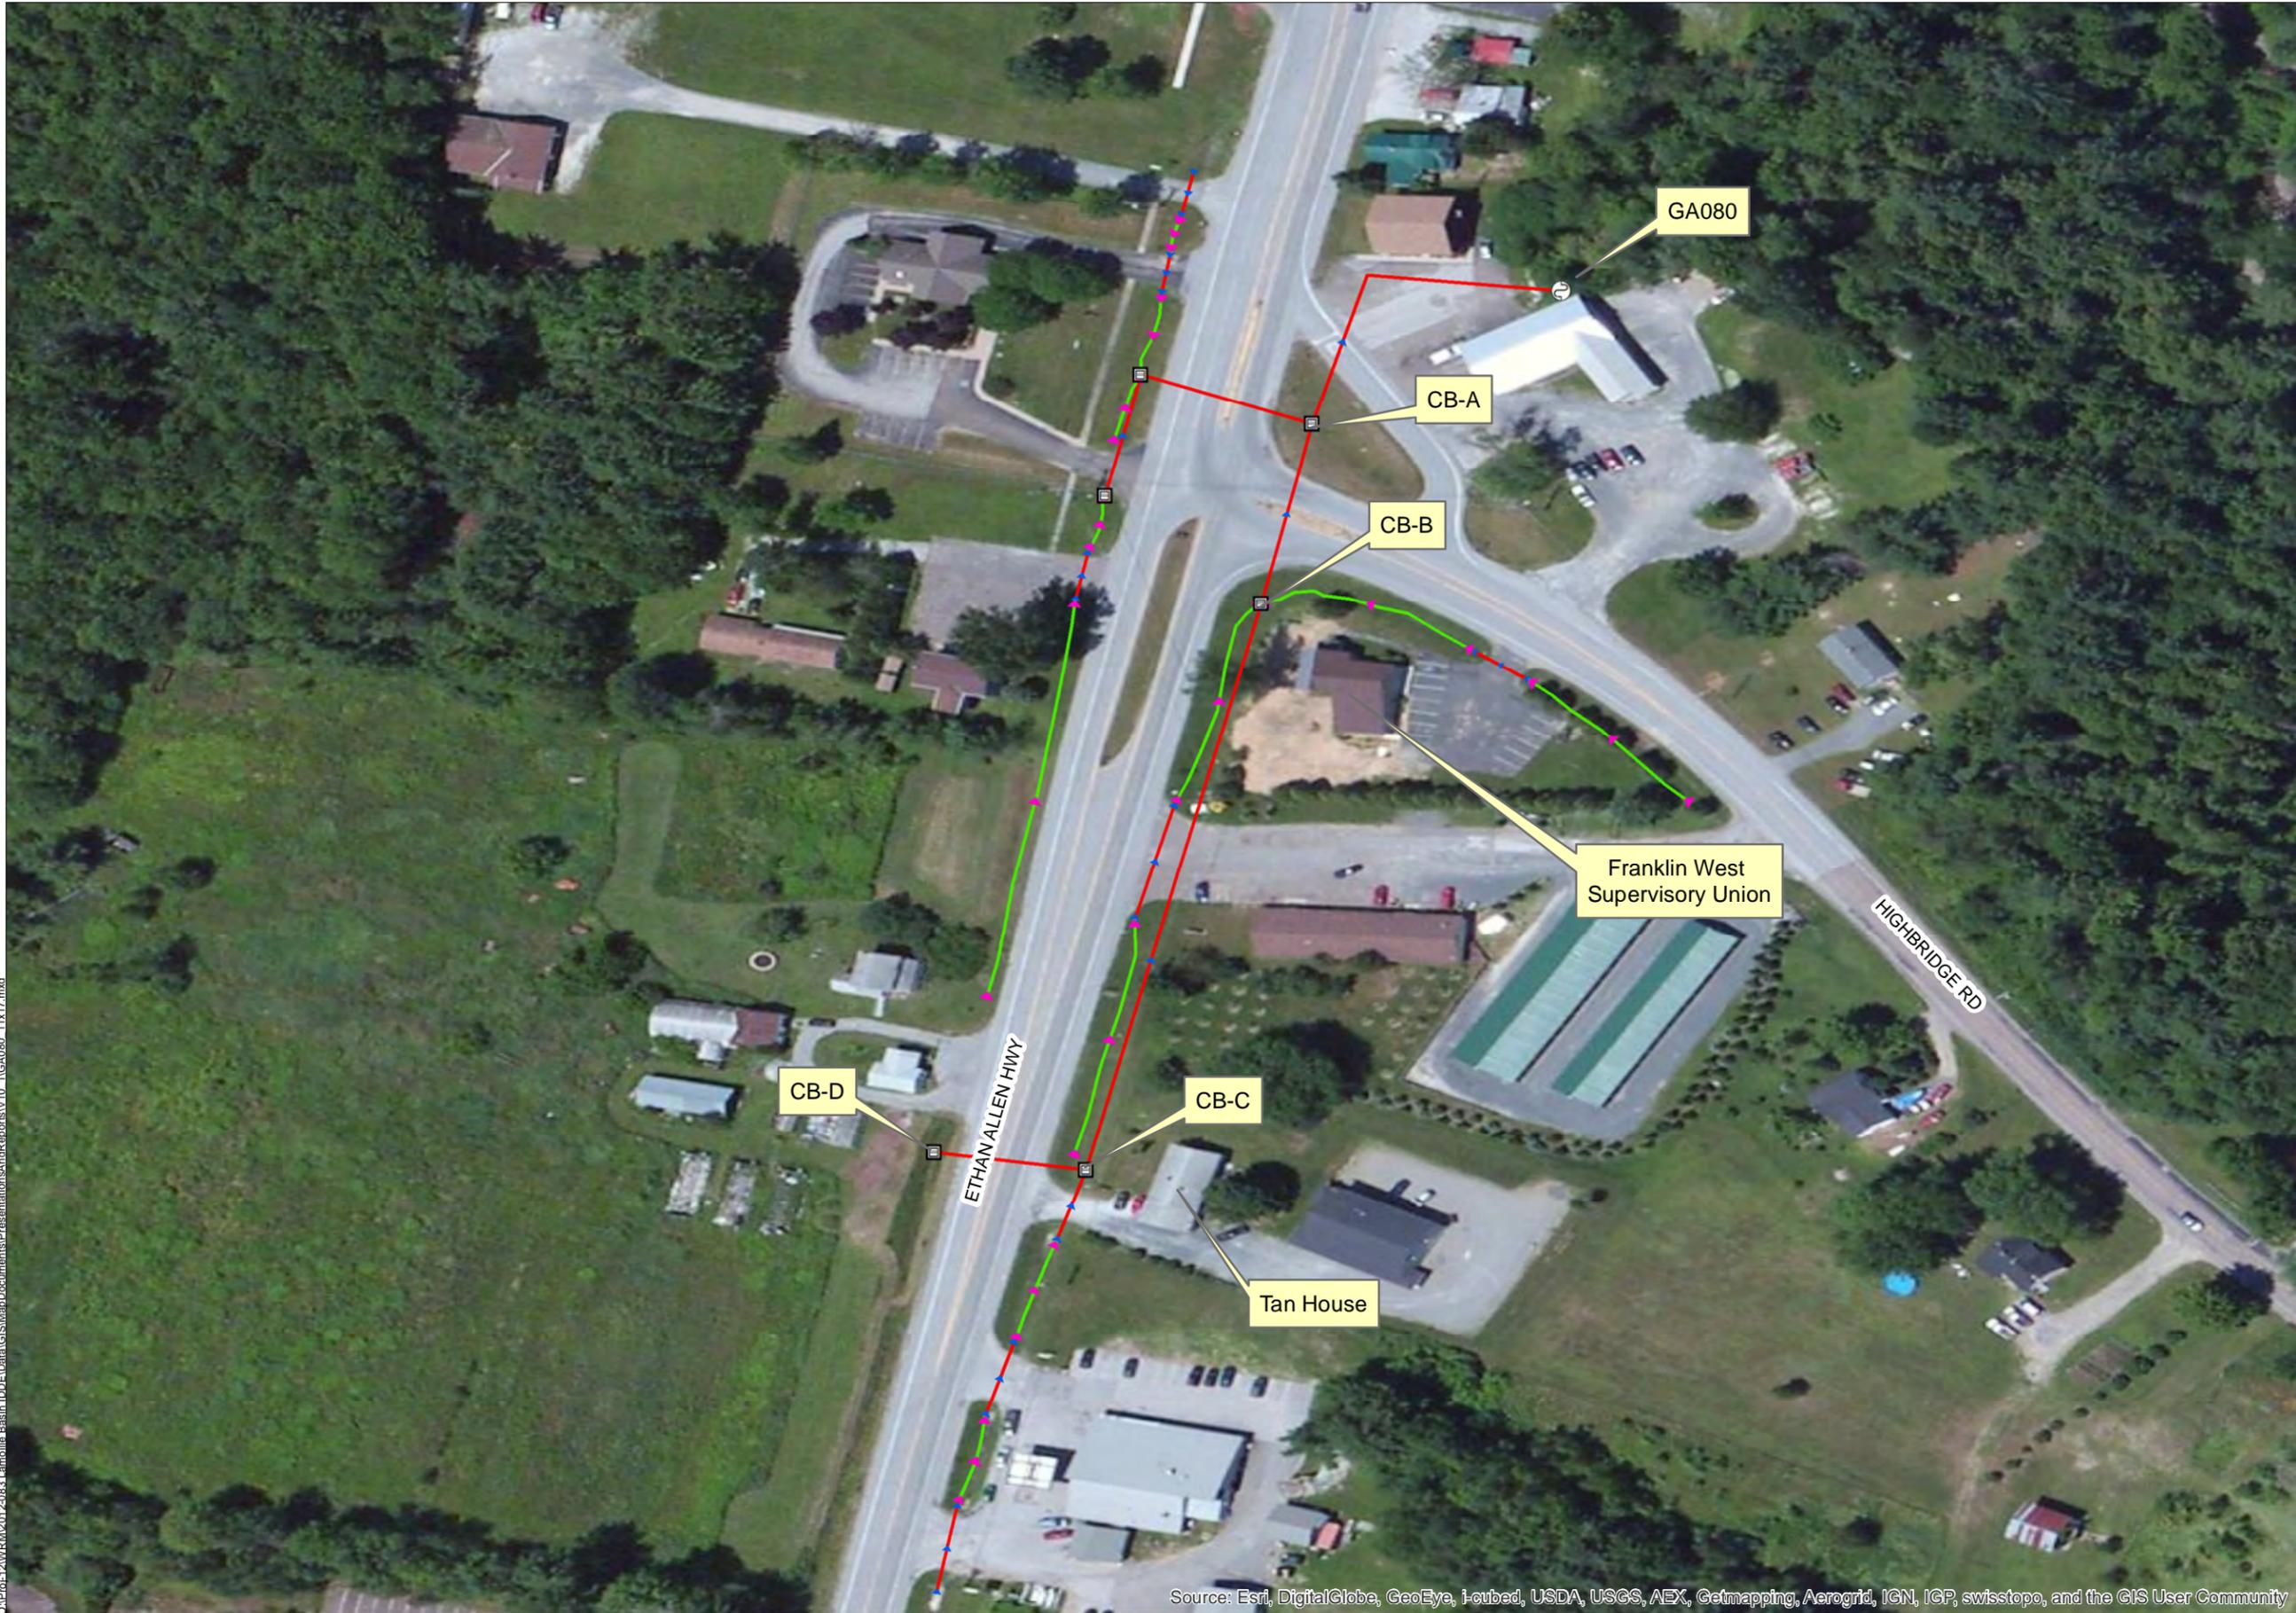
Map 5. System GA080
Lamoille River Basin IDDE
 Georgia, VT

The GA080 outfall is an 18-in. corrugated black plastic pipe. This system drains a portion of Route 7 and discharges on the north side of Highbridge Road (104A) at its intersection with Route 7, behind an auto service station (Appendix C, Map 5). Water quality data for this outfall are presented in Table 9. On July 27, 2012 a petroleum odor was observed at the outfall; this may have resulted from fumes from the

service station. A distinct laundry odor was observed in the first three catchbasins up-pipe from the outfall. The odor was strongest in the second catchbasin up-pipe from the outfall, CB-B. Water in the sump of CB-B was opaque and blue-gray in color (Figure 2). Ammonia and MBAS detergents were detected at low concentrations at the outfall and optical brightener was detected at the outfall and in the first three up-pipe catchbasins.

August 23, 2013. Pads placed in CB-A, CB-B, and CB-C showed strong optical brightener fluorescence. Because no pipes enter CB-B and CB-C, we suspect the source of the laundry detergent is infiltration from the onsite wastewater treatment system at the tan ranch house located on Route 7 in front of the bike shop and kitchen store. A second possible source is infiltration from the newly constructed (2011) mound system at the Franklin West Supervisory Union building at 4497 Highbridge Road.

Given the presence of laundry detergent and the location of the tan house relative to the storm drain, we suspect that the onsite wastewater treatment system serving this property is not providing adequate wastewater treatment. The question becomes: what level of treatment constitutes failure? *E. coli* levels measured at the outfall were low; therefore the system may provide adequate pathogen removal. The phosphorus concentration was also low, suggesting that phosphorus removal in the leachfield soils may be adequate. We expect mobile constituents such as nitrogen, chloride, and optical brighteners to pass from onsite wastewater treatment systems to groundwater. This is not necessarily a problem. In our view, the strongest basis for finding that the system was not providing adequate wastewater treatment was the bluish-gray color observed in catchbasin CB-B on July 27, 2012 and the laundry odor repeatedly observed in CB-B and CB-C.

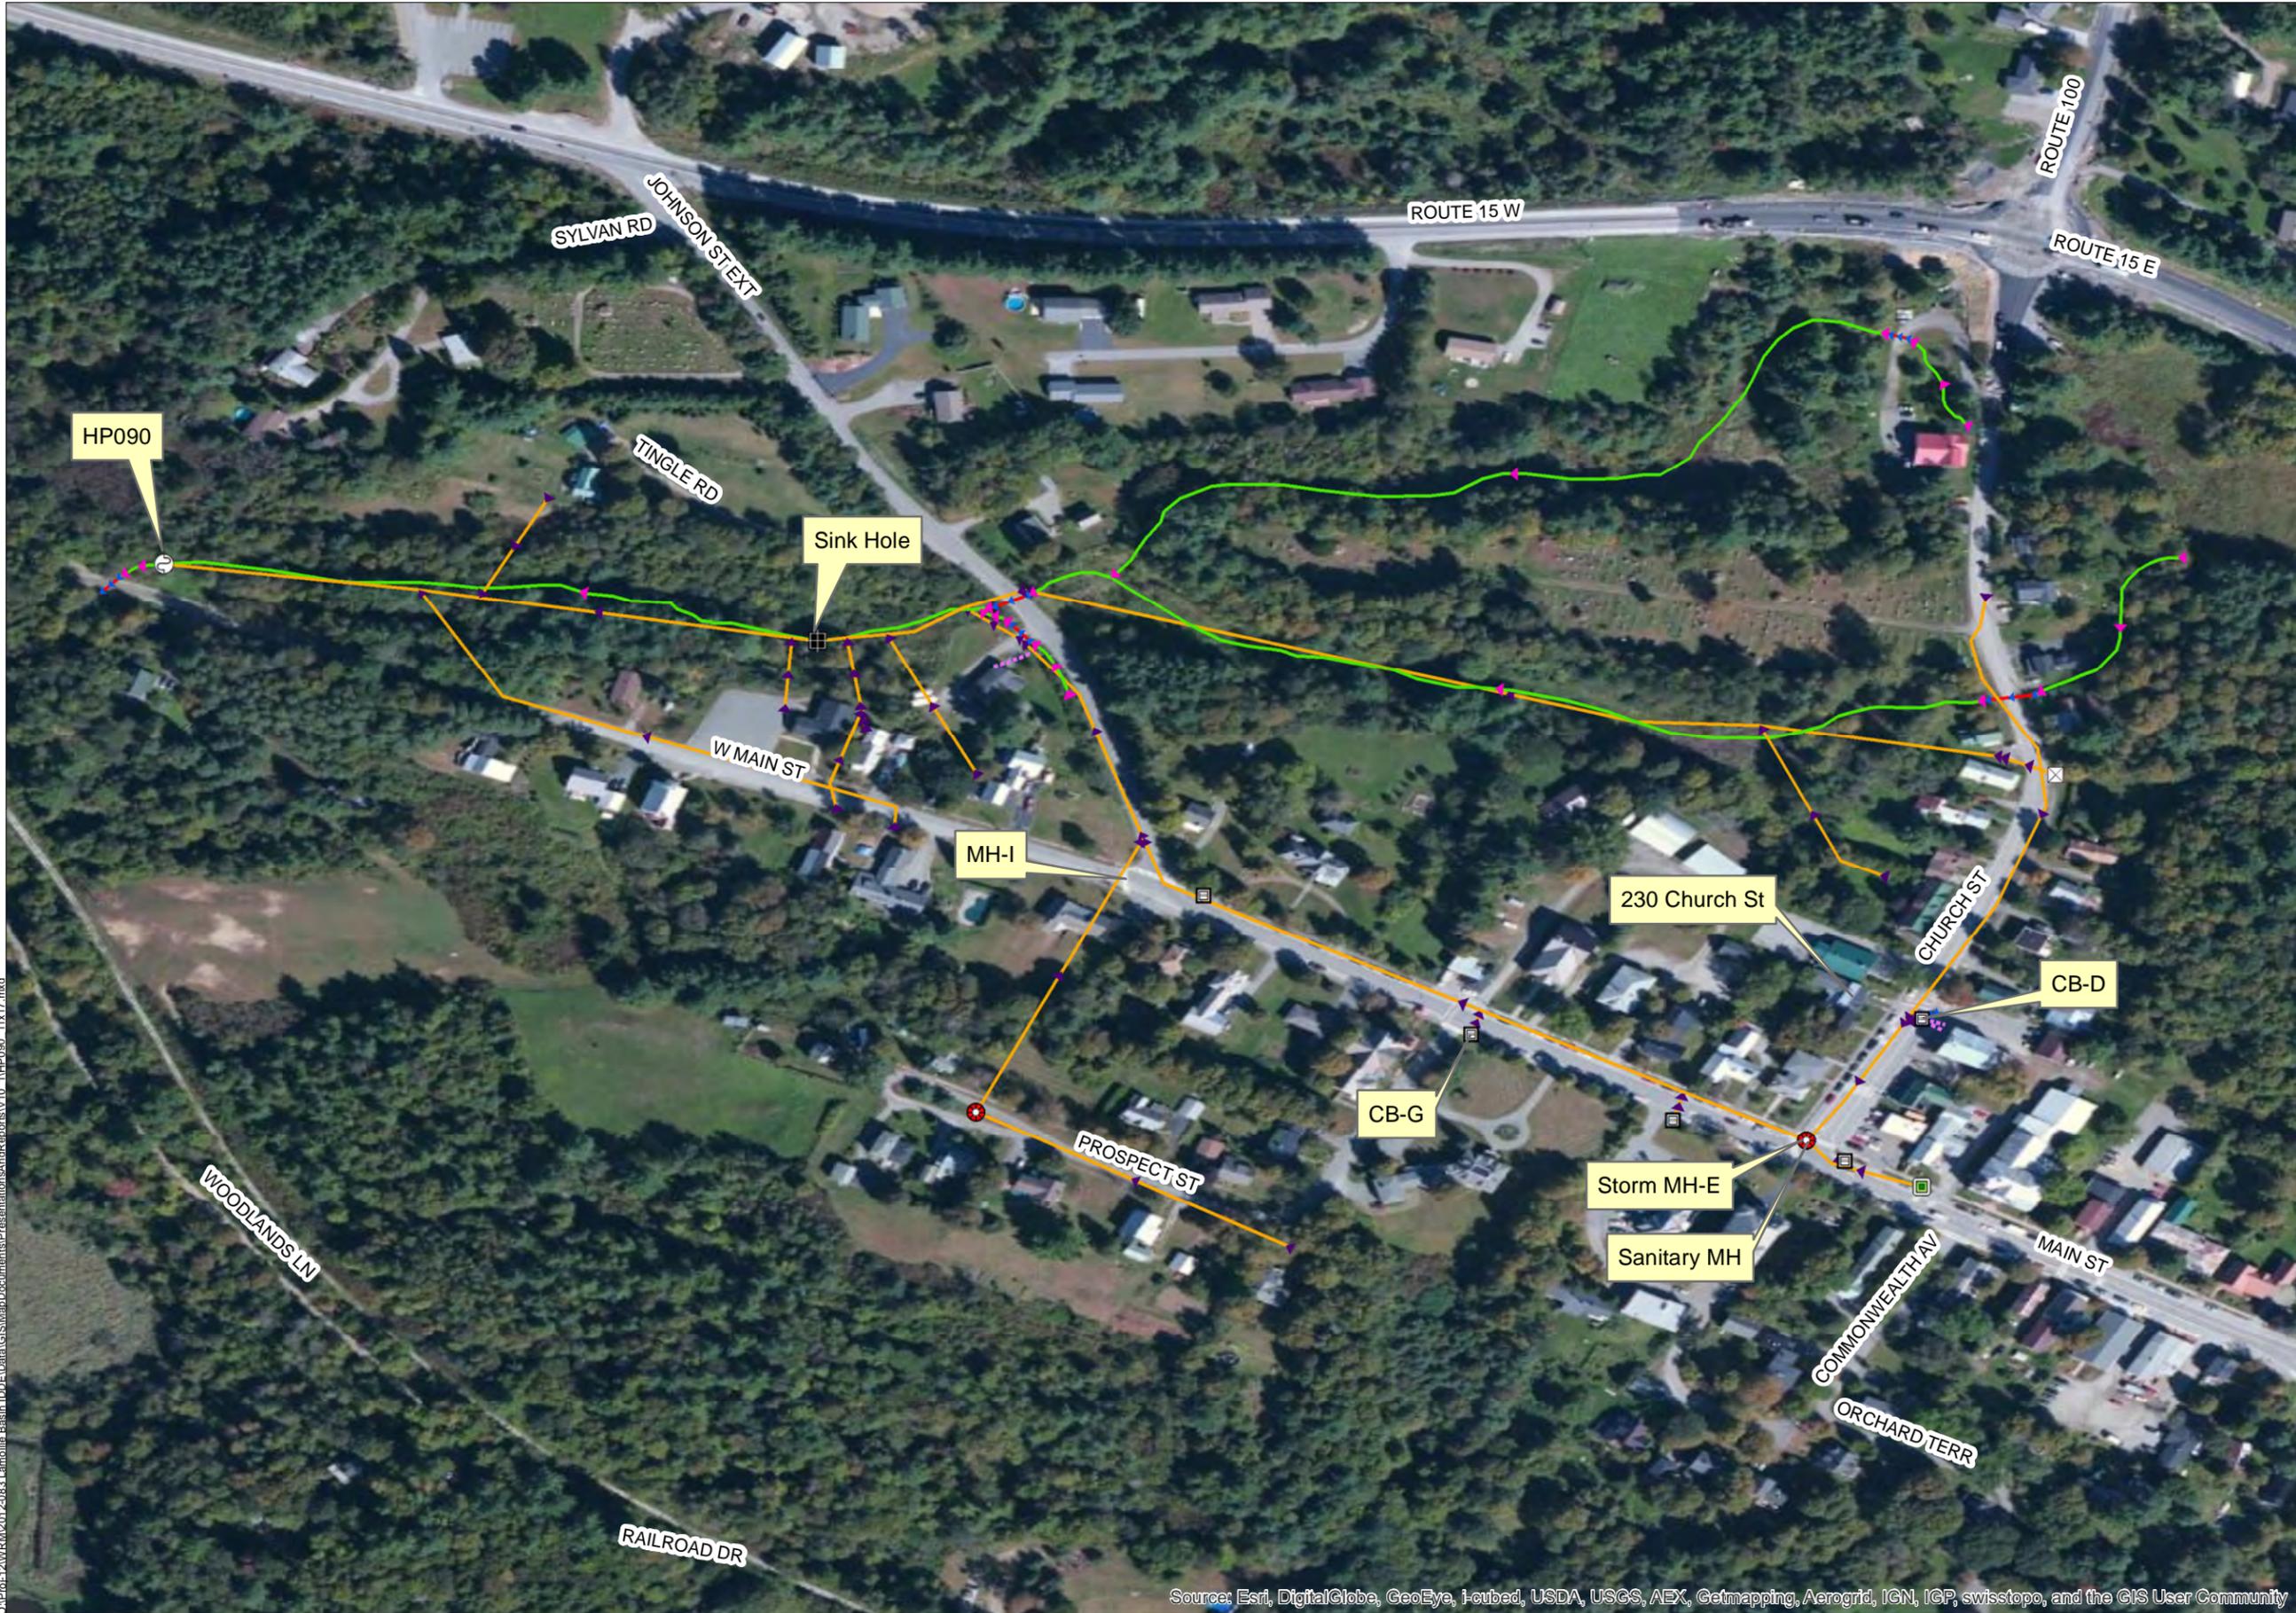
Map 14. System HP090
Lamoille River Basin IDDE
 Hyde Park, VT

On November 13, 2012, we attempted to follow the path of the buried stormline up from the outfall. The vitrified clay line is broken in places, creating two sinkholes. The sinkhole pictured in Figure 4 had a wastewater odor and condoms were visible, indicating a wastewater source. Optical brightener monitoring pads were placed at the outfall, the sinkhole, CB-D, and MH-I. Optical brightener was

and Carol Robertson, the Village General Manager, to discuss the HP090 system. A site visit was made immediately following a rain storm and substantial flows were observed discharging from both the outfall and the sinkhole into the ephemeral stream running through the ravine. A wastewater odor was observed at both the outfall and the sinkhole. Because it was unclear what the broken pipe in the sinkhole was connected to, a plan was made to excavate the pipe to determine its connections and create access for sampling closer to Johnson Street Extension.

On October 31, 2013 excavation at the sinkholes quickly revealed that they were holes over breaks in the former combined sewer main. In the previously sampled sinkhole (closer to Johnson Street Extension), both ends of the broken vitrified clay line were exposed. Because the line was the main and not a broken lateral, attention shifted to finding the source of the contamination within the downtown area. All residences located on Main Street between Church Street and Johnson Street Extension were dye tested on October 31, 2013 and over the following weekend. In every case, dye was seen in the sanitary system and not the stormwater system (at MH-I).
