**DETECTION AND ELIMINATION OF
NON-STORMWATER DISCHARGES
TO THE
NORTH BRANCH, DOG RIVER AND THE STEVENS
BRANCH
IN
MONTPELIER, BERLIN AND NORTHFIELD**

July 2009

FRIENDS OF THE WINOOSKI RIVER
PO Box 777 Montpelier VT 05601

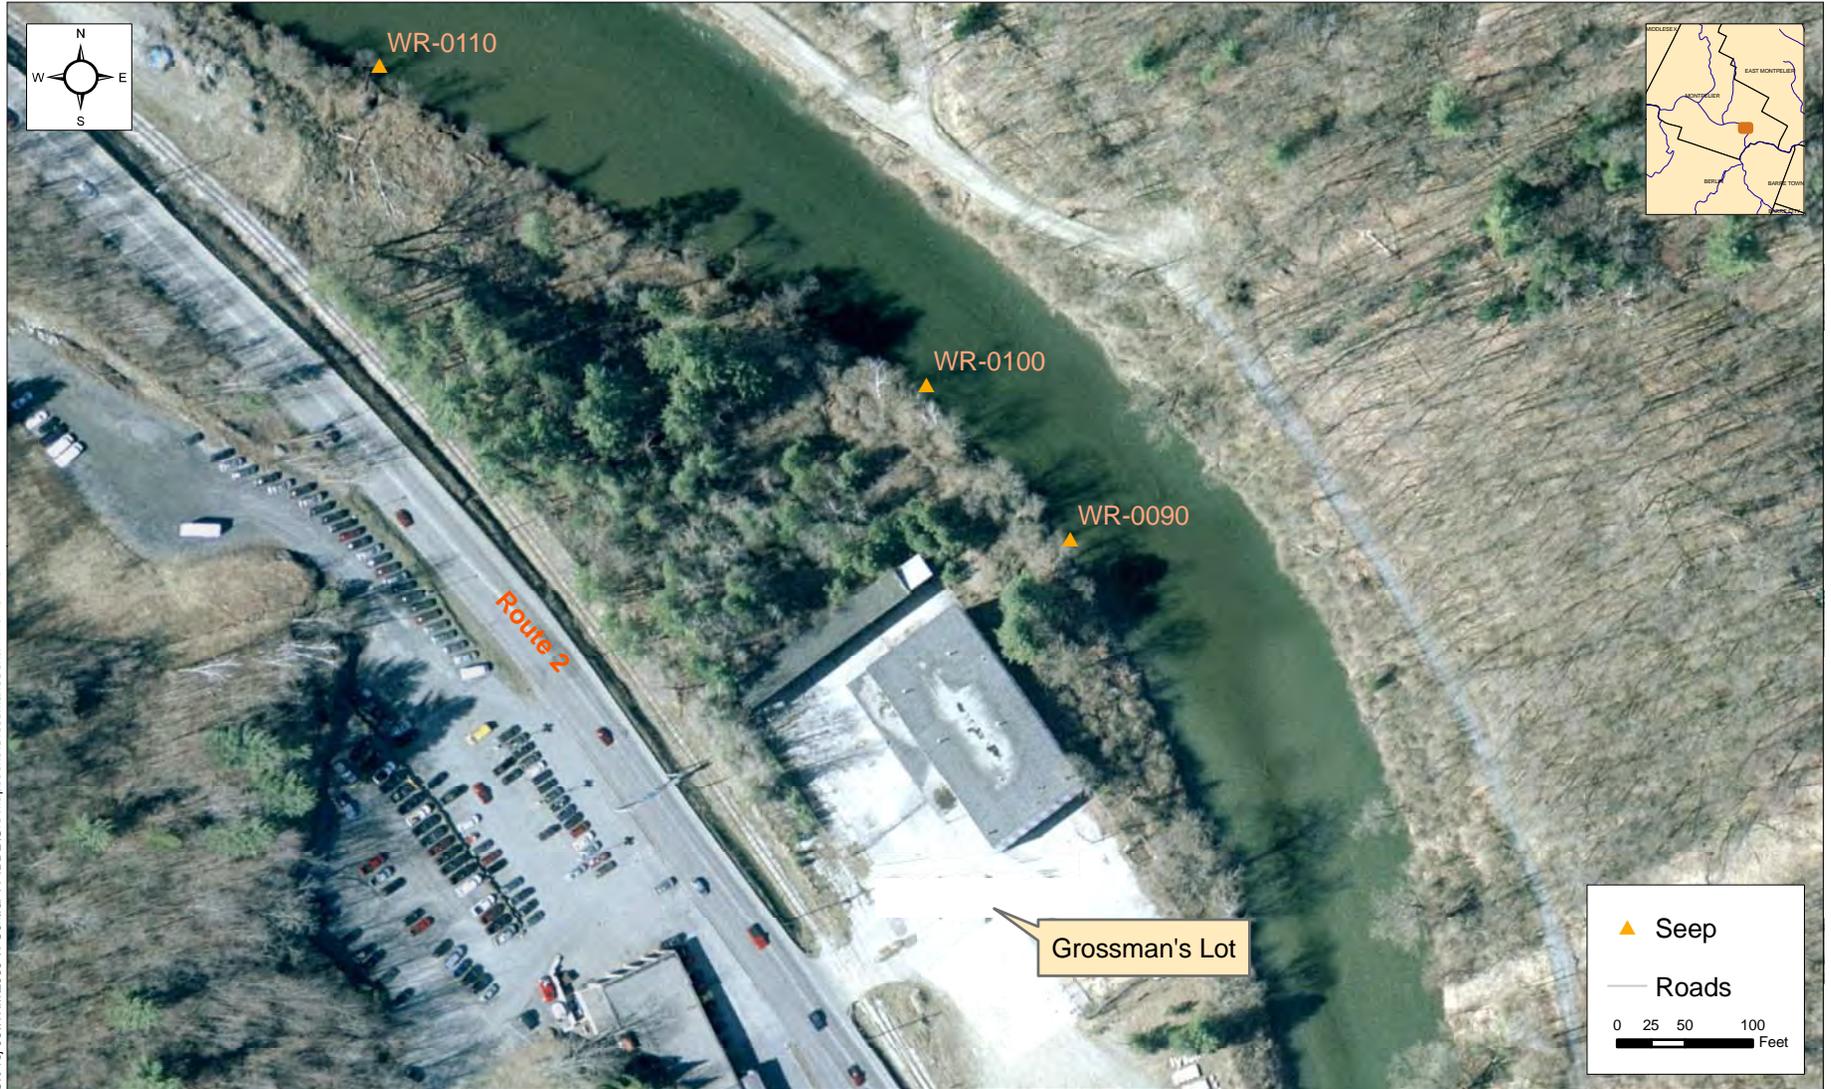
Contaminant Seepage to River, Grossman's Site Winooski River, Montpelier

This site was brought to our attention following a complaint received on April 27, 2009. It was an anonymous report from a former Grossman's employee (Grossman's was the former lumber business on site) who alleged that he observed pools of coal tar in the woods that were each a few feet across. In the fall of 2008 a complaint was also received from Stone Environmental who was performing unrelated river assessment work for the Friends of the Winooski River. This report was of significant chemical odors and sheens from seeps emanating from the site that were entering the Winooski River.
