City and Town of St. Albans Illicit Discharge Detection and Elimination (IDDE) Study

Final Report

Ecosystem Restoration Program
Contract #2012 ERP-1-01

12/13/2012

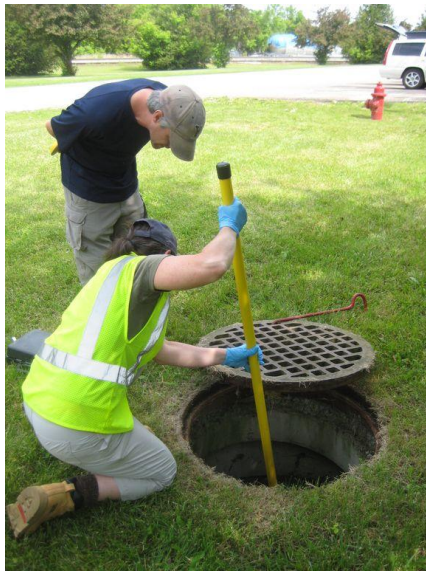
Figure 2: Field Technicians conducting bracket sampling at structure 24.CBA, on June 8th, 2012.

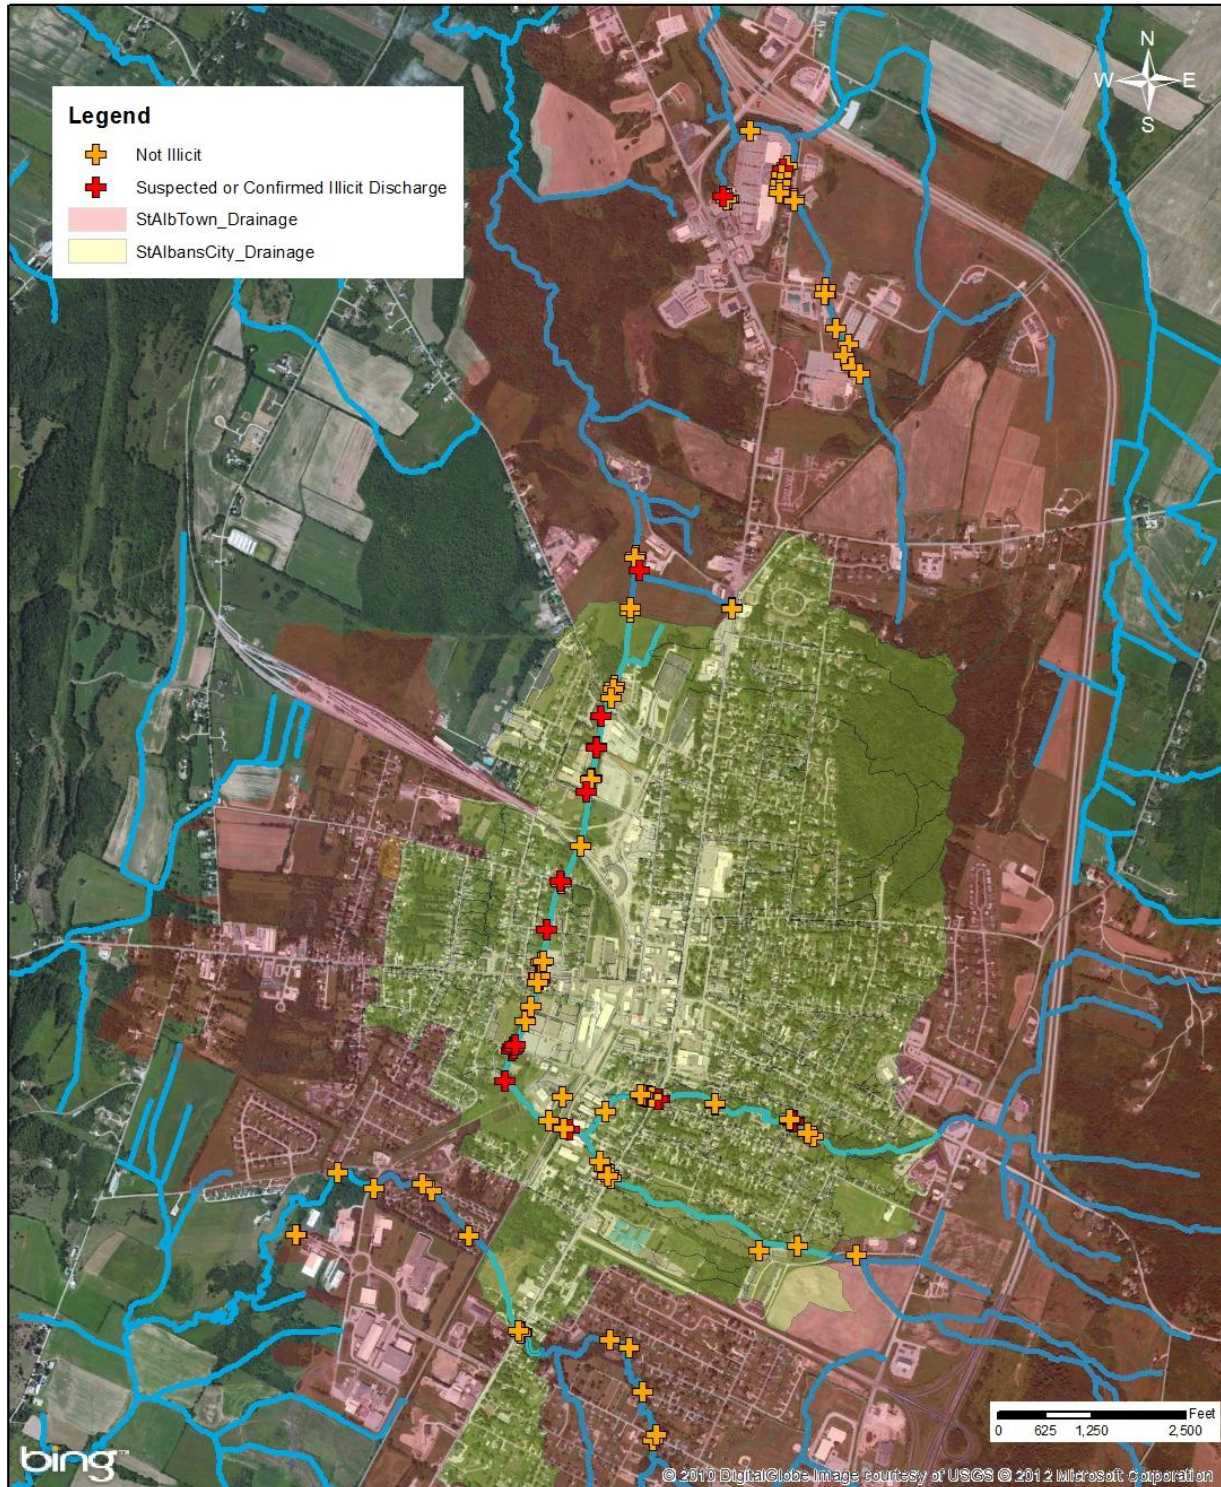
Figure 3: Outfalls Investigated During IDDE Study

During the Dry Weather Survey, a total of 103 outfalls were assessed, including 65 in the City and 38 in the Town. At the time of the survey, 46 outfalls had dry weather flow (Table 4). Of the flowing outfalls, 15 were surface drainage discharges, while the rest were various types of pipe discharges. Additionally, there were 27 previously unmapped outfalls discovered during the Dry Weather Survey. After analysis of the physical indicators and water quality results, 24 of the total number outfalls surveyed (23%) were suspected to have illicit discharges based on the criteria outlined in Section 3.3. Figure 3 at the end of this section shows a map of the surveyed outfalls, indicating the illicit discharges. A map including just the new outfalls identified as a part of this study is included as well below (Figure 4). Results from the Dry Weather Survey are included in Appendix 3-1.

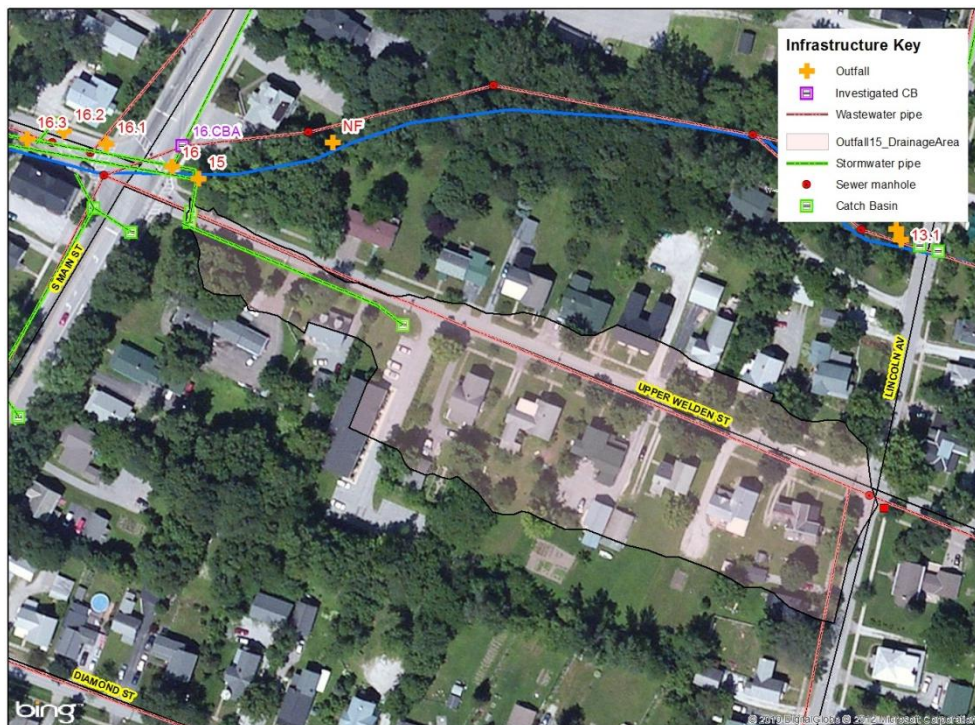
Figure 24: Outfall 15 Drainage Area

An Optical Brightener Monitoring Pad (OBM) was deployed for 12 days, from August 16th – 27th 2012. The OBM had a False Positive reading due to the presence of specks of dust that appeared to be optical brighteners, but were determined to be from contamination of the OBM after collection. The pipe was found to have a large crack about 10 ft from the outlet. The pipe and the fact that the pipe exits from the side of a steep slope, suggests that the dry weather flow was a result of groundwater infiltration (Figure 23). Due to the presence of high potassium and phosphorus levels in discharge from Outfall 15 but a lack of optical brighteners, the discharge was determined to be groundwater infiltration into the pipe contaminated by non-point source pollution from the use of fertilizers in the drainage area Figure 24 (see full map in Appendix 5-8).

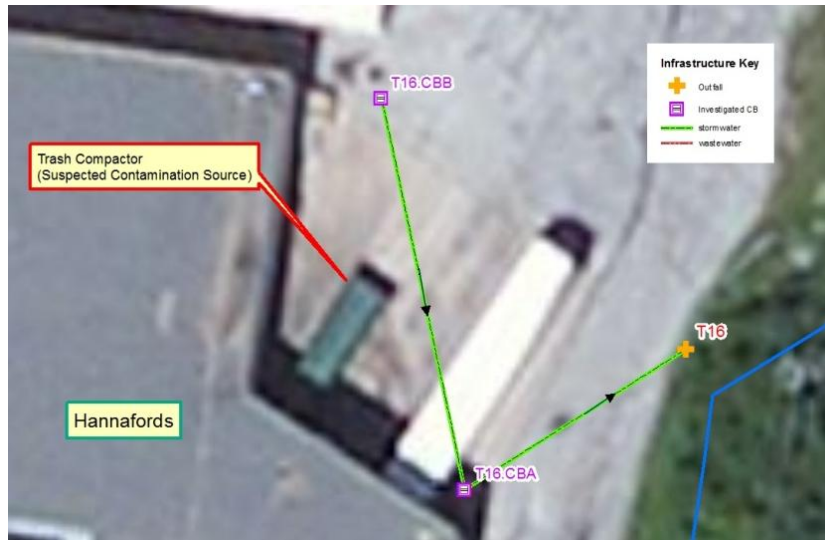
Figure 28: Outfall T16 Drainage System

Outfall T16 is a 15" HPDE drainage pipe that connects to a catch basin located in the loading dock area behind Hannafords Store, within the Highgate Shopping Center (Figure 28-see full map in Appendix 5-10). On June 6th, outfall T16 was surveyed and found to have approximately 0.0001 cfs of dry weather flow (Figure 27). Benthic growth and discoloration were present in the flow line suggesting a possible illicit discharge.

Sample water was then tested and found to contain elevated levels of ammonia, fluoride, potassium, detergents, conductivity, and E.coli (Table 16). Of particular concern was the elevated level of E.coli which was Too Numerous To Count (TNTC), indicating an unsafe concentration of E.coli in discharge to the outfall. The conductivity level at 4500 μ S was also of concern as it was elevated well above the benchmark to levels often found in industrial waste discharge. The outfall was flagged as a priority site for further investigation due to the combination of elevated levels of *all* water quality parameters and the presence of physical indicators.

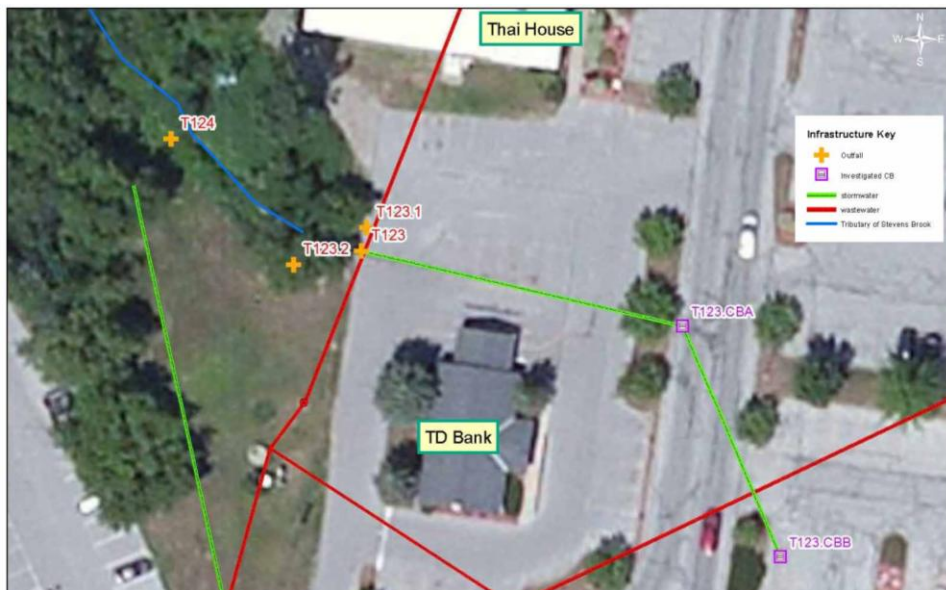
Figure 30: Outfall T123 Drainage System

Outfall T123 is a discharge pipe for a series of catch basins located within the Highgate Shopping Center Parking lot as mapped in Figure 30 (see full map in Appendix 5-11).

The outfall was re-inspected the following day on June 8th, 2012. Dry weather flow was observed and sampled again for Ammonia revealing an elevated level of 0.80 mg/L, consistent with the previous day's testing results. Field technicians inspected the drainage system displayed in Figure 30 and found a slight trickle entering the outlet pipe of the first catch basin (T123.CBA) up the line. The basin had two inlet pipes; one from the south that had a slight trickle and one pipe from the north parallel to the roadway with no flow. The catch basin (T123.CBB) connected to the southern pipe was full of sediment and no standing water was visible. It is possible there was water within the pores of the sediment resulting in a slow trickle into basin T123.CBA. The next catch basin up the line from T123.CBC was also inspected and found to be full of sediment.

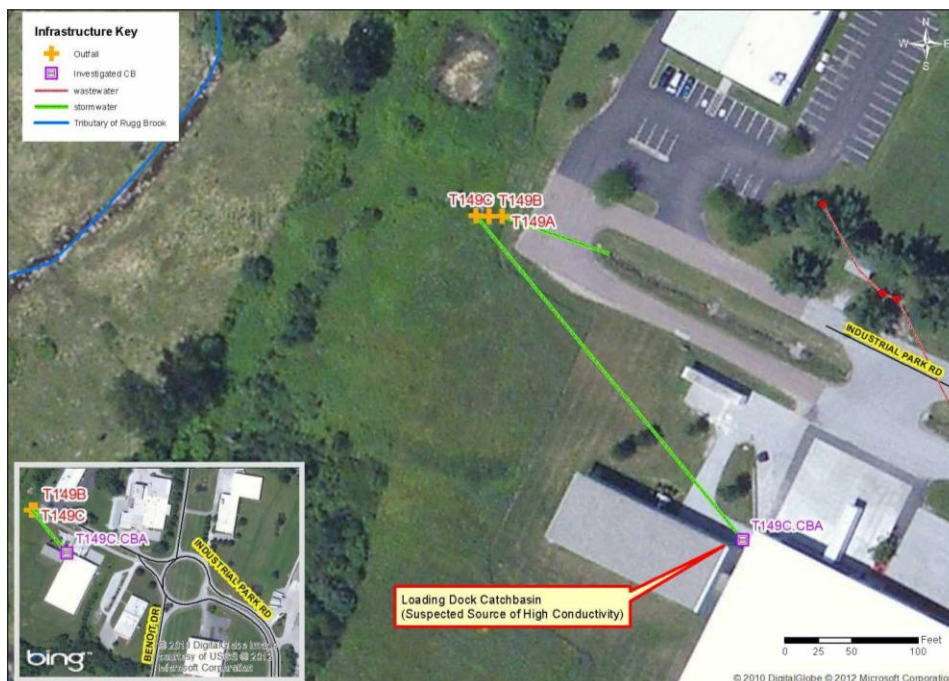
Figure 32: Outfall T149C Drainage System

Outfall T149C is a drainage outlet for a catch basin (T149.CBA) located in the loading dock of the nearest industrial building (occupant unknown). The outfall is located at the end of Industrial Park Extended Road, within the St. Albans Industrial Park as marked in Figure 32 (Full map in Appendix 5-12). On June 20th, 2012 dry weather flow was observed coming from the 15" HDPE outfall pipe (Figure 33).

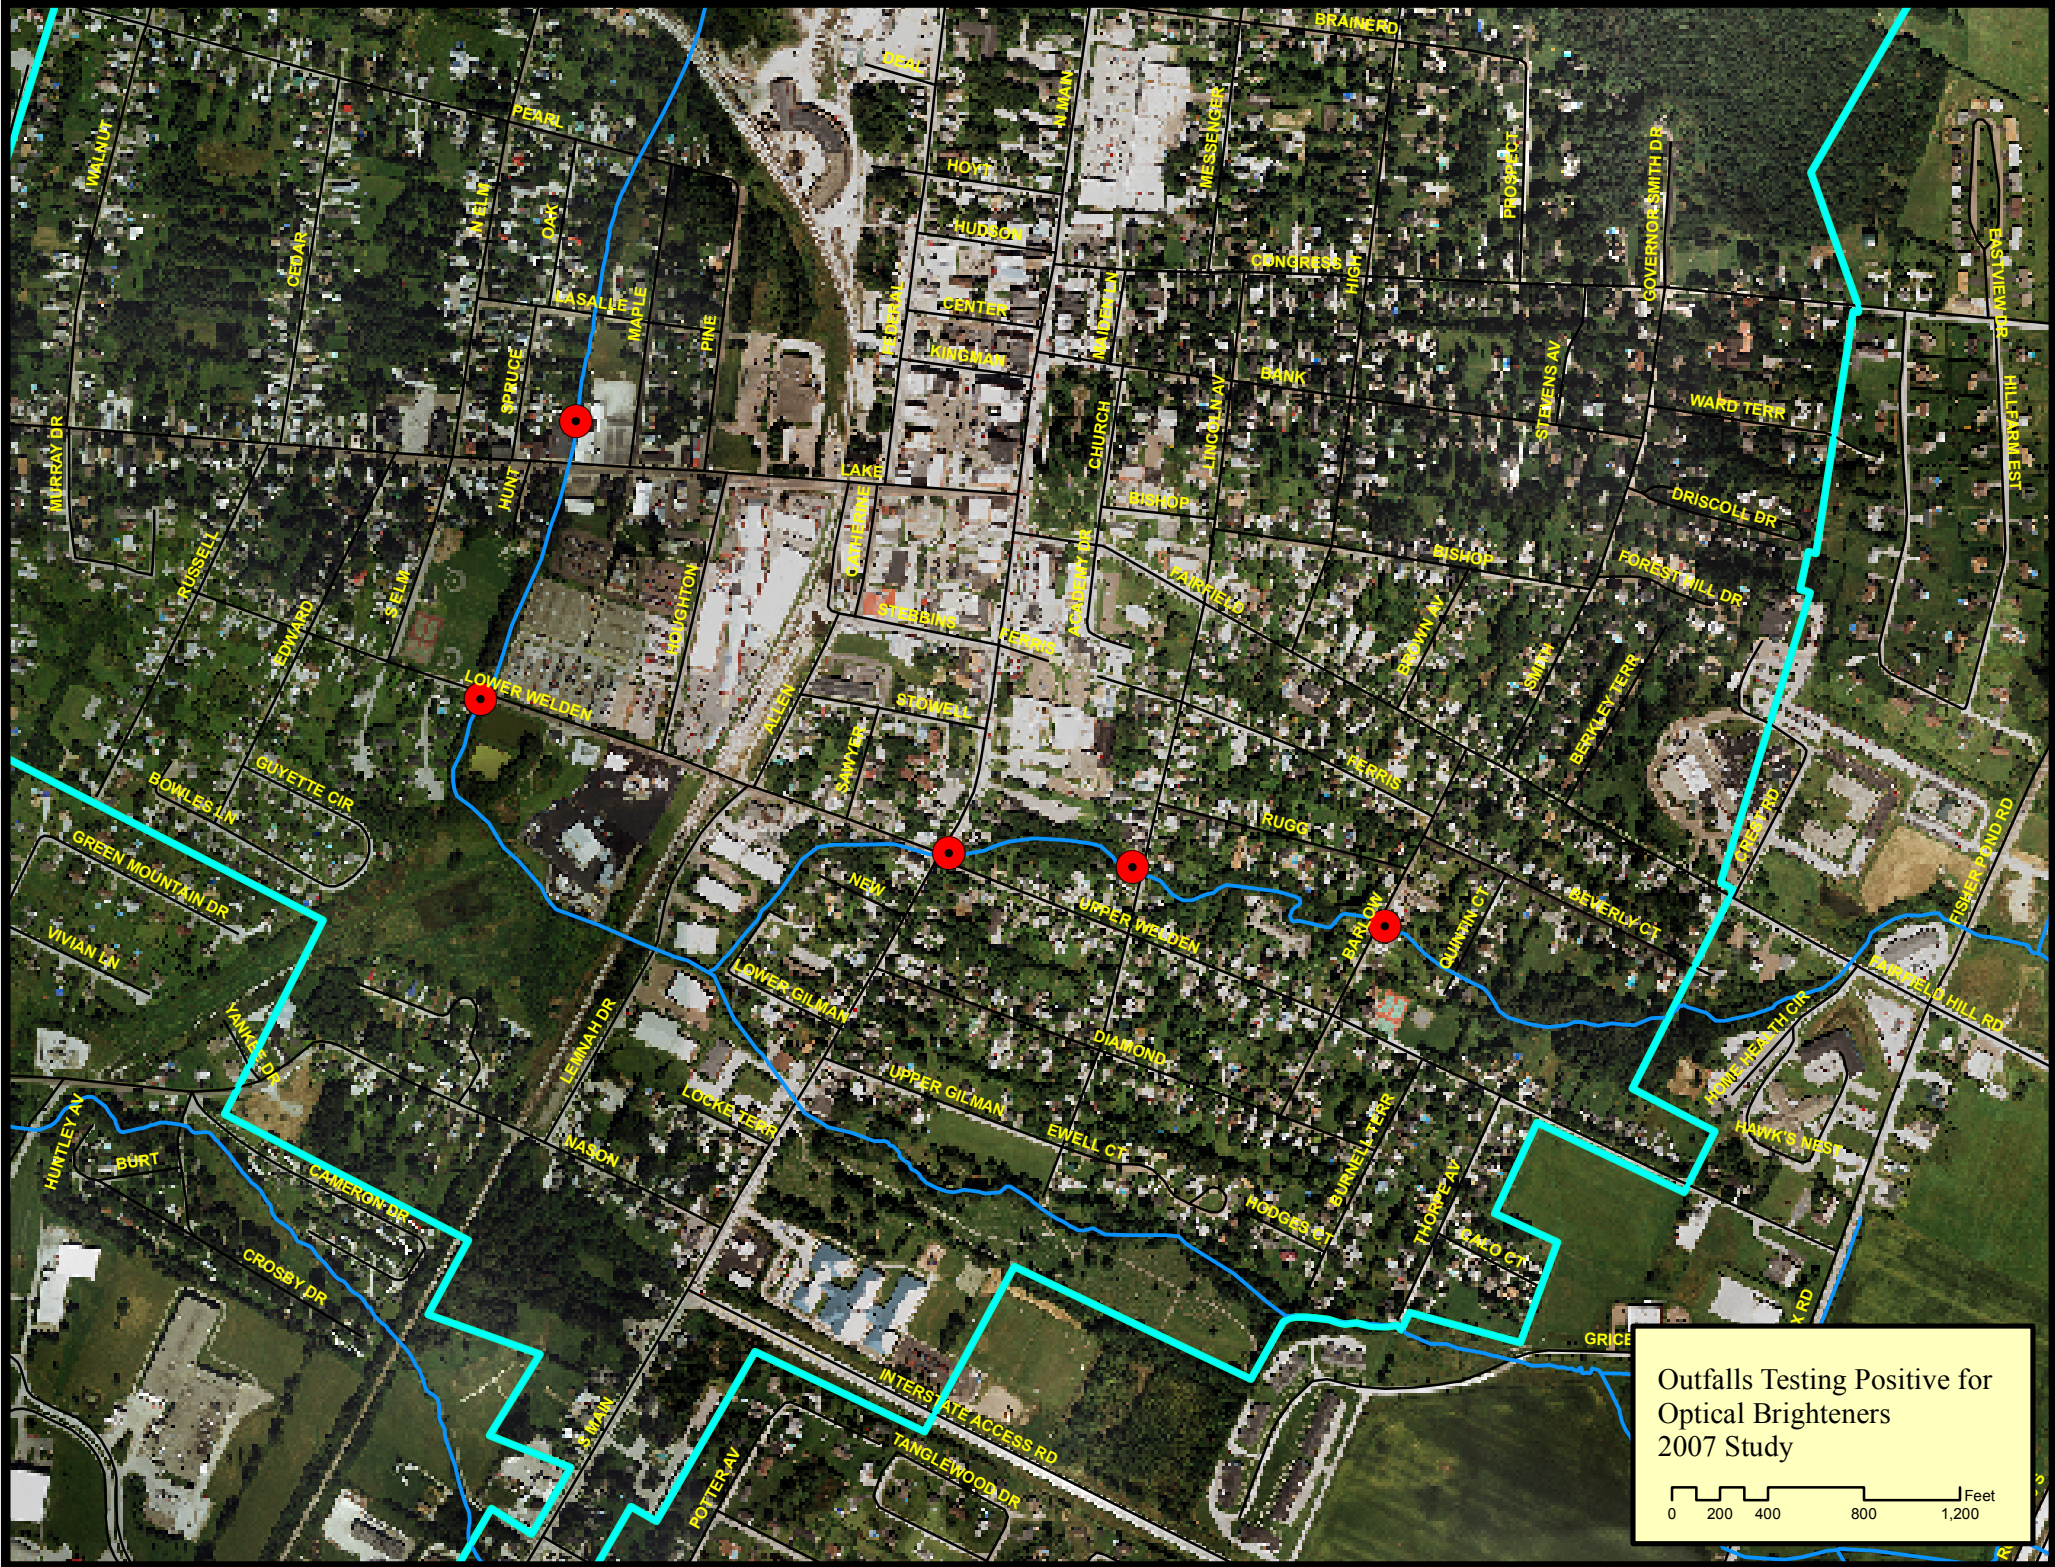
Outfalls Testing Positive for
Optical Brighteners
2007 Study

A small-scale IDDE study was completed within the City in 2007 by Jeff Rouleau, Bellows Free Academy science teacher, and Karen Bates, DEC watershed coordinator. Unbleached cotton pads were deployed to 30 outfalls for a period of several days. The pads were collected and tested for optical brighteners (OB), a fluorescent white dye used in laundry detergents. The study found 5 outfalls tested positive for OB during either minimal rain or no rain periods of time, suggesting that an illicit discharge may have occurred (or is occurring) at these outfalls. A sixth outfall testing was inconclusive and the study investigators suggested further investigation to determine if an illicit discharge may also be present at this location. Overall there was good correlation between the 2007 study and the current study. Three of the outfalls that were identified as potentially illicit in the 2007 study were reconfirmed as potentially illicit in this study (Table 6). A map showing the outfalls that tested positive during this study is included in Appendix 1.
