Detecting and Eliminating Illicit Discharges to Improve Water Quality in the Lake Memphremagog Basin

Final Report

August 14, 2015

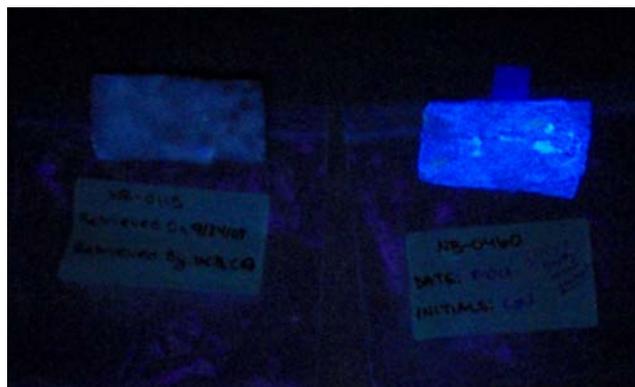
Figure 1. Optical brightener monitoring pads under UV light

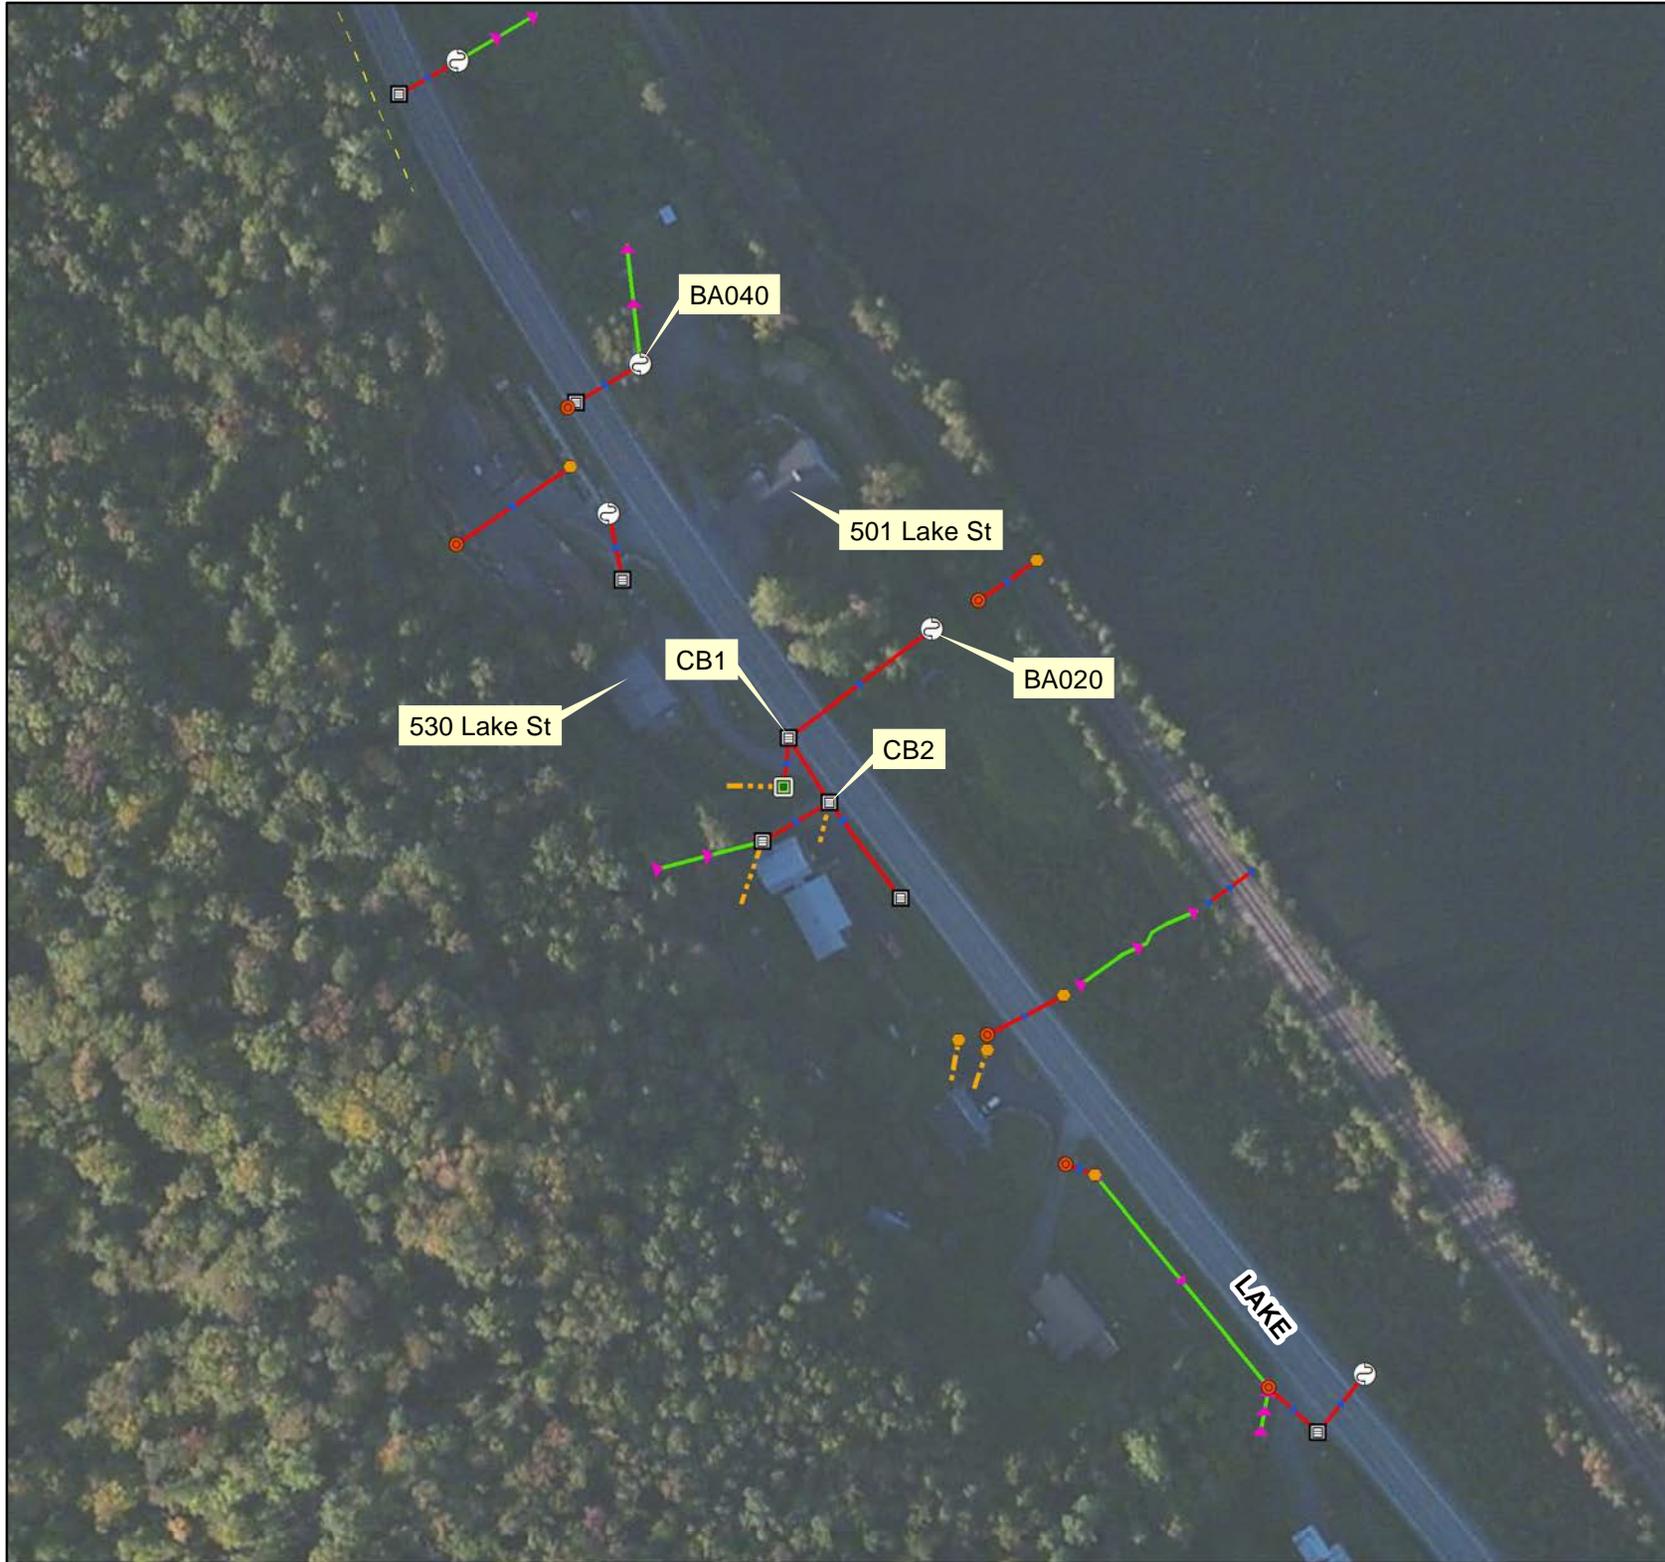
Map BA-1
Systems BA020 and BA040
Barton, VT

Structure ID	Simple AI	Complex AI	Status
BA020	X		Identified a malfunctioning septic system with surfacing effluent flowing to the stormdrain. Problem referred in writing to the Barton Town Health Officer. On July 15, 2015, the problem was referred to enforcement by the DEC project manager.
BA040	X		No chronic illicit discharge.
BA060	X		No chronic illicit discharge.
BA080	X		A small flow of municipal water appears to enter this system from a leak in the distribution system. The Town (Nathan Sicard) was apprised of this finding. Unrelated fuel oil contamination in an adjacent structure was referred to DEC Hazardous Waste Management Program (John Schmeltzer).
BA140		X	No illicit wastewater discharge confirmed. Chlorine detection likely related to transient swimming pool discharge.
BA270-- Pipe A branch		X	Identified a direct sanitary connection from 112 High Street to the stormdrain. Written notice was sent to the Village of Barton on November 13, 2014. The sanitary connection was eliminated in June 2015 and the house was connected to the sewer main.

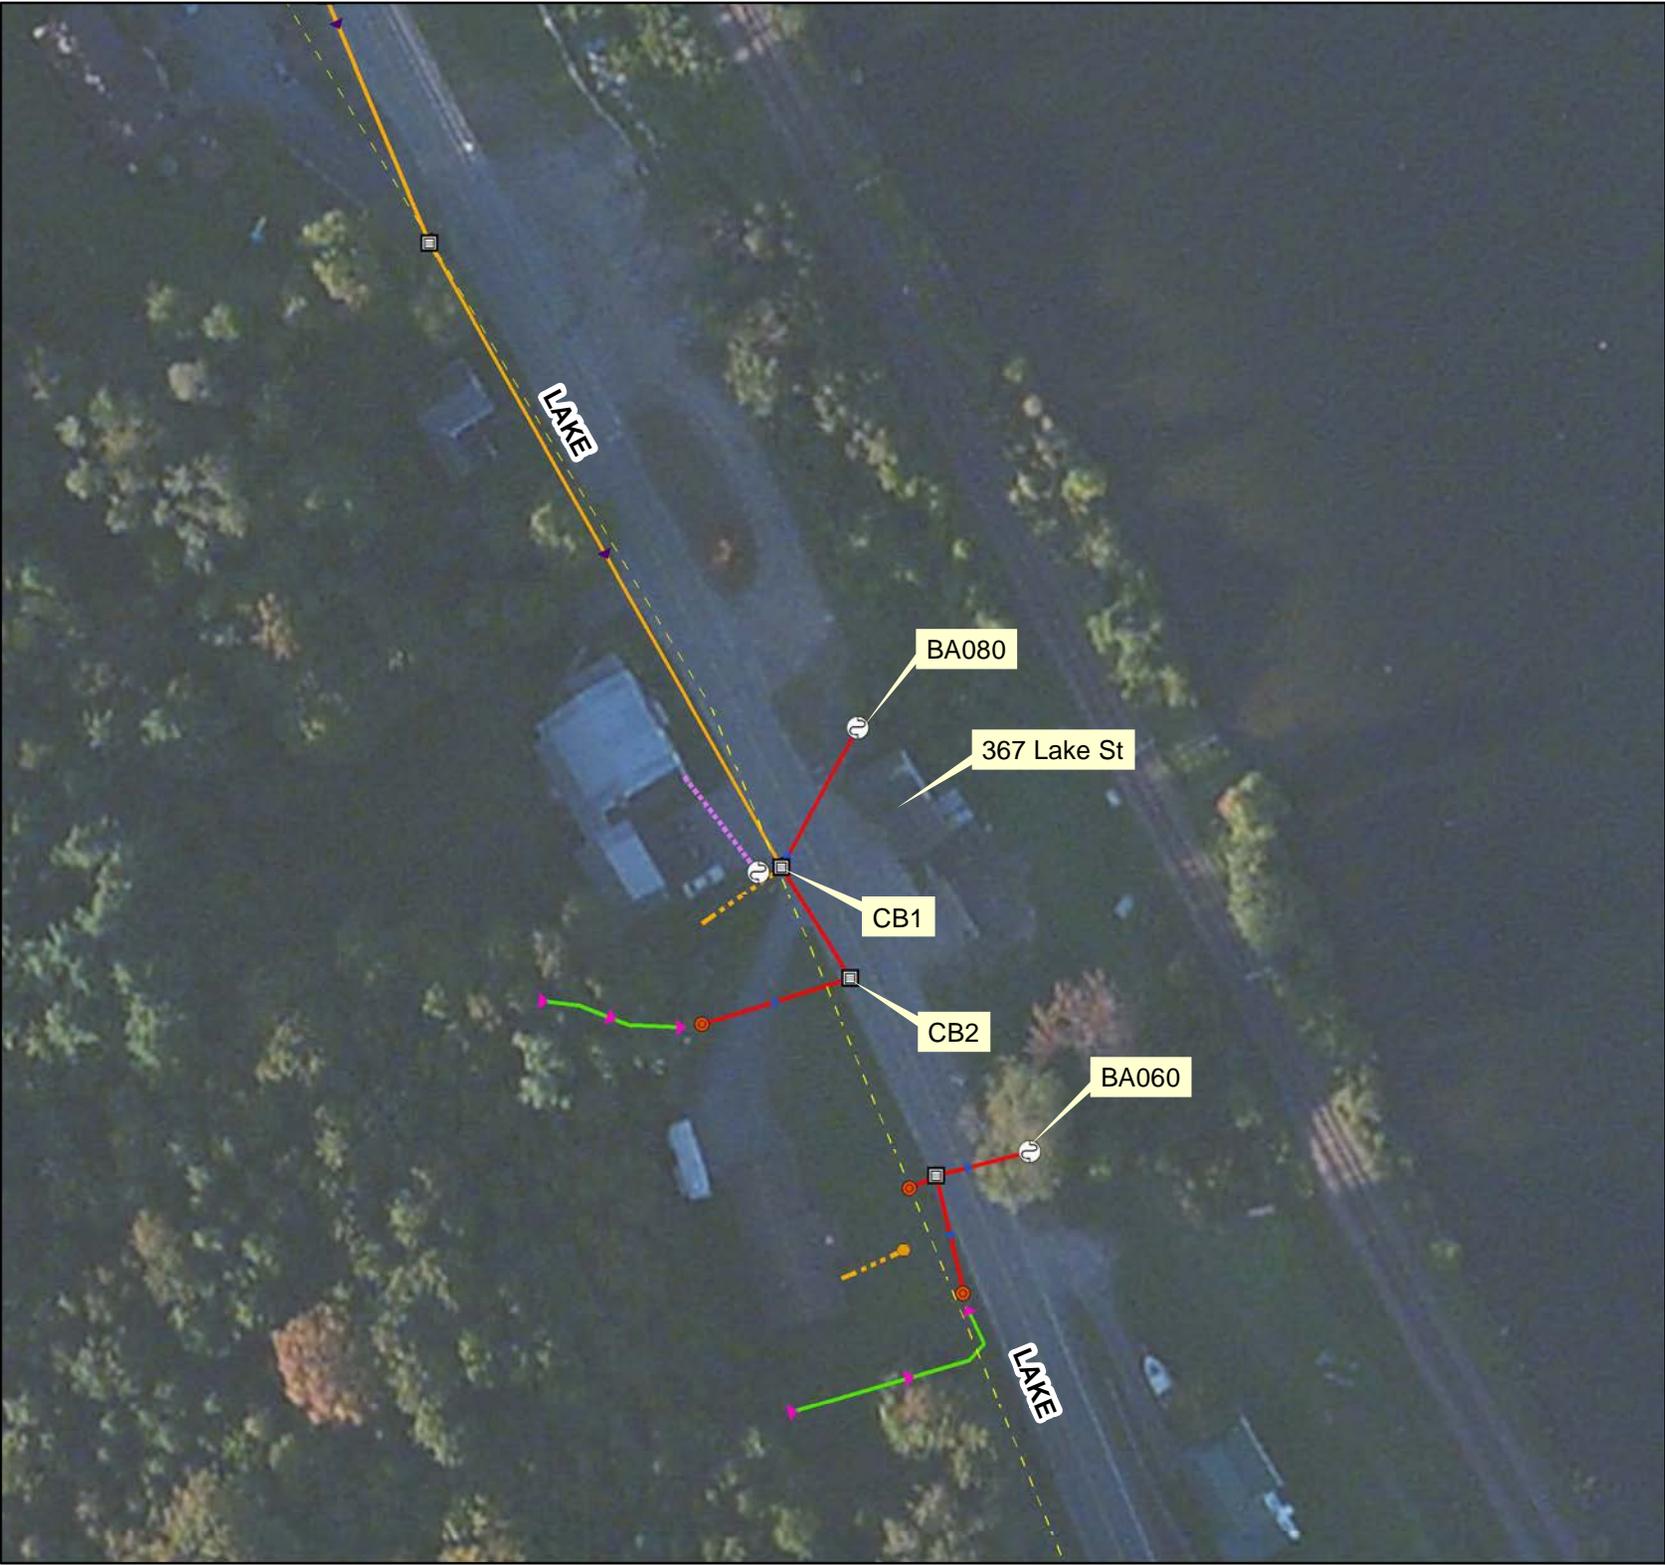
Map BA-2
Systems BA060 and BA080
Barton, VT

- On October 9, 2014, a low concentration (0.06 mg/L) of chlorine was measured in a leak in the wall of catchbasin CB1.
- While investigating system BA080 on October 9, 2014, we opened a manhole at the end of the driveway at #358 Lake Street and observed a strong petroleum odor. This manhole is adjacent to catchbasin CB1 but is not connected with it. The manhole cover is incorrectly marked “water”. Nathan Sicard, a member of the Barton Village Board of Trustees, was notified about the petroleum odor. Mr. Sicard began looking into the problem immediately and learned that there had been a spill or release of fuel oil at the property in 2013 and an effort had been made to clean up the fuel. Mr. Sicard indicated that the manhole is actually connected to an abandoned sanitary sewer line.

Conclusion: Based on the clearly elevated chlorine concentration measured at the outfall on July 22, 2014, we suspect there is a municipal water leak entering catchbasin CB1. The strong petroleum odor observed in the adjacent manhole on October 9, 2014 must indicate that the fuel oil release was not entirely cleaned up.

Resolution: The Town of Barton was notified of the suspected water leak in this location on October 9, 2014. The Department of Environmental Conservation Hazardous Waste Management Program (John Schmeltzer) was notified of the petroleum problem on October 11, 2014. We understand that DEC took action to inspect the manhole in question.

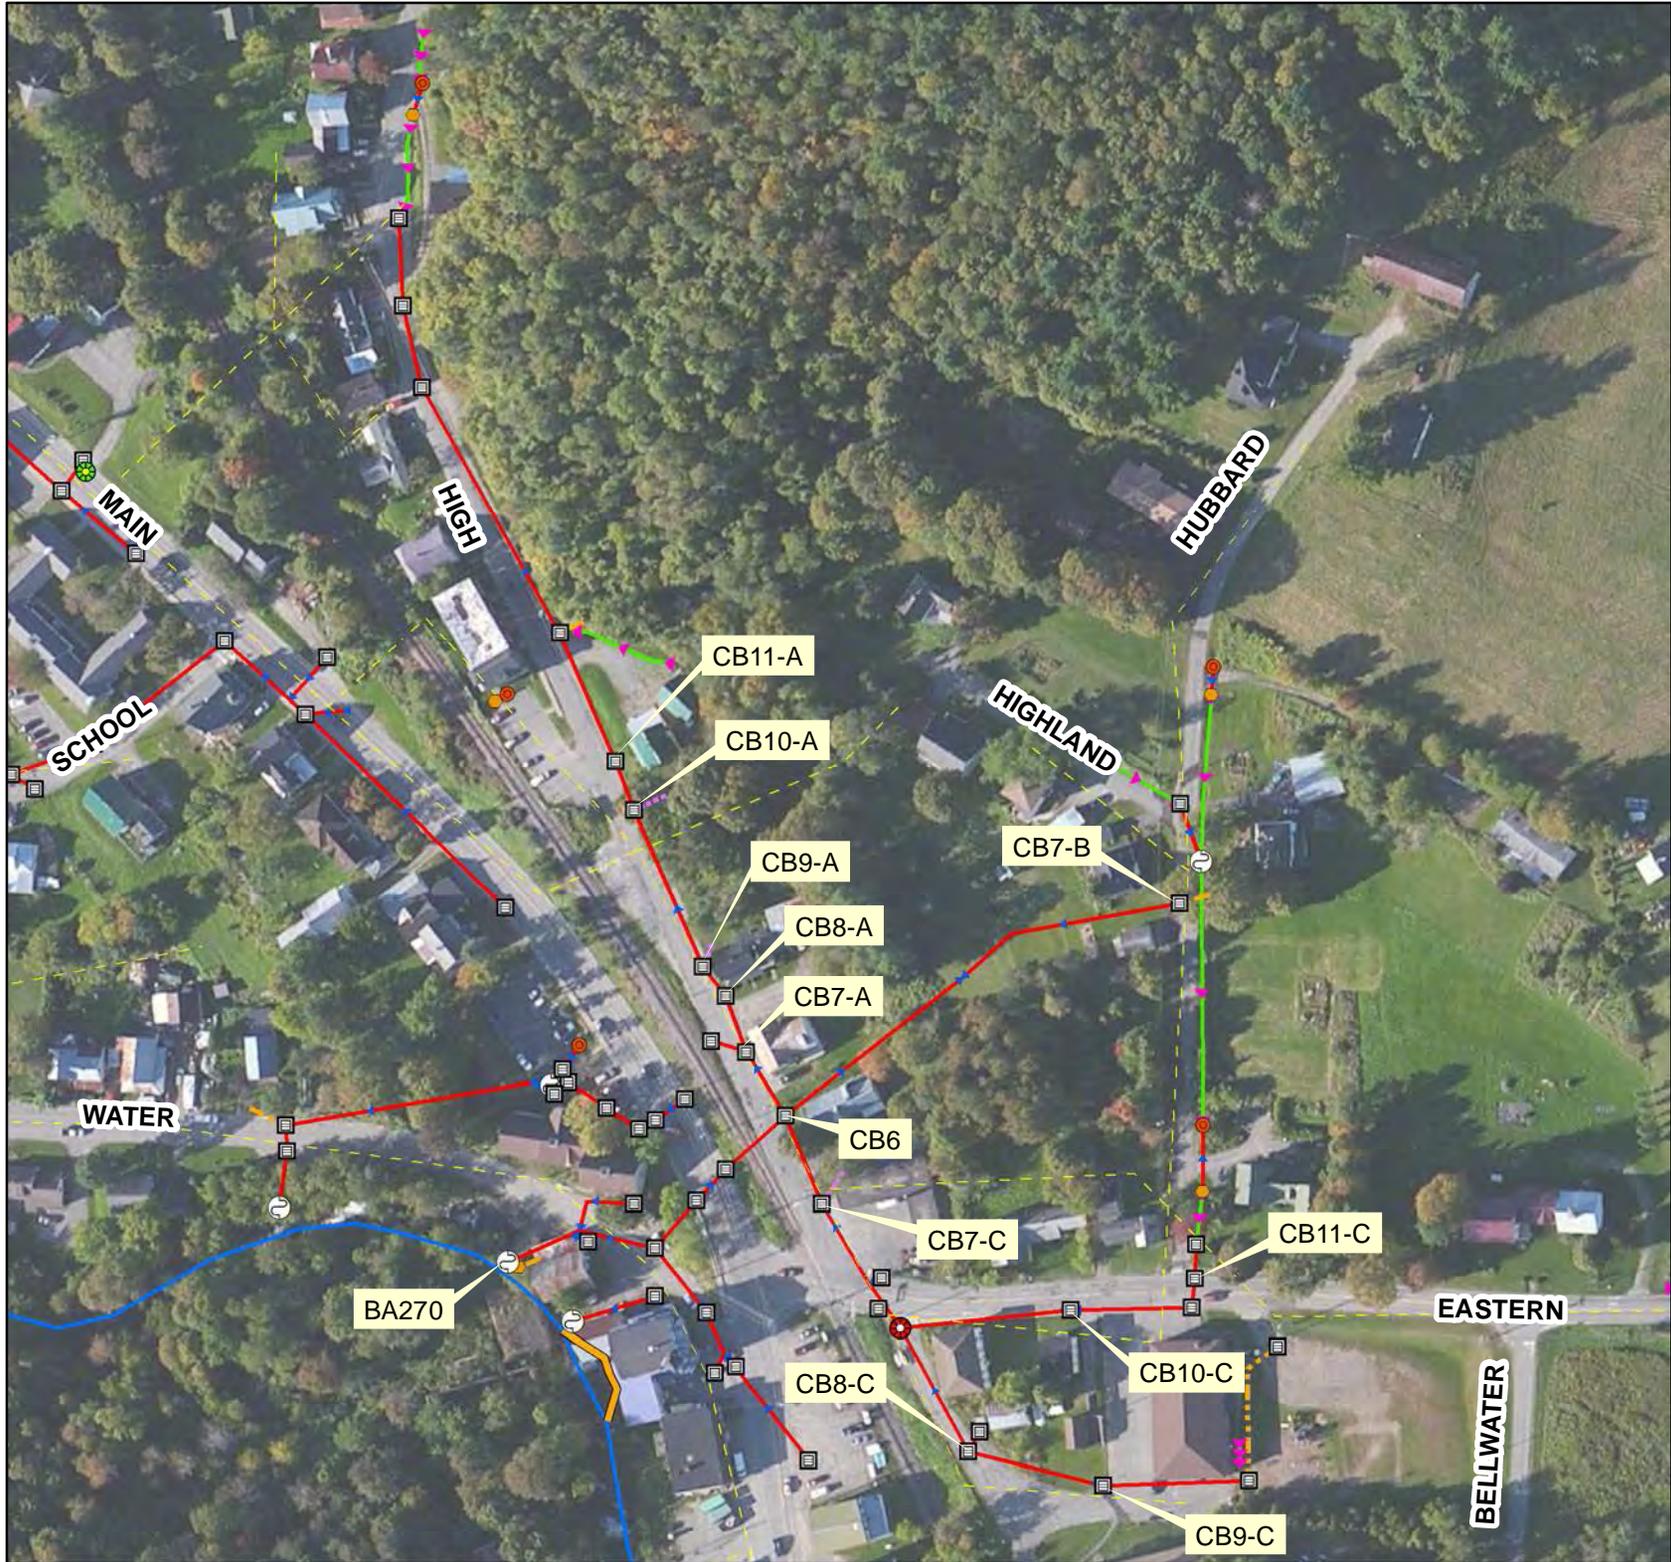
Map BA-4
System BA270
Barton, VT

BA270-- Pipe B branch		X	Identified a corroded sewer pipe elbow at 72 Hubbard Avenue. This elbow appeared to be slowly leaking into a perimeter drain beneath it, which we believe is connected to the municipal stormdrain. Written notice was sent to the Village of Barton on November 13, 2014. In June 2015, the Village of Barton sent the homeowner a letter describing Stone's findings. The homeowner reportedly retained a plumber who did not see a problem. On July 18, 2015 a member of the Barton public works staff inspected the sanitary connection and found it deteriorated but not leaking.
BA270-- Pipe C branch		X	Contamination traced to a catchbasin on the Barton Christian School property. A maintenance person at the school was reportedly dumping mop water into the catchbasin at the corner of the building every evening. The school director stated she would require him to use a sink instead.
BA280	X		Contaminated groundwater entering system from municipal salt storage facility. Not considered an illicit discharge.

- Optical brightener results suggested that sanitary wastewater or washwater is entering Branch B of the BA270 system above CB7-B.
- Dye testing revealed that the sewer main on Hubbard Avenue is not a source of contamination.
- On November 12, 2014, inspection of the plumbing facilities in the house at 72 Hubbard Avenue revealed a corroded sanitary elbow that appears to be slowly leaking into an opening in the perimeter drain beneath it (Figure 3). We expect that the perimeter drain is connected to catchbasin CB7-B.

Conclusion: We believe the source of the optical brightener detected at catchbasin CB7-B is a leaking sewer pipe fitting in the basement of 72 Hubbard Avenue. This fitting is above a perimeter drain.

Resolution: Written notice was sent to the Village of Barton on November 13, 2014. In June 2015, the Village of Barton sent the homeowner a letter describing Stone's findings. The homeowner reportedly retained a plumber who did not see a problem. On July 18, 2015 a member of the Barton public works staff inspected the sanitary connection and found it deteriorated but not leaking. Apparently the Village

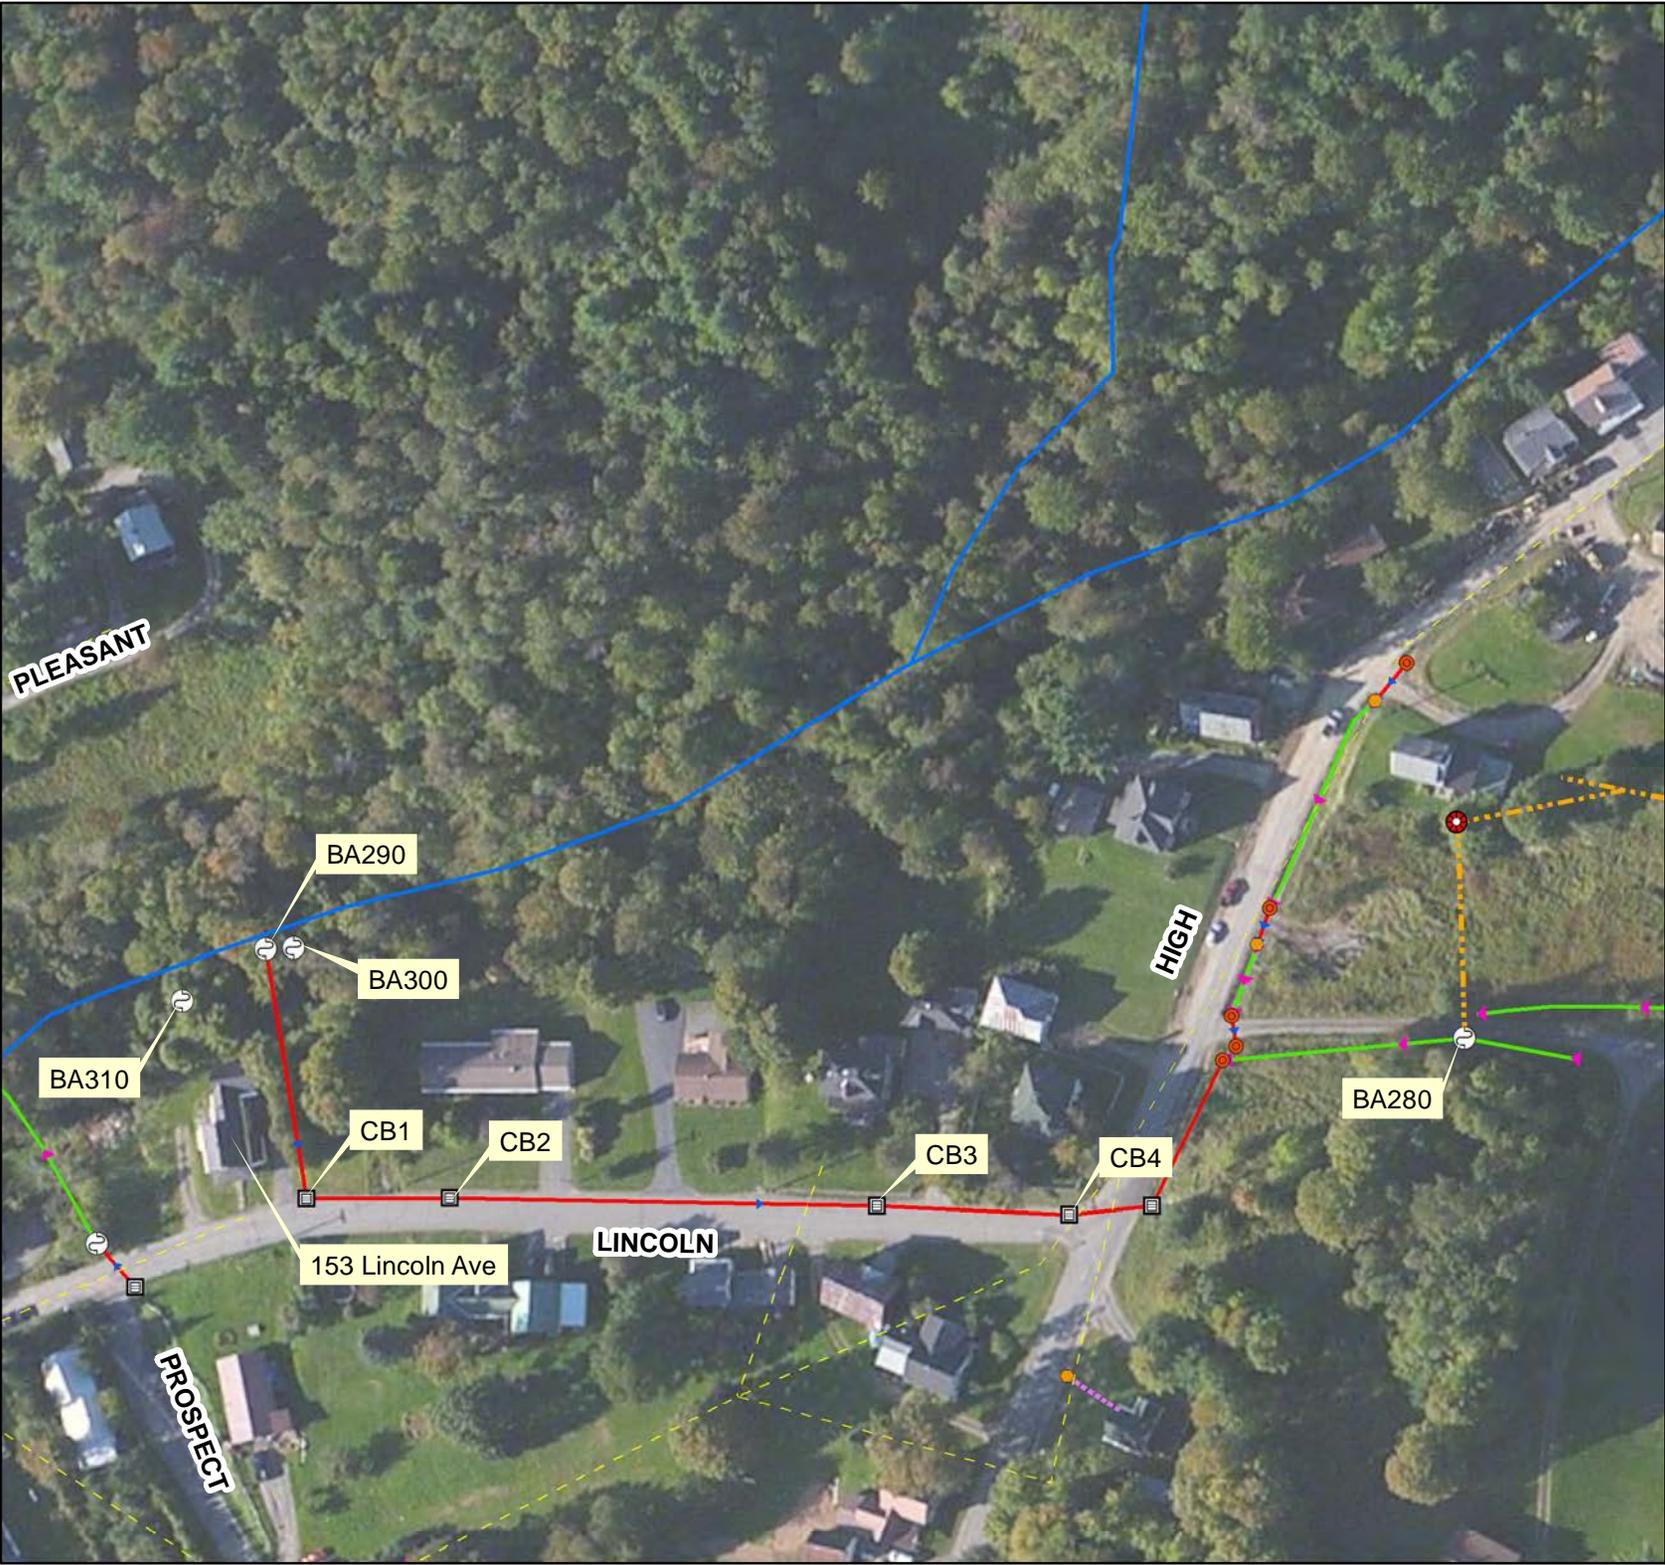
Map BA-6: Systems
BA290, BA300 and BA310
Barton, VT

BA290	X		No chronic illicit discharge.
BA300		X	Our current explanation for presence of optical brightener is infiltration of groundwater contaminated by a leaking sanitary sewer line. Further investigation is being performed under DEC contract 28937.

Structure ID	Simple AI	Complex AI	Status
BA310		X	Our current explanation for presence of optical brightener is infiltration of groundwater contaminated by a leaking sanitary sewer line. Further investigation is being performed under DEC contract 28937.
BA360		X	Written notice was sent to the Village of Barton on November 13, 2014. Direct sanitary connections were identified from 79 Porter Lane and 82 Lincoln Avenue to the stormdrain. Both sanitary connections were eliminated in July 2015.
BA380	X		No chronic discharge.
BA400	X		No chronic discharge.
BA470	X		No chronic discharge.
BA540	X		No chronic discharge.
