# Stormwater Master Plan Town of Rupert, Vermont

December 4, 2015

**Fitzgerald Environmental Associates, LLC.**  
18 Severance Green, Suite 203  
Colchester, VT 05446

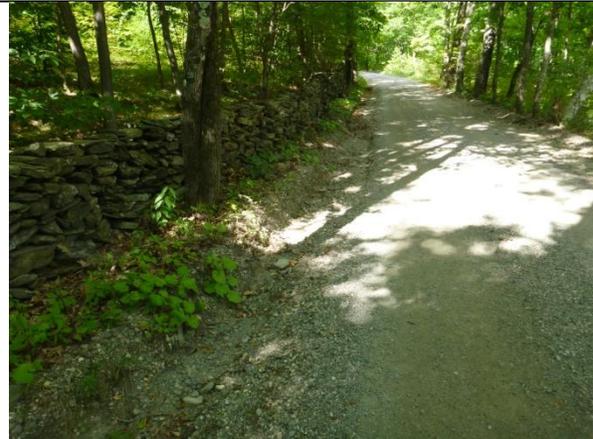
**Photo 2:** Shallow ditch is eroding and generating large volumes of sediment

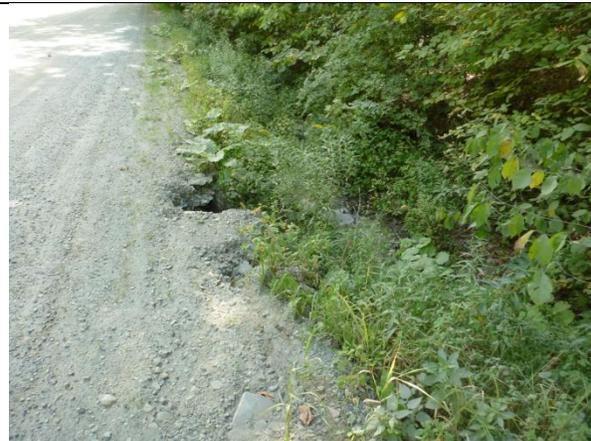
**Photo 2:** Erosion along the road edge delivering sediment to ditch

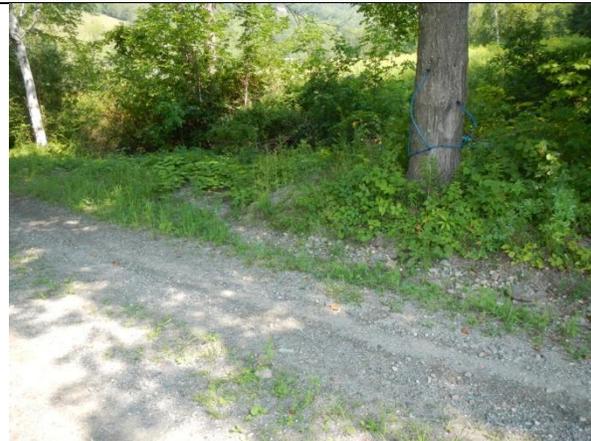
**Photo 2:** Stormwater flowing across Clark Road is causing erosion and rilling of the road surface

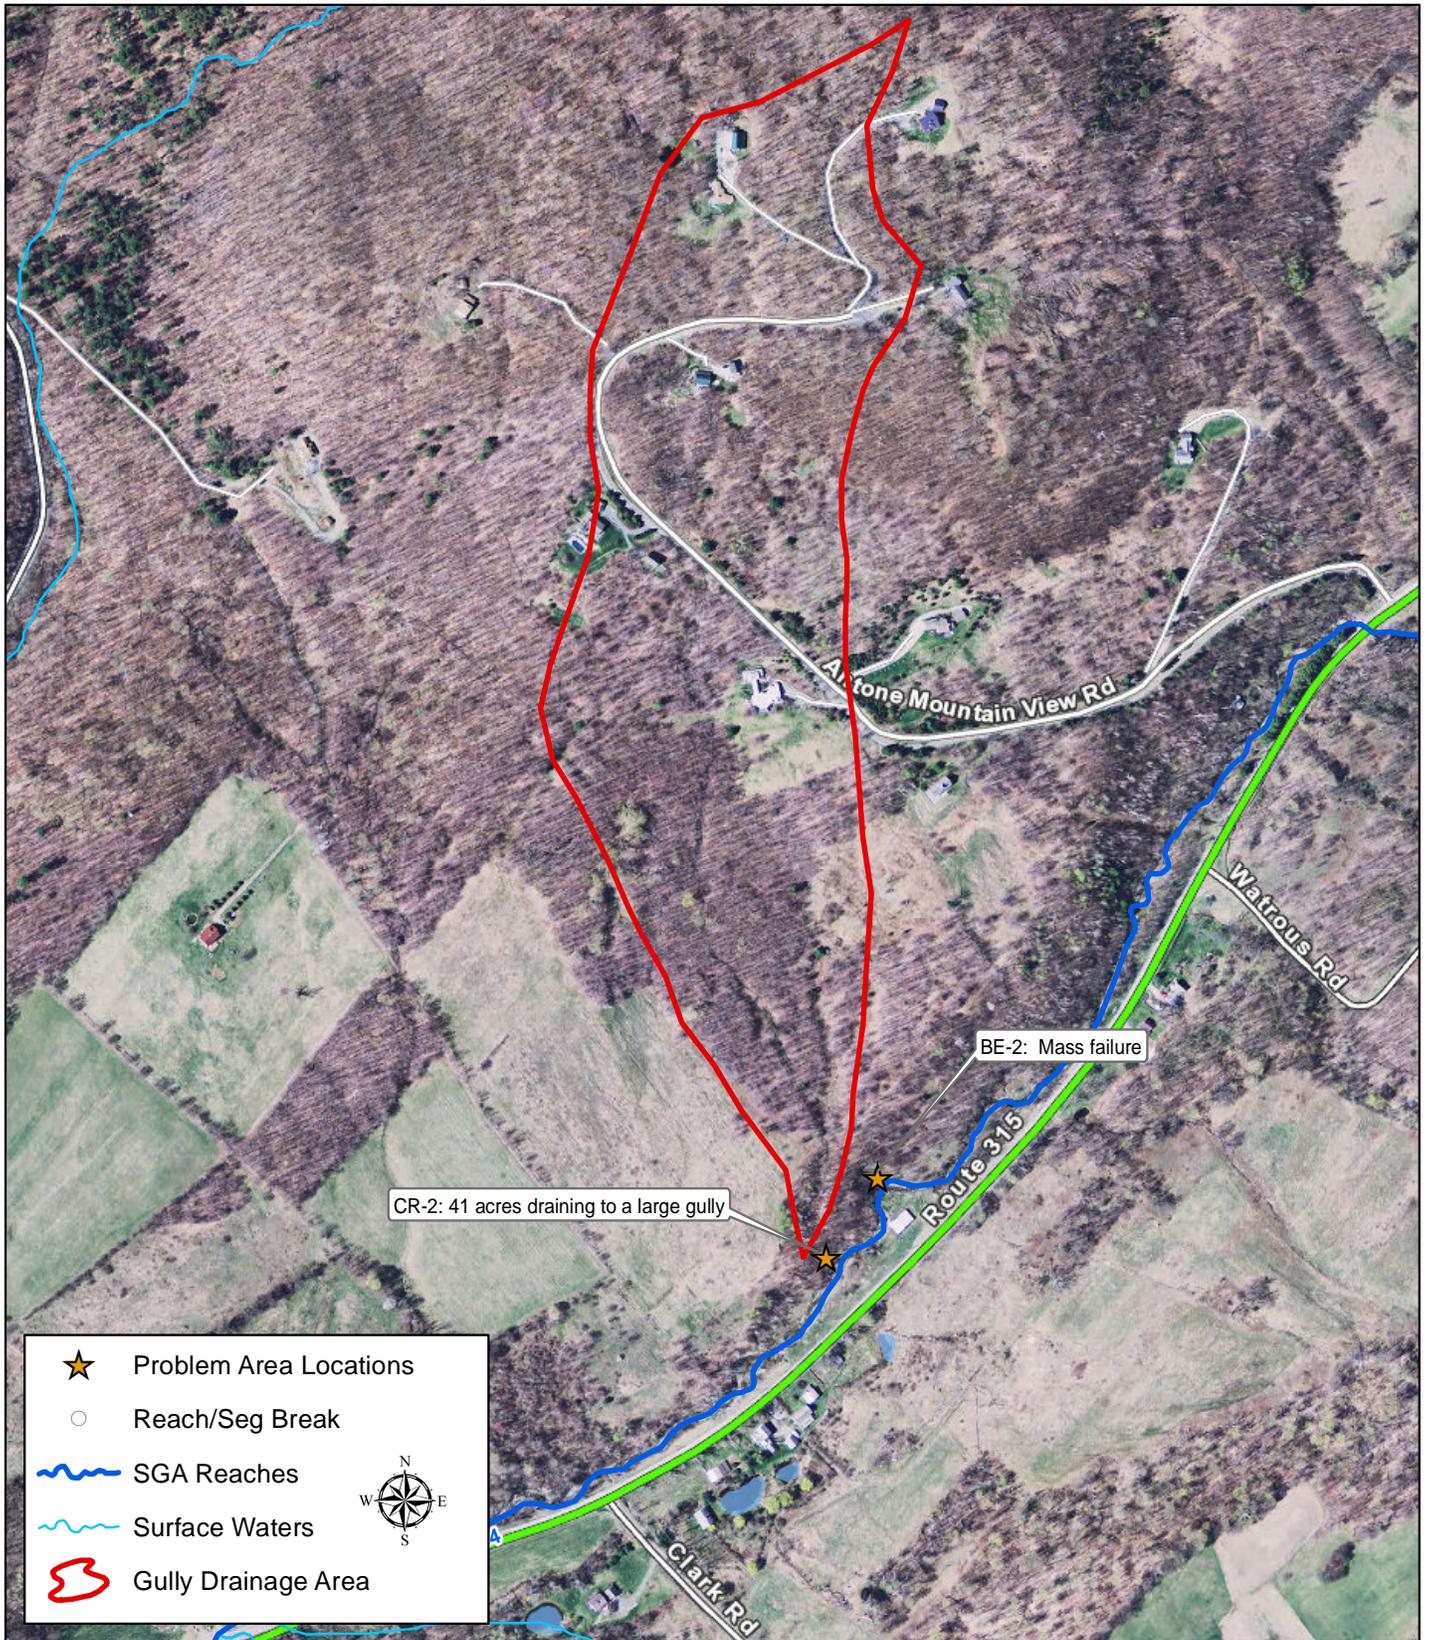
| Project ID | Location | Description | Water Quality Risk | Flood and Erosion Risk to Infrastructure | Site Ranking | Recommendations | Ballpark Cost |
|---|---|---|---|---|---|---|---|
| BE-2 | Route 315 between Watrous and Clark Road | Two areas of bank erosion/mass failure along the north bank where the stream channel is pushing into the steep valley wall. | Moderate to High | Low | 2 | Protect mature forest vegetation along the top of each bank. Consider mass failure stabilization with bioengineering approach with plantings. | 5-10K |

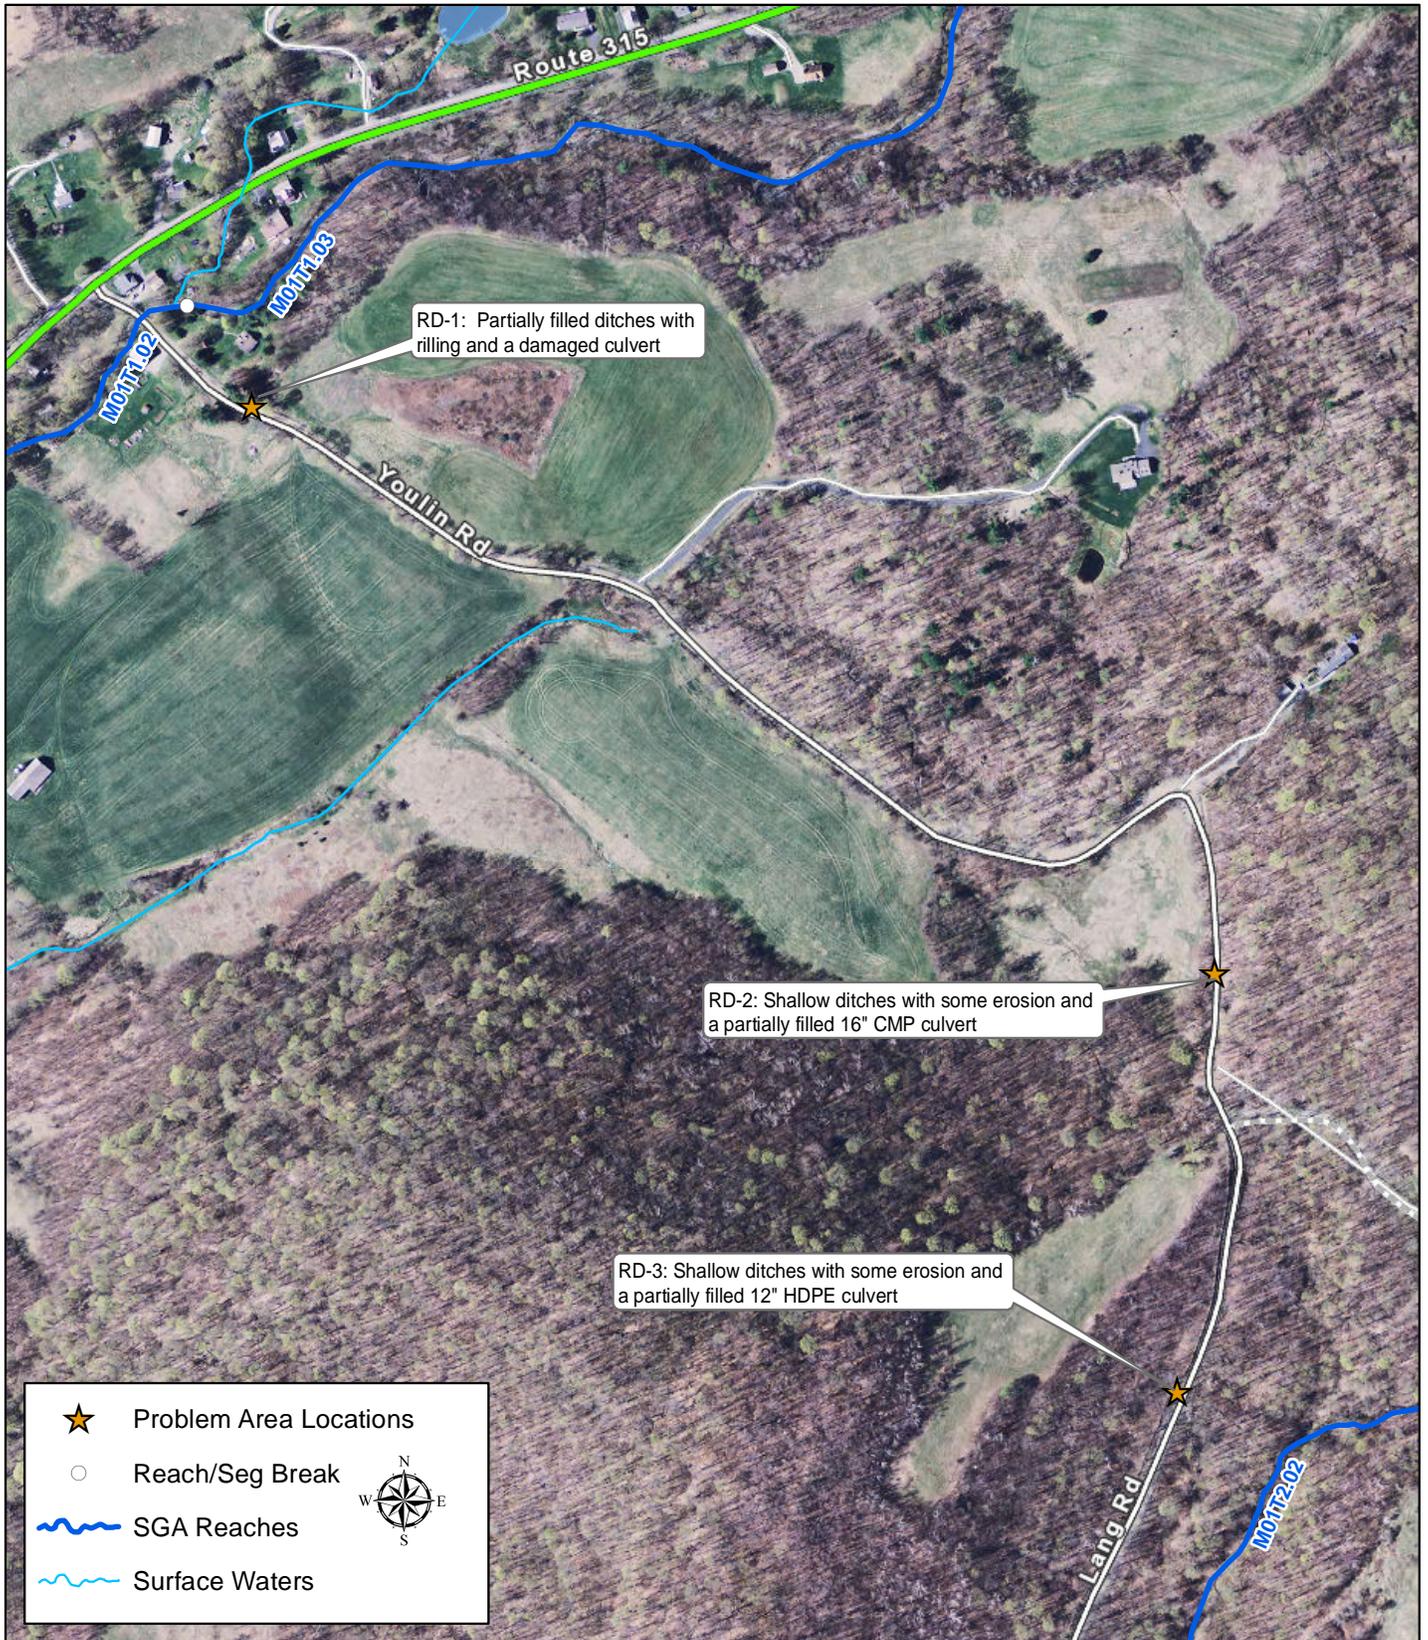
| Project ID | Location | Description | Water Quality Risk | Flood and Erosion Risk to Infrastructure | Site Ranking | Recommendations | Ballpark Cost |
|---|---|---|---|---|---|---|---|
| RD-1 | Youlin Road | Ditches on both sides of Youlin Road are filled in and have reduced capacity. The east edge of the road does not fully drain to the ditch causing erosion and sediment deposition on the road. A cross culvert is set near the road surface and is damaged. | Moderate | Moderate | 3 | Recommend raising the road bed to shed runoff to the north and cleaning out ditches to better direct runoff and reduce erosion. Replace damaged culvert as necessary. | 5-10K |
| RD-2 | Youlin Road | Ditch along steep section of Youlin Road is eroding and generating large volumes of sand/gravel, clogging a drainage culvert. | Low to Moderate | Moderate | 2 | Recommend stabilizing ditch using stone check dams. | <2K |
| RD-3 | Youlin Road | Ditch along moderately steep section of Lang Road is eroding and generating large volumes of sand/gravel, clogging a drainage culvert. | Low to Moderate | Moderate | 2 | Recommend stabilizing ditch using stone check dams. | <2K |
