# STORMWATER MANAGEMENT PLAN FOR FRANKLIN

FINAL REPORT

Stone Project ID 14-053

March 11, 2015

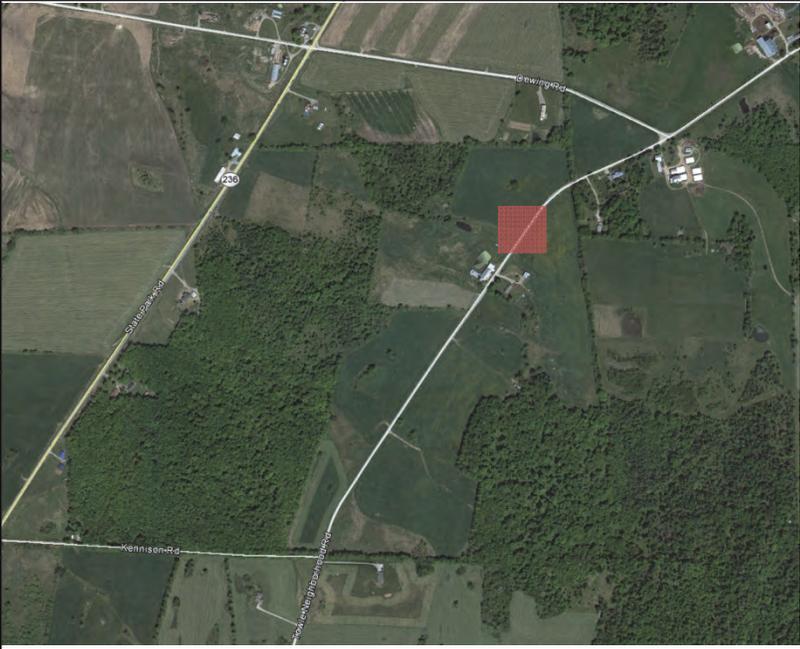
<b>Problem Area ID:</b> LC-02	<b>Latitude:</b> 44.976930°	<b>Longitude:</b> -72.836989°
<b>Watershed:</b> Lake Carmi

**Description of Observed Conditions:**  
 Culvert is too short for current road width. Banks above the culvert inlet and outlet are over-steepened and actively eroding.

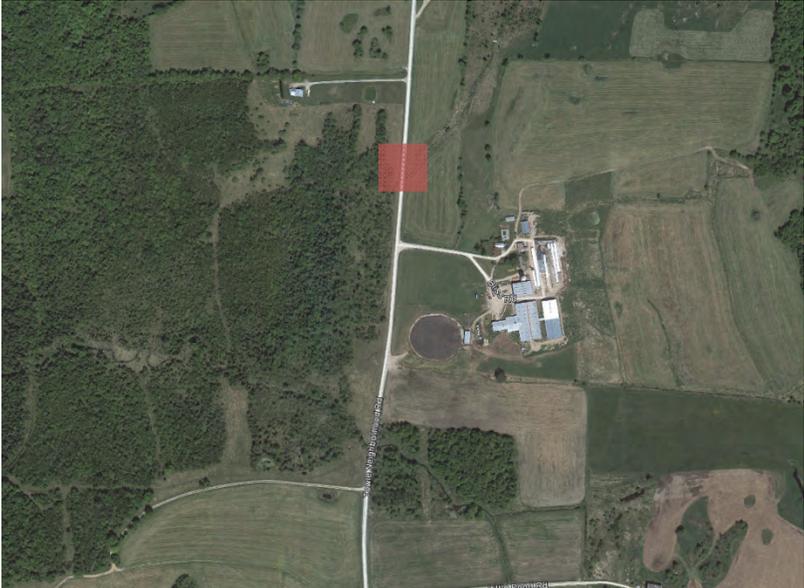
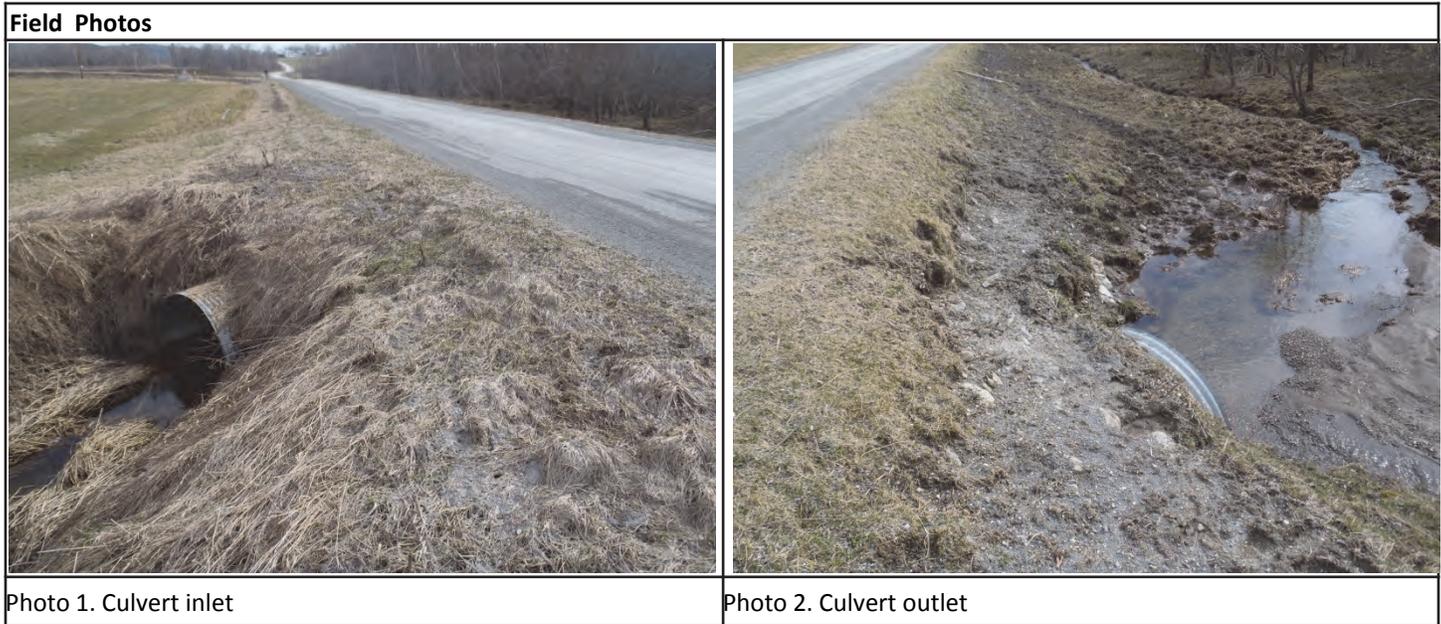
<b>Problem Area ID:</b> LC-03	<b>Latitude:</b> 44.957182°	<b>Longitude:</b> -72.844940°
<b>Watershed:</b> Lake Carmi

**Description of Observed Conditions:**  
 Banks above the culvert inlet and outlet are over-steepened. Ditch banks immediately downstream of the culvert are actively eroding. Adjoining agricultural field above the culvert outlet (west side of Towle Neighborhood Road) was recently ditched and is actively eroding; evidence of recent animal access downstream of the culvert outlet.

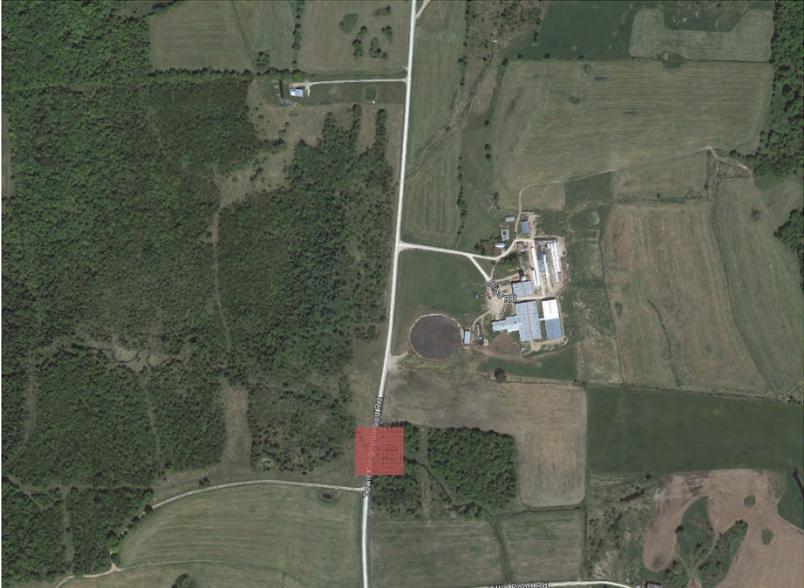
<b>Problem Area ID:</b> LC-04	<b>Latitude:</b> 44.953297°	<b>Longitude:</b> -72.845571°
<b>Watershed:</b> Lake Carmi

**Description of Observed Conditions:**  
 Marsh Brook crossing. Banks above the culvert inlet and outlet are too steep. Banks are actively collapsing and have covered both the inlet and outlet. Some evidence of direct animal access to area around culvert outlet.

Treatment Opportunity:  
 LC-03/LC-04: Culvert headwalls at the inlets of both culverts and the outlet of LC-04 are needed. Approximately 300 feet of road shoulder south of LC-03 on the west-side of Towle Neighborhood Rd needs stabilization. Animal exclusion fencing at both culvert inlets is critical to long-term project viability.

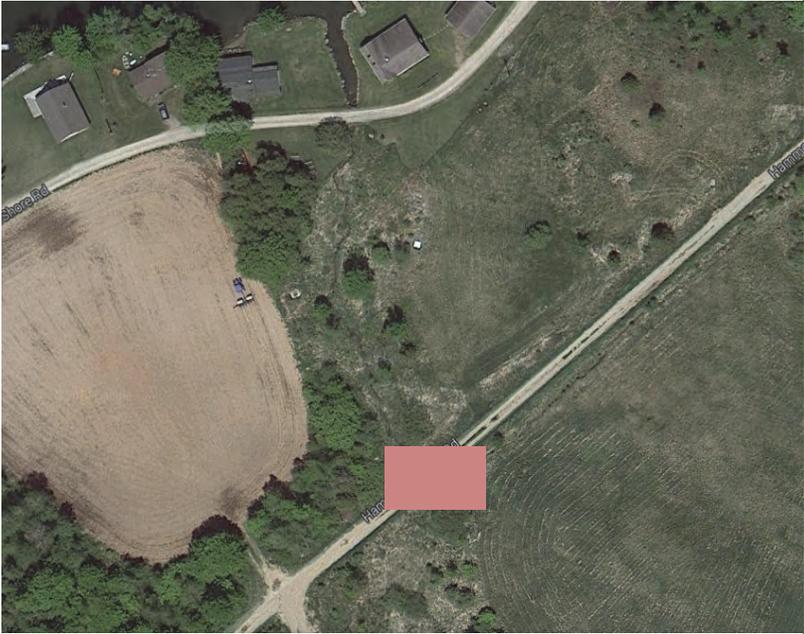
**Description of Observed Conditions:**  
 Culvert under Hammond Shore Rd is too short; shoulders on both side of road are actively collapsing into the channel. The culvert receives significant road runoff and agricultural drainage.

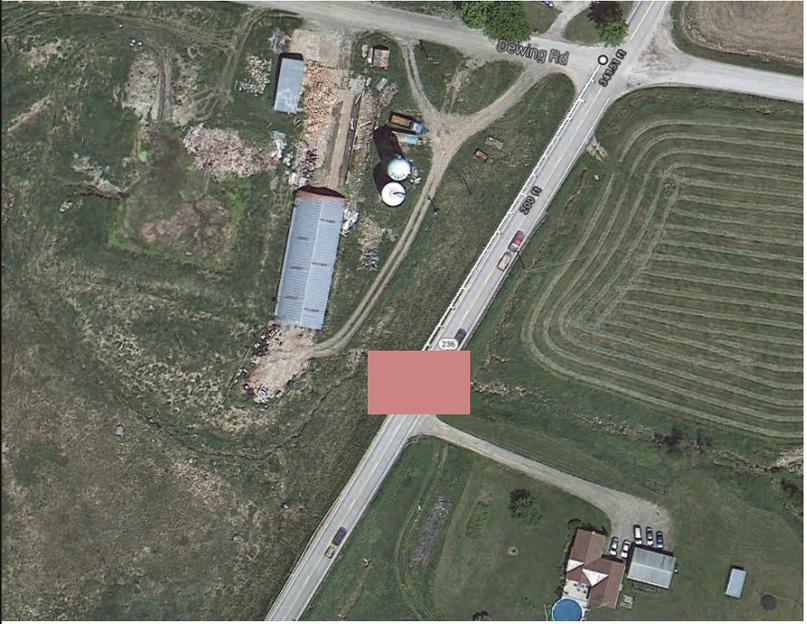
**Description of Observed Conditions:**  
 Sinkhole in the road shoulder has formed above the upstream end of the culvert; rocks have been installed in an effort to stabilize the scour pool at the downstream end of the culvert.

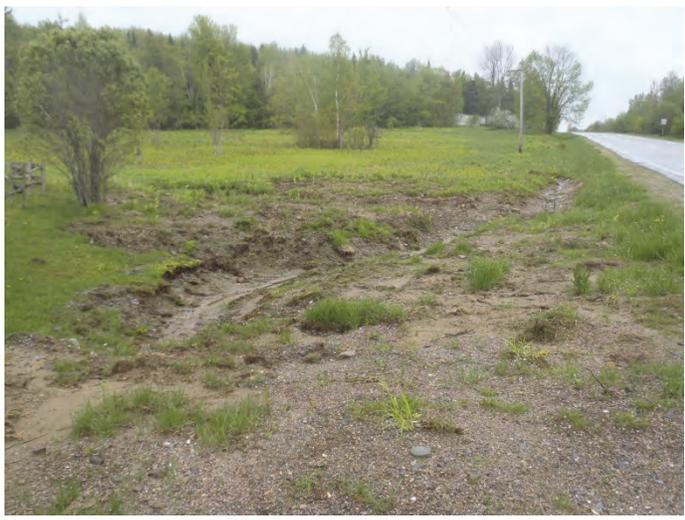
Photo 1. Looking south along State Park Rd across from park entrance

**Description of Observed Conditions:**  
 Recent ditching along State park Rd. in front of #3006 and across from the entrance to the park is actively failing.

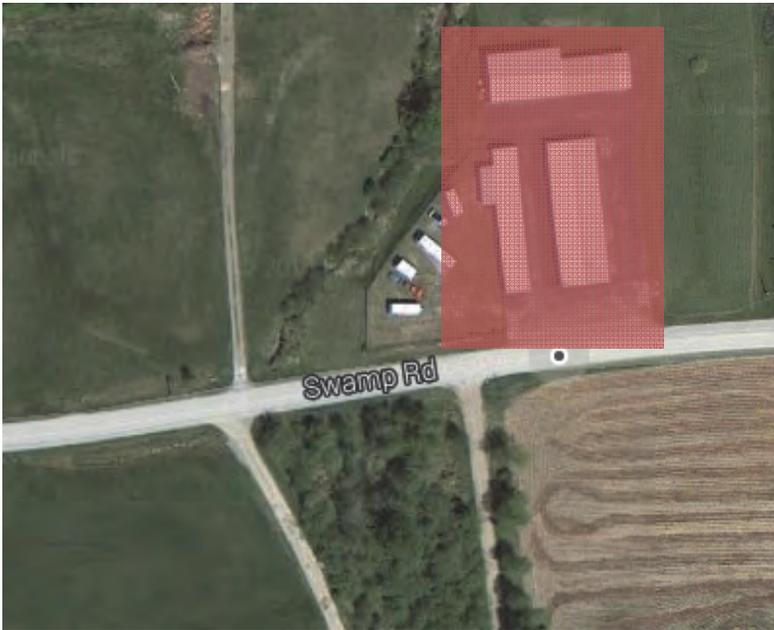
**Description of Observed Conditions:**  
 Uncontrolled stormwater runoff from Favereau's Storage runs along road shoulder and discharges to unnamed tributary to Lake Carmi. Runoff flows along fence-line; some signs of localized erosion including where reaches tributary (see MQ-03). Town reports that right-of-way in this area is 25' from road centerline.

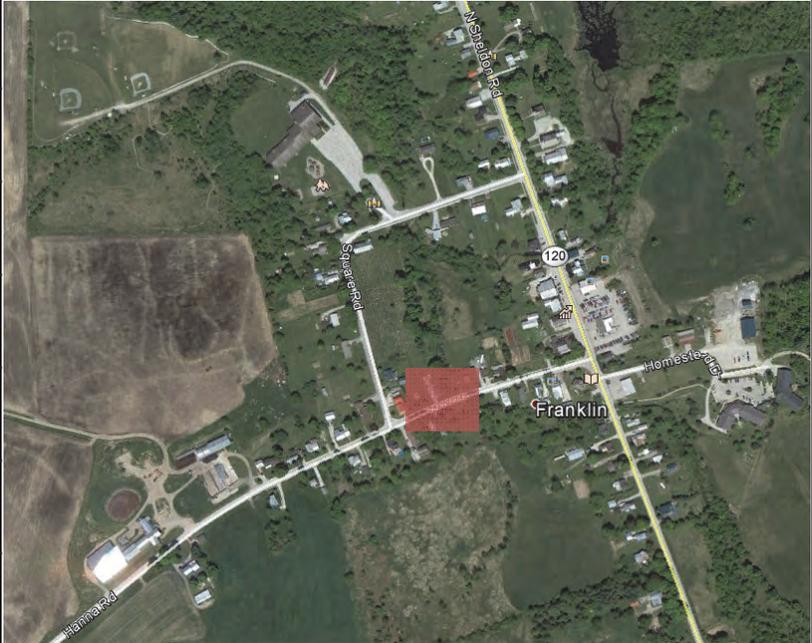
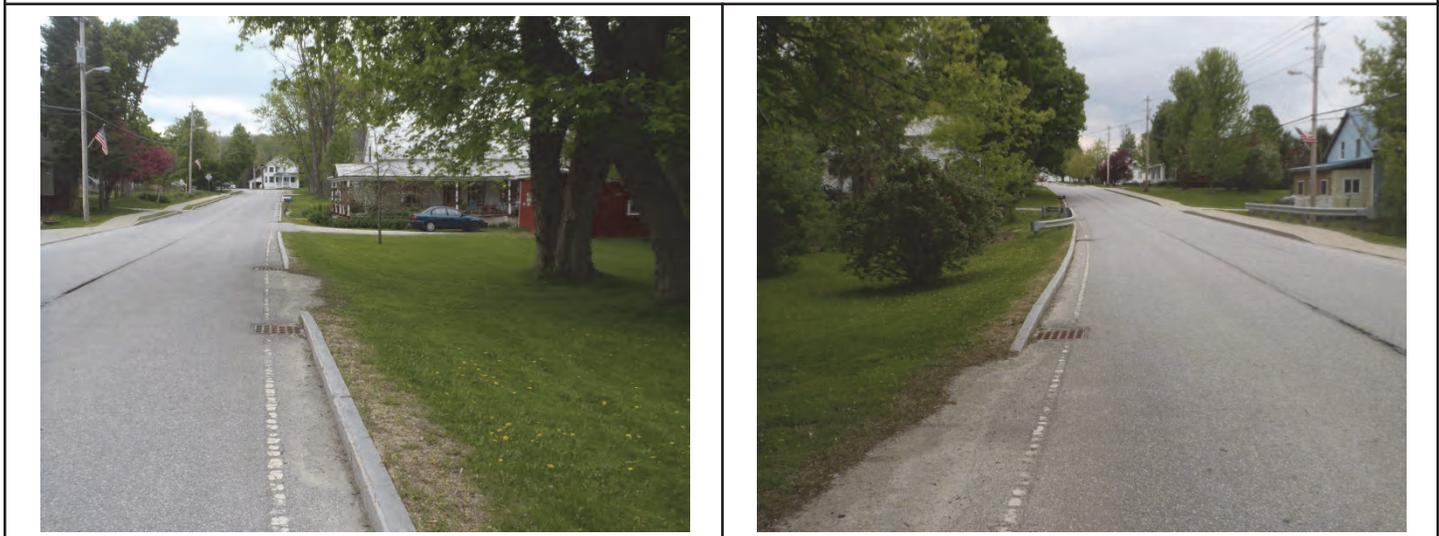
<b>Problem Area ID:</b> PK-08	<b>Latitude:</b> 44.981335°	<b>Longitude:</b> -72.917603°
<b>Watershed:</b> Pike River

**Description of Observed Conditions:**  
 Stormwater runoff along Hanna Rd. could be directed to existing green space on the south side of the road. Would require landowner cooperation and the modification of several existing drop inlets.

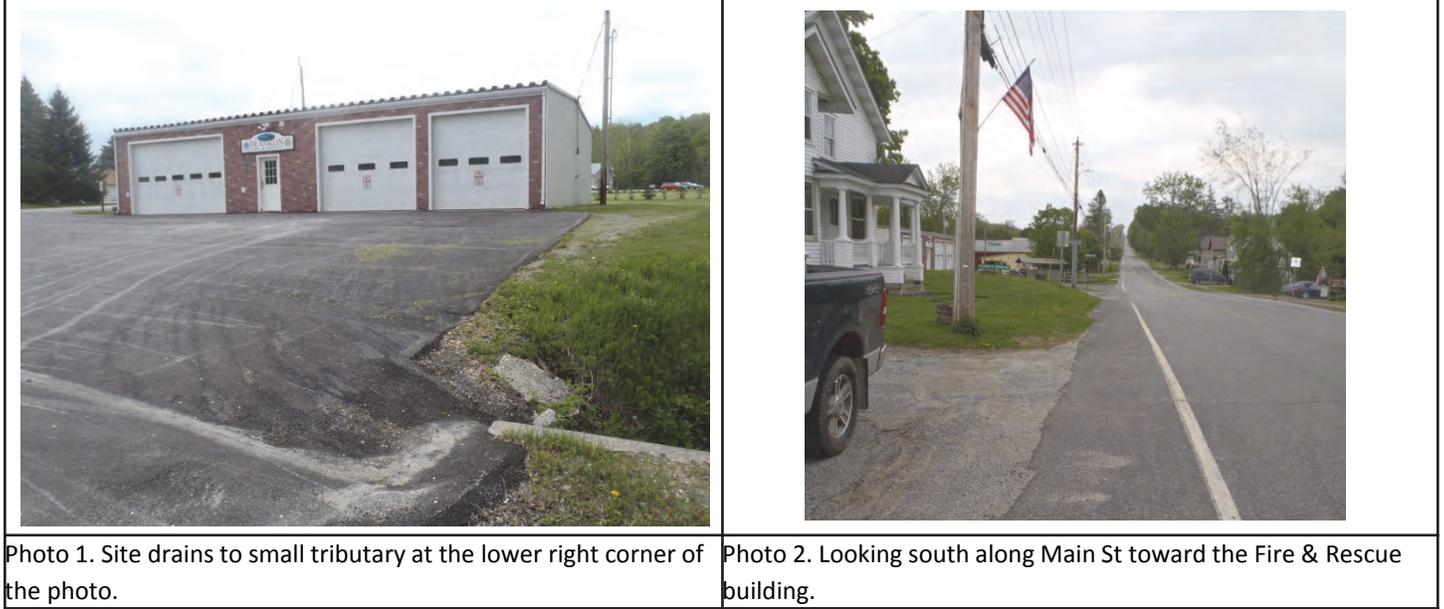
**Description of Observed Conditions:**  
 Stormwater runoff from Fire & Rescue building and parking lot, as well as a portion of N. Sheldon Rd and local Ford dealership, drains un-treated to stream at the corner of the lot.

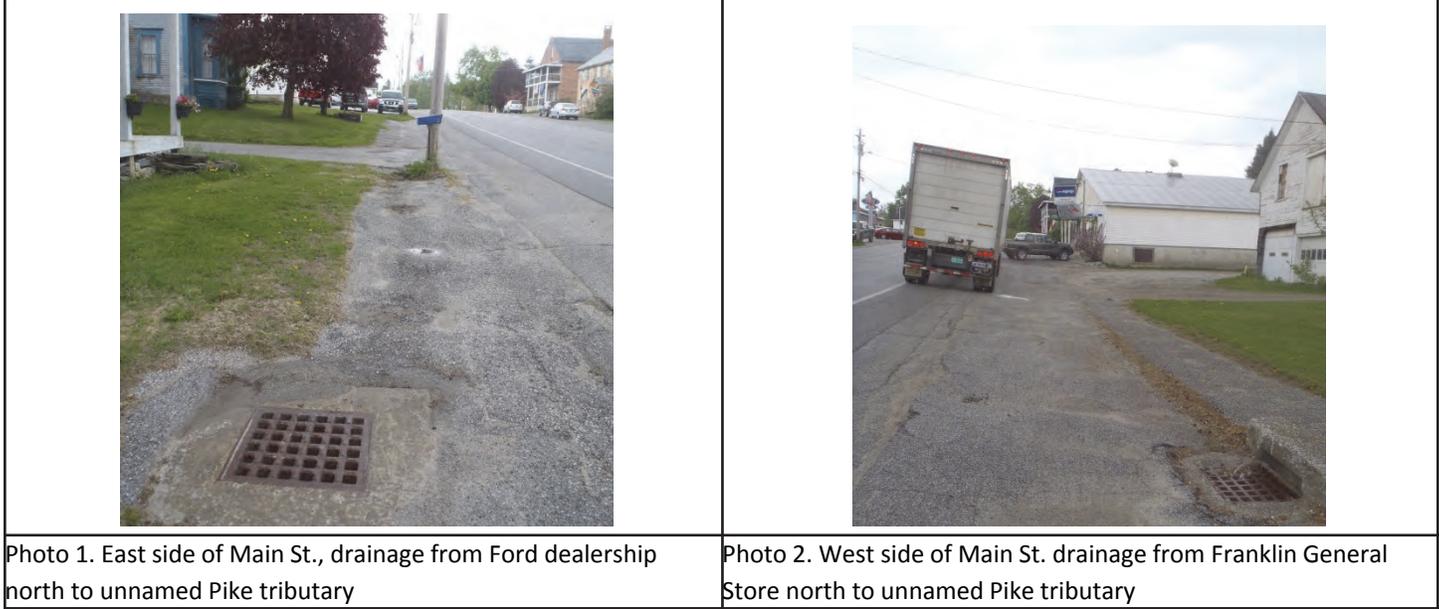
**Description of Observed Conditions:**  
 Stormwater runoff from the Franklin General Store building and parking, as well as a section of Main St., drains along the northwest edge of Main St. to a small tributary to the Pike River.

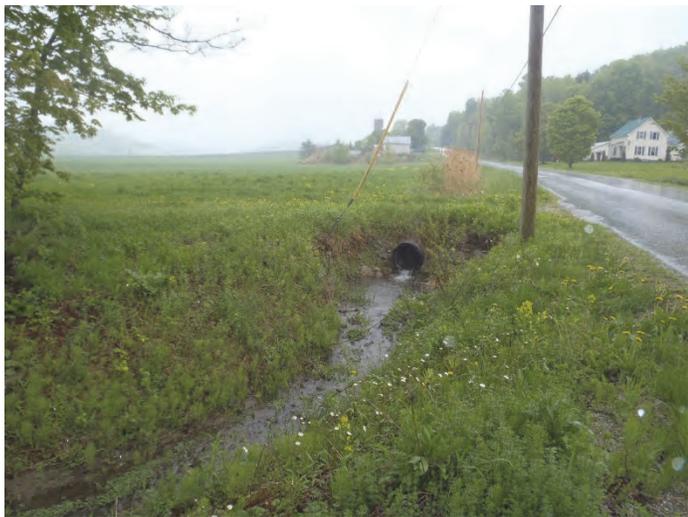
Photo 1. Confluence of drainage and the Rock River

Large, black plastic, perched culvert carrying road and agricultural drainage under farm access road discharges just above downstream end of culvert carrying the Rock River under Hanna Road. Some erosion is visible at the downstream ends of both culverts and a small sinkhole has formed along the guardrail at the upstream end of the Rock River culvert.
