Winhall River Watershed Corridor Plan

Winhall, Jamaica, & Londonderry, Vermont
October 27, 2014

Prepared by:
Bear Creek Environmental, LLC
149 State Street, Suite 3
Montpelier, Vermont 05602

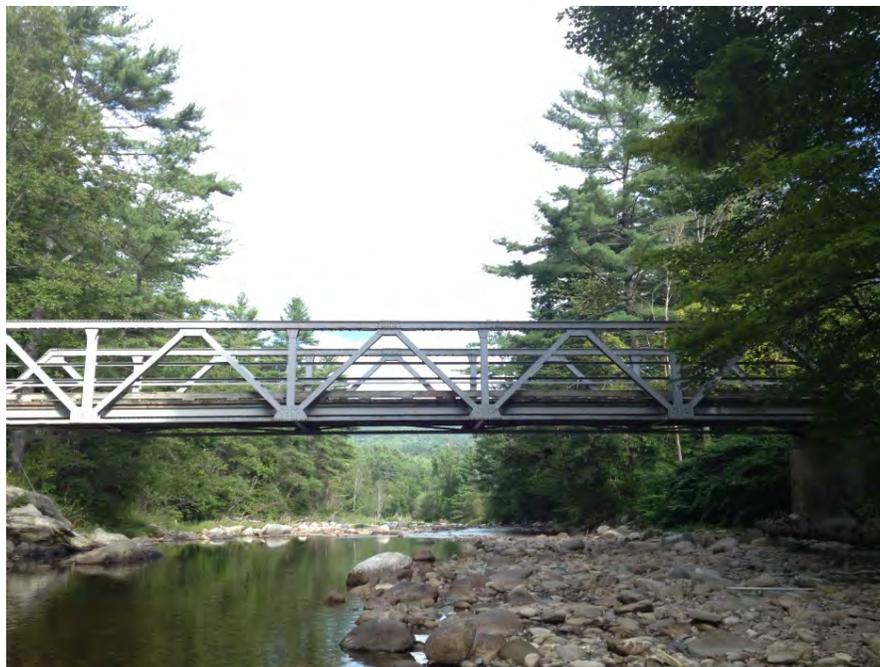
The most downstream reach on the Winhall River was not split into segments during assessment. The reach begins at the confluence with the West River and continues upstream for 4,000 feet to the reach break. The stream channel flows through a broad valley as it enters the West River. This reach is an *alluvial fan*, which occurs as the channel slope drops to meet the West River, creating a depositional area. Corridor encroachments throughout the reach, including Winhall Station Road, are limiting floodplain access in many areas. Residential development has impacted buffers greatly, particularly on the southern side of the river. Erosion is frequent along the south bank in areas where the riparian buffer is lacking. The channel underwent extreme historic incision as well as minor recent incision, as evidenced by glacial till present in the streambed. Aggradation is a major process that is currently occurring as the channel forms large bars and steep riffles. The channel is also widening and adjusting planform slightly through large flood chutes. Due to these processes, reach T11.01 is in **fair** geomorphic condition. The reach is also in **fair** habitat condition due to its impacted buffers, eroding banks, and lack of large woody debris (LWD).

Figure 5.2. Stream crossing at the upstream end of T11.01.

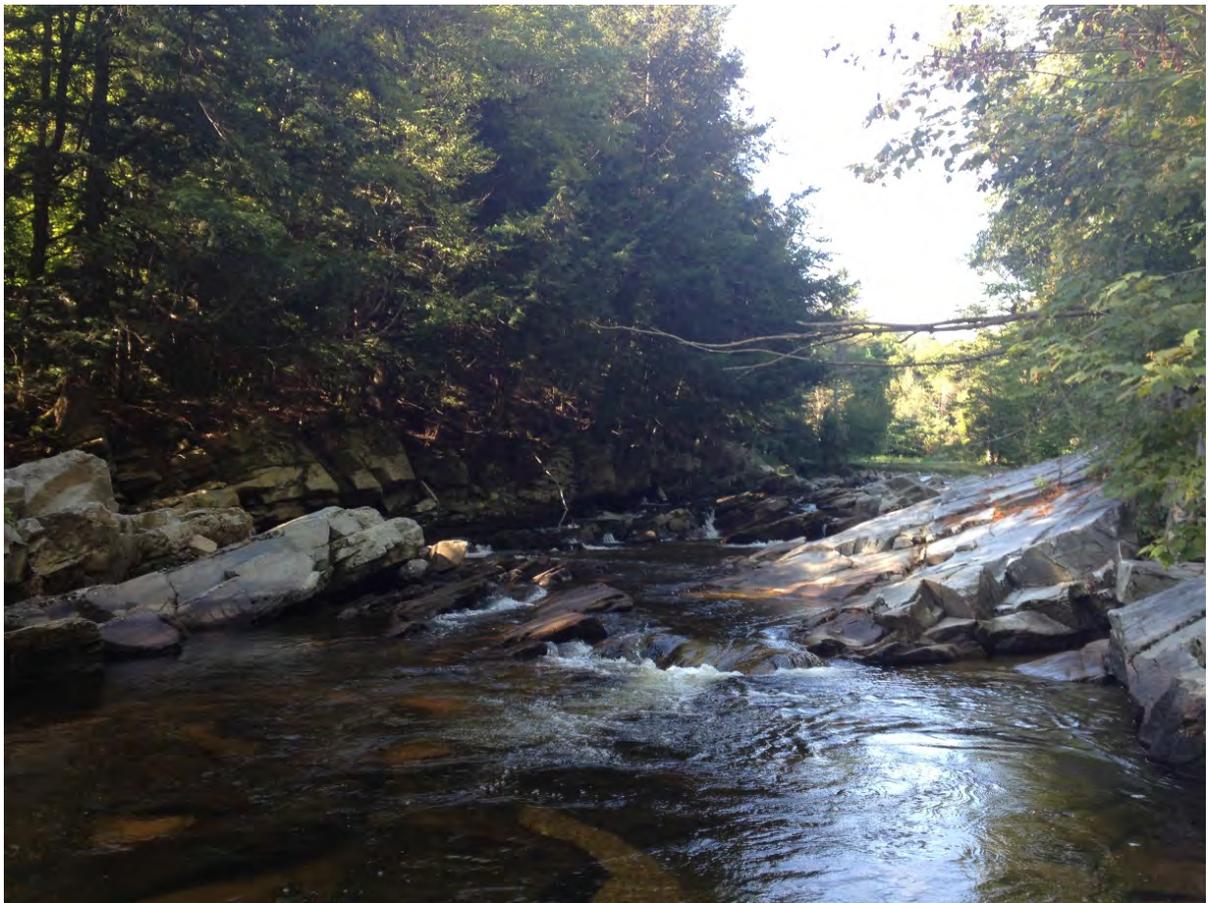
This segment is located within a bedrock gorge in a narrowly confined valley. Several bedrock grade controls are present in the segment, which prevent stream channel adjustment. The segment begins approximately 1,000 feet downstream of the Cohen Road stream crossing and continues upstream 500 feet to the reach break. T11.01-B was not fully assessed due to the presence of the bedrock gorge. Administrative judgment was used to determine reference and existing stream type, bed material, and bedform. Overall, the segment is in good geomorphic condition due to the stability of the bedrock grade controls.

Figure 5.6. T11.02-B is located within a bedrock gorge.

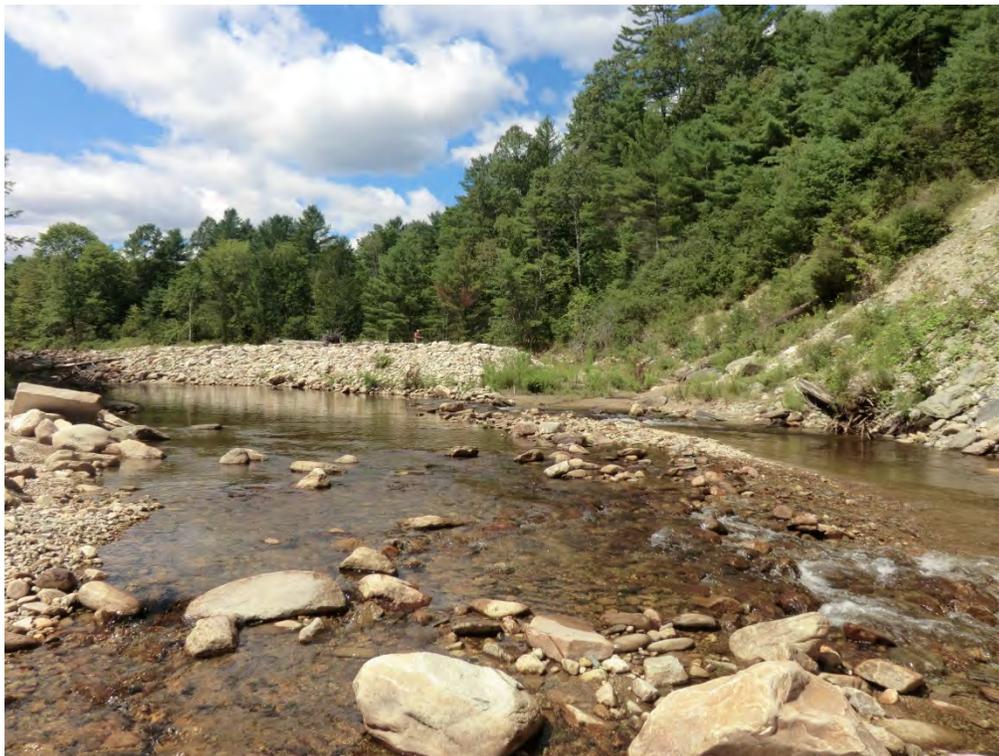
This segment begins where the Winhall River flows away from Gooddaleville Road and ends 1,500 feet upstream just above the confluence of Mill Brook with the Winhall. T11.03-C flows through a very broad valley and the river corridor is encroached upon by Gooddaleville Road only at the most downstream end of the segment. Erosion is common on both sides of the river, and a high width to depth ratio indicates that the channel has widened significantly. Segment T11.03-C is undergoing active planform adjustment and moving laterally through multiple flood chutes. A juvenile floodplain is being built via very large bars. Channel incision occurred historically, but floodplain connectivity remains. Gravel mining was noted where the Winhall River approaches Gooddaleville Road. Overall, T11.03-C is in **poor** geomorphic condition due to the adjustments that have occurred and are currently occurring in the segment. Habitat conditions are better in this segment than the rest of the reach, but T11.03-C is still in the **fair** category due to impacted bank and buffer vegetation, channel morphology, and hydrologic characteristics.

Figure 5.9 The Winhall River is building a juvenile floodplain through large bars in T11.03-C.

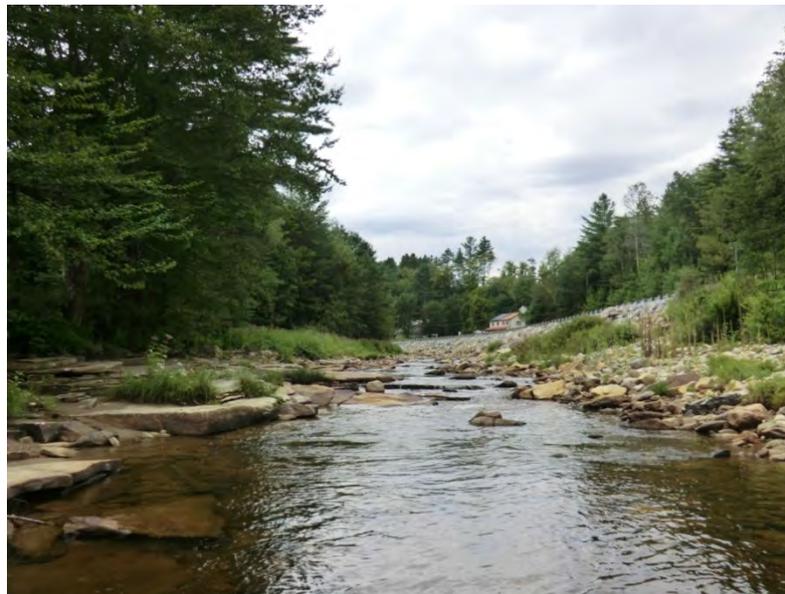
This segment begins at the reach break and continues upstream just over 5,300 feet to where Rt. 30 is no longer a corridor encroachment and the valley width increases. T11.05-A was historically straightened along VT Rt. 30 for almost its entire length, and portions of the channel were windrowed post-TSI, creating berms. Bank armoring is common in areas where the river flows directly along Rt. 30, as are impacted buffers. Erosion is common along both banks of T11.05-A. The historic and recent channel straightening has led to extreme channel incision, causing a stream type departure and greatly reducing floodplain access in this segment. The reference bedform of riffle-pool has also been lost and converted to plane bed. Bedrock in the stream channel is limiting further bed degradation and incision. Aggradation is limited in this segment, as is widening due to boundary conditions. Overall, T11.05-A is in **fair** geomorphic condition. The loss of channel bedform, lack of woody debris, and impacted banks and buffers have caused this segment to be in **fair** habitat condition.

Figure 5.11. Bedrock is limiting further incision throughout T11.05-A.

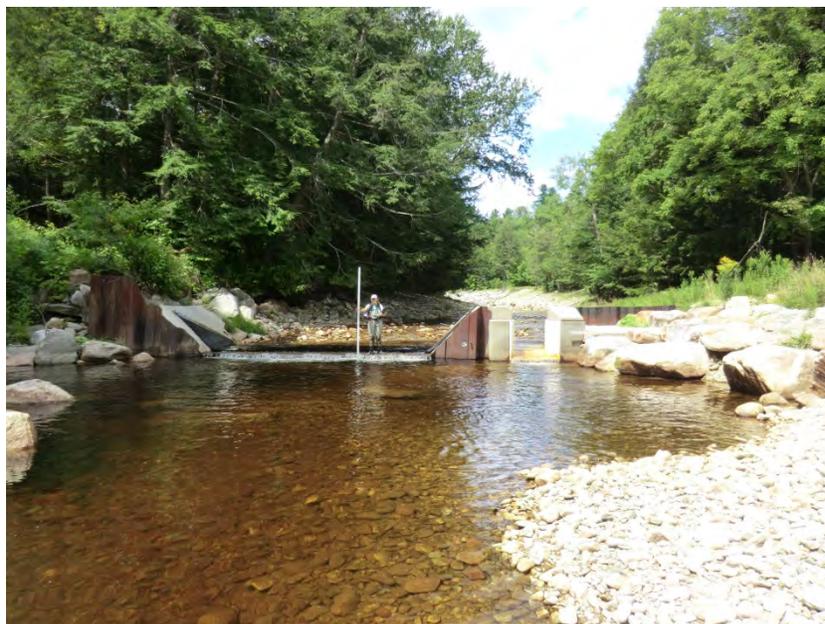
This segment begins above the bedrock in T11.06-B and ends just downstream of Rocky Dell Road. The Winhall River was historically straightened along Kendall Farm Road for almost the entirety of T11.07-A. A stretch of the river that runs directly along the road was windrowed post-Irene, and bank revetments are common along the road. Historic incision has led to a stream type departure in this segment and has limited floodplain access. A weir is present in T11.07-A, which acts as a grade control and a withdrawal to a snowmaking pond owned by Stratton Mountain. The snowmaking withdrawal is likely impacting the sediment dynamics in this segment. Widening is currently occurring in this segment as evidenced through bank erosion and a high width to depth ratio at the cross section. Due to these historic and recent changes in the channel morphology, T11.07-A is in **fair** geomorphic condition. A lack of LWD and poor river banks and buffers in this segment have created **fair** habitat conditions as well.

Figure 5.15. A weir in T11.07-A is impacting sediment transport throughout the segment.

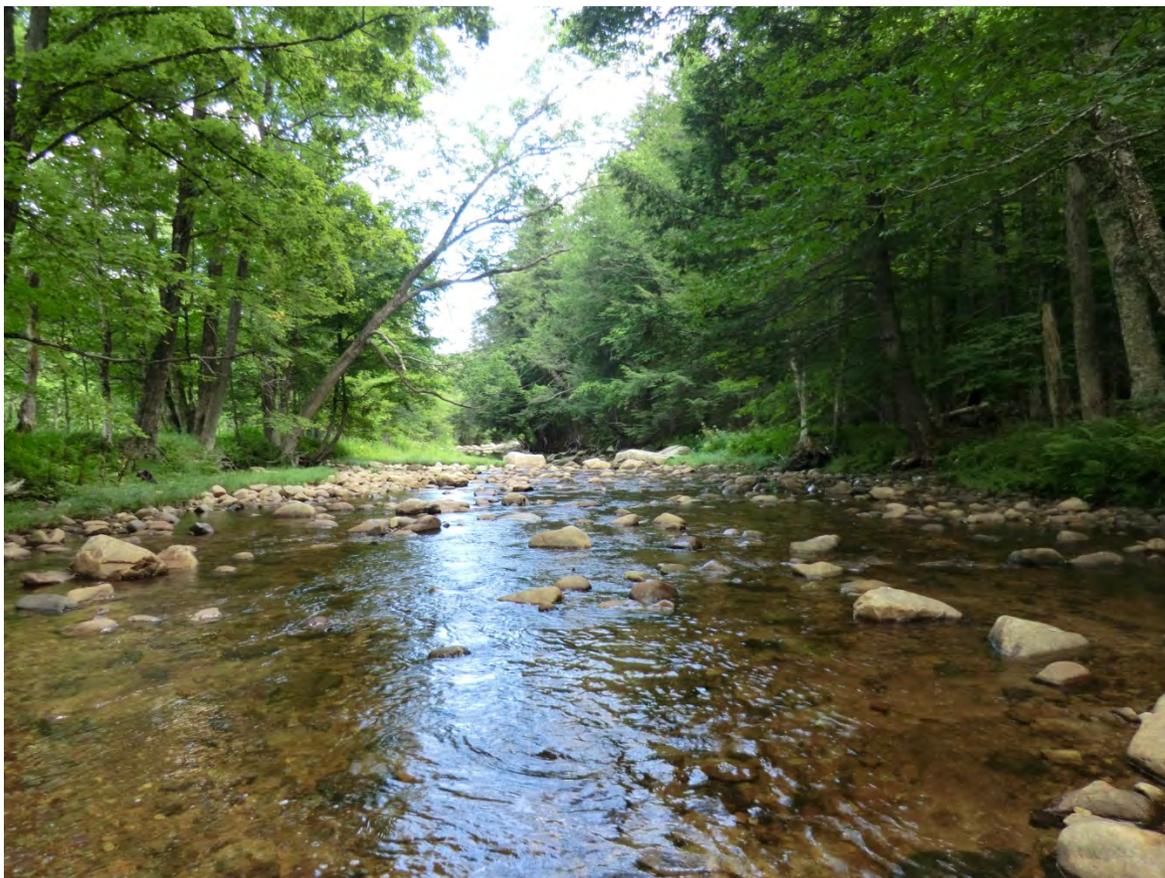
This segment begins just downstream of Rocky Dell Road and continues upstream to just above Hunker Road. T11.07-B overall has good floodplain access and has only experienced minor historic incision due to straightening along Kendall Farm Road. Bank erosion abounds in T11.07-B and one very large mass failure is present along the valley wall. A berm exists in the area with the mass failure, but its origin is unknown and it may be natural piling of sediment. T11.07-B is very aggradational, with bars and sedimented riffles common. The riparian buffer along the north bank of the stream has been impacted due to Kendall Farm Road and agricultural fields that abut the river. Overall, T11.07-B is in **fair** geomorphic condition due to historic incision and recent aggradation. This segment’s habitat condition is also **fair** due to poor bank and buffer conditions and changes in channel morphology.

Figure 5.16. The Winhall River has good floodplain access in T11.07-B.

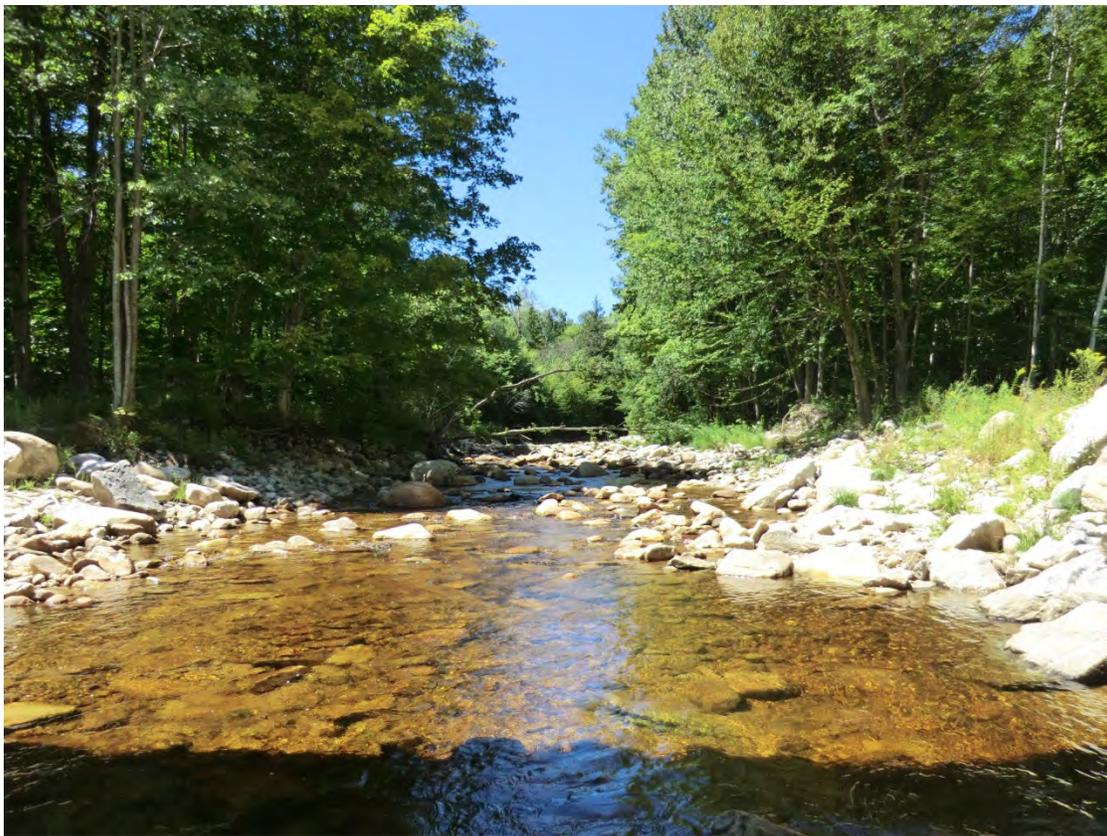
This segment begins just below the Lightfoot Camp Road stream crossing and continues upstream to past the cul-de-sac on Kendall Farm Road. T11.08-B flows through a very broad valley by reference that has been altered to a narrow valley due to the presence of Kendall Farm Road. The segment is characterized by a riffle-pool bedform and extensive historic and recent channel berming and windrowing. The placement of Kendall Farm Road and aforementioned berms led to historic channel incision and a stream type departure. The channel is widening and changing planform as evidenced by bank erosion and multiple flood chutes. There is a wetland across the road from the river that was likely historically accessed by the stream, but the road now impedes this access. Due to historic incision and current lateral adjustments, T11.08-B is in in **fair** geomorphic condition. Despite this, there is good instream cover and refuge for organisms, placing the segment in **good** habitat condition.

Figure 5.18. T11.08-B historically incised, forming a “B” channel with limited floodplain access.

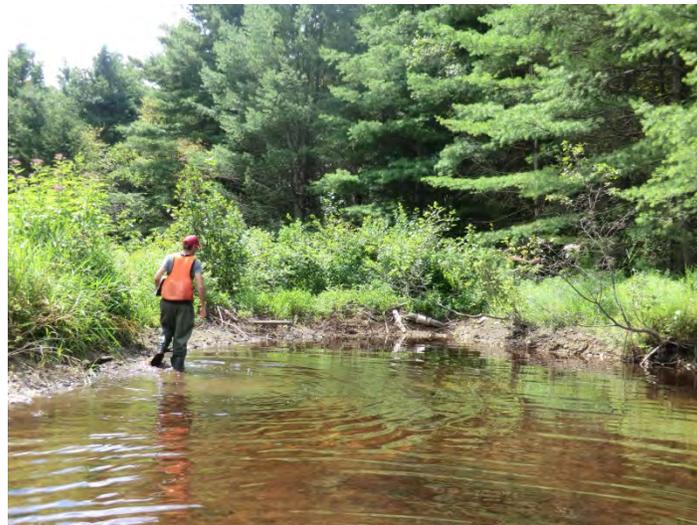
This segment begins at the mouth of the brook and continues upstream to about 1,800 feet above the culvert at River Road. This reach is an alluvial fan, which has formed as the channel slope drops and river valley widens to meet the Winhall River valley. T11.S3.01-A flows through a beaver meadow, with several intact and breached beaver dams present. The alluvial fan and beaver activity have led to major aggradation and planform adjustment in this segment. Flood chutes and channel avulsions are common in T11.S3.01-A. Bank erosion is present in areas where there are active flood chutes. A culvert under River Road has created a major channel constriction, and the stream has significantly aggraded above the structure and scoured below it. There is also a channel avulsion directly upstream of the structure, which could put it at an elevated risk of being undermined during future high flow events. Due to the aggradation and planform adjustment occurring in T11.S3.01-A, it has been placed in **fair** geomorphic condition. However, the beaver dams create a diversity of bed features and supply LWD to the channel, creating **good** habitat conditions.

Figure 5.19. One of many beaver dams present in T11.S3.01-A.

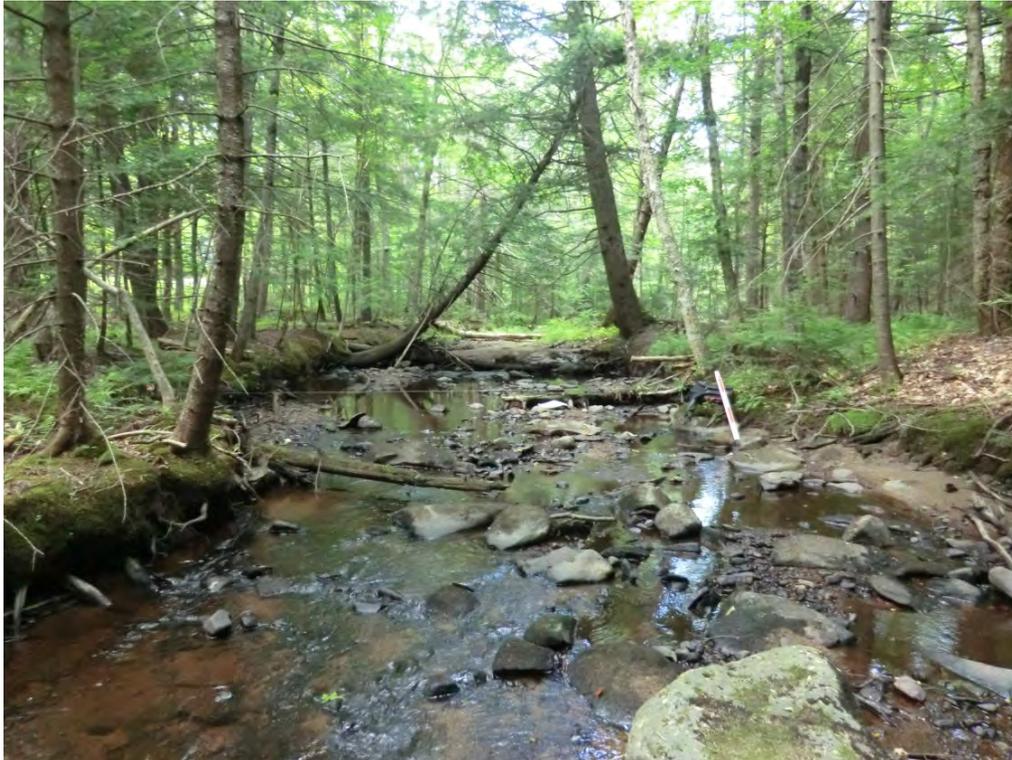
This segment begins about 1,800 feet upstream of the River Road stream crossing and ends just below the upstream-most crossing at Raspberry Hill Road. Directly upstream of this reach is an on-stream pond at Strattonwald Recreation Club. Despite the presence of the pond, severe incision was not observed in T11.S3.01-B. Typically, an on-stream pond disrupts sediment transport regimes, and the section of river downstream of it can become sediment starved. This is not the case for T11.S3.01-B. Aggradation is major in this segment, and the source of which is unknown. There are abundant bars in this segment, which could have formed during TSI. Also, numerous debris jams are present, which have formed flood chutes and channel avulsions. These were also likely formed during Irene. Erosion is present on both banks in T11.S3.01-B. The downstream-most Raspberry Hill Road crossing is undersized and causing significant aggradation above and scour below the structure. Overall, the segment is in **fair** geomorphic condition due to channel aggradation, planform adjustment, and slight historic incision. Debris jams provide LWD to the stream for aquatic organism cover, as do undercut banks and plunge pools. These and other features create **good** habitat conditions in T11.S3.01-B.

Figure 5.20. T11.S3.01-B has good floodplain access and good cover for aquatic biota.

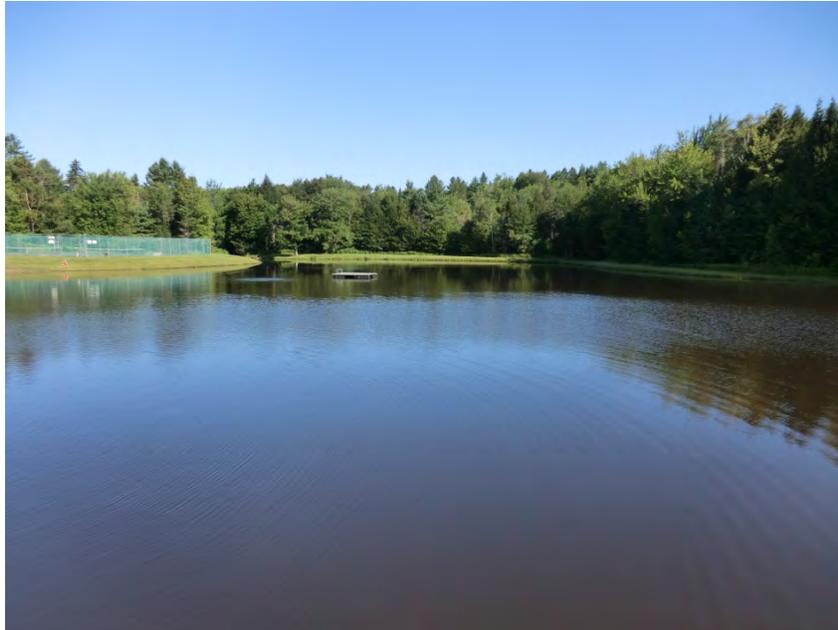
This segment is an on-stream pond located at Strattonwald Recreation Club. The segment begins at the upstream-most Raspberry Hill Road crossing and continues upstream for 600 feet. A small run of the river dam is present at the downstream end of the segment, impounding the water behind it. The dam also acts as a grade control for the stream, and likely poses a significant barrier to aquatic organism passage (AOP). There is a large overflow outlet for the small dam and two small culverts. There is no riparian buffer surrounding the pond, which is used for recreation purposes.

Figure 5.21. T11.S3.01-C is an on-stream pond used for recreation.

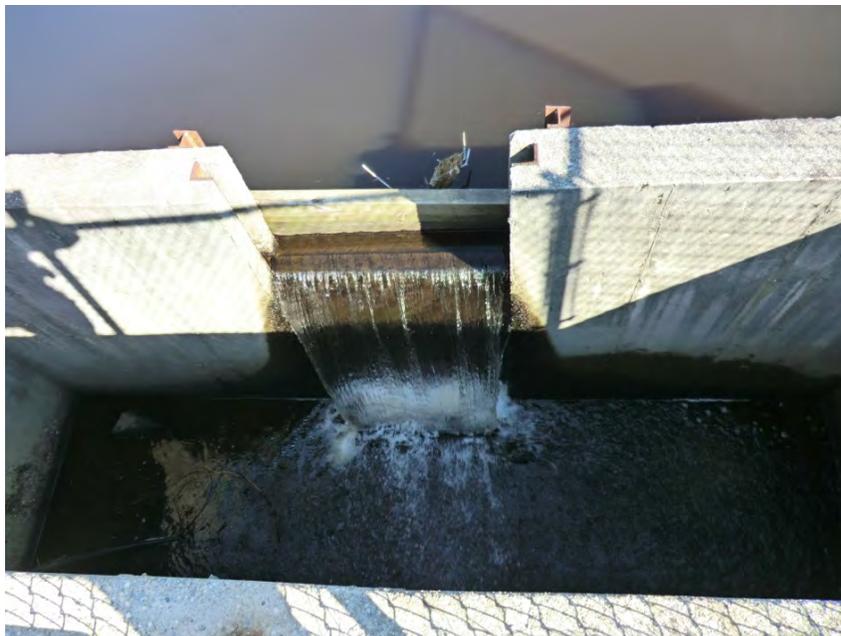
Figure 5.22. The dam at the pond outlet likely poses an AOP barrier.

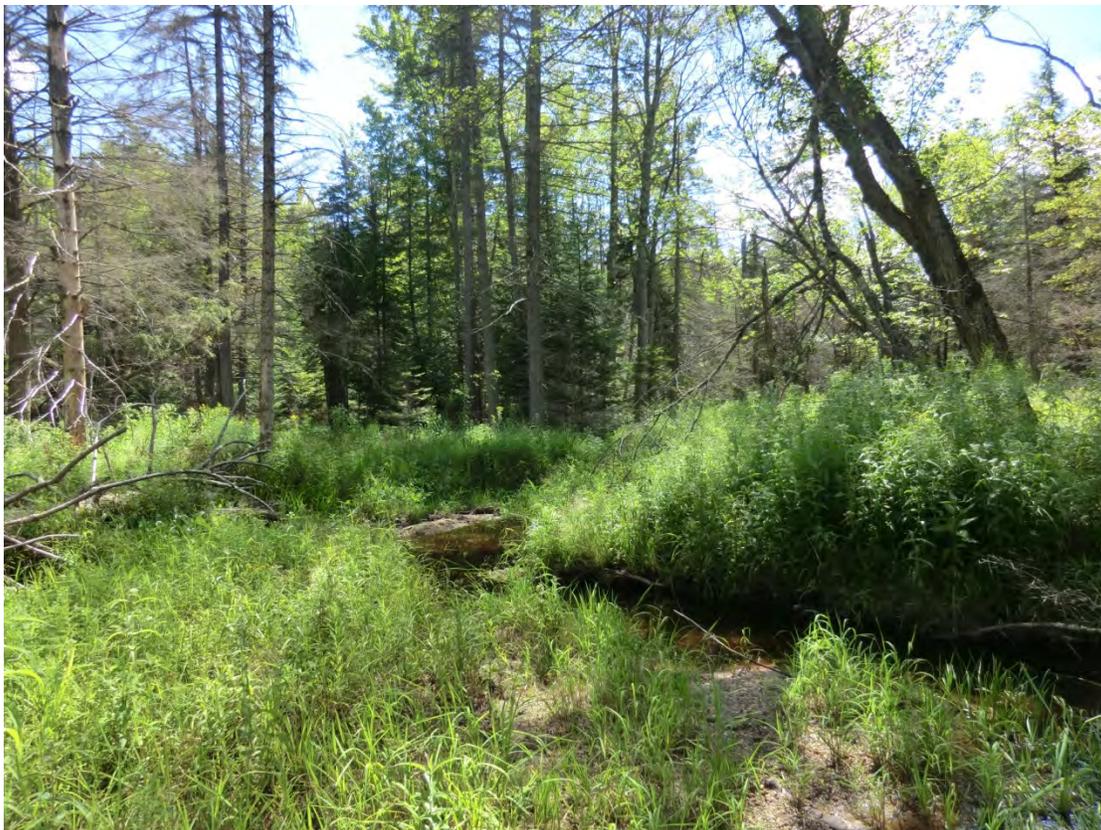
This segment begins 1,100 feet below the stream crossing at Winhall Hollow Road and ends just upstream of the crossing. T11.S3.01-E is characterized as a wetland that has evidence of past and possibly current beaver activity. There is one intact beaver dam in this segment and ten debris jams, which are creating flood chutes and channel avulsions and spreading out flow throughout the wetland complex. There is almost no bank erosion present in this segment, and no channel incision. Minor aggradation has occurred in T11.S3.01-E as a result of its low slope and beaver dam/debris jams. Red Brook retains its reference bedform of ripple-dune in this segment. Overall, the stream channel is stable throughout the wetland, and is in **good** geomorphic condition. A variety of streambed features are present in the wetland, LWD is abundant, and undercut banks create good cover for aquatic biota. For these reasons, T11.S3.01-E is also in **good** habitat condition.

Figure 5.24. T11.S3.01-E flows through a wetland complex.

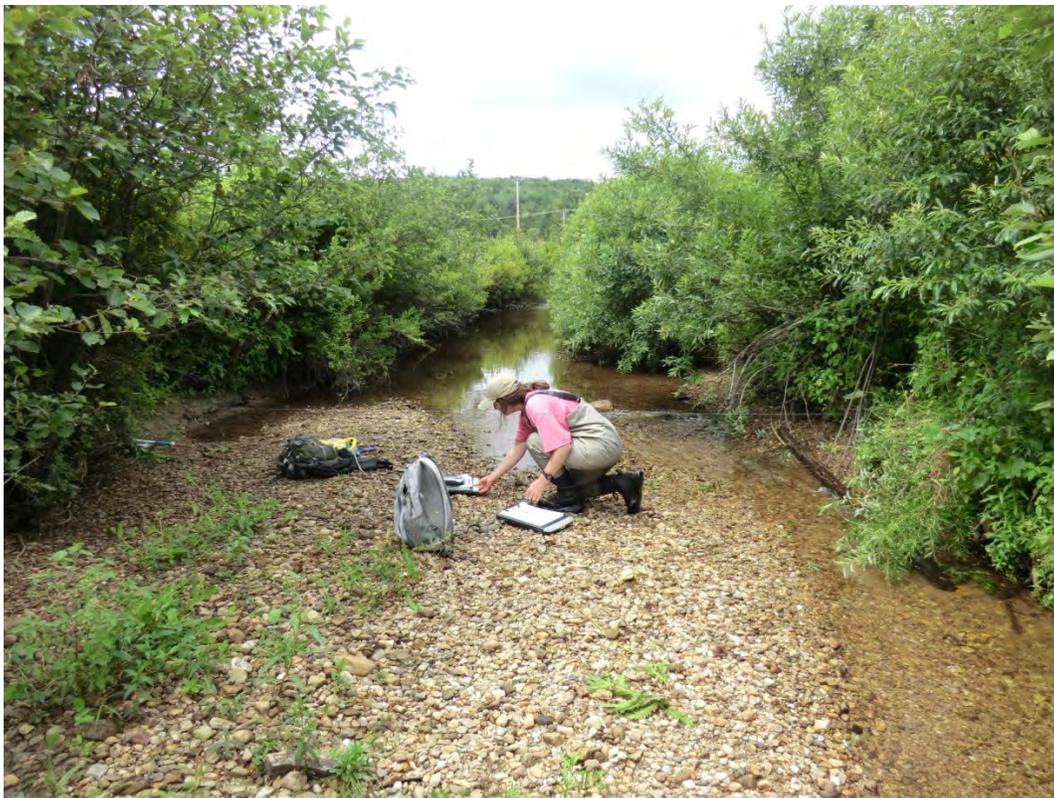
This segment begins just downstream of the Rt. 30 culvert and continues upstream approximately 1,000 feet to just above the stream crossing at Stratton View Road. The entirety of the segment is encroached upon by Rt. 30 and areas have been historically straightened due to its presence. Bank armoring is present around both stream crossings in T11.S4.01-B, which are also channel constrictions. The channel has undergone historic incision and is actively widening. In areas that have widened, aggradation is common. The channel is surrounded by wetlands, which can be accessed in bankfull events. A stream type departure has occurred due to channel incision and widening. Tributary 4 has also lost its reference bedform of riffle-pool in this segment, which has been replaced by a featureless plane bed channel. Due to these impacts, T11.S4.01-B is in **fair** geomorphic condition. The lack of diverse bed features and impacted banks and buffers place this segment in **fair** habitat condition.

Figure 5.26. T11.S4.01-B is actively widening and aggrading.

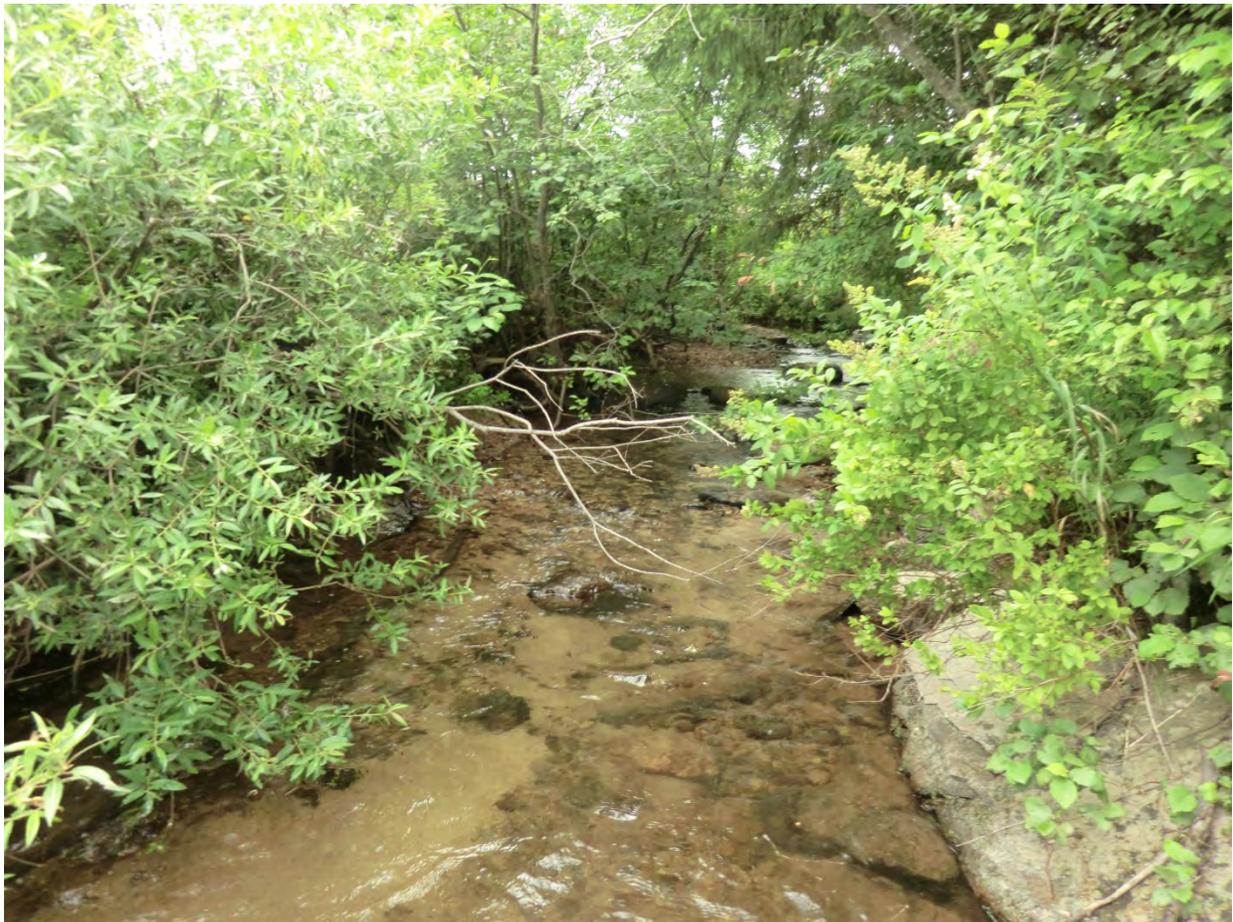
This segment begins just above the stream crossing at Stratton View Road and continues upstream to the reach break near Goslings Way. It was not fully assessed due to limited property access on the both sides of the stream. Administrative judgment was used to determine reference and existing stream type, bed material, and bedform. Overall, the segment was rated as fair geomorphic condition due to various impacts, such as extensive corridor encroachments, and conditions observed immediately upstream and downstream of the segment.

Figure 5.27. T11.S4.01-C was not assessed due to limited property access.

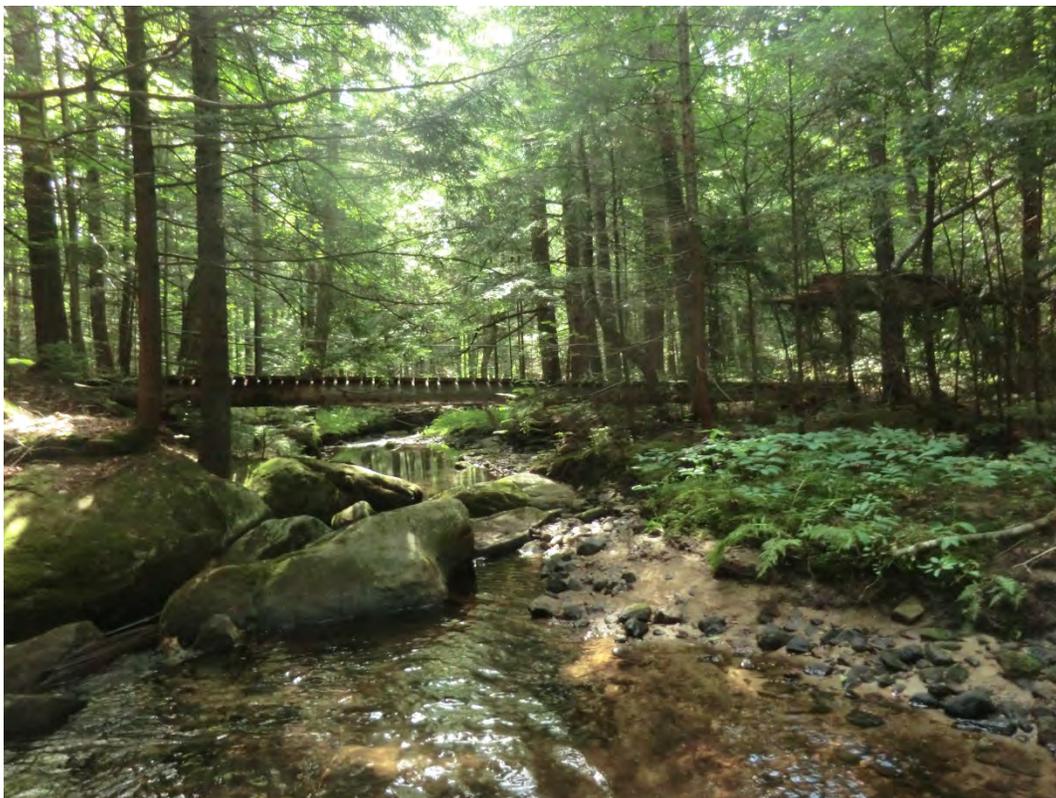
This segment begins approximately 500 feet upstream of the Rt. 30 culvert and continues upstream to where the stream begins flowing directly south and farther away from the road. T11.S4.02-B is not impacted by Rt. 30 as a corridor encroachment as the downstream reaches are. Development is minimal within the corridor, as is channel straightening, and adjacent wetlands abound. Erosion is common, though not extensive, on both banks and there is one mass failure present in this segment. The channel does not appear to be incised; however, aggradation and planform adjustment are occurring. A large amount of fine sediments was noted in this segment, the source of which could be eroding banks and logging activities. There is moss on the stream banks and in the channel in areas, indicating a stable channel. Despite this, the segment is in **fair** geomorphic condition due to the planform changes and aggradation that is occurring. Habitat conditions in T11.S4.02-B are **good** as a result of abundant LWD and cover for aquatic biota and well forested banks and buffers.

Figure 5.29. A variety of bed features and forested buffers create good habitat conditions in T11.S4.02-B.

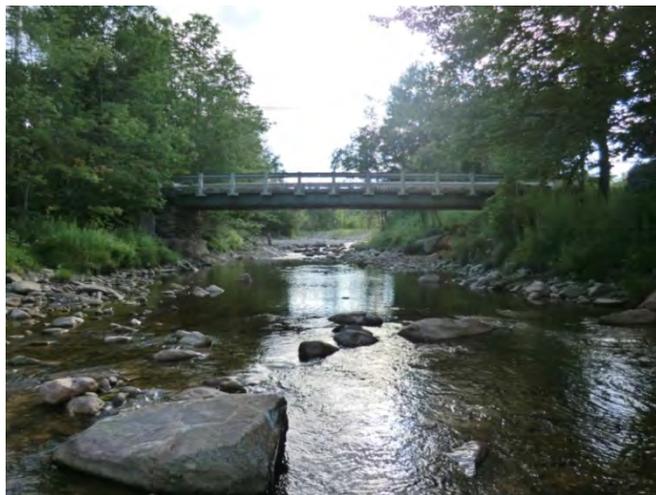
A bridge on Lower Taylor Hill Road in T11.06-A (Figure 5.31) has also been recommended for replacement at a low priority. This bridge was closed to traffic at the time of assessment and had scour around its footers, wingwalls, and abutments. It is a channel constriction because of riprap placed within the structure. The streambed has scoured through the structure.

Figure 5.31. Lower Taylor Hill Rd bridge was closed at the time of assessment.

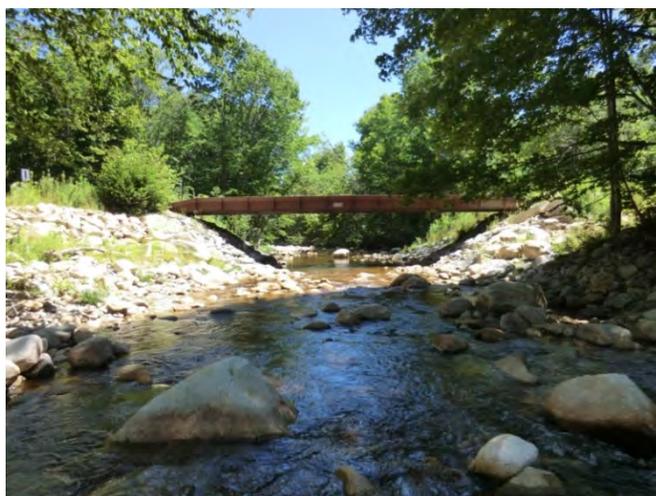
The final stream crossing structure recommended for replacement on the Winhall River is located in segment T11.08-B on Lightfoot Camp Road and is shown in Figure 5.32. This bridge is a channel constriction due to the placement of riprap within the structure. There is also a flood chute that enters the river immediately upstream of the structure, which could pose a risk to it during high flow events. It is recommended for replacement with a low priority.

Figure 5.32. Channel constriction on Lightfoot Camp Road

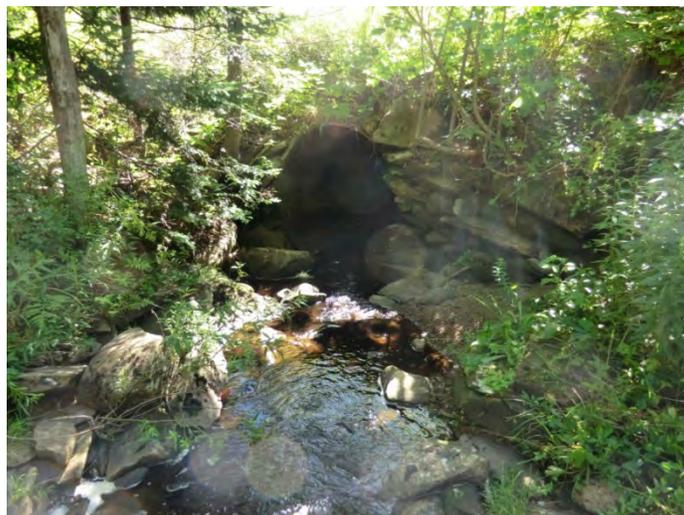
A culvert under Winhall Hollow Road in segment T11.S3.01-E has been recommended for replacement with a high priority. This structure is severely undersized and is not well aligned with the channel. The streambed has scoured below the structure and aggraded above it. Bank scour both above and below the culvert are present (Figure 5.36).

Figure 5.36. The culvert under Winhall Hollow Rd is not well aligned.

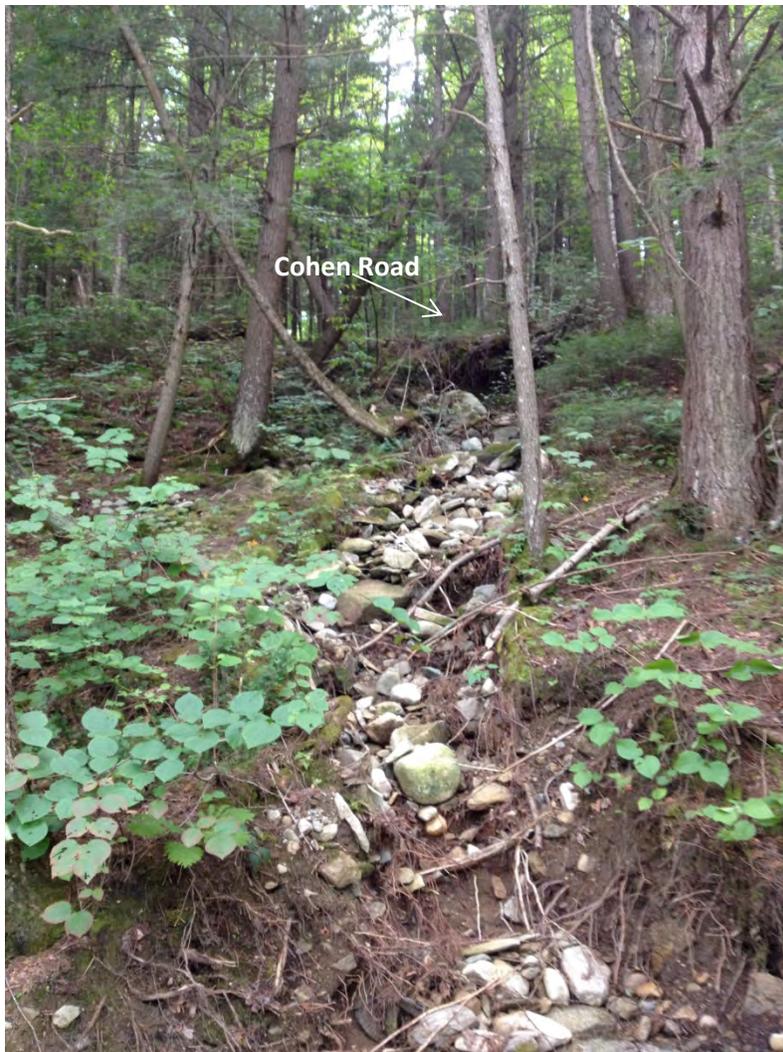
| Project # Segment | Type of Project | Site Description Including Stressors and Constraints | Project or Strategy Description | Technical Feasibility and Priority | Benefits | Potential Partners/ Programs |
|---|---|---|--|--|---|---|
| Project #2 T11.02-A | Active Restoration | A gully is present along the south side of the river that is delivering sediment from Cohen Road. There are several locations in this segment where overland flow from the road appears to enter the river. | Stabilize/ Remediate Gully; Improve Stormwater Infrastructure | Moderate Priority | Improved geomorphic stability, water quality, and habitat | WRC, VANR, CRWC, Town of Londonderry |

Project #2 – Stabilize/ Remediate Gully; Improve Stormwater Infrastructure

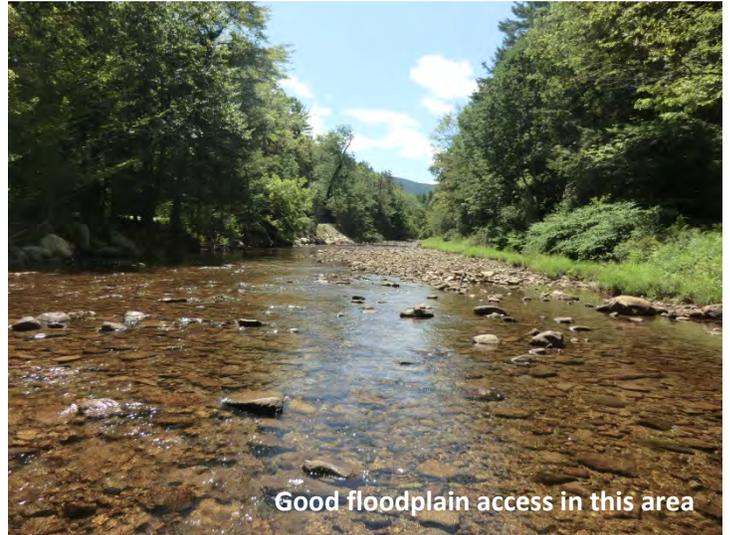
Good floodplain access in this area

Project #7 – River Corridor Easement

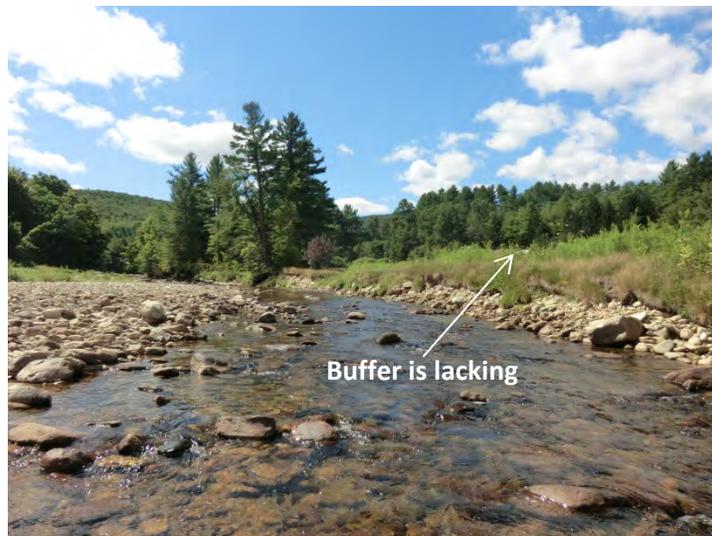
| Project # Segment | Type of Project | Site Description Including Stressors and Constraints | Project or Strategy Description | Technical Feasibility and Priority | Benefits | Potential Partners/ Programs |
|--|---|---|---|---|--|--|
| Project #8 T11.03-C & T11.04 | Passive Restoration | Riparian buffer is lacking on the western bank of the Winhall. The bank is actively eroding and contributing sediment to the river. | Streamside Plantings | Moderate Priority | Improved habitat and water quality | Landowners, WRC, VANR, CRWC TFS |

Buffer is lacking

Project #8 – Streamside Plantings

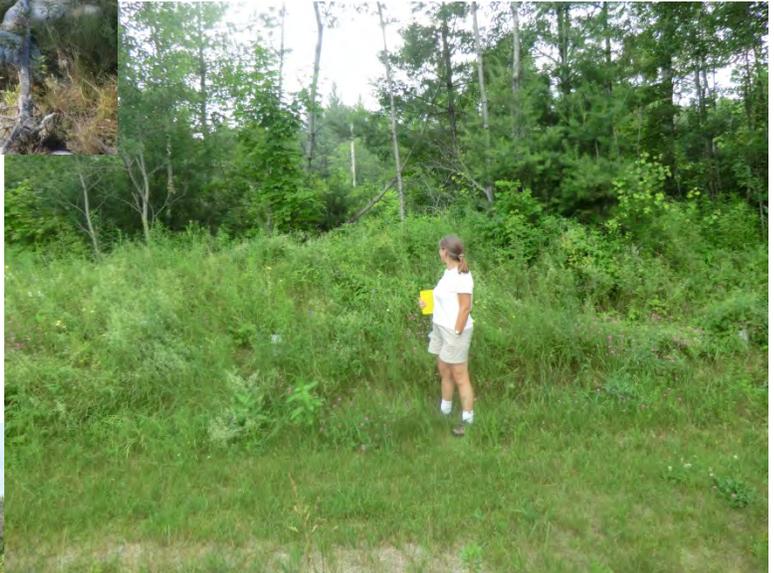
Project #12B – Return Windrowed Material to Channel & Streamside Plantings

| Project # Segment | Type of Project | Site Description Including Stressors and Constraints | Project or Strategy Description | Technical Feasibility and Priority | Benefits | Potential Partners/ Programs |
|---|---|---|--|---|--|---|
| Project #12B T11.05-A | Active & Passive Restoration | Channel was windrowed post-TSI, creating a two-foot berm along the southern bank of the river. Berm is protecting fairgrounds, which were damaged during Irene. Riparian buffer is also lacking in the same location. | Return Windrowed Material to Channel & Streamside Plantings | Moderate Priority (High bank, property damaged during Irene) | Improved geomorphic stability, habitat, and water quality; attenuation of floodwaters and sediment | Landowners, WRC, VANR, CRWC, Town of Winhall TFS |

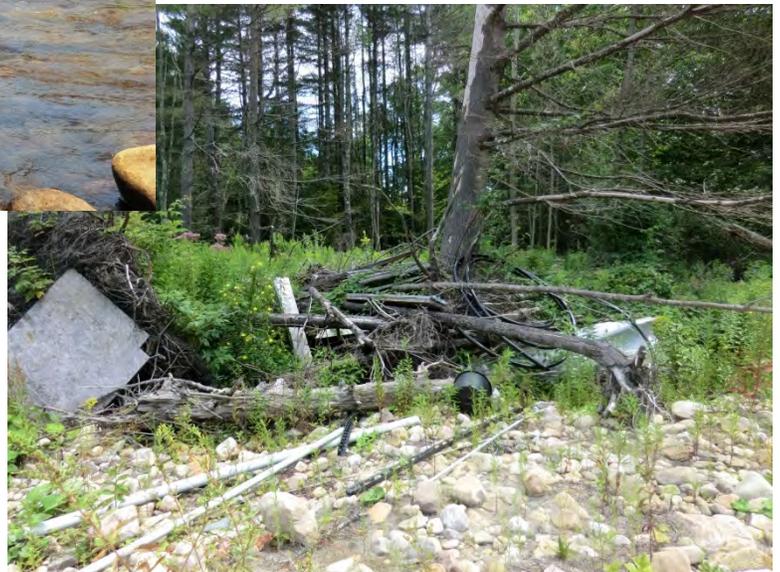
Project #14 – Arrest Headcut & Clean Up Trash on Banks

| Project # Segment | Type of Project | Site Description Including Stressors and Constraints | Project or Strategy Description | Technical Feasibility and Priority | Benefits | Potential Partners/ Programs |
|---|---|---|--|---|--|---|
| Project #14 T11.05-B | Active Restoration | The stream channel in T11.05-B is actively degrading via one small headcut. At the same location, there is trash piled on the north bank of the river. | Arrest Headcut & Clean Up Trash on Banks | Moderate Priority | Improved geomorphic stability, habitat, and water quality | Landowners, WRC, VANR, CRWC |

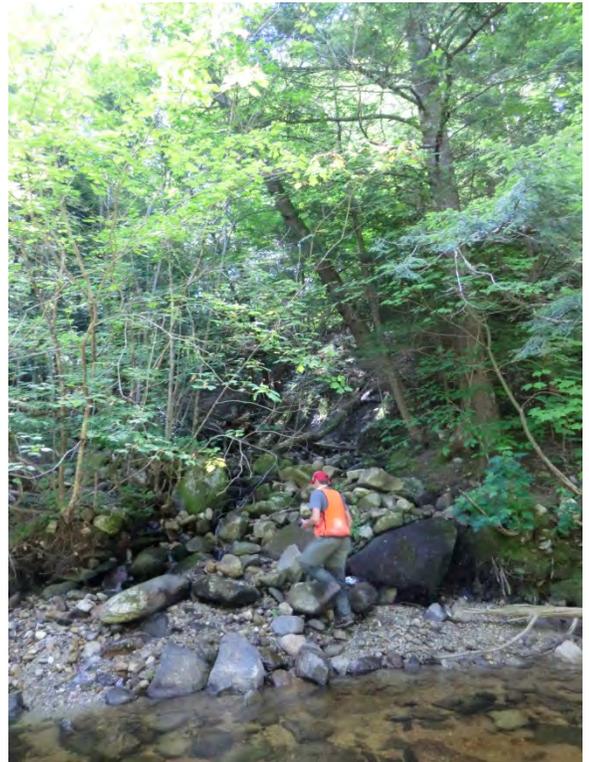
Project #18 – Remove Berm & Investigate Gully

| Project # Segment | Type of Project | Site Description Including Stressors and Constraints | Project or Strategy Description | Technical Feasibility and Priority | Benefits | Potential Partners/ Programs |
|---|---|---|---|---|--|--|
| Project #18 T11.07-B | Active Restoration | A berm exists on the north bank of the Winhall where no infrastructure is present – only an agricultural field. The river could likely access this floodplain if the berm were not present. A gully exists on the south bank and is contributing sediment to the river. The source of the gully is unknown. | Remove Berm & Investigate Gully | Moderate Priority | Improved geomorphic stability, habitat, and water quality; attenuation of floodwaters and sediment | Landowners, WRC, VANR, CRWC |

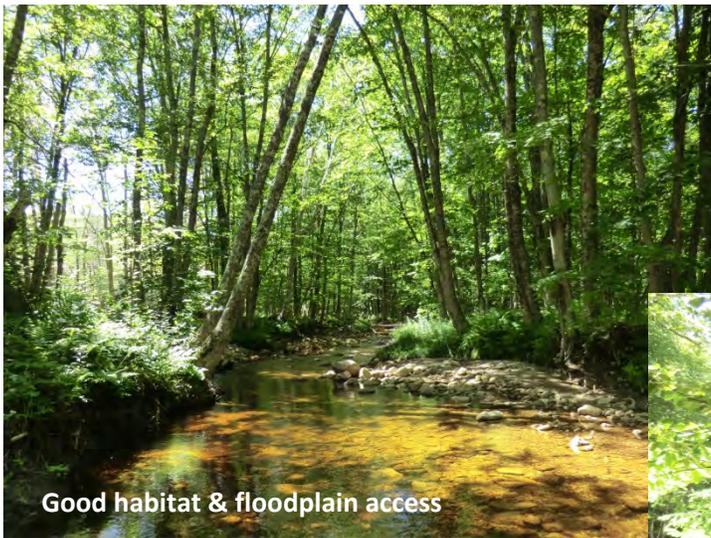
Project #19 – River Corridor Easement

| Project # Segment | Type of Project | Site Description Including Stressors and Constraints | Project or Strategy Description | Technical Feasibility and Priority | Benefits | Potential Partners/ Programs |
|---|---|---|---|---|--|--|
| Project #19 T11.08-A & B | Passive Restoration | This section of the Winhall River is undergoing extreme planform adjustment via several channel avulsions and flood chutes. It is braided and will continue to adjust into the future. Riparian buffers are well forested and habitat conditions are good. | River Corridor Easement | High Priority (River is actively adjusting, has good floodplain access, and landowner interest) | Improved habitat and water quality; attenuation of floodwaters and sediment | Landowners, WRC, VANR, CRWC, Town of Winhall RCE |

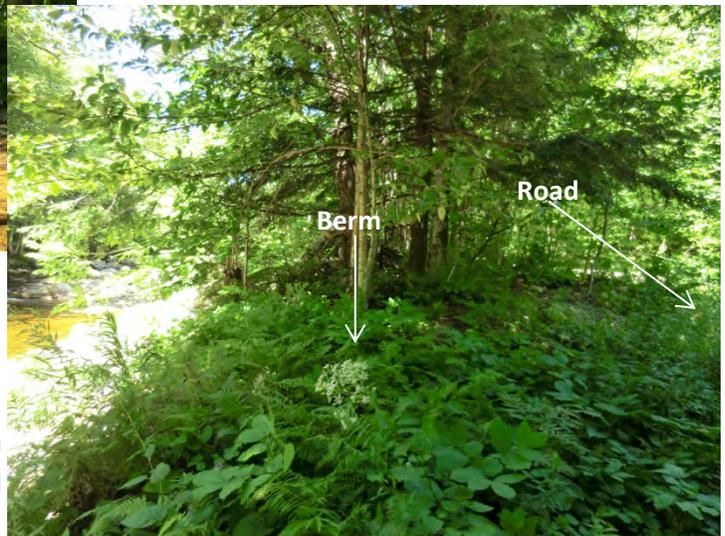
Project #20 – Investigate Berm Removal & Lowering Road

| Project # Segment | Type of Project | Site Description Including Stressors and Constraints | Project or Strategy Description | Technical Feasibility and Priority | Benefits | Potential Partners/ Programs |
|---|---|---|---|---|--|--|
| Project #20 T11.08-B | Active Restoration | The extension of Kendall Farm Road has caused the river to lose access to once-adjacent wetlands. A historic berm along the road has furthered this segment's loss of floodplain access. Access to this wetland could provide important flood water & sediment attenuation. | Investigate Berm Removal & Lowering Road | Low Priority | Improved geomorphic stability, habitat, and water quality; attenuation of floodwaters and sediment | Green Mountain National Forest, WRC, VANR, CRWC, Town of Winhall |
