Wardsboro Brook Watershed Corridor Plan

Wardsboro & Jamaica, Vermont
October 27, 2014

Prepared by:
Bear Creek Environmental, LLC
149 State Street, Suite 3
Montpelier, Vermont 05602

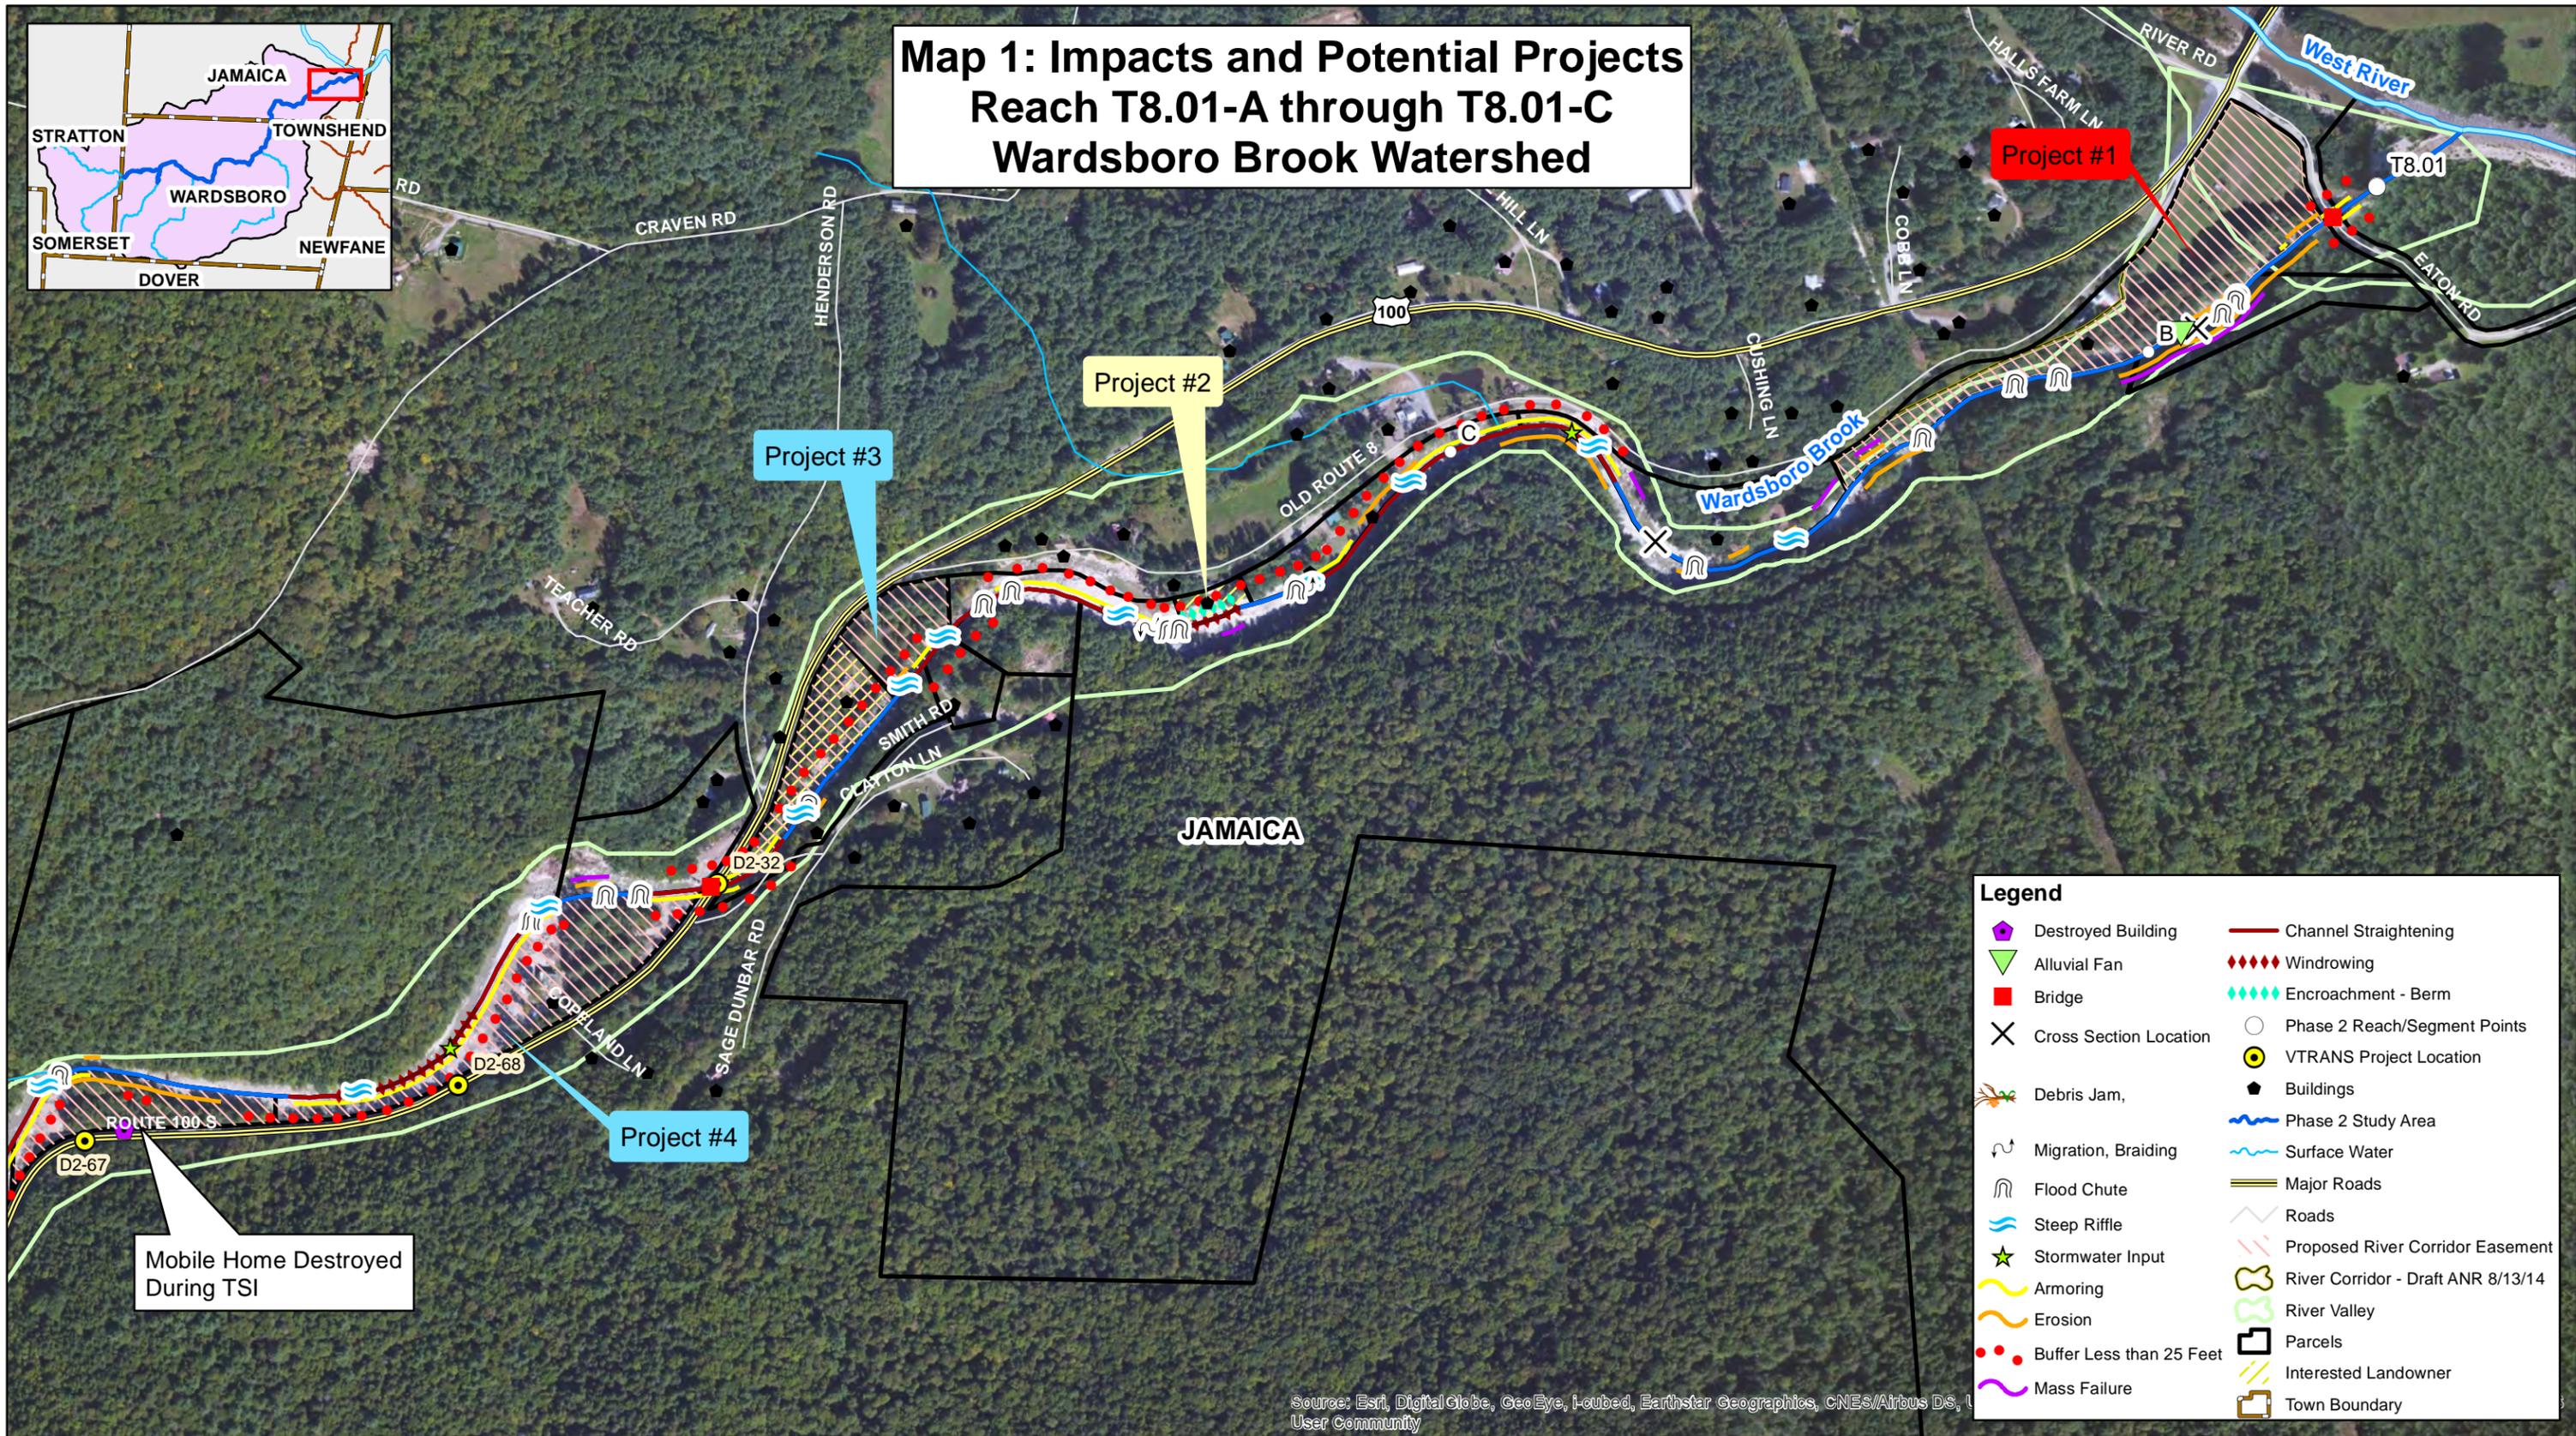
Map 1: Impacts and Potential Projects Reach T8.01-A through T8.01-C Wardsboro Brook Watershed

Mobile Home Destroyed During TSI

Project # Segment	Type of Project	Site Description Including Stressors and Constraints	Project or Strategy Description	Technical Feasibility and Priority	Benefits	Potential Partners/ Programs
Project #1 T8.01-A	Passive Restoration	Alluvial fan present just above confluence with West River in a broad valley. Channel has been pushed up against the valley wall and is incised.	River Corridor Easement	High Priority (alluvial fan)	Improved habitat and water quality	Landowner, WRC, VANR RCE
Project #2 T8.01-C	Active Restoration	Channel was windrowed & excavated after TSI and a five foot berm was built to protect a house along the north bank of the brook.	Return Windrowed Material to Channel/ Remove Berm	Low Priority (Berm is protecting house from floodwaters; landowner will likely not want to remove)	Improved geomorphic stability, habitat, and water quality	Landowners, WRC, VANR
Project #3 T8.01-C	Passive Restoration	Valley is broad but brook is confined by Rt. 100 on one side. Active planform adjustment is occurring where possible.	River Corridor Easement	Moderate Priority (interested landowner & abandoned parcel w/ building destroyed during TSI)	Improved habitat and water quality	Landowners, WRC, VANR, Town of Jamaica RCE

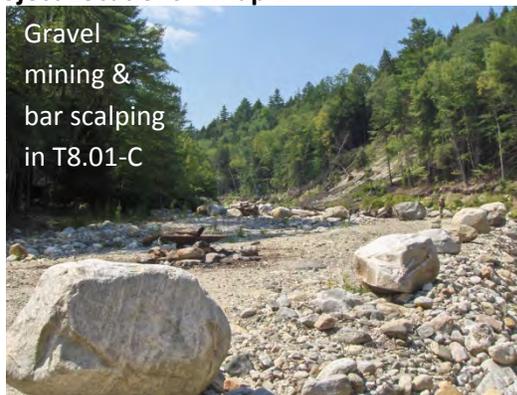
Gravel
mining &
bar scalping
in T8.01-C

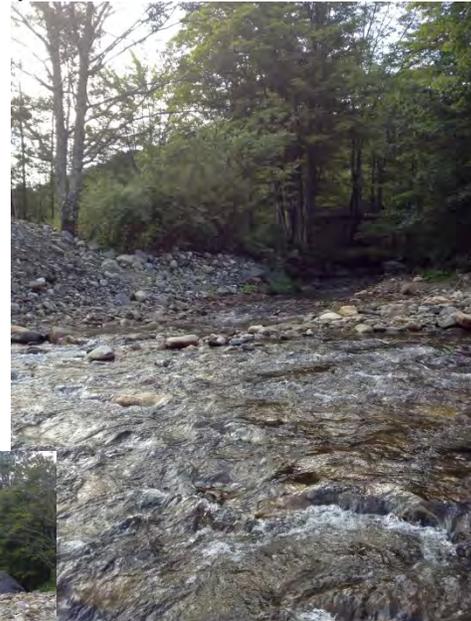
Project #13 – Return Windrowed Material

Project #13 T8.02-C & T8.03	Active Restoration	Just upstream of the floodplain bench project site, the windrowing continues. This windrowing could be returned to the brook at the same time the floodplain bench is constructed.	Return Windrowed Material to Channel	High Priority (same location as town project)	Improved geomorphic stability, habitat, and water quality	Landowners, WRC, VANR, Town of Wardsboro

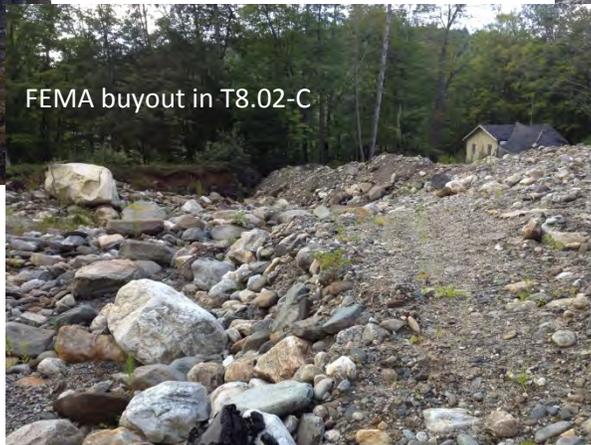
FEMA buyout in T8.02-C

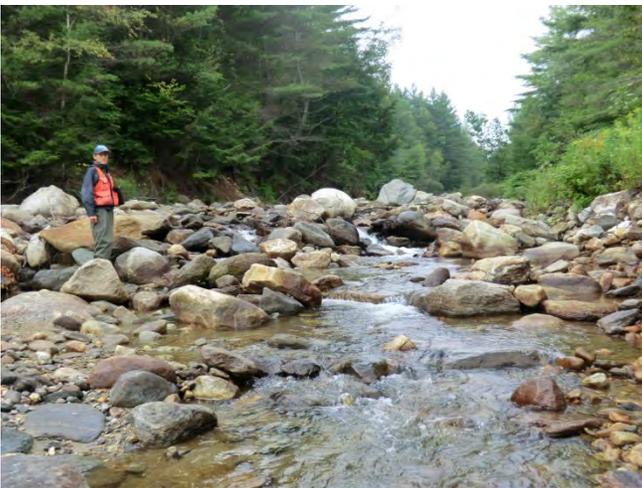
Project #19 – Arrest Headcut

Project #19 T8.04	Active Restoration	Stream channel was historically straightened and is actively headcutting.	Arrest Headcut	Moderate Priority	Improved geomorphic stability, habitat, and water quality	Landowners, WRC, VANR
Project #20 T8.05-A	Active Restoration	Above this segment, there is a large sediment plug, which has caused a major headcut at the top of the segment. Headcut may move upstream into area with good floodplain access. Sediment plug has led to a sediment-starved segment that has incised. Post-TSI windrowing has exacerbated these impacts.	Return Windrowed Material to Channel & Arrest Headcut	Moderate Priority	Improved geomorphic stability, habitat, and water quality	Landowners, WRC, VANR
Project #21 T8.05-B	Passive Restoration	Riparian buffer is poor on one side due to private lawn. Not a large area for planting & bank is windrowed.	Streamside Plantings	Low Priority	Improved habitat and water quality	Landowner, WRC TFS

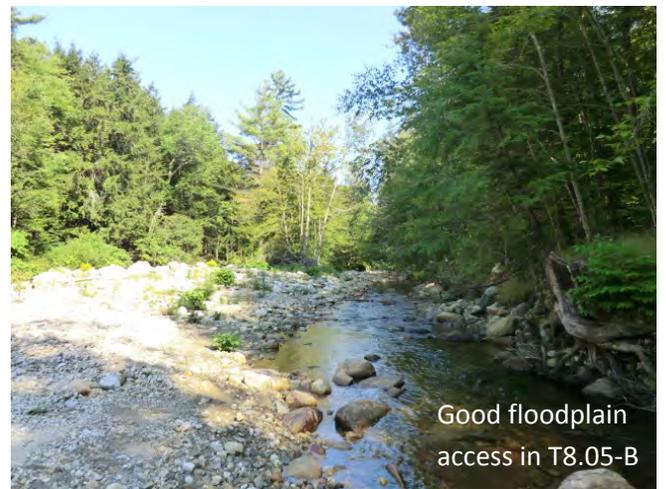
Project #22 – River Corridor Easement

Project #22 T8.05-B & C	Passive Restoration	Channel is undergoing active planform adjustment. Segment has good floodplain access.	River Corridor Easement	High Priority (one of the only segments in study area with good floodplain access)	Improved geomorphic stability, habitat, and water quality	Landowners, WRC RCE
Project #23 T8.05-B & C	Active Restoration	Channel was excavated & windrowed post-TSI along Rt. 100 and two houses, restricting floodplain access and creating a 4 foot berm. Berm is protecting a house.	Return Windrowed Material to Channel	Low Priority (Berm protecting a house)	Improved geomorphic stability, habitat, and water quality	Landowners, WRC, VANR

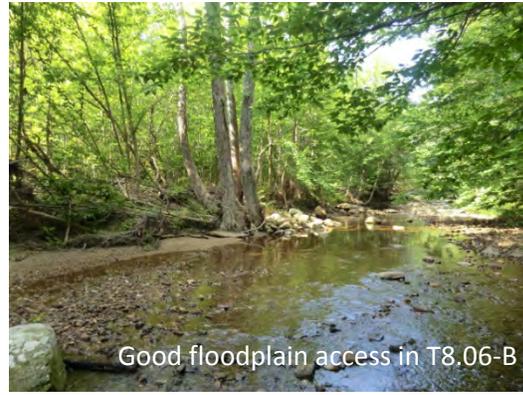
Good floodplain access in T8.06-B
