# River Corridor Plan for the Saxtons River Watershed Windham County, Vermont

September 30, 2010

**Fitzgerald Environmental Associates, LLC.**  
316 River Road  
Colchester, VT 05446

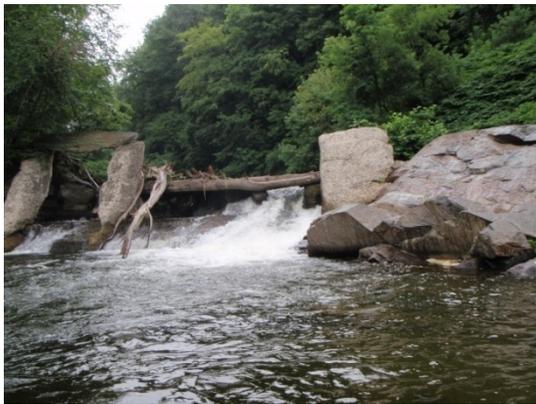
Figure 4.1 Blake and Higgins dam buttresses on a grade control

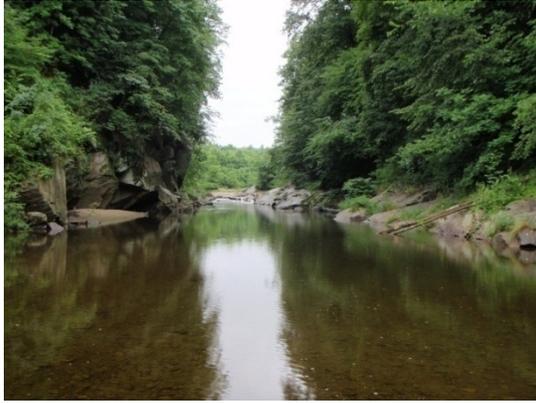
Figure 4.3 Upstream view from the dam at the bedrock gorge

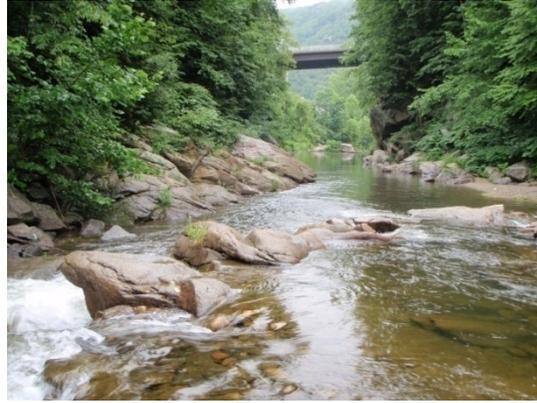
Figure 4.4 Looking downstream at the gorge toward Route 5

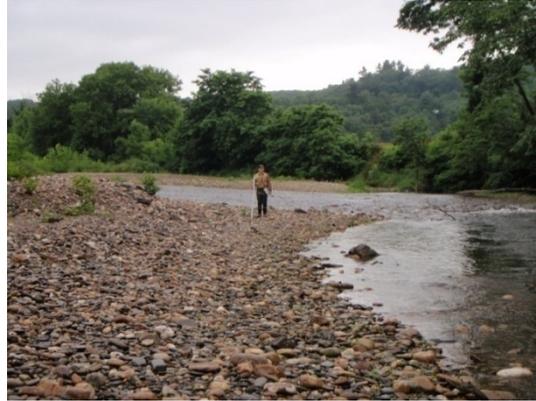
Figure 4.6 Sediment aggradation at steep riffle near M01

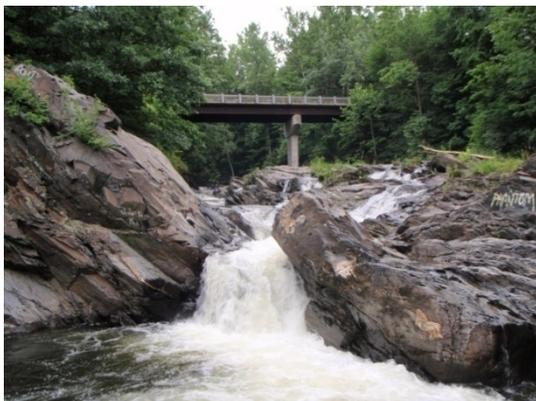
Figure 4.7 The grade control downstream of Covered Bridge Rd

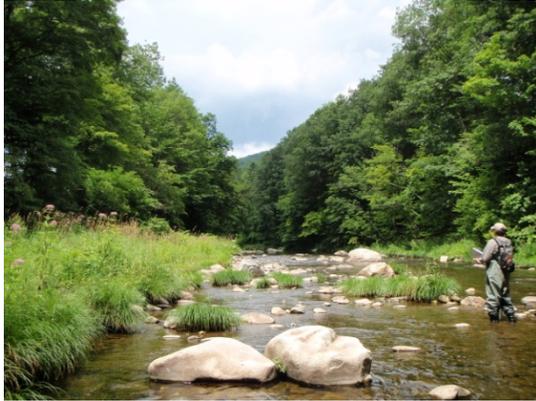
Figure 4.13 Looking upstream at B-Type channel

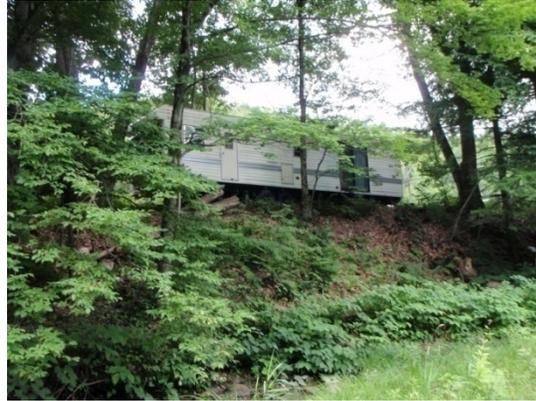
About 30% of the right corridor is developed and the residential buildings found within the corridor could be at risk during extreme events, especially where the valley wall broadens in the upper reach (Figure 4.14). The geomorphic condition is "Fair" and widening is the dominant adjustment process. The channel is in stage III of the CEM because of its moderate widening and incision. The habitat condition has been reduced by the availability of wood (LWD/Mile = 2) and pools (Pools/Mile = 5; RHA score = "Fair"). The buffer and bank condition is adequate for much of the reach keeping the condition "Fair" despite the low woody debris and pool densities.

Figure 4.14 Development on the RB along Route 121

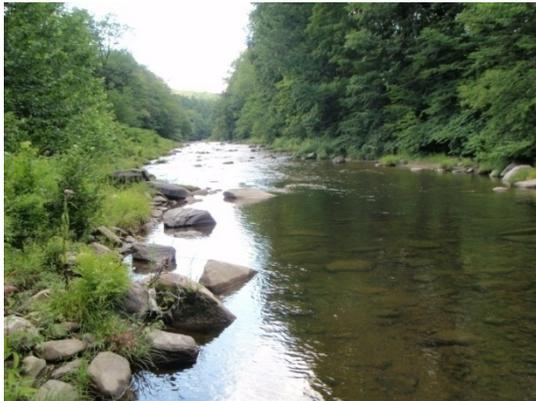
Figure 4.17 Plane bedform with little habitat

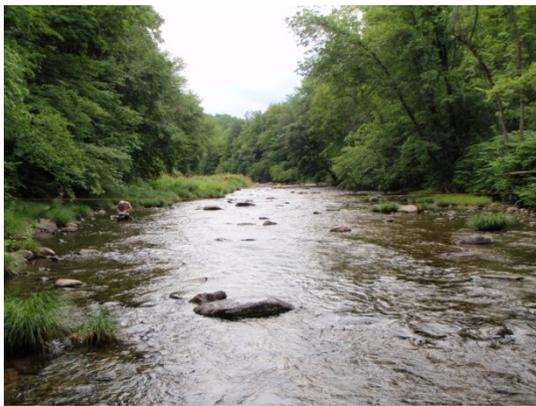
riffle-pool. The dominant substrate observed was cobble (43%) and the median substrate size was 60mm. Channel geometry reflects some widening (WDR = 28.5), with minor incision (IR = 1.6), and C-type entrenchment (ER = 3.2; Figure 4.19). One channel crossing, at McBride Road, seemed to be causing some bank scour and deposition above. The upstream end of the reach on the left bank had reduced buffer width because cattle are allowed to graze up to the channel's edge.

Figure 4.19 Channel geometry indicative of C-type morphology

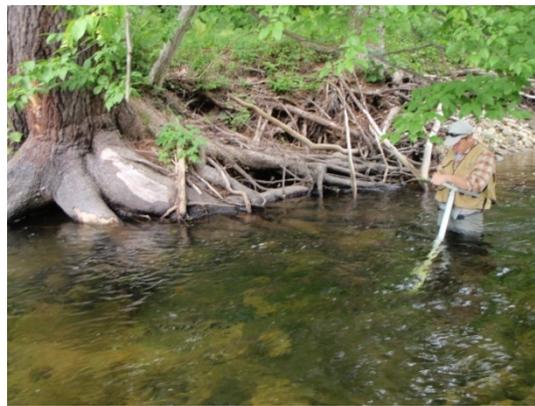
Upstream, in reach M09, channel migration and widening is causing sediment to be transported downstream. Reach M08 is aggrading the coarse substrate from upstream and its channel is also widening (RGA score "Fair"). The channel is currently in stage III of the CEM. M08's habitat condition does not seem to be seriously impacted by the aggrading sediment. However, the excessive widening and lack of woody debris (LWD/mile = 15) is reducing the habitat condition (RHA score = "Fair"). Pools were limited (pools/mile = 10), but several nice habitat features including undercut banks were noted (Figure 4.20).

Figure 4.20 Undercut bank located in area of migration

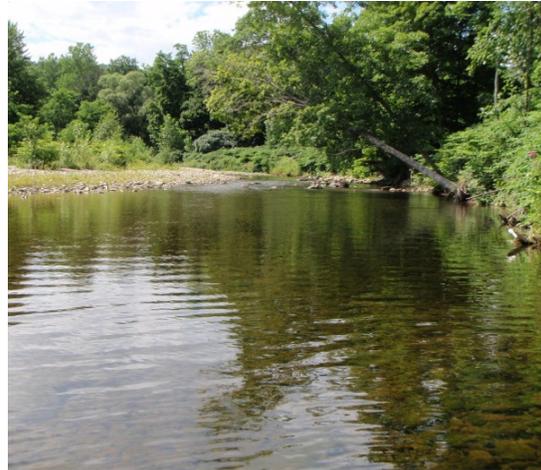
The multiple flood chutes present, along with aggradation and side bar development indicates widening and planform changes. The geomorphic condition is highly unstable and the lack of grade controls has likely led to the advanced stage of the CEM (RGA score = "Fair"; CEM stage = IId, D-model). Some restoration efforts were made on the right bank (Figure 4.21). There, willow plantings and rip-rap were installed to prevent further channel migration and potential avulsions out into the hay field to the southeast. The habitat was influenced by the shallow nature of the channelized flow (Figure 4.22). Pools were limited (pools/mile = 9), and the channel was often too shallow to support a diverse assemblage of aquatic species. Woody debris was quite low (LWD/mile = 17) and the habitat condition seemed to reflect the geomorphic condition (RHA score = "Fair").

Figure 4.22 Wide, shallow channel with little available habitat

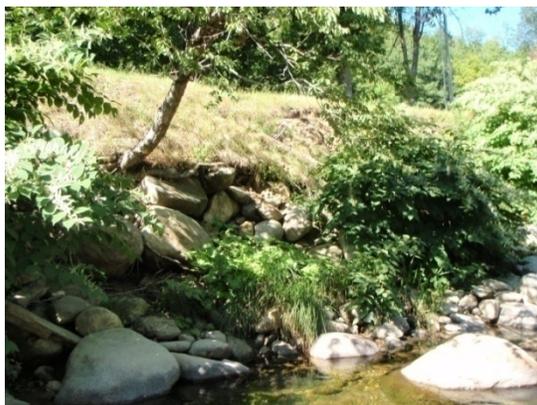
Figure 4.23 Human elevated floodplain in lower reach

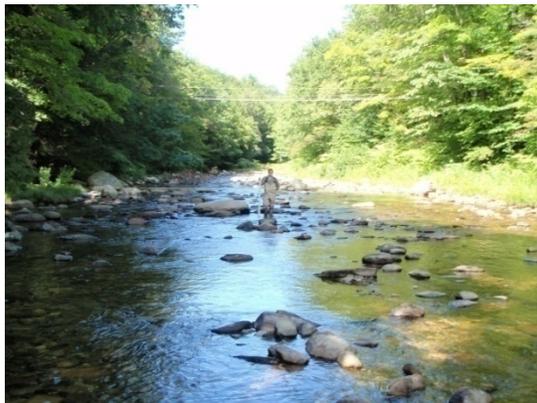
Figure 4.25 Cross-section looking upstream at C-type geometry Figure 4.26 Deep pool feature downstream of Rt 121 crossing

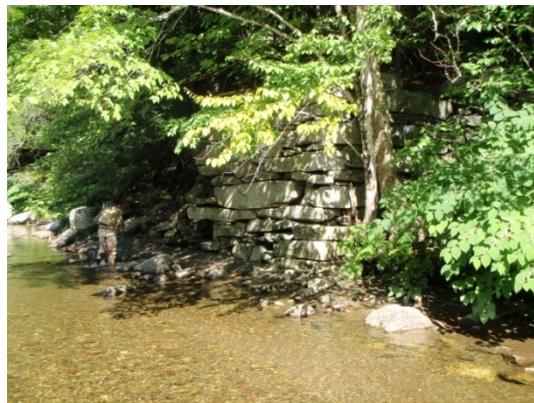
The channel is encroached upon entirely by Route 121, which has led to substantial changes in the natural geomorphic adjustment processes. Incision caused by road encroachment has caused a stream type departure, from C to B<sub>c</sub> due to lack of extensive floodplain (RGA score = "Fair"). The stream is in stage II of the F-model of CEM. Some meandering profile and habitat formation was noted in the lower reach, but extensive historical channel encroachment has led to a simplified form with limited habitat. Fine sediment deposition also reduces the viable habitat (RHA score = "Fair"; Figure 4.28).

Figure 4.28 Fine sediment deposition near Route 121 crossing

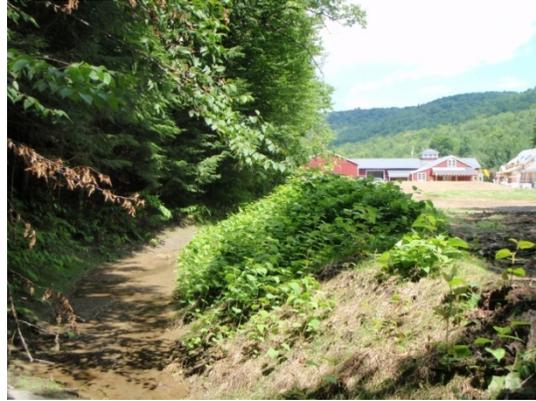
The encroachment has affected the natural channel form significantly, but not as much as it did in M14. M15 still retains a riffle-pool bedform with some regularity in its riffle spacing. The geomorphic condition is "Fair" and the large number of side bar features (13 total) indicates that the channel is beginning to change its planform and is in stage III of the CEM. The alpaca farm in the upper reach has a dredged farm ditch to divert water coming off the steep valley wall into the channel and prevent ponding in the fields (Figure 4.34). This feature could be adding significant amounts of fine

Figure 4.34 Farm ditch that drains water from steep slope

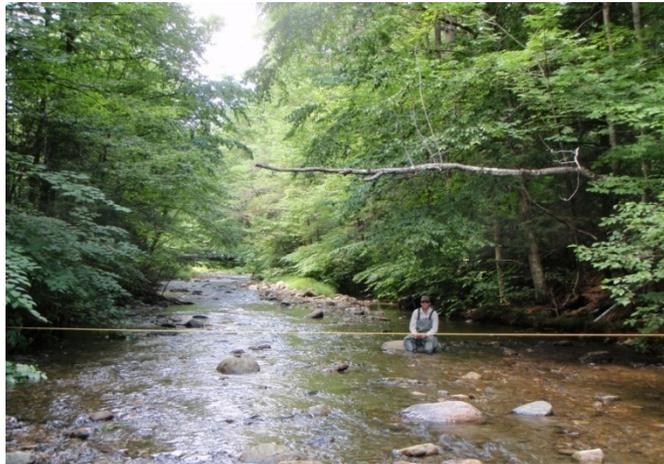
Like M15, M16 also runs along Route 121. The reach begins north of the alpaca farm and extends 0.7 miles upstream to the reach break by a snowmobile bridge. Reach M16 is set in a semi-confined valley. The low slope for this setting (slope = 0.8%) is causing sediment to aggrade and give the channel a plane bedform. The channel exhibits C-type morphology, with a width-to-depth and entrenchment ratio of 21.3 and 1.8, respectively (Figure 4.35). The entire length of the channel is encroached upon by Route 121, which has limited the ability of the channel to shift its planform and redevelop sinuosity. The substrate is predominately gravel (45%) and cobble (42%), with a median particle size of 60mm. Some incision on this reach can be attributed to the encroachment of Route 121 (IR = 1.6). The human elevated floodplain in the form of fill from Route 121 has made the natural floodplain much smaller (HEIR = 2.8).

Figure 4.35 M16 Cross-section looking upstream

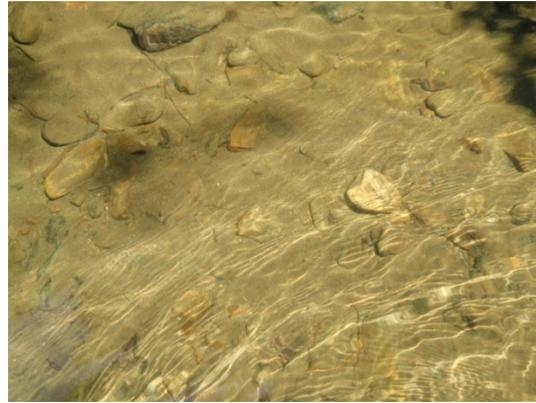
amount of fine sediment depositing upstream with very high embeddedness (Figure 4.36; Figure 4.37). Limited pools (pools/mile = 10) and woody debris (LWD/mile = 12), along with the encroachment reduced the habitat condition (RHA score = "Fair").

Figure 4.37. Deposition of fines and high embeddedness

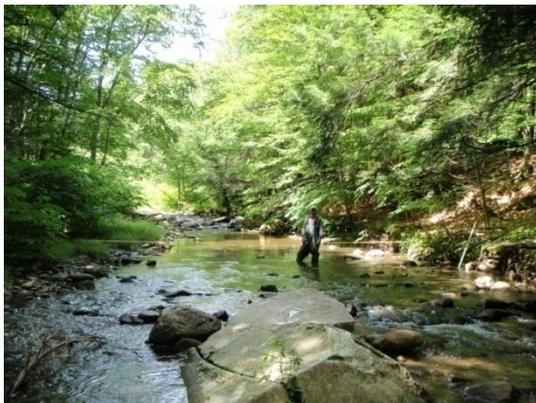
Reach M18 is 0.5 miles in length and extends up Route 121 until the change in slope. The stream has B-type morphology and a subclass slope of c (slope = 1.6%). The width-to-depth and entrenchment ratios both reflect the stream typing (WDR = 22.3; ER = 1.6). No incision (IR = 1.0) was observed at the cross-section (Figure 4.40). M18’s valley is narrowly confined and has human-caused change from Route 121. The encroachment and change to the valley width has not affected the bedform, which remains riffle-pool. The reach’s substrate is predominately gravel (43%) and cobble (36%), with a median particle size of 55mm. Off the left bank mid-reach there is a flood chute that extends downstream about 1,100 feet and parallels the road (Figure 4.41). The flood chute had some water in it at the time of the survey, but flows through it are likely quite large during spring snowmelt.

Figure 4.40 M18 cross-section looking upstream.

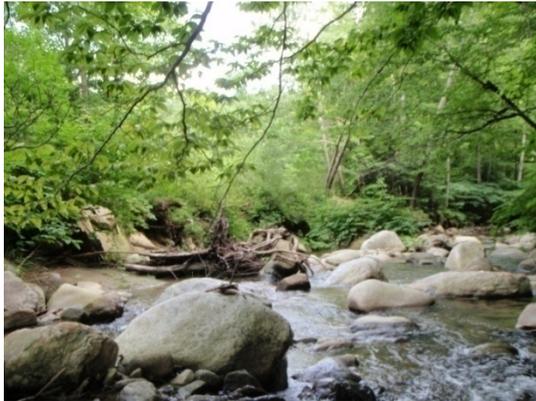
While Phase 2 assessments were underway a stream bank revetment project was completed on 750 feet of channel mid-reach. The land owners were concerned about the banks receding into their field and received the permits necessary to work in the channel. The reach was assessed prior to installation, and then reexamined after rip-rap lined a good portion of both banks. Prior to construction this area had the best habitat in the reach, with deep pools (pools/mile = 22), overhung banks, and woody debris (LWD/mile = 12) that slumped into the channel (Figure 4.43). The habitat features that were present in the reach prior to the revetment project yielded a "Good" RHA score. After the rip-rap was installed most of the quality habitat features were removed and all wood was removed from the channel (Figure 4.44). The current RHA score is not known, but given the extent of rip-rap and pool filling, it is likely that it would score in a lower category. Shifts in planform associated with eroding banks and some minor widening were observed. The reach scored "Fair" for the RGA. Much of the upper reach is controlled vertically by bedrock outcrops, but the majority of the channel is in stage IV of the CEM.

Figure 4.43 The left bank prior to rip-rapping

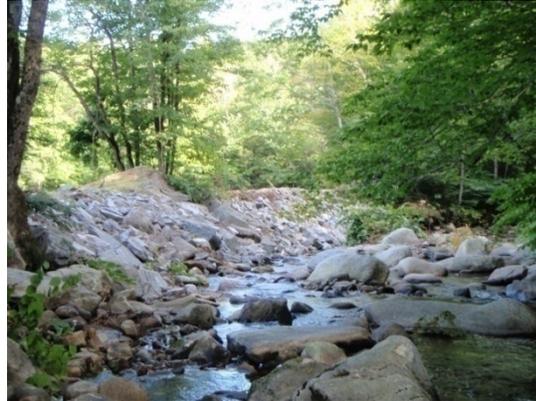
Figure 4.44 Rip-rap and the removal of vegetation on the LB

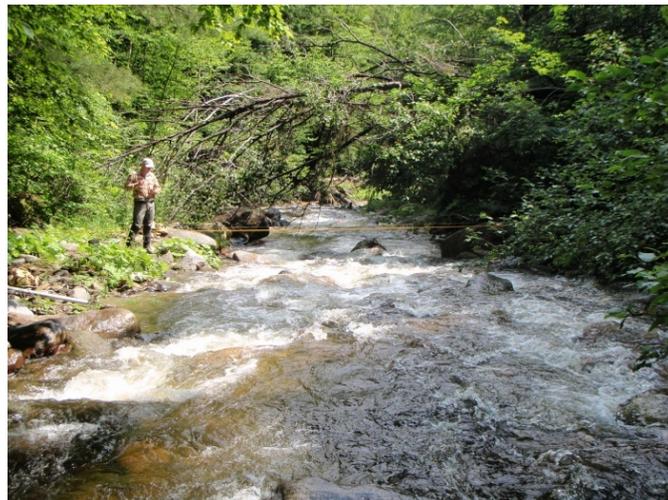
Figure 4.45 M20-A cross-section looking downstream

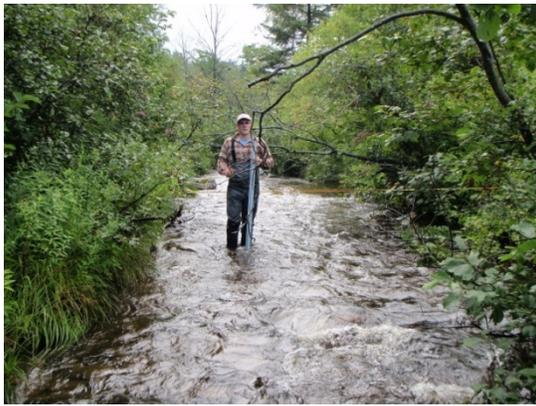
Figure 4.47 M20-B cross-section looking upstream

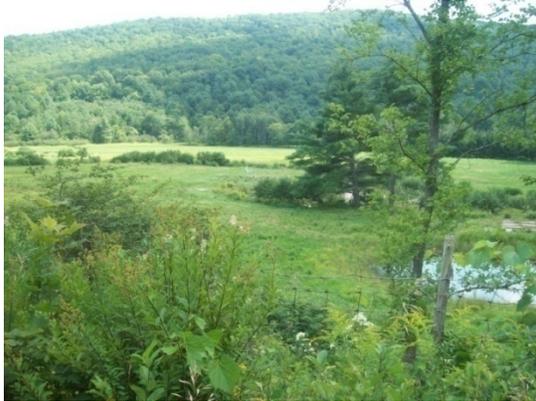
Figure 4.50 Wide alluvial valley of T4.01-A

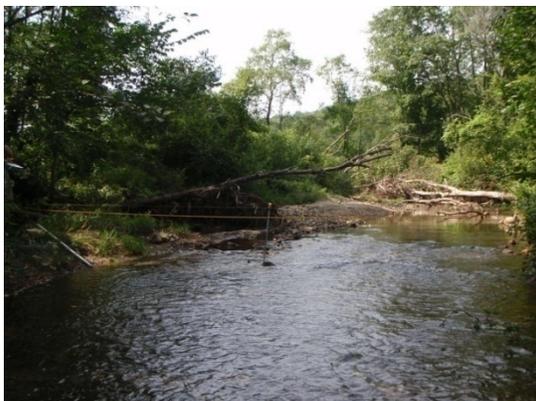
Figure 4.52 Cross-section location looking upstream

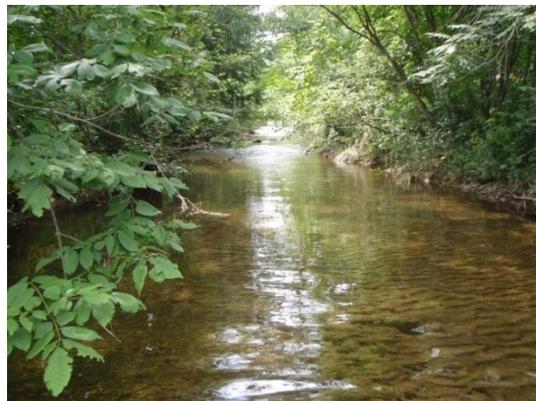
Segment T4.01-B begins at the segment break just upstream of a farm road crossing off Brookline Road and ends at the confluence with tributary Athens Brook (T4.S1.01). The segment is 2.0 miles in length and an average slope of 0.6%. The channel exhibits C-type morphology with a width-to-depth ratio and entrenchment ratio of 12.9 and 15.8, respectively (Figure 4.52). The substrate is predominately gravel (39%) and cobble (34%) with a median particle size of 30mm (gravel). The segment showed signs of minor incision, but not enough to drastically reduce the floodplain connectivity ( $IR = 1.2$ ). Bedform in this segment was predominately riffle-pool, with some areas resembling plane bed because of historic channel straightening and armoring (Figure 4.53).

Figure 4.53 Straightened area along Brookline Road

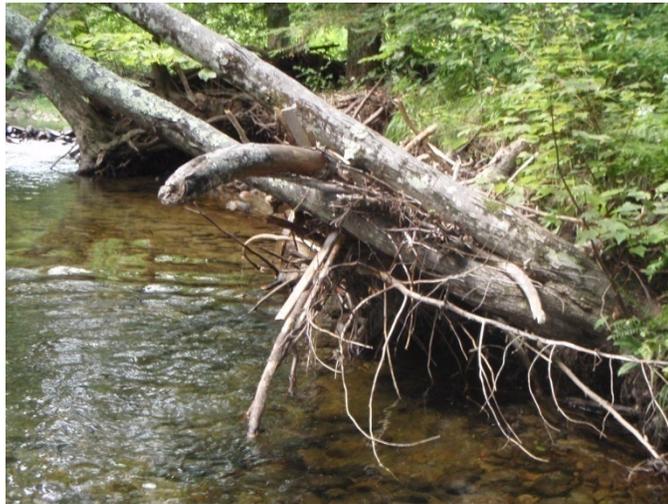
T4.01-B is a dynamic channel with a high bed load, active meander bends, and excellent pool formation (pools/mile = 35). Most pools had good cover over a large portion of the pool area or were in conjunction with undercut banks (Figure 4.54). Existing habitat potential is very high and could be improved in the lower segment with reforestation and planting projects. The area with historical channel straightening mid-segment where the bedform is plane bed had limited habitat and slightly lowered the overall score (RHA score = "Good"). Large woody debris was common (LWD/Mile = 62). The lower segment lacks woody buffer in some areas, which has led to some moderate erosion on the outside of meander bends. Shifting planform is the dominant geomorphic adjustment observed in this segment. The overall geomorphic score was influenced because of a neck-cutoffs and other areas of possible avulsion (RGA score = "Fair"). Evidence of historic incision and some widening are good indicators of stage III of the CEM.

Figure 4.54 Pool and undercut bank located in the upper segment

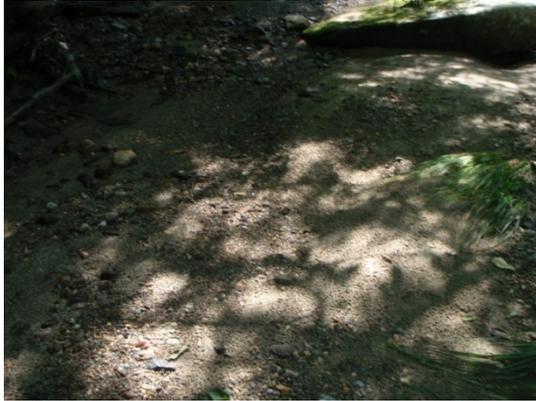
Figure 4.55 Fine substrate deposits behind a boulder

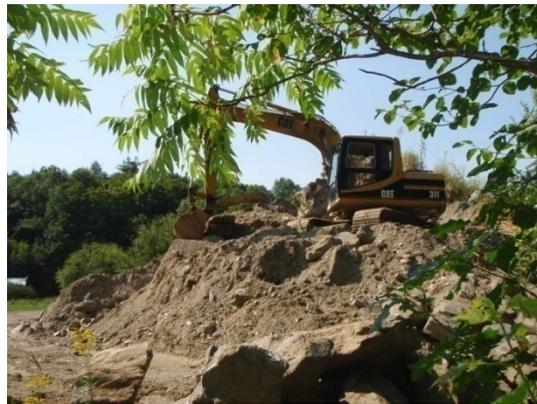
Geomorphically, this reach is nearly stable but responding to the increase in sediment from upslope sources. The reach is in stage II of the F model CEM and the RGA score is “Fair”. The lower part of this reach had good habitat features despite the increase in fine sediment from the mass failure and breached beaver dams. (LWD/mile =75; pools/mile = 28) The quality of habitat in the lower reach can be attributed to the adequate bank and buffer vegetation, as well as accessible floodplain (RHA score = “Fair”). However, the upper reach had some extensive development in the left corridor. The land was cleared there, exposing surficial material and fill. At the time of the Phase 2 survey no silt fences or sediment management practices were in place to protect the channel from sedimentation (Figure 4.57). Upstream, a pile of fill soil was within 25 feet of the channel, again with no management practices in place (Figure 4.58).

Figure 4.58 Fill and excavator within 25 feet of channel

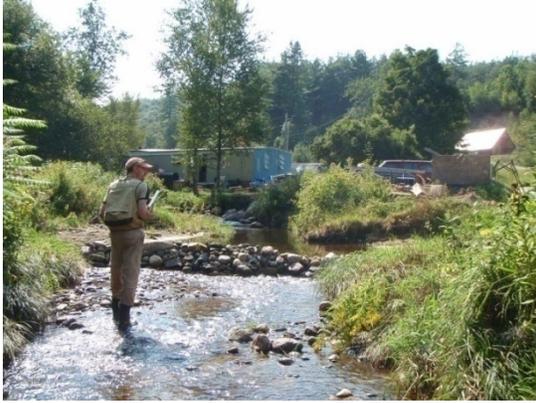
The upstream end of this reach has extensive impacts to the banks and riparian zone because of development within the stream corridor. A trailer park straddles the channel and many trailers are within the floodprone area, sitting very close to the bankfull channel elevation (Figure 4.59). Structures in this area are at risk during flood events and the low buffer width has impacted the channels banks. One stream crossing in the upper reach is acting as a bankfull channel constriction. The clearance of this structure is also very low and could pose a problem during high flow events and washout (Figure 4.60).

Figure 4.59 Development and low buffer width in upper reach

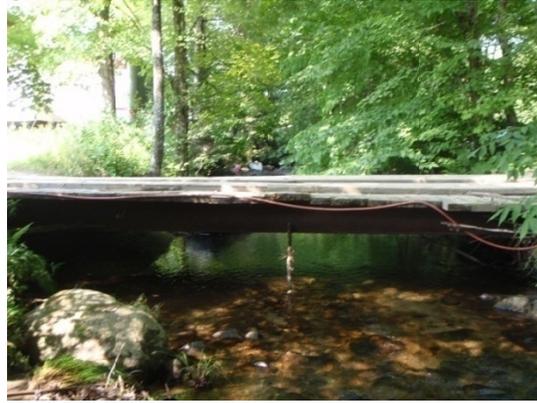
Figure 4.60 Bridge with low clearance; 22 ft construction

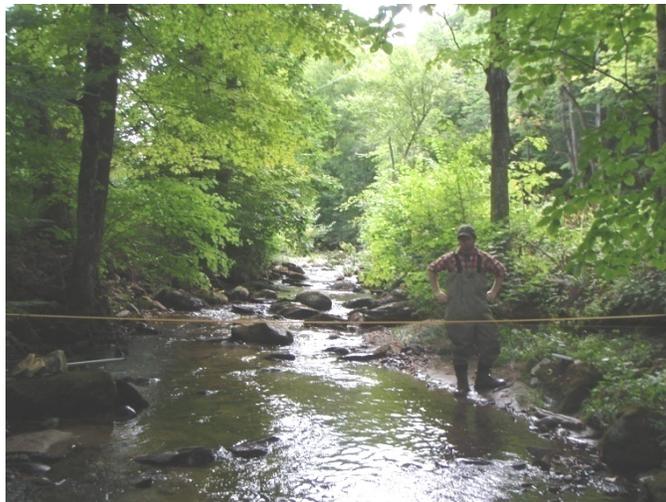
Figure 4.61 Cross-section looking upstream with Brookline Road in the left corridor (Photo Right)

There is little evidence of continued incision and degradation; the stream type departure from C to F-type likely happened when the road was built and is an historic adjustment. The channel is in stage III of the CEM because some widening is occurring now in areas that the stream bank is not armored by the road embankment. Planform changes are occurring now as the channel tries to develop some sinuosity in the confined setting (RGA score = "Fair"). Habitat quality in this segment is reduced because of the poor buffer width and bank condition on the left side (RHA score = "Fair").

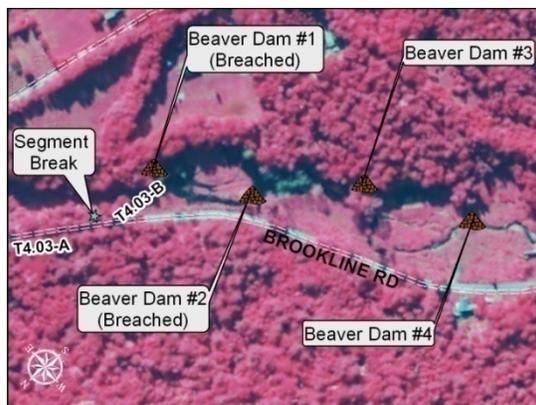
In total, T4.03-B has 4 beaver dams (Figure 4.62). Two of them have been breached by humans or have been blown out during a large storm event (Figure 4.63). The other two dams are intact and trapping extensive amounts of sediment upstream. The channel is responding to the base water level drop following the loss of the two major dams. The changes in channel state have occurred rapidly, because in 2008 both lower dams were intact.

Figure 4.62 Infrared aerial imagery of the beaver dam area

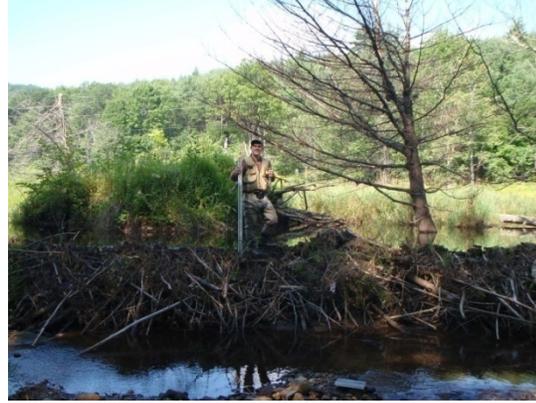
Figure 4.65 3rd beaver dam causing extensive ponding

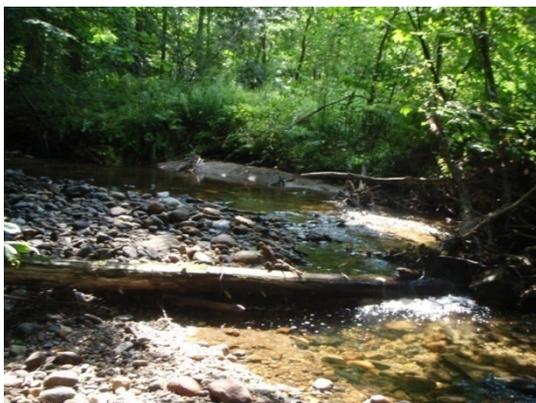
Segment C is 0.7 miles long and extends up to the reach break with T4.04 just upstream of the Brookline Road crossing. T4.03-C has Cb-type geometry with width-to-depth, entrenchment, and incision ratios of 17.0, 2.4, and 1.6, respectively. The segment is set in an unconfined, very broad valley but does not have any impacts associated with beaver activity. The slope is approximately 2.6%, giving the segment a subclass slope (b). The substrate is predominately cobble (45%) and gravel (41%) with a median substrate size of 60mm (gravel). The dominate bedform was riffle-pool, but areas in the upper reach had step-pool features (Figure 4.66).

Figure 4.66 The start of well-formed riffle-pool in stage IV CEM

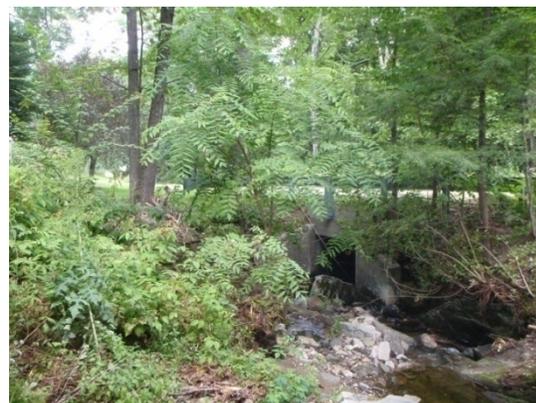
Figure 4.67 Area where channel crossed Brookline Road

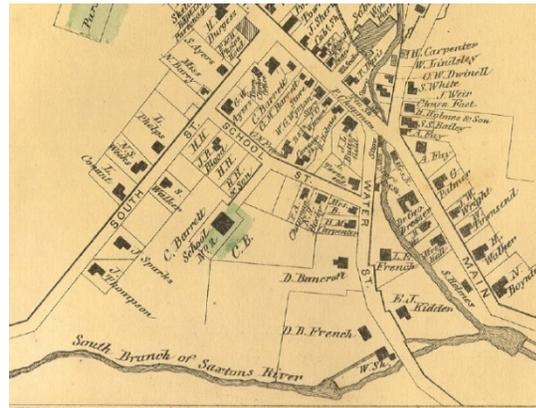
Figure 4.69 1869 Beer's Atlas showing dam and sluiceway

A section of a breached dam remains in place in the lower reach approximately 300 feet upstream of the covered bridge at the Kidder Hill Road crossing (Figure 4.68). This structure was part of a raceway diversion to a mill located along the north bank (Figure 4.69) just west of Kidder Hill Road (previously called Water Street). The structure was constructed on a grade control that spans at least half of the channel. Although the structure is partially breached, the concentration of flow and debris around the structure may limit the passage of juvenile fish into the upper reaches of the South Branch. In addition, sediment deposition occurring upstream of the structure is causing minor bank instability on the left bank. The removal of this structure to improve fish passage and channel stability is explored further in the project development summary in Appendix F.

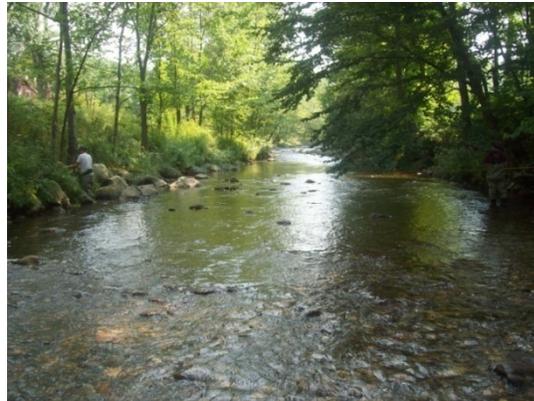
severe channel incision ( $HEIR = 2.8$ ;  $IR = 2.2$ ) resulting from straightening, bank armoring and encroachment of the road along the river corridor (Figure 4.70), a stream type departure was noted from C to F-type geometry ( $WDR = 13.1$ ;  $ER = 1.5$ ; Figure 4.71). The bed substrate is dominated by cobble (43%) and coarse gravel (34%), with limited fining noted in the riffles.

Figure 4.71 Cross-section location looking upstream

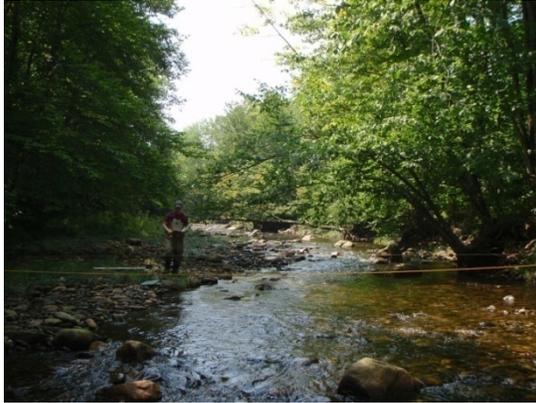
Figure 4.72 Cross-section location looking upstream

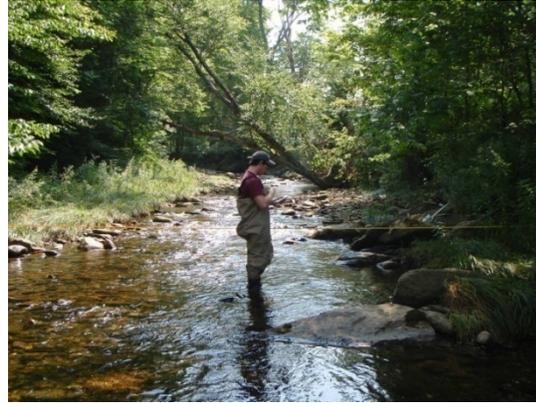
Reach T6.03 is 0.9 miles in length and begins at the confluence with Howe Brook (T6.S1.01) and ends at the confluence with Willie Brook (T6.S2.01). The reach is very similar to that of T6.02; it is almost entirely encroached upon by Townshend road and has a slope of 1.1% (Figure 4.75). The upslope drainage area is smaller because Howe Brook has a watershed area of 5.1 square miles. By reference T6.03 would be a meandering C-type channel with riffle-pool bedform, but impacts from encroachments and straightening have caused a stream type departure. T6.03 now exhibits Bc-type channel geometry with a width-to-depth ratio of 20.4 and an entrenchment ratio of 2.1 (Figure 4.76). The substrates are predominately cobble (42%) and gravel (33%) and the median particle size

Figure 4.76 Cross-section location looking upstream

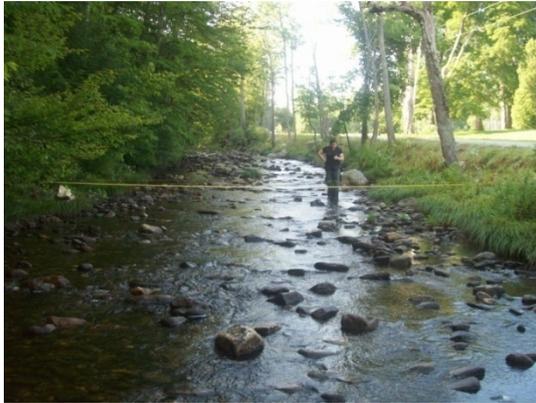
Figure 4.78 Cross-section mid-segment in T6.04-A

Some channel aggradation and widening were noted in the cross-section mid-segment. Straightening within the alluvial fan in the upstream segment may be causing excess sediment transport into this area. Some fining in the bed substrate was noted, and the overall RGA condition for the segment was noted as “Fair” with a CEM stage of III. Pool and LWD densities were within the expected ranges for riffle-pool stream types; however a majority of these features fell within the smaller size classes, indicating a lack of habitat diversity. Impacts to the bank and buffer conditions resulted in an overall rating of “Fair”.

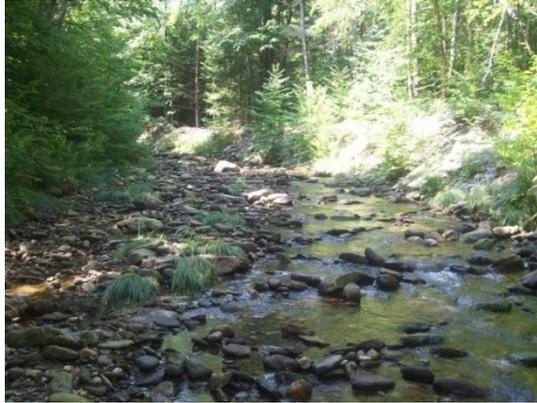
Figure 4.80 Old stone walls along the left bank of Styles Brook

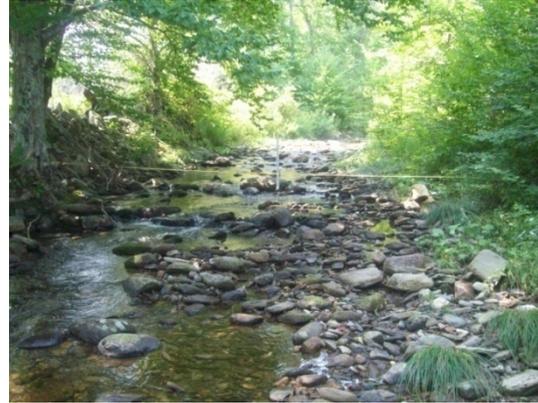
Figure 4.81 Cross-section mid-segment on T6.04-B

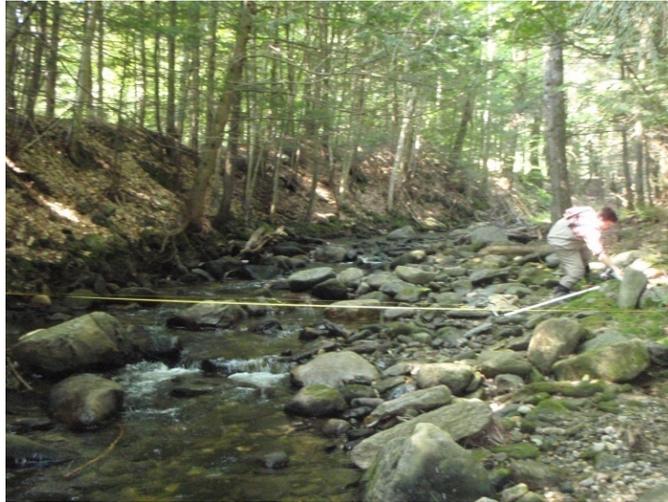
The width-to-depth, entrenchment, and incision ratios are 16.2, 1.5, and 2.0 respectively. The abandoned floodplain is high above the active channel, occurring at the same elevation of the hay field to the south. The substrate is predominately cobble (42%) with a median substrate size of 95mm (cobble). Bedform in T6.S1.01-A is plane bed, and the valley is semi-confined. Reference conditions were kept as B-type, because the alluvial fan must have been straightened so long ago that no visible remains of historical channels and floodchutes were observed.

**Figure 4.83** Cross-section with B-type channel geometry looking upstream

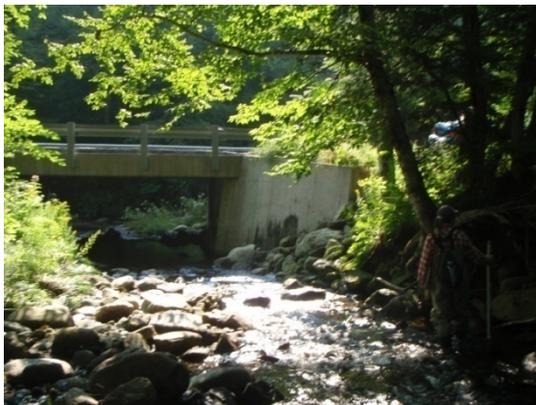
**Figure 4.84** Townshend Road crossing; dredging location

The Townshend Road crossing at the reach break is undersized and potentially problematic. Following the floods in the late 1990's the crossing became blocked by sediment and dredging was done to clear the structure (Figure 4.84). The planform is much more dynamic in the upper segment. There are some braided flows and more evidence of the alluvial fan. A historic berm on the right bank that prevents water from flowing out to the south where the channel bends to the north has led to a mass failure on the left bank downstream (Figure 4.85). The geomorphic condition of this reach has been impacted by the past land use and human modification of the channel (RGA score = "Fair"). It seems that the straightening and berming have resulted in tremendous degradation (with no stream type departure) and the channel does not seem to be able to advance from stage II of the CEM. Bank and buffer width is adequate in the upper segment, but the lower area near Townshend road has mowed lawn up to hard bank armoring on the left bank. Pools (pools/mile = 25) and large woody debris (LWD/mile = 78) were more common in the upper segment and the over RHA condition was "Fair".

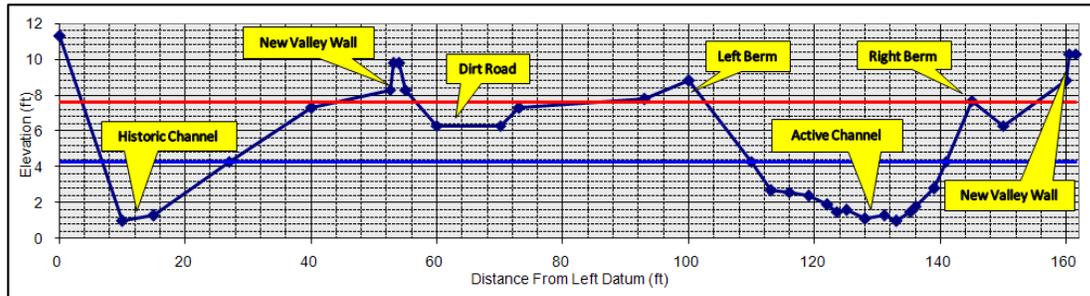
Figure 4.86 Cross-section of Willie Brook, showing historic channel and modified valley width

Willie Brook, reach T6.S2.01 is a long reach (4.5 miles) that extends up to the northwest toward Burt Hill. The high slope of the reach transitioning into the flat valley of the South Branch of the Saxtons River made it a probable location for an alluvial fan. For Phase 2 analysis only the portion of the reach impacted by the alluvial fan was assessed. This area was segmented to distinguish it from the upslope channel that was not assessed. This segment has significant dredging and straightening throughout the alluvial fan; the channel bed elevation is likely much lower than the pre-straightened elevation. The lower portion of Willie Brook has extensive evidence of previous channels that suggest a past history as an alluvial fan (Figure 4.86). The segment is 0.3 miles in length and as a channel slope of approximately 4.0%. Currently, T6.S2.01-A exhibits F-type channel morphology with width-to-depth and entrenchment ratios of 14.0 and 1.3, respectively. Incision from the natural floodplain to the right of the right berm is 1.6. The median substrate size is 110mm with 53% cobble and the bedform is plane bed. By reference this segment would be a braided D-type channel with an unconfined setting. However, the modifications to the channel have reduced the valley width to 107 feet, which is a semi-confined valley.

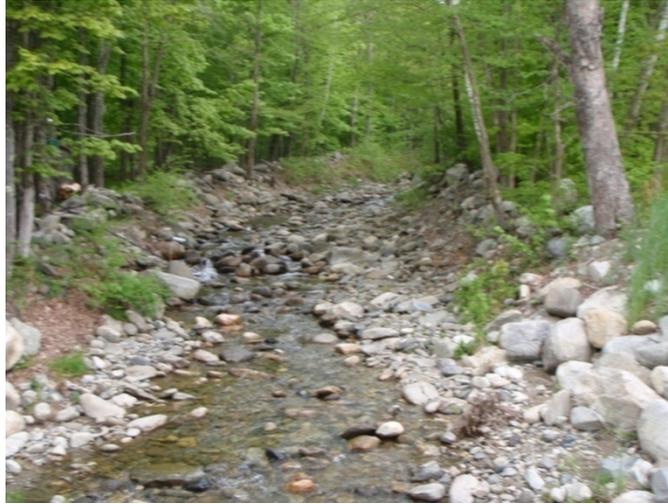
**Figure 4.87** Looking upstream from the Townshend Road crossing at the dredged and straightened channel

Human modification through straightening and berming has increased transport capacity and made the Townshend Road crossing in the lower reach a problematic area for debris jams during flooding events. Field observations and interviews with local land owners indicate that the bridge is undersized and was problematic during the large floods in the late 1990's. Following the flood, the bridge was completely clogged with sediment and the channel was extensively dredged (Figure 4.87). Stone pilings from the dredging remain on either side of the channel downstream of the crossing (Figure 4.88; Figure 4.89)

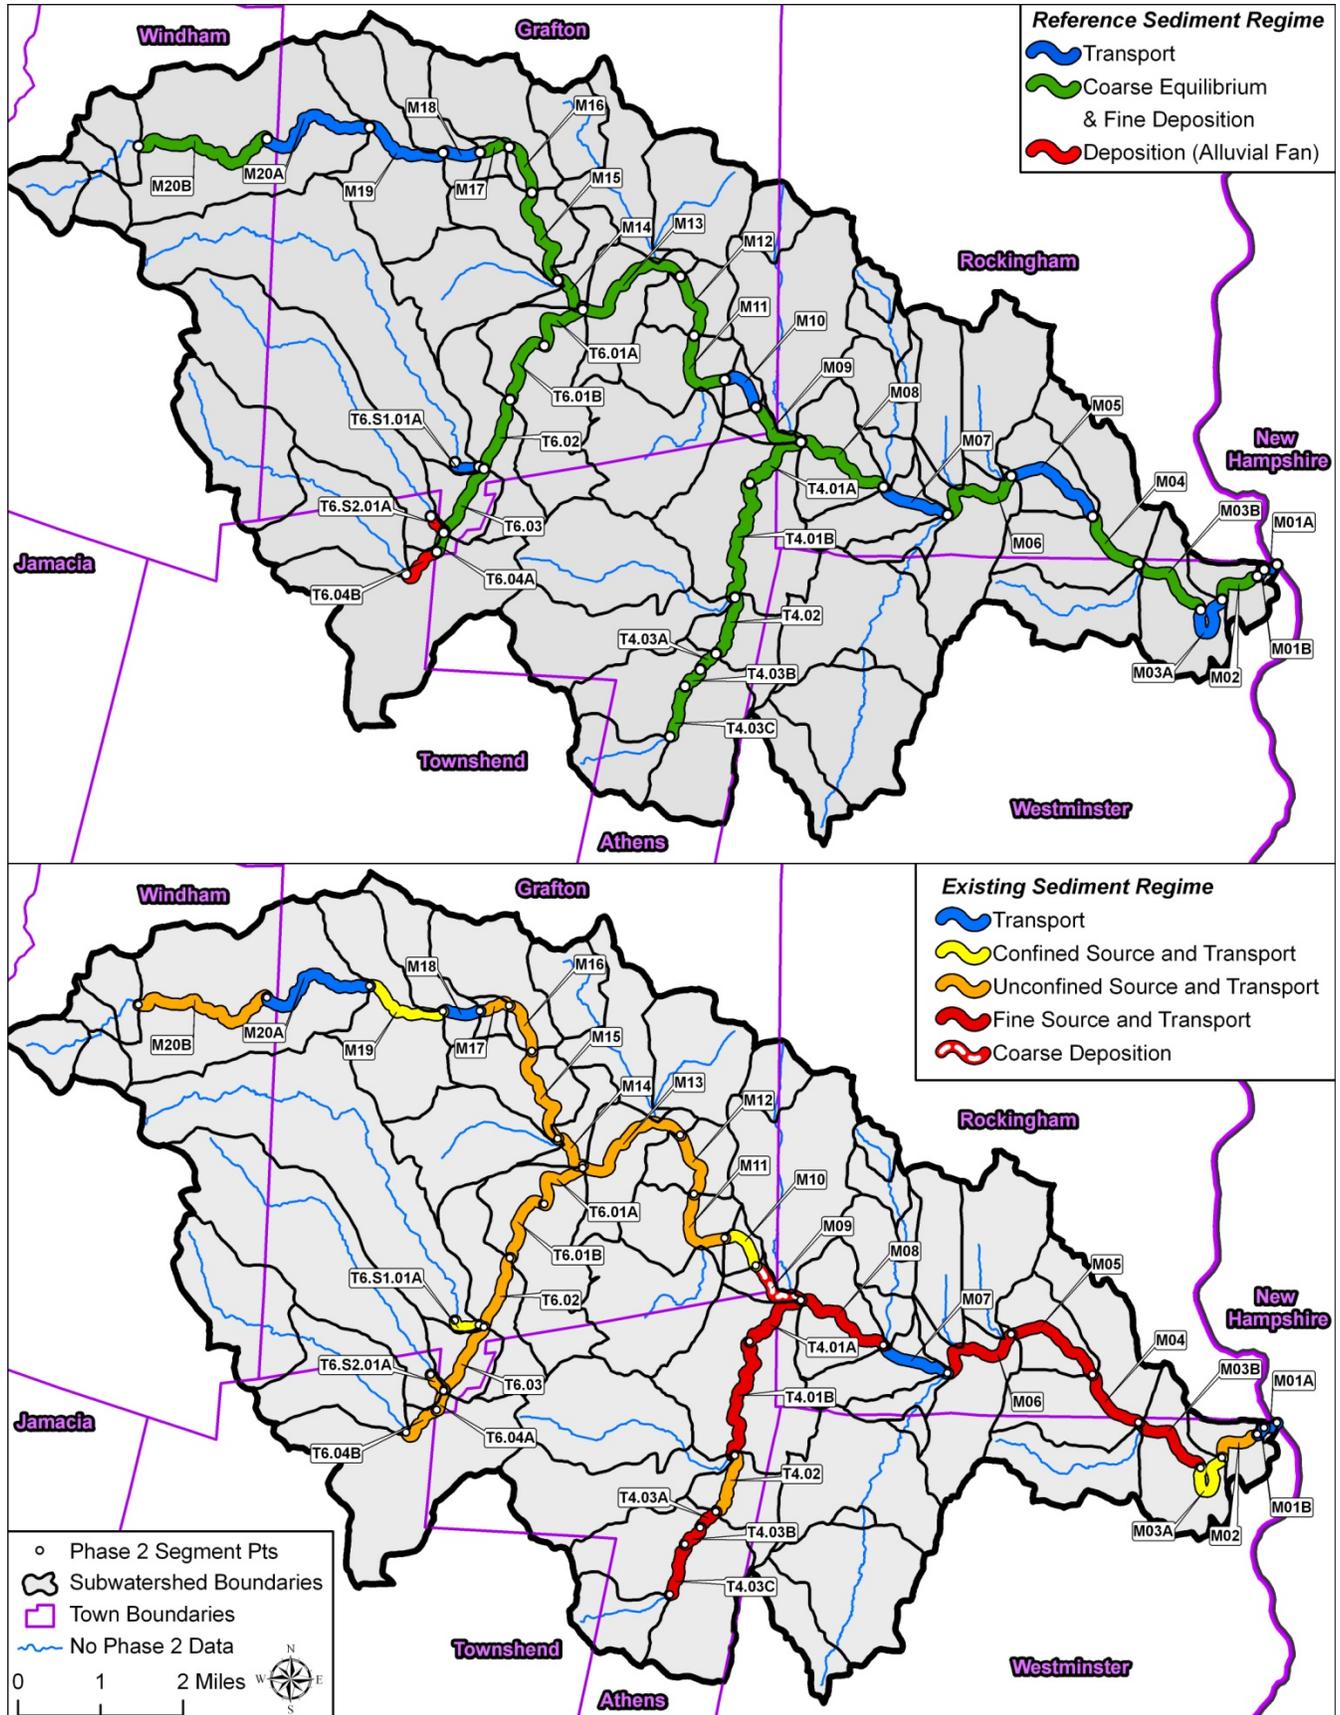
Figure 4.90 Reference and Existing Sediment Regime Maps for the Saxtons River

The reference and existing sediment regime types have been mapped using data from the Phase 1 and 2 assessments (Figure 4.90). Many segments have undergone a departure in sediment regime type due to channel incision and/or widening as a result of: 1) historical land uses, 2) encroachments or development in the river corridor, or 3) extensive straightening and bank armoring. Reach stream type departures are summarized below to help better describe the

reaches where physical changes in channel morphology have accompanied sediment regime change (Table 4.3). The most common stream type departures observed were C to B and C to F.

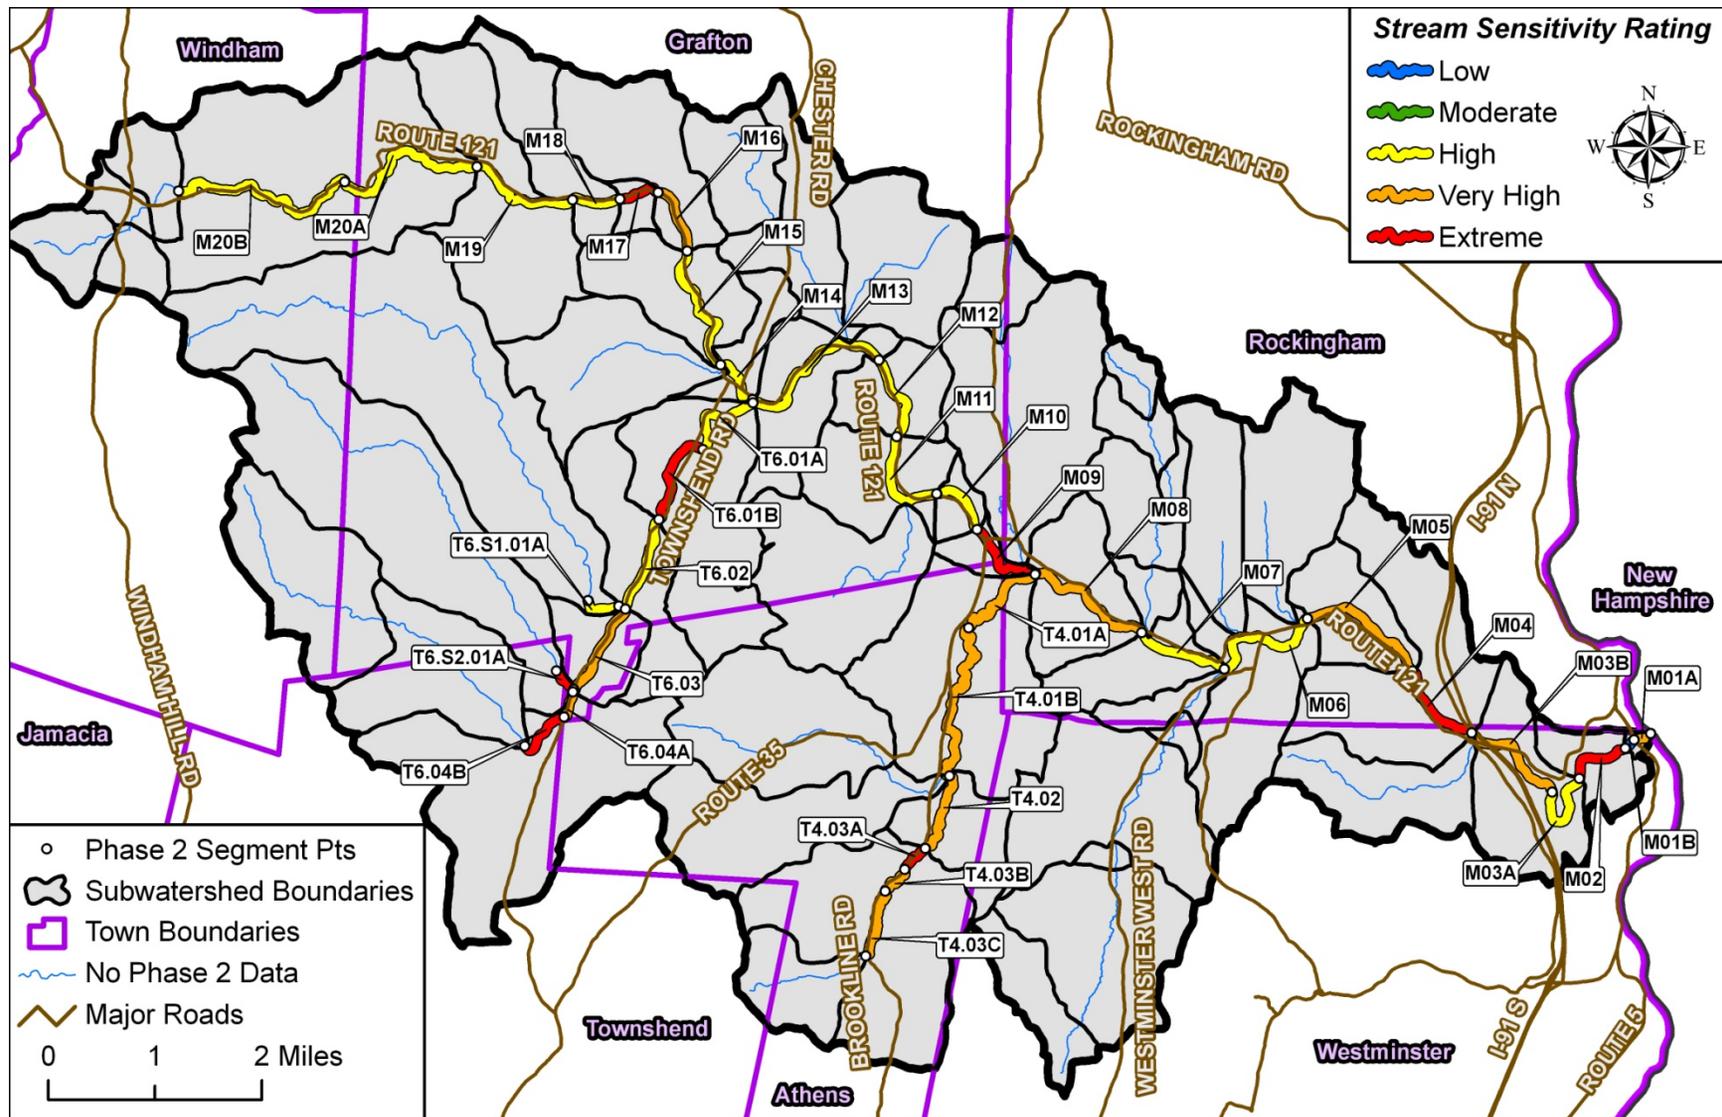
Figure 4.91 Stream Sensitivity Rating Map for the Saxtons River

The methods outlined in the Corridor Planning Guide have been used to describe the stream sensitivities of the segments in the Saxtons River study area. Using the stream geometry and substrate data in conjunction with overall geomorphic stability (RGA score) as determined during the Phase 2 surveys, stream sensitivity ratings have been assigned to each segment (Figure 4.91).
