TOWN OF GEORGIA

STORMWATER MANAGEMENT PLAN

FINAL REPORT

Stone Project ID 112475-W
February 20, 2013

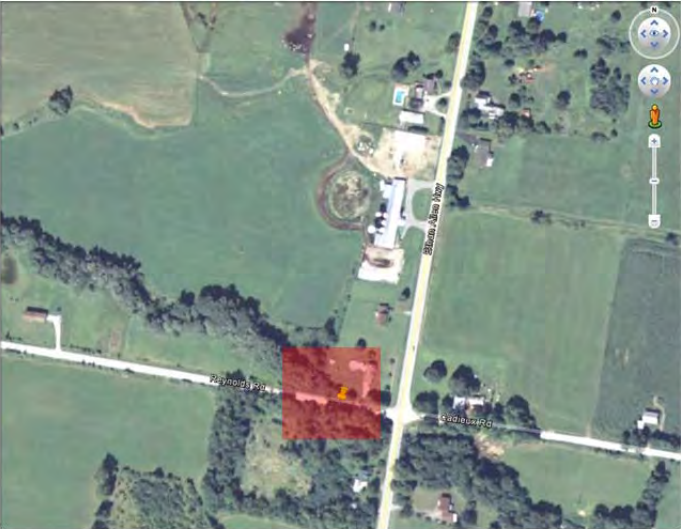
Watershed:	Mill River													
Location:	Reynolds Rd., just east of intersection with Route 7													
Problem Type:	Drainage/Culvert													
Identification Source:	Fluvial Erosion Hazard Mapping and Phase 2 SGA Report													
Ownership:	Local													
Classification Level:	2b													
Problem Description:														
Stormwater pipe inputs along Mill River from road crossings and agriculture field drainage ditches causing incision and stream departure.

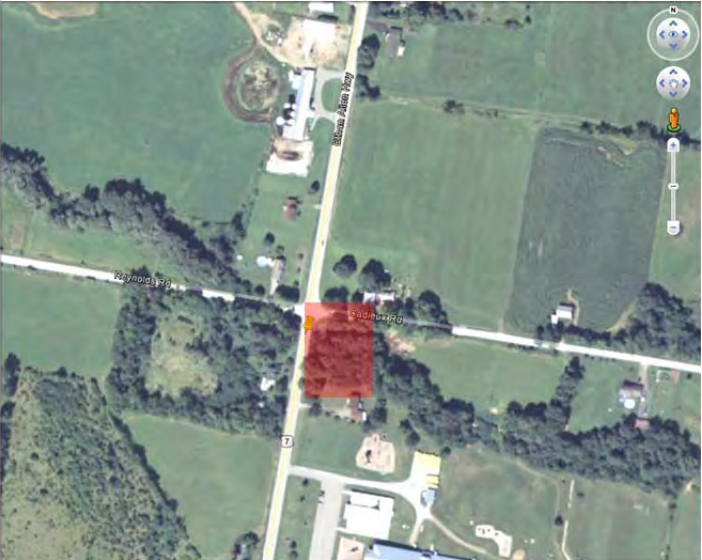
Watershed:	Mill River													
Location:	Cadieux Rd., just east of intersection with Route 7													
Problem Type:	Altered Geomorphology													
Identification Source:	Fluvial Erosion Hazard Mapping and Phase 2 SGA Report													
Ownership:	Local													
Classification Level:	1 – geomorphology 3 – road runoff													
Problem Description:														
<p>Gullies have formed along the roadside and are contributing sediment to Mill River. Significant erosion is occurring within this reach of the Mill River, attributed to historic channel straightening and increased flows associated with road runoff.</p>

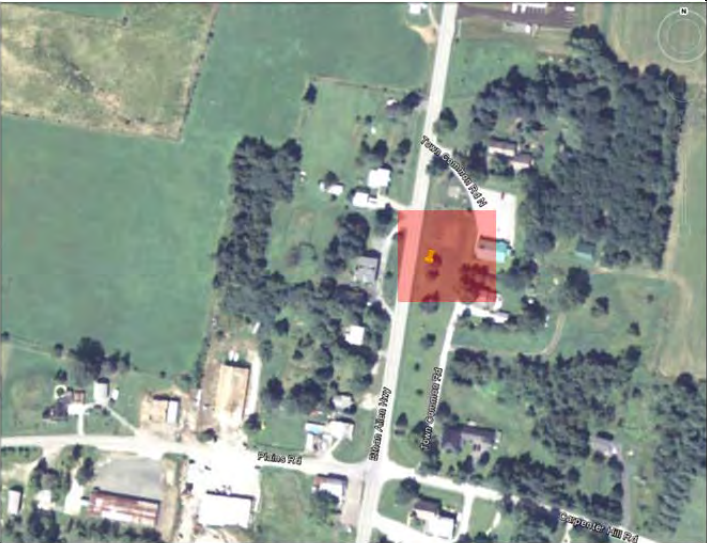
Watershed:	Mill River													
Location:	Route 7, north of the intersection with Plains and Carpenter Hill Rds													
Problem Type:	Local Drainage													
Identification Source:	Fluvial Erosion Hazard Mapping and Phase 2 SGA Report													
Ownership:	Local/State													
Classification Level:	3													
Problem Description:														
Stormwater pipe inputs along Mill River from road crossings and agricultural field drainage ditches causing incision and stream departure.

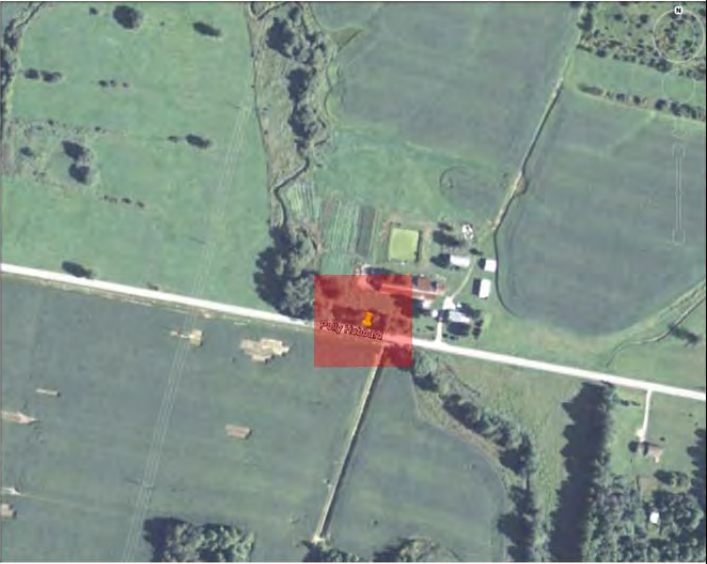
Watershed:	Mill River													
Location:	Polly Hubbard Rd., about ½ mile east of Georgia Middle Rd													
Problem Type:	Altered Geomorphology													
Identification Source:	Fluvial Erosion Hazard Mapping and Phase 2 SGA Report													
Ownership:	Private													
Classification Level:	1 – road alignment 3 – riparian buffer													
Problem Description:														
<p>Much of the original woody riparian vegetation has been removed as a result of agricultural activities, residential development, and road infrastructure – leading to significant erosion in and along the stream channel.</p>

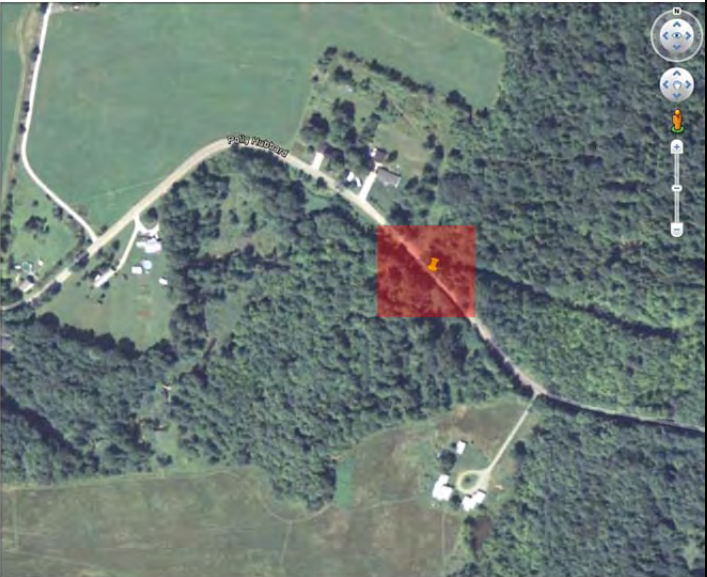
Watershed:	Mill River													
Location:	Polly Hubbard Rd., about ½ mile west of the intersection with Route 7													
Problem Type:	Altered Geomorphology													
Identification Source:	Fluvial Erosion Hazard Mapping and Phase 2 SGA Report													
Ownership:	Private/Local													
Classification Level:	1 – geomorphology 3 – road runoff													
Problem Description:														
Significant erosion and mass failure in mainstem in reaches.

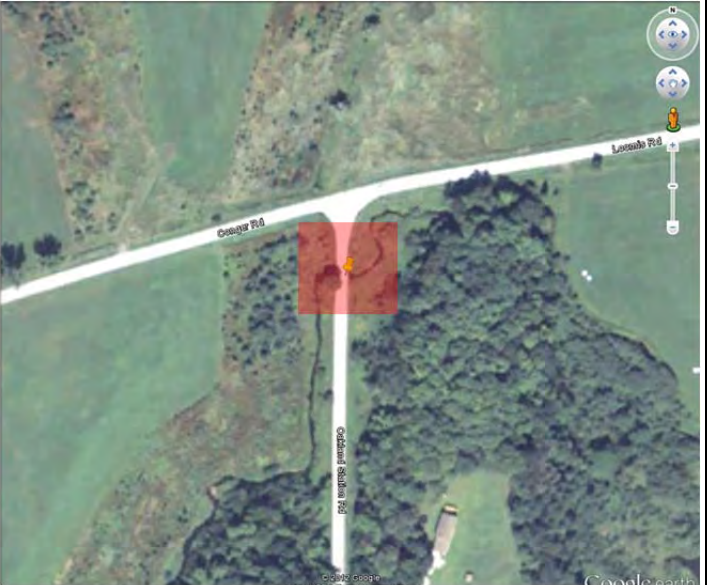
Watershed:	Mill River													
Location:	Oakland Station Rd., near intersection with Conger Rd													
Problem Type:	Altered Geomorphology													
Identification Source:	Fluvial Erosion Hazard Mapping and Phase 2 SGA Report													
Ownership:	Local													
Classification Level:	1 – geomorphology 3 – road runoff													
Problem Description:														
Erosion and mass failure on embankment of box culvert carrying Mill River under Oakland Station Rd.

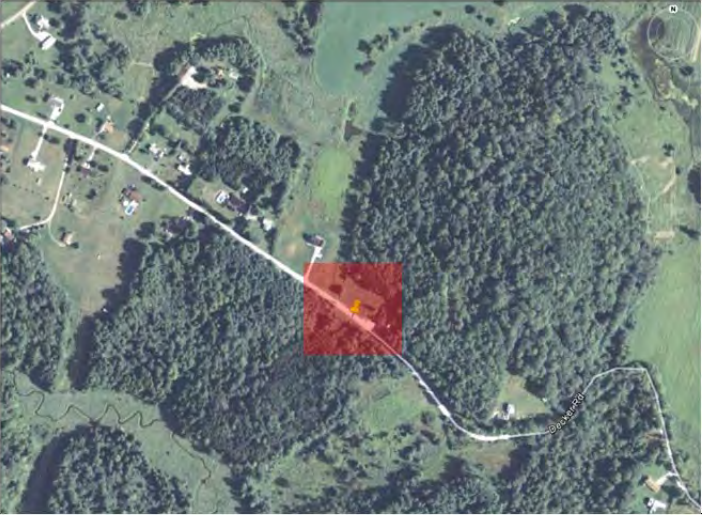
Watershed:	Stonebridge Brook													
Location:	Decker Rd., about 1000' west of intersection with Sodom Rd													
Problem Type:	Local Drainage/Erosion													
Identification Source:	field visit													
Ownership:	unknown													
Classification Level:	3													
Problem Description:														
Significant quantities of fill being placed along the southside of Decker Rd.

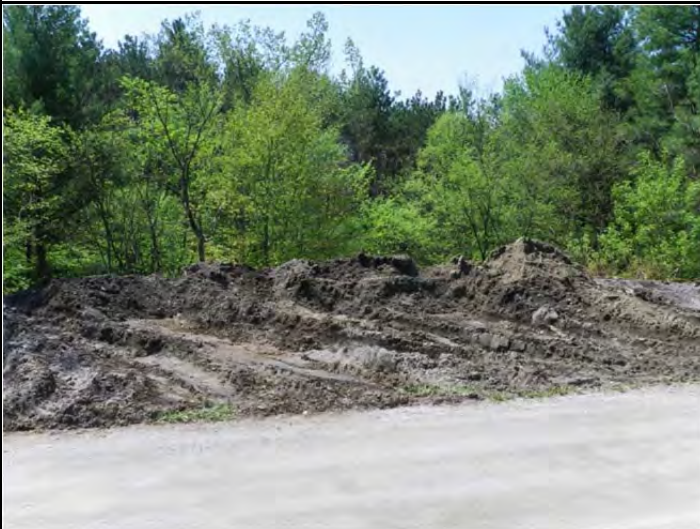
Photo 1. Fill on south-side of Decker Rd

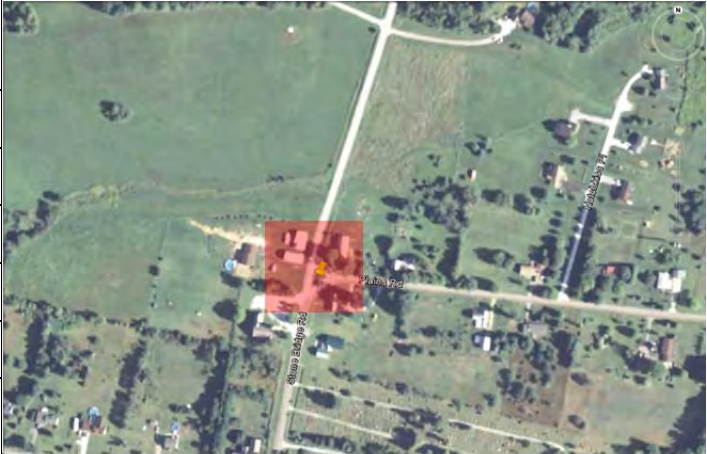
Watershed:	Mill River													
Location:	"Y" @ Plains/Middle Rd													
Problem Type:	Local Drainage													
Identification Source:	Town Feedback													
Ownership:	Local													
Classification Level:	3													
Problem Description:														
Culvert occasionally plugs at "Y" intersection.

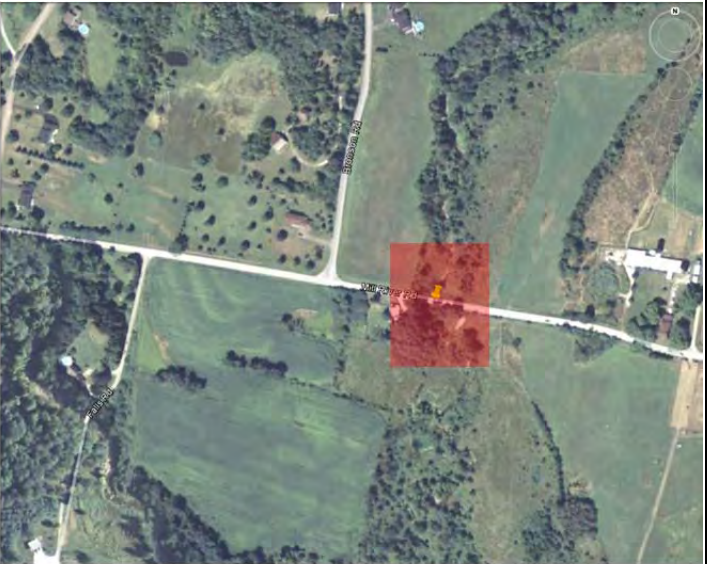
Watershed:	Rugg Brook													
Road Name:	Mill River Rd., east of the intersection with Bronson Rd													
Problem Type:	Altered Geomorphology													
Identification Source:	Fluvial Erosion Hazard Mapping and Phase 2 SGA Report													
Ownership:	Private/Local													
Classification Level:	1 – geomorphology 3 – road runoff													
Problem Description:														
Erosion and mass failure on embankment of box culvert carrying Rugg Brook under Mill River Rd.

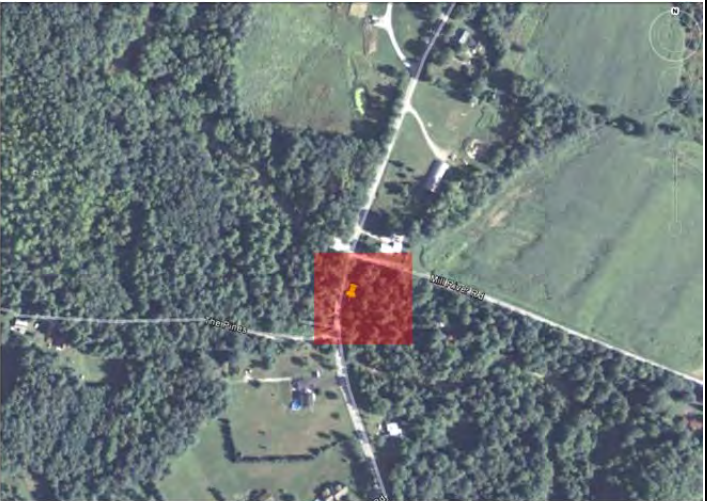
Watershed:	Mill River													
Location:	Georgia Shore Rd., south of intersection with Mill River Rd													
Problem Type:	Culvert/Bridge													
Identification Source:	Town Feedback													
Ownership:	Local													
Classification Level:	1													
Problem Description: On-going streambank failure(s) creating concern for the long-term stability of the bridge crossing Mill River on Georgia Shore Road.

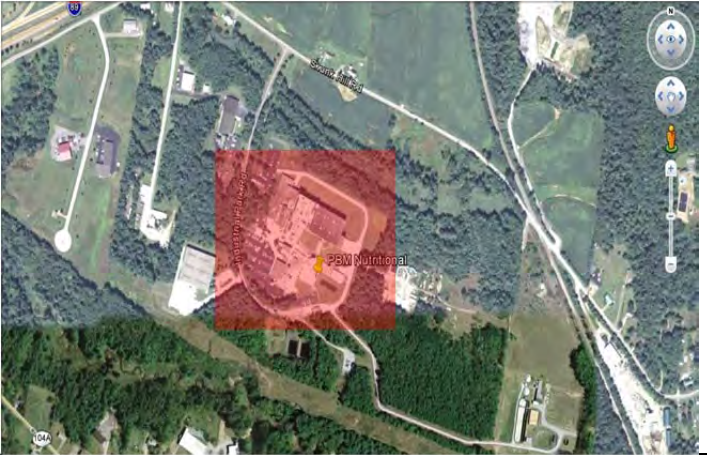
Watershed:	Deer Brook													
Location:	Industrial Park Road													
Problem Type:	Local Drainage													
Identification Source:	DEC SW Mapping													
Ownership:	Private													
Classification Level:	3													
Problem Description: Ponds that were designed and installed prior to 2002 are used to treat stormwater runoff.

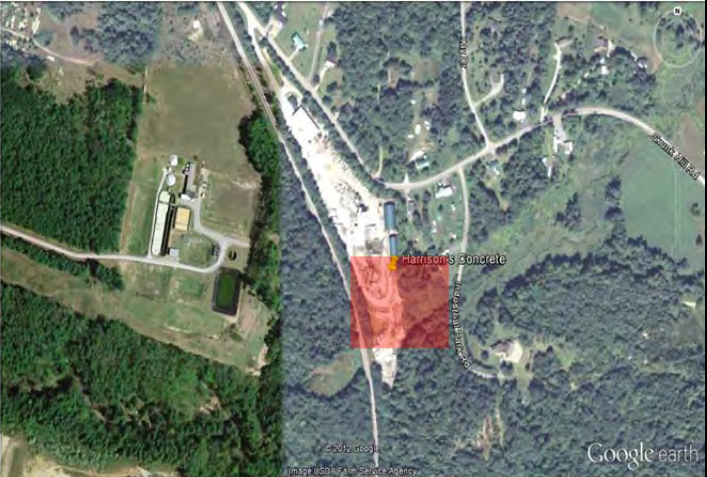
This facility is currently operating under an individual stormwater discharge permit as well as Vermont's Multi-Sector General Permit (MSGP) for Stormwater Discharges; its ultimate outfall sends stormwater over a steep embankment to Deer Brook.

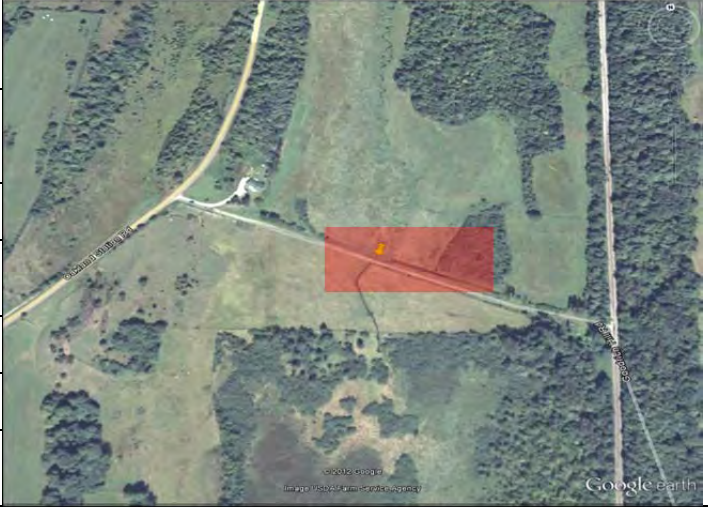
Problem Area ID: DB 7	Latitude: 44.724333 N	Longitude: 73.087519 W
Watershed: Deer Brook

Road Name: TH45 Goodrich Hill Rd, east of Oakland Station Rd		
Problem Type: Culvert/Bridge		
Identification Source: Bridge and Culvert Inventory Data		
Ownership: Local		
Classification Level: 1		
Problem Description:		
Culvert on TH45 poorly aligned with stream approach at a sharp bend.

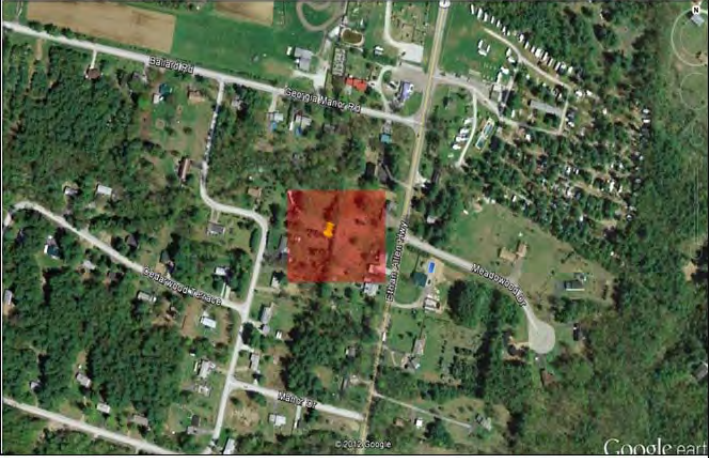
Problem Area ID: SB 1	Latitude: 44.689733 N	Longitude: 73.109897 W
Watershed: Stone Bridge Brook

Location: Manor Dr/Cedarwood Tr		
Problem Type: Local Drainage		
Identification Source: Town Feedback		
Ownership: Local		
Classification Level: 3		
Problem Description:	Localized flooding on Manor Drive, Cedarwood Terrace and Rt. 7.

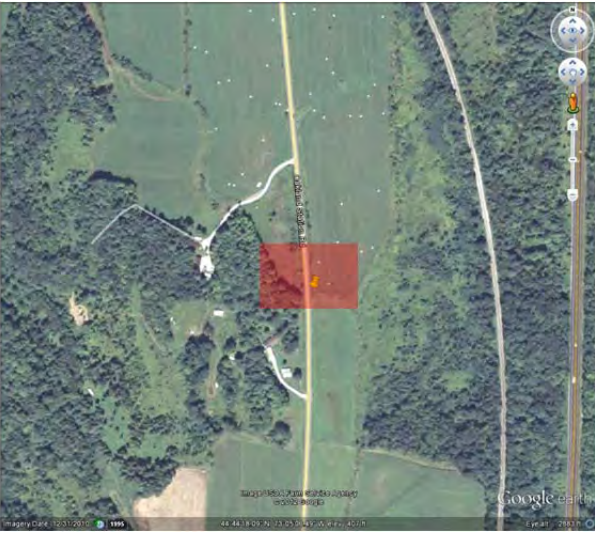
Watershed:	Deer Brook													
Location:	Oakland Station Rd., 1500' south of the intersection with Cary Rd													
Problem Type:	Local Drainage/Culvert													
Identification Source:	Bridge and Culvert Inventory Data													
Ownership:	Local													
Classification Level:	1													
Problem Description:														
Culvert on Oakland Station Road poorly aligned and located.

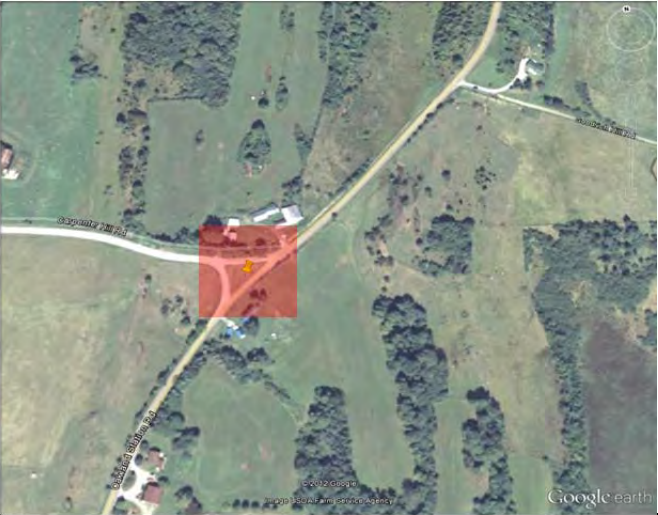
Watershed:	Deer Brook													
Location:	Carpenter Hill Rd., near intersection with Oakland Hill Rd													
Problem Type:	Local Drainage													
Identification Source:	Town Feedback													
Ownership:	Local													
Classification Level:	3													
Problem Description:														
Culvert in "Y" intersection is partially obstructed.

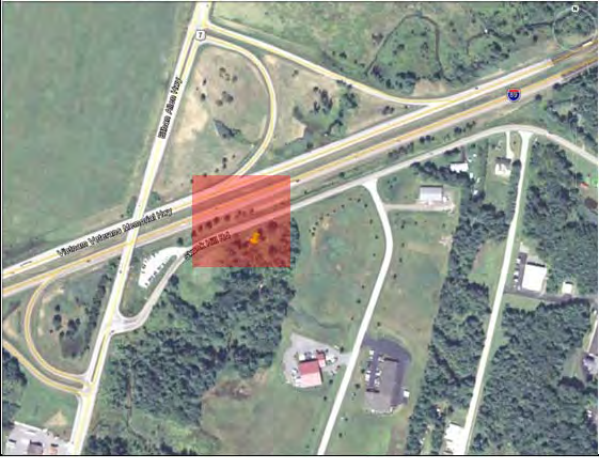
Problem Area ID: DB 3	Latitude: 44.699038 N	Longitude: 73.104430 W
Watershed: <u>Deer Brook</u> Location: <u>I-89, exit 18 interchange</u> Problem Type: <u>Altered Geomorphology</u> Identification Source: <u>Deer Brook SGA</u> Ownership: <u>State</u> Classification Level: <u>1</u>

Problem Description: Brook straightened and culverted to pass under I-89.

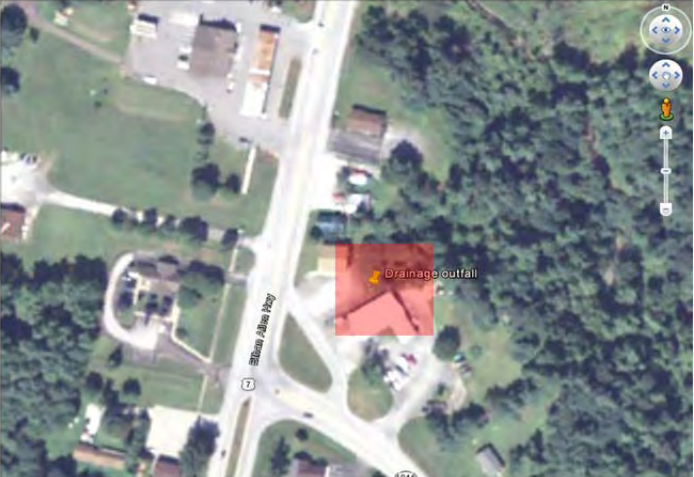
Problem Area ID: DB 3	Latitude: 44.695330 N	Longitude: 73.107033 W
Watershed: Deer Brook

Location: Rt. 7/Rt.104A		
Problem Type: Local Drainage		
Identification Source: DEC Deer Brook Gully Remediation Study		
Ownership: Private, State		
Classification Level: 4		
Problem Description: Stormwater runoff has created a large gully leading down to Deer Brook. The head of the gully is located near the intersection of Rt. 7 and Rt. 104A.

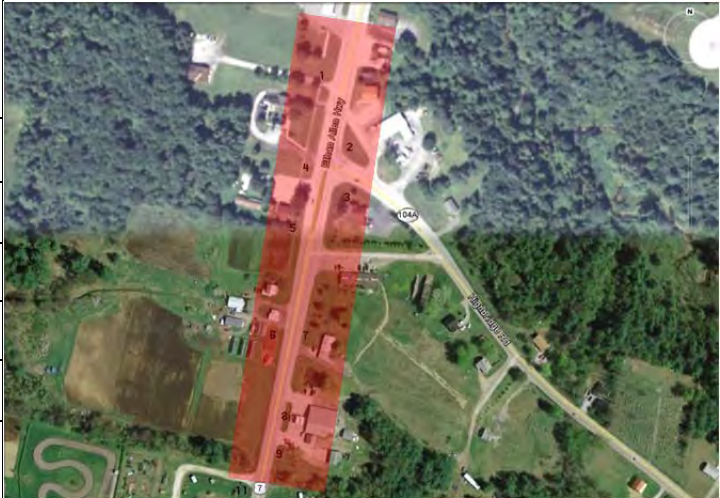
Watershed:	Deer Brook													
Road Name:	Rt. 7/Rt.104A													
Problem Type:	Future Opportunities													
Identification Source:	Town Feedback													
Ownership:	Local													
Classification Level:	4													
Problem Description: <p>The South Georgia Village may become a sub-regional growth center because of its access to Interstate-89, the Route 7 corridor, and the potential for additional industrial and commercial development. Knowing that the Town of Georgia wishes to concentrate future development in this area, strategies need to be investigated that both address current and potential future stormwater concerns.</p>

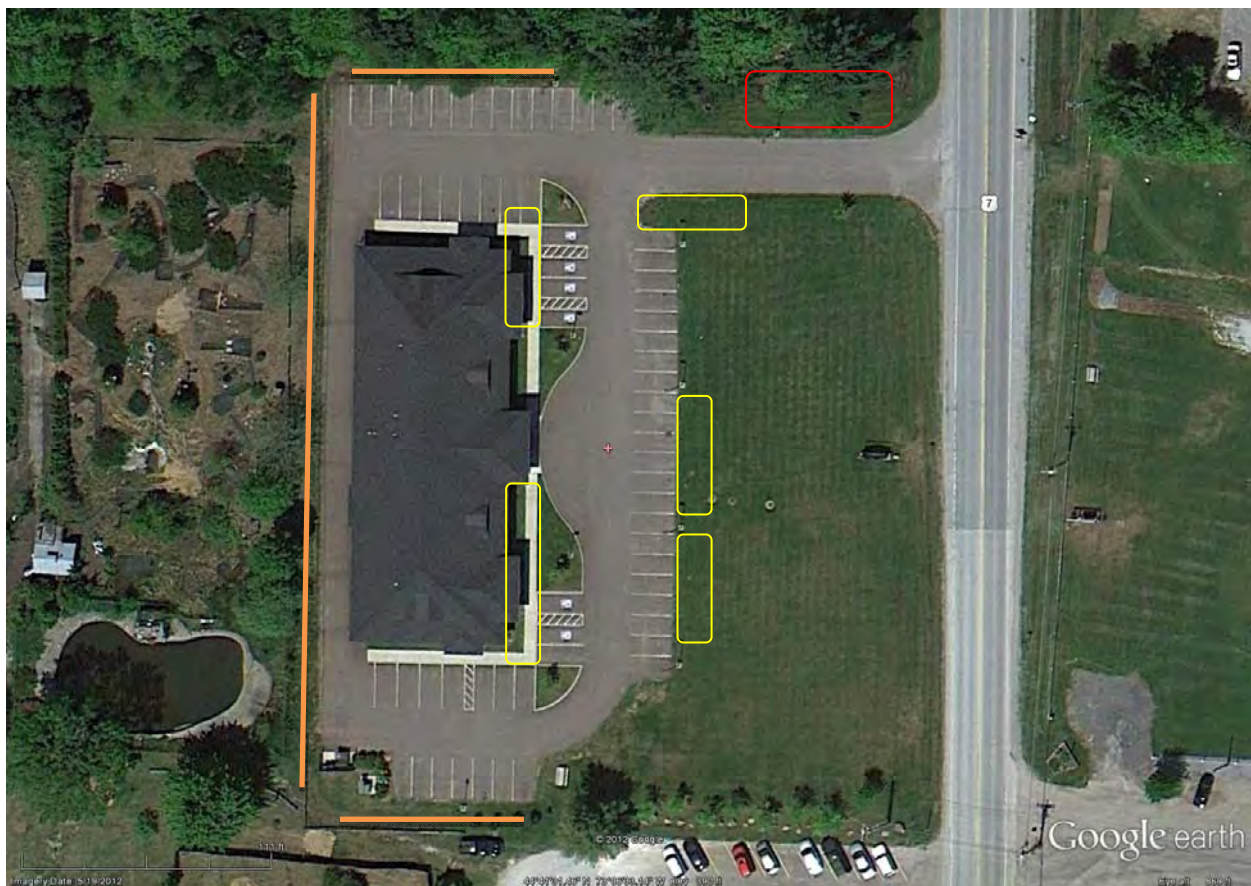
Figure 1. Potential treatment opportunities at the Georgia Eye Center/ Northwest Occupational Health Building. Rain-Garden and bioretention opportunities highlighted in yellow and open channel opportunities highlighted in orange.

The building housing the *Georgia Eye Center* and *Northwestern Occupational Health* includes approximately one acre of impervious area, which is nearly 50% of the parcel. Impervious surfaces include the building roof, sidewalk, and asphalt parking area. The roof is drained by gutters with downspouts connected to the stormwater drain. The parking lot is drained by two catch basins – one within the asphalt footprint and one

Roof runoff could be treated by redirecting the existing downspouts to route stormwater through rain gardens or similar soak-away practices. Overflow drains could be connected to existing stormwater drain at the location of the downspouts. The result would be a relatively simple, low risk retrofit that would increase infiltration, and reduce stormwater discharge emanating from the roof top.

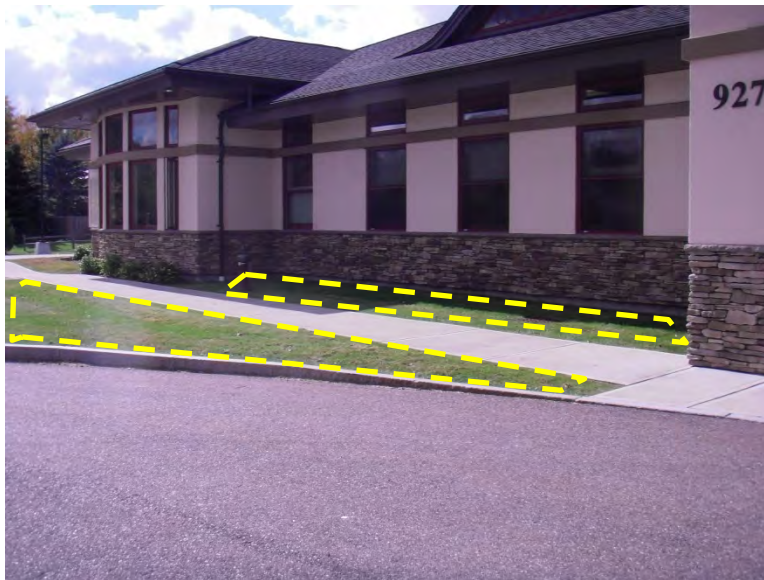
Figure 2. Example of area where roof runoff could be routed to a rain garden.

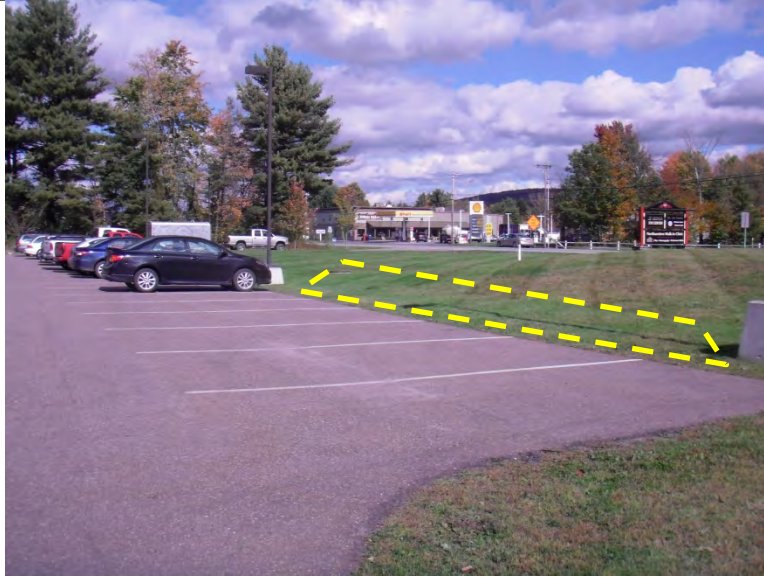
Figure 3. Catch basin is located beneath red pickup truck in the photo. Stormwater from half of parking lot could be routed to lawn area shown right half of photo.

Runoff from the parking lot could be treated with bioretention basins designed to encourage infiltration. The southern half of the front parking area drains east, toward the front lawn and north towards to basin near the middle of the lot. Stormwater south of the catch basin could be intercepted and routed to a bioretention area designed to maximize infiltration. Drainage exceeding the capacity of the treatment practice would backup into the existing catch basin at reduced rate compared to present conditions.

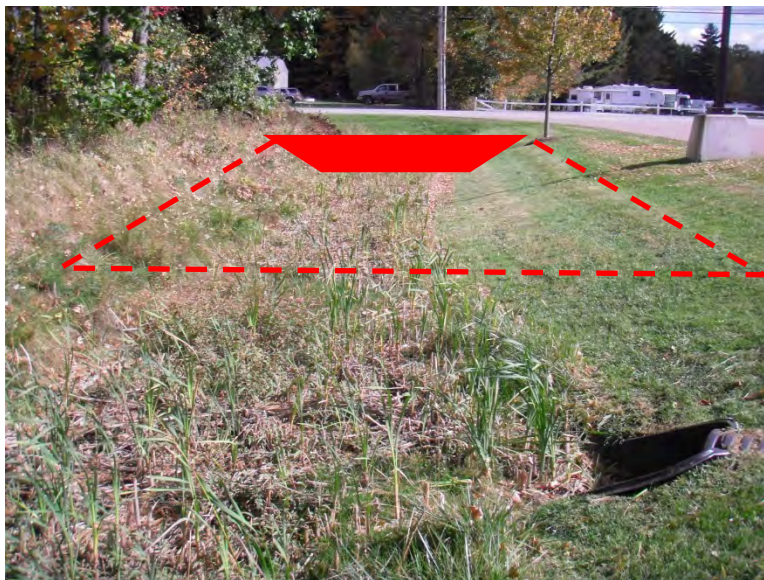
Figure 6. A bioretention basin could be located between the existing stormwater outfall and road side ditch.

An additional or alternative stormwater treatment option would be to create a bioretention/infiltration basin or similar structure at the north end of the property between the existing stormwater outfall and the existing roadside ditch along the west side of US Route 7.

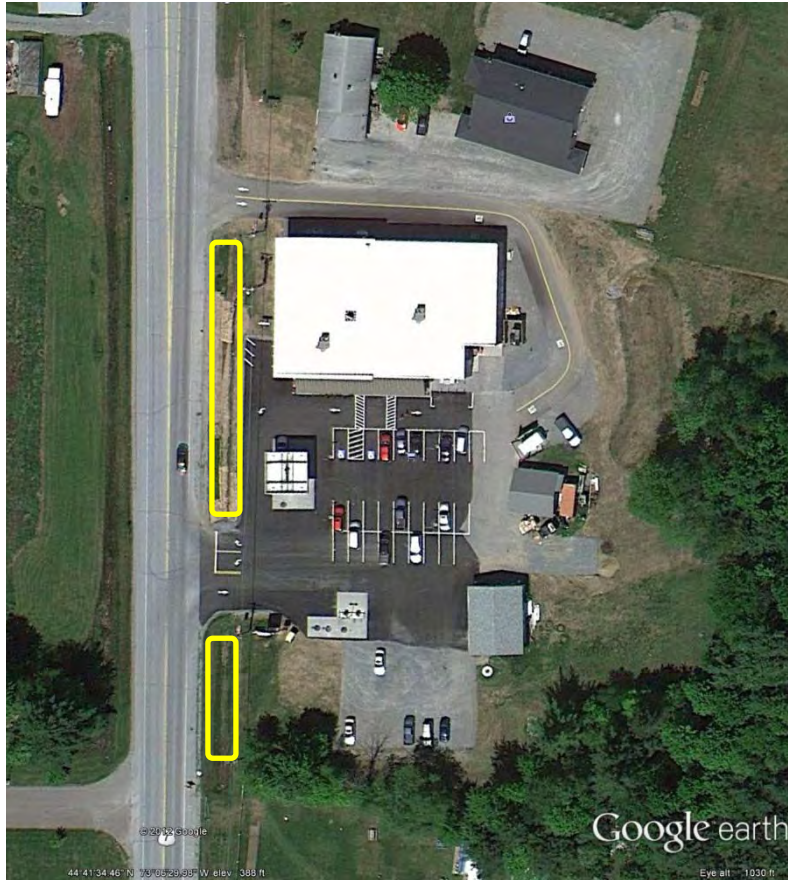
Figure 7. Treatment opportunities along U.S. Route 7 near the Georgia Market Property.

The southern-most location denoted in Figure 7 receives stormwater via ditch conveyance from Rt. 7 as far south as Ballard Rd. This includes the Georgia Eye Center/Northwest Occupational Health Property. The next site to the north then includes approximately 0.25 acres of the 1 acre Georgia Market impervious area. The stormwater from the remaining 0.75 acres is treated via a recently installed vegetated swale at the back of the property.

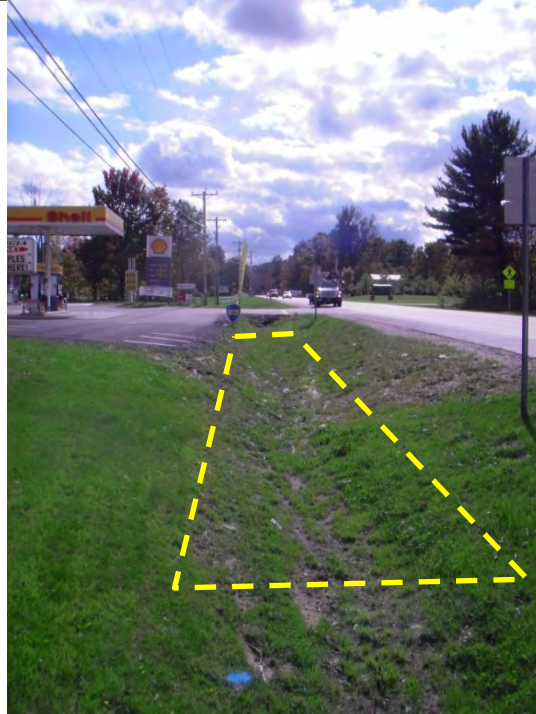
Figure 8. Looking south along the east side of Route 7 in front of the Georgia Market.

Location of the proposed flow control device is behind the photographer.

Directly in front of the market the wide, deep roadside ditch could be used for storage and infiltration by installing a simple flow-control device on the existing culvert under the drive that accesses the back of the Georgia Market property. This could serve to treat all upstream stormwater. Figure 8 shows a photo with a rough location of the proposed treatment practice.

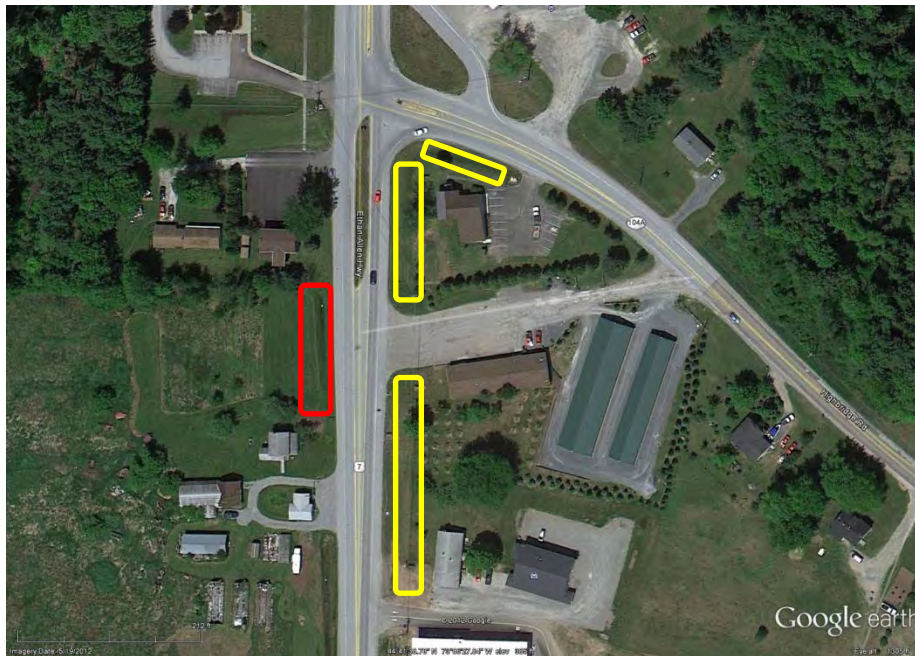
Figure 9. Potential stormwater treatment areas along U.S. Route 7 and VT Route 104A north of the Georgia Market property.

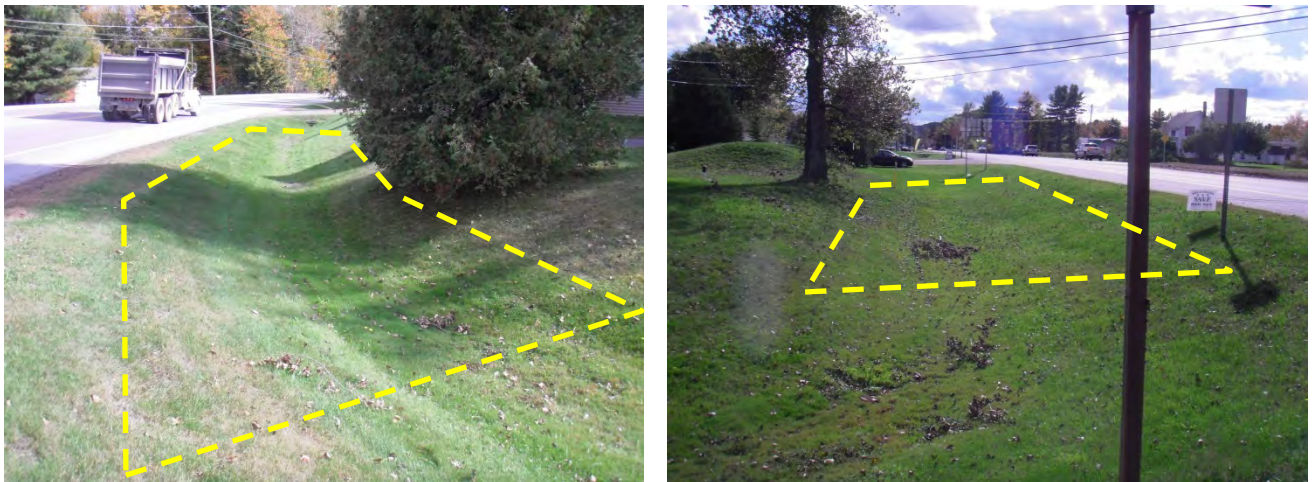
Figure 11. View of roadside ditches looking south. VT Rt. 104A (left) and US Rt. 7 (right).

A similar practice could be implemented near the at the Rt. 7 and VT Rt. 104A intersection; see Figure 11. Adding a riser pipe with a flow-control device to the existing catch basin would increase the storage potential and infiltration in each ditch.

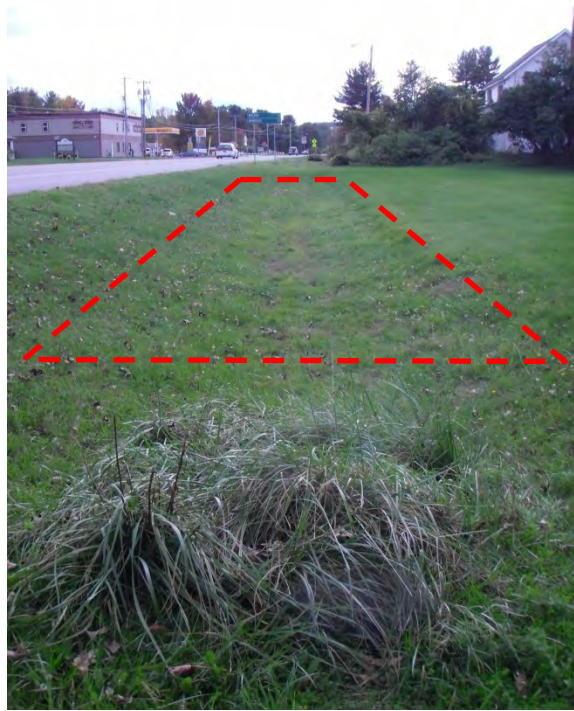
Figure 12. Potential treatment location along west side of Rt. 7, south of KA Hairdesigns.

The existing catch basin (surrounded by tall grass in photo) could be retrofitted with a standpipe and flow control device. The other location is to the north of this is located between the People's Trust Bank and the Mobil gas station. See Figure 13.

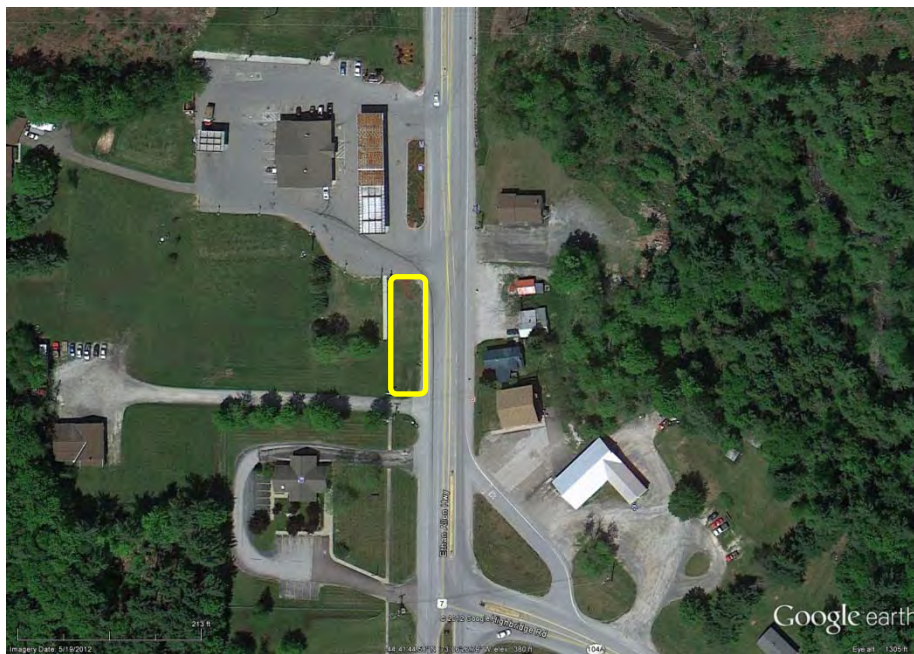
Figure 13. Potential location for stormwater treatment along the west side of Route 7, north of VT Route 104A.

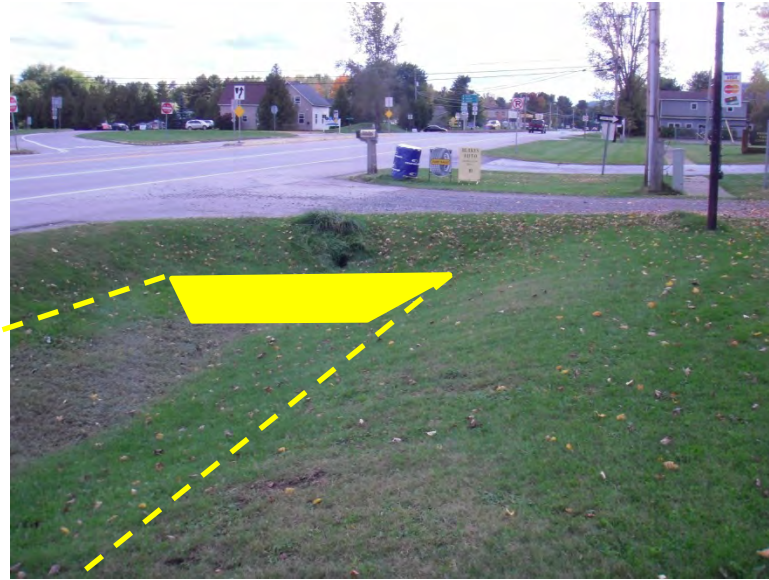
Figure 14. Potential location for stormwater treatment along Rt. 7 south of Mobil Station

Similar to those previously mentioned, adding a simple, flow-control retrofit such as a weir with a flow control device prior to the driveway culvert would allow stormwater to be temporarily stored and/or infiltrated (Figure 14).

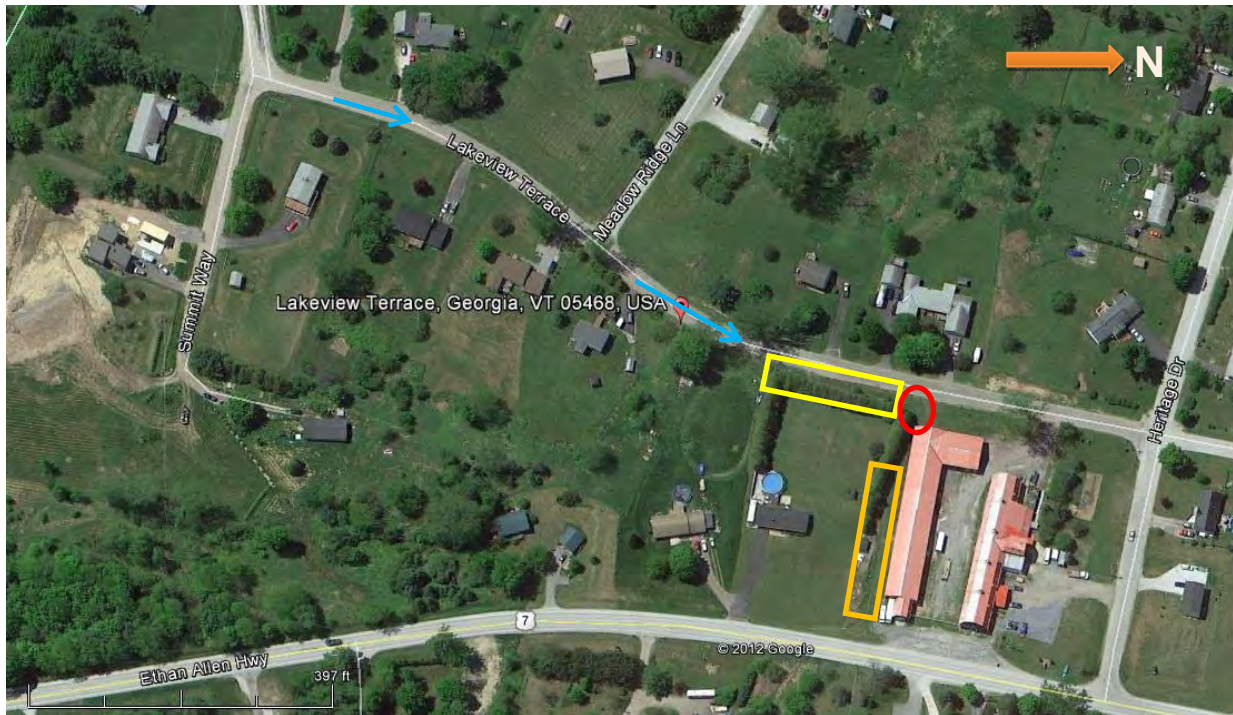
Figure 15. Red Barn property and surrounding neighborhood. Location of existing scour hole shown in red. Potential STP locations shown in yellow and orange.

Stormwater draining down Lakeview Terrace from south to north discharges from the roadside ditch between the Red Barn Storage property and the neighboring property to the west (Figure 15). Where the channel turns west, away from the road, a significant scour hole approximately 7-8 ft wide and 3-4 ft deep has developed (Figure 16). Eroded soil is then conveyed with stormwater along the Red Barn Storage property before crossing under Rt. 7 and flowing to Arrowhead Mountain Lake via a small tributary. Two potential solutions merit consideration.

Repair and reinforcement of the scoured channel of the scoured channel would reduce sediment loads downstream. Installation of a STP such as a bioretention basin, in the existing roadside ditch along the hedge row (upstream of the scour hole) would work to improve water quality and also prevent future degradation (i.e. erosion or scouring) of the channel (see Figure 17Figure 17). Soils in this area are Hydrologic Class B soils—well-drained and suitable for infiltration¹¹. Any practice that is implemented should include features to promote infiltration.

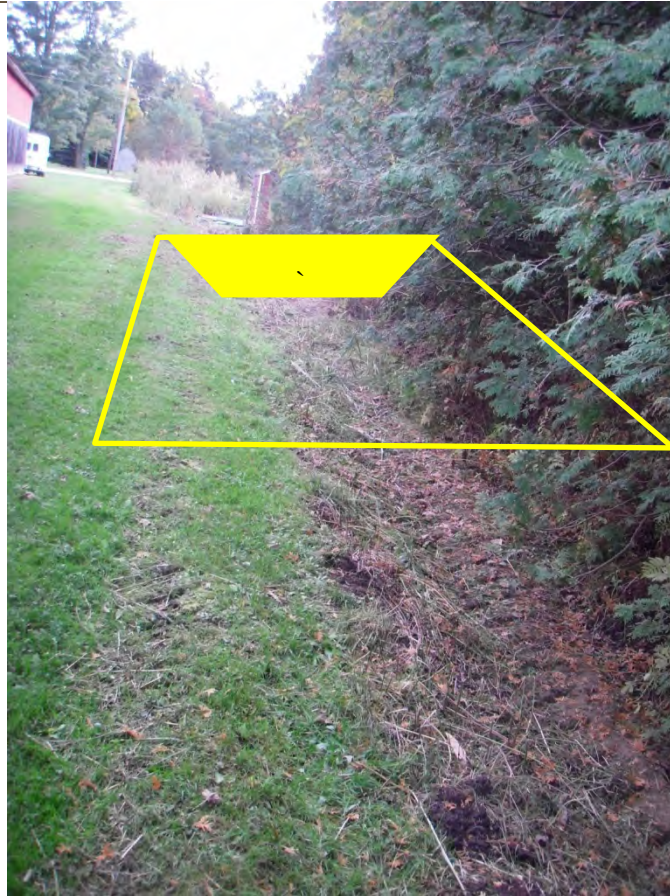
Figure 17. Potential location for stormwater treatment along Lakeview Terrace near the Red Barn Rental Business property.

An alternative or addition to a solution along Lakeview Terrace would be to locate a treatment practice encouraging infiltration along the southern border of the Red Barn Storage property. Locating the treatment practice in this location would increase the available land area and potential for infiltration. Soils here are Hydrologic soil group (HSG) A—very well-drained, with a lower water table. This location would also include the added benefit of capturing the roof runoff from half of the Red Barn Rental structure (approximately 5700 ft²). The drawback of this option is that it is outside the town right-of-way, and would require cooperation from a private landowner.

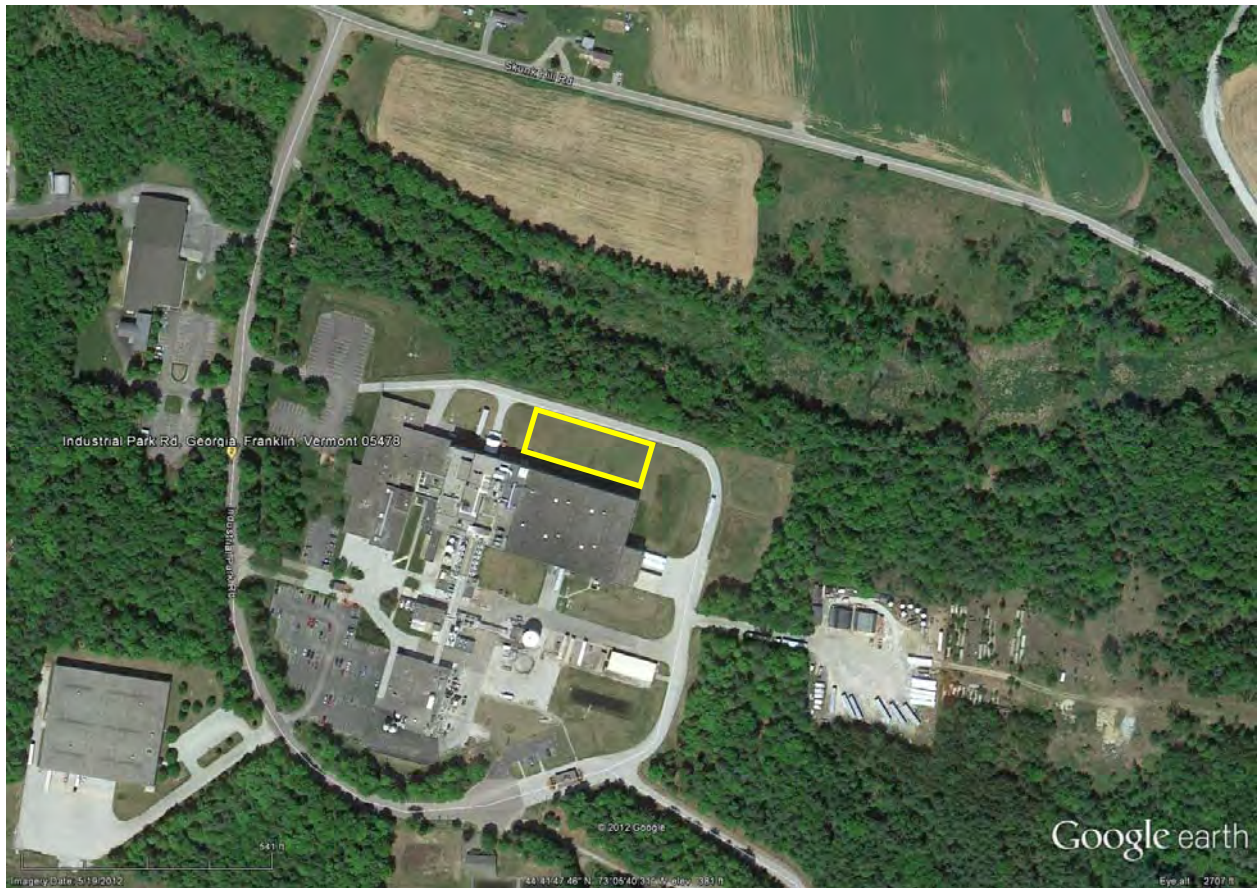
Figure 18. Georgia Industrial Park off of Skunk Hill Rd. Detention area highlighted in yellow.

The Georgia Industrial Park contains a large amount of impervious area. This property is equipped with permitted stormwater treatment facilities, largely in the form of dry wells and dry ponds (Figure 18). Soils are HSG A and therefore stored water is likely to quickly infiltrate. Before considering any potential retrofits to these facilities, we recommend monitoring to determine whether the facilities discharge. Stone suggests that these facilities be monitored for the presence of discharge following storm events with particular attention being paid to the detention pond highlighted in Figure 18. If evidence of significant discharge is found, further investigation can assess if opportunities may exist to improve the treatment by modifying the existing facility, or reducing or slowing stormwater closer to the source.
