STORMWATER MANAGEMENT PLAN FOR HIGHGATE

FINAL REPORT

Stone Project ID 112475-W

March 1, 2013

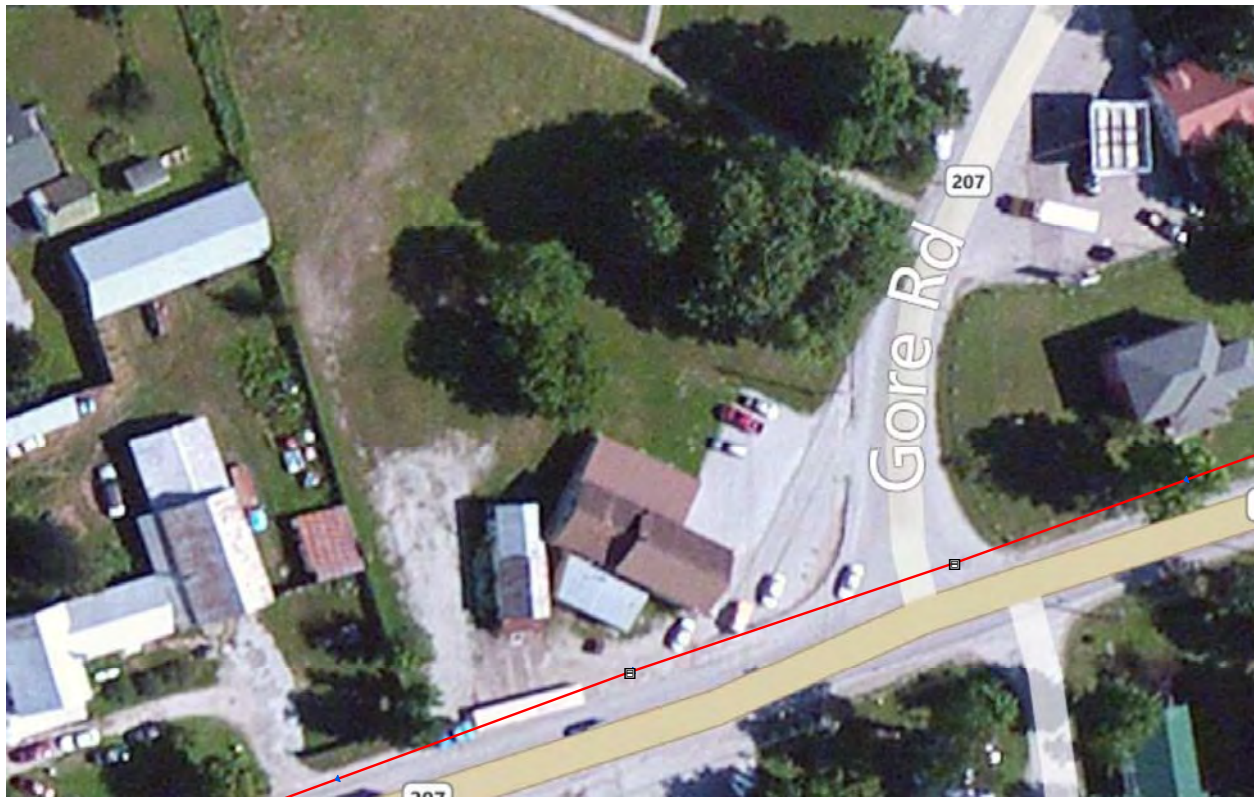
Figure 5. The Highgate Municipal Town Plan proposes the construction of a Park-and-Ride facility at the corner of Vermont Routes 207 and 78. Soil conditions favor infiltration-based practices, such as porous pavement, at this site.

Soils in at this location appear to be well-drained Windsor loamy fine sands, with a seasonal high water table more than five feet below ground surface. These soil conditions, coupled with the site’s flat topography, make infiltration-based practices an effective STP option. As plans develop, low-impact design practices such as porous pavement and infiltration features should be strongly promoted. Alternatively, if plans for a Park-and-Ride facility at this location have been abandoned, the existing impervious pavement could be removed and natural site hydrology restored.

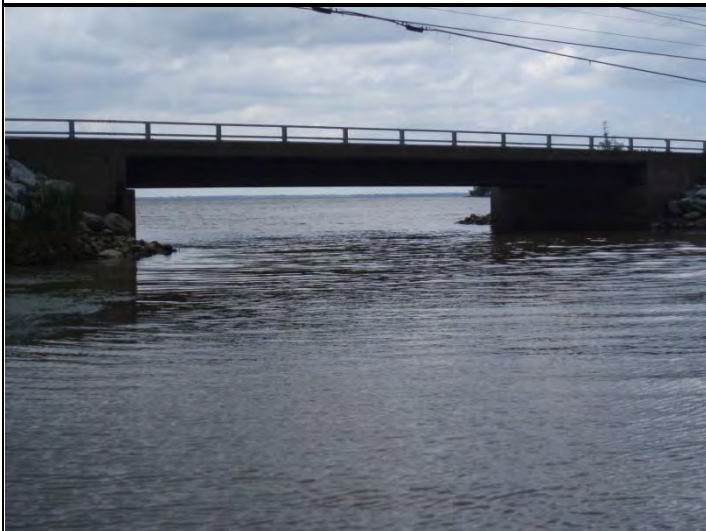
Watershed:	Rock River													
Location:	Route 7, as it crosses over the mouth of the Rock River													
Problem Type:	Flooding													
Identification Source:	Town Feedback													
Ownership:	State													
Classification Level:	1													
Problem Description:														
River often overflows its banks along Rt. 7, flooding the road.

Photo 1. Route 7 bridge over the Rock River

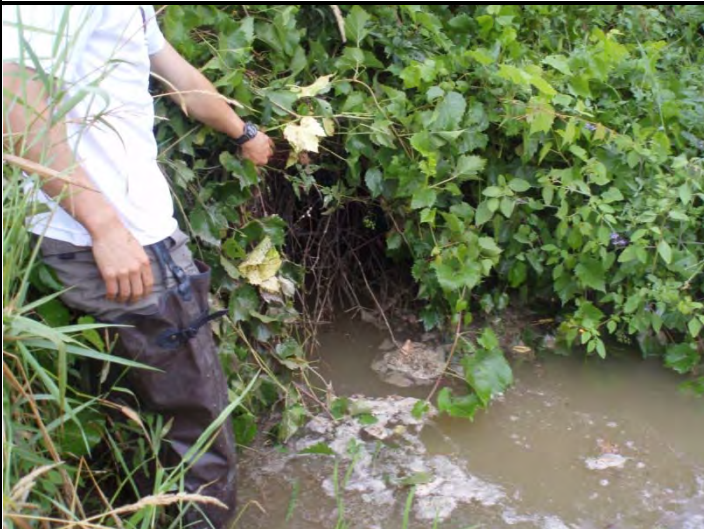
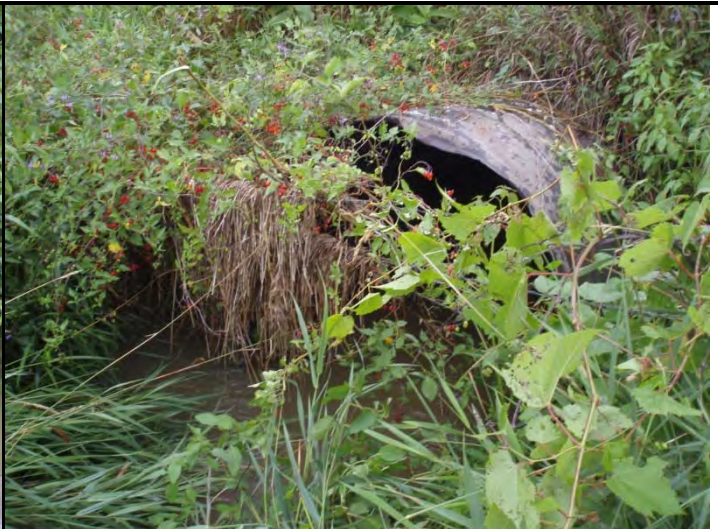
Watershed:	Rock River													
Location:	Tarte Rd, just north of the intersection with Gore Rd													
Problem Type:	Culvert/Bridge Issue													
Identification Source:	SGA, Rock River													
Ownership:	Local													
Classification Level:	2a													
Problem Description:														
Culvert is constricting bankfull channel width.

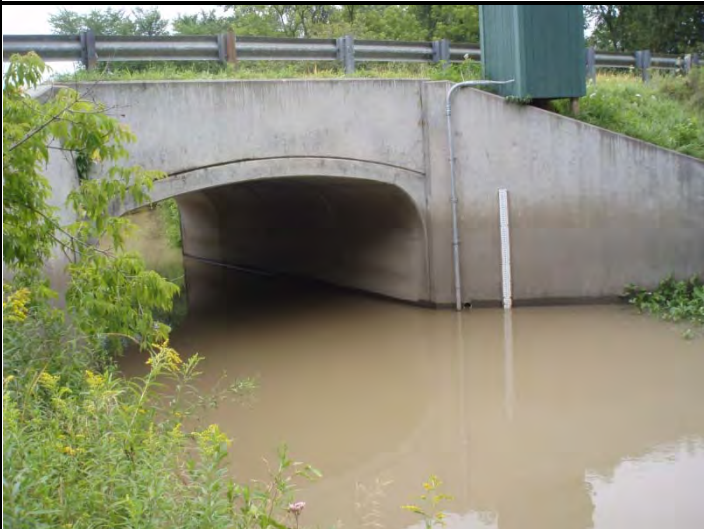
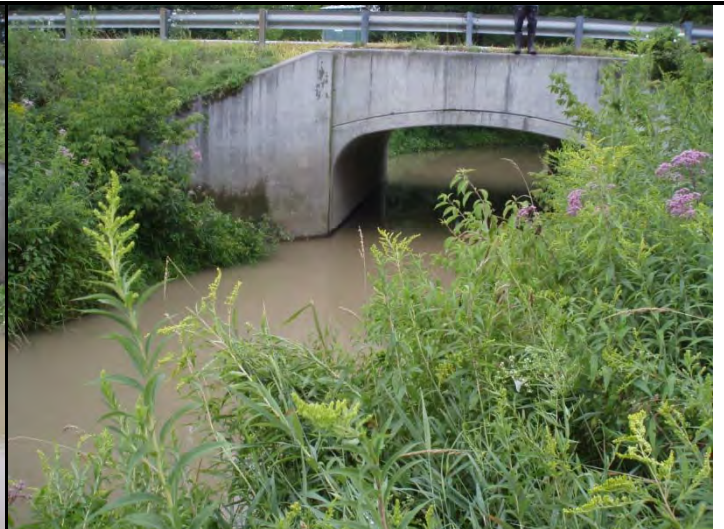
Problem Area ID: RR-6	Latitude: 44.96357 N	Longitude: 72.991937 W
Watershed: Rock River <hr/> Location: Cassidy Rd, just east of intersection with Bouchard Rd <hr/> Problem Type: Culvert/Bridge Issue <hr/> Identification Source: SGA, Rock River <hr/> Ownership: Private <hr/> Classification Level: 1 <hr/> Problem Description: Bridge is constricting bankfull channel width.

Photo 1. Downstream of bridge

Photo 2. Upstream of bridge

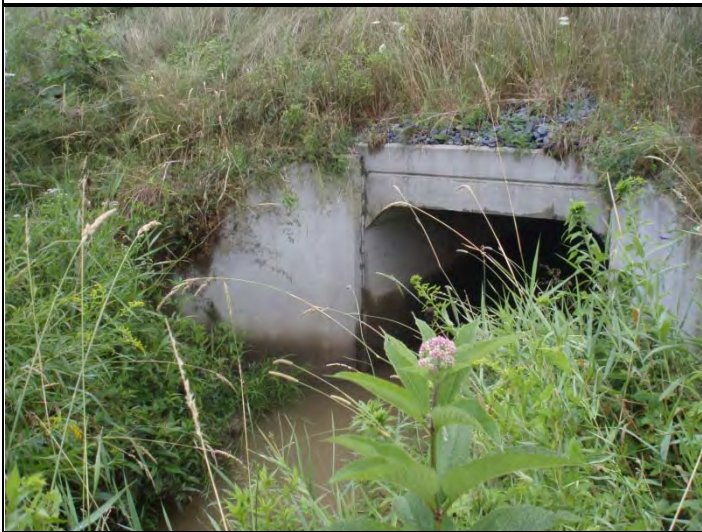
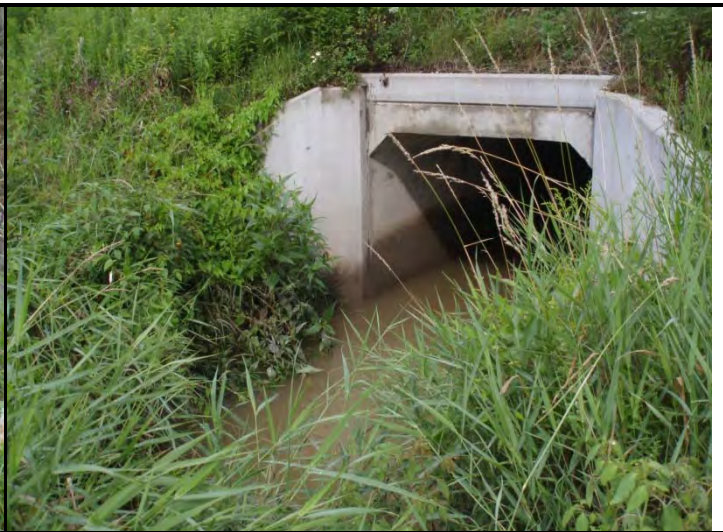
Watershed:	Rock River													
Location:	Franklin Rd, southeast of the intersection with the Cassidy Rd													
Problem Type:	Culvert/Bridge Issue													
Identification Source:	SGA, Rock River													
Ownership:	Local													
Classification Level:	1													
Problem Description:														
Bridge is constricting bankfull channel width.

Photo 1. Downstream of bridge

Photo 2. Upstream of bridge

Minor erosion at outlet, no sign of damage to upstream side. Label on bridge notes "Bridge number C17655, 6x6 "B" B-3, installed 9/13/05."

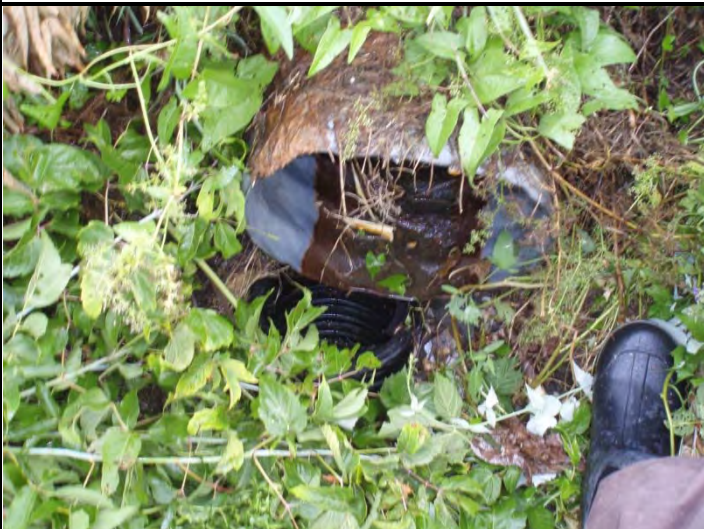
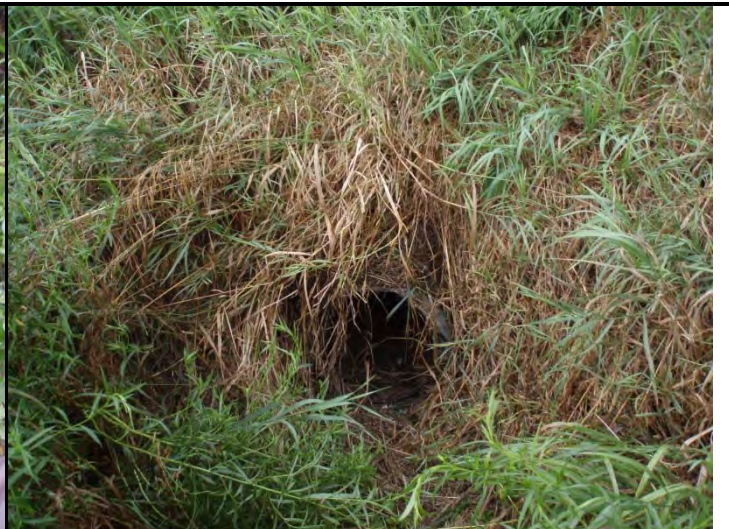
Location: Cassidy Rd, east of the intersection with the Gore Rd		
Problem Type: Culvert/Bridge Issue		
Identification Source: SGA, Rock River		
Ownership: Local/Private		
Classification Level: 2a		
Problem Description:		
Culvert is constricting bankfull channel width.

Photo 1. Downstream culvert drains to pipe

Photo 2. Upstream culvert in dense veg. of road ditch

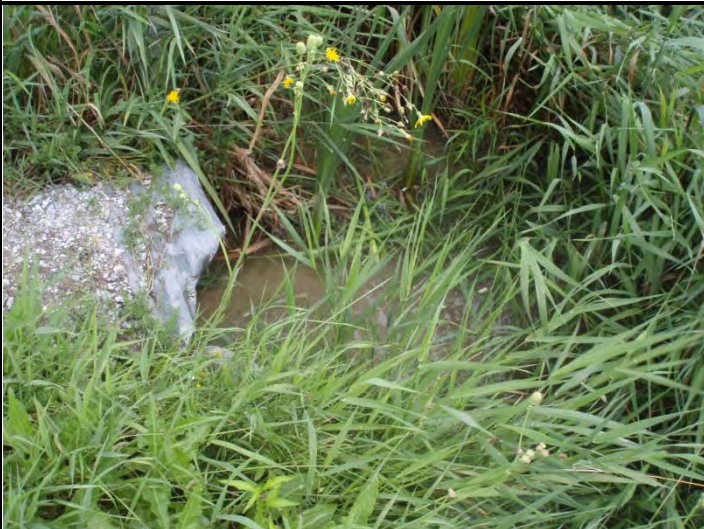
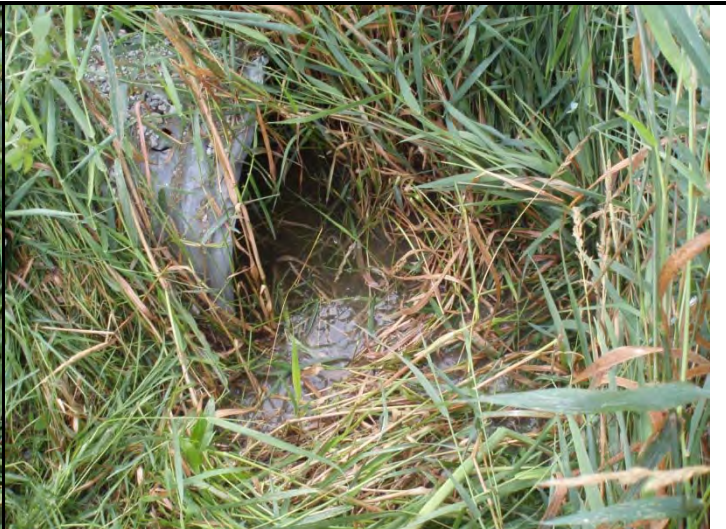
Problem Description:		
Culvert is constricting bankfull channel width.

Photo 1. Upstream culvert

Photo 2. Downstream culvert

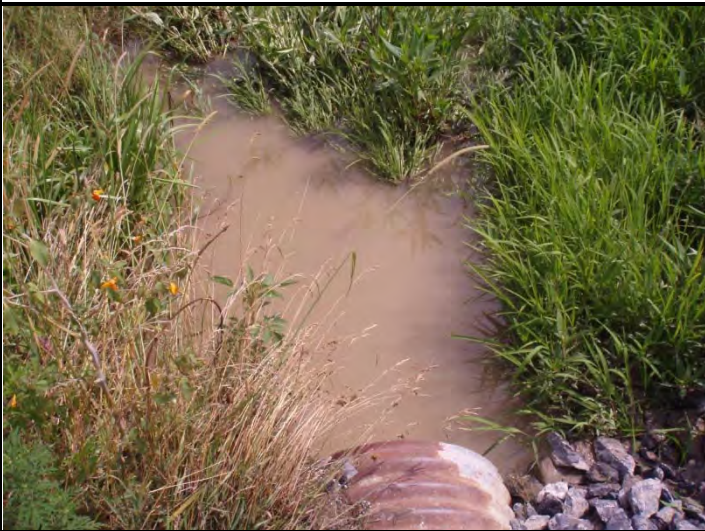
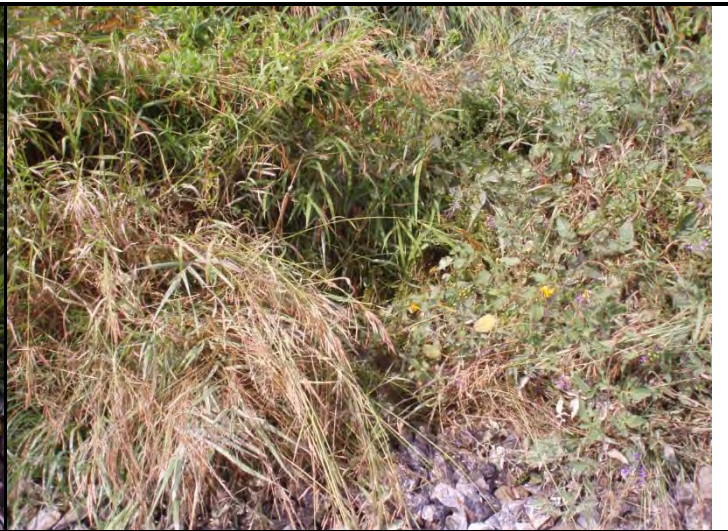
Watershed:	Rock River													
Location:	Tarte Rd, north of the intersection with Parent Rd													
Problem Type:	Culvert/Bridge Issue													
Identification Source:	SGA, Rock River													
Ownership:	Private													
Classification Level:	3													
Problem Description:	<p>Culvert is constricting bankfull channel width.</p>

Photo 1. Upstream of farm road bridge

Photo 2. Downstream of farm road bridge

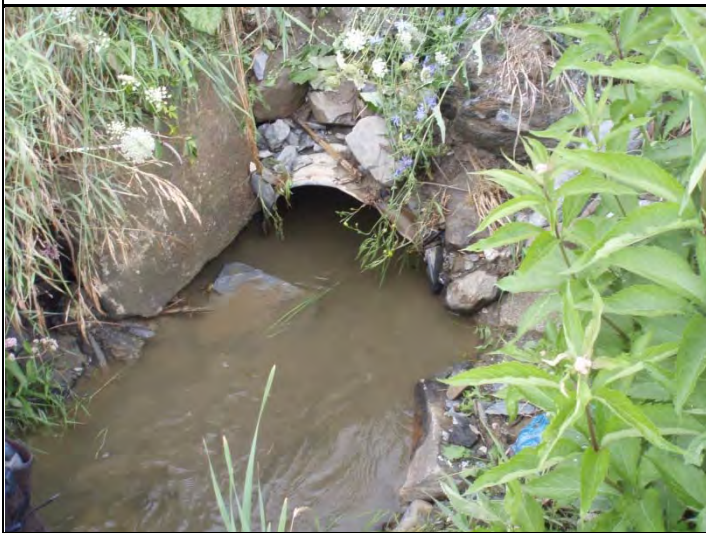
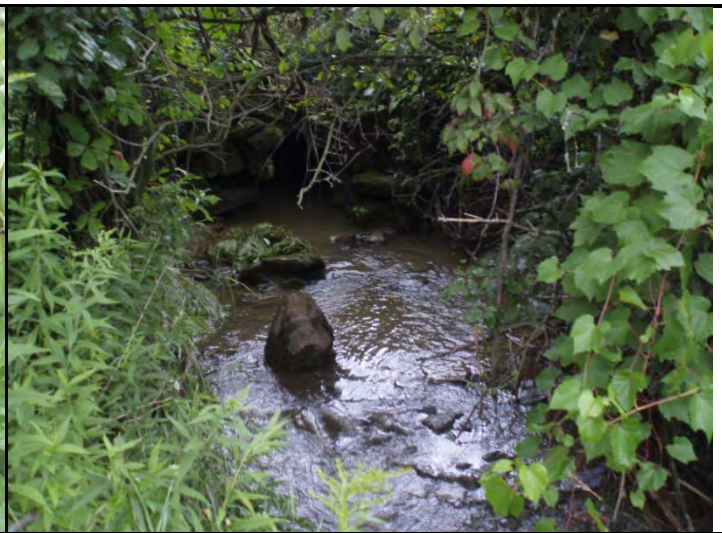
Watershed:	Rock River													
Location:	Durkee Rd													
Problem Type:	Culvert/Bridge Issue													
Identification Source:	SGA, Rock River													
Ownership:	Local													
Classification Level:	2b													
Problem Description:														
Culvert is constricting bankfull channel width.

Photo 1. Upstream of culvert

Photo 2. Downstream of culvert

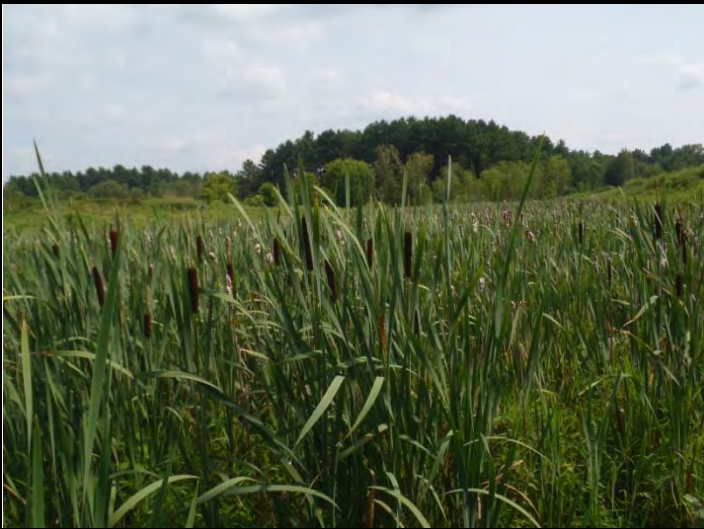
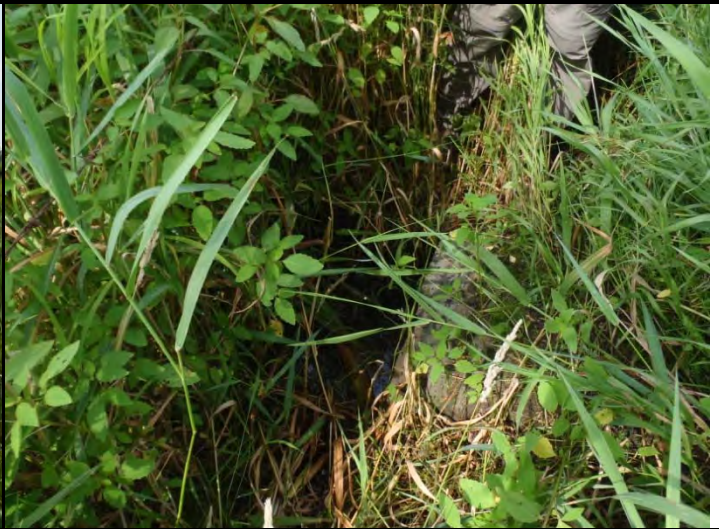
Photo 1. Wetland upstream of culvert

Photo 2. Downstream of culvert

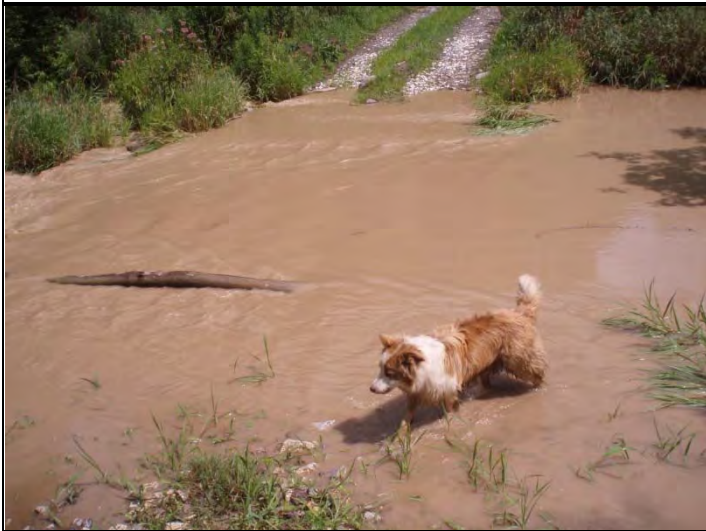
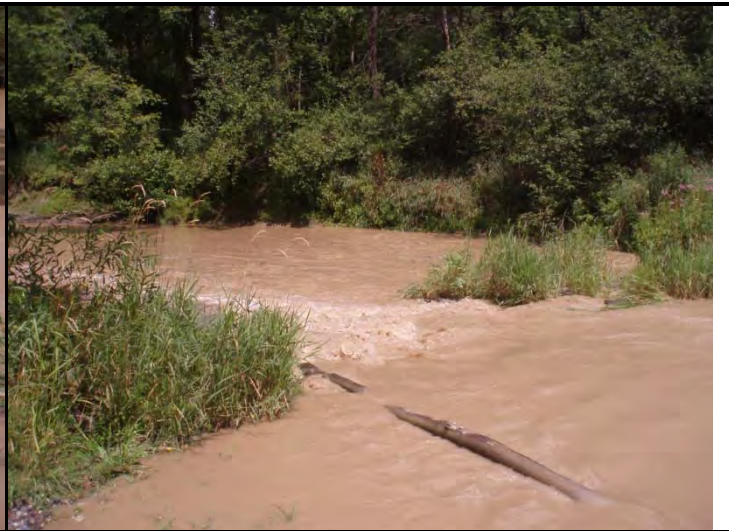
Photo 1. Farm road ford across Rock River

Photo 2. River downstream of ford

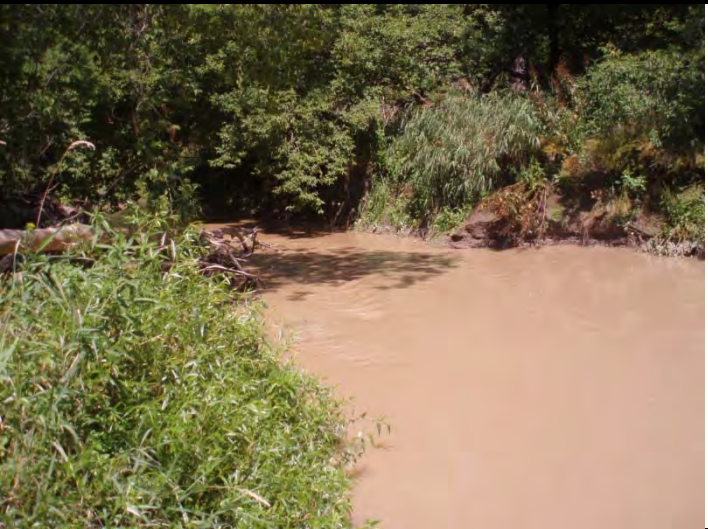
Photo 1. Farm road ford across Rock River	Photo 2. River downstream of ford

Description of Observed Conditions:
Major erosion along banks at farm crossing, and on unimproved access road down to the river. Obvious struggles to ford the Rock River evident. Entire farm area may be susceptible to erosion—steep banks, erosive soils. Have contacted AAFM about resources that might be available to improve the crossing.

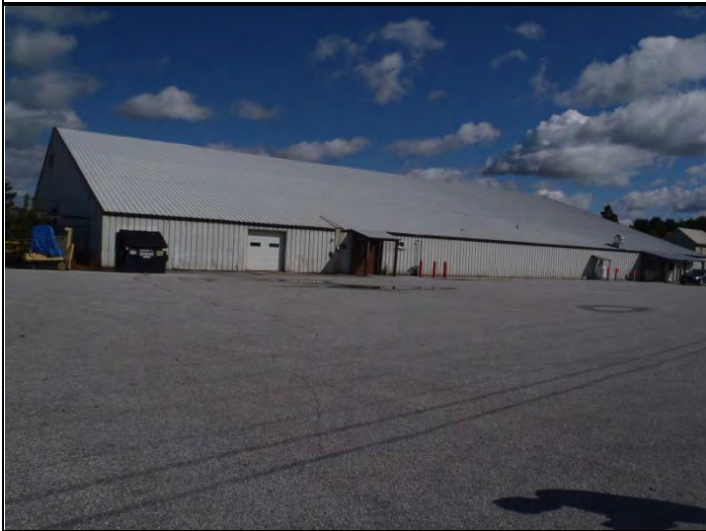
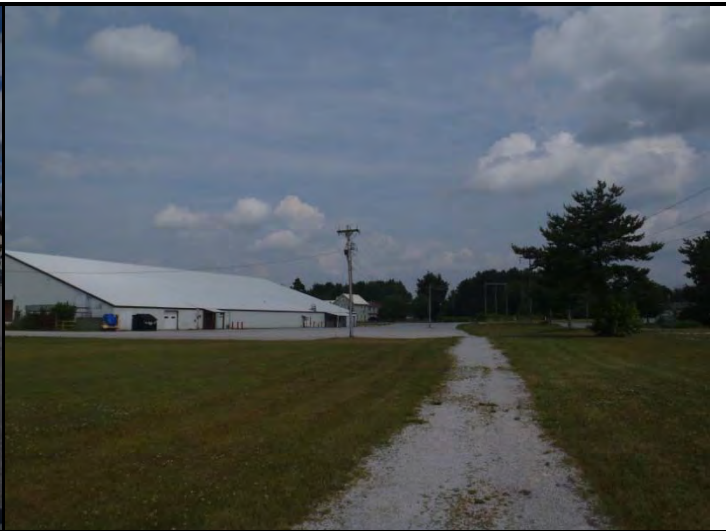
Photo 1. Ice Arena

Photo 2. Field west of Ice Arena

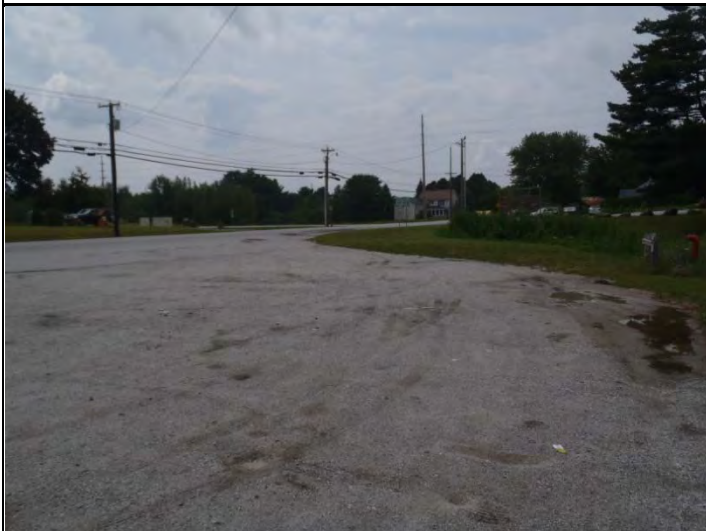
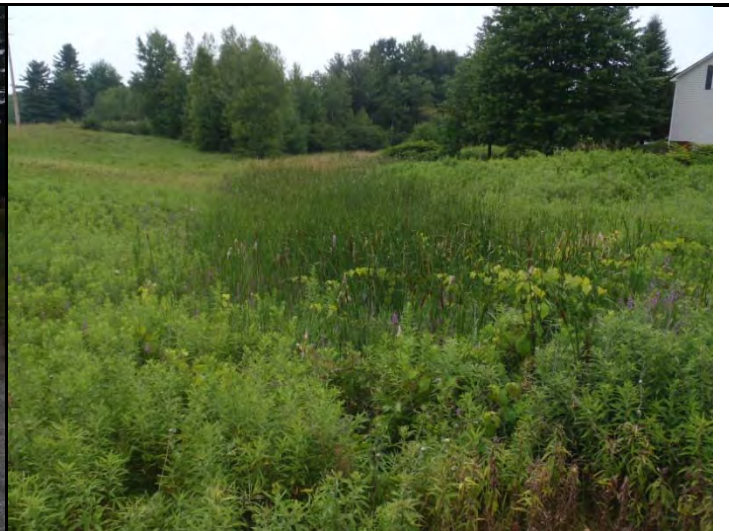
Photo 1. Highgate Park and Ride

Photo 2. Wetland SW of junction of Routes 207 and 78

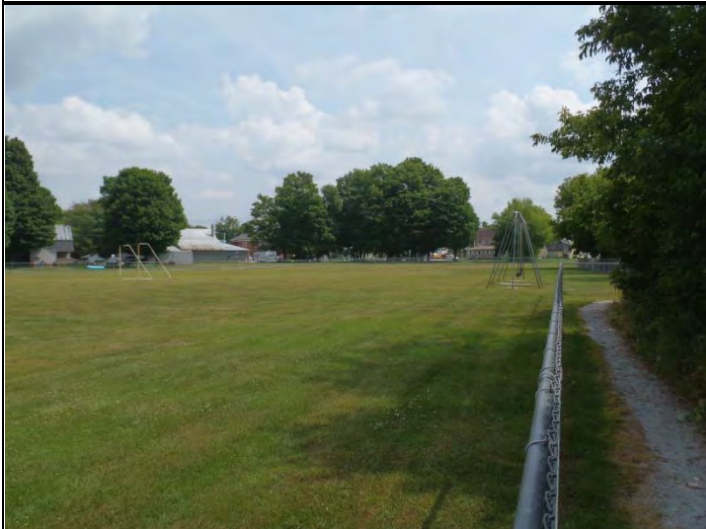
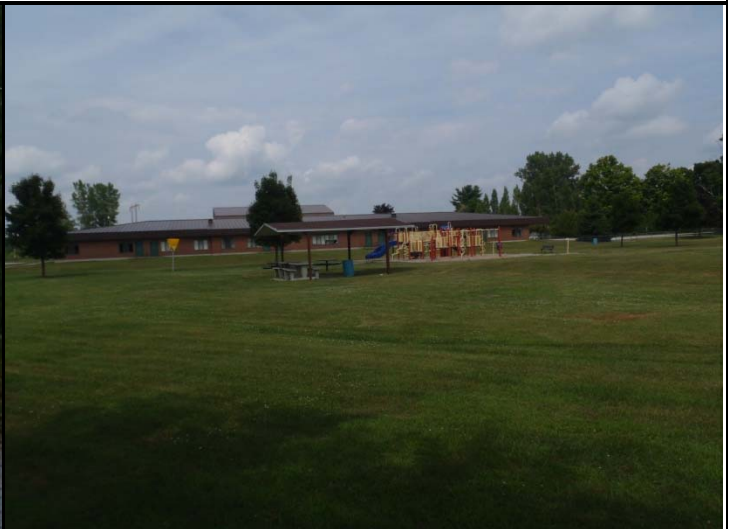
Watershed:	Missisquoi River													
Location:	Franklin St, bounded by St. Armand and Gore Rds													
Problem Type:	Local Drainage													
Identification Source:	Town Feedback													
Ownership:	Local/Private													
Classification Level:	3													
Problem Description:														
Unmanaged stormwater runoff in village area north of Franklin St., bounded by St. Armand and Gore Rd, including Highgate Elementary School parcel.

Photo 1. Taken from west edge, looking south

Photo 2. Taken from west edge, looking north

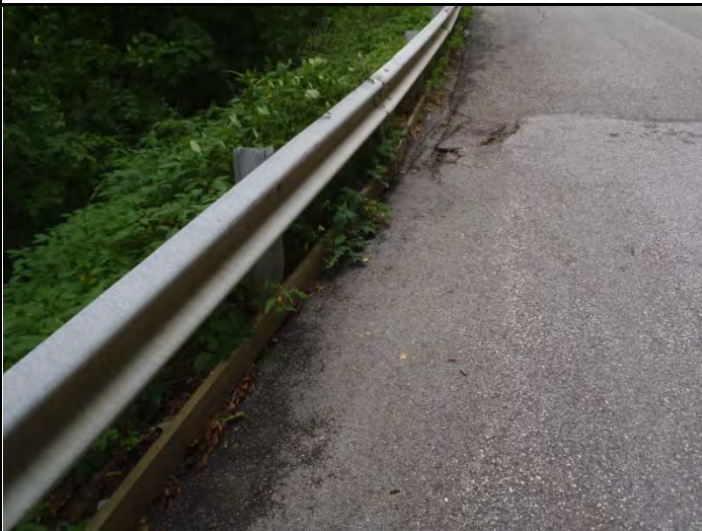
Photo 1. Erosion along roadside

Erosion in ditches along road, and major blowout at the end of guardrail were observed. Additional turnouts or other measures could be used to help reduce the volume and velocity of stormwater flows along Mill Hill.

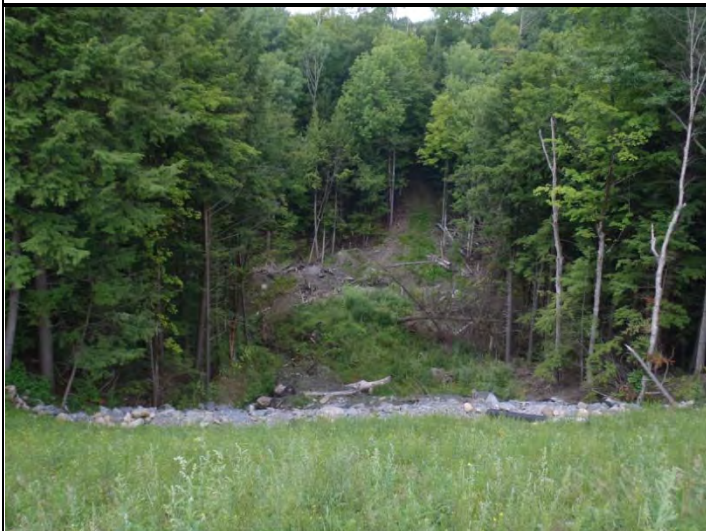
Photo 1. Looking down landslide from town shed

Flooding during Irene caused massive landslide; has been built back with stone and graded to approximately at 60 degree angle. Stream at bottom of hillside was plugged with sediment; the Town reports using an excavator to re-channelize the stream, but flow has been greatly restricted. Grass area near shed now has surface drain, flows down 18" corrugated plastic pipe to stream. Tile drain also installed—drains to 8" corrugated plastic pipe along bank. Water also flowing off parking area down SW bank, causing 8" gully erosion. (Additional photos included on the next page.)

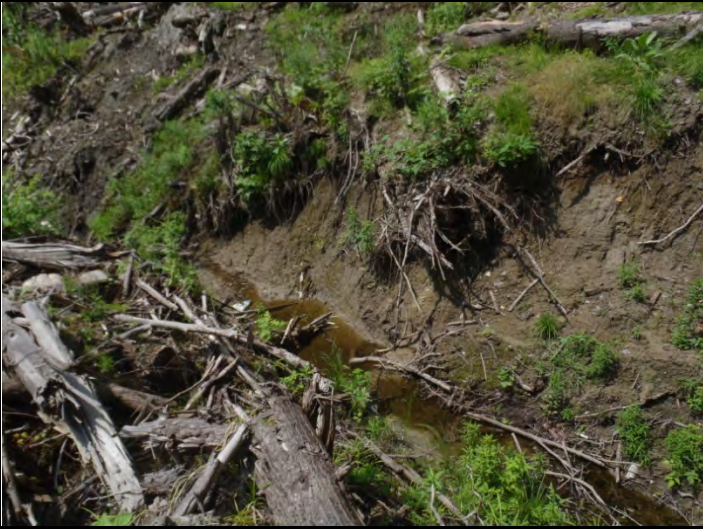
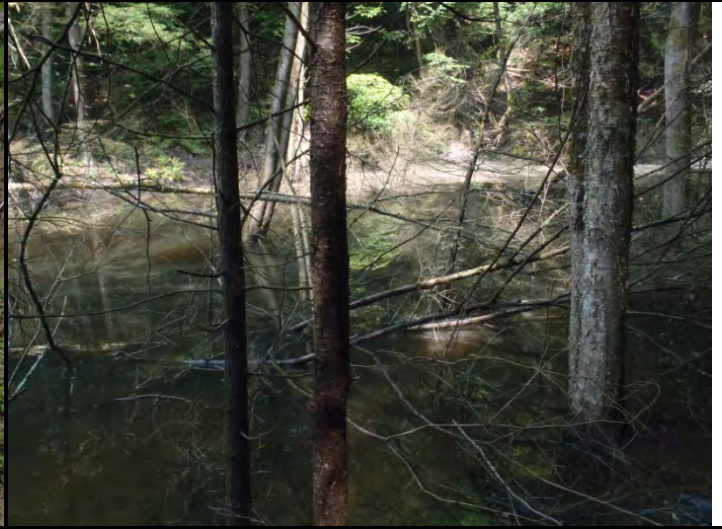
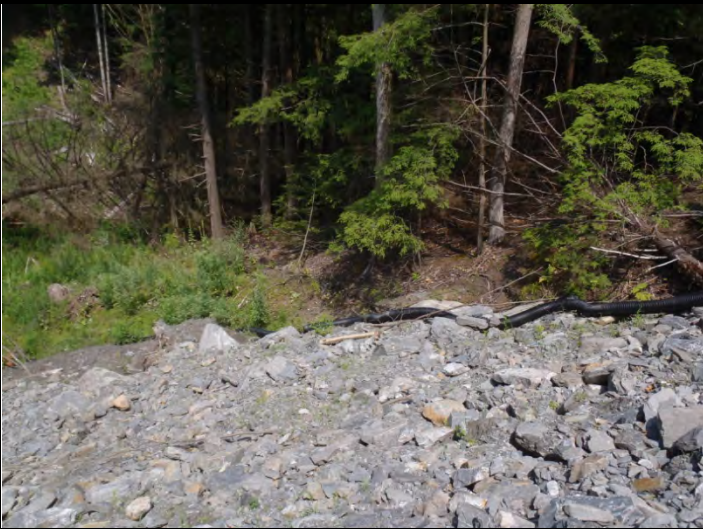
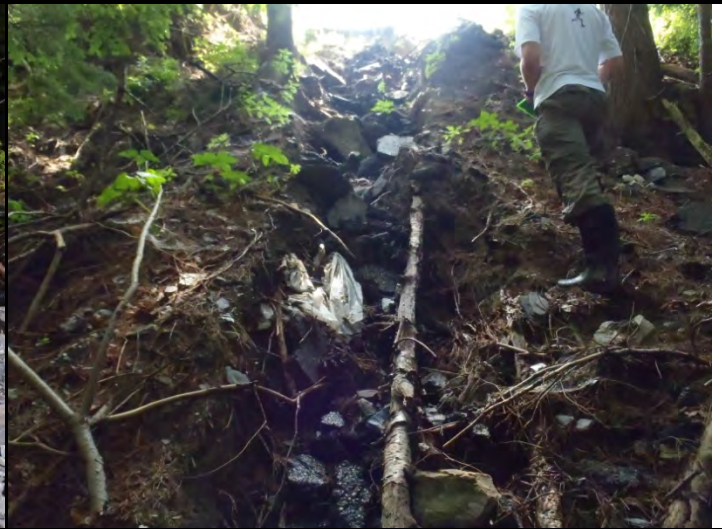
Photo 3. Channel dug by town to allow water flow

Photo 4. Standing water in the stream, upstream of debris jam

Photo 5. Pipe that now drains parking lot area

Photo 6. Stormwater flow down hillside to west, with visible erosion

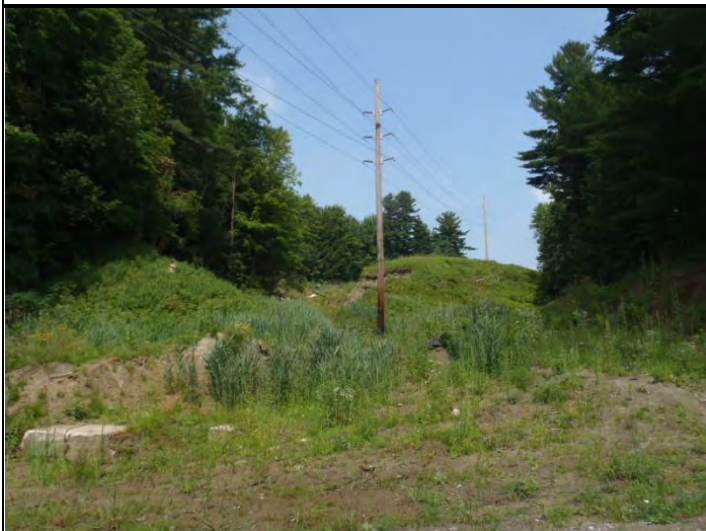
Photo 1. Landslide area from access road

Massive landslide, caused by Irene, took down two utility poles. 25-50 feet of eroded banks above access road. Some evidence of dumping (e.g., tires and trash). No real source of flow upstream; some springs at toe of bank. Area north of landslide is the utility right-of-way (grass).

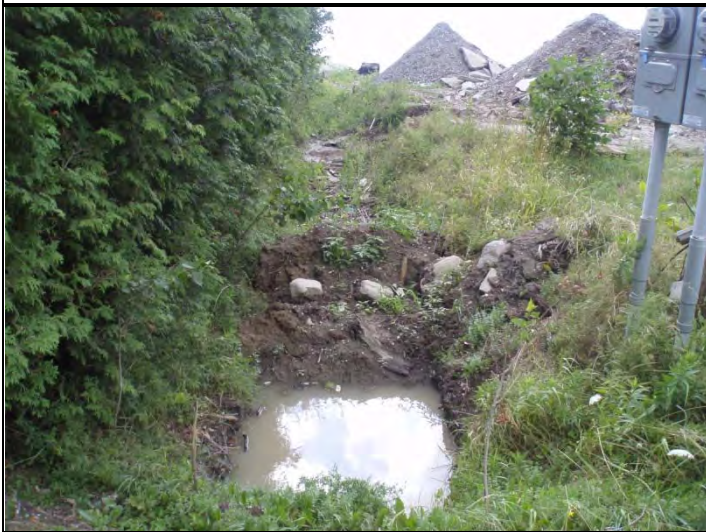
Photo 1. Potential culvert outfall area

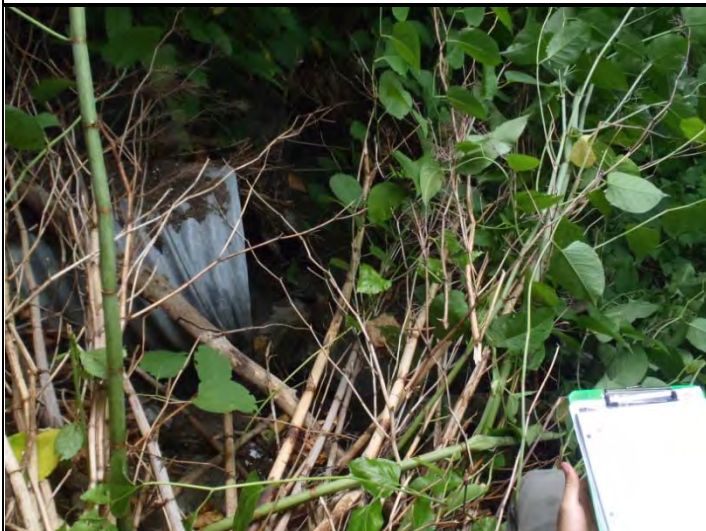
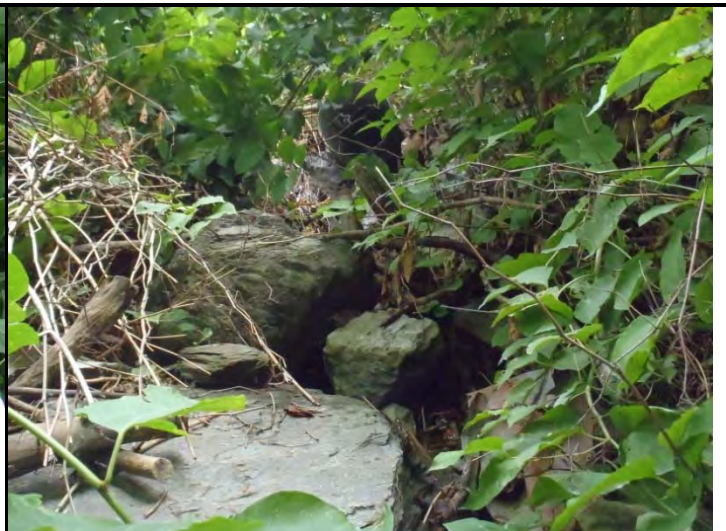
Photo 1. Outfall from under-road culvert

Photo 2. Looking back up at outfall

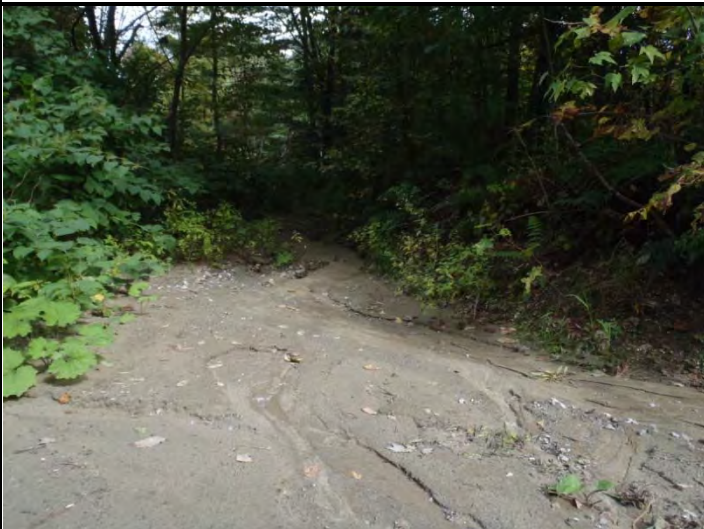
Watershed:	Missisquoi River													
Location:	Pine Plains Rd, south of intersection with Route 78													
Problem Type:	Local Drainage													
Identification Source:	Town Feedback													
Ownership:	Unknown													
Classification Level:	4													
Problem Description:														
Significant erosion along Pine Plains Rd.

Photo 1. Overland flow near base of Pine Plains Rd

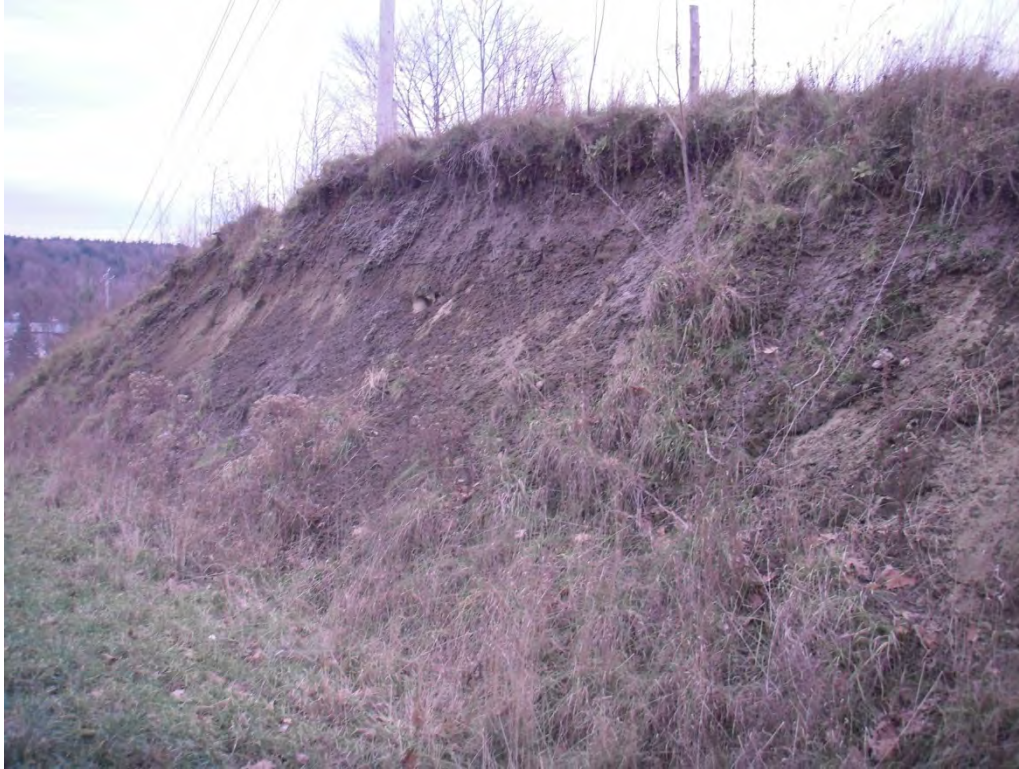
Recent roadway improvement work along Durkee Road in Highgate Center has resulted in over-steepened banks causing erosion of sections of the ditch backslopes along both sides of the road. The section of road affected is fairly steep, and is located only about a third of a mile from the Missisquoi River. Approximately 300 feet of road side ditch is affected, with the backslope reaching a maximum approximate height of 10 ft (see Figure 2 and Figure 3).

Figure 2. Oversteepened and eroding ditch backslope on west side of Durkee Rd. in Highgate Center.

The simplest solution would be to re-grade the backslopes to a maximum 3:1 slope and establishing vegetation. A drawback to this solution is the encroachment on private land when the slopes are partially flattened. Alternatively the backslopes could be re-graded to a maximum 2:1 slope and erosion control matting or a riprap blanket (stone armoring) installed. A third and even more intensive solution would be to install structures such retain walls. This approach would require engineering design and heavy construction work, but would minimize encroachment on private property.

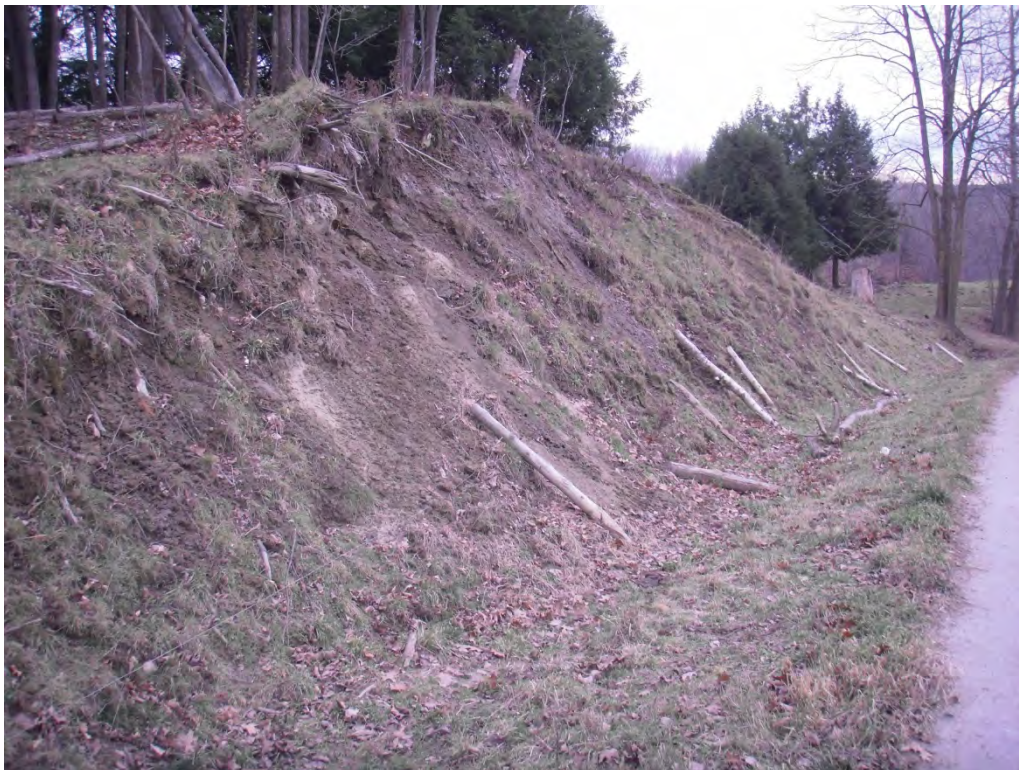
Figure 3. Eroding ditch backslope on the east side of Durkee Road in Highgate Center.

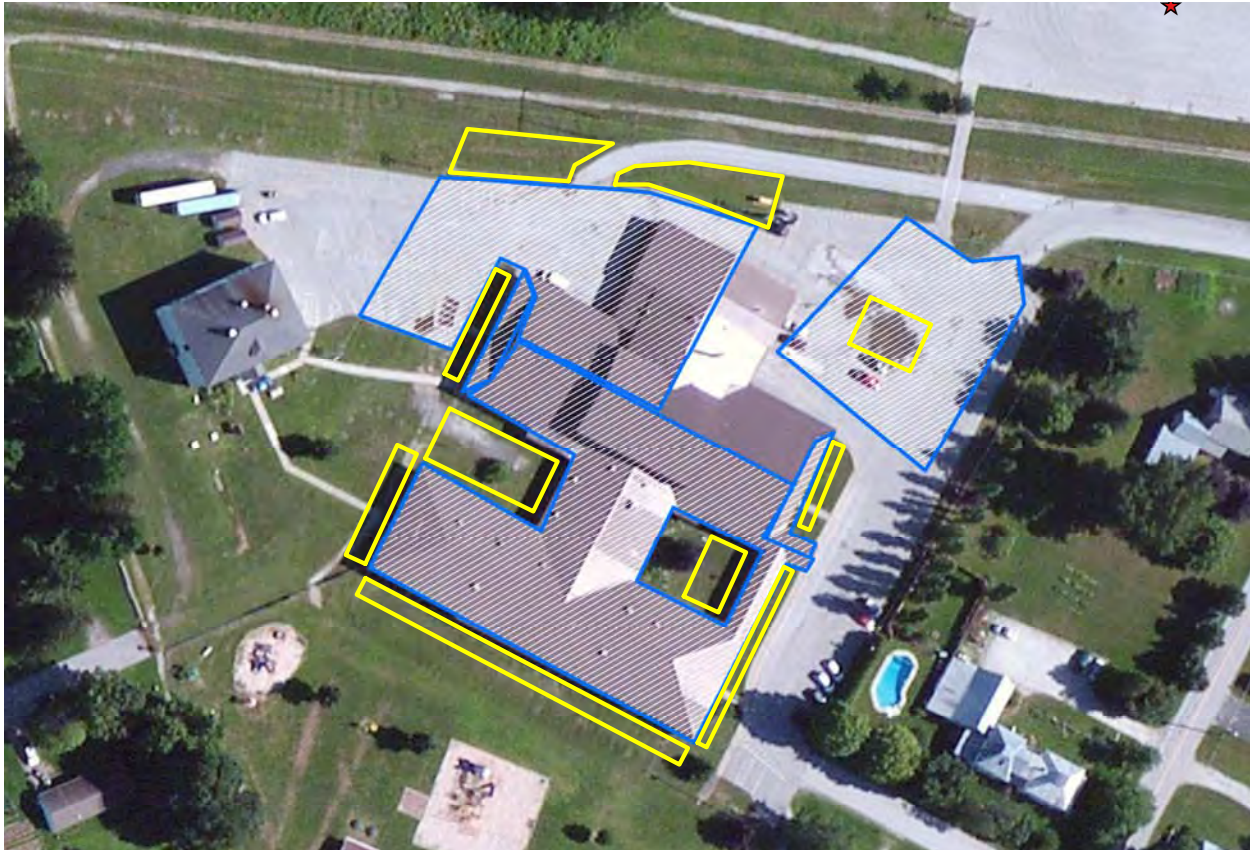
The Highgate Elementary School campus includes a large amount of impervious surface; 2.3 acres of roof top and asphalt parking area have been identified as treatable impervious areas. Figure 4 shows treatable impervious area (blue outline) and potential stormwater treatment practice (STP) locations (yellow outline). Roof runoff could be captured and treated in bioretention areas and rain gardens installed around below the drip-edge around the perimeter of the building and in the two center courtyards (Figures 5-7).

Figure 4. Highgate Elementary School. Treatable impervious surface is highlighted in blue and potential STP locations are shown in yellow.

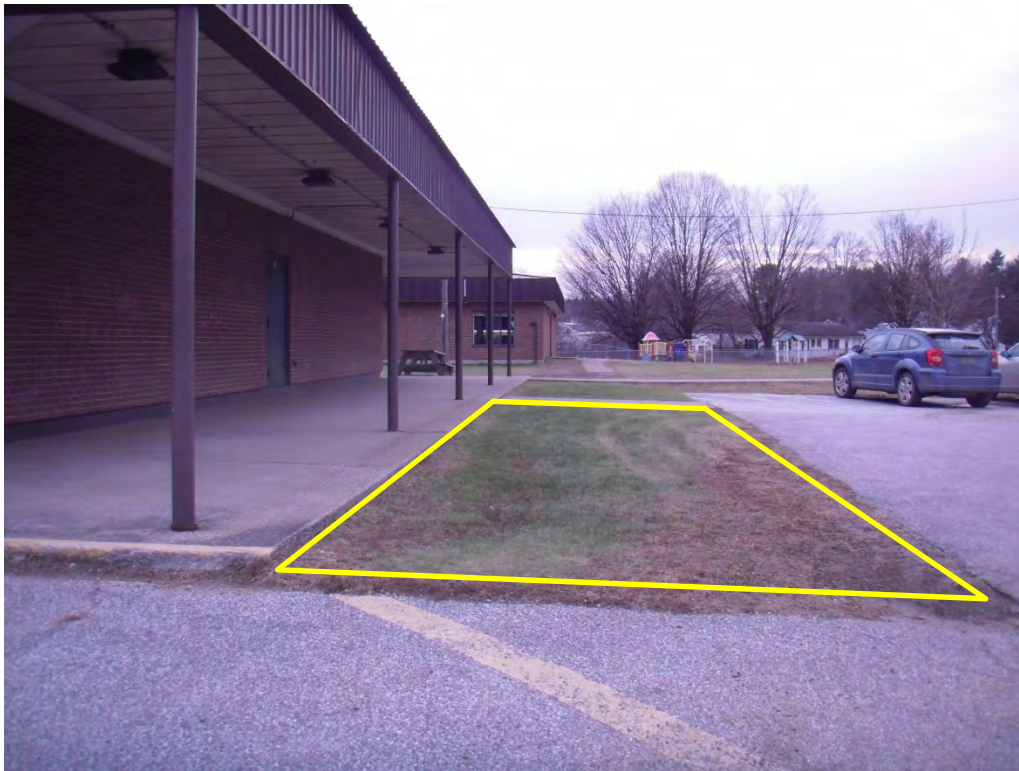
Figure 6. Infiltration area opportunity in the back of the school.

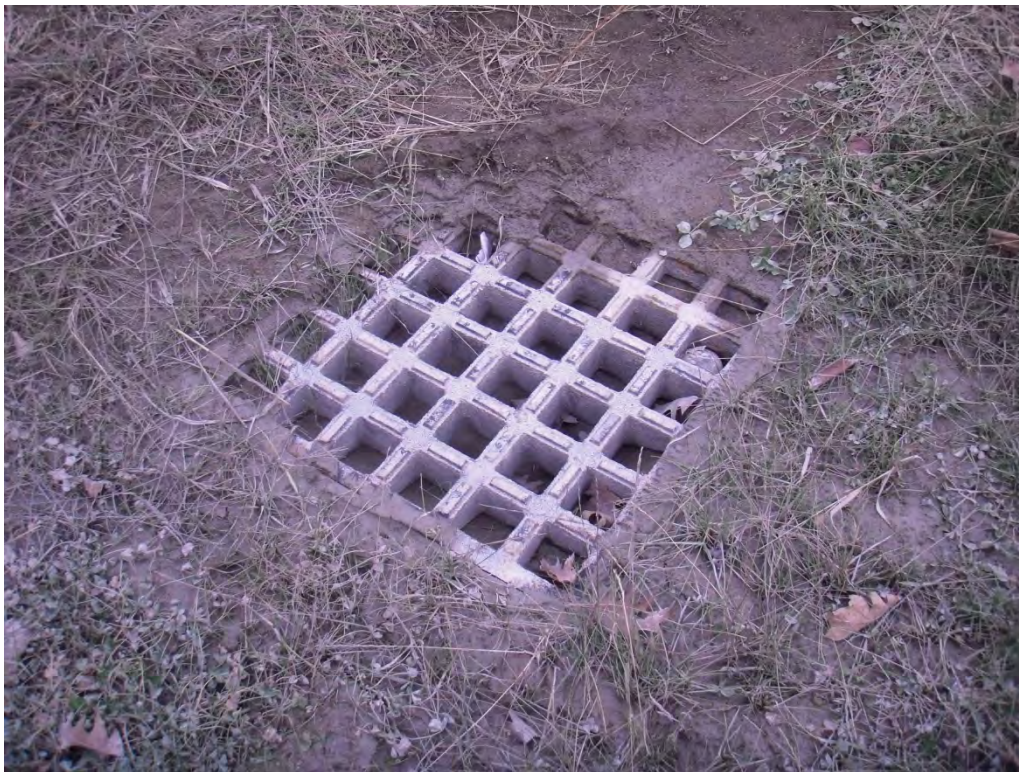
Figure 12. Sediment has completely filled catch basin at the Highgate town sand shed.

An infiltration-based STP could be constructed using the existing catch basin as an outlet. The STP could help keep sediment on-site reduce impacts to water quality and reduce the need to clean out the catch basin as often.
