STORMWATER MANAGEMENT PLAN FOR HIGHGATE

FINAL REPORT

Stone Project ID 112475-W

March 1, 2013

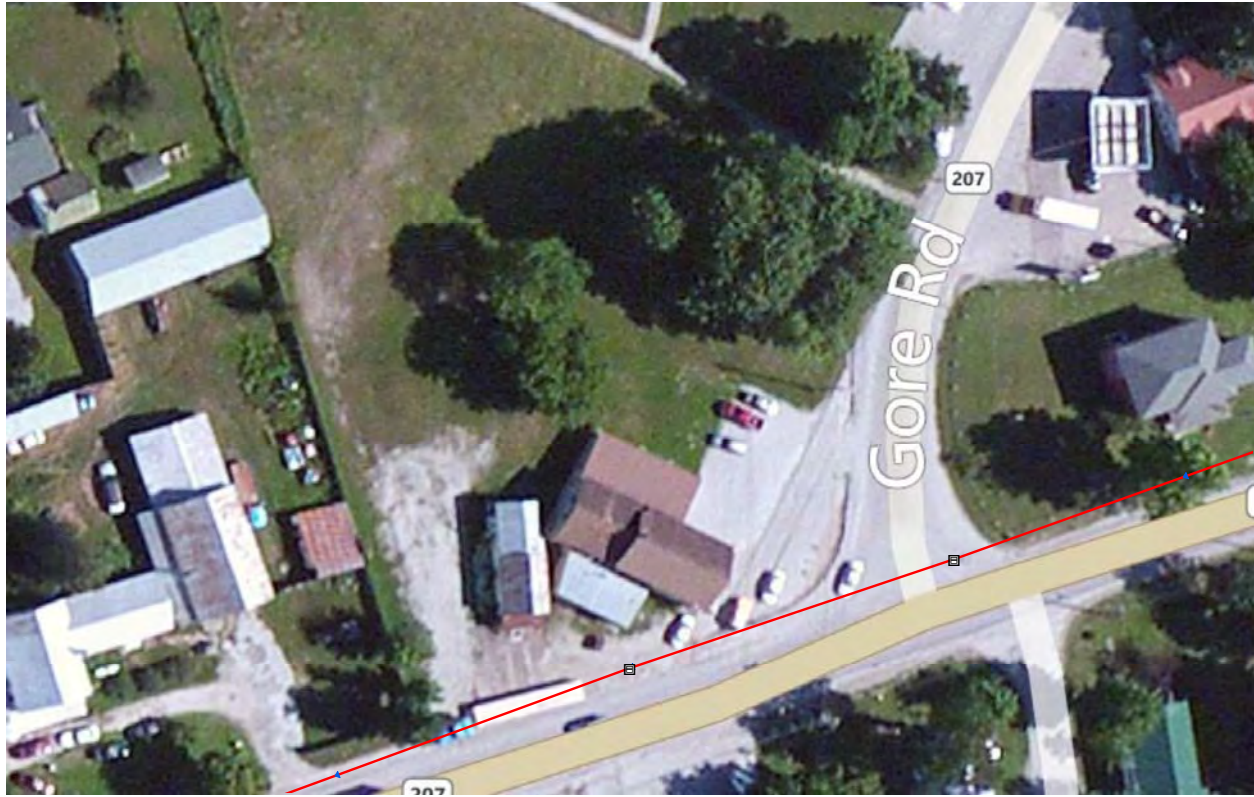
The Town of Highgate Municipal Plan reports an on-going initiative to locate a Park-and-Ride facility at the corner of VT-207 and VT-208 in downtown Highgate. A significant portion of the area is currently paved, the asphalt being a relic from when the intersection was reconfigured several years ago. This area currently drains to the stormwater outfall described in more detail in Section 1.5 of this memo.

Figure 14. The Highgate Municipal Town Plan proposes the construction of a Park-and-Ride facility at the corner of VT-207 and VT-78. Soil conditions favor infiltration practices such as porous pavement at this site.

Soils in at this location are reported by the NRCS as Windsor loamy, fine, sand with a deep water table (over 200 cm). These soil conditions and flat topography make infiltration practices an effective option. As plans develop, low-impact design practices such as porous pavement and infiltration features should be strongly promoted. Alternatively, if plans for the Park-and-Ride facility at this location are abandoned, the existing pavement could be removed and natural site hydrology restored.

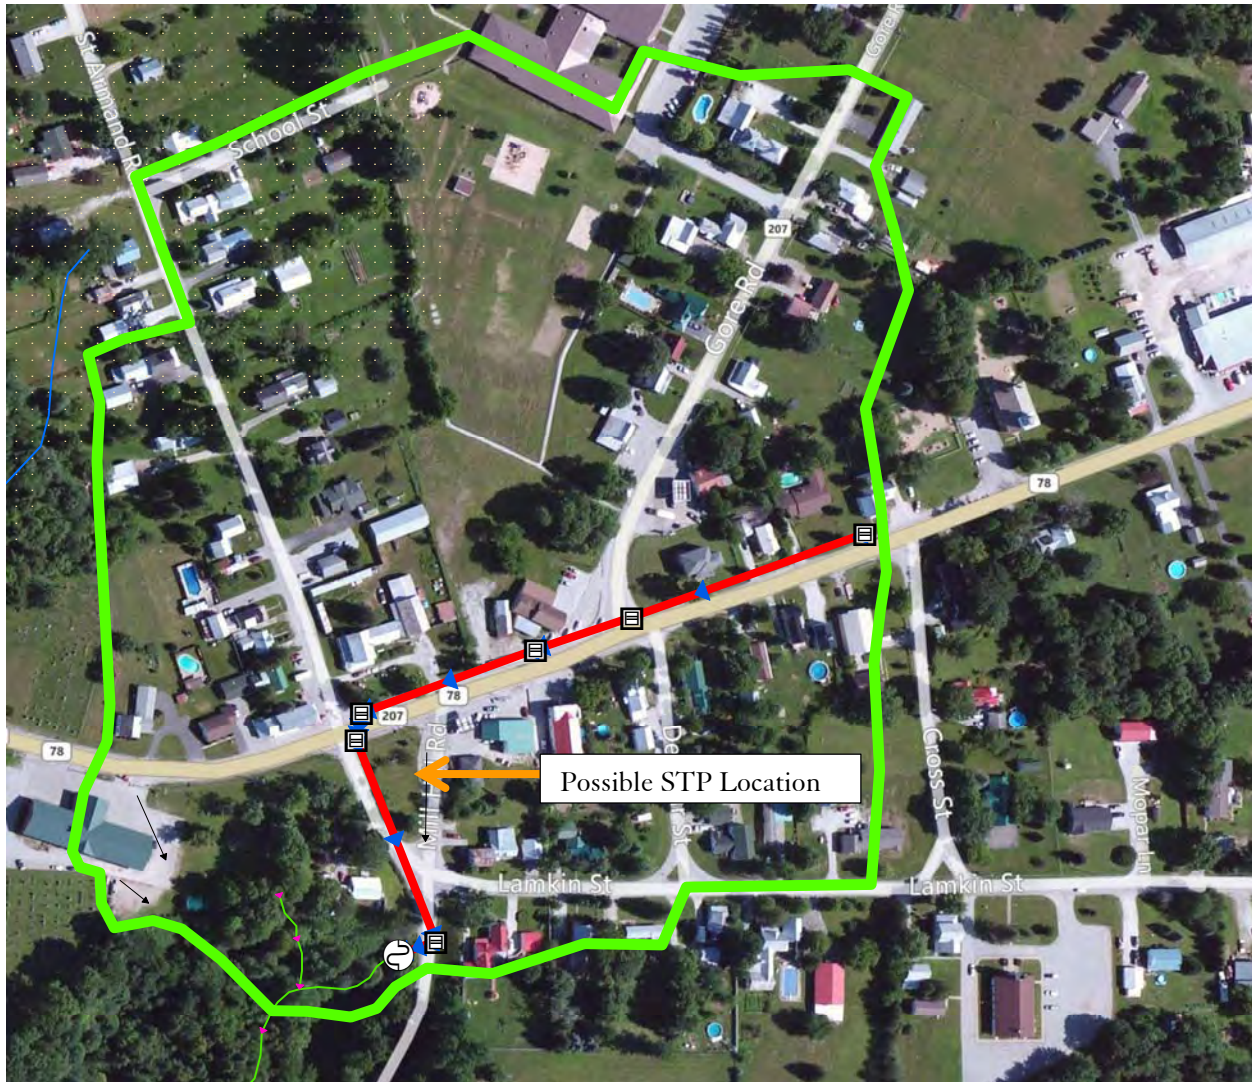
Figure 15. The downtown area of Highgate is shown in this figure. Storm sewer is shown flowing from east to west, then to an outfall south of town on Mill Hill Rd. The contributing watershed is shown in green.

Much of downtown Highgate, a 32 acre catchment, drains to a large swale along Mill Hill Rd. A storm sewer collects stormwater along a section VT-78 and discharges directly to this swale (see Figure 15). Direct drainage from the road and discharges from the storm sewer has created a localized erosion issue (see Figure 16). Armoring below this outfall with riprap is recommended, although this is obviously not a complete solution. To achieve more substantial improvements in stormwater conditions, source control is recommended. This would involve creating “upland” opportunities to capture and slow stormwater runoff, either within the road right-of-way or on adjacent private property. Another option to consider is the installation of a STP in the triangle median at the intersection of VT-207, VT-78, and Mill Hill Rd.

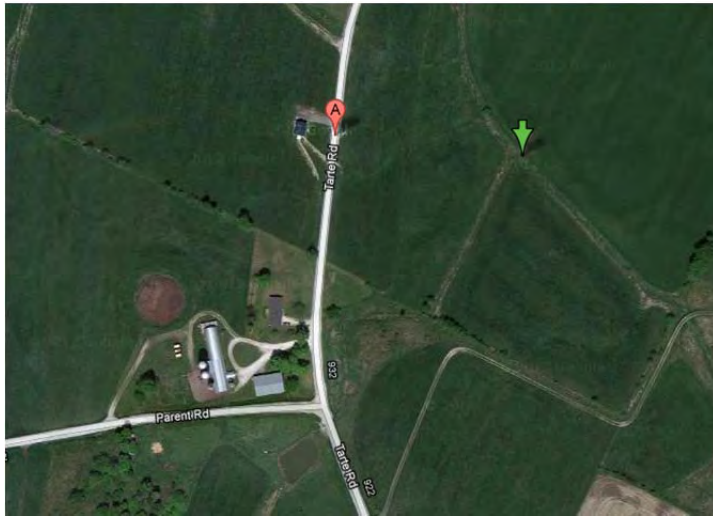
1.7.1 Tarte Rd, Crossing #1

Figure 20. Farm road crossing #1.

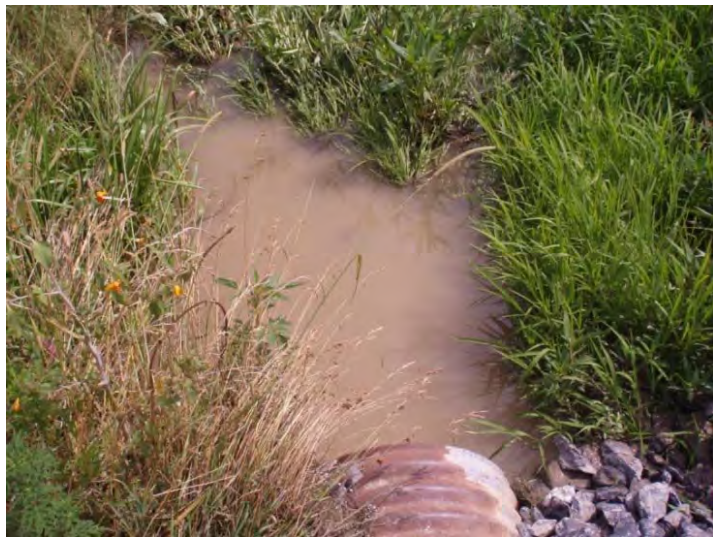
Figure 21. Scour pool at outfall from undersized culvert that carries unnamed Rock River tributary under farm road. Some rip rap has been placed by the landowner to address localized erosion around the culvert.

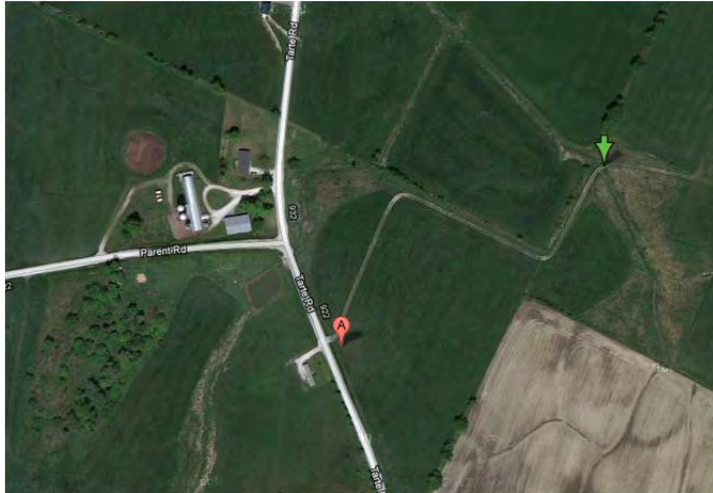
1.7.2 Tarte Rd, Farm Road Crossing #2

Figure 22. Farm road crossing #2.

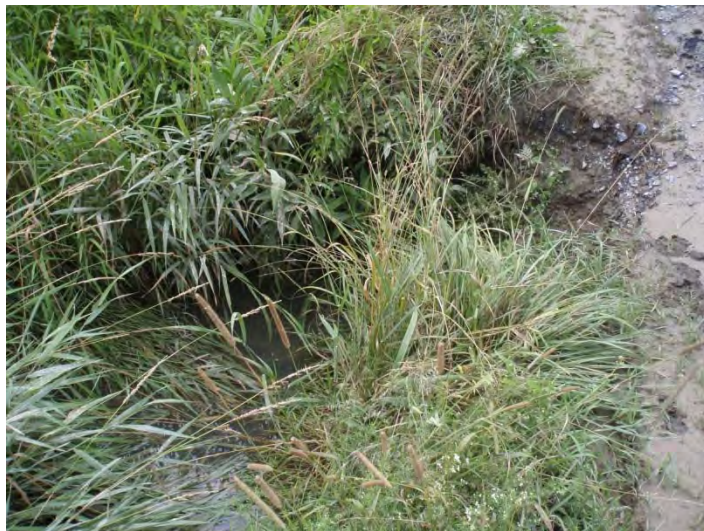
Figure 23. Undersized culvert under farm road. Erosion occurring from road surface as well as in scour pools at the upstream (shown) and downstream ends of the culvert.

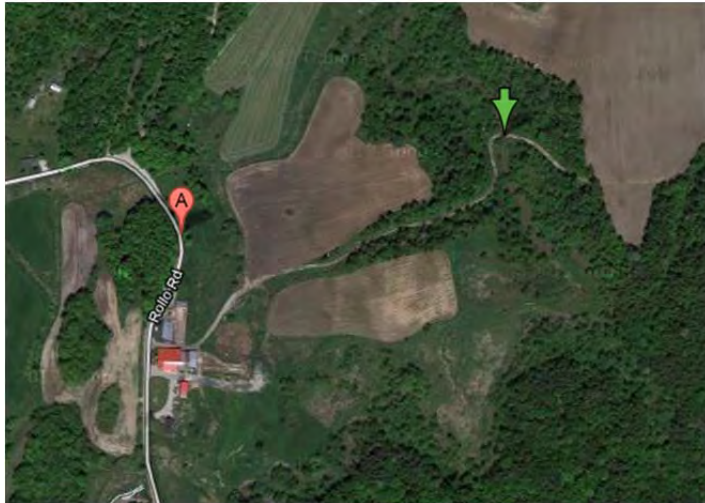
1.7.3 Rollo Rd, Farm Road Crossing #3

Figure 24. Farm road crossing #4.

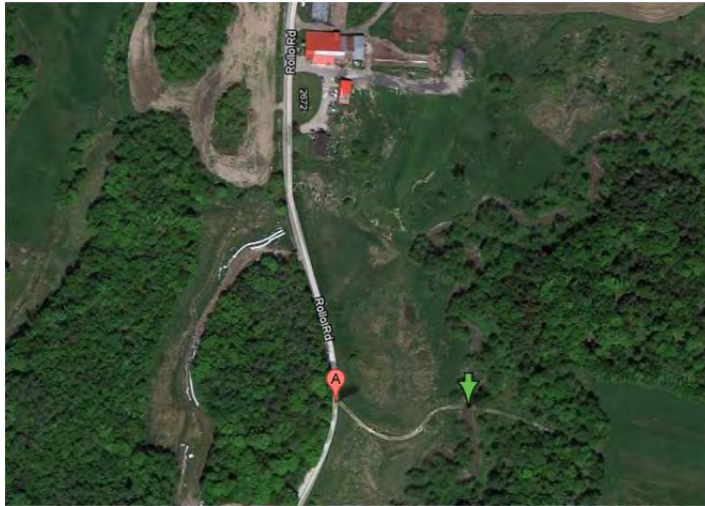
1.7.4 Rollo Rd, Farm Road Crossing #4

Figure 26. Farm road crossing #4.
