STORMWATER MANAGEMENT PLAN FOR SWANTON TOWN AND VILLAGE

FINAL REPORT

Stone Project ID 112475-W
February 21, 2013

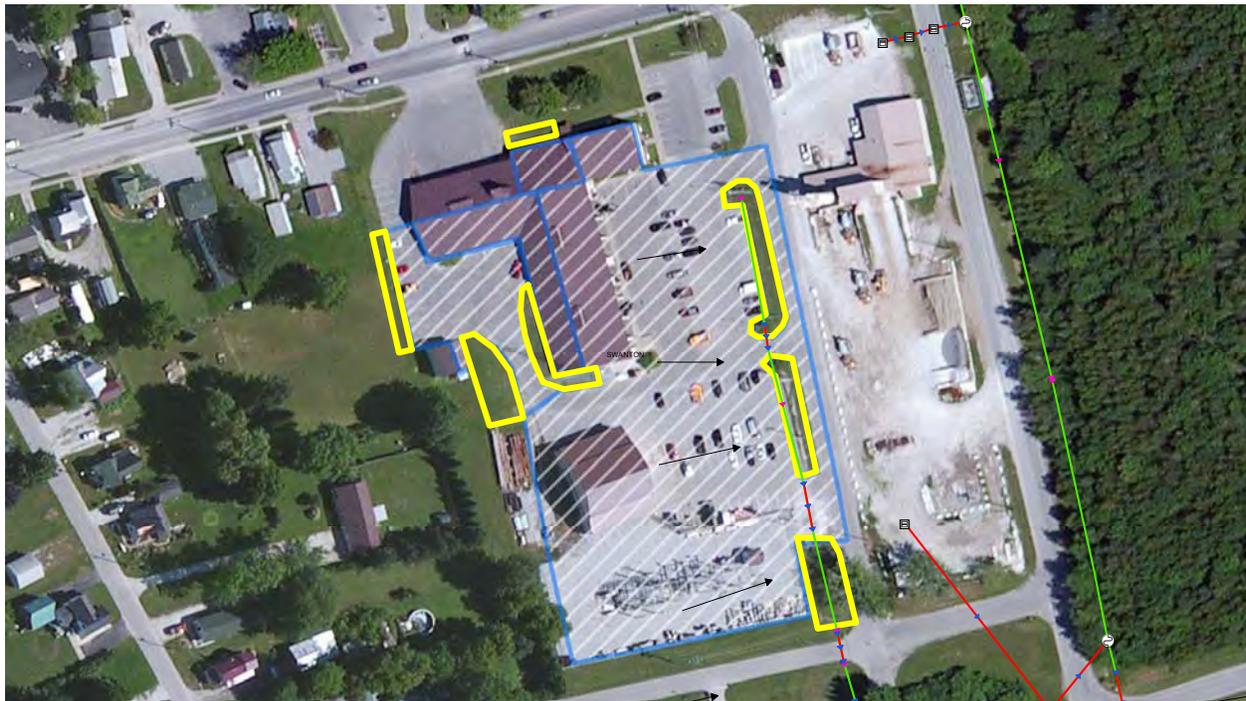
Figure 1. Swanton Village Municipal Complex: Treatable impervious areas are highlighted in blue, while locations for potential treatment practices are highlighted in yellow.

Stormwater from three acres of impervious surface at the Swanton Village Municipal Complex could be routed to potential stormwater treatment practices (STPs) located as shown yellow in Figure 1. Areas of impervious surface that are considered to be treatable are highlighted in blue in Figure 1. Predominant soil types are Windsor loamy fine sand (HSG A) with a deep water table, meaning there is potential to soak away a large amount of stormwater that is currently draining from this property.

The existing swales along Elm St. could be retrofitted to provide relatively simple, yet effective infiltration-based STPs. The presence of underground utilities in the area will need to be fully and carefully investigated as part of any design.

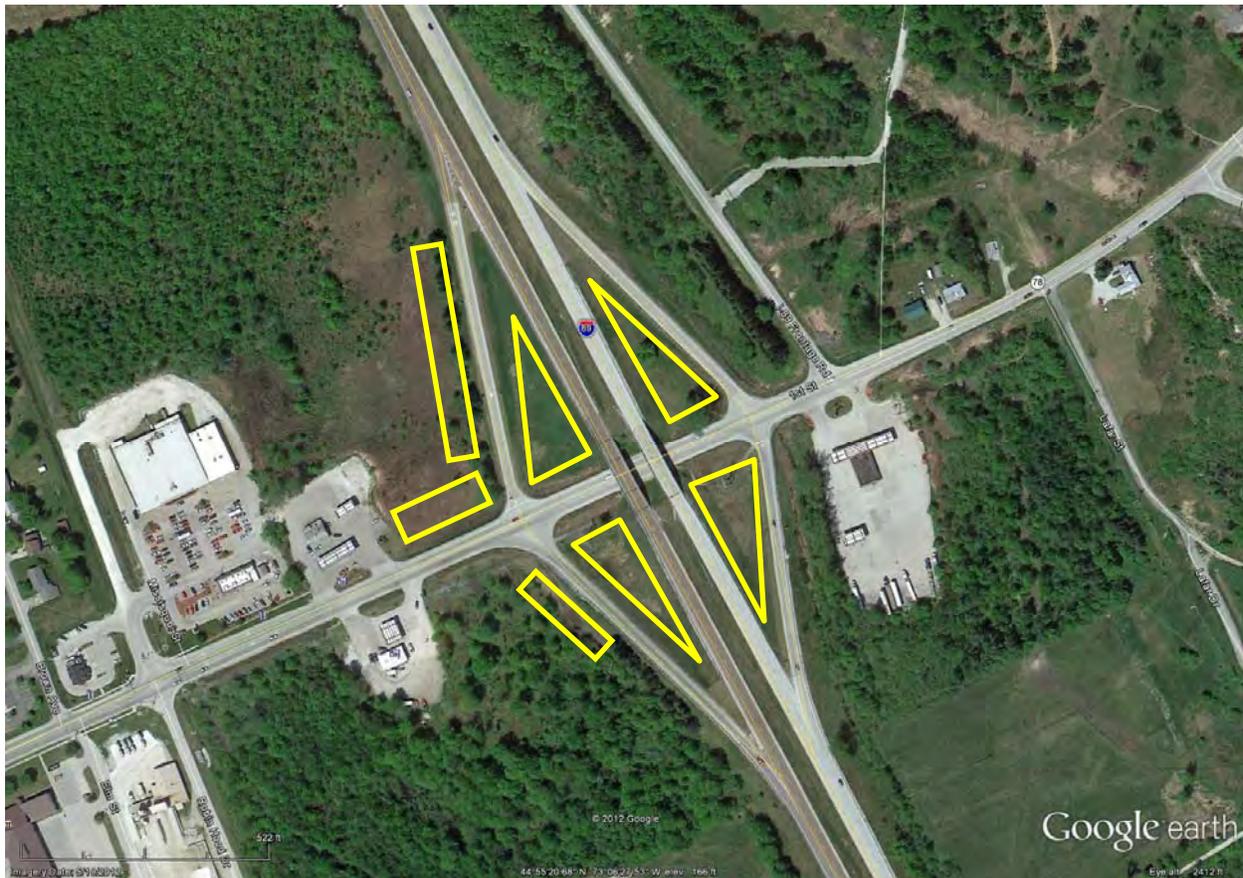
Figure 2. I-89 (Exit 21)-VT RT 78 Interchange. Potential sites for stormwater treatment practices highlighted in yellow.

Green space within and adjacent to the I-89 Exit 21 interchange could accommodate the construction of stormwater treatment practices. The diamond interchange at Exit 21 includes a stormwater conveyance system that drains the highway. The 30-acre subwatershed includes 3.8 acres of impervious surface. The large amount of open space and existing conveyance structures simplify design and construction efforts required to implement a stormwater treatment practice at this location. A storm water treatment practice similar to that which was recently constructed in the highway median at I-89 Exit 20 could be effective here.

The most suitable practices are likely to be bioretention and filtration systems that include an underdrain. Soils are reported by the USGS to be Georgia stony loam and Massena stony loam, Hydrologic Soil Group (HSG) C with high water tables. These characteristics mean that infiltration cannot be expected to be a suitable treatment practice. Additionally, roadway subsoil strength can be affected by saturated soils. The proximity of the roadway further supports the need for non-infiltration-based systems.

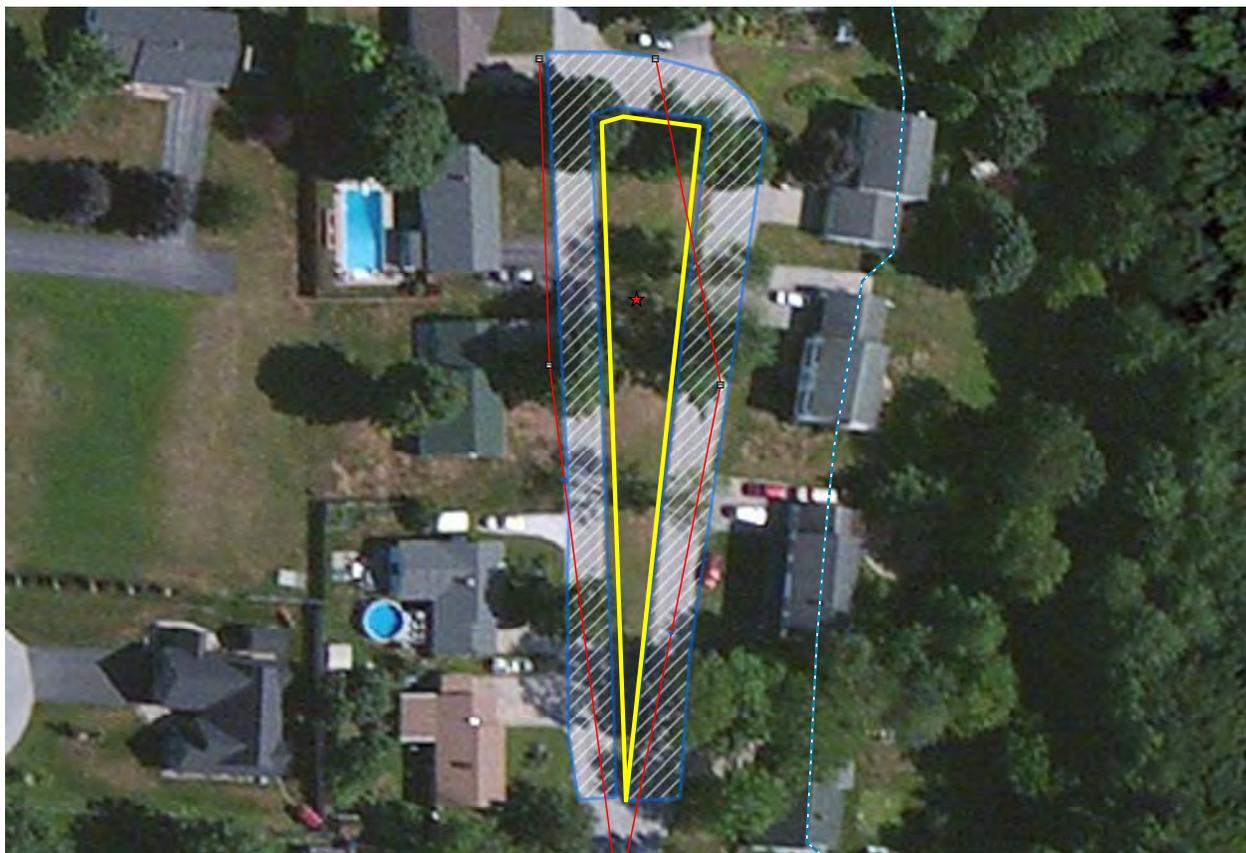
Figure 3. The Taylor Drive cul-de-sac offers ample treatment opportunity (shown in yellow). The contributing impervious area is outlined in blue.

Taylor Drive is a residential street with a large cul-de-sac that includes a median that is well-suited for stormwater treatment. Currently, water drains from the street and some of the adjacent residential lots toward the cul-de-sac where it is collected in catch basins along the existing curb.

The reported soil types in the area are Windsor loamy fine sand (HSG A) with a deep water table. This means that infiltration practices could be used to soak away a large portion of stormwater runoff from this neighborhood. Curb cuts could allow stormwater to drain to a potential stormwater treatment practice within the green space at the center of the cul de sac.

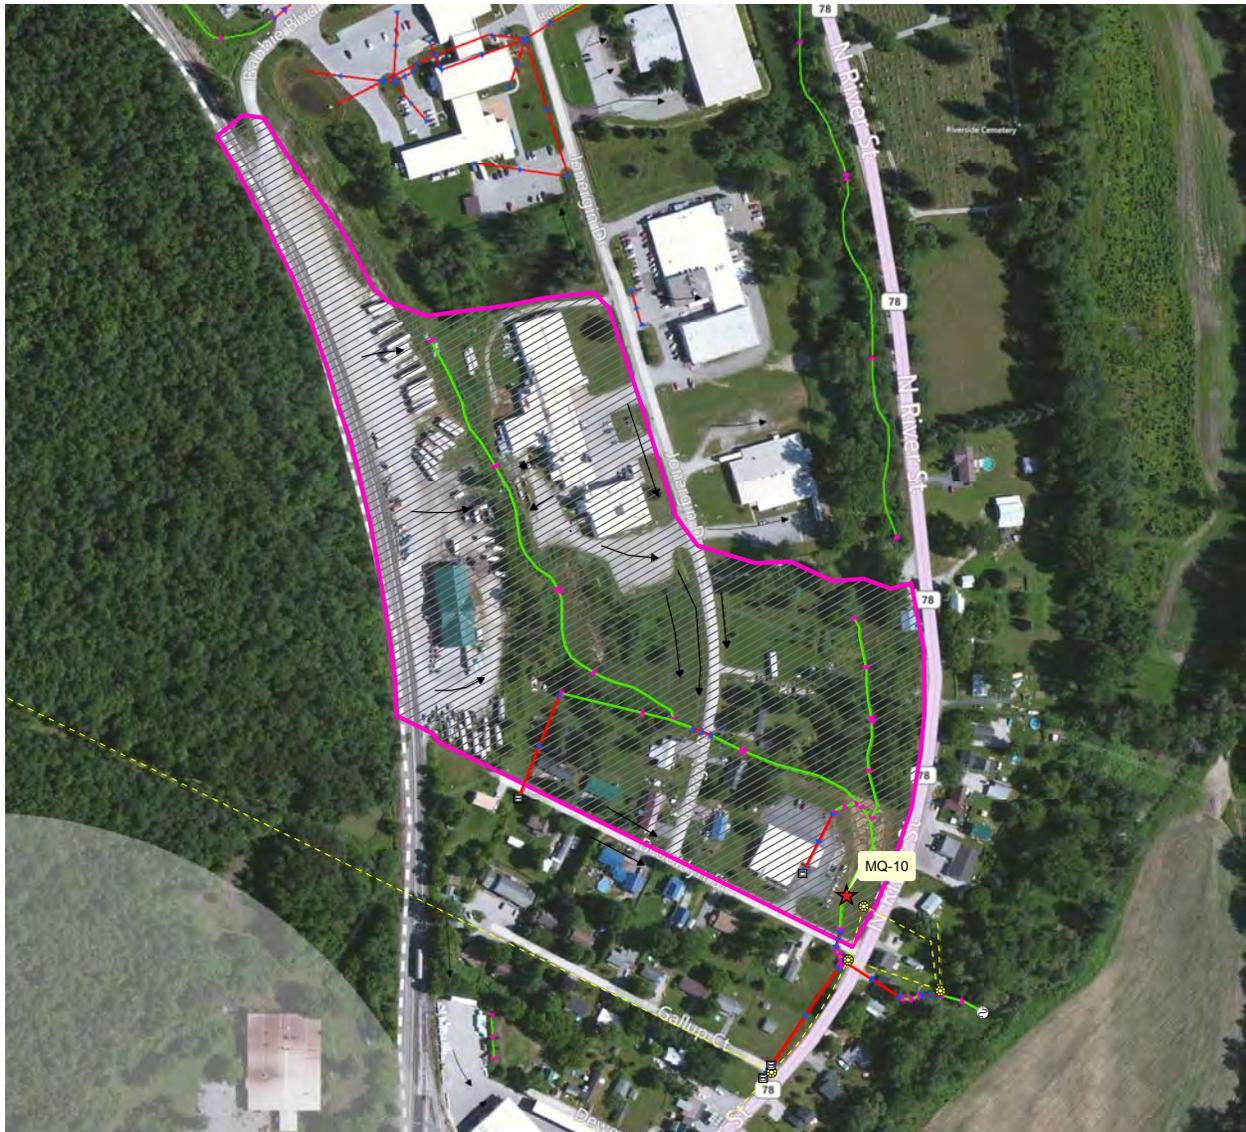
Figure 4. Subwatershed draining to a culvert at the southeast corner of the Fourniers Door and Window business at the corner of Rt. 78 and Brooklyn St.

Stormwater runoff from approximately 22 acres drains to a culvert at the corner of Route 78 and Brooklyn Rd., where the Fournier business is located. This 22-acre subwatershed includes 7.1 acres of impervious surface (approximately 3.6 acres of roof tops and asphalt, and 3.5 acres of compacted gravel surface). Stormwater from this subwatershed appears to receive no treatment before being routed through two culverts under Route 78 and discharged to the Missisquoi River.

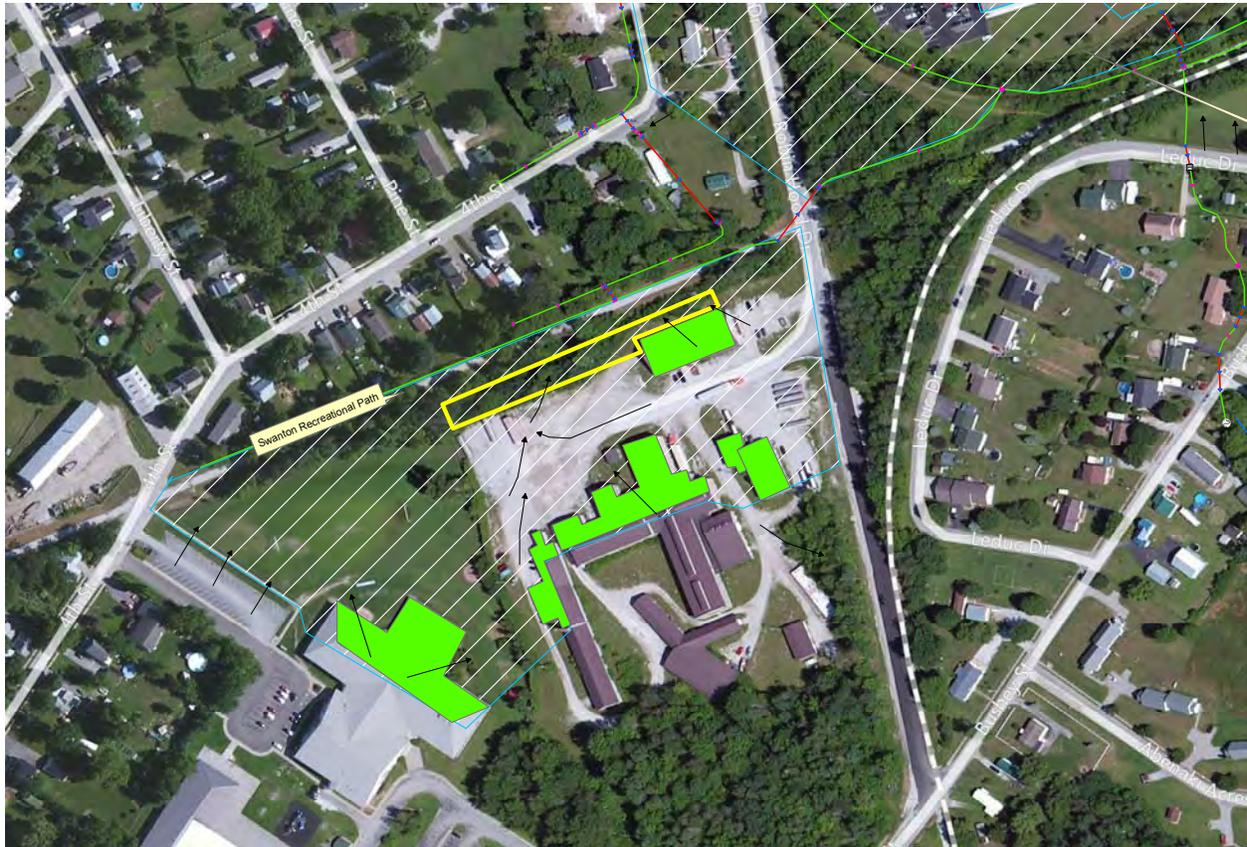
Figure 5. Drainage area at and around Swanton Elementary School: location for potential STP shown in yellow. Portions of rooftop that drain toward the potential STP are highlighted in green.

Potential stormwater treatment opportunities exist along the Swanton Recreation Path near Robinhood Drive. The subwatershed contains portions of the Swanton Elementary School and former Robinhood Ammunition plant property. The 10.5 acre subwatershed includes 3.2 acres of impervious surface (1.4 acres of roof tops and 1.8 acres of compacted gravel). The remainder of the subwatershed consists primarily of athletic turf on the school property. Athletic fields are often highly compacted and can have low infiltration rates. Stormwater drains north to a swale that flows to the northeast along the south side of the recreation path. From the end of this swale, stormwater flows through approximately 0.5 miles of storm sewer and open channel conveyance to the Missisquoi River.

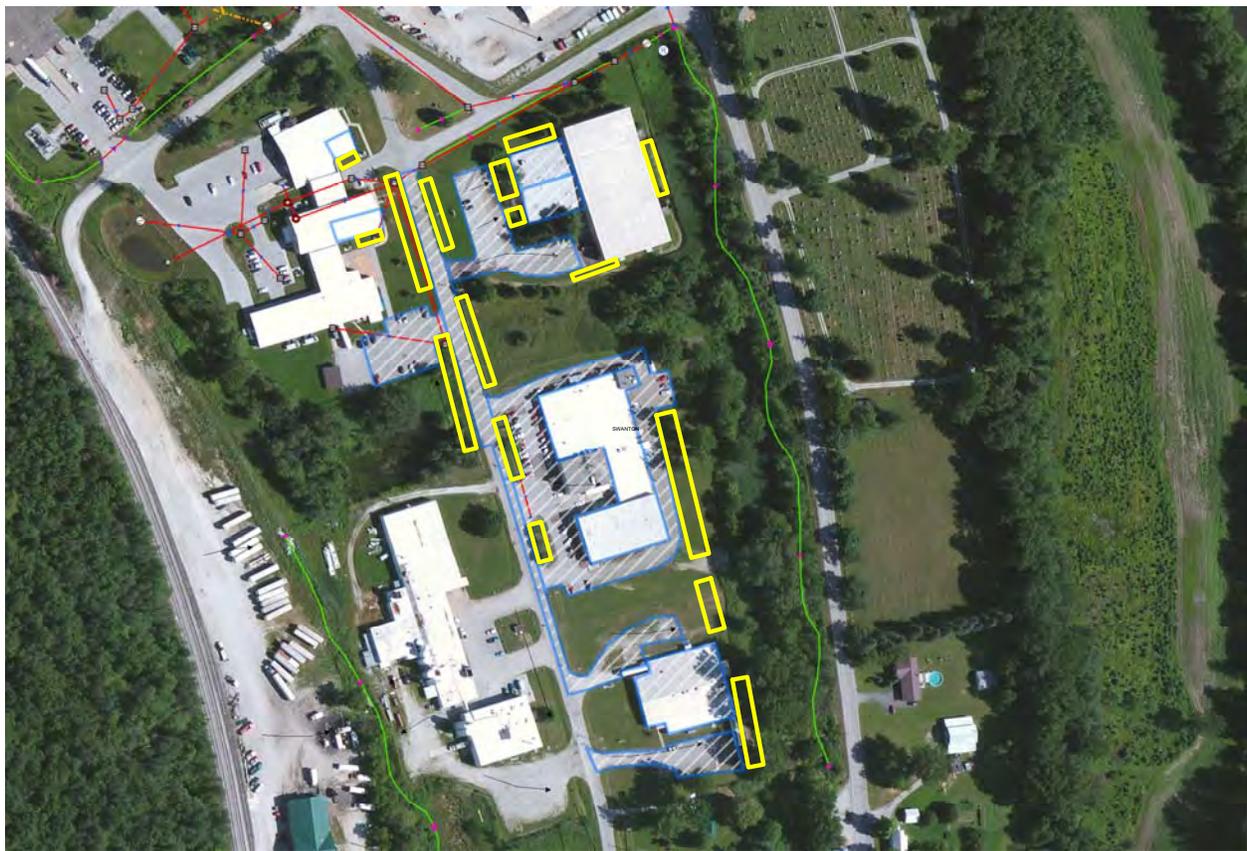
The industrial area along Jonegrin Dr. and Babbie Blvd. includes a significant amount of impervious area; 3.9 acres within the subwatershed have been identified as potentially treatable. Stormwater runoff from this subwatershed makes its way to the Missisquoi River with no retention and little, if any, treatment. Many options have been identified for location of STPs as shown by the yellow highlight in Figure 6. Stormwater from a large segment of the industrial development near Jonegrin Dr. and Babbie Blvd. is untreated and drains to the Missisquoi River. Massena stony loam and Raynham silt loam are the predominant soil types in this area. Both soils are reported to be HSG C with a shallow water table. Infiltration practices will not be a likely option. However, many opportunities exist for retrofitting the existing stormwater infrastructure with filtration-type treatment practices.

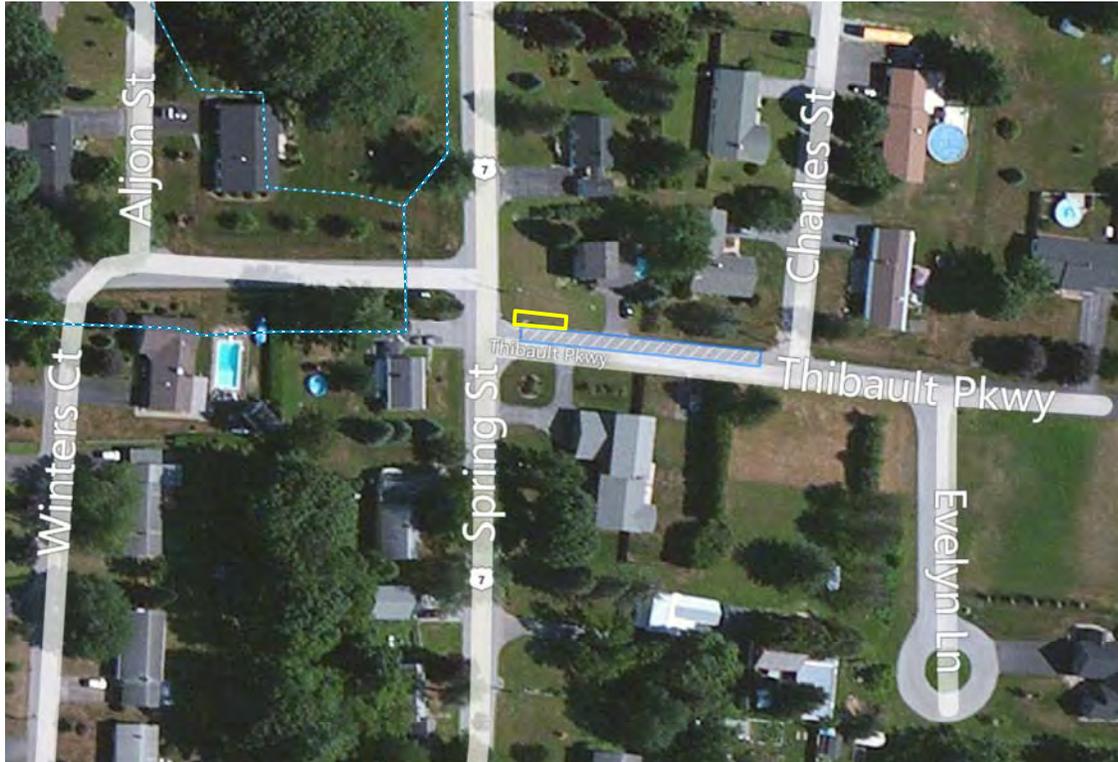
Figure 7. Stormwater treatment opportunity at corner of Thibault Parkway and Spring Street

A catch basin adjacent to Thibault Parkway could be retrofitted and utilized as part of an STP, such as a simple rain garden. Site conditions, including Windsor loamy fine sand (HSG A) and a deep water table, would enable detention and infiltration of a significant portion of stormwater runoff from 0.04 acres of impervious surface draining to the existing catch basin.

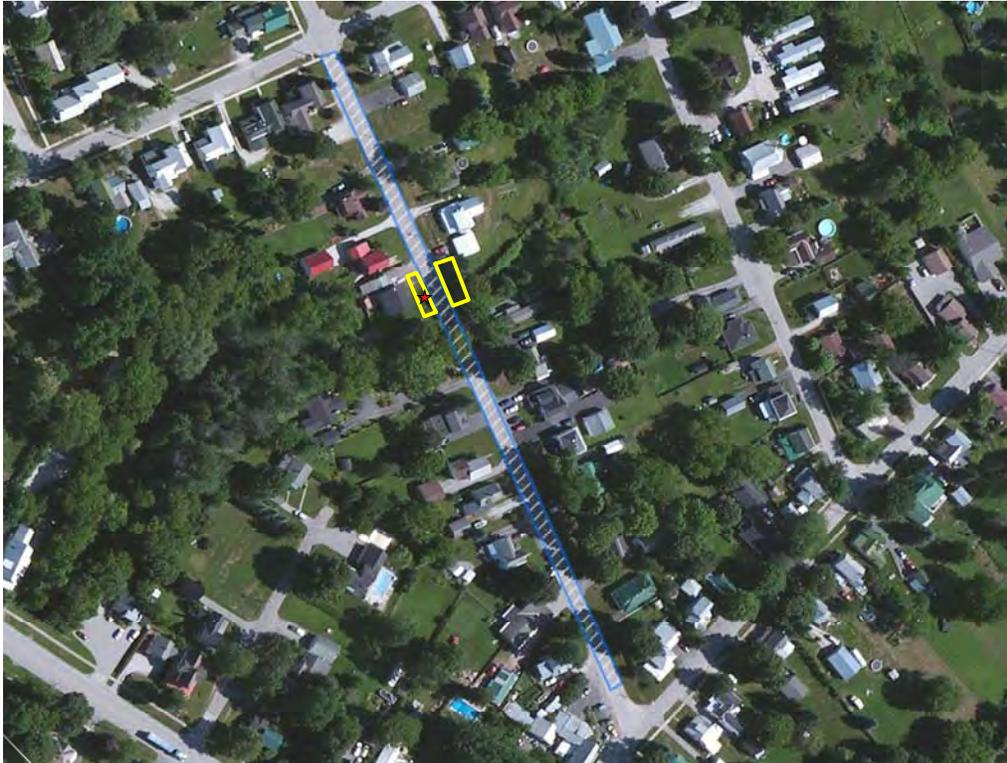
Figure 8. Greenwich Ave. drains to two existing catch basins near the middle of the block where two STPs could be located.

Two existing catch basins on Greenwich Avenue between 2nd St. and Platt St. are well-situated to be utilized as part of stormwater treatment practice. Approximately 0.4 acres of Greenwich Ave. drains toward the center of the block where stormwater is collected by two existing catch basins on either side of the street. The predominant soil type is reported to be Windsor loamy fine sand (HSG A) with a deep water table. This means that there is potential to soak away a large portion of the stormwater draining from this neighborhood. The existing catch basins could then act as overflow relief for an infiltration-based STP.

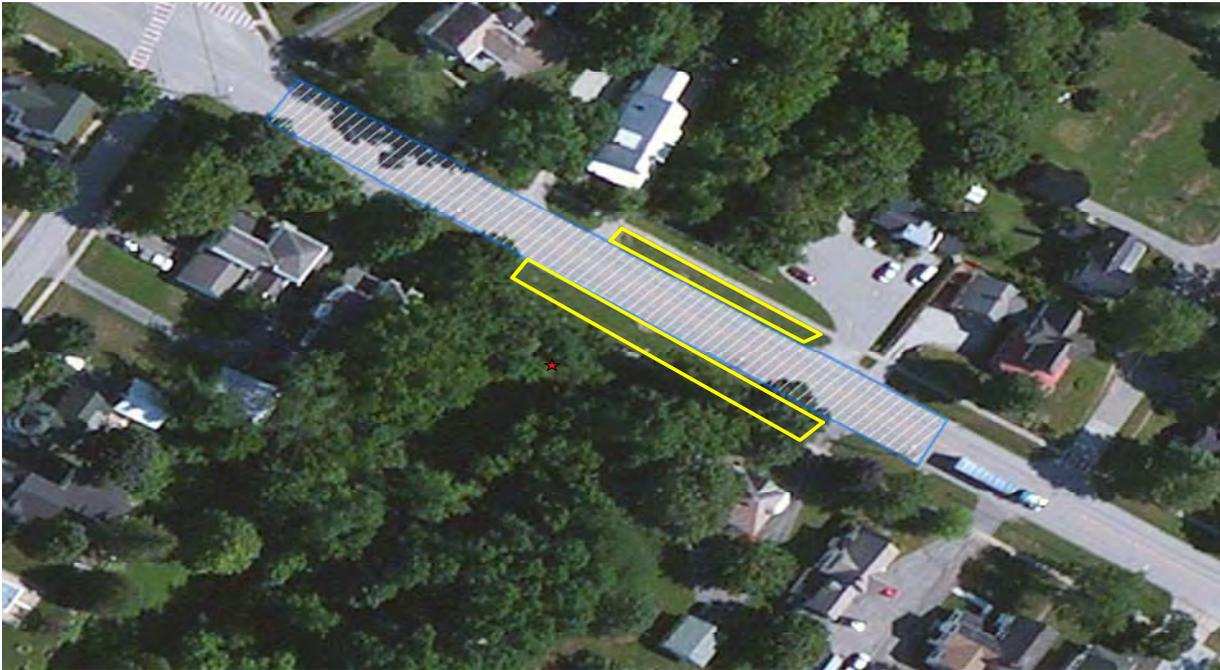
Figure 9. Grand Ave. stormwater could be treated with infiltration practices located between Farrar St. and Furnam Pl.

Stormwater runoff from 0.3 acres of Grand Ave., between Farrar St. and Furman Place, could be treated before draining to existing catch basin in the green strip. Stormwater drains toward the center of the block from both directions. Catch basins between the street and sidewalk collect stormwater on either side of Grand Ave. The predominant soil type is Windsor fine sand (HSG A) with a low water table. Given the well-drained soils and position of existing catch basins, stormwater from this section of Grand Ave., could be treated with an infiltration-based STP.

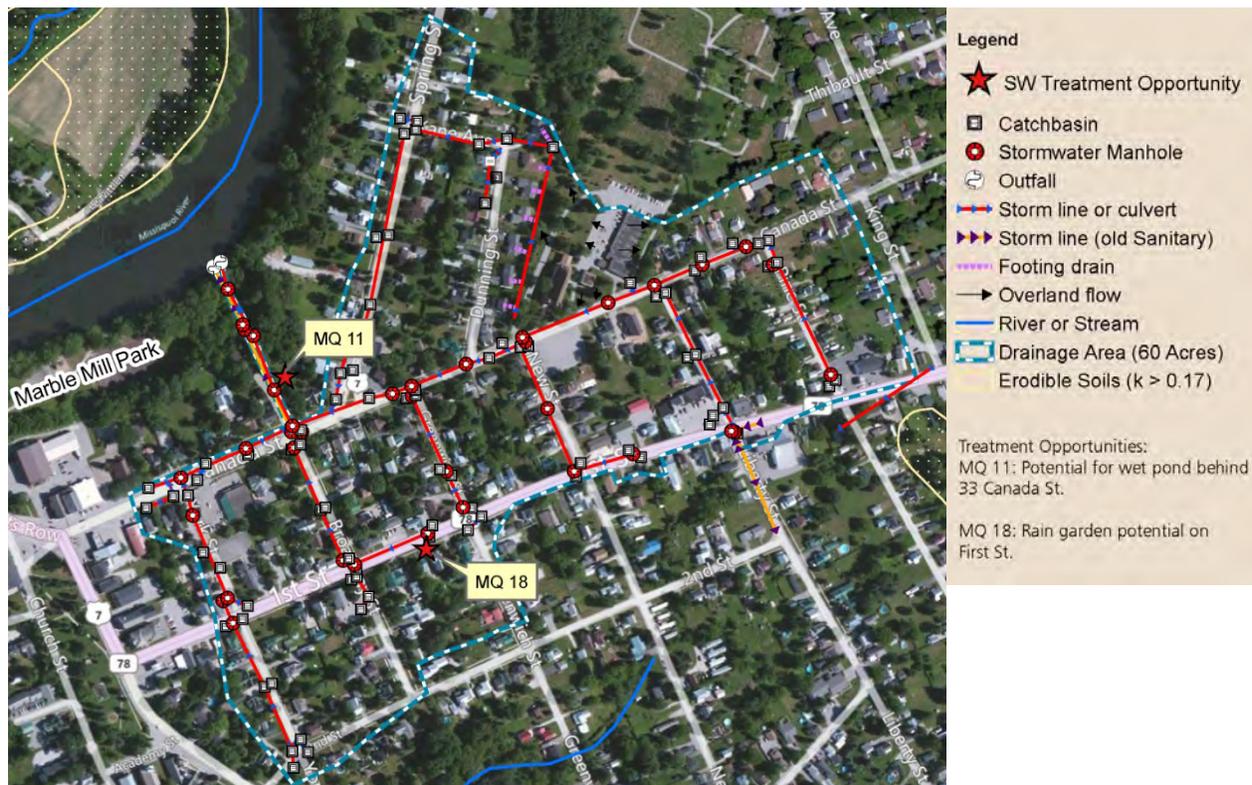
Figure 10. Marble Mill Park problem area, with areas of identified issues highlighted in red.

A significant portion of the stormwater runoff from the closed drainage system in Swanton Village is piped to Marble Mill Park, where it is discharged without treatment to the Missisquoi River. The area of the park near this outfall also contributes untreated runoff to the Missisquoi, including active erosion in the road and path leading to the park, runoff from the parking lot, and a washout leading from the park to the river’s edge near the outfall. The Village previously worked with the Northwest Regional Planning Commission to obtain grant funding from VT DEC to develop a comprehensive solution for stormwater management at Marble Mill Park, and a design has been prepared. Unfortunately the Village has faced a number of challenges in seeing the design implemented, including concerns raised over any construction activity within the 100-year floodplain of the Missisquoi, and nothing has been built to date.

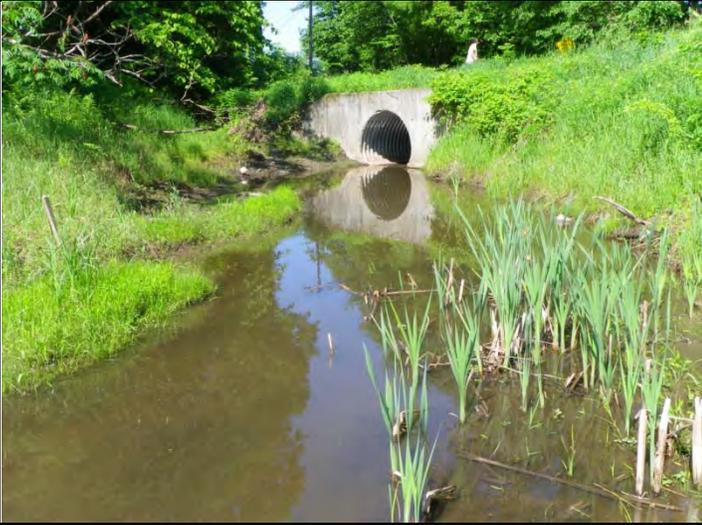
Photo 1. Culvert Entrance (C1)	Photo 2. Ponding downstream of culvert C2

C1- 5' corrugated culvert inside concrete armor wall. Poor alignment is causing left bank to erode as stream is forced to turn to enter culvert (Photo 1). C2- Large pool forming at outfall, exacerbated by large (20-25') grass island in channel (Photo 2). A large tree is growing adjacent to the culvert. Culvert entrance is tilted upwards (Photo 3, below) causing water to pool at entrance and possibly undermine the culvert.

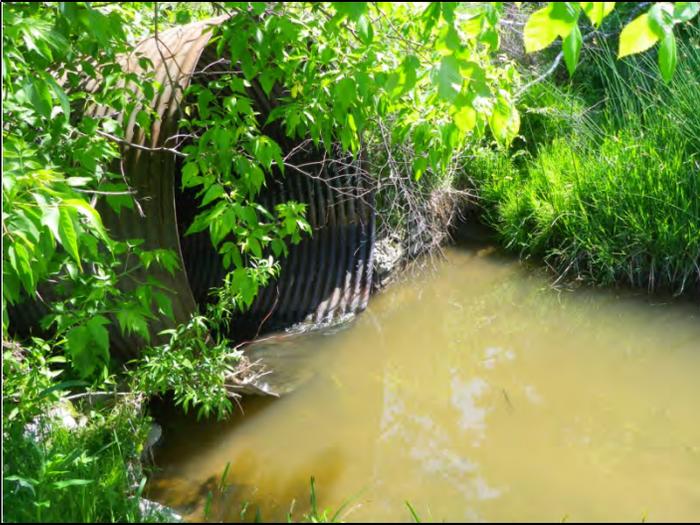
Photo 3. Poorly set culvert

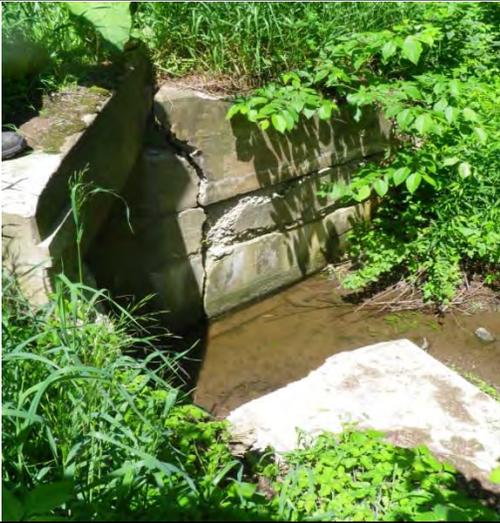
Photo 1. Deteriorated concrete armor	Photo 2. Straightened stream flowing downhill to culvert

Description of Observed Conditions:
 South side of concrete armor has fallen into stream. Some evidence of erosion present. Two drainage ditches and a stream merge directly at bridge crossing. Stream has significant slope and could see heavy flows during rain events.

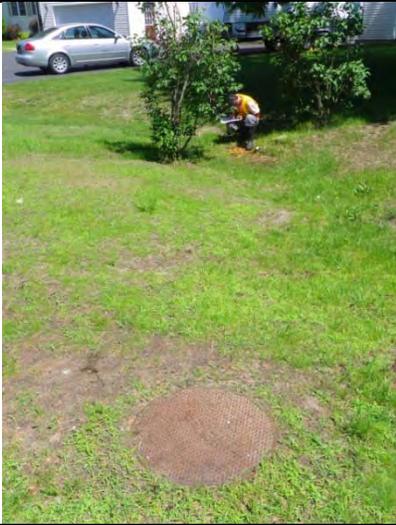
Photo 1. Catch basin (in background) seem to be working and flowing throughout neighborhood	Photo 2. Evidence of ponding water and localized erosion

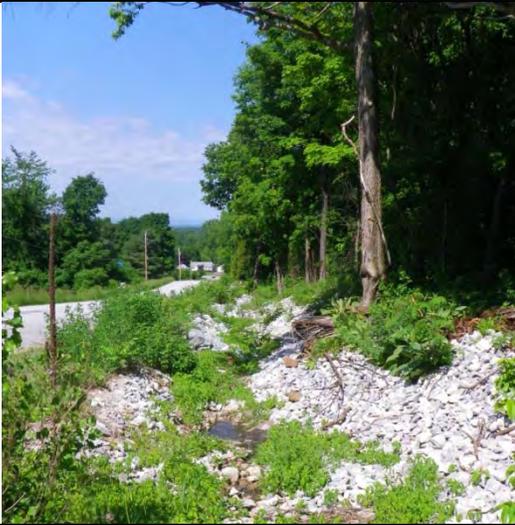
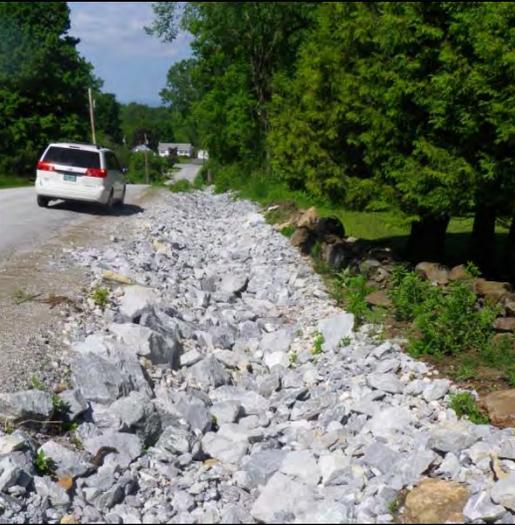
Photo 1. Upper portion of road	Photo 2. Lower section of road

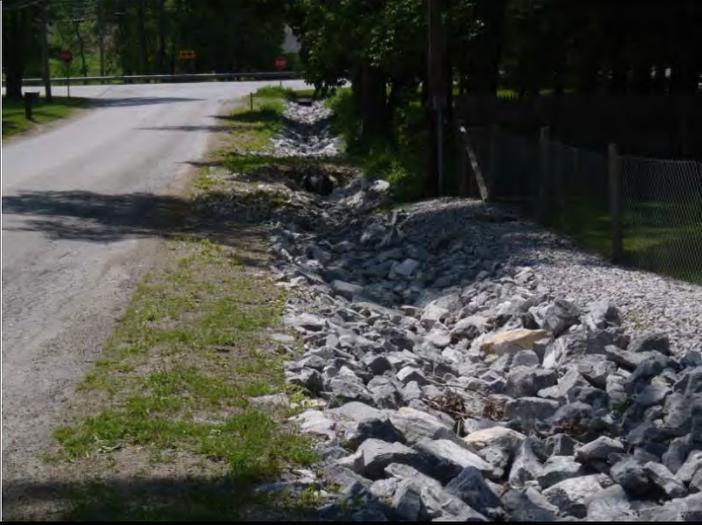
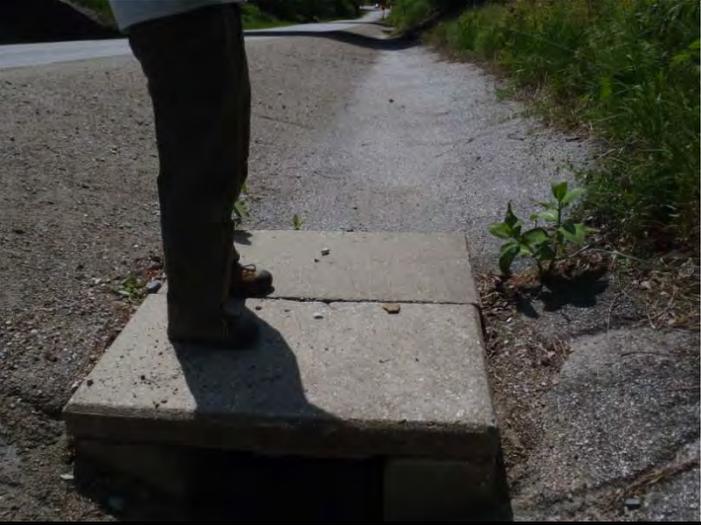
Road Name: Woods Hill Road		
Problem Type: Local Drainage		
Identification Source: Town Feedback		
Ownership: Local/State		
Classification Level: 2a		
Problem Description:		
Woods Hill Road at I-89: erosion in roadside ditch along steep section of roadway (some work done already).

Photo 1. Rip rap	Photo 2. Drop inlet

Rip rap has been placed in the ditch along the north side of road west of I-89; asphalt ditch runs below both directions of I-89. Several drop inlets exist in the ditch and the drainage system ends east of I-89 at a drop inlet. No damage visible. There may be an opportunity to use check dams or similar measures to further slow flow, if warranted.

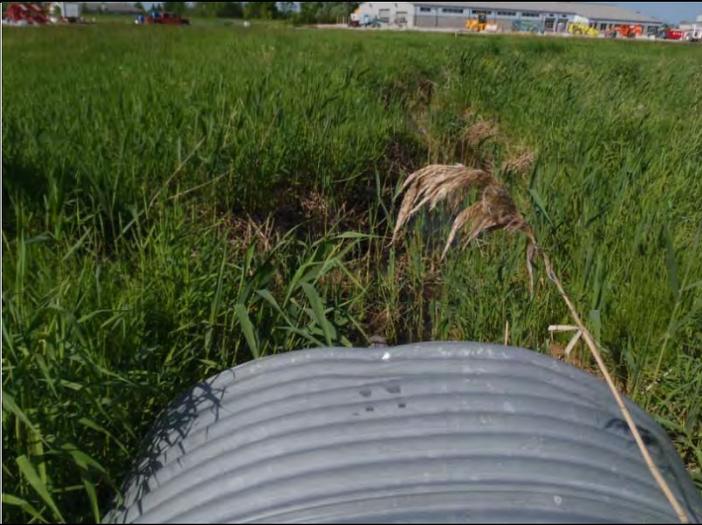
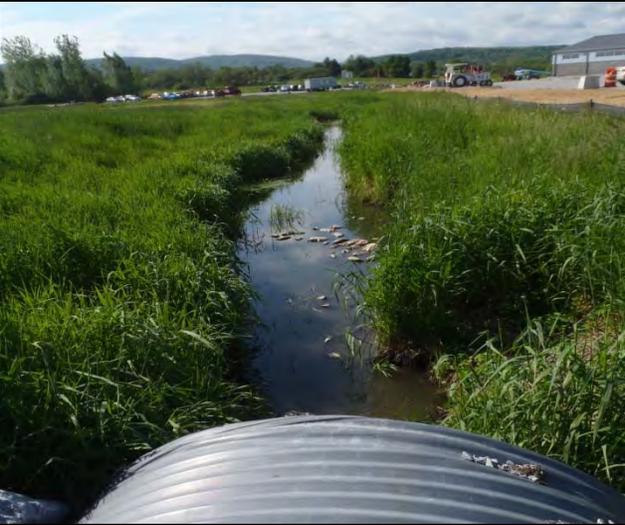
Photo 1. Paquette Rd. looking towards I-89	Photo 2. Paquette Rd. looking towards industrial park

Description of Observed Conditions:
The Town of Swanton wishes to encourage and concentrate future development at the Exit 20 interchange. Upstream segments of Stevens Brook are considered "stormwater impaired;" strategies need to be investigated that both address current stormwater concerns and take proactive steps to guard against the cumulative impacts of future development in order to ensure that these tributaries are not added to the State's list of impaired waters.

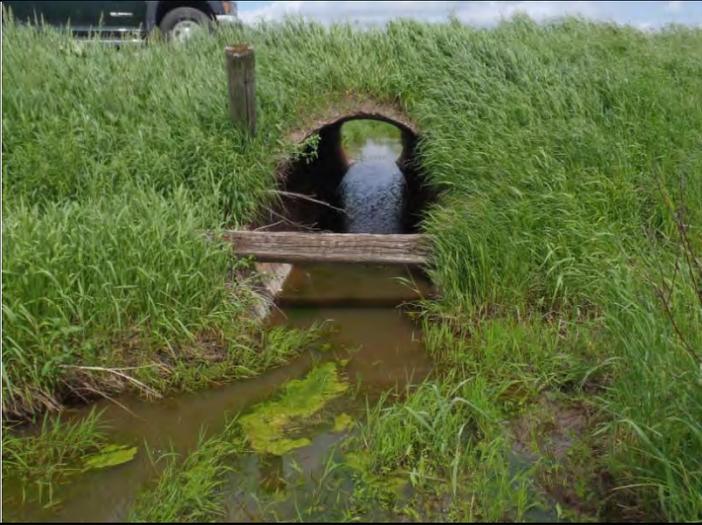
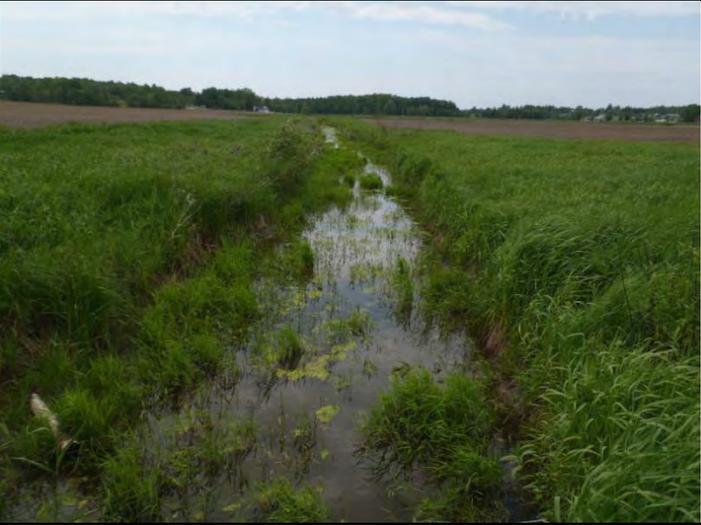
Road Name: Woods Hill Rd		
Problem Type: Altered Geomorphology		
Identification Source: Hungerford Brook SGA		
Ownership: Private		
Classification Level: 1		
Problem Description:		
Extensive straightening throughout the stream reach.

Photo 1. Culvert C1	Photo 2. Channel straightening, upstream of C1

C1- Extensive channeling between the two fields, no visible signs of erosion. C2- Bridge crossing; pooling upstream of bridge, channel is not aligned with the bridge. C3- 6' corrugated metal culvert, with 4" of flow. Culvert is perched with deterioration in the bottom middle of culvert evident; undercutting of culvert occurring as well.

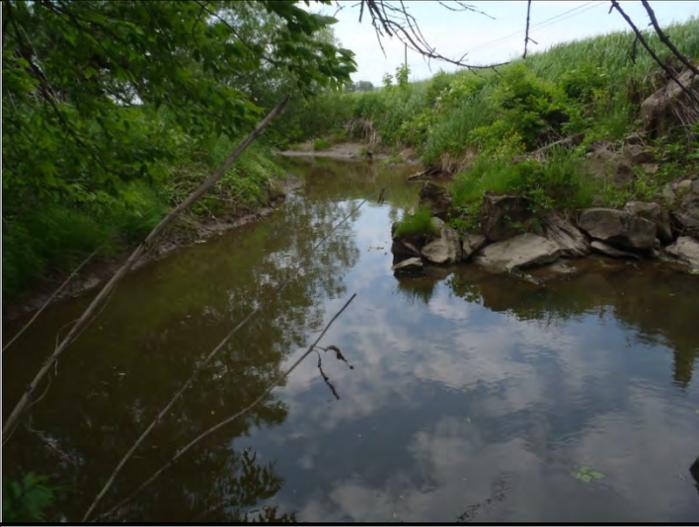
Photo 3. Pooling upstream C2

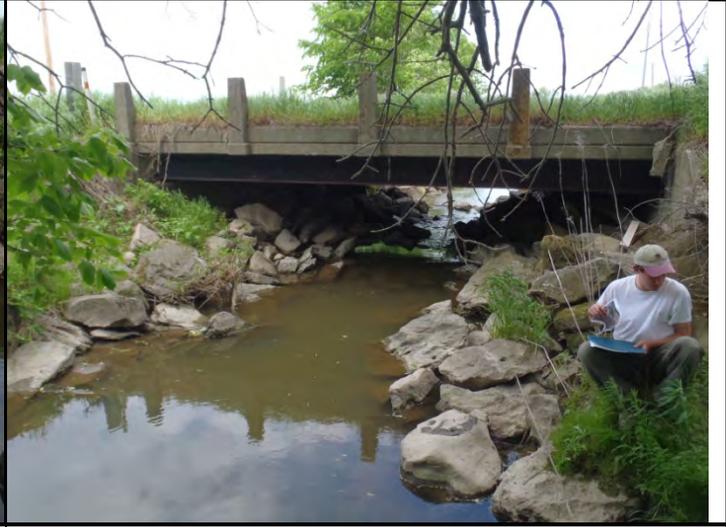
Photo 4. Bridge crossing C2

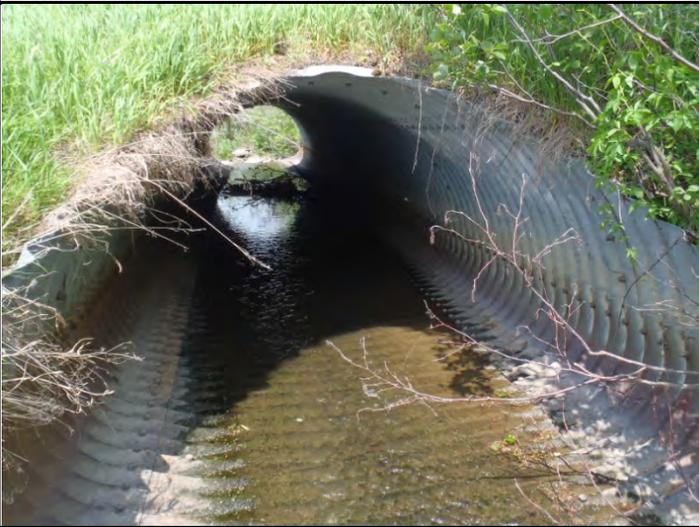
Photo 5. Culvert C3

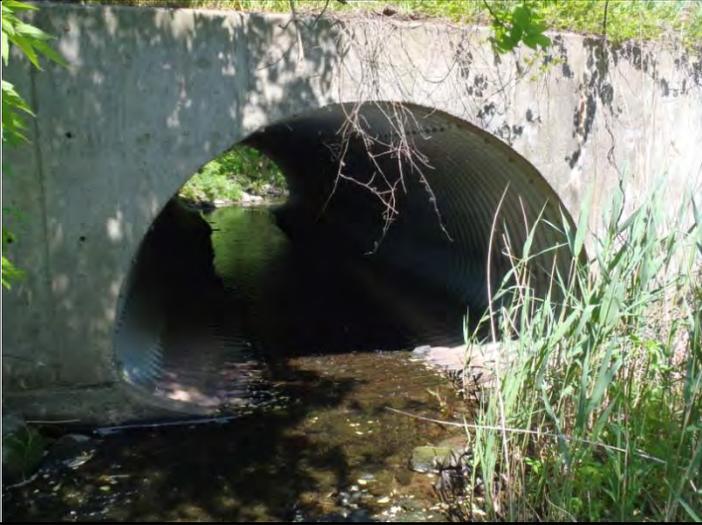
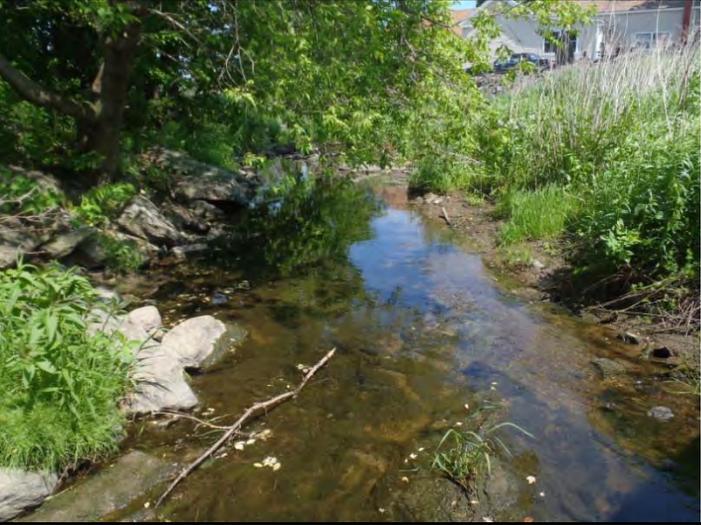
Photo 1. Metal lined concrete bridge	Photo 2. House on bank

Description of Observed Conditions:
 7' tall, crushed metal culvert lining a concrete tunnel. 4" of flow, no significant erosion. Fish passage is possible. Evidence of direct livestock (cow) access directly downstream of culvert, floodplain constricted by road crossing and homes encroaching on the riparian area

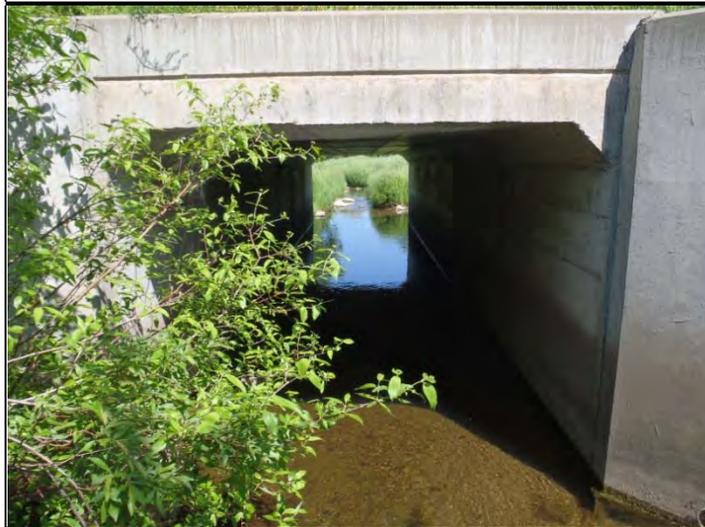
Problem Description:			
Numerous concerns identified, including: loss of floodplain, direct access by cows, lack of vegetative buffer, channelization and straightening in reaches.			
Date of Field Data Collection: <u>5/25/2012</u>			
Field Photos

Photo 1. Concrete Tunnel

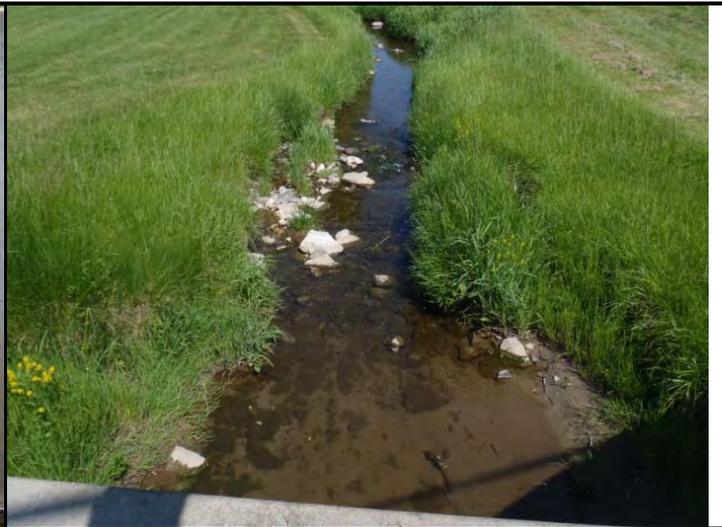
Photo 2. Grass buffers

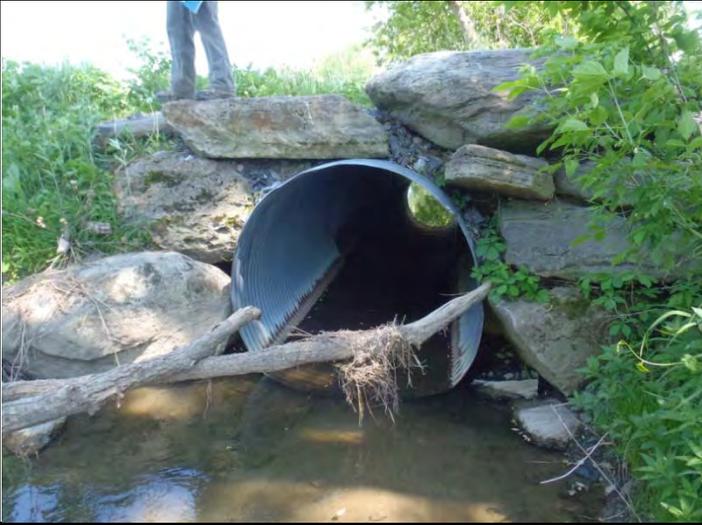
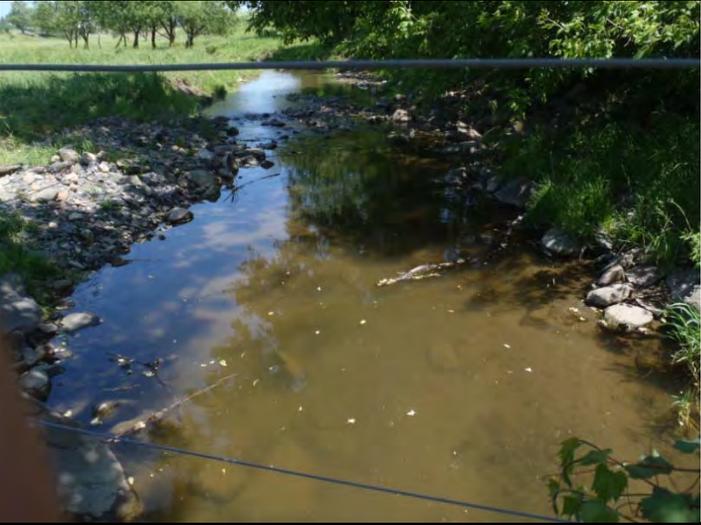
Photo 1. C1- Culvert	Photo 2. Cow access near C1 culvert

C1- Corrugated metal 5' culvert. Evidence of direct animal (cow) access on the north-side of the stream. C2- concrete bridge on farm road. 4' high, 15' across. Erosion present downstream; more signs of cow access. C3-concrete bridge is too small and constricts flow; erosion is present. Structure is also damaged, cinder blocks in stream. C4- rocky tunnel with extensive damage; pooling at outlet and erosion downstream. C5- Brook bypassing culvert. Major erosion and pooling at culvert. 36" culvert too small for stream flow.

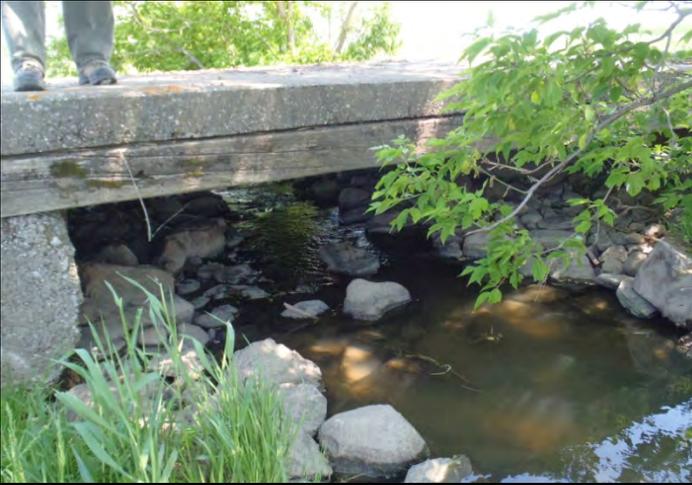
Photo 3. Concrete bridge C2

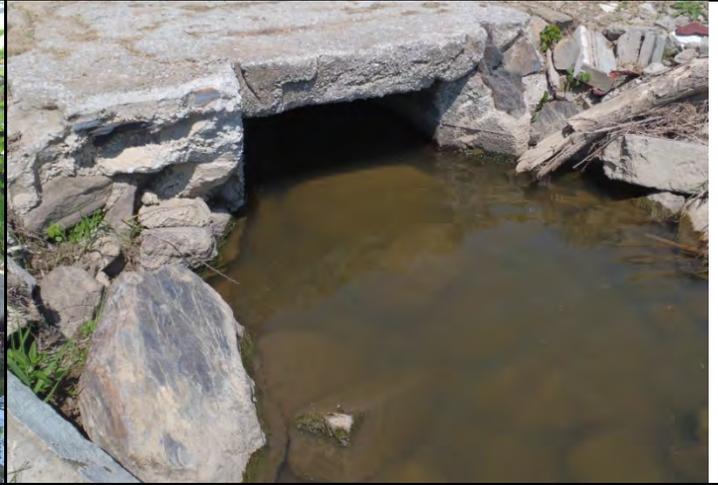
Photo 4. Small Concrete bridge C3

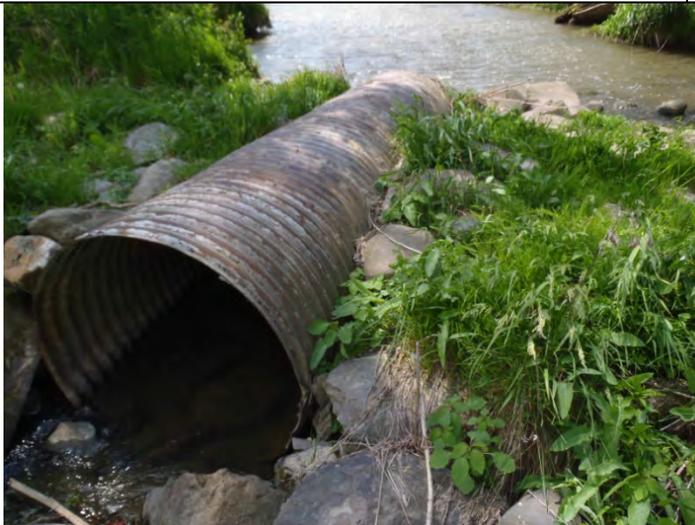
Photo 7. Undersized culvert C5

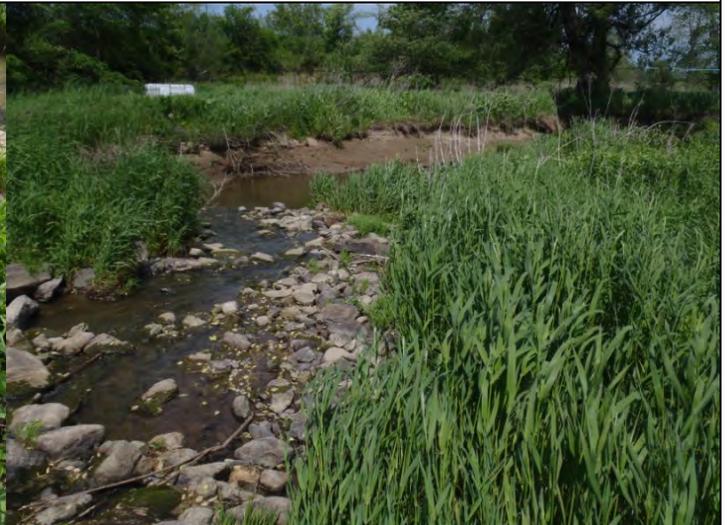
Photo 8. Cow access near C5
