STORMWATER MANAGEMENT PLAN FOR SWANTON TOWN AND VILLAGE

FINAL REPORT

Stone Project ID 112475-W
February 21, 2013

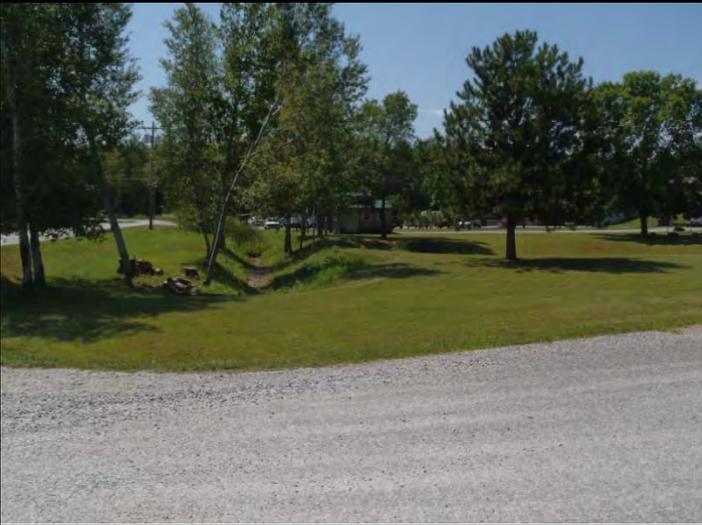
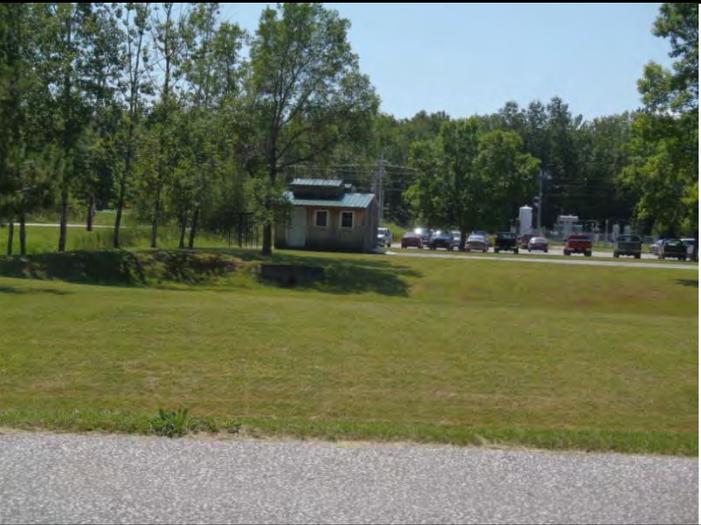
Missisquoi River													
Road Name:	Jonergin Dr.													
Problem Type:	Local Drainage													
Identification Source:	Town Feedback													
Ownership:	Private													
Classification Level:	3													
Problem Description:														
Stagnant water in Jonergin Dr. ditches, causes discolored discharges during heavy storms.

Photo 1. Grass swale east of Leader Evaporator	Photo 2. Lawn/dry pond east of Leader Evaporator

Description of Observed Conditions:
No stagnant water observed, likely due to recent dry conditions. Dry pond and/or grass swale retrofits may be possible to improve stormwater treatment.

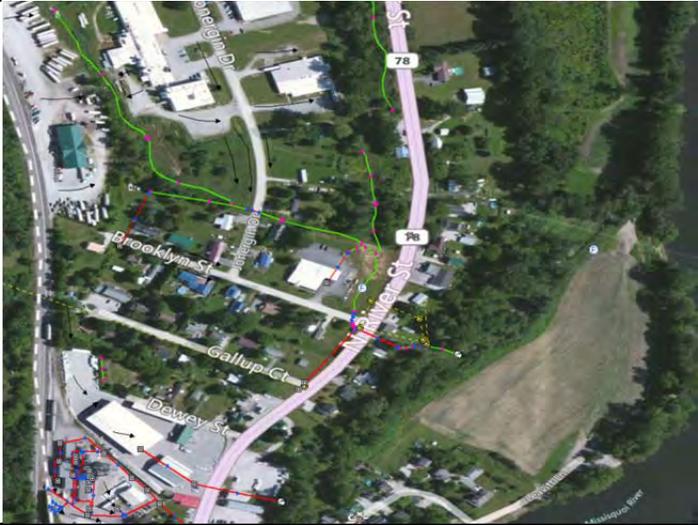
Photo 1. Stormwater infrastructure in Goose Pt area

Description of Observed Conditions:
<p>Currently leased by the town to a local farmer for corn production, Goose Point could serve to mitigate stormwater from the industrial area (Brooklyn St and Jonergin Dr). Further study would be required to determine if a centralized solution on Goose Point is preferably to pursuing more localized opportunities within the industrial park.</p>

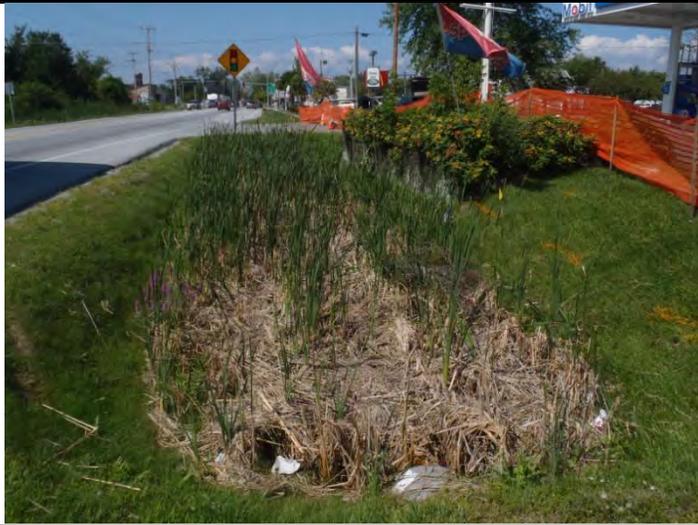
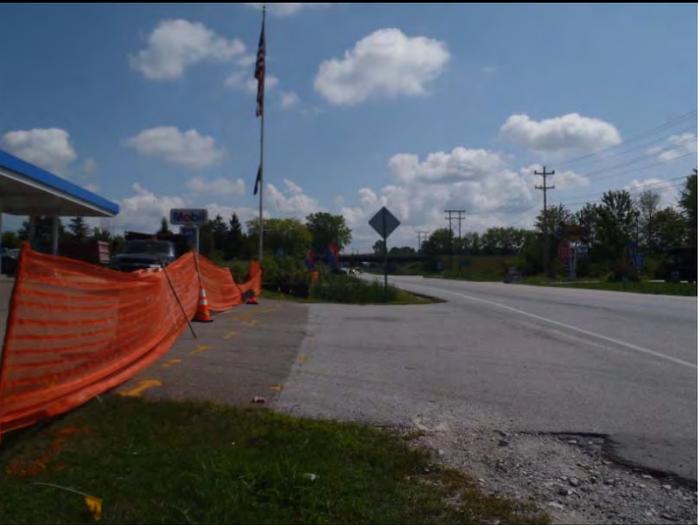
Photo 1. Existing swale/wetland in front of Mobil	Photo 2. Looking east to drainage area

Description of Observed Conditions:
Could retrofit existing wet swale to enhance treatment. Existing wetland plants currently provide some filtration. A gas line present to the immediate north of the swale may prohibit widening, but swale could potentially be dug deeper. Proximity to Route 7 could make construction challenging.

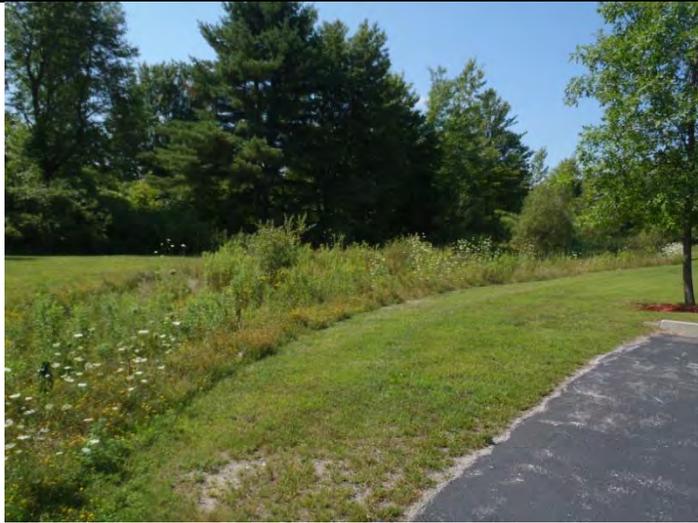
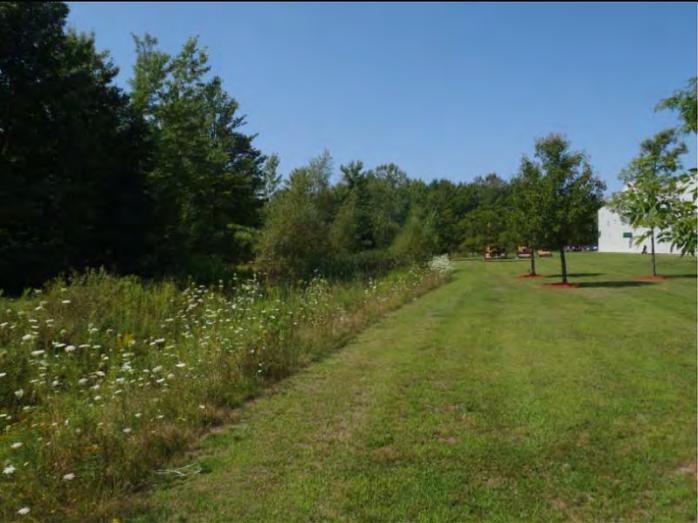
Photo 1. SE corner of VT Precision looking to the west	Photo 2. Same as Photo 1, longer extent

Description of Observed Conditions:
Large area of impervious surface feeding directly into swale system. Depending on landowner interest, system could be retrofitted to improve treatment; large “campus” may offer other opportunities for low-impact type retrofits.

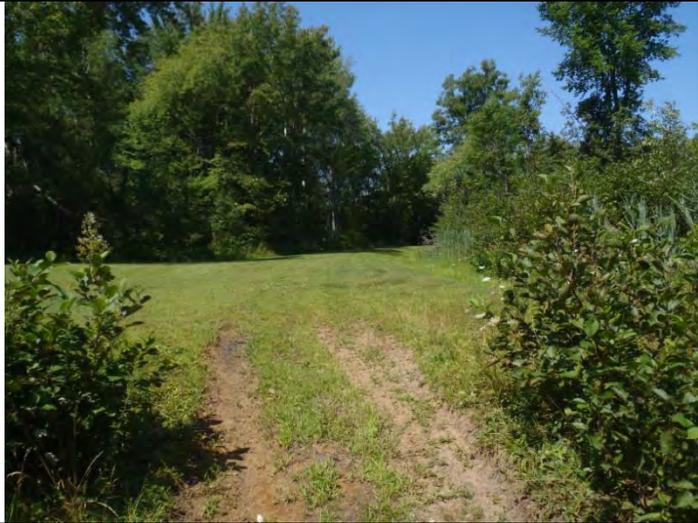
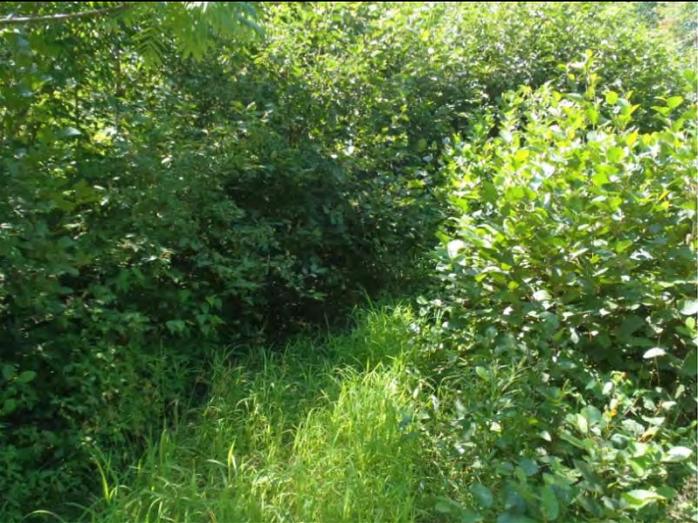
Problem Description:		
Two swales meet in the meadow visible to the lower left in the above photo, draining Elm St, 4 th St, and the entirety of Robinhood Drive.

Photo 1. Looking NW to potential treatment area	Photo 2. Looking west from swale junction

Description of Observed Conditions:
Potential exists to install a treatment practice in the meadow, treating the stormwater before it crosses the Rail Trail and Leduc Drive. Landowner interest/willingness is unknown.

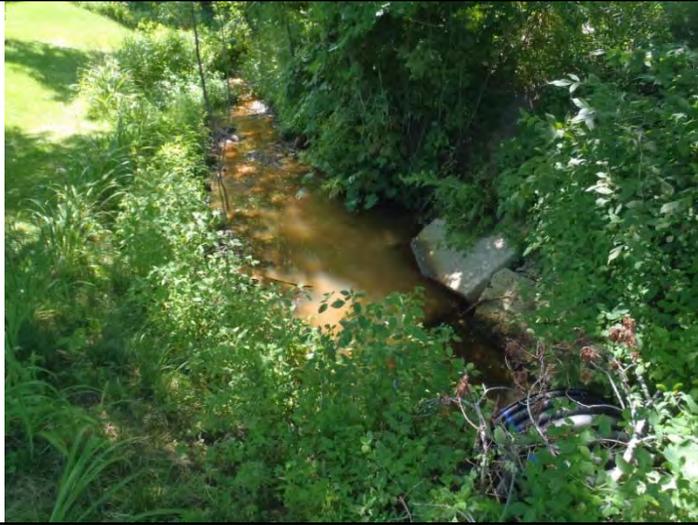
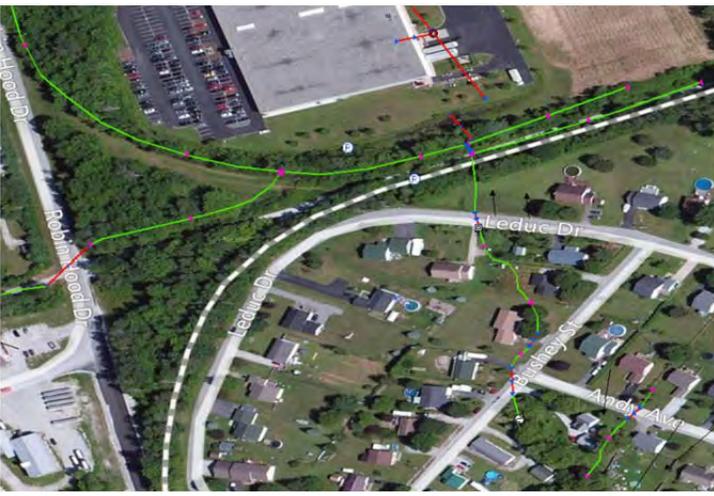
Problem Description:		
Outfall of sections of the rail trail, Elm St, and Robinhood Drive. Base flow during summer, low flow conditions suggests that conveyance may be a stream in addition to stormwater ditch, although waterway is entirely culverted through the Bushey Ave area.

Photo 1. Outfall from culvert under Bushey Ave.	Photo 2. Existing stormwater infrastructure

Description of Observed Conditions:
Potential exists to slow stormwater and/or enhance treatment in the swale near Precision Lane. Water at outfall appeared to have an orange tint, but fish and frogs visible, suggesting that oxygen is present.

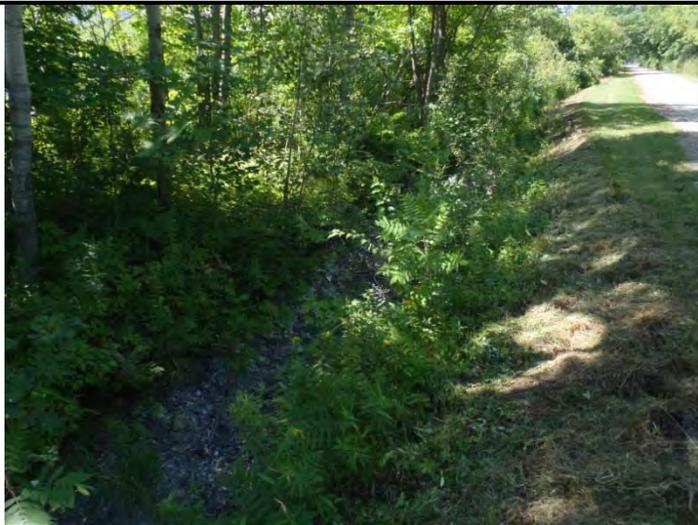
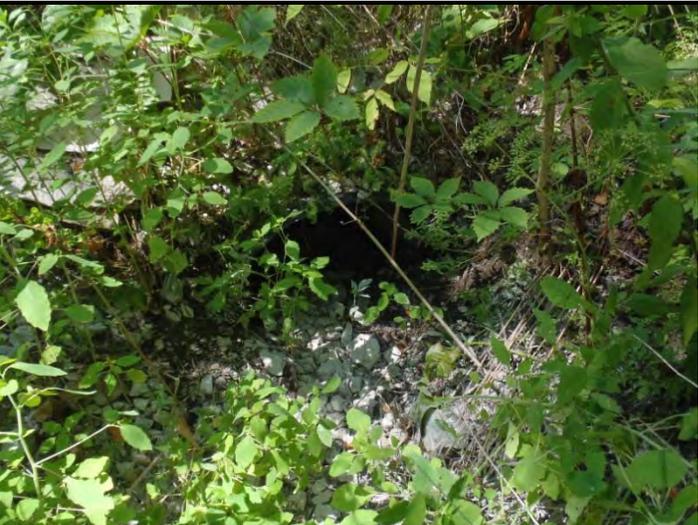
Road Name: Robinhood Dr.		
Problem Type: Local Drainage		
Identification Source: VT DEC		
Ownership: Public (Town)/Private		
Classification Level: 3		
Problem Description:	Erosion in culvert and swale system around the intersection of Robinhood Dr. and the rail trail.

Photo 1. Ditch on SW corner of intersection	Photo 2. Under-road culvert NW corner of intersection

Description of Observed Conditions:
Ditch condition suggests high volume of water during storm events, likely clogging culvert in Photo 2. A system of check dams could be used to reduce the energy of stormwater as it moves through the system, in addition to abating further erosion. Other retrofits might be possible depending on landowner interest and ROW constraints.

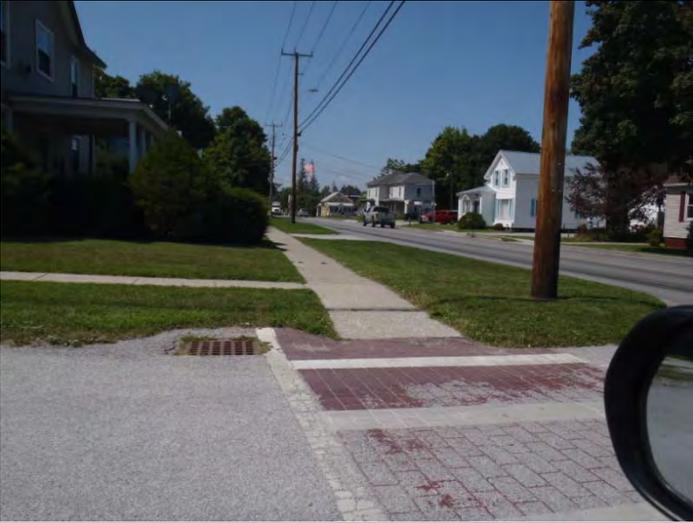
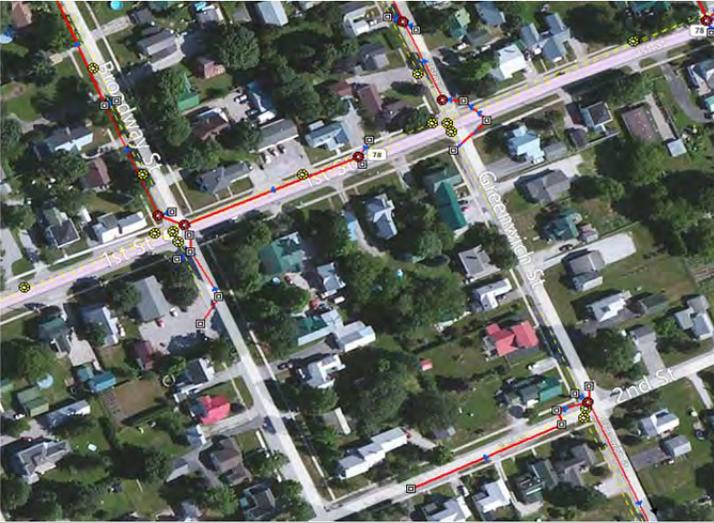
Road Name: First St.		
Problem Type: Local Drainage		
Identification Source: SWMP evaluation		
Ownership: Private		
Classification Level: 3		
Problem Description:		
Untreated/unmanaged stormwater runoff throughout the Village.

Photo 1. SW corner of First and Greenwich	Photo 2. Stormwater infrastructure

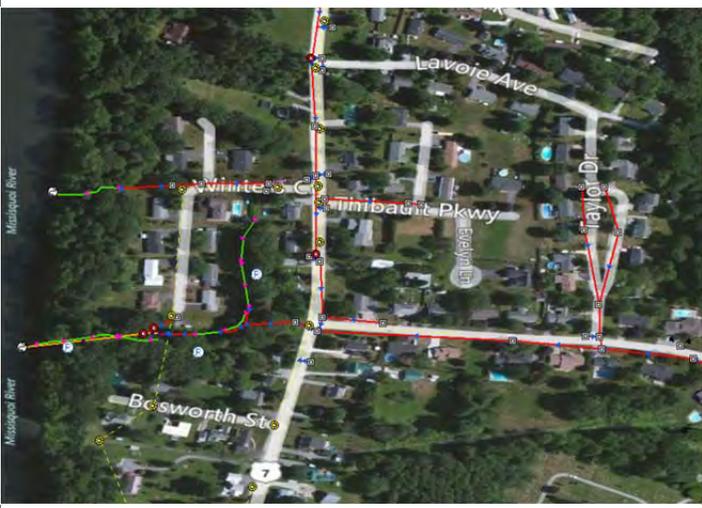
Photo 1. Stormwater infrastructure

Description of Observed Conditions:
<p>Several roof gutter systems outfall onto driveways and flow into stormlines on Taylor Dr. Substantial green space in center of loop may offer opportunity to disconnect these downspouts from the stormline system and direct runoff to a soak away area.</p>

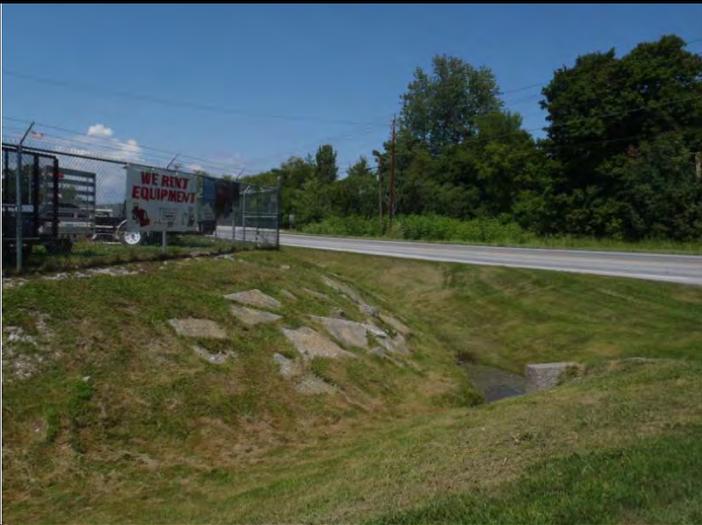
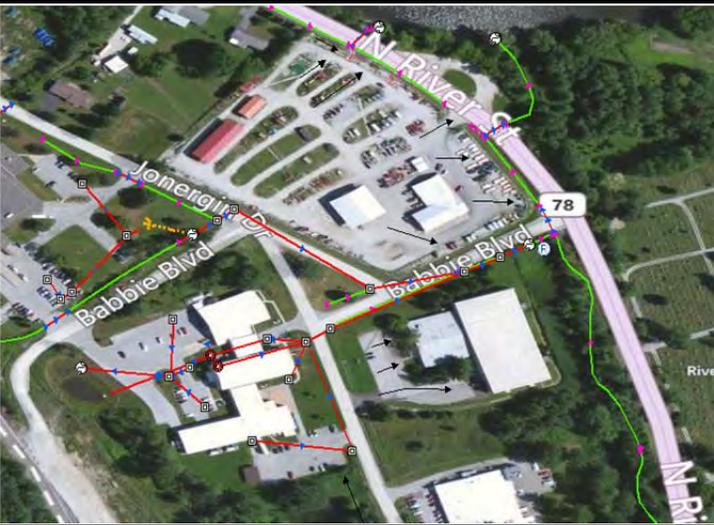
Road Name: Route 78 N		
Problem Type: Local Drainage		
Identification Source: Collin Smythe, VTDEC mapping project		
Ownership: Private		
Classification Level: 3		
Problem Description:		
Grassed swale SW along Route 78 provides limited treatment before discharging directly to the Missisquoi River.

Photo 1. Grass swale SW of Fournier's dealership	Photo 2. Stormwater infrastructure

Description of Observed Conditions:
Water from culvert under Town Highway 61 flows through this swale, then under Route 78 to outfall in the Missisquoi. Potential retrofit opportunities include converting the area to a wetland to slow/treat stormwater runoff. Landowner interest/willingness is unknown.

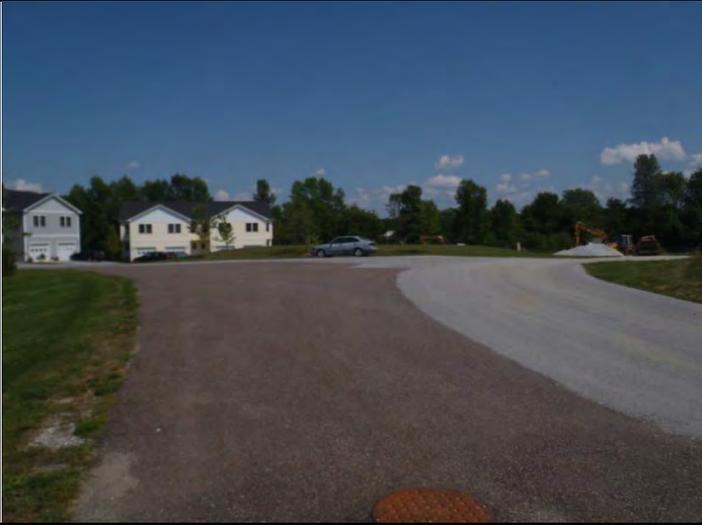
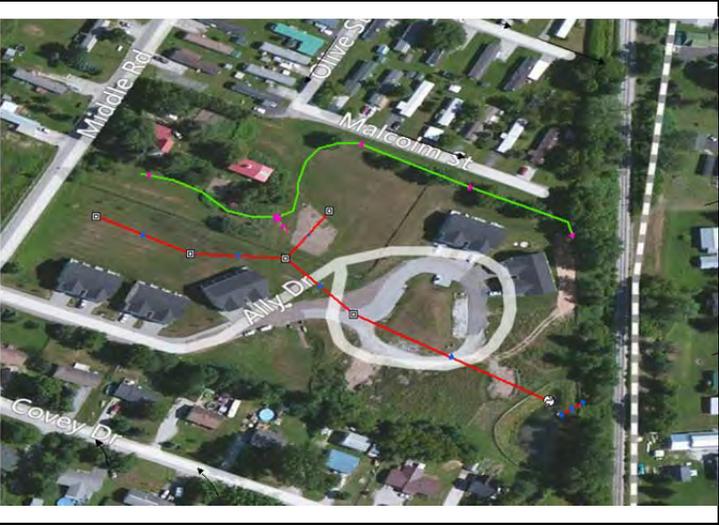
Missisquoi River													
Road Name:	Ally Dr.													
Problem Type:	Local Drainage													
Identification Source:	Town Plan													
Ownership:	Private													
Classification Level:	2a													
<p>New development on Ally Drive has created disproportionately large amount of impervious area, including road layout and driveways.</p>

Photo 1. Ally Dr, looking east toward cul-de-sac	Photo 2. Stormwater infrastructure

Ally Drive development has a great deal of pavement, as seen in Photo 1 and the aerial image above. The need for stormwater treatment practices can often be minimized by employing so-called "better site design" techniques; full implementation of better site design techniques may necessitate changes in land use and development regulations.

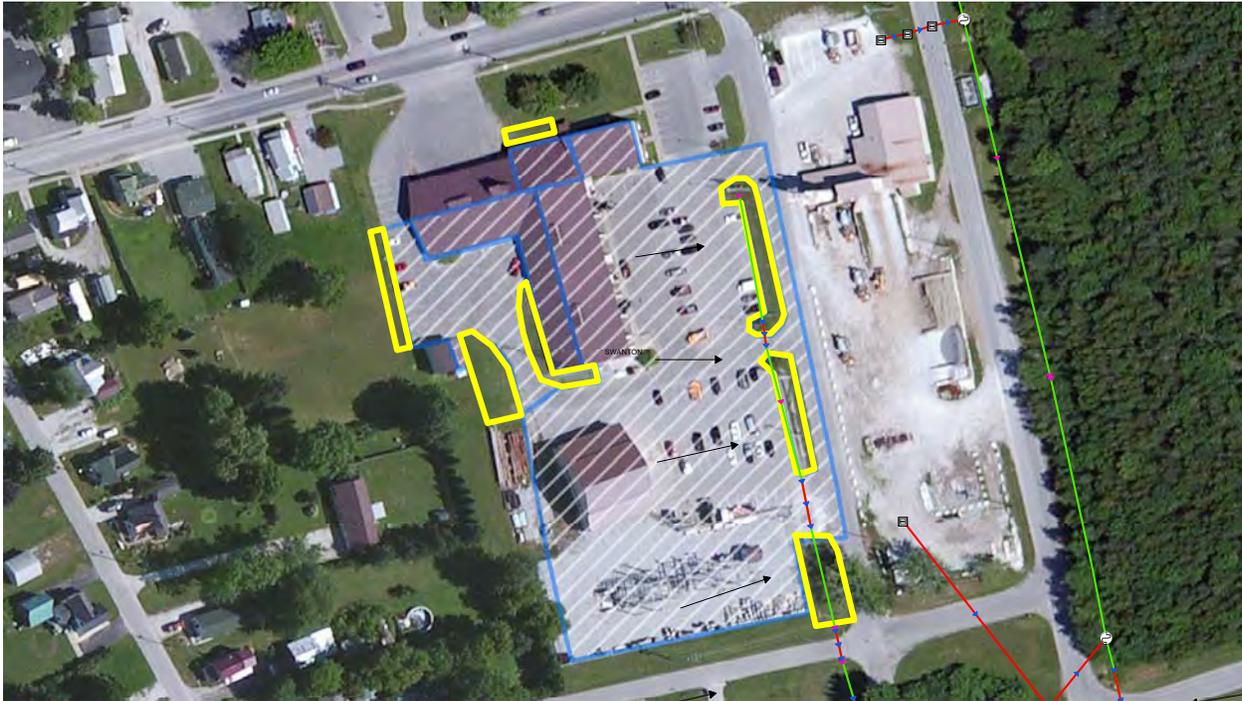
Figure 1. Swanton Village water office, fire department, and road maintenance garage: Treatable impervious area highlighted in blue and locations for potential treatment practices highlighted in yellow.

Stormwater from three acres of impervious surface at the Swanton Village Municipal Complex and adjacent electrical substation could be routed through potential stormwater treatment practices (STPs) located as shown in yellow in Figure 1.

Predominant soil types are Windsor loamy fine sand (HSG A) with a deep water table. This means there is potential to soak away a large amount of stormwater that is currently running-off from this property.

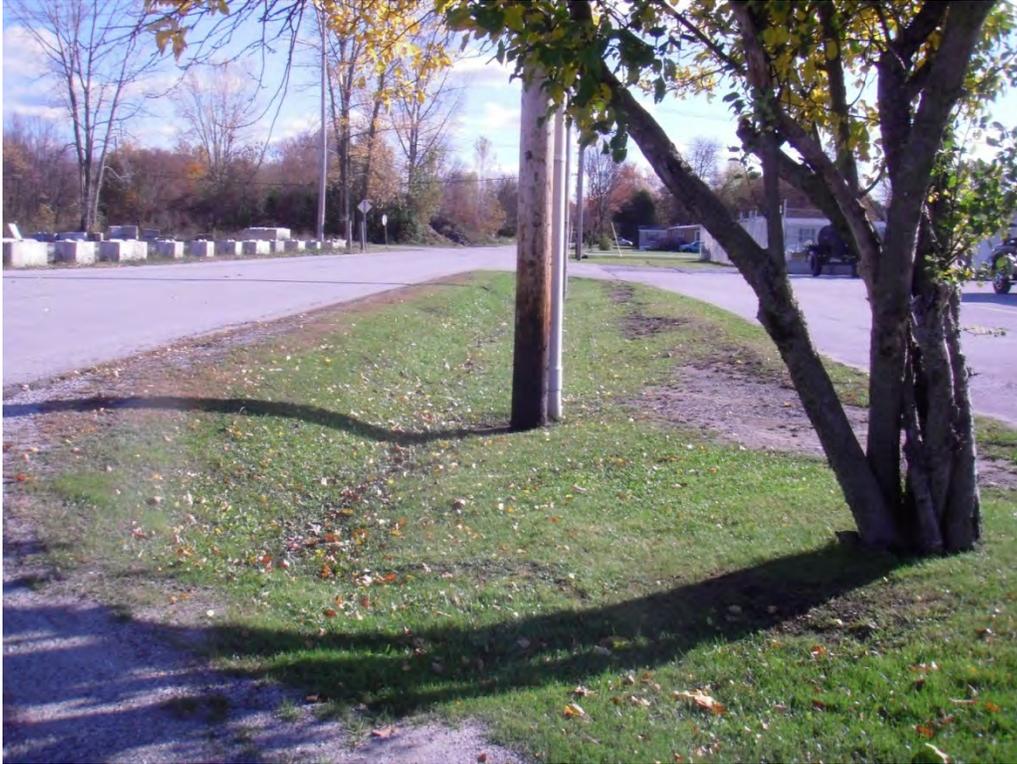
Figure 2. The absence of curbs along the large green strip at the Village garage simplifies design and construction of stormwater treatment practices at this location.

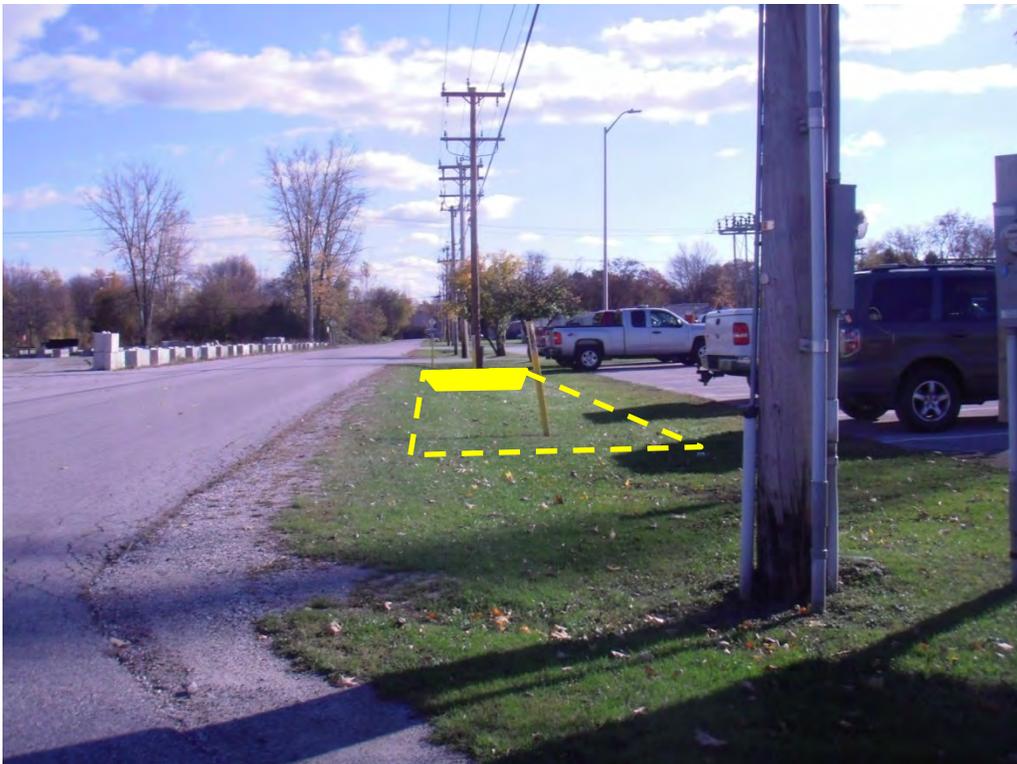
Figure 3. The existing shallow swale could easily be modified to enhance infiltration of stormwater runoff.

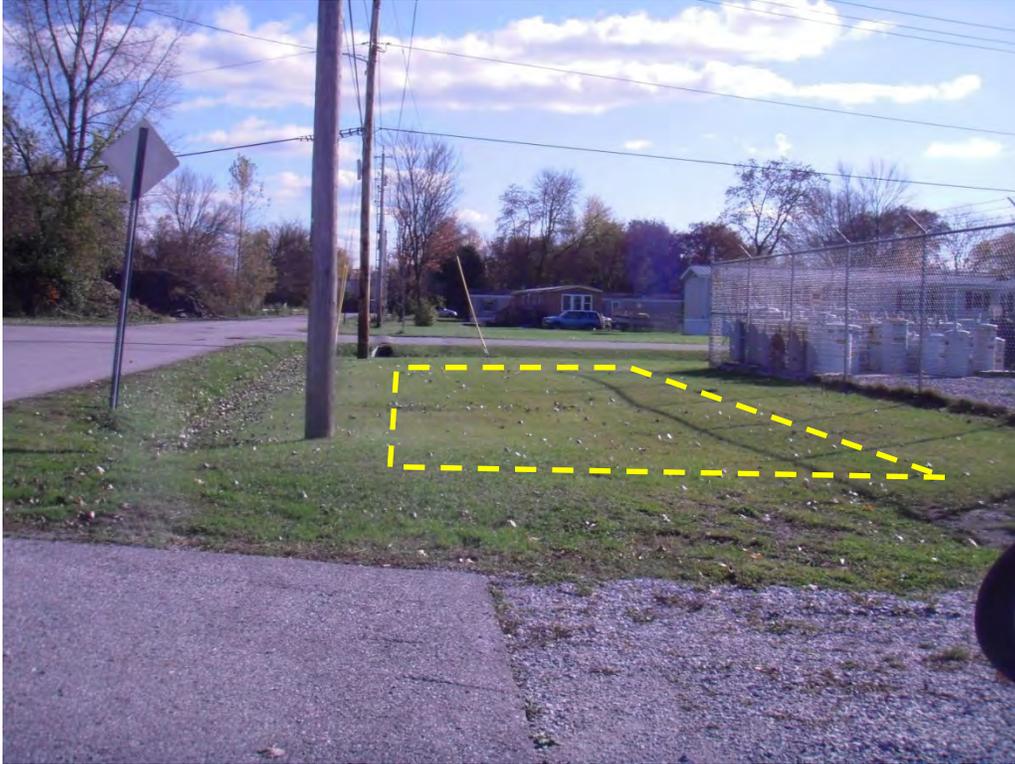
Figure 4. A large unused portion of greenspace in front of the electrical substation could be utilized to treat stormwater runoff from the substation and adjacent town properties.

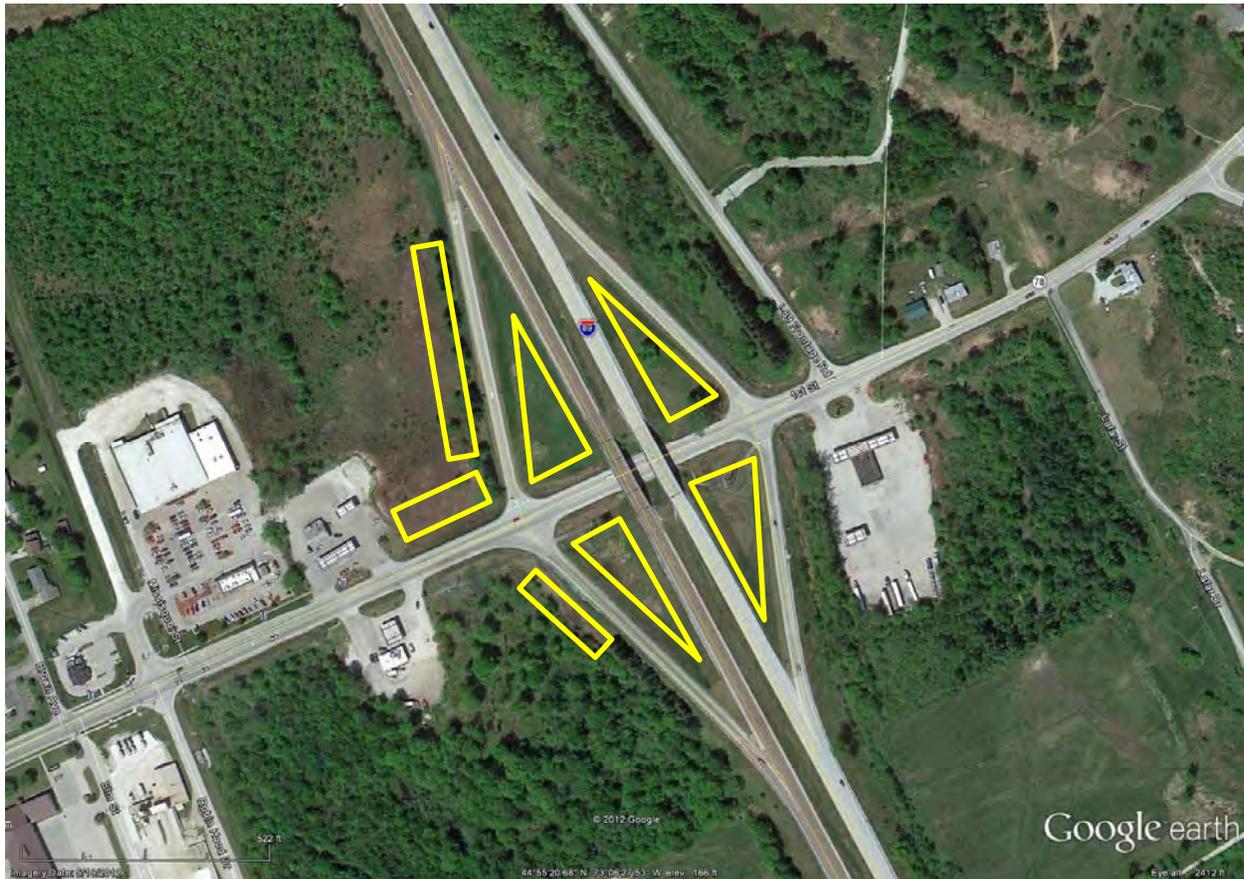
Figure 5. I-89 (Exit 21)-VT RT 78 Interchange. Potential sites for stormwater treatment practices highlighted in yellow.

Green space within and adjacent to the I-89 Exit 21 interchange could accommodate the construction of stormwater treatment practices. The diamond interchange at Exit 21 includes a stormwater conveyance system that drains the highway. The 30-acre subwatershed includes 3.8 acres of impervious surface. The large amount of space and existing conveyance structures simplify design and construction efforts required to implement a stormwater treatment practice at this location. A storm water treatment practice similar to that which was recently constructed in the highway median near I-89 Exit 20 could be effective here.

The most suitable practices are likely to be bioretention and filtration systems that include an underdrain. Soils are reported by the USGS to be Georgia stony loam and Massena stony loam, Hydrologic Soil Group (HSG) C with high water tables. These characteristics mean that infiltration cannot be expected to be a suitable treatment practice. Additionally, roadway subsoil strength can be affected by saturated soils. The proximity of the roadway further supports the need for non-infiltration-based systems.

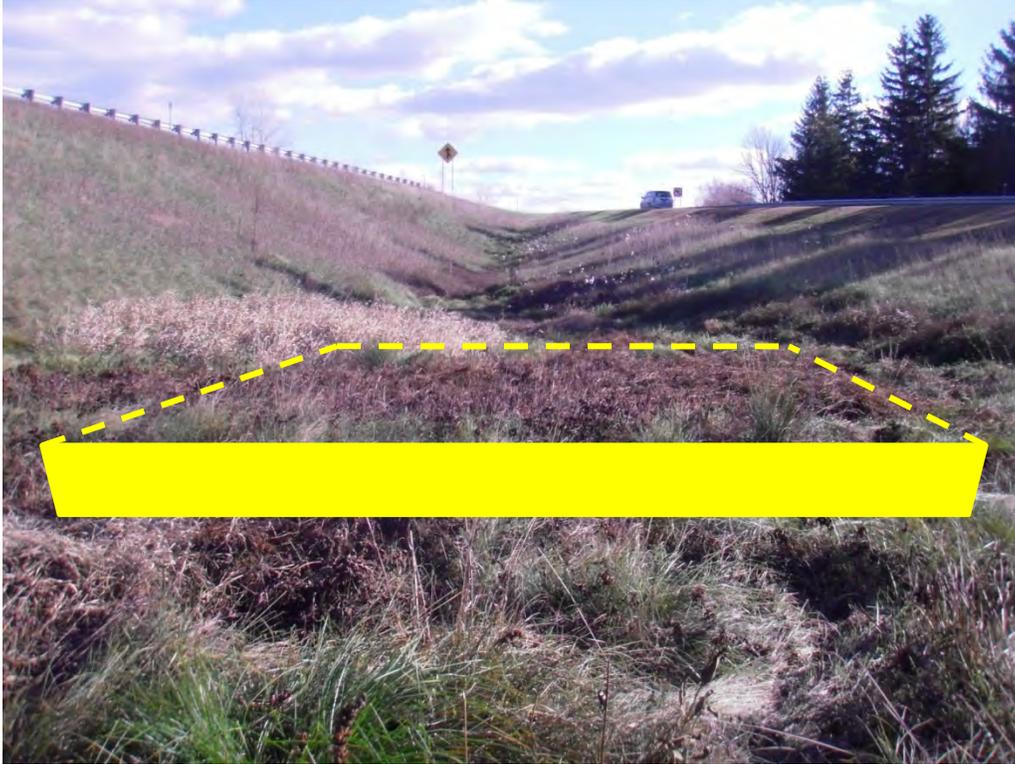
Figure 6. Conceptual example of STP installation within interchange diamond.

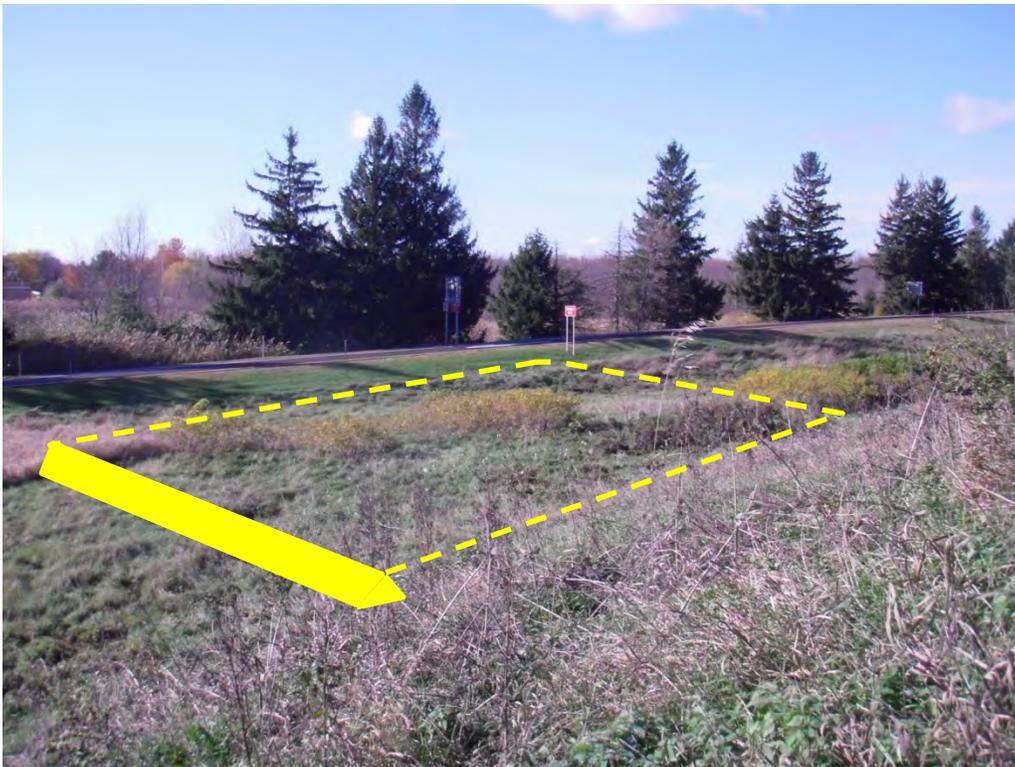
Figure 7. Another view of a conceptual STP layout within the I-89 Exit 21 interchange diamond.

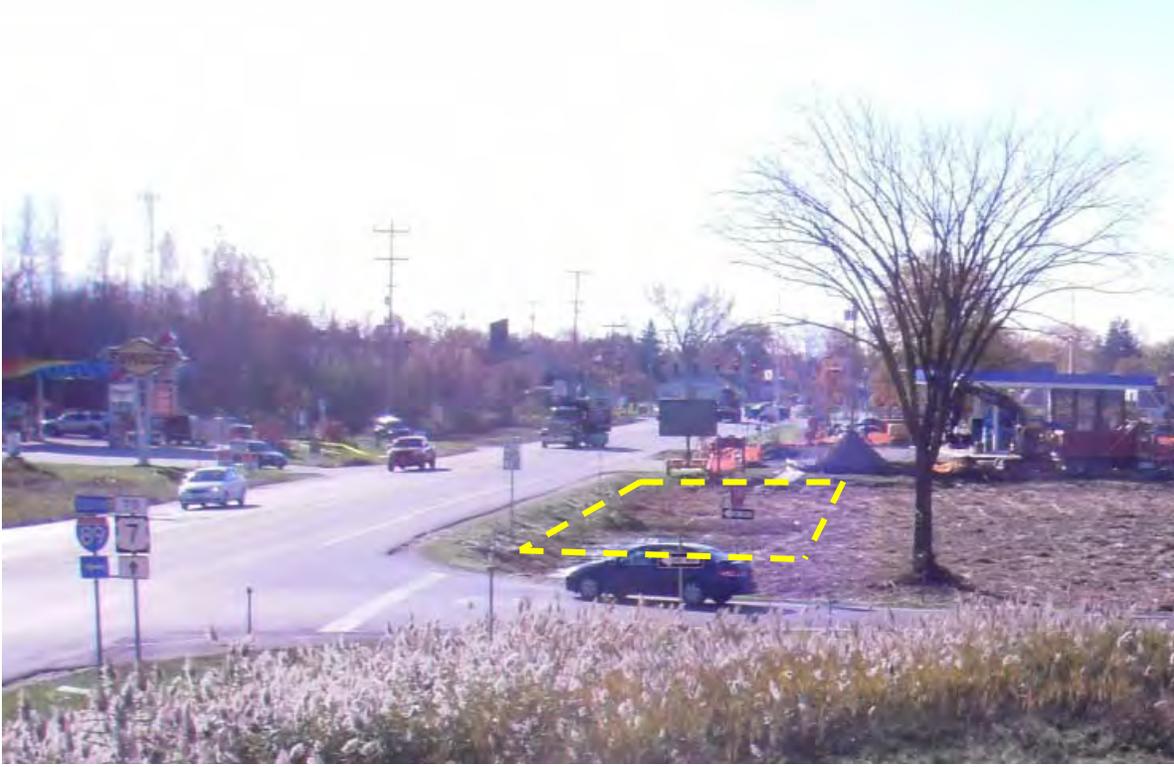
Figure 8. Conceptual location of STP outside of the I-89/Exit 21 interchange.

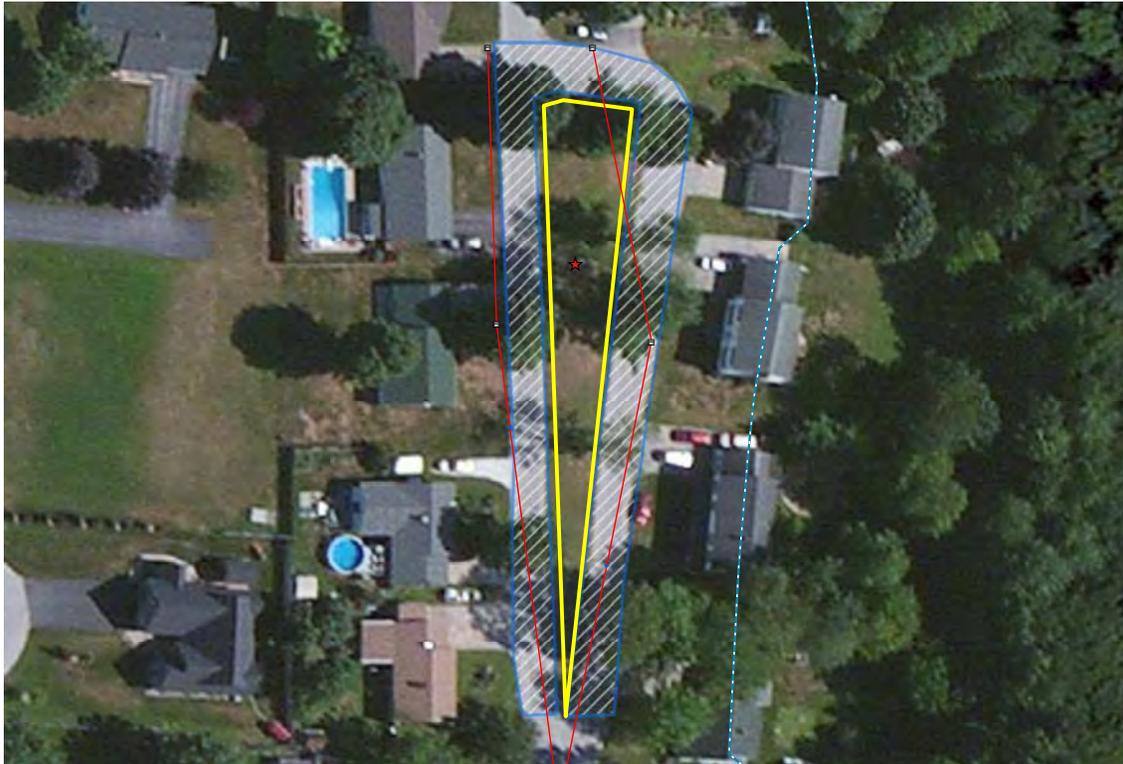
Figure 9. The Taylor Drive cul-de-sac offers ample treatment opportunity (shown in yellow). The contributing impervious area is outlined in blue.

Taylor Drive is a residential street with a large cul-de-sac that includes a median that is well-suited for stormwater treatment. Currently, water drains from the street and some of the adjacent residential lots toward the cul-de-sac where it is collected in catch basins along the existing curb.

The reported soil types in the area are Windsor loamy fine sand (HSG A) with a deep water table. This means that infiltration practices could be used to soak away a large portion of stormwater runoff from this neighborhood. Curb cuts could allow stormwater to drain to a potential stormwater treatment practice within the green space at the center of the cul de sac. The existing catch basins are located such that they could act as overflow relief for the proposed stormwater treatment practices. Figure 10 through Figure 12 show conceptual locations for the STPs and associated curb cuts.

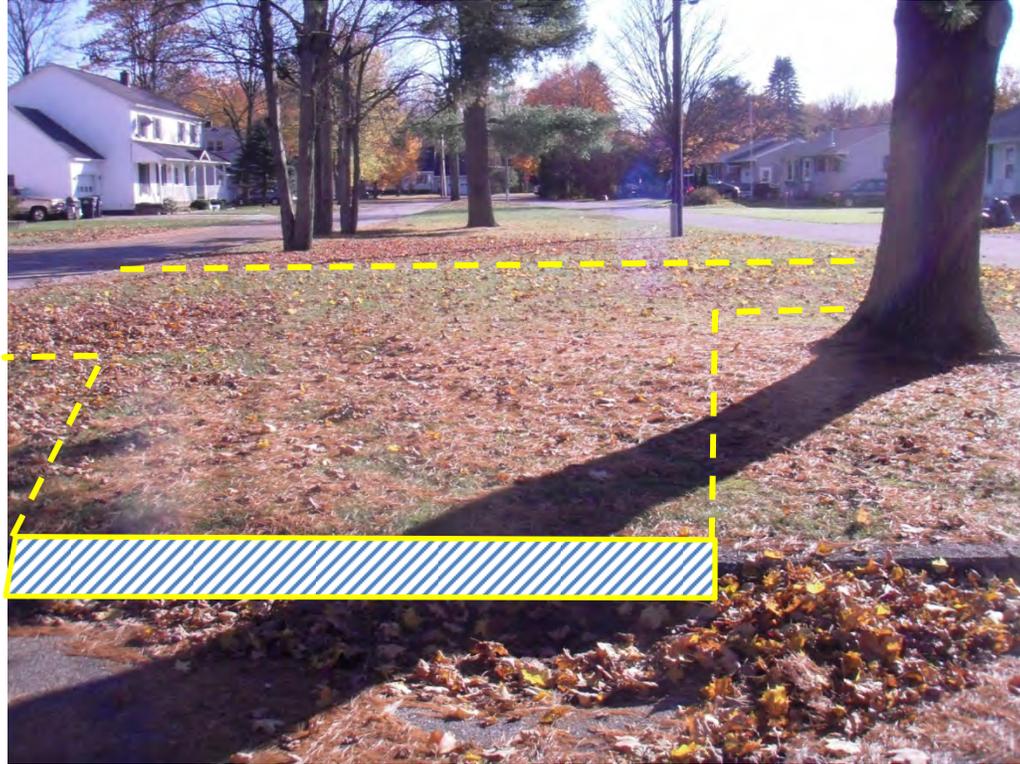
Figure 10. The green space within the cul-de-sac provides a great opportunity for infiltration practices with curb cut inlets.

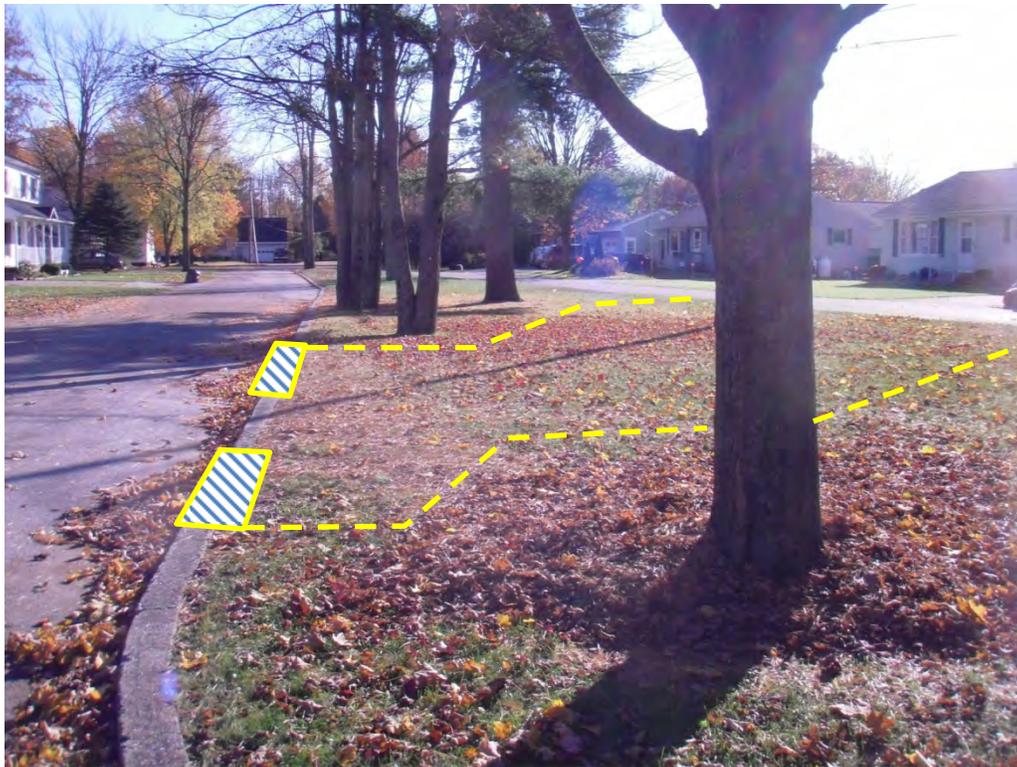
Figure 11. Curb cuts along street would allow stormwater to drain to STPs inside the cul-de-sac. In high flow events, water would back up and drain to existing catch basins.

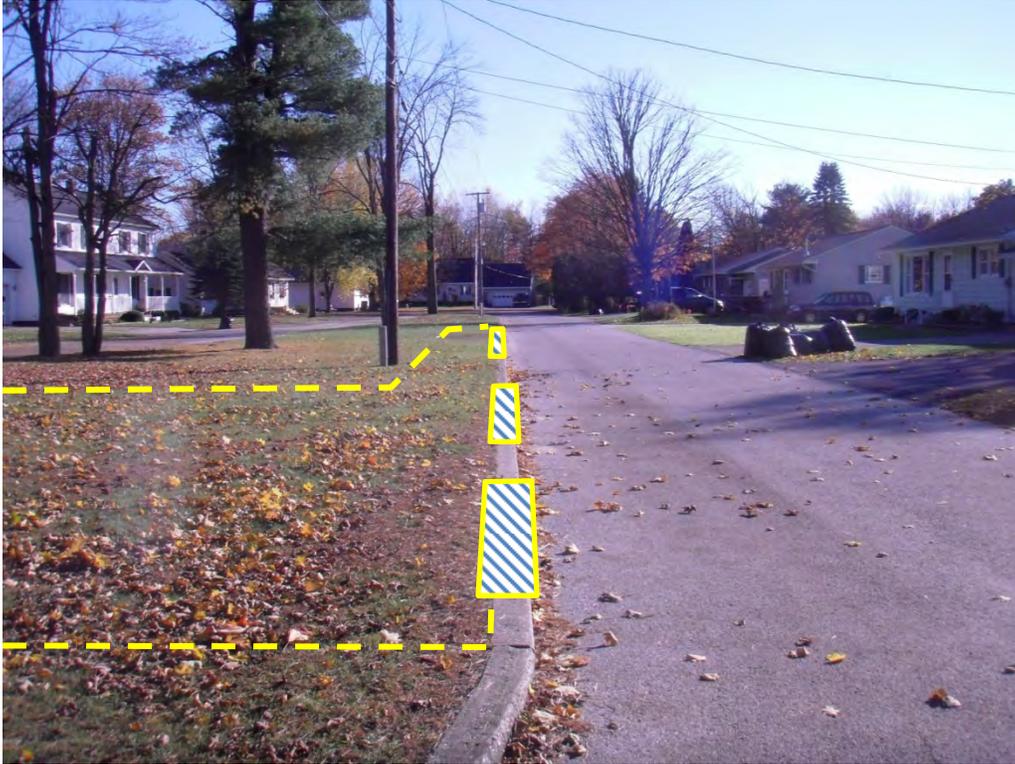
Figure 12. Curb cuts on the east side of the Taylor Dr. cul-de-sac would allow stormwater runoff to access proposed STPs.

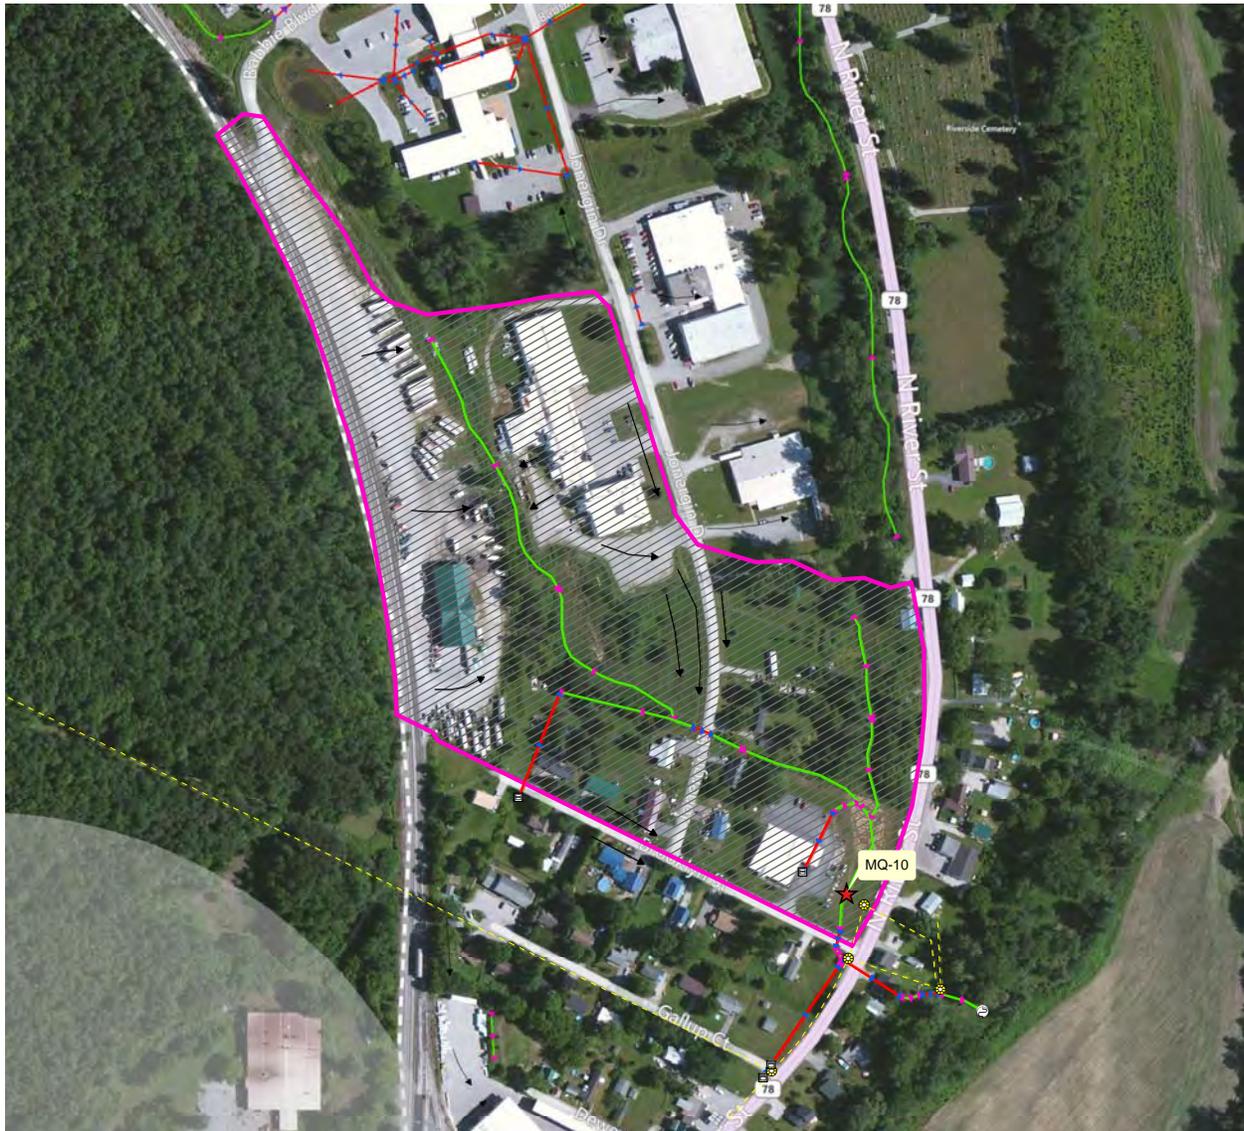
Figure 13. Subwatershed draining to a culvert at the southeast corner of the Fourniers Door and Window business at the corner of Rt. 78 and Brooklyn St.

A significant stormwater treatment opportunity exists near the Fourniers Door and Window property. Stormwater runoff from approximately 22 acres drains to a culvert at the corner of Route 78 and Brooklyn Rd., where the Fournier business is located. This 22 acre subwatershed includes 7.1 acres of impervious surface (approximately 3.6 acres of roof tops and asphalt, and 3.5 acres of compacted gravel surface). Stormwater from this subwatershed appears to receive no treatment before being routed through a culvert under Route 78 and discharged to the Missisquoi River.

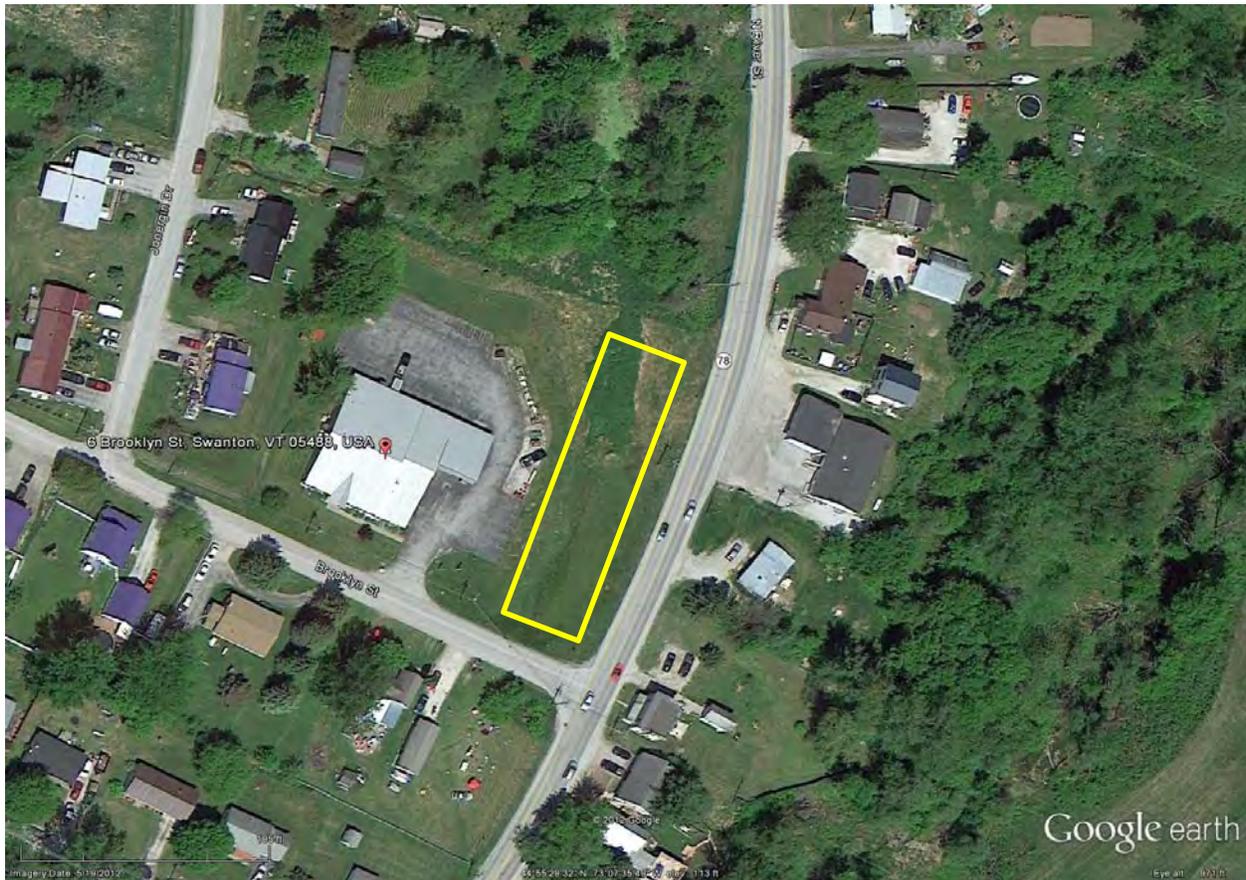
There is a large swale on the east side of the Fournier property that extends 250 ft. upslope, north of an existing 24" culvert. Stormwater drains from upslope properties via this swale and picks up runoff from the Fournier property before flowing south through the culvert under Brooklyn St. Approximately 0.5 acres of

open space shown in yellow in Figure 14, appears to be a suitable location for a stormwater treatment practice.

Figure 14. STP opportunity at Brooklyn St. and Route 78 (N. River St.) near Fourniers Door and Window.
