STORMWATER MANAGEMENT PLAN FOR SWANTON TOWN AND VILLAGE

FINAL REPORT

Stone Project ID 112475-W
February 21, 2013

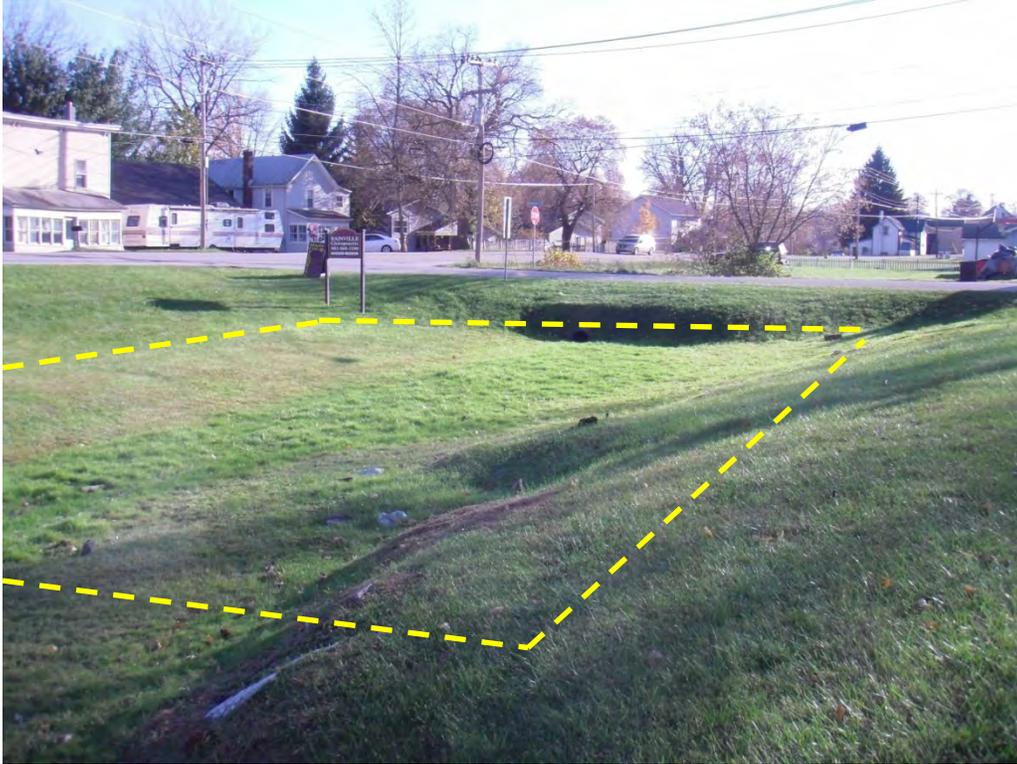
Figure 15. Location for potential treatment at Brooklyn St. and VT Rt. 78 near Fourniers Door and Window business.

Given the existing topographic conditions, a bioretention basin or small treatment wetland would be most appropriate for this property. Alteration of the existing land form would be minimal. The presence of poorly drained soils (HSG D) would necessitate an underdrain system. A practice such as bioretention or constructed-wetland treatment system would detain and slowly release water while removing sediment and solids through settling and filtration. A conceptual location for the proposed STP is shown in Figure 15.

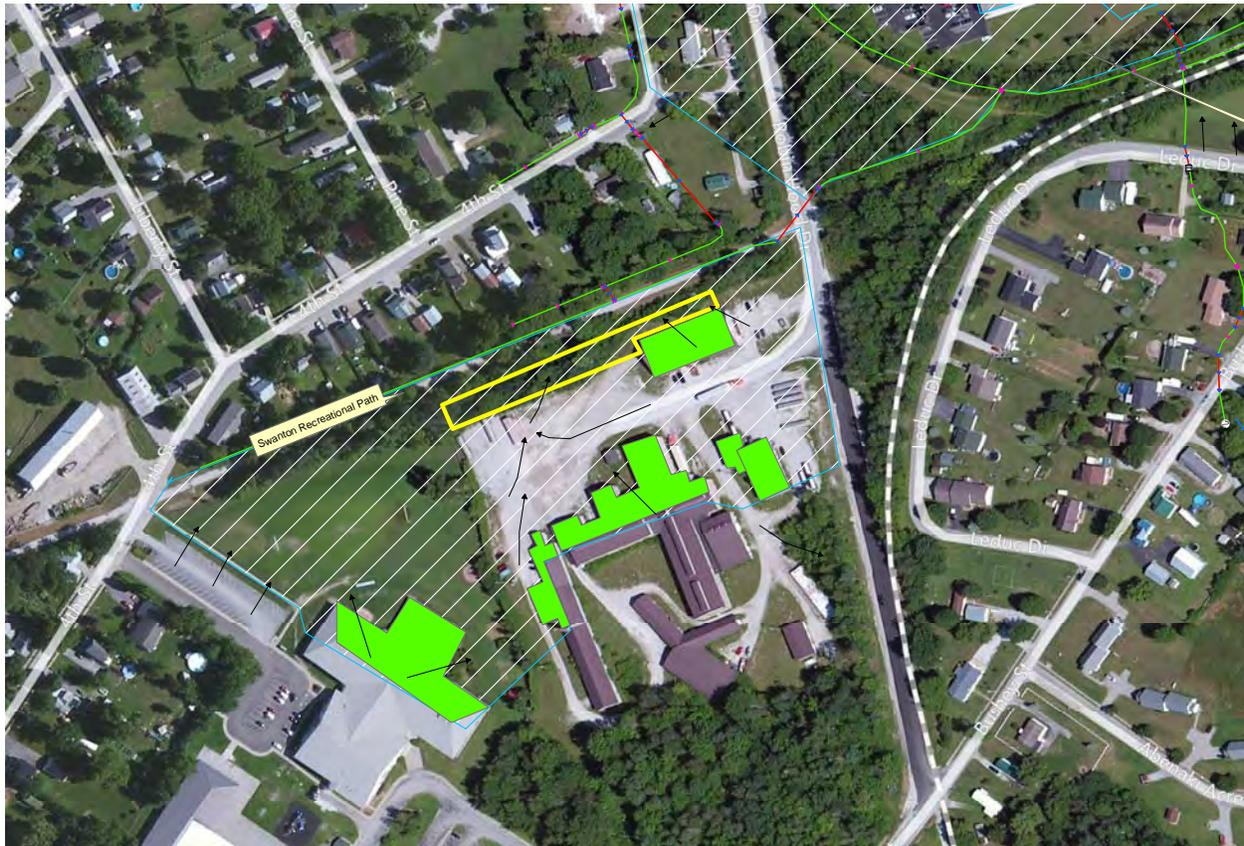
Figure 16. Drainage area at and around Swanton Elementary School: location for potential STP shown in yellow. Rooftop areas that drain to the potential STP are shown in green.

Potential stormwater treatment opportunities exist along the Swanton Recreation Path near Robinhood Drive. The subwatershed contains portions of the Swanton Elementary School and former Robinhood Ammunition plant property. Stormwater drains north to a swale that flows to the northeast along the south side of the recreation path. From the end of this swale, stormwater flows through approximately 0.5 miles of storm sewer and open channel conveyance to the Missisquoi River

The 10.5 acre subwatershed includes 3.2 acres of impervious surface (1.4 acres of roof tops and 1.8 acres of compacted gravel). The remainder of the subwatershed consists primarily of athletic turf on the school property. Athletic fields are often highly compacted and can have low infiltration rates.

A detention and filtration practice, such as a bioretention basin, could be effective in treating runoff from these properties. A conceptual location for an STP is highlighted in yellow in Figure 16 and Figure 17. The prevailing soil type is Deerfield loamy fine sand (HSG B) with a moderately high seasonal water table. This means that infiltration features could improve treatment by soaking away a portion of the treated runoff. Still, an underdrain system is recommended to ensure proper drainage throughout the year.

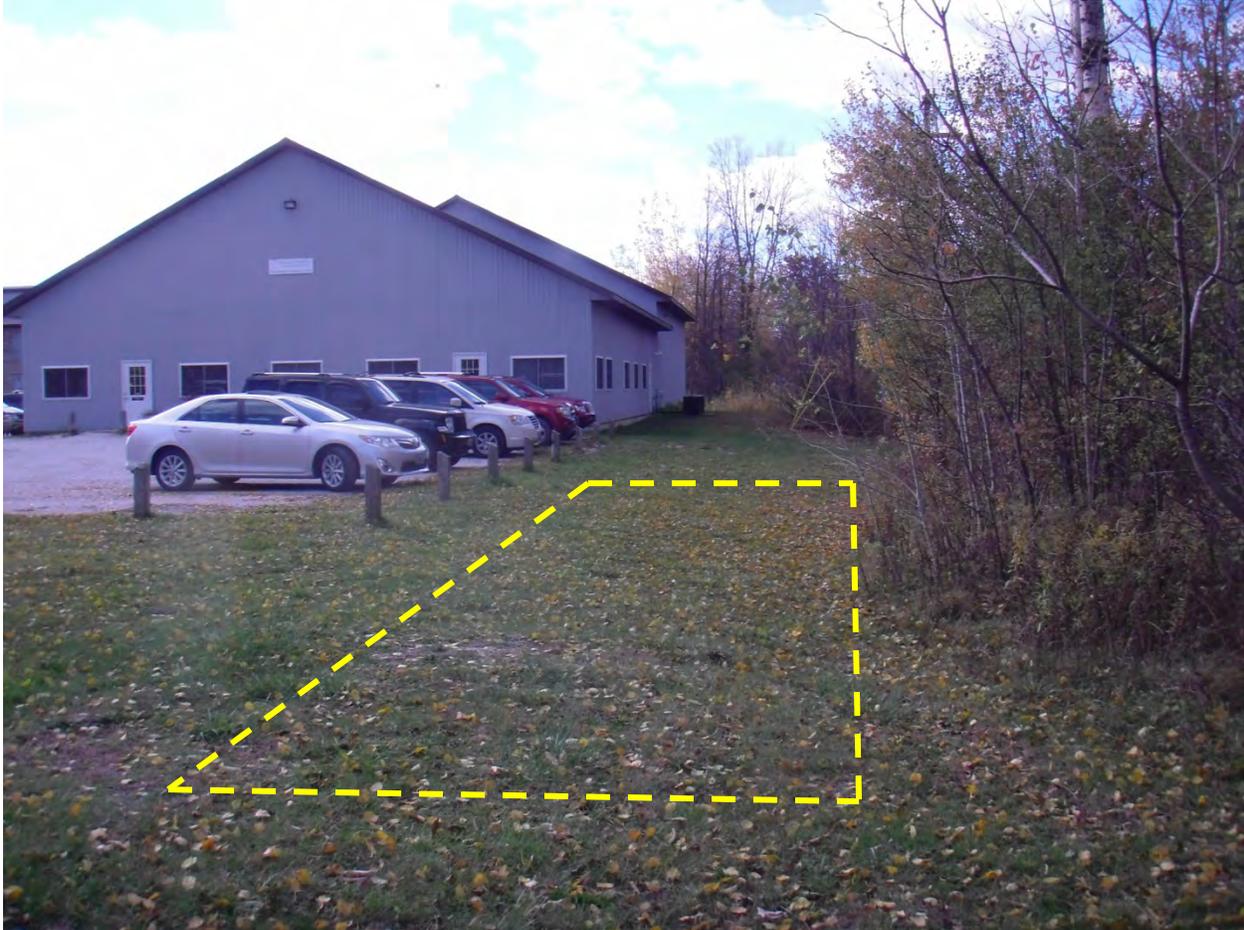
Figure 17. Proposed location for stormwater treatment at the former Robinhood Ammunition property.

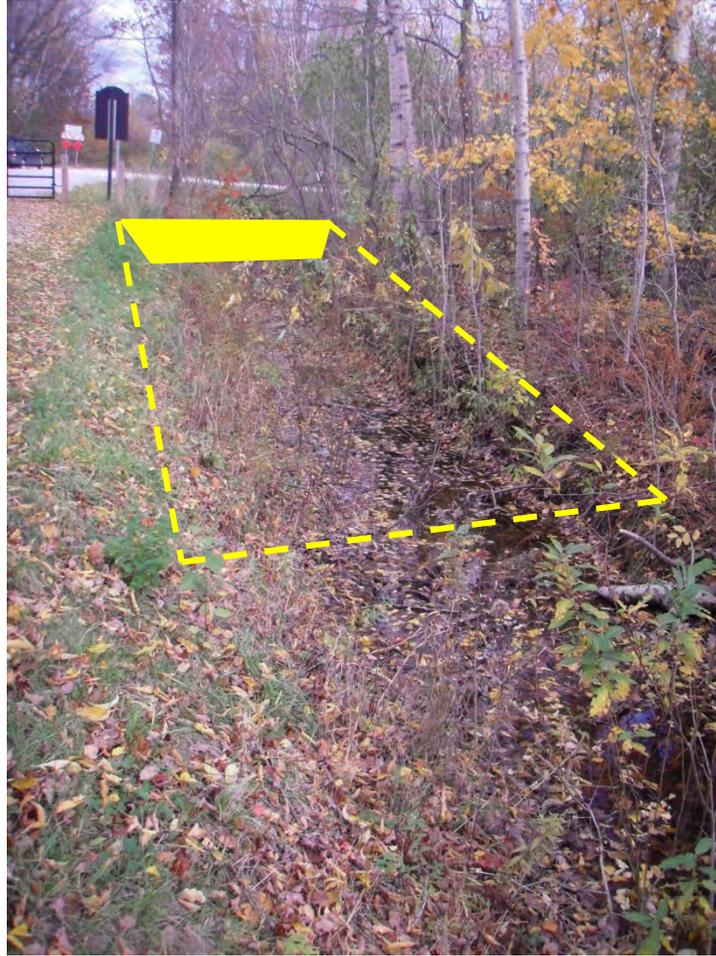
Figure 18. The existing swale along the recreation trail could be modified to improve stormwater treatment.

Additionally, or as an alternative, it may be possible to modify the existing swale along the recreation path to enhance stormwater treatment (see Figure 18). Beyond improving water quality, installing an STP at this location will improve the aesthetic conditions along the recreation path, while providing an educational opportunity. The proximity of Swanton Elementary School and the recreation path would mean that an STP at this location could be accessible by student groups and visible to recreation path users. Interpretive signage could be used to inform users of the recreational path about water quality, stormwater treatment practices, and the benefits to the community and local environment.

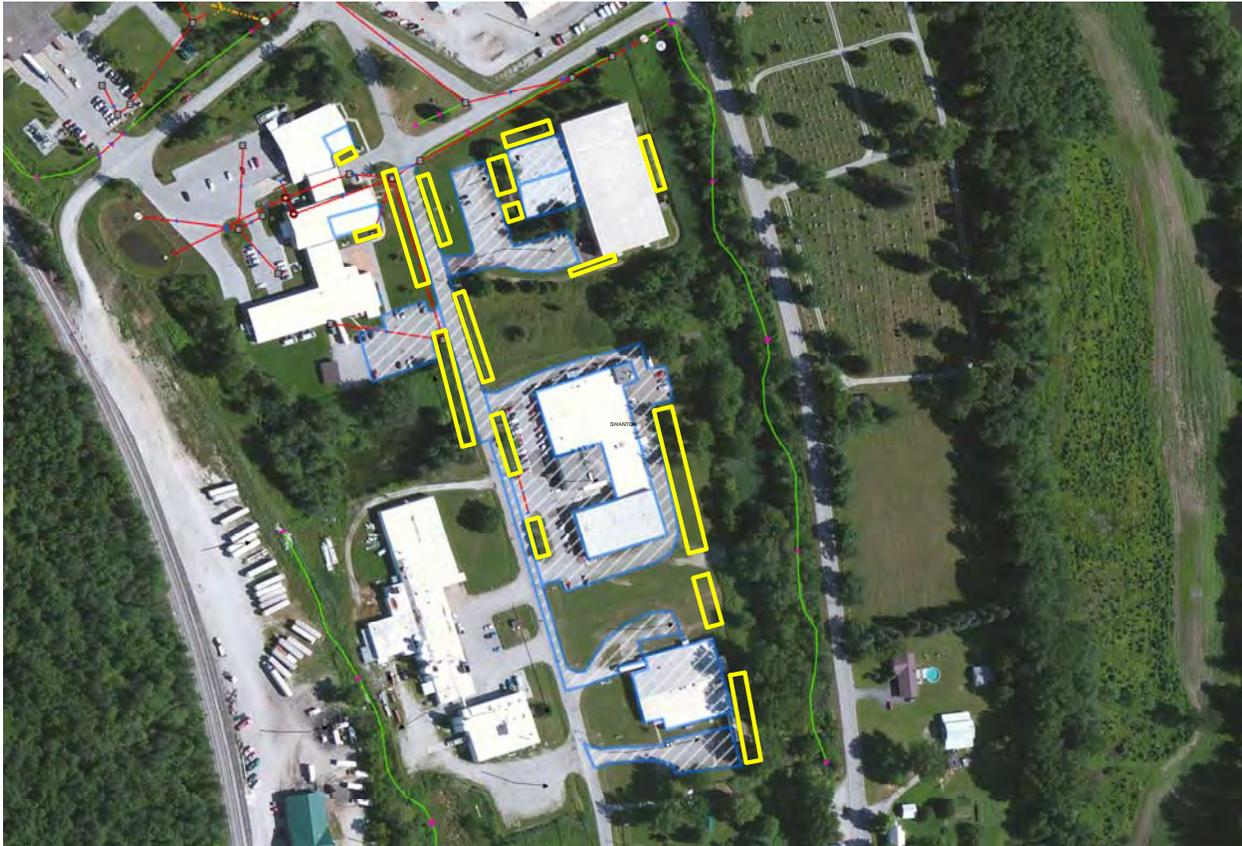
Figure 19. Stormwater from a large segment of the industrial development near Jonegrin Dr. and Babbie Blvd. is untreated and drains to the Missisquoi River. Treatable impervious area is highlighted in blue and potential locations for STPs highlighted in yellow.

The industrial area along Jonegrin Dr. and Babbie Blvd. includes a significant amount of impervious area; 3.9 acres within the subwatershed have been identified as potentially treatable. Stormwater runoff from this subwatershed makes its way to the Missisquoi River with no retention and little, if any, treatment. Many options have been identified for location of STPs as shown by the yellow highlight in Figure 19. Stormwater from a large segment of the industrial development near Jonegrin Dr. and Babbie Blvd. is untreated and drains to the Missisquoi River. Treatable impervious area is highlighted in blue and potential locations for STPs highlighted in yellow.

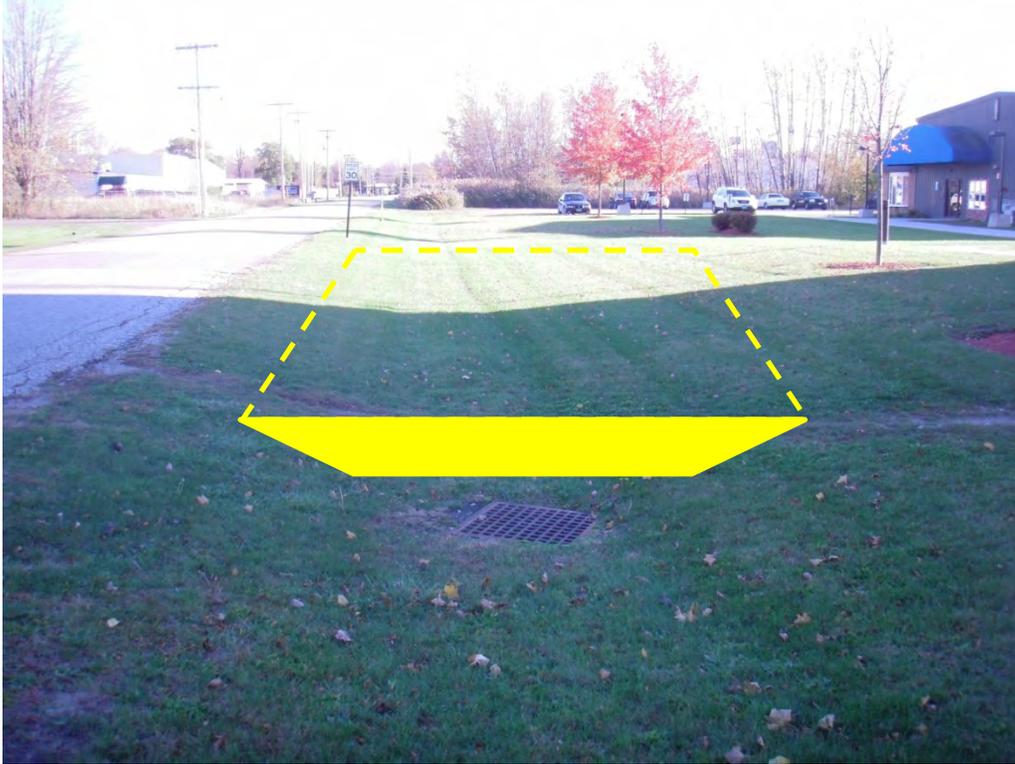
Massena stony loam and Raynham silt loam are the predominant soil types in this area. Both soils are reported to be HSG C with a shallow water table. Infiltration practices will not be a likely option. However, many opportunities exist for retrofitting the existing stormwater infrastructure with filtration-type treatment practices (see Figure 20).

Figure 20. Existing catch basins in front of the Mylan Technologies building and neighboring property could easily be retrofitted with filtration practices.

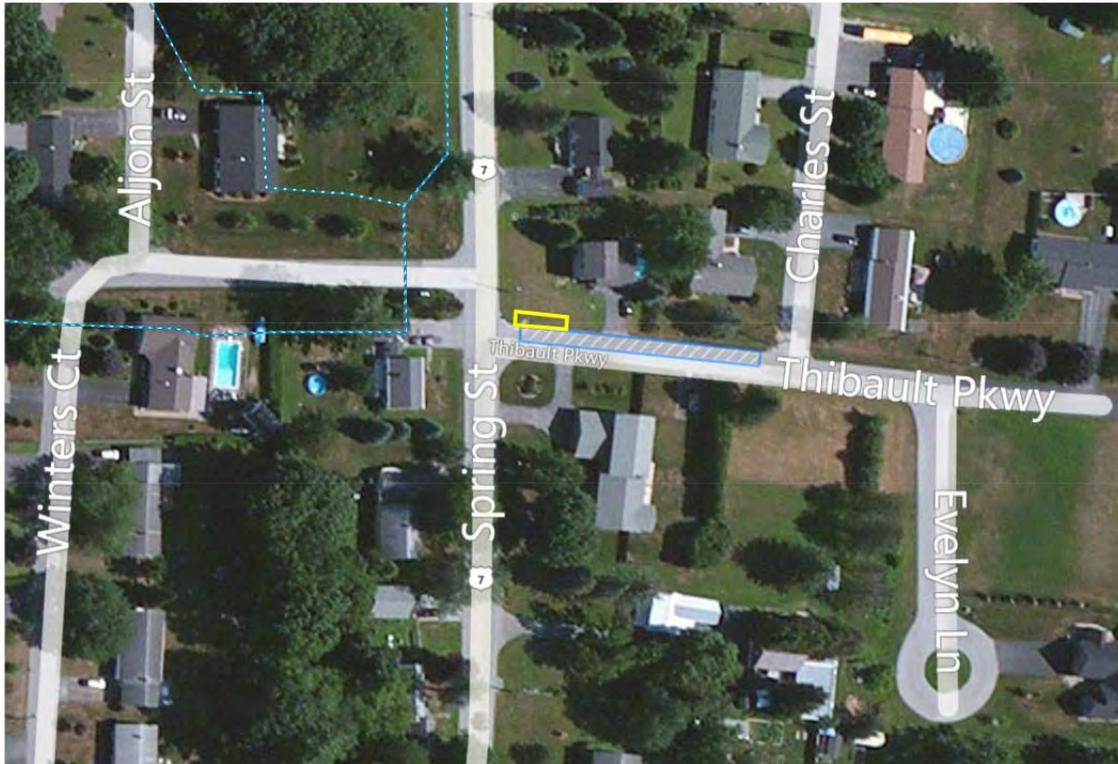
Figure 21. Stormwater treatment opportunity at corner of Thibault Parkway and Spring St.

A catch basin adjacent to Thibault Parkway could be retrofitted and utilized as part of an STP, such as a simple rain garden. Site conditions, including Windsor loamy fine sand (HSG A) and a deep water table, would enable detention and infiltration of a significant portion of stormwater runoff from 0.04 acres of impervious surface draining to the existing catch basin.

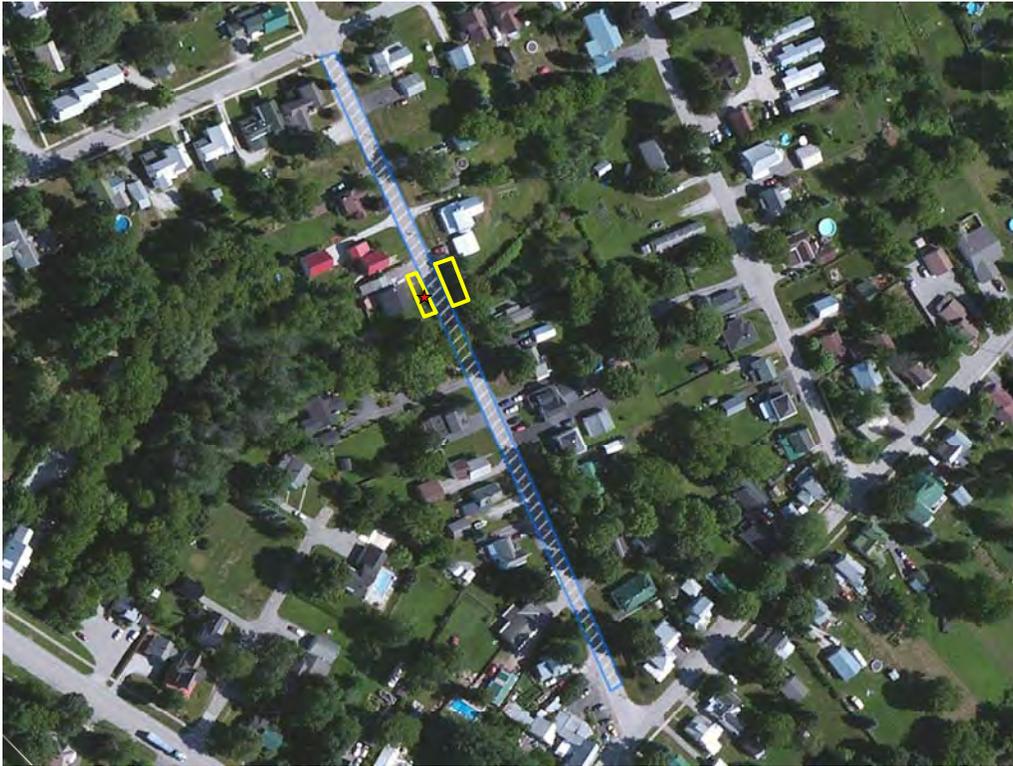
Figure 23. Greenwich Ave. drains to two existing catch basins near the middle of the block where two STPs could be located.

Two existing catch basins on Greenwich St. between 2nd St. and Platt St. are well-situated to be utilized as part of stormwater treatment practice. Approximately 0.4 acres of Greenwich Ave. drains toward the center of the block where stormwater is collected by two existing catch basins on either side of the street.

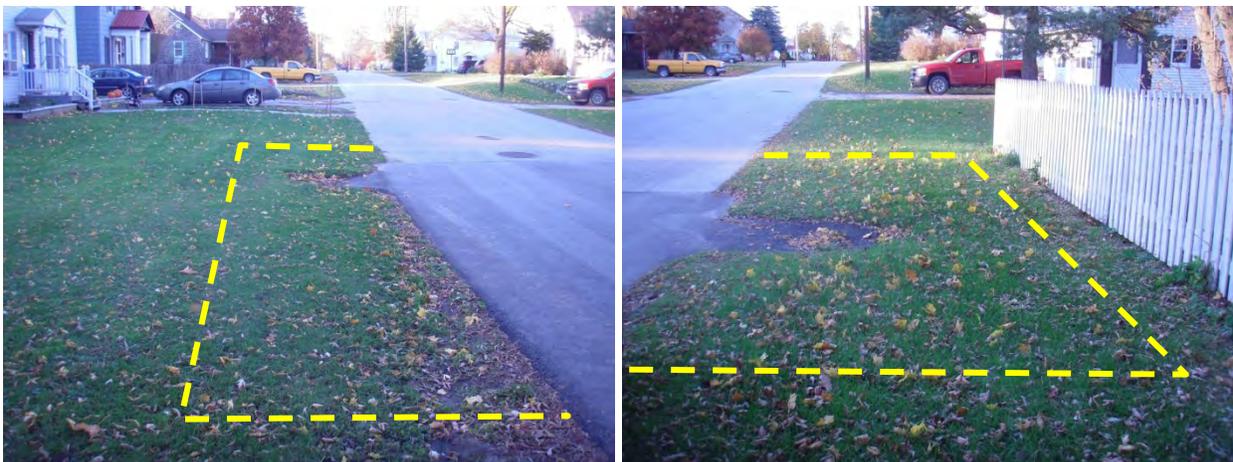
Figure 24. Catch basins on along Greenwich St. could be modified and used as overflow relief for an infiltration focused STP.

The predominant soil type is reported to be Windsor loamy fine sand (HSG A) with a deep water table. This means that there is potential to soak away a large portion of the stormwater draining from this neighborhood. The existing catch basins could then act as overflow relief for an infiltration-based STP.

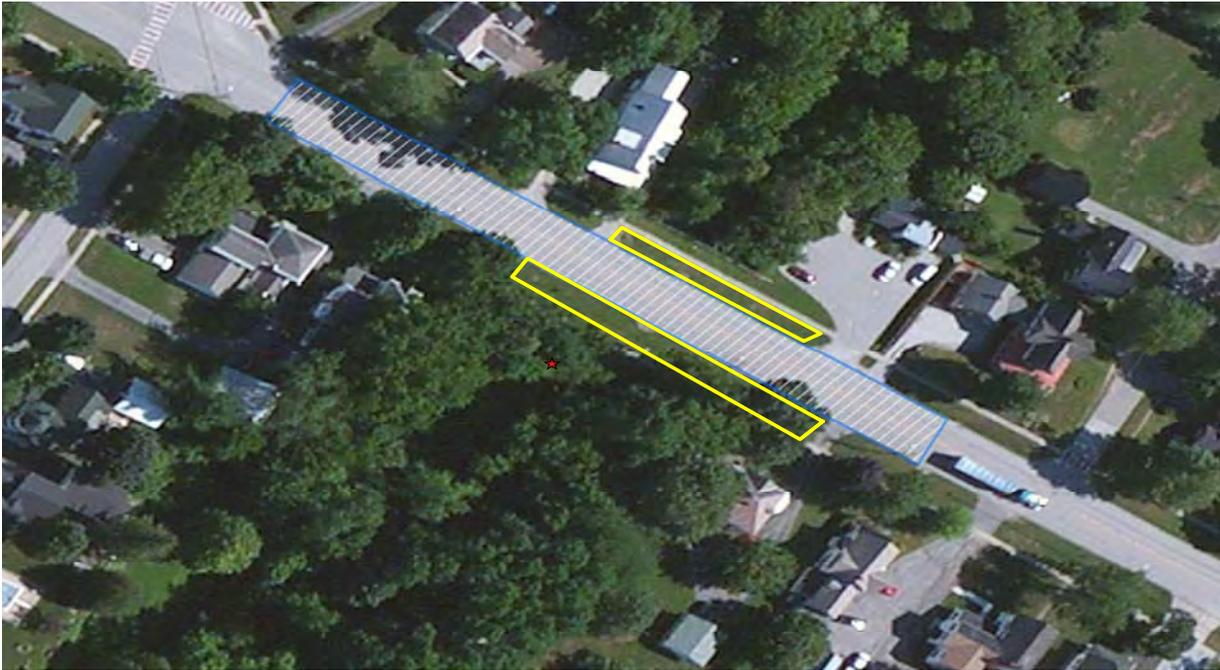
Figure 25. Grand Ave. stormwater could be treated with infiltration practices located between Farrar St. and Furnam Pl.

Stormwater runoff from 0.3 acres of Grand Ave., between Farrar St. and Furman Place, could be treated before draining to existing catch basin in the green strip. Stormwater drains toward the center of the block from both directions. Catch basins between the street and sidewalk collect stormwater on either side of Grand Ave. The predominant soil type is Windsor fine sand (HSG A) with a low water table.

Given the well-drained soils and position of existing catch basins, stormwater from this section of Grand Ave., could be treated with an infiltration-based STP (see Figure 26 and Figure 27). Water would infiltrate the underlying soils, or otherwise be slowly released with sediment removal occurring through settling and filtration.

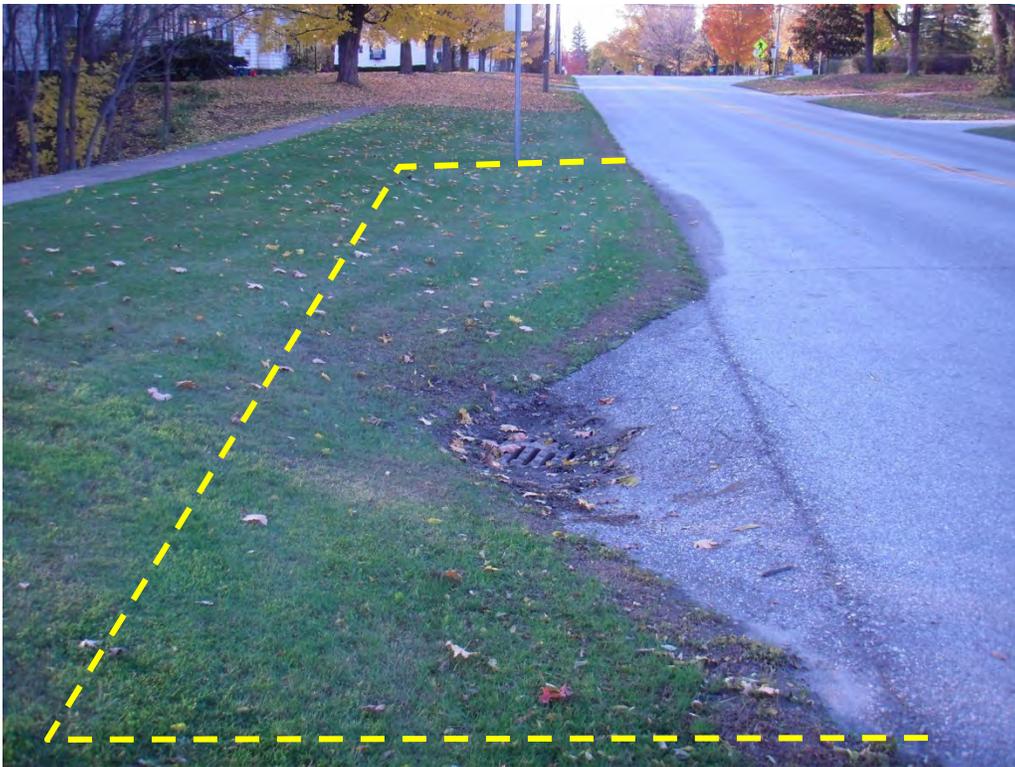
Figure 27. Catch basin on north side of Grand Ave. that could be modified as part of an STP.

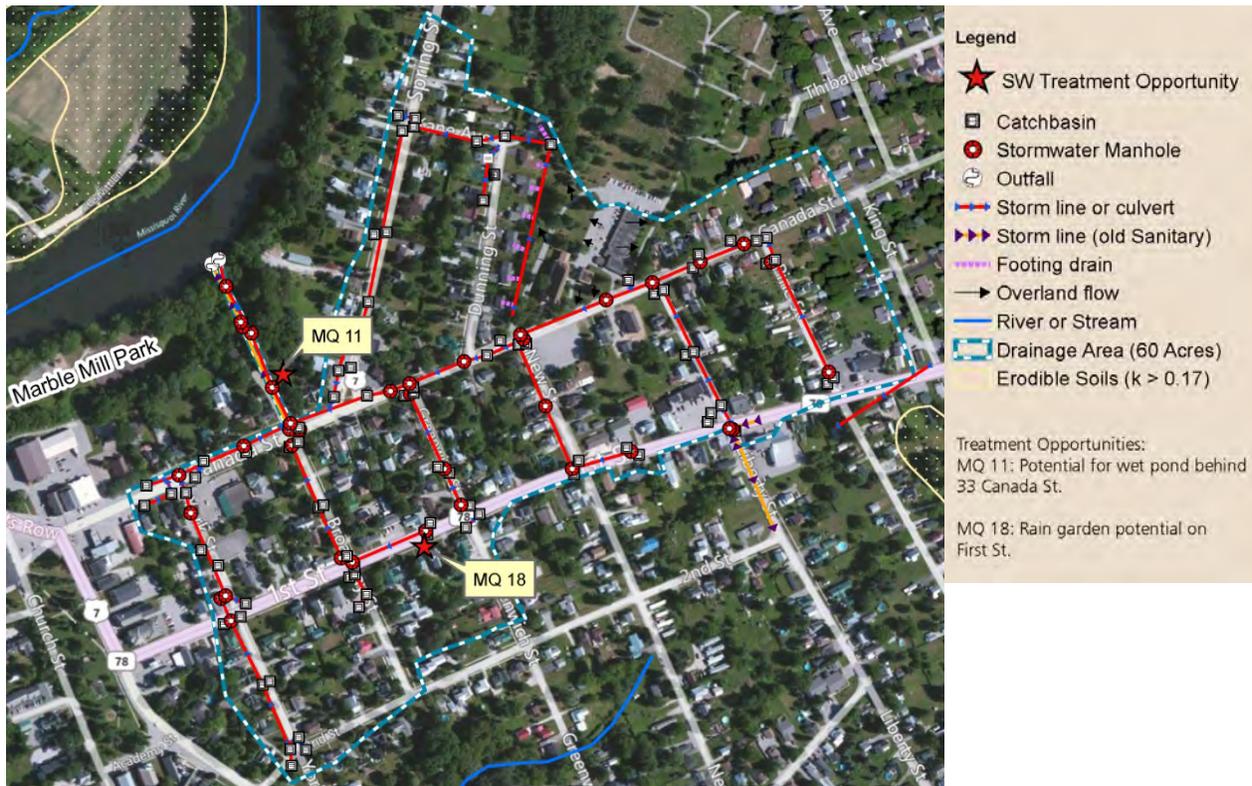
A significant portion of the stormwater runoff from the closed drainage system in Swanton Village is piped to Marble Mill Park, where it is discharged without treatment to the Missisquoi River. The area of the park near this outfall also contributes untreated runoff to the Missisquoi, including active erosion in the road and path leading to the park, runoff from the parking lot, and a washout leading from the park to the river's edge near the outfall. The Village previously worked with the Northwest Regional Planning Commission to obtain grant funding from VT DEC to develop a comprehensive solution for stormwater management at Marble Mill Park, and a design has been prepared. Unfortunately the Village has faced a number of challenges in seeing the design implemented, including concerns raised over any construction activity within the 100-year floodplain of the Missisquoi, and as a result nothing has been built to date.

Figure 28. Marble Mill Park problem area.
