Lake Watershed Action Plans

Alison Marchione

Vermont Department of Environmental Conservation

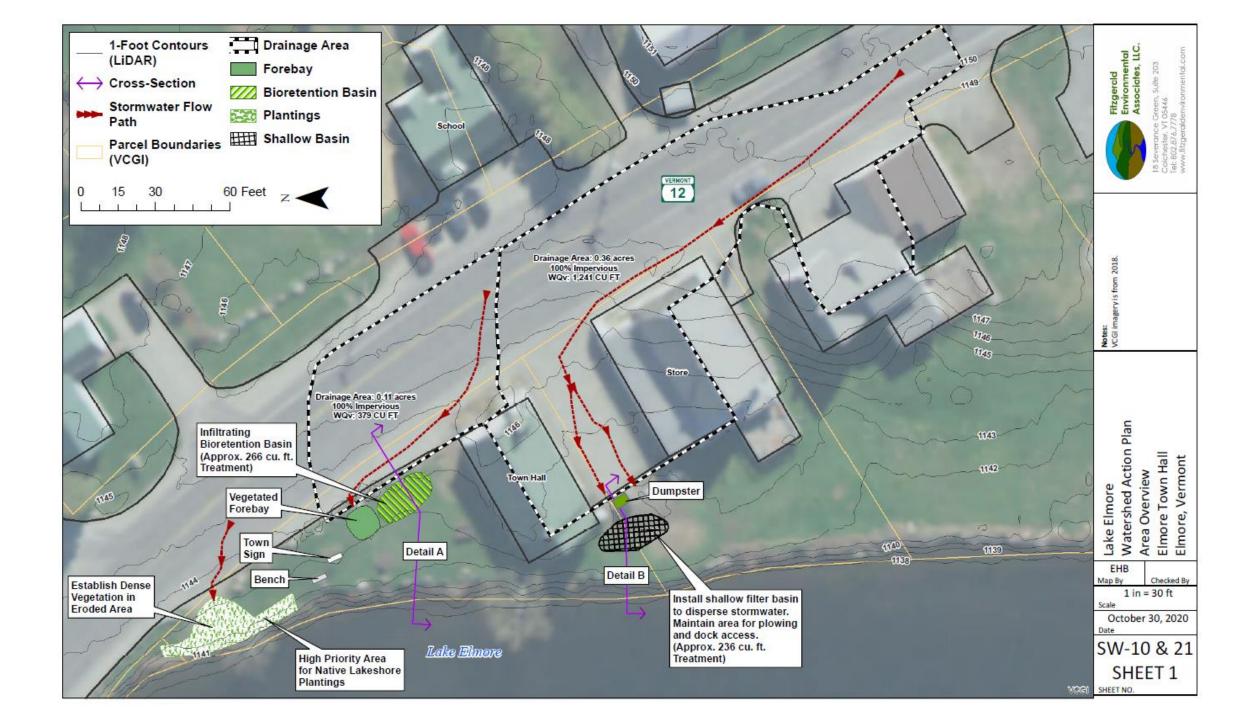
Detail A: Infiltrating Bioretention Feature Typical Detail - Town Hall (SW-10)

- Gravel drive runs off into the lake
- Drainage includes the impervious surfaces along route 12
- No buffer
- Add basin along the edge of the gravel to treat stormwater runoff
- Public area

Site Description: Gravel parking area between the Town Offices and Store slopes toward the lake. Opportunity to treat runoff from a large area of impervious surfaces near the lake. See Concept design in Appendix F for updated scope and cost opinion.

BMP Description: Opportunity to add a small/medium sized basin along the edge of the parking area to slow and treat stormwater runoff.
