Vermont Geological Survey Open File Report VG2016-4

Final Report on a Landslide Inventory of the Town of Highgate, Vermont

August 30, 2016

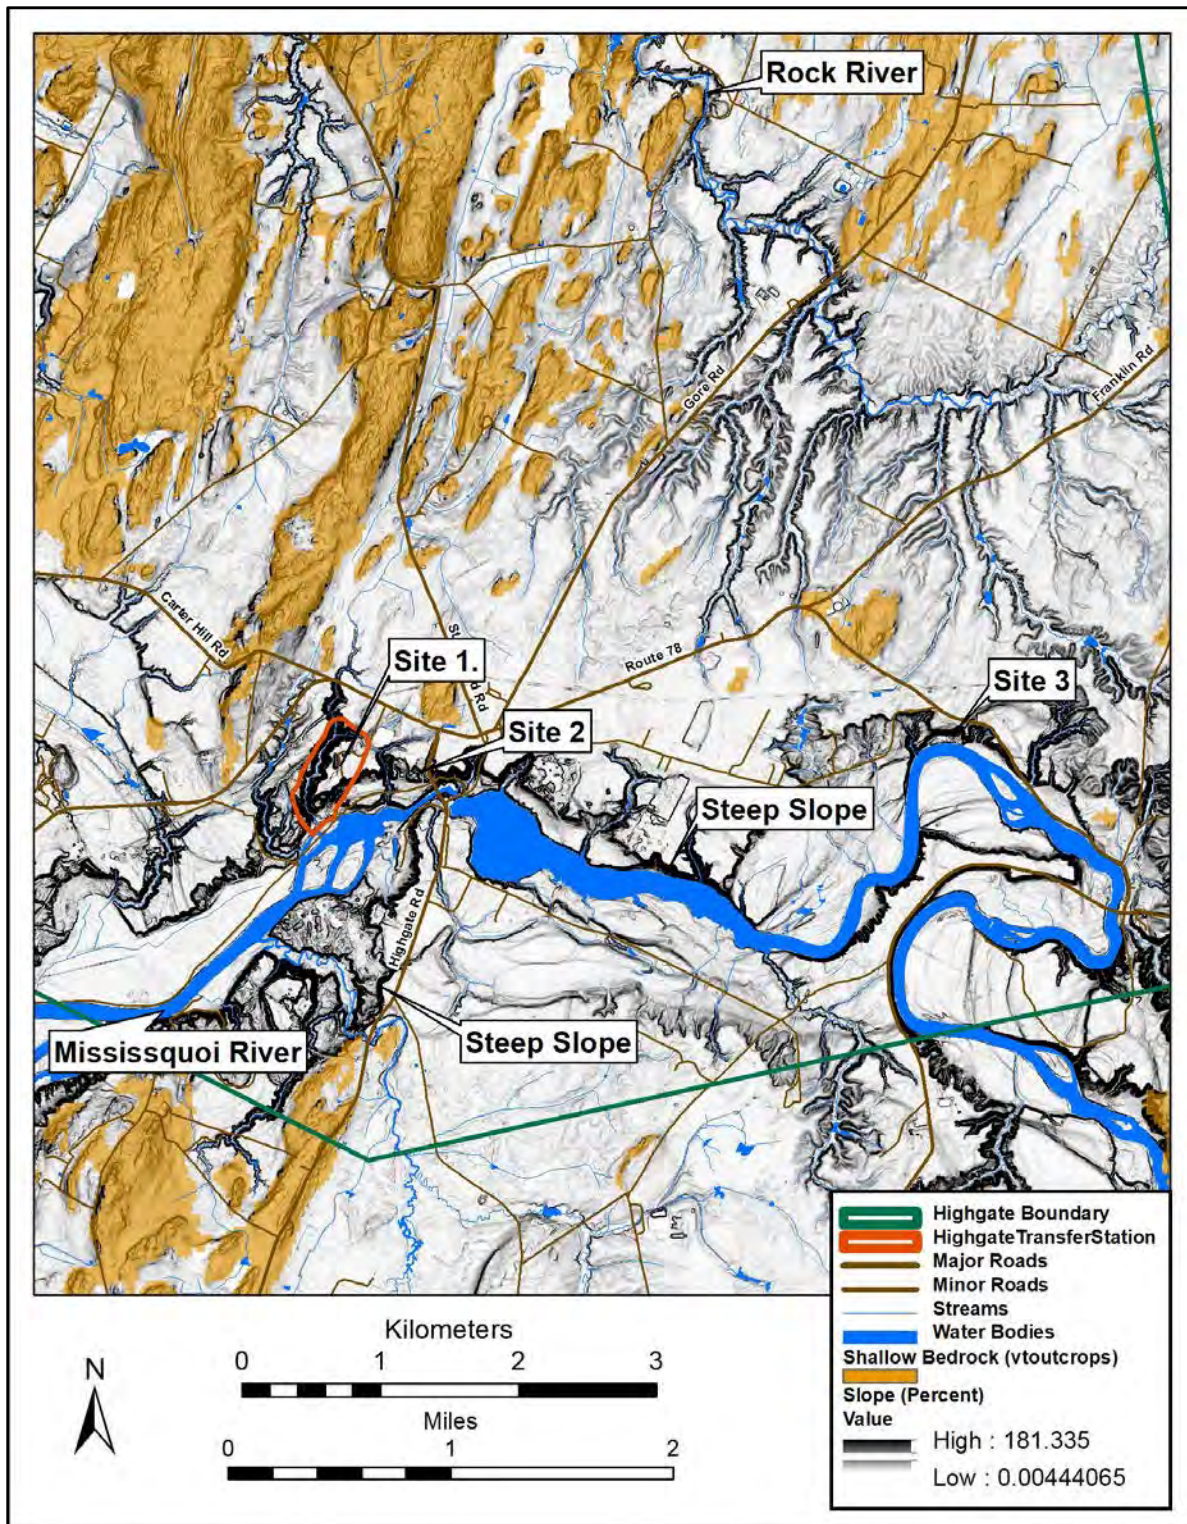
Four sites are described in the following sections. The locations of Sites 1 through 3 are shown on Figure 2. The location of Site 4, which is east of the study area, will be shown on Figure 16). These sites are typical of landslides encountered along the Missisquoi River. Landslides on the Rock River and the tributaries are smaller, but substantial landslides can occur even on quite small streams.

Figure 2. Map of south-central Highgate showing Sites 1 through 3. Steep slopes derived from lidar are shown as dark gray and black and areas of possible shallow bedrock derived from NRCS Soil Survey data are shown in orange.

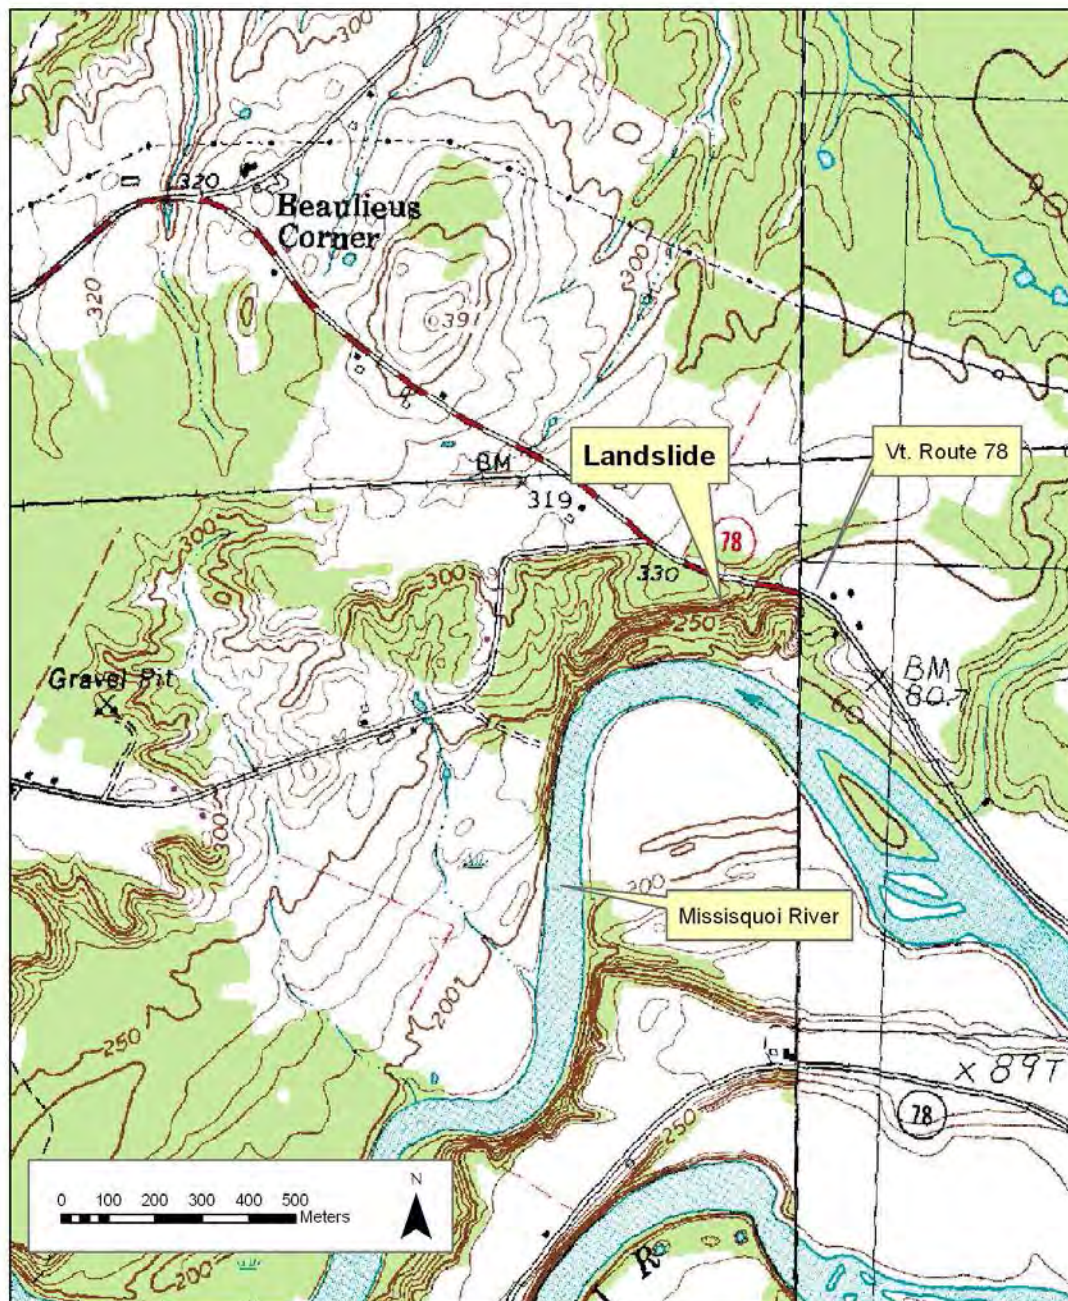
Figure 9. Location Map.

A substantial landslide located to the north of the Missisquoi River was the site of a recent FEMA buyout of two homes (Figure 9). This site is important for the landslide study as it is an example of a site where a slope failure has occurred that is not due to riverine erosion. On May 9, 2013 I visited the Simmons property on the south side of Riverview Lane, which is on the south side of VT Route 78. The top of the landslide is located south and southeast of the Simmons house and is about 130 feet above the Missisquoi River. This steep slope consists of a wooded, gullied slope. The upper 60 feet of the slope is very steep, with an average angle of 42°. The top 10 feet or so is even steeper.

Mr. Simmons stated that he first noticed that the slope was failing after Hurricane Sandy. Since then, landslide movements have led to displacement of substantial blocks of soil and trees have toppled outward onto the landslide. It does appear that the primary cause of this landslide was high groundwater levels due to precipitation.

The edge of the landslide was 25.0 feet from the southeast corner of the house at the time of my visit. The top of the slide is shown in Figures 14 and 15. I did not observe any cracks on the outside of the foundation and Mr. Simmons stated that he did not know of any cracks visible on the inside. I recommended that a qualified engineer evaluate this site as soon as possible. Subsequent evaluations led the Town to conduct FEMA buyouts of this and an adjacent property.

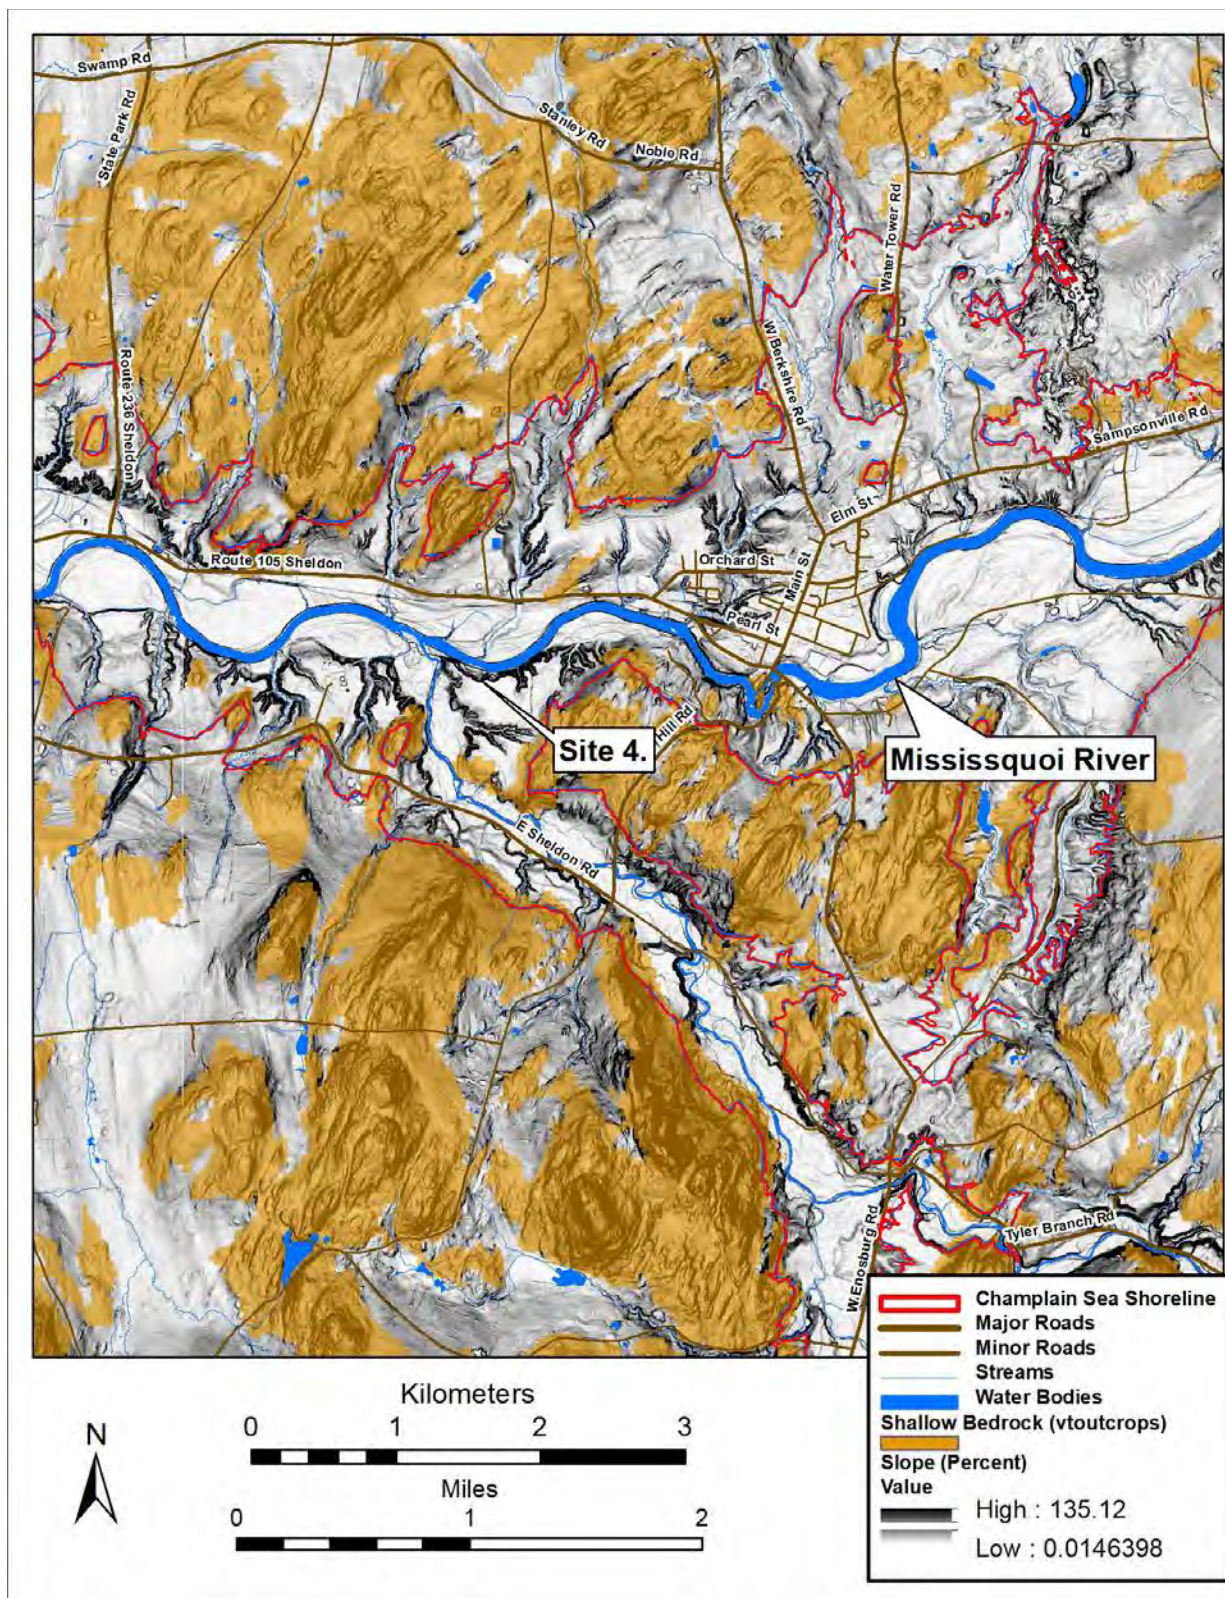
This site is a large landslide on the south side of the Missisquoi River in the Town of Sheldon (Figure 16). It is included here because it is a large, well-exposed rotational slide-flow that has formed in similar surficial materials to those along the river in Highgate. Similar landslides have occurred in the past along the banks of the Missisquoi River in Highgate. The last major failure at the Sheldon site was in the spring of 2009. I visited the site on May 28, 2009 and on June 7, 2011. The slope is 60 to 70 feet high and the landslide has an overall angle of 10 degrees. The landslide toe deposit pushed far out into the river as shown in Figures 17 and 18. Views from the top are shown in Figures 19 and 20.

This landslide is located on the outside of a meander bend of the river and appears to have been caused principally by erosion of the toe of the deposit. The landowner on the north bank of the river reported that landslides had occurred here in earlier years. This fits with observations made on the site and interpretation of the lidar slope data.

The low runout angle of the landslide suggests that the material has, when saturated, a very low shear strength. Similar materials are present in the deeper layers in the deposits downstream in Highgate.

Figure 16. Location map for the Sheldon landslide. This site is a well-exposed example of one of the types of landslides that occurs in the Highgate study area.
