# Two Decades of Collaborative Landslide Research in Vermont

Presented at the Joint Southeastern & Northeastern Section Meeting of the Geological Society of America in Reston, VA on March 17, 2023

# What We've Learned About Landslides in Vermont

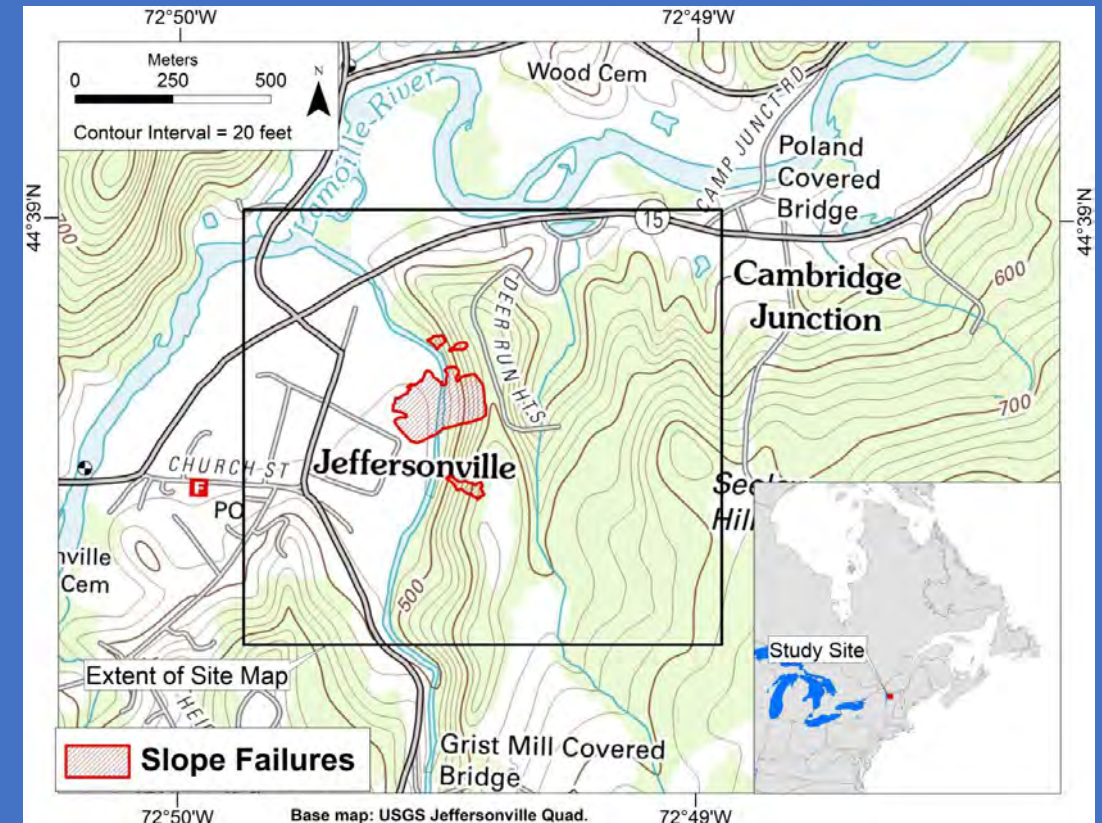
Three complex earth slide-flows in 1999, totaling ~27,000 cubic meters, 43 m high, Runout length ≈233 m, Travel angle of 11.2°.

**Landslides on April 11 and 18, and July 4, 1999. Note house at top of slope at left. This was abandoned after the first landslide.**

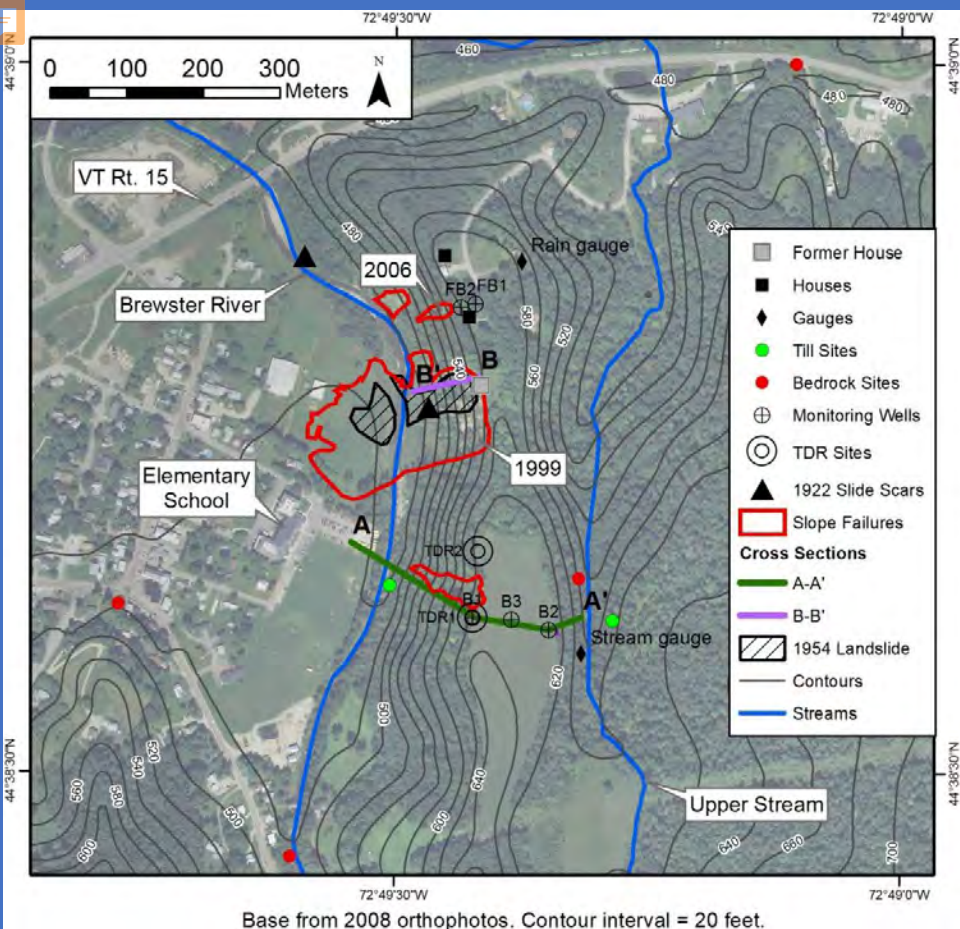
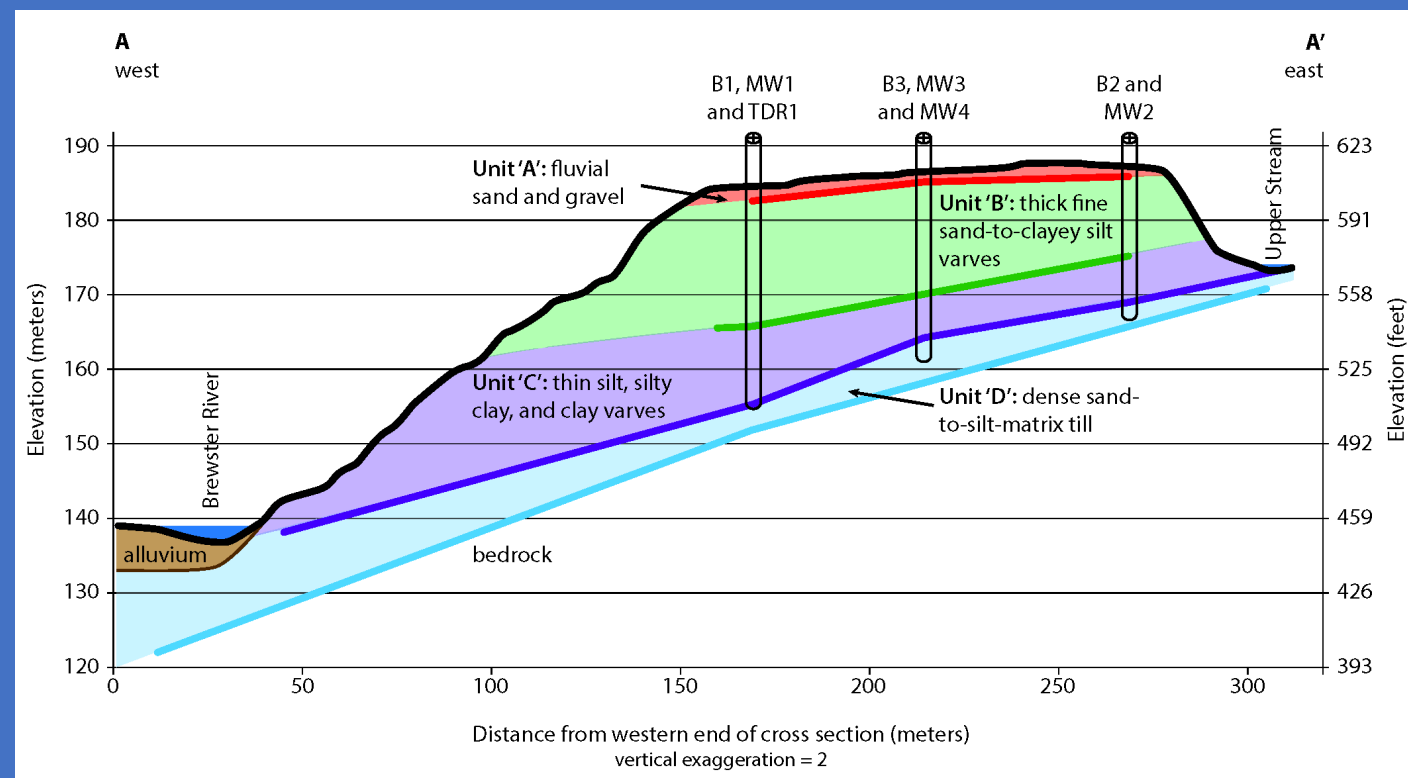
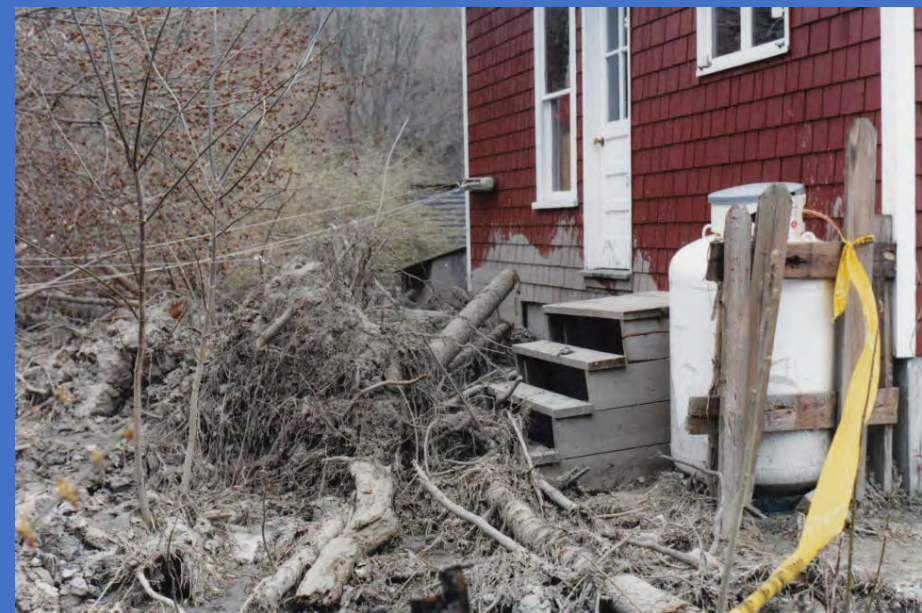
**Above: Jeffersonville landslide site map.**  
**Above right: Stratigraphy.**  
**Bottom right: Mud from 1999 landslide splashed up against house at southwest corner of landslide deposit.**

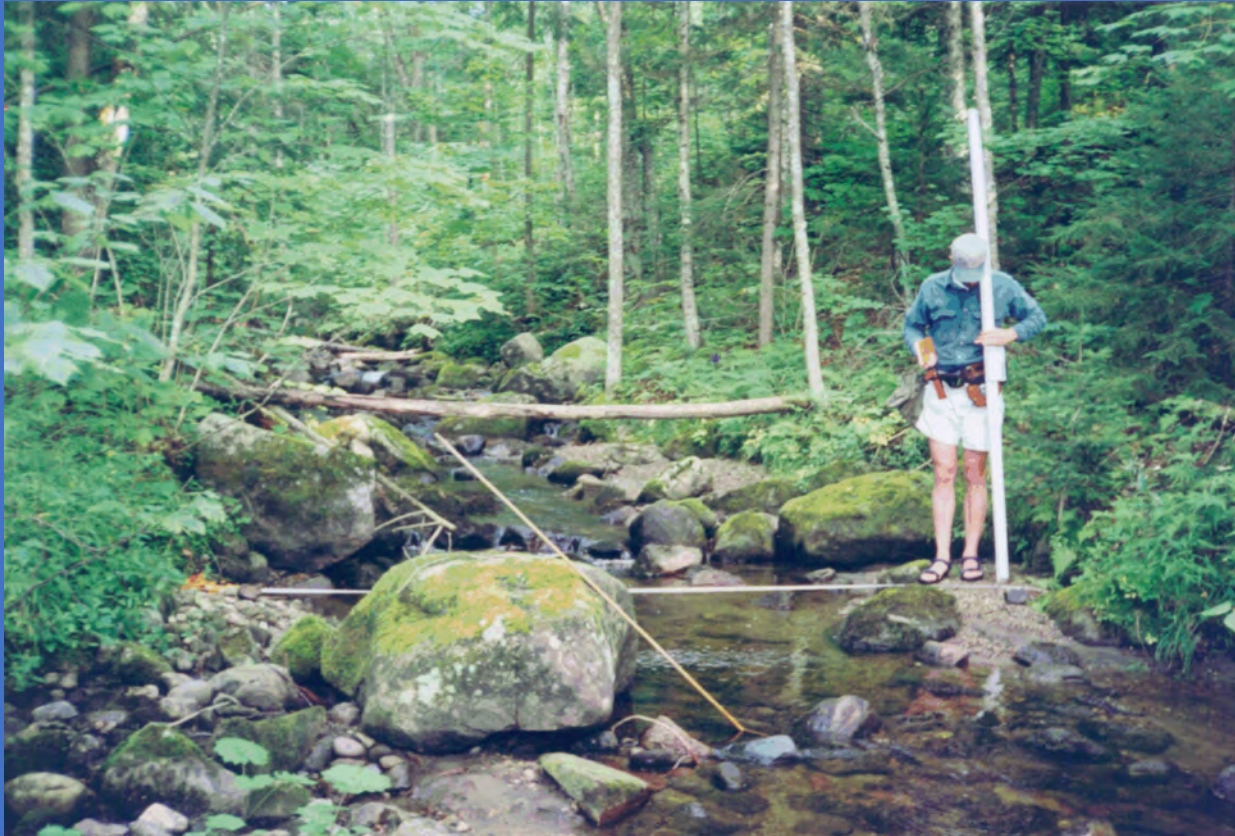
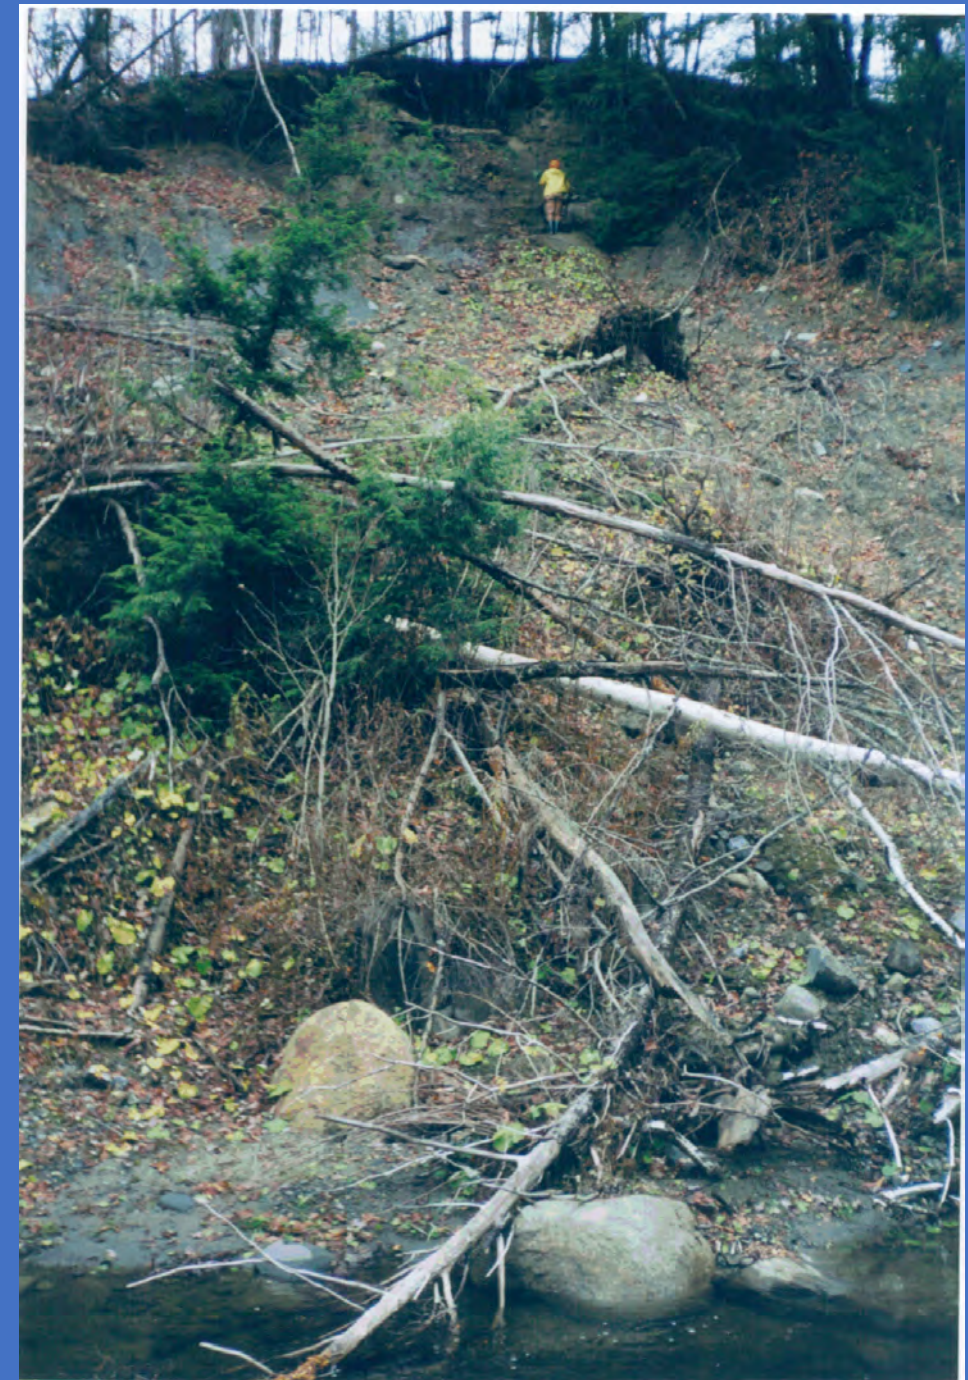
**Great Brook: complete characterization of a watershed: Fluvial geomorphology, surficial geology, detailed flood history, plus a 3-year hydrologic study by the Plainfield Conservation Commission. Below: A stable upstream reach. Right: One of many large landslides along the unstable lower reaches of the brook.**

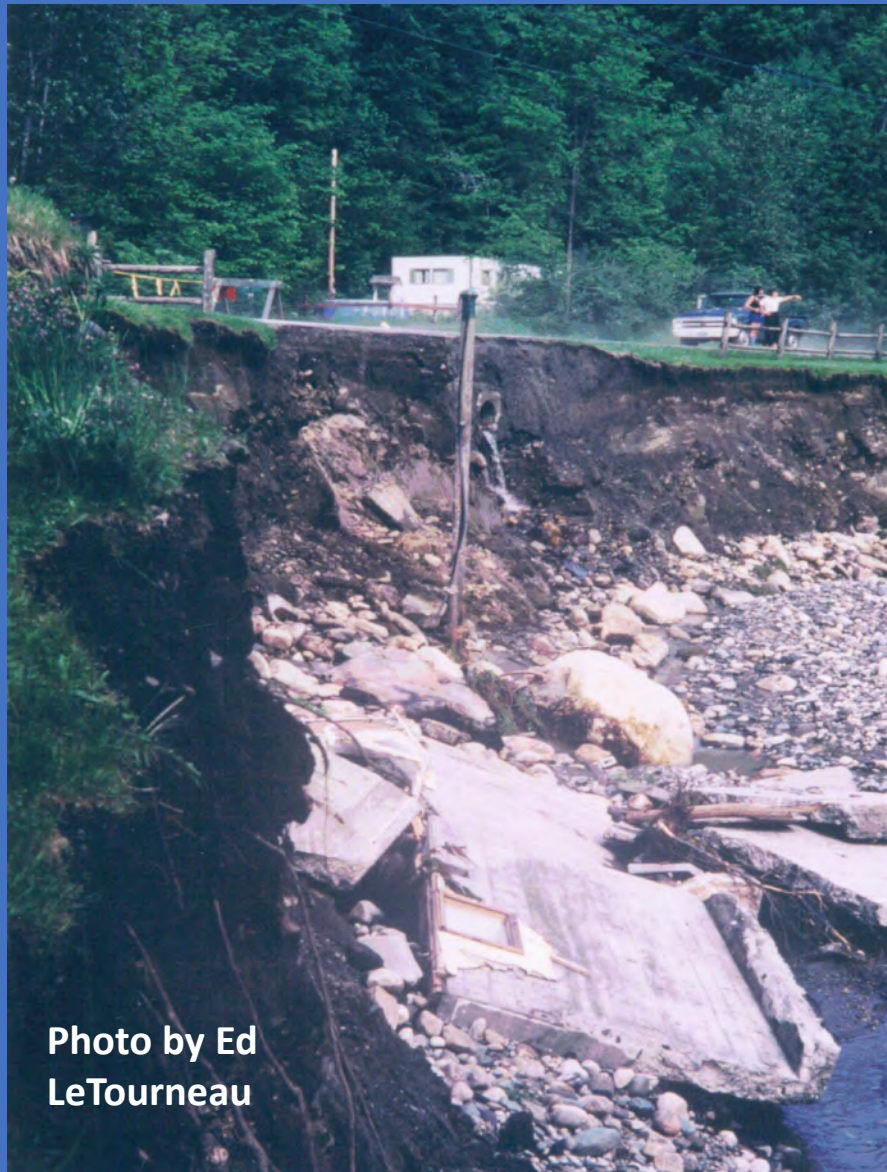
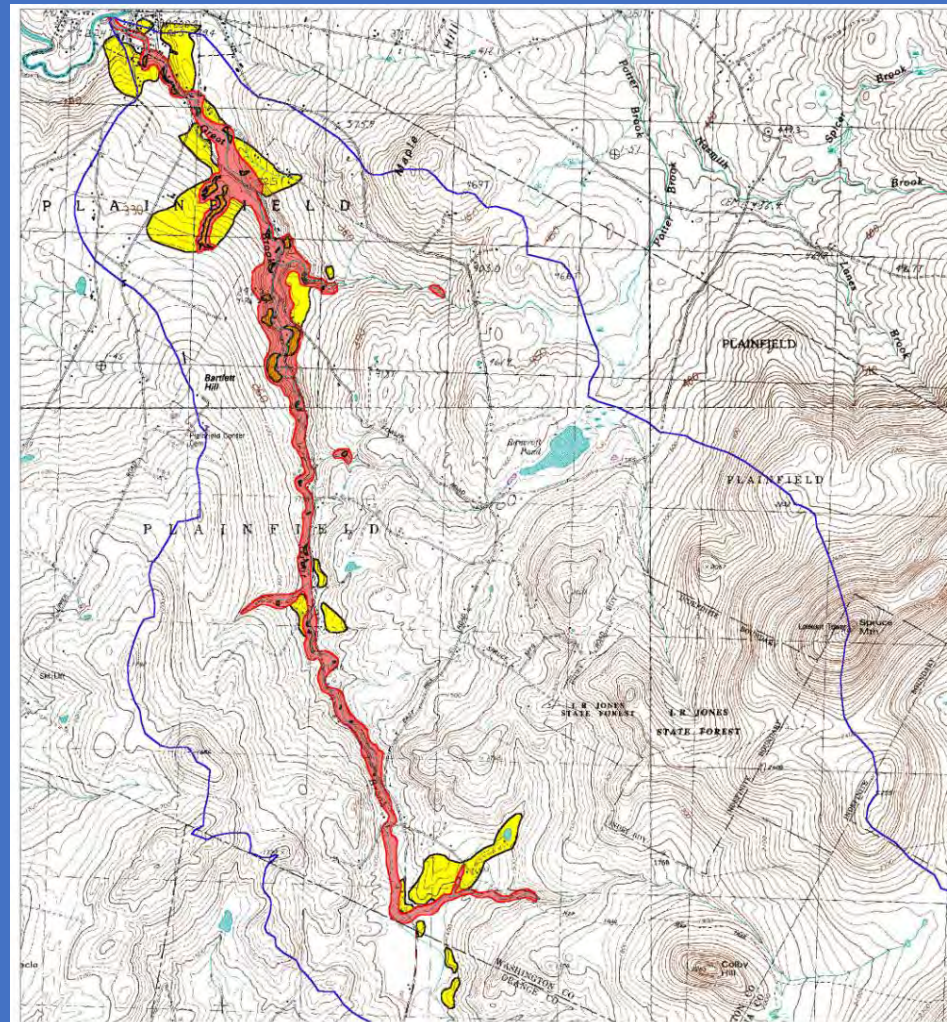
Below: Site of a house destroyed in the 1984 Flood. Note well casing still standing in center of photo.

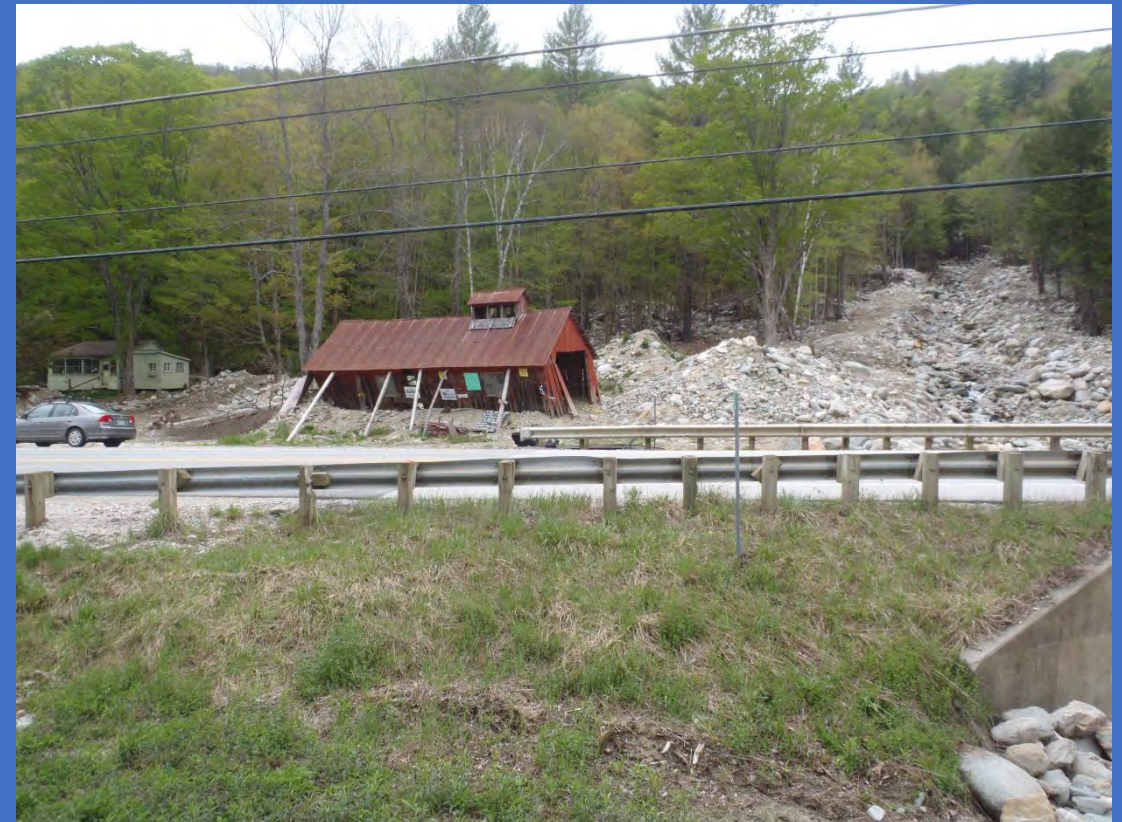
Top right: Boulders moved during flood.  
Lower right: Alluvial fan and Vt Route 100.

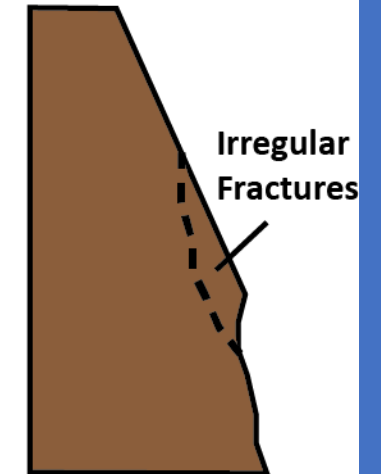
#### Stage 4A

Slope is destabilized by continued erosion at toe. Weathering of fresh material begins.

Processes: Undercutting of an existing landslide due to fluvial shear, followed by irregular block detachment.

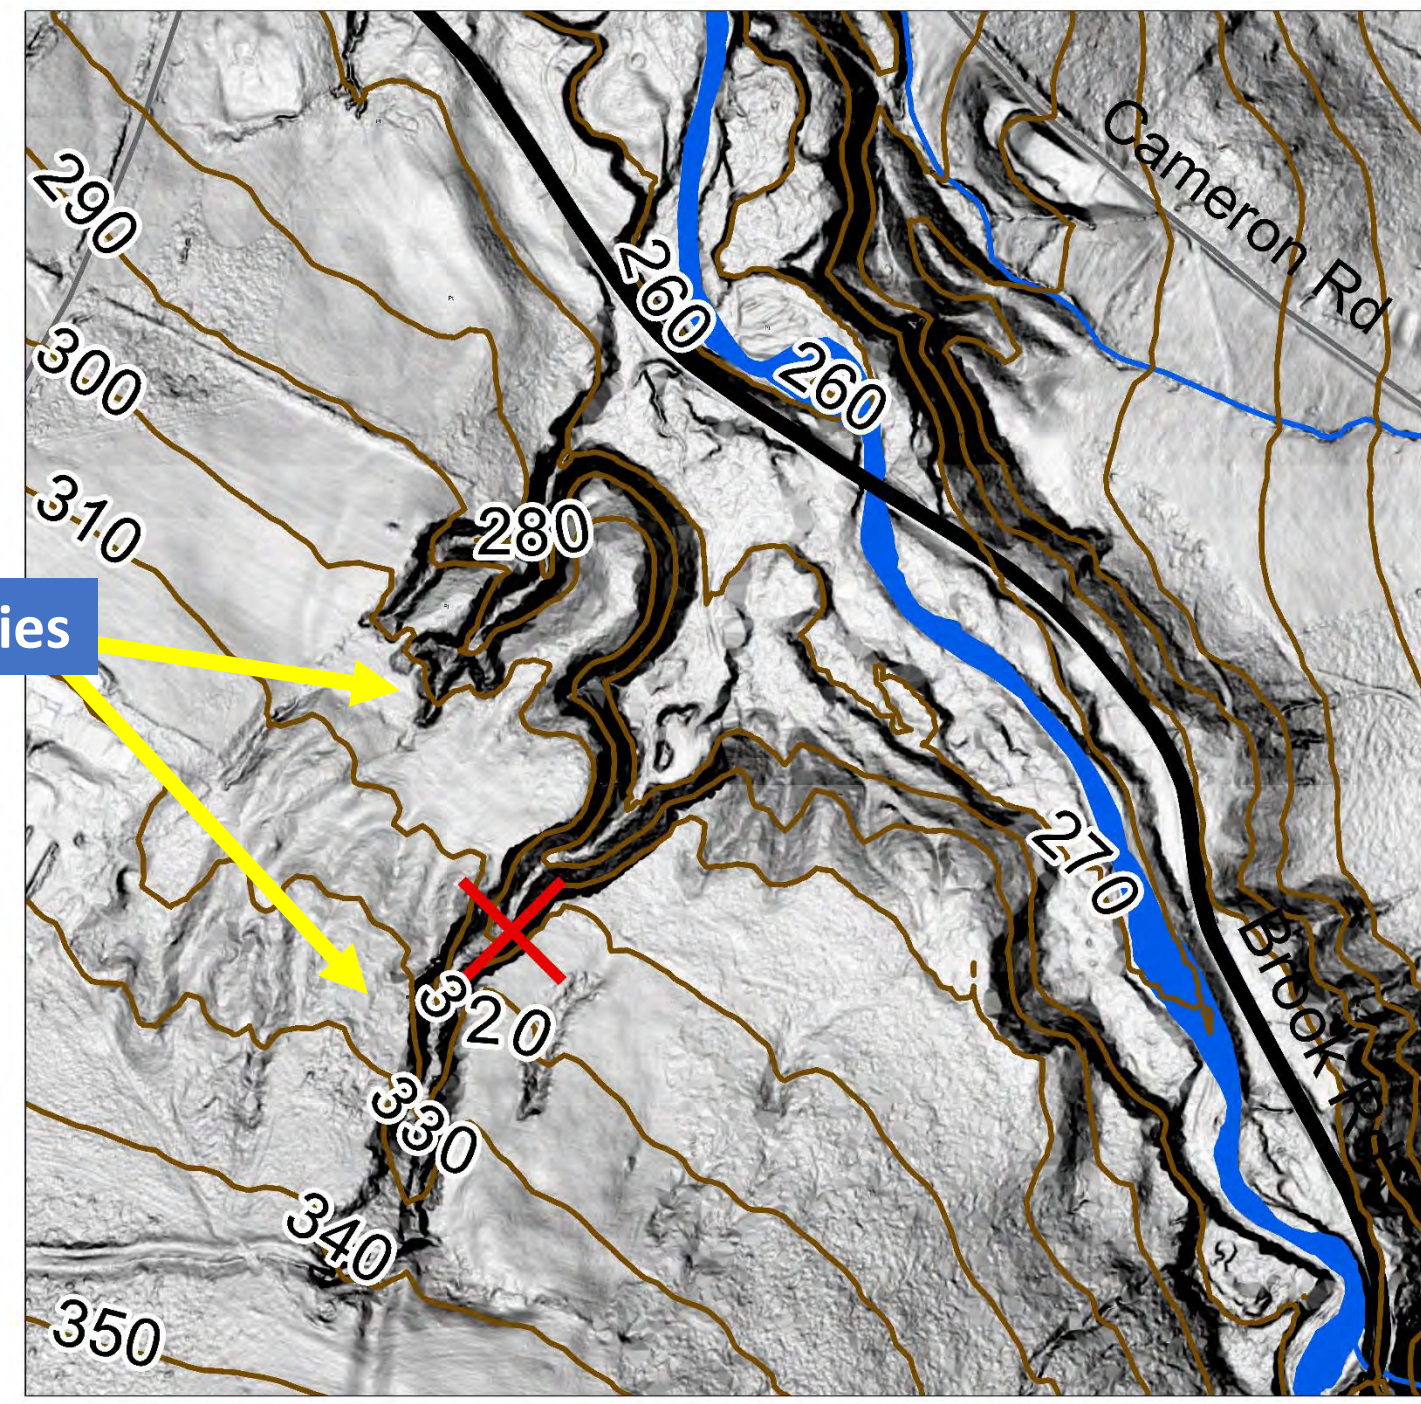
Large gullies in highly erodible sand and silt. These features have been reactivated by additional runoff from an agricultural drainage ditch. Site GB-1010.

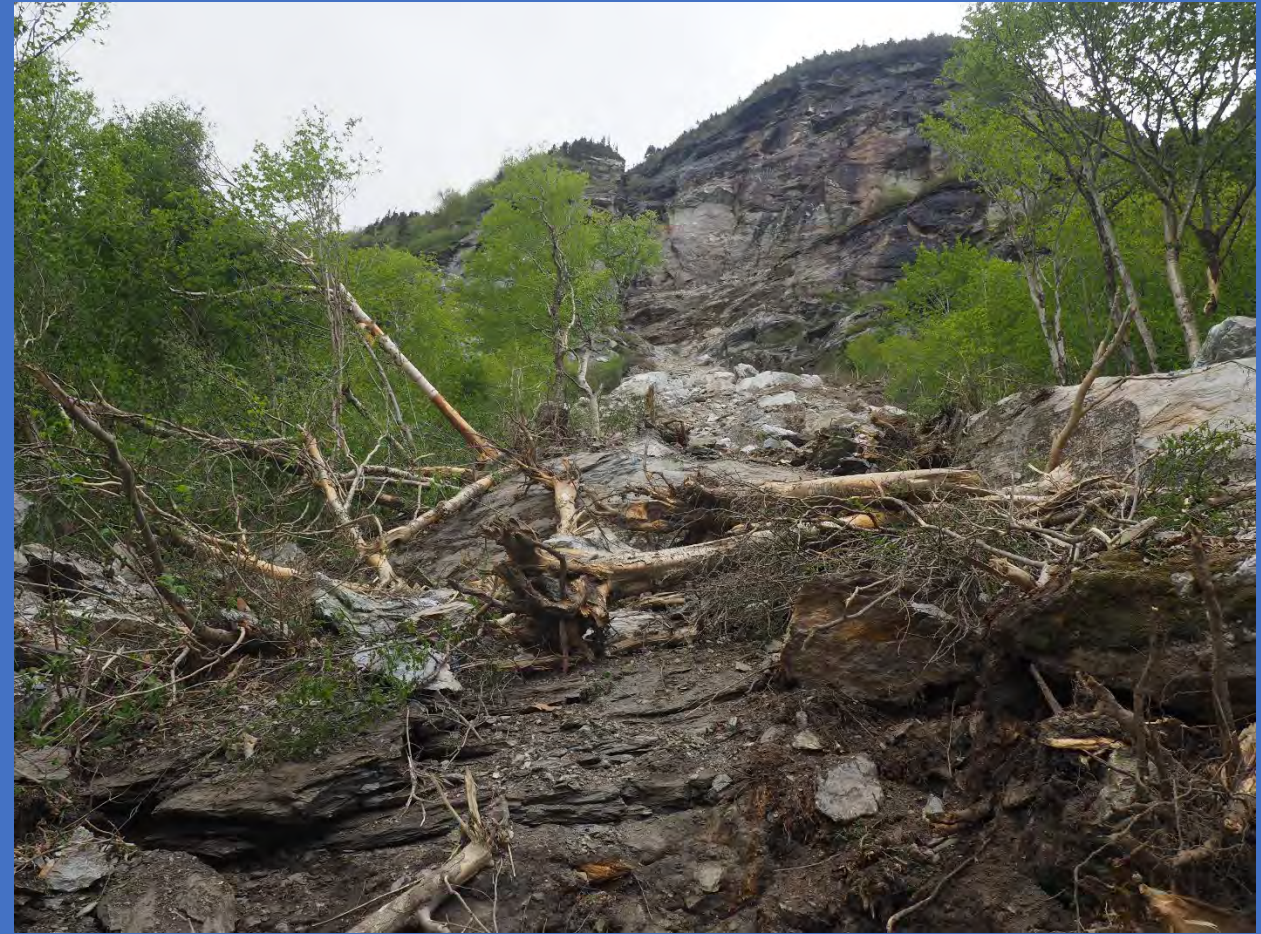
**Above: One of two boulders that reached Rt. 108 in Smugglers Notch, May 30 to June 1, 2020. Right: Source area of rock fall on cliff north of Cass's Gully.**

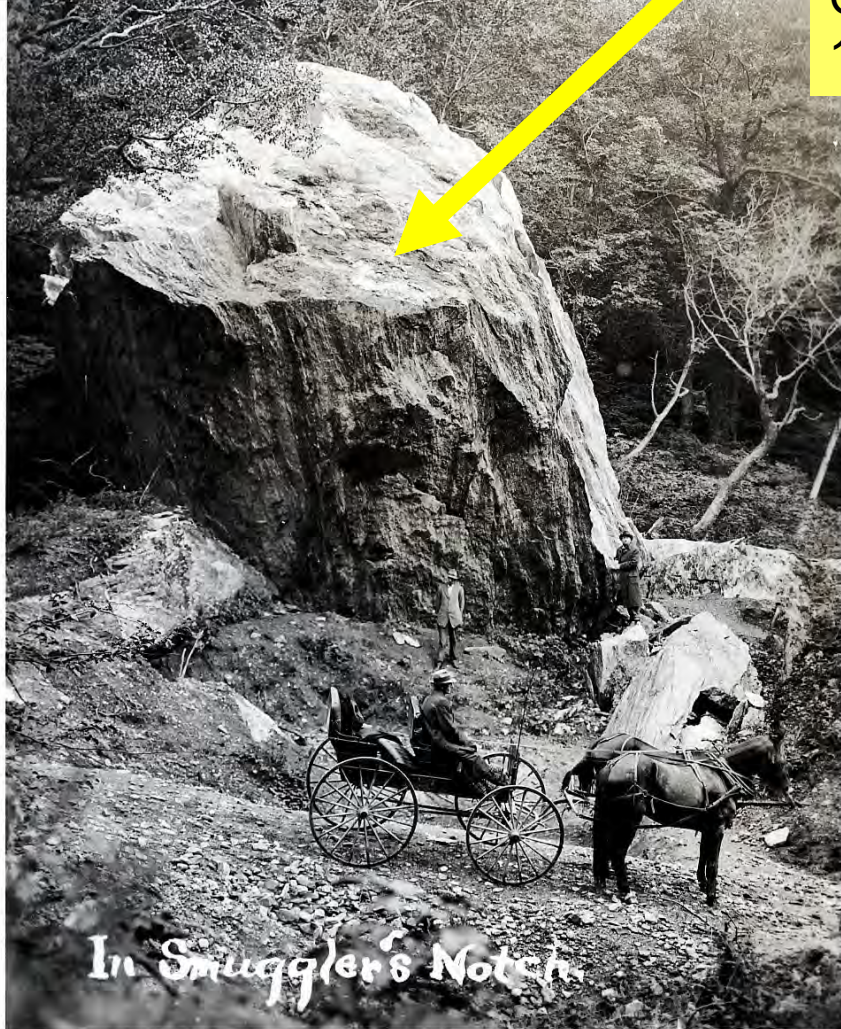
King Rock  
and the  
slide scar  
north of  
Cass's  
Gully in  
1911.

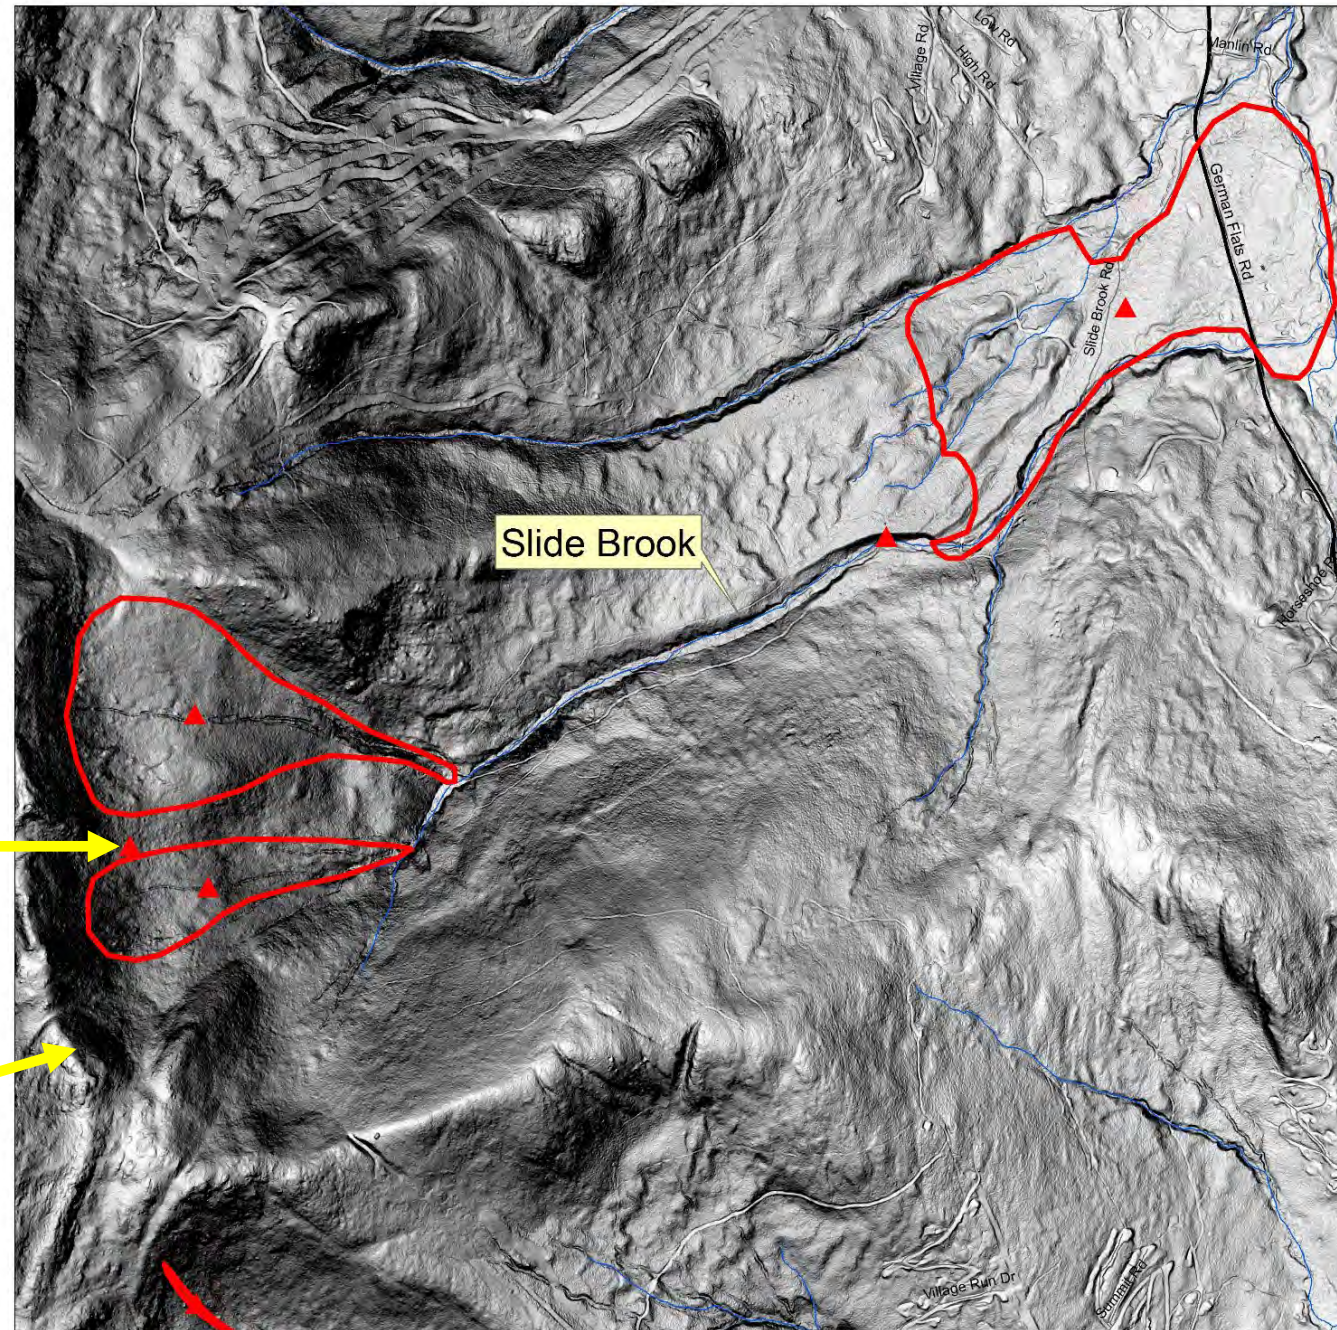
Lidar slope map of Slide Brook, Warren. Two red polygons on left delineate areas of earlier landslides. 2017 slide occurred in area between the polygons.
