# **Landslide Inventory of Chittenden County, Northwest Vermont**

## **Vermont Geological Survey Open File Report VG2018-6**

George Springston  
Norwich University Department of Earth and Environmental Sciences 108  
Harmon Drive  
Northfield, VT 05663  
802-485-2734  
gsprings@norwich.edu

June 30, 2018

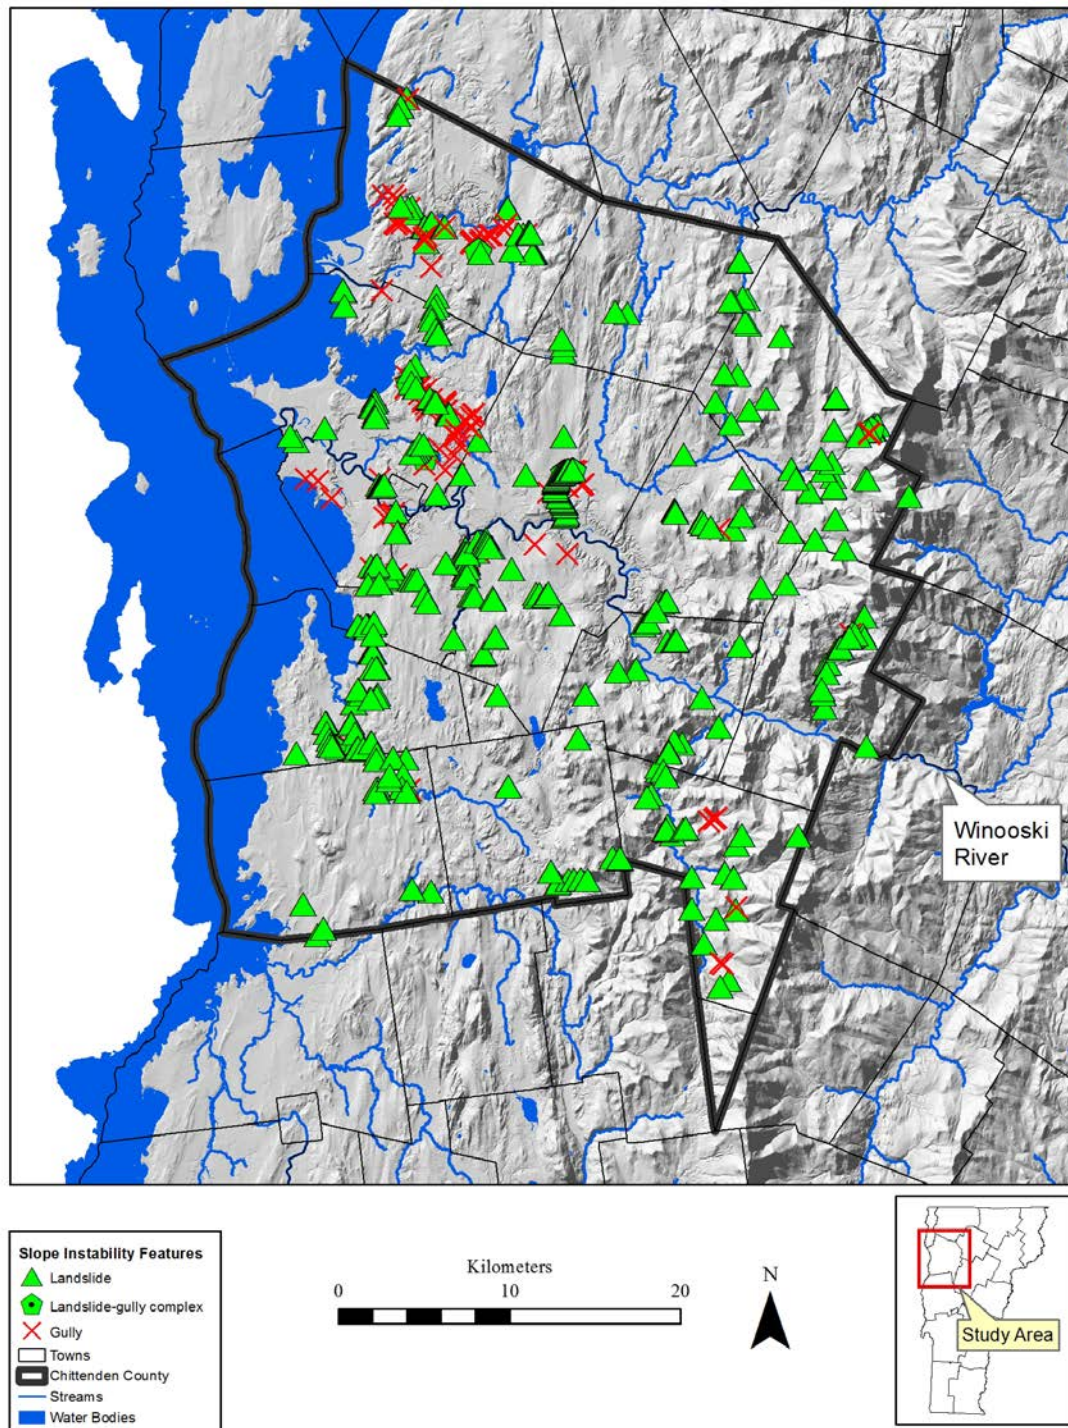
Figure 3. Generalized map of all slope instability hazard sites. This includes landslides, landslide-gully complexes, and gullies. These features are shown at a larger scale on Plate 1.

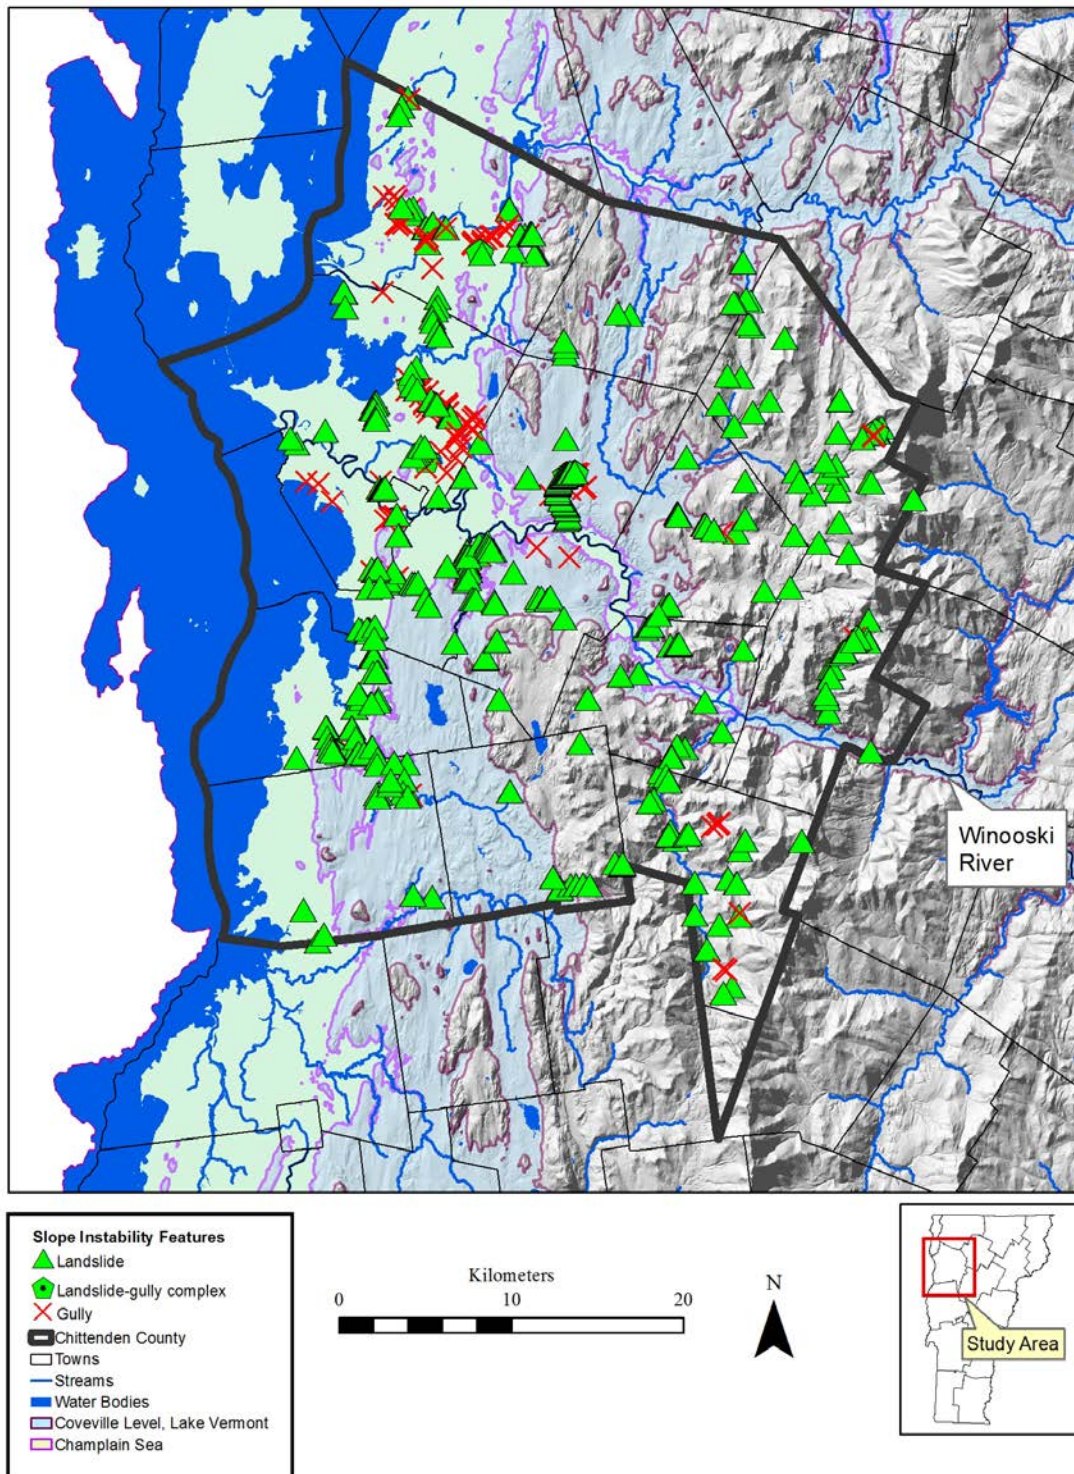
Figure 4. Slope instability hazard sites, shown along with approximate extents of the highest level of glacial Lake Vermont (Coveville level) and the Champlain Sea. Note that landslides occur throughout the County, but gullies are most concentrated within the extent of the Champlain Sea.

Unstable gullies are common in many parts of Chittenden County. As Figure 4 shows, they are most common at lower elevations within the extent of the Champlain Sea. Many of the actively eroding gullies in the County appear to be closely associated with stormwater runoff from developed areas. These developed areas are largely concentrated at low elevations in the western portions of the county which are also within the extent of the Champlain Sea. The sandy and silty components of the Champlain Sea deposits are highly erodible and thus, this combination of urbanization and soils that are susceptible to erosion may explain the abundance of gullying in these areas.

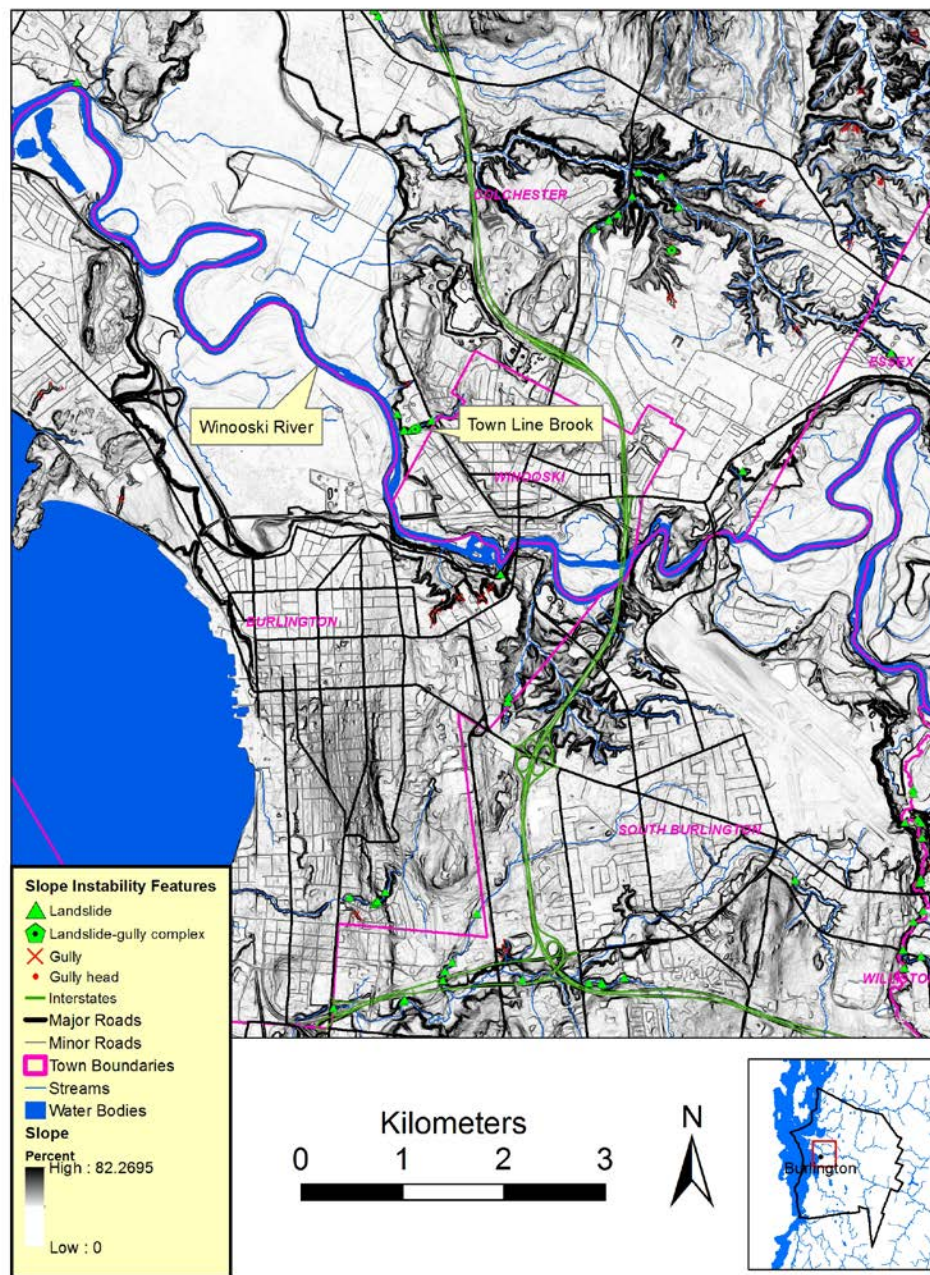
A landslide-gully complex located northwest of the Winooski/Colchester town line is discussed below (Figure 5). Here, a stream known as “Morehouse Brook” or “Town Line Brook” has cut a steep-sided gully into a terrace with a top elevation of about 55 meters (Figure 6). The floor of the gully is freshly incised and the banks are lined with active and currently inactive landslides (Figures 7, 8, and 9). The gully drains westward into the Winooski River.

During the 2006 visit we observed active headcuts in the floor of the gully. These indicate that the brook is actively lowering its bed (Figure 7). No bedrock was observed in the gully bottom or on the sides. The downcutting is the immediate cause of the slope failures on the gully sides. From the observed pattern of active and inactive slides, it appears that the active slides are migrating upstream in response to headcut migration. The erosion from the gully results in substantial sedimentation into the Winooski River (Figures 11 and 12).

The sides of this gully are in a very sensitive state due to the channel incision that is occurring. The cause of this incision is at least partly due to increased stormwater runoff due to urbanization in the upper parts of the gully watershed. Another cause may be a long-term pattern of aggradation and degradation in the Winooski River valley: An archaeological and geomorphological study of the Howe Farm site farther down in the Winooski valley indicates that significant aggradation occurred on the Winooski River floodplain during the nineteenth century (Thomas (1985). This was the same time period at which upland soil erosion due to land clearance was at its highest (Thomas, 1985; Bierman and others, 1997). The gully was probably undergoing active erosion during this time and may have graded itself to the new, higher, Winooski Valley floodplain. Following the peak of agricultural activity, the gully revegetated and at least partly stabilized. However, subsequent downcutting of the Winooski into its alluvium may be one cause for the incision that is active in the gully today.

Repeated measurements of landslide scarp retreat at the site reported in Bierman and others (1999) indicate episodic but active landsliding from 1995 to 1999. The 2006 site visit and recent lidar and orthophotos indicate that bank retreat has continued.

Figure 5. Slope instability features in Burlington, Winooski, and vicinity.

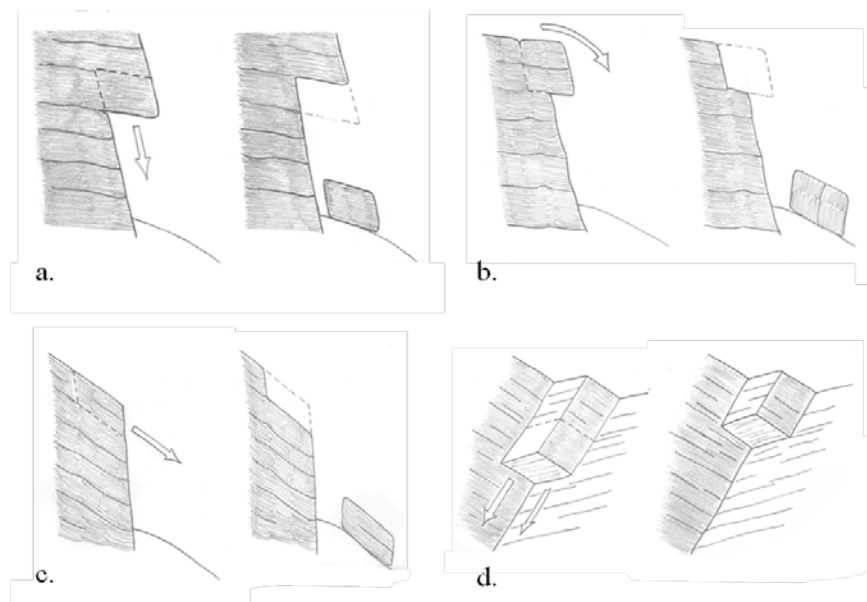
Figure 13. Types of rock slope failure encountered at Smugglers Notch. a) Rock fall. b) Rock topple. c) Rock slide. d) Wedge failure. Note that the rock slide fails by sliding down-dip on a single surface while the wedge fails by sliding on two surfaces and moves downward parallel to the intersection of the two surfaces.

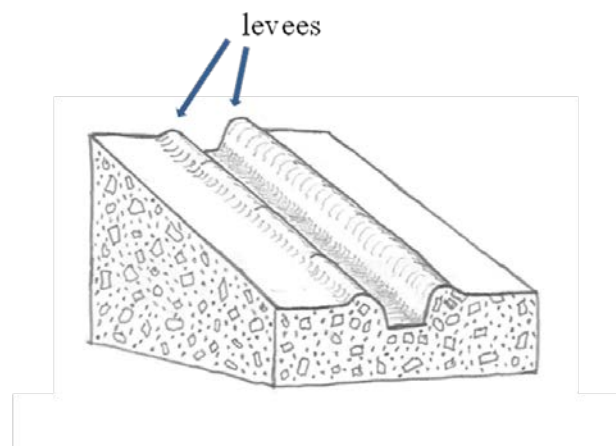
abundant evidence on the slopes that these flows shift locations over time in response to channel blockages and perhaps shifting patterns of rock fall. A block diagram illustrating the common Smugglers Notch debris flow morphology is shown in Figure 15. Upon reaching less steep terrain the debris flow can no longer transport all of the entrained material and the flow spreads out laterally, leaving behind a spatulate, steep-fronted terminal lobe or snout deposit composed of very poorly sorted bouldery, pebbly cobble gravel and woody debris. What little fine-grained material that was present in the flow has generally been washed further downstream. According to Costa (1998), the levees and steep-fronted terminal lobes are strong indications that these features should be classified as debris flow deposits rather than stream flow deposits. These features are characteristic of laminar rather than turbulent flow and are only formed by deposits that have very high sediment/water ratios. Such flows have been called *channelized debris flows* (VanDine, 1985.) The coarse-grained nature of the deposits here is also characteristic of such channelized debris flows (Cruden and Varnes, 1996; VanDine, 1985; Hungr and others, 2001.) As there appear to be no other types of debris flows here, we will call them simply debris flows.

Figure 15. Schematic block diagram of a section of a debris flow at Smugglers Notch. Note the levees on the margins of the channel. For ease of portrayal, these are shown as continuous features in the sketch, but they are actually discontinuous, at some locations being well-developed along both sides of the channel, at other locations only on one side, and at still others being absent altogether.
