Open File Report VG2021-2

Landslide Inventory of Caledonia County, Vermont

June 30, 2021

Prepared for
Vermont Geological Survey

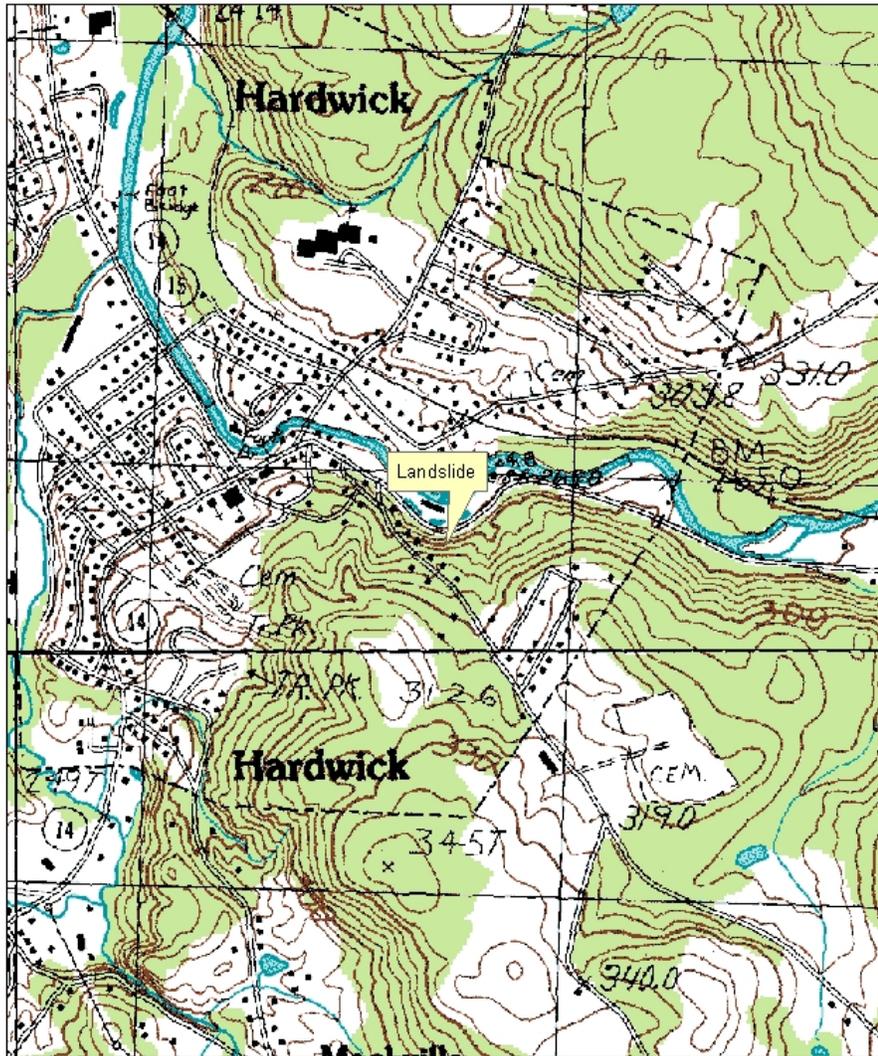
As an example of the type of damage that can result from even a moderate-sized landslide, the following case study is presented: In November of 2003 the Vermont Agency of Transportation (VTrans) alerted the VGS that a landslide was developing on the outer face of a high terrace above VT Route 15 in Hardwick (Figure 11). Site visits on November 10 and 21 revealed an area of active slope movement on a wooded slope south of the highway. Many of the trees on parts of this slope outside the present landslide had curving trunks, indicating at least some previous down-slope movement has occurred. The slope appears to be an ancient cut-bank formed by the Lamoille River, which presently is located to the north of the road. The area of sliding was about 400 feet long, about 105 feet high, and had an overall slope angle of 28 degrees. A general view of the slide as it was in November of 2003 is shown in Figure 12. Using the landslide classification of Cruden and Varnes (1996), this is an active, complex landslide consisting of several rotational earth slumps and a central earth flow. This flow can be seen in Figures 12 and

Figure 11. Map showing location of the Hardwick landslide. From U.S. Geological Survey Caspian Lake 7.5 minute quadrangle. Contour interval 6 meters.

Investigations showed that a large amount of fill had indeed been placed on the top of the slope. Scarps developed in this material are shown in Figures 17 and 18. Although the main failure surface was coated with a thin layer of silt and clay (Figure 19), scraping revealed that much of the slope was underlain by dense glacial till (Figure 20). Although the landslide was not immediately adjacent to the Lamoille River, a large quantity of fine-grained sediment from the slope failure was delivered to the river via culverts. VTrans subsequently undertook a major remediation project involving removal of fill that had been placed on the upper part of the slope, installation of soil drains, and an engineered buttress at the base of the slope. The slope is currently believed to be stable.

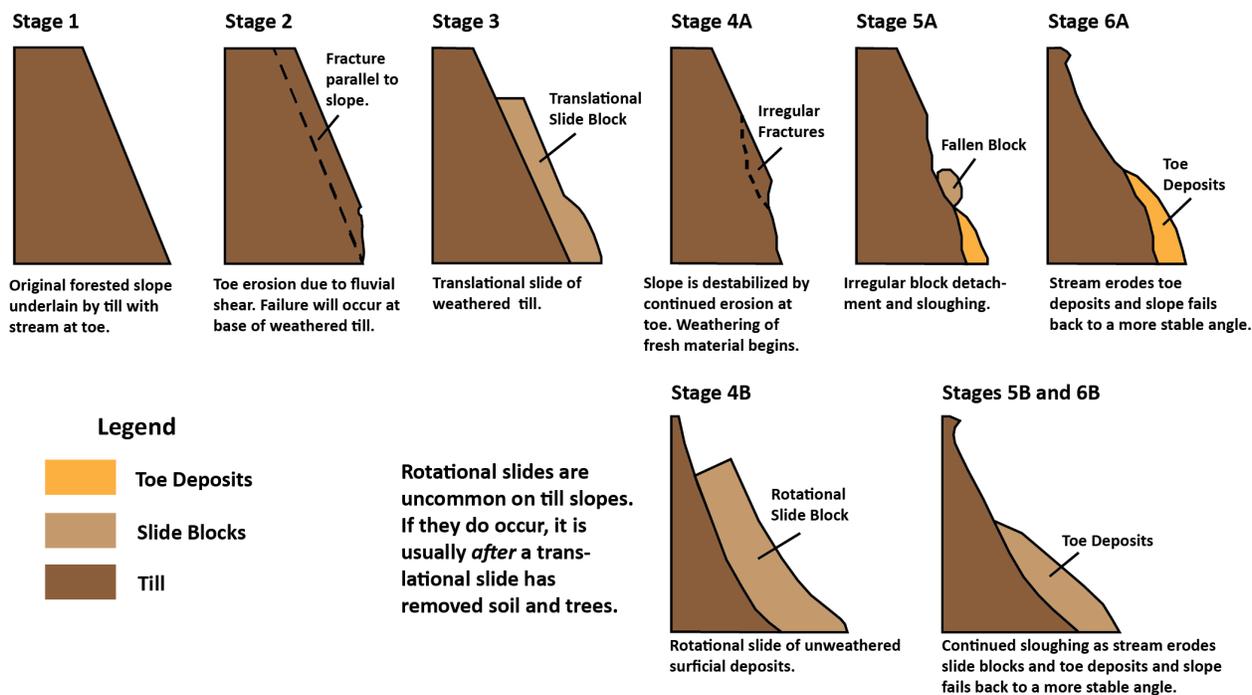
Many of the landslides in Caledonia County originate in glacial till deposits. A typical landslide in till is shown in Figure 22. Observations of the landslides here and elsewhere in Vermont suggest the following as a common sequence of events on till-dominated slopes in response to catastrophic flood events (Springston and Thomas, 2018). Note that the events described below will not always take place in a sequence of discrete steps. For example, a translational slide on the upper part of a landslide may be occurring at the same time that the base is being undercut by flood waters. The model is illustrated in Figure 24.

- Fluvial shear results in erosion of the bank and/or bed, over-steepening the slope and, if bed erosion occurs, increasing the effective height of the slope (Figure 23). Dense till and lacustrine diamict typically are detached as irregular blocks. Loose materials typically are detached as single grains. At sites where the material is very strong, the stream may undercut the bank, leaving an overhang. Infiltration of rainfall results in an increase in pore-pressure in the surficial material, reducing the effective shear strength of the material.

Figure 24. Model for landslides on till slopes originally developed in Springston and Thomas (2018). The initial stages of failure of a wooded streambank by a translational failure are shown in Stages 1 to 3. Stages 4A to 6A show the continued failure of the slope by the detachment of irregular blocks of till. Stages 4B to 6B show an alternate style of rotational failure in till that may occur after heavy stream erosion.

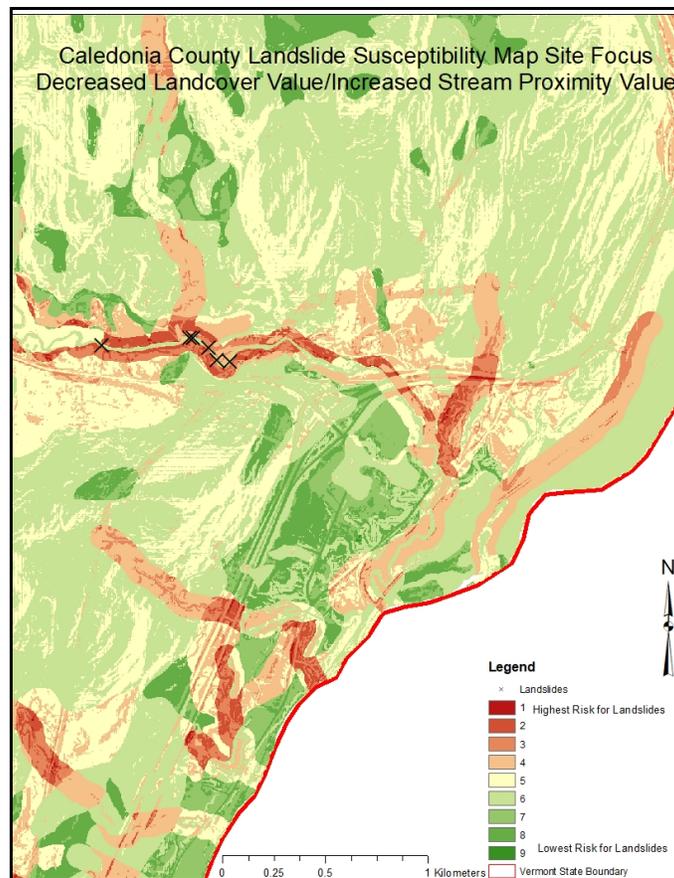
This inventory of slopes that are presently unstable can be the basis for producing a model of potentially unstable slopes within the county. An important step toward this was made by Carlson (2021) who produced GIS models of potentially unstable slopes in the study area. Carlson worked on a Senior project at Norwich University (mentored by the present author and Dr. John Gartner) to analyze a variety of landslide characteristics and environmental variables for known landslides in eastern Vermont (808 sites) and then used the results to develop weighted overlay models in GIS for Caledonia County. The final variables chosen by Carlson were proximity to streams, slope, presence of highly erodible soils, distribution of bedrock outcrops, and land cover. The resulting maps show a good correlation between known landslides and the areas predicted to be unstable (Figure 25). The new data produced during this Caledonia County inventory can now be added to that available to Carlson and will be used to create a refined landslide susceptibility map that should result in even better agreement between the model and reality.

Figure 25. Portion of final landslide susceptibility map from Carlson (2021). Red areas have highest susceptibility and green areas have lowest. Black X symbols indicate known landslides.
