# Advanced Illicit Discharge Investigations in the Lamoille River, Otter Creek, and Poultney River Basins: Final Report

15-090

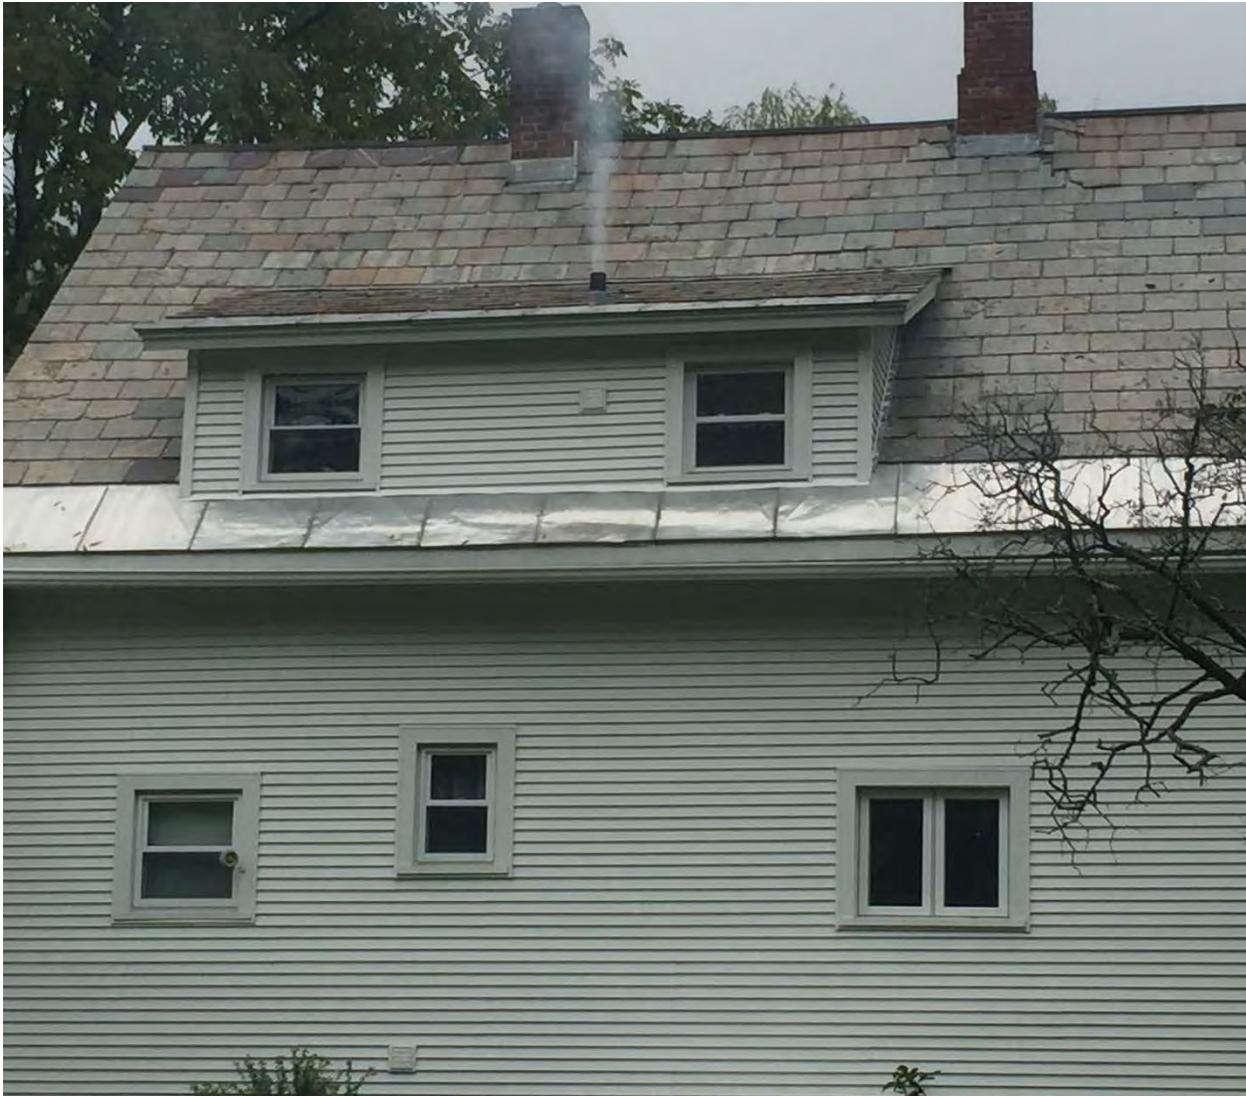
*Cover photo:  
Smoke testing of a  
stormdrain in  
Proctor revealed a  
sanitary  
wastewater  
connection from  
this house (note  
smoking sewer  
vent)*
