Detecting and Eliminating Illicit Discharges in Basin 10: Final Report

16-179

David Braun / Senior Water Resources Scientist
Stone Environmental, Inc.
535 Stone Cutters Way
Montpelier, VT 05602
dbraun@stone-env.com
802.229.5379

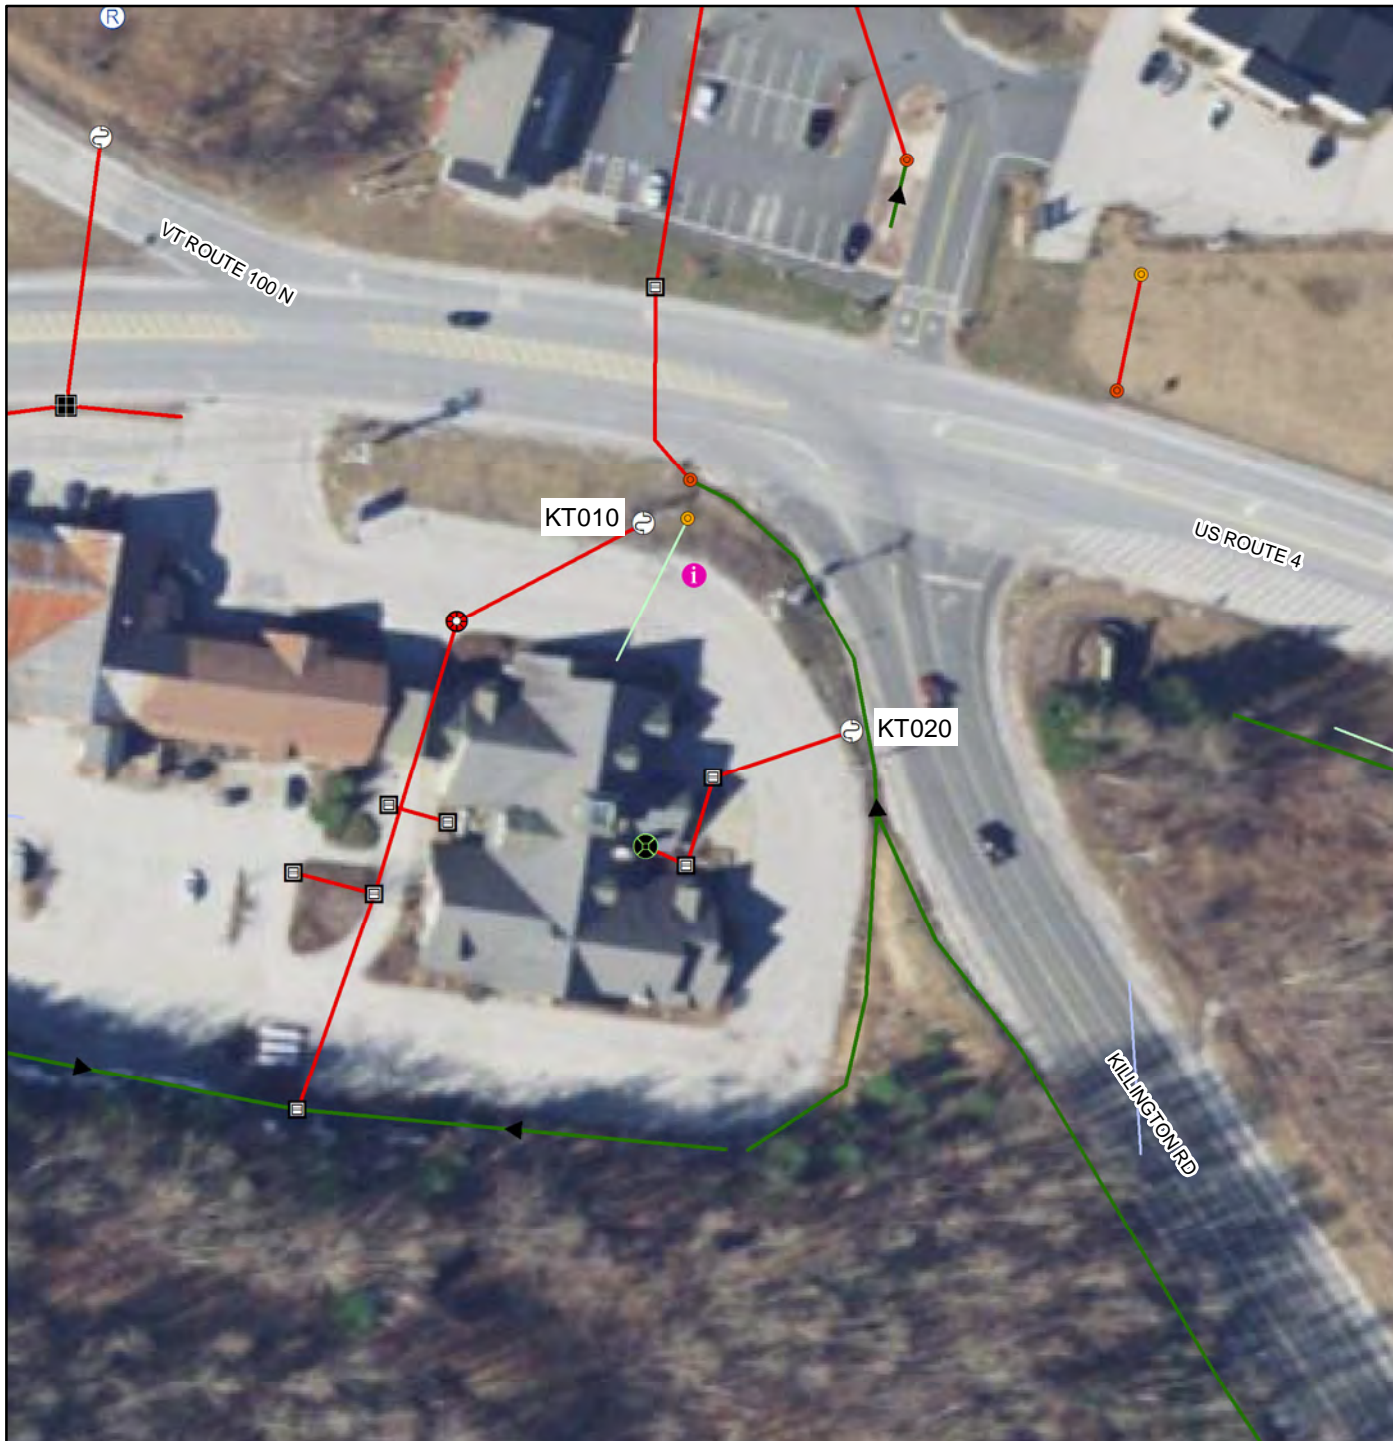
Structure ID	Date	Flow Condition	Ammonia (mg/L)	Free Chlorine (mg/L)	Raw / Corrected MBAS (mg/L)	Specific Conductance ($\mu\text{S}/\text{cm}$)	OB Result	Observations
KT020	7/07/17	Trickling	0.3	0.53	0.75/ 0.14	8,790	Neg	Clear, no odor. Algae at outlet.
KT020-CB1	5/31/18	Wet/no flow	0.0	0.09	0.75/ 0.00	12,360	NA	Clear, no odor. Algae at outlet.
KT020-CB1	7/13/18	Wet/no flow	0.0	0.06	0.75/ 0.49	3,790	NA	Clear, no odor. Algae at outlet.

Conclusion: Exceedingly high specific conductance measured in this and several other systems in Killington likely results from a history of heavy road salt application in the vicinity of the system. We have found that MBAS concentration has a positive linear correlation with specific conductance (which is a function of dissolved solids content) due to chemical interference. Also, field tests for ammonia and free chlorine can be unreliable at exceedingly high specific conductance, though these correlations are less consistent than the MBAS – specific conductance correlation. We conclude that road salt application resulted in exceedingly high specific conductance and estimated chloride concentrations as high as 4,000 mg/L.

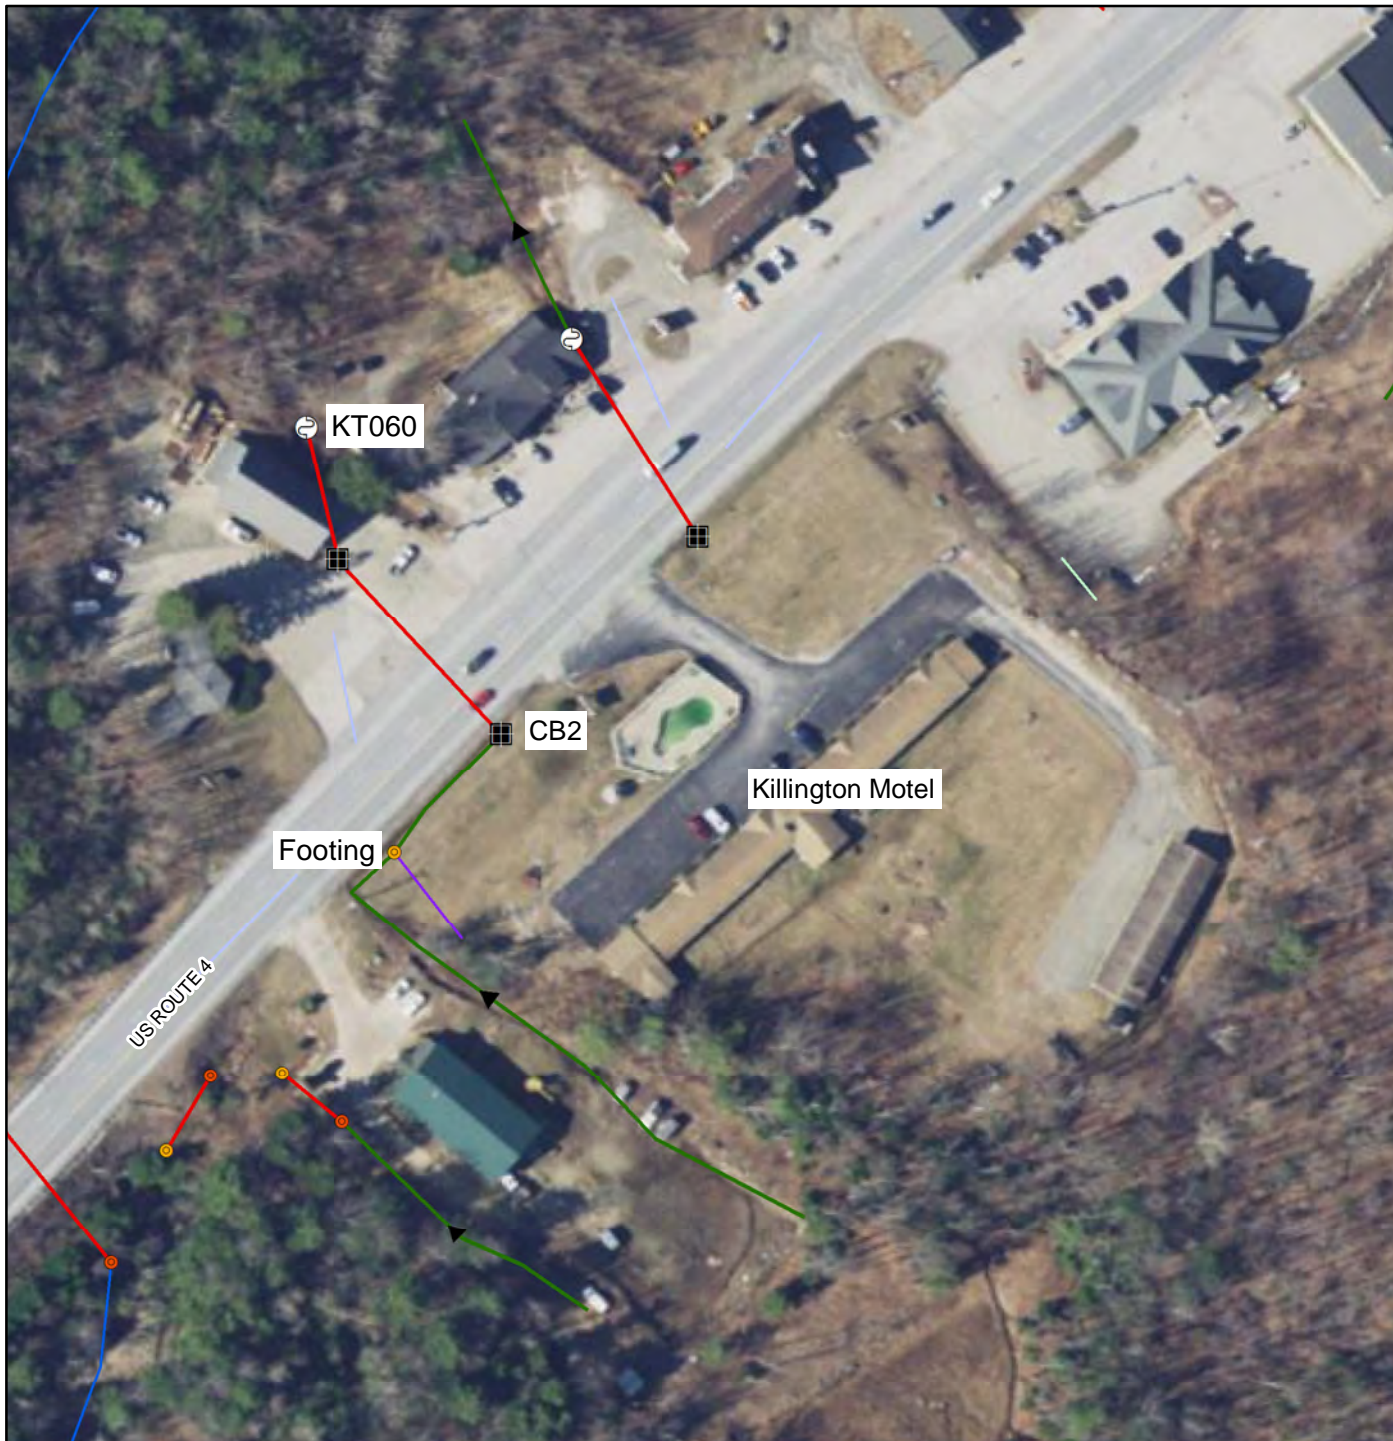
Map #2
Killington, Vermont

Structure ID	Date	Flow Condition	Ammonia (mg/L)	Free Chlorine (mg/L)	MBAS (mg/L)	Sp. Cond. (µS/cm)	OB Result	Observations
KT060	7/07/17	Trickling	0.0	0.22	0.18	387	Negative	Clear, no odor
KT060	5/31/18	Wet/no flow	0.0	0.17	0.10	600	NA	Turbid, no odor
KT060- footing drain	7/13/18	Wet/no flow	NA	0.00	NA	447	NA	Iron staining
KT060	10/5/18	Wet/no flow	NA	0.02	NA	511	NA	Turbid, no odor

- Stone revisited the system on July 13, 2018. A drainage swale was found dripping into catchbasin CB2, and all the flow from the swale was from a footing drain near the Killington Motel. There was significant iron staining and iron floc around this drain outlet (Figure 2). A low concentration of free chlorine (0.11 mg/L) was detected in a sample from the footing drain; however, there was a significant amount of iron floc in the sample. After carefully decanting the sample into a cuvette to ensure no iron floc was present, zero free chlorine was detected.

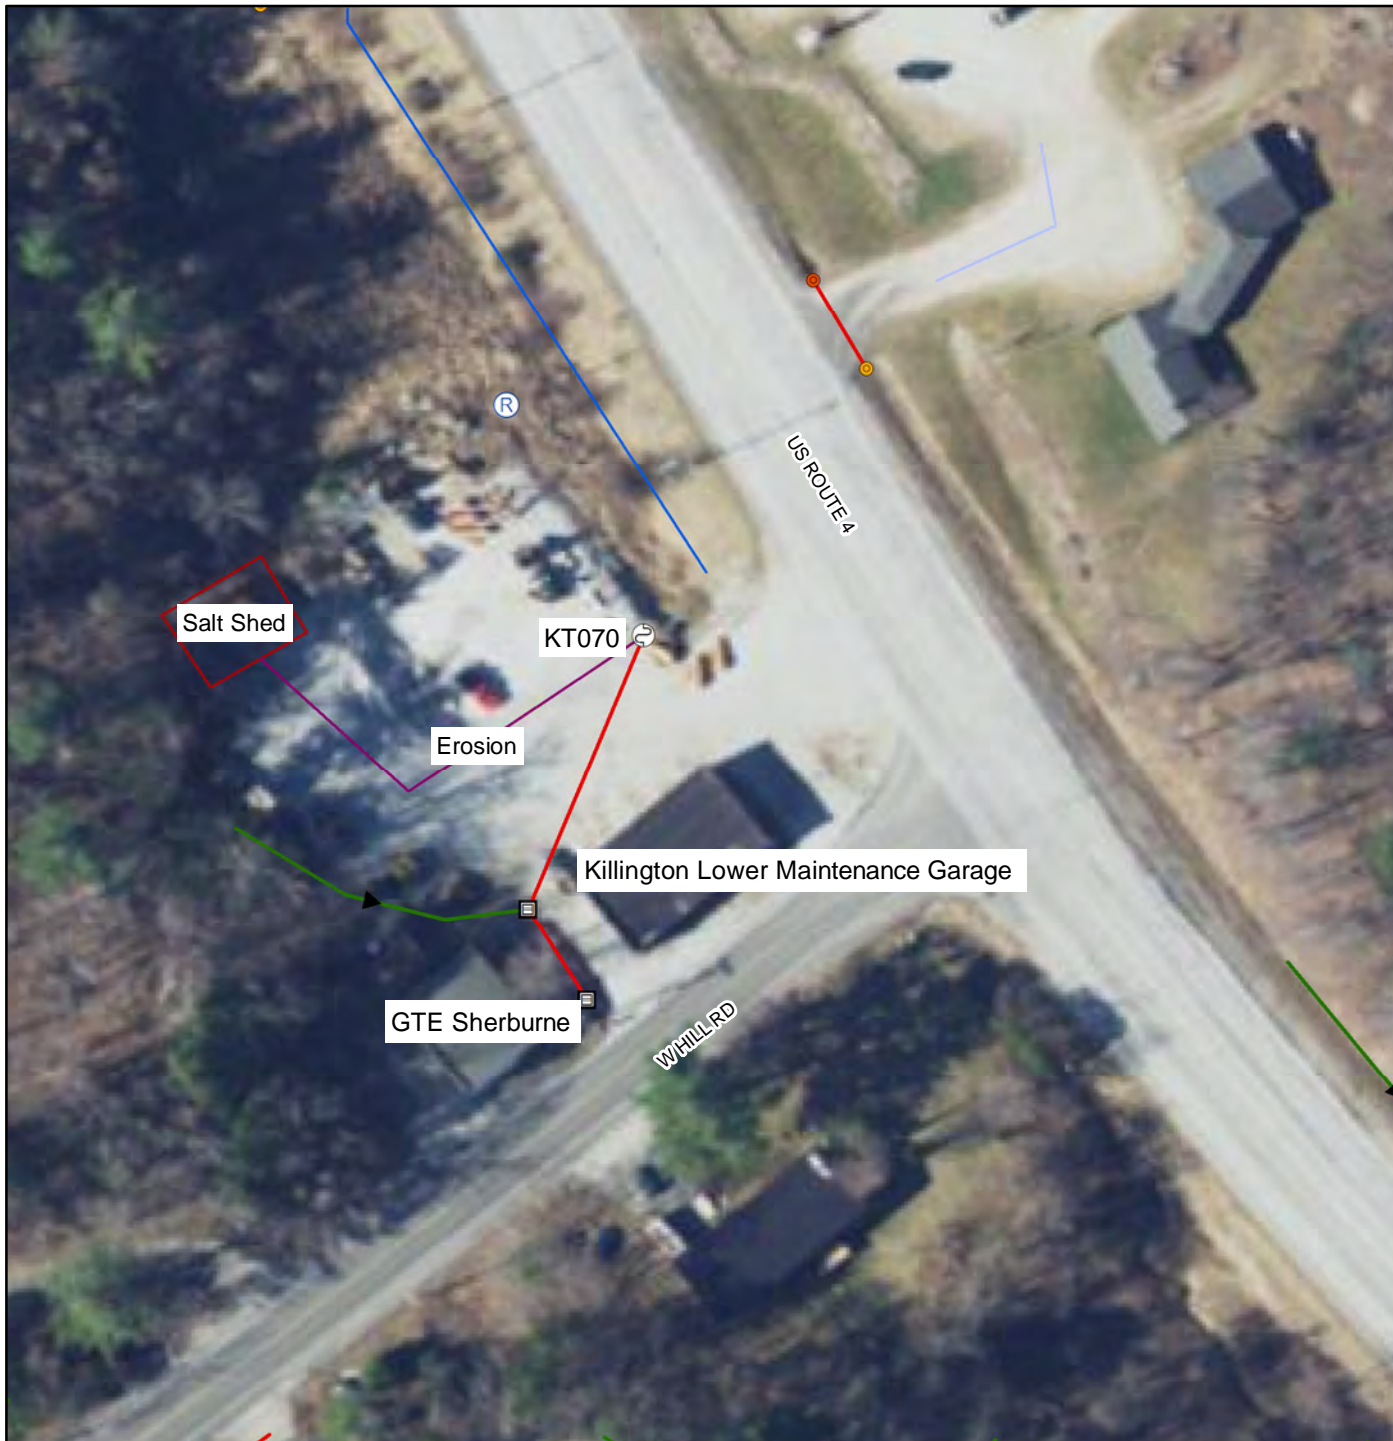
Structure ID	Date	Flow Condition	Ammonia (mg/L)	Free Chlorine (mg/L)	Raw / Corrected MBAS (mg/L)	Specific Conductance ($\mu\text{S}/\text{cm}$)	OB Result	Observations
KT070	7/07/17	Flowing	0.15	0.13	0.20/ 0.08	1,823	Negative	No odor, iron floc
KT070	5/31/18	Trickling	0.0	0.06	0.25/ 0.04	3,120	NA	Iron staining
KT070	7/13/18	Trickling	0.0	0.13	NA	3,700	NA	Iron staining

- A low concentration of free chlorine (0.13 mg/L), and high specific conductance (1,823 $\mu\text{S}/\text{cm}$) were measured at the outfall on July 7, 2017. An estimated chloride concentration of 450 mg/L was calculated based on the specific conductance.
- The system was reassessed on May 31, 2018. The outfall was trickling, and significant iron staining was noted. Low concentrations of free chlorine (0.06 mg/L) and MBAS (0.25 mg/L) and exceedingly high specific conductance (3,120 $\mu\text{S}/\text{cm}$) were measured; the MBAS concentration was detection when corrected for high specific conductance.
- When the system was revisited on July 13, 2018, the outfall trickling and significant iron staining was present at the outfall and upstream in the swale. All catchbasins in the system were dry. A low

- There is a salt shed at the northeast corner of the property and a small gully between the shed and the top of the outfall (Figure 3). The parking lot appeared to have dried salt across the area.
- Based on review of the VT ANR Environmental Research Tool, this property and the abutting property to the east are both listed hazardous waste sites. At the Killington Lower Maintenance Garage (SMS #95-1905), there was an historic gasoline UST release that resulted in contamination to groundwater. At GTE Sherburne (SMS#93-1516) a diesel UST was removed in 1993 and petroleum contaminated soil was discovered in the UST grave.

Conclusion: We believe the water quality data recorded at the outfall are explained by a history of heavy road salt application in the vicinity as well as runoff from the salt shed on the property. The extensive iron staining throughout the swale is consistent with contamination by degraded petroleum products, likely the result of known releases from fuel oil USTs on the property and from an abutting property.

Resolution: By this report, the problem is referred to the DEC Hazardous Waste Management Section. While we are unable to provide specific guidance on the application of deicing agents by the town, or any private entities, reducing application rates should over time result in decreased chloride concentrations and lower specific conductance.

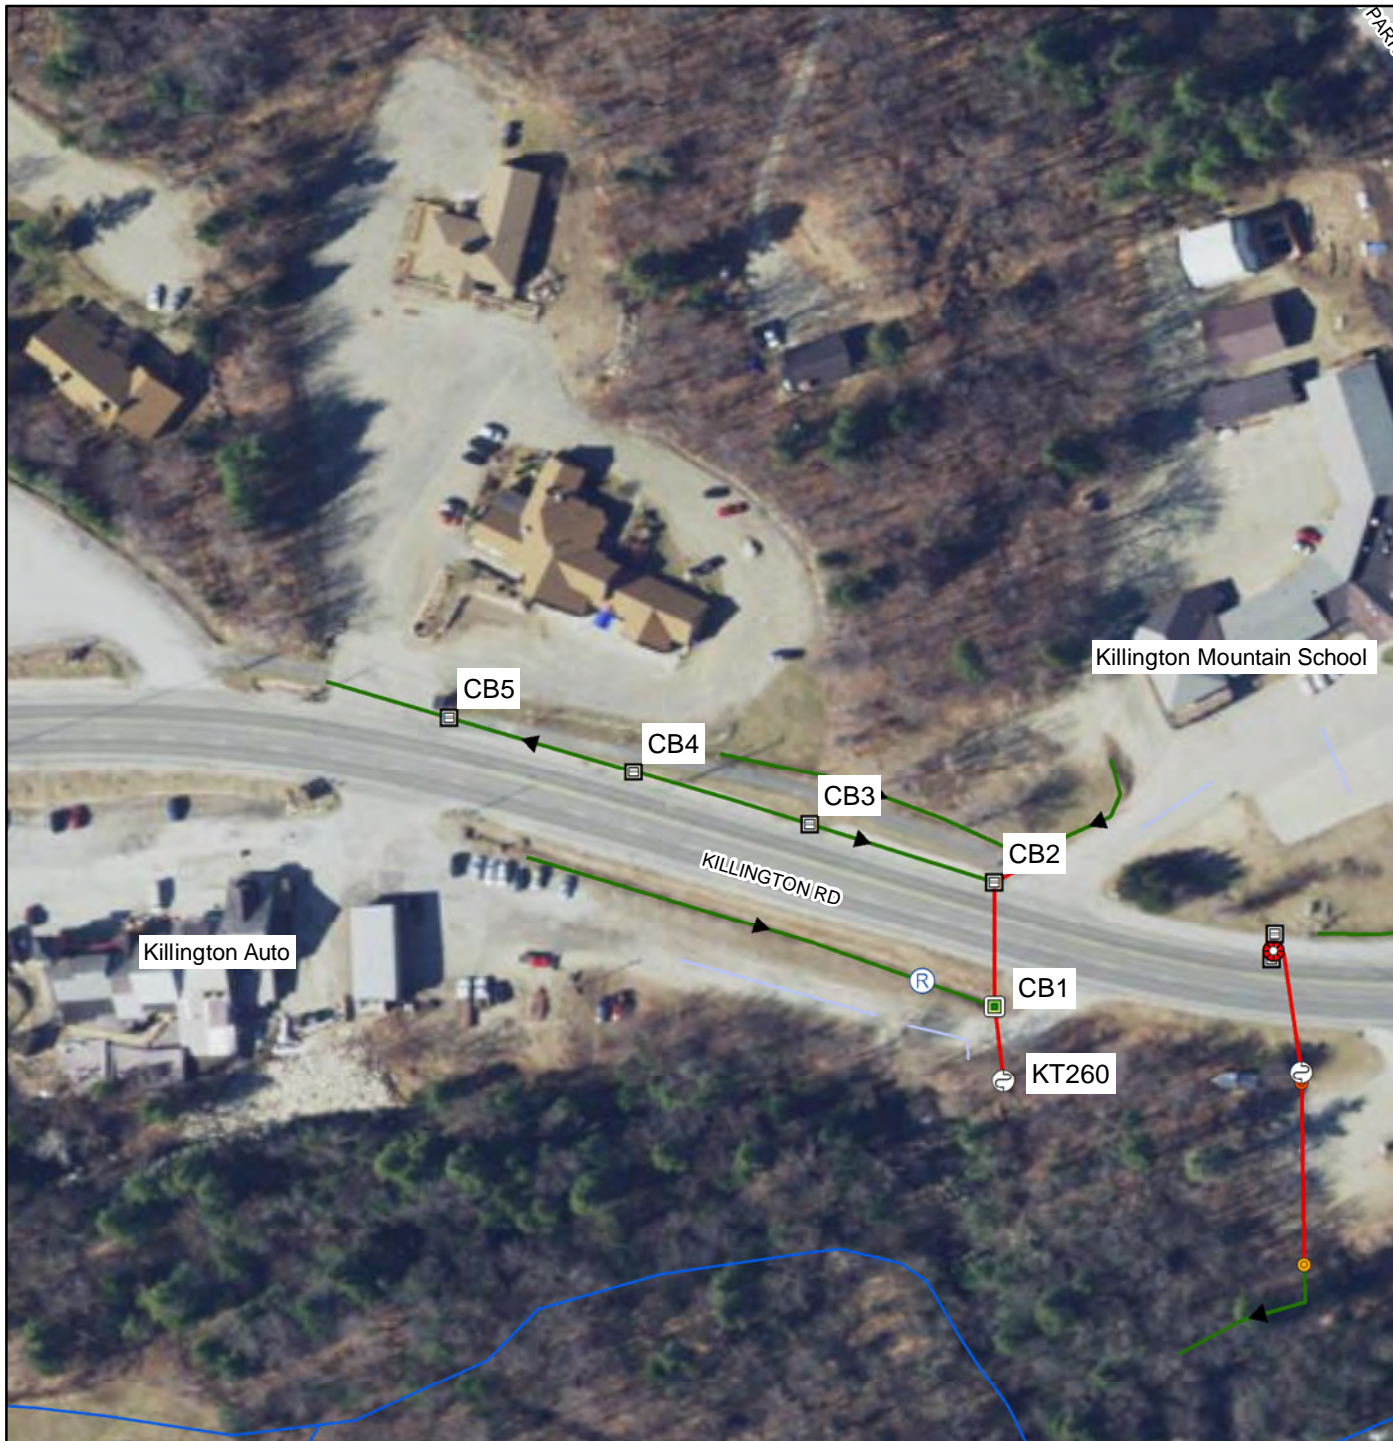
Structure ID	Date	Flow Condition	Ammonia (mg/L)	Free Chlorine (mg/L)	Raw / Corrected MBAS (mg/L)	Specific Conductance ($\mu\text{S}/\text{cm}$)	OB Result	Observations
KT260	7/26/17	Flowing	0.30	0.01	0.25/ 0.05	2,850	Negative	Clear, no odor
KT260	5/31/18	Dripping	0.10	0.04	0.25/ 0.00	3,700	NA	Iron staining
KT260	7/13/18	Flowing	0.15	0.03	0.50/ 0.28	3,200	NA	Iron staining
KT260	10/5/18	Flowing	0.10	0.02	0.25/ 0.03	3,220	NA	Clear, no odor

- A low concentration of ammonia (0.30 mg/L), and high specific conductance (2,850 $\mu\text{S}/\text{cm}$) were measured at the outfall on July 26, 2017. A low concentration of MBAS (0.25 mg/L) was also measured, but this concentration is significantly lower (0.05 mg/L) when corrected for high specific conductance. An estimated chloride concentration of 796 mg/L was calculated based on specific conductance.
- When the system was revisited on May 31, 2018, exceedingly high specific conductance (3,700 $\mu\text{S}/\text{cm}$) was observed. An estimated chloride concentration of 1,083 mg/L was calculated based on specific conductance.

- There was no flow from the swale by the entrance to the Killington Mountain School and no flow in either of the stormwater swales to the north of Killington Road. The sumps of catchbasins throughout the system were tested and moderate specific conductance was noted (ranging from 694 to 822 $\mu\text{S}/\text{cm}$).

- The system was revisited on October 5, 2018 and exceedingly high specific conductance (3,220 $\mu\text{S}/\text{cm}$) was observed. An estimated chloride concentration of 912 mg/L was calculated based on specific conductance.
