Detecting and Eliminating Illicit Discharges in Basin 11

18-027

Detecting and Eliminating Illicit Discharges in the West-Williams-Saxtons-Lower Connecticut River Basin: Final Report

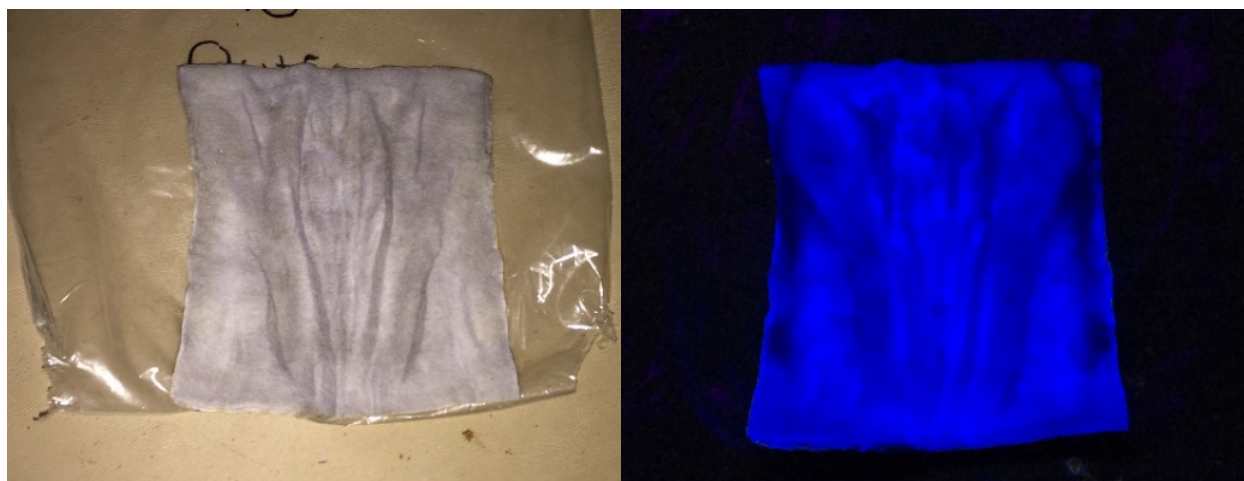
Optical brightener monitoring was performed at outfalls and selected catchbasins and manholes that were flowing at the time of inspection, in accordance with Stone Environmental SOP SEI-5.52.2 (Appendix A). To test for optical brightener, a cotton pad was placed in the flow stream for a period of 4–10 days, after which the pad was rinsed, dried, and viewed under a long-wave ultraviolet light (“black light”). Florescence of the pad (see example in Figure 1) indicates the presence of optical brightener. Pads were held in a sleeve of fiberglass window screen, affixed to the rim of the outfall pipe or secured with fishing line to a rock or other anchor. At catchbasins and manholes located at junctions in the storm sewer, pads were deployed in incoming pipes if possible, but were often hung from the catchbasin grate or manhole rung into the sump. An advantage of optical brightener monitoring is that some intermittent or dilute wastewater discharges can be detected due to the multiple-day exposure of the pad, whereas the contaminant may not be detected in tests performed on grab samples.

Figure 1. Positive optical brightener monitoring pad under fluorescent (left) and UV (right) lamps.
