Detecting and Eliminating Illicit Discharges in Basins 1 and 12

18-151

Detecting and Eliminating Illicit Discharges in Basin 1 and Basin 12: Final Report

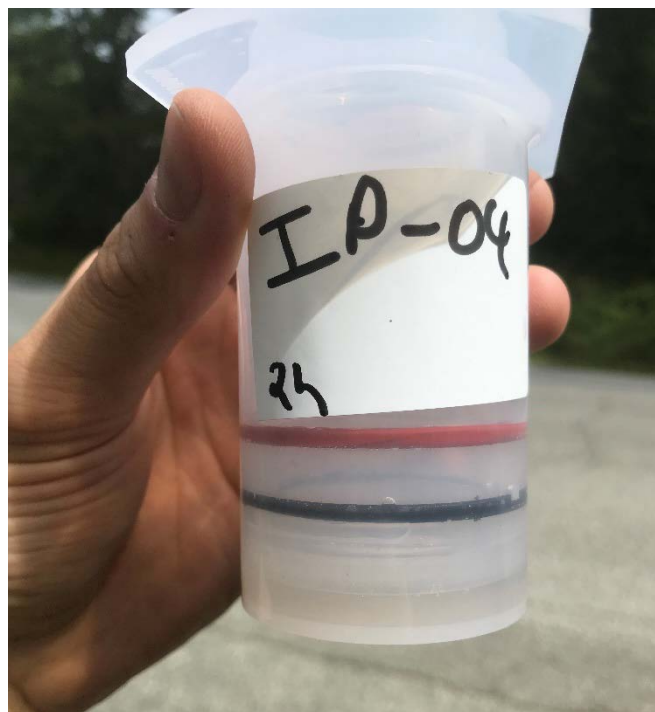
E. coli was assessed at each stream location by one of two methods. An in-field *E. coli* detection method, Mobile Water Kit 2.0, was used at half the sites (Figure 2). The Mobile Water Kit 2.0 method involves adding a sample to a 100-mL vial containing a prepared hydrogel solution, filtering the sample by depressing a plunger with a built-in filter into the vial, discarding the filtrate, holding the residual under ambient conditions, and observing any color change approximately hourly for 4-6 hours. A violet or pink color indicates presence of *E. coli* and the intensity of the color is proportional to the *E. coli* concentration.

We observed no positive tests using the Mobile Water Kit 2.0 method. Due to our concern about the potential inaccuracy of this method in this application, water samples collected at the remaining sites were submitted to VAEL for *E. coli* analysis using Standard Methods 9223B Colilert Quanti-tray.

Figure 2. Mobile Water Kit 2.0 test, Ellis Brook, Dover, VT
