Illicit Discharge Detection and Elimination in Brattleboro

FINAL REPORT

January 9, 2012

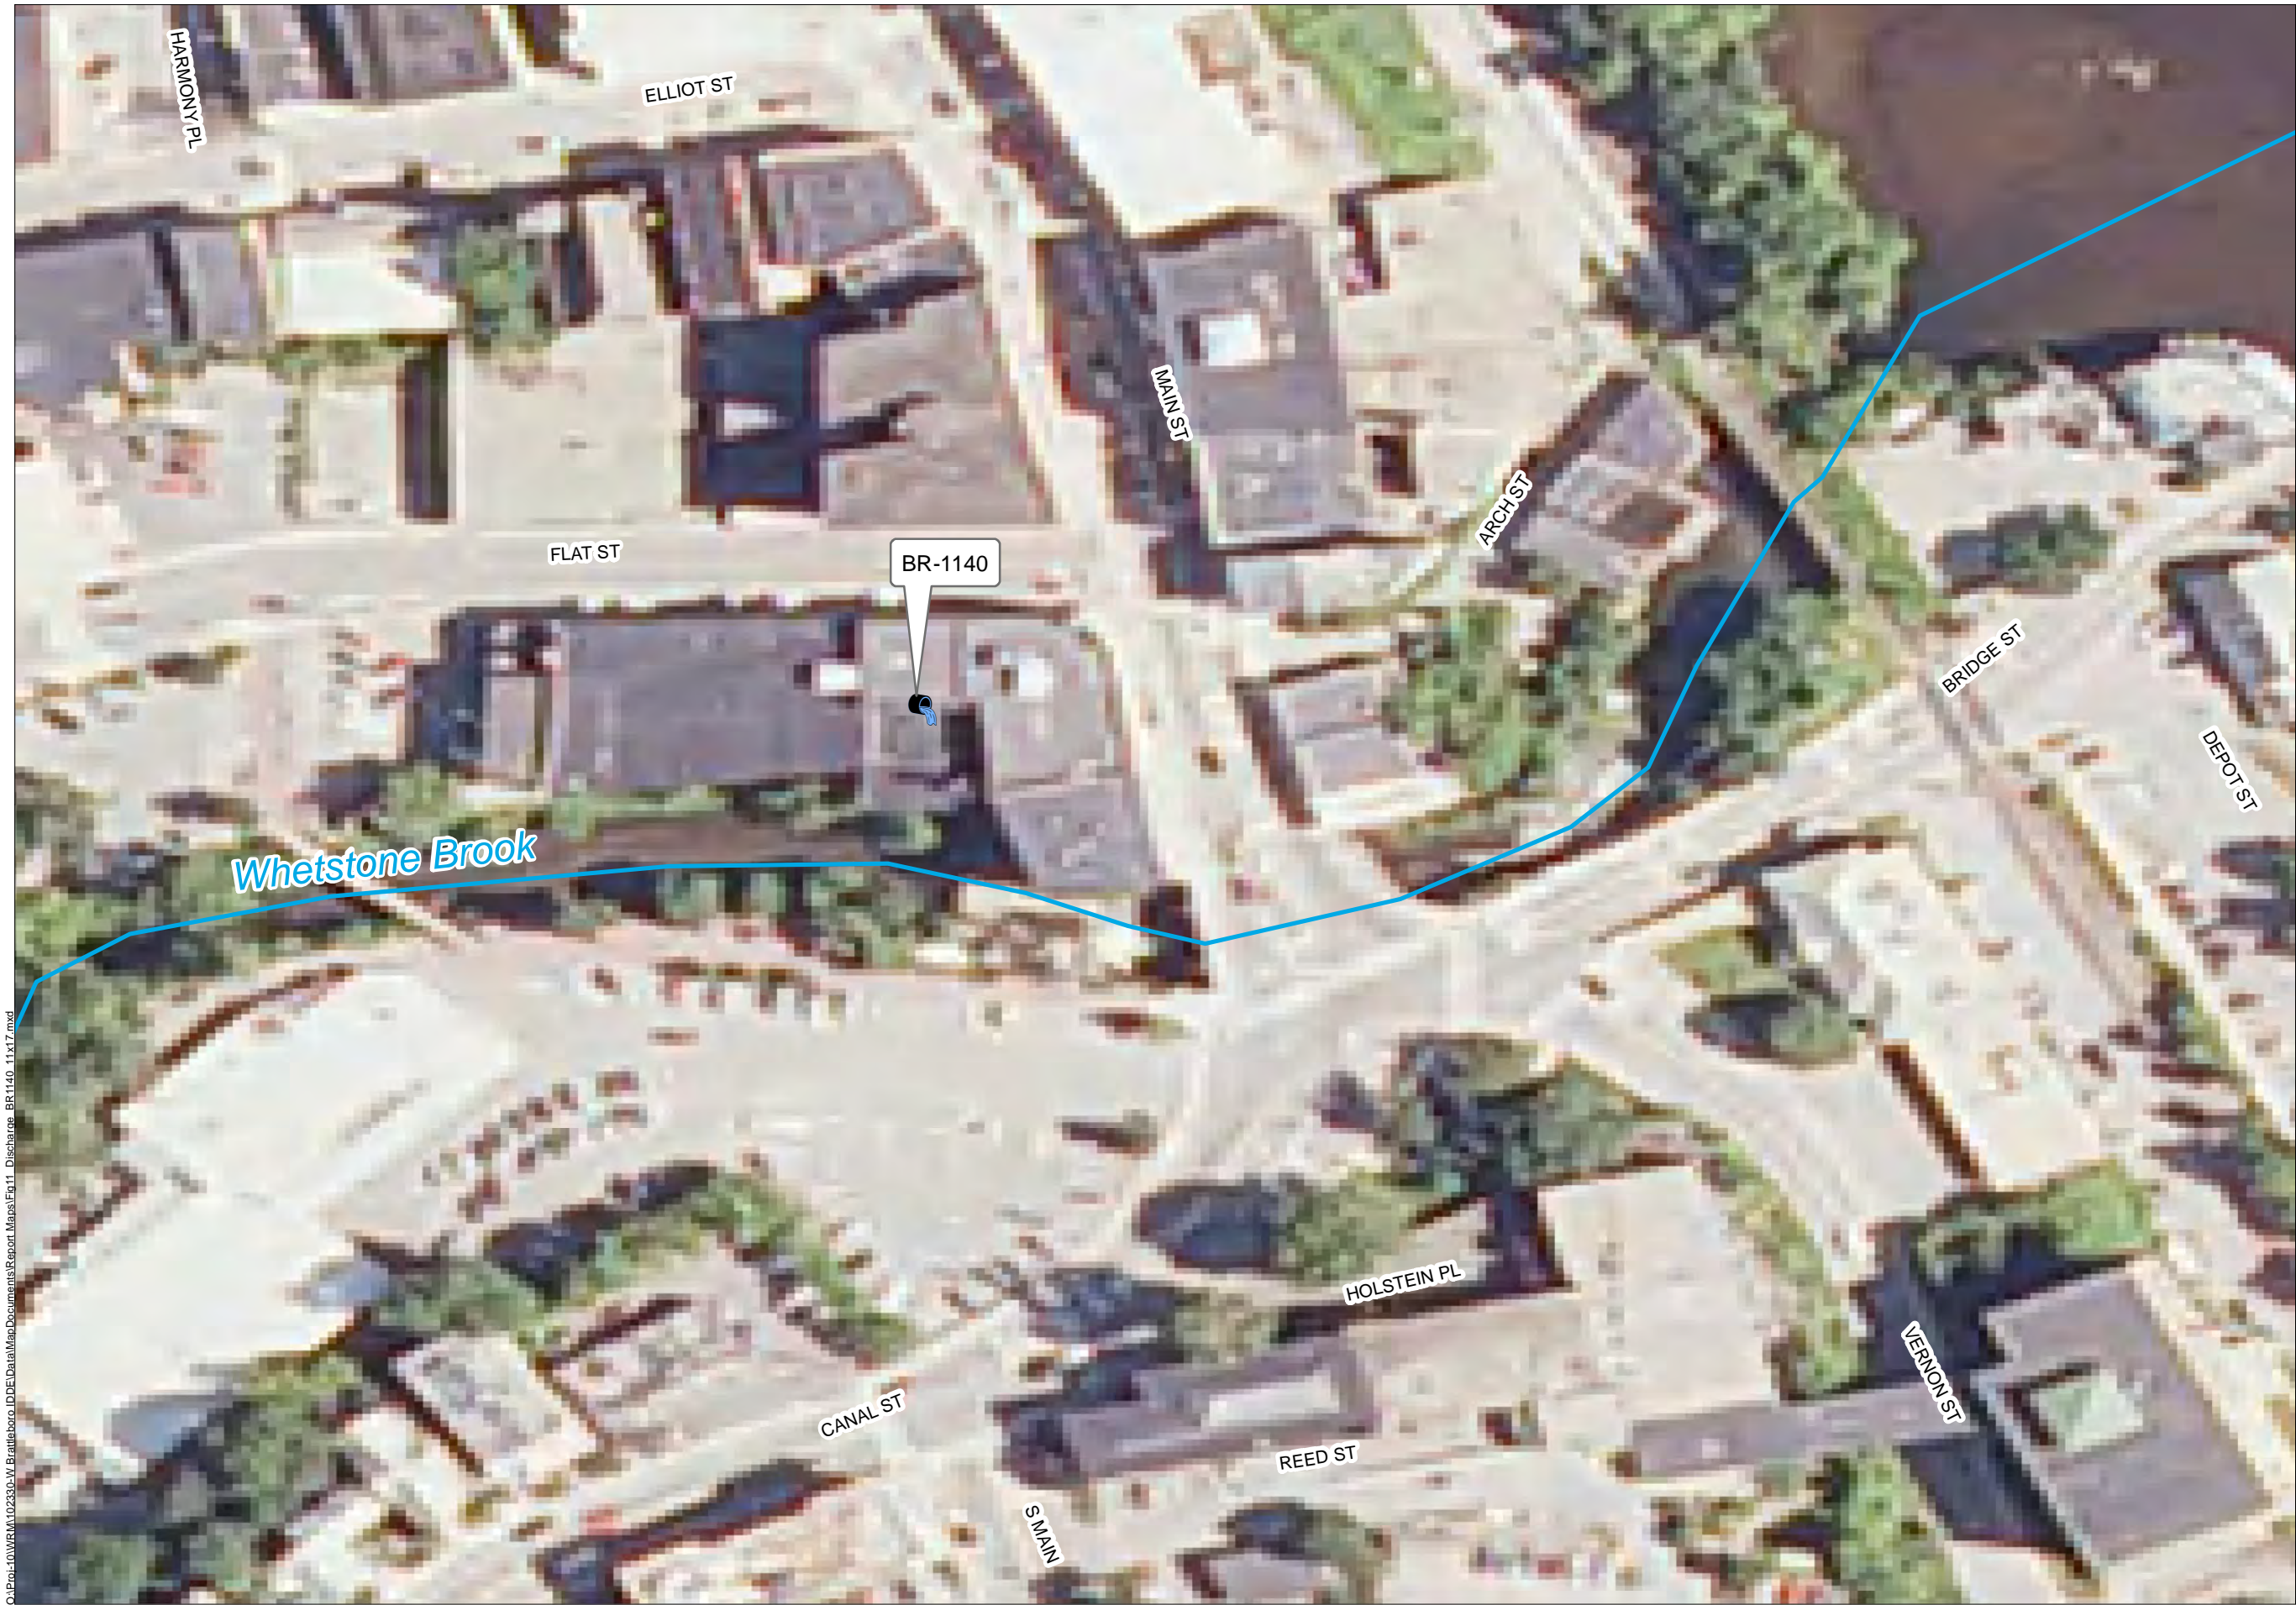
Figure 11
Brattleboro IDDE
Brattleboro, VT

Outfall BR-1140 is a small diameter (1.5-inch) pipe next to the air conditioning unit behind the Latchis Theater (Figure 11; Photo 7). This small flow appears to be tapwater. When assessed on October 20, 2010, the chlorine concentration was high (0.53 mg/L) and no ammonia or MBAS detergent were detected (Table 12). The site was pointed out to Rick Ethier on July 21, 2011, who indicated that DPW would discuss the source of the flow with the property owner to seek its elimination.

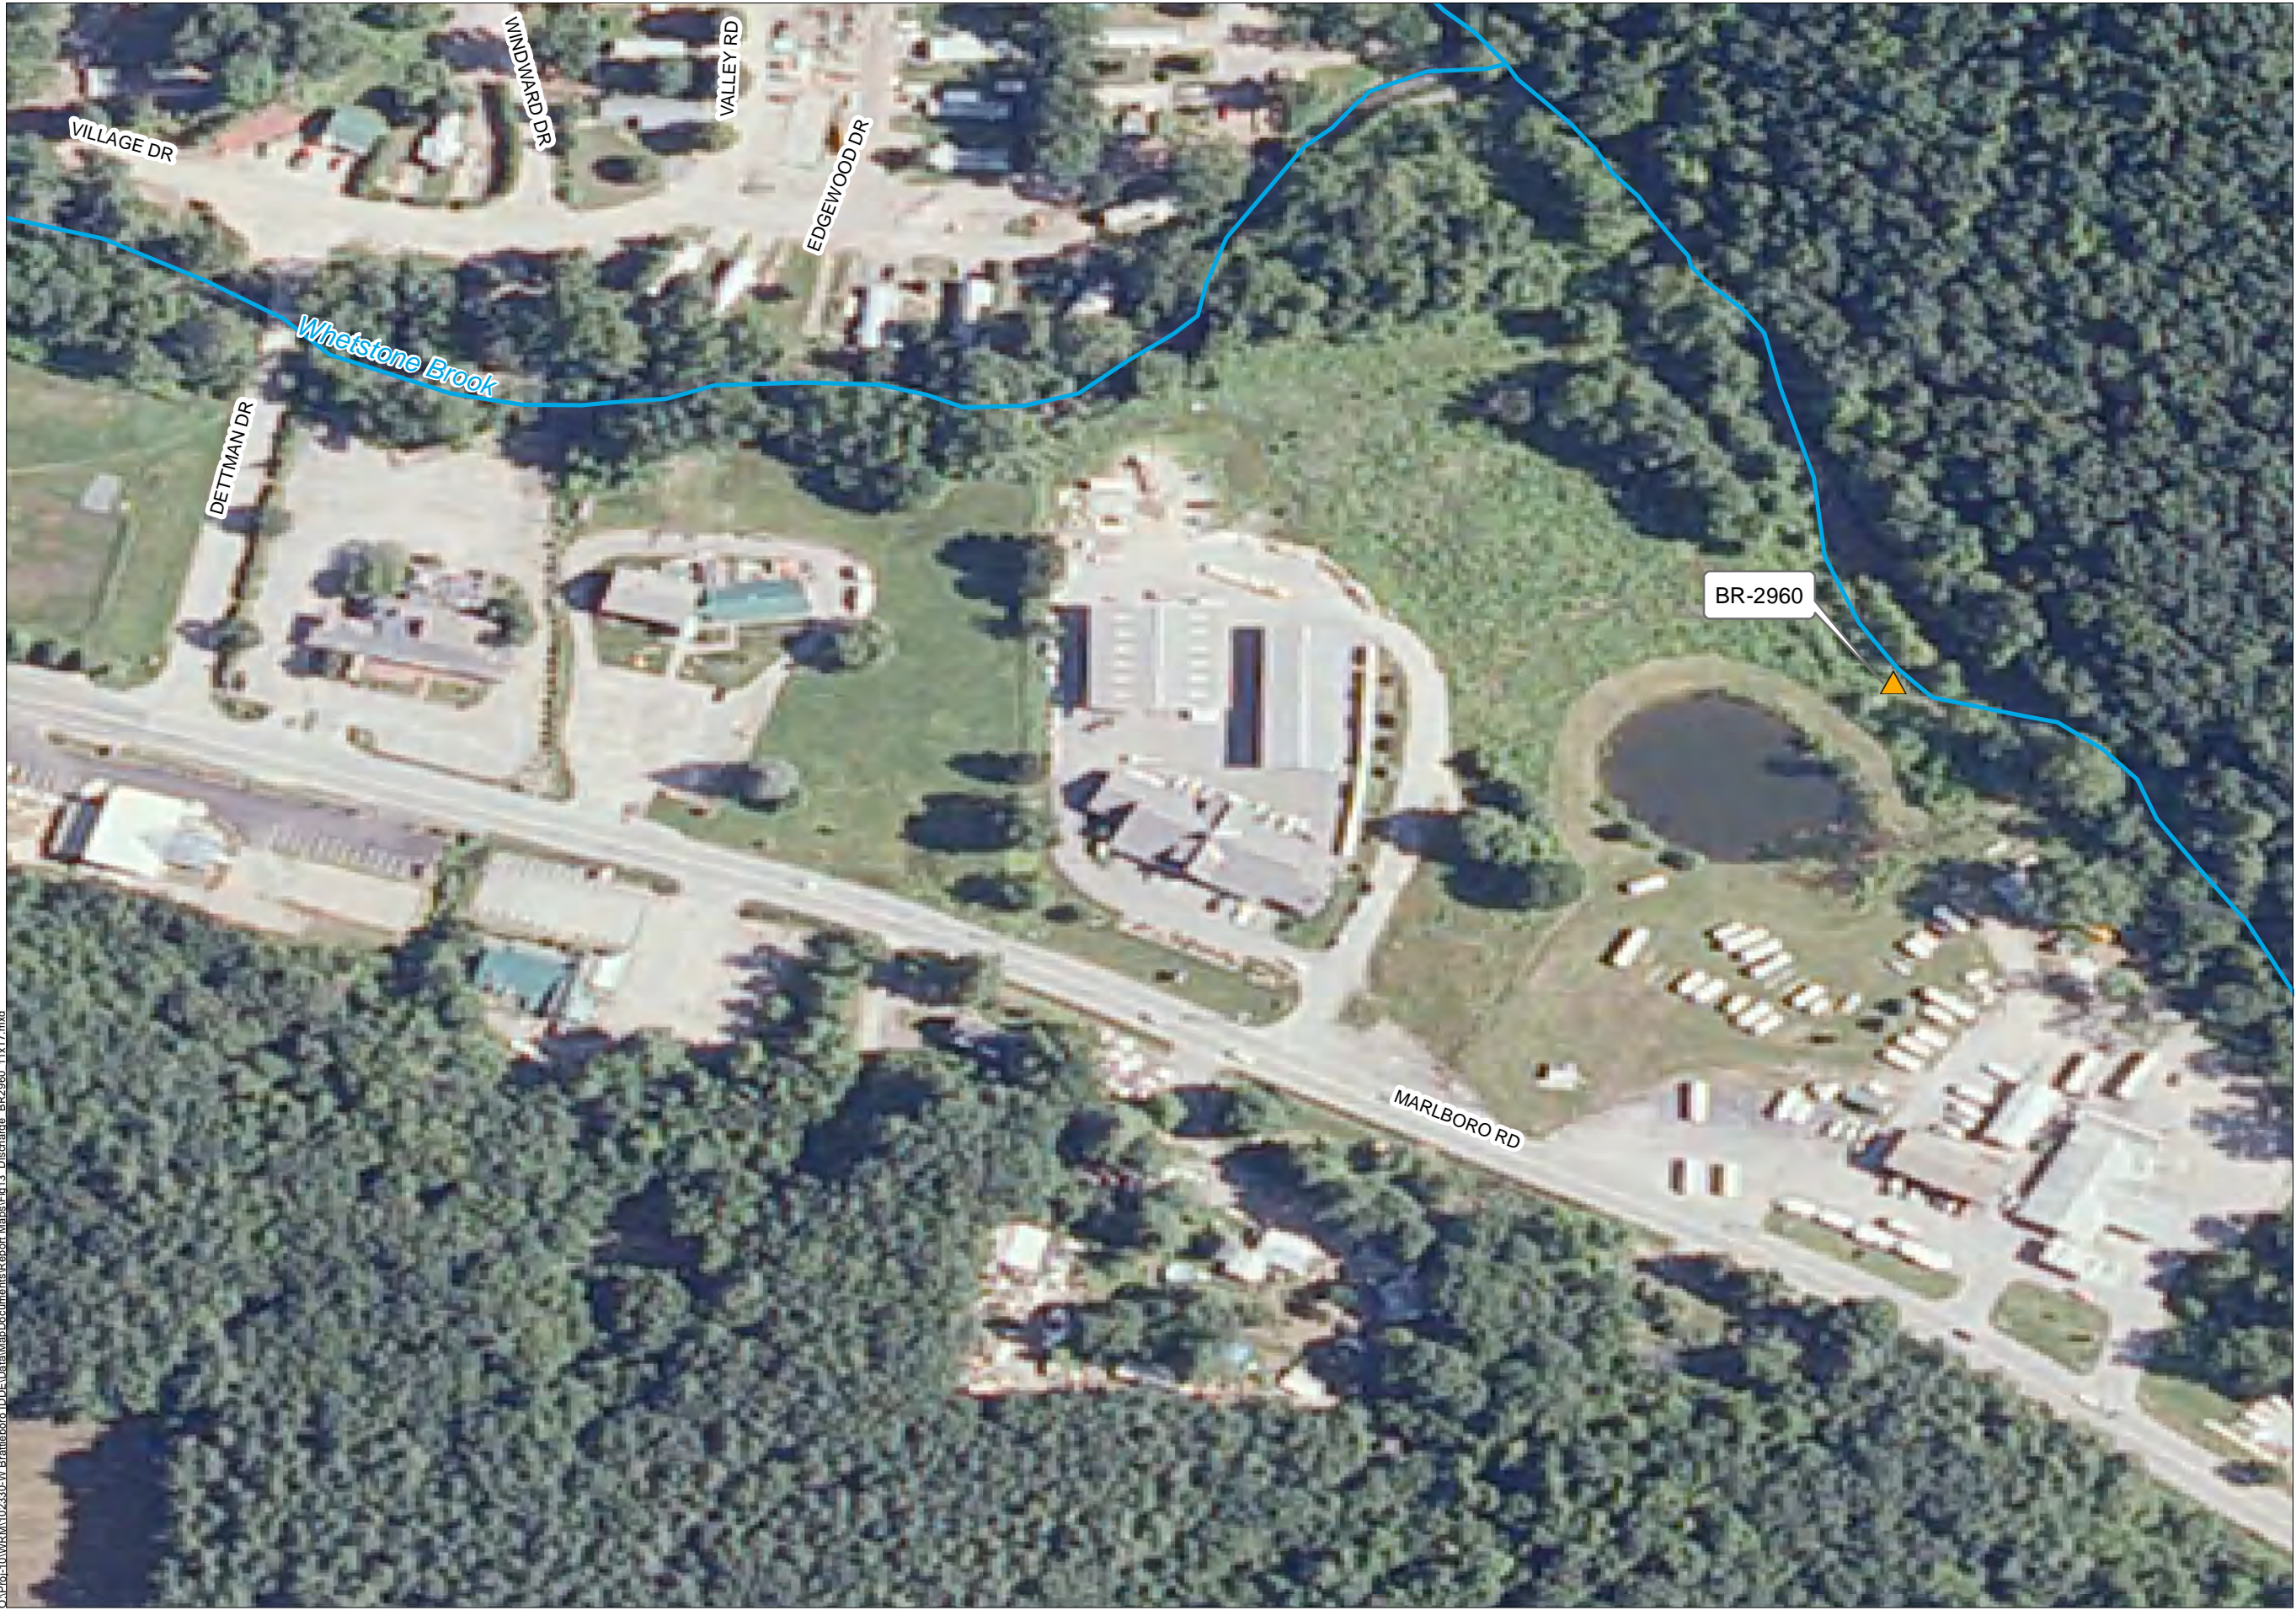
Figure 13
Brattleboro IDDE
Brattleboro, VT

BR-2960 is a seep area discharging to a secondary channel of Whetstone Brook (Figure 13). This channel (Photo 11) is located behind a lumber supply lot on Route 9 in West Brattleboro. The channel had a heavy accumulation of orange floc and a slight petroleum odor when assessed on November 25, 2010.
