APPENDICES

APPENDIX A: LETTER TO VILLAGE OF ENOSBURG FALLS

SEI No. 082119-W RE: Enosburg Falls IDDE results to date

APPENDIX B: CAMERA INSPECTION REPORTS FOR

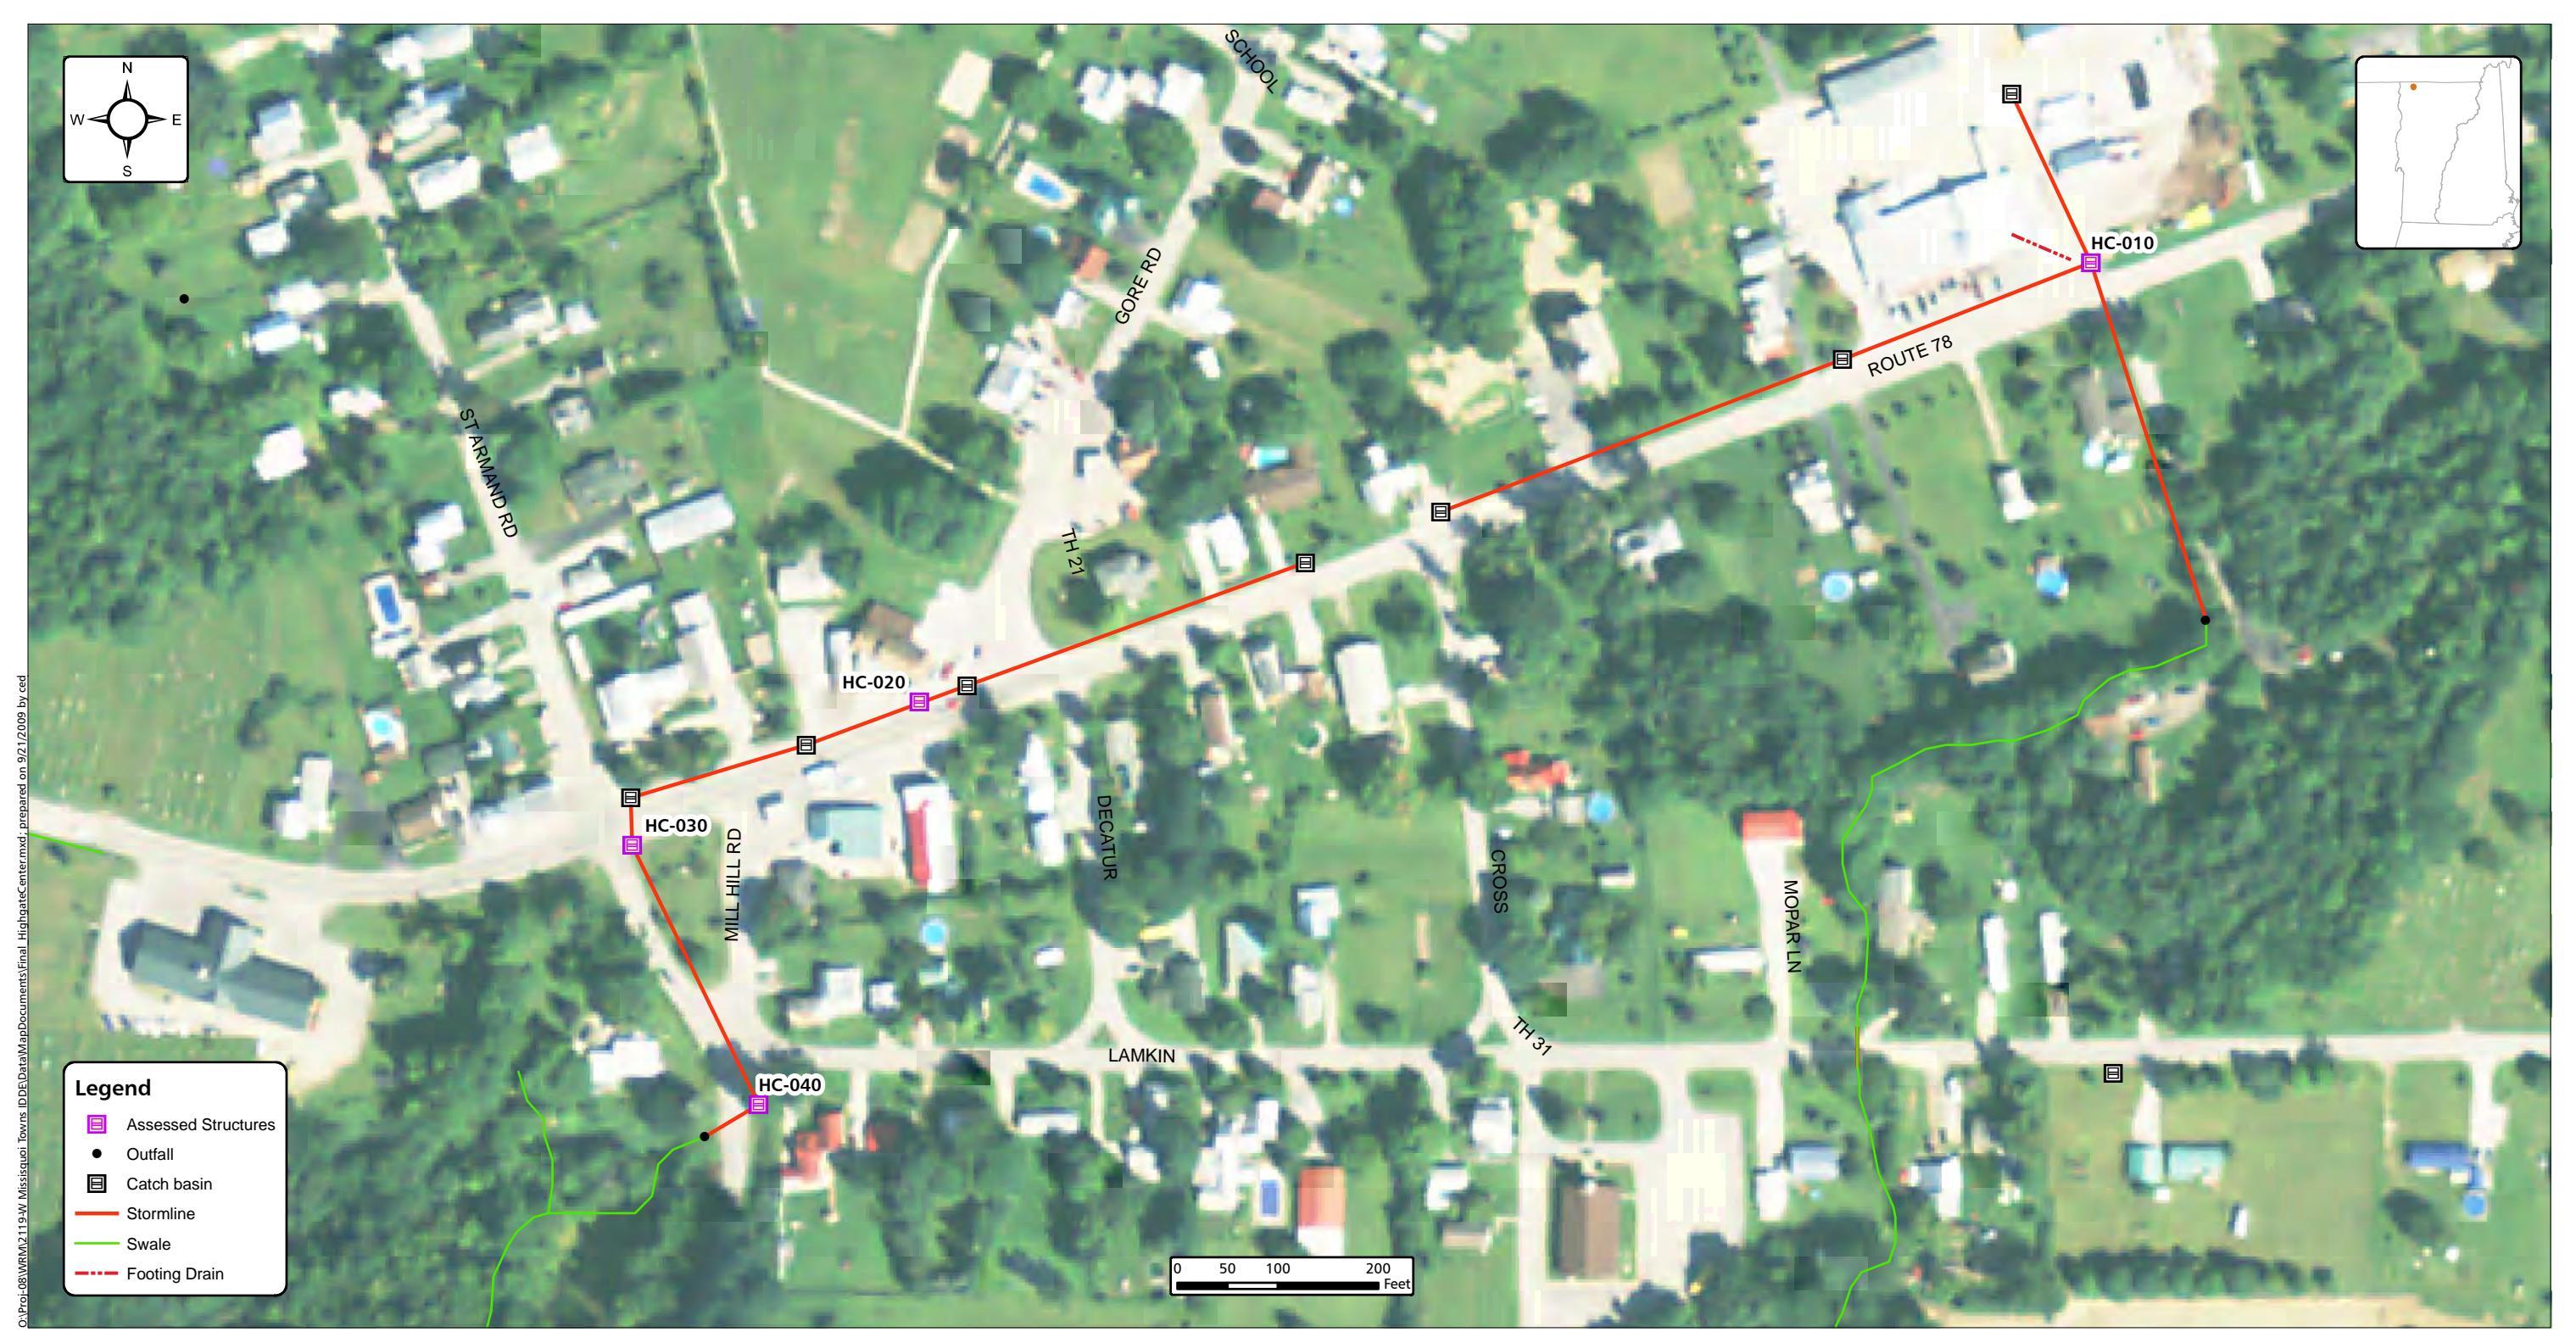
Figure 1: Illicit Discharge, Detection, & Elimination Assessment Points Highgate Center, Vermont - Summer 2009

On July 22, 2009, water quality tests were conducted at four catchbasins in Highgate Center during dryweather conditions (see Figure 1). We tested for ammonia, detergents (specifically, methylene blue active substances), specific conductance (electrical conductivity), and optical brighteners, which are fluorescent dyes contained in most laundry detergents. Results from the assessment are summarized in Table 1 below.

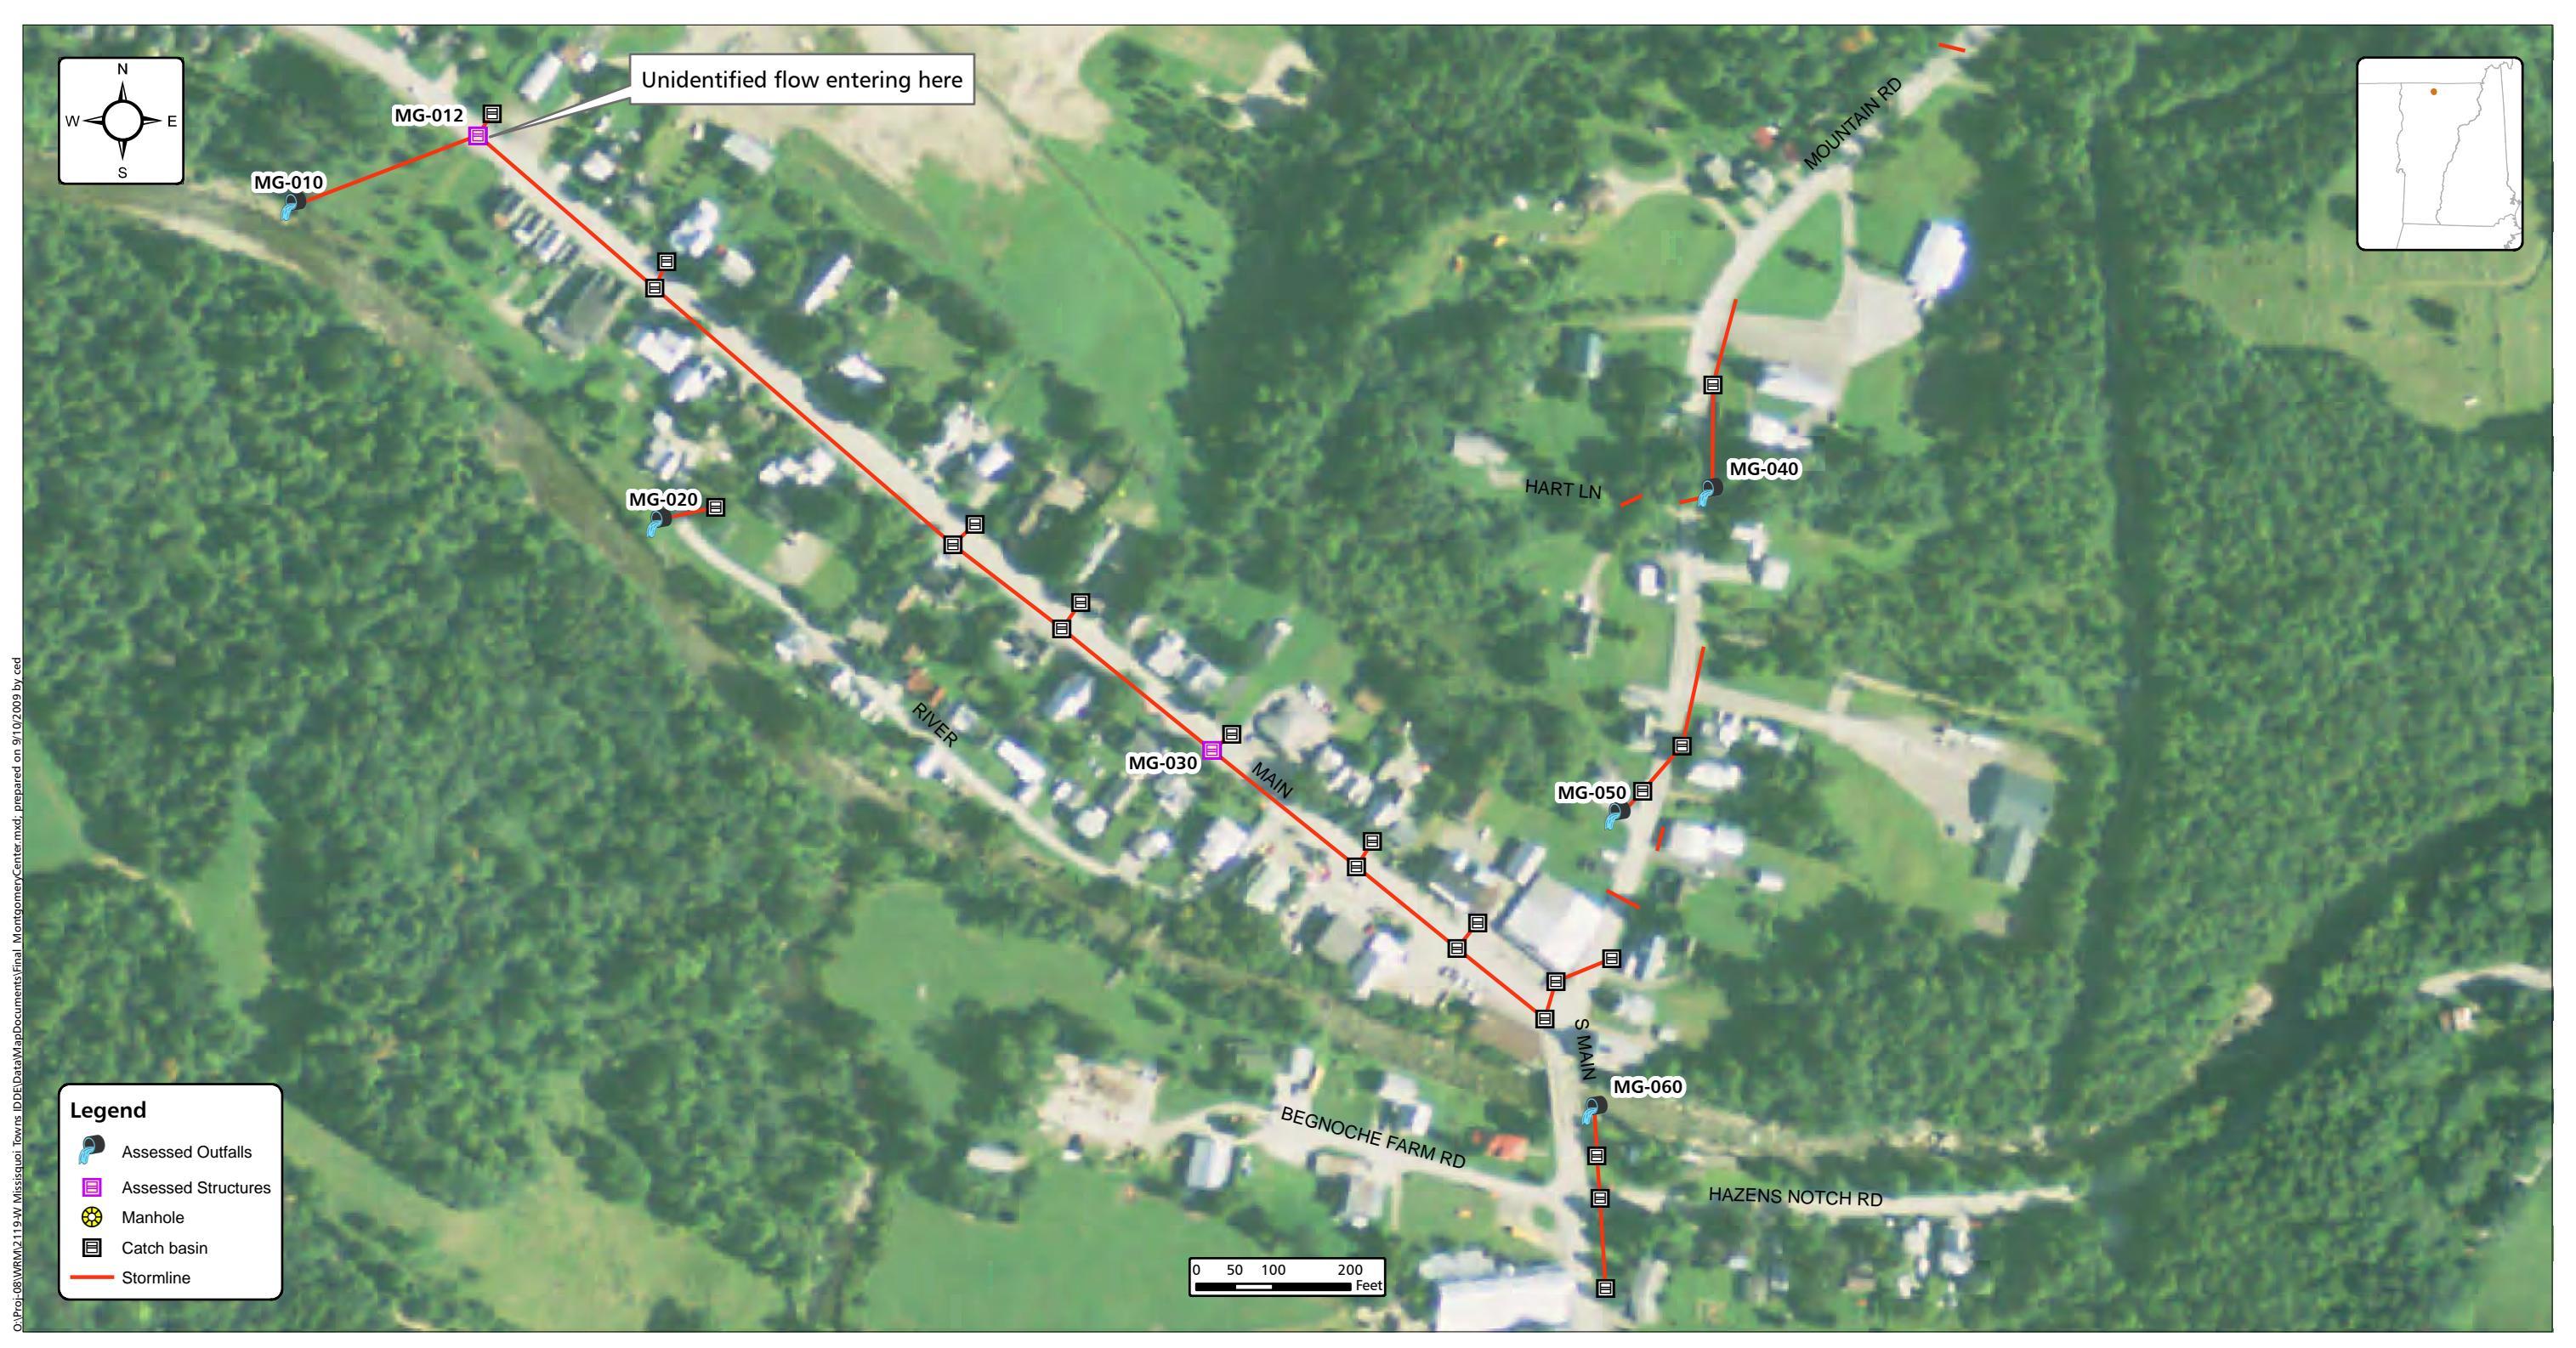
Figure 1: Illicit Discharge, Detection, & Elimination Assessment Points Montgomery Center, Vermont - Summer 2009

On July 6, 2009, we assessed six stormwater structures in Montgomery Center (see Figure 1) during dryweather conditions. Outfalls labeled MG-020 and MG-060 were not flowing. Water quality tests were conducted at three flowing outfalls and at a catchbasin on Main Street (labeled MG-030). We tested for ammonia, detergents (specifically, methylene blue active substances), specific conductance (electrical conductivity), and optical brighteners, which are fluorescent dyes contained in most laundry detergents. Results from the initial assessment are summarized in Table 1 below. No ammonia, detergents, or optical brighteners were detected at the outfalls. We did detect both ammonia and detergents at catchbasin MG-030, although the detergents test result is of questionable accuracy.

In summary, we detected no contaminated dry-weather flows in stormwater structures in Montgomery Center, except for a one-time occurrence of ammonia and detergents in catchbasin MG-030 on Main Street. We suspect the contamination observed in catchbasin MG-030 was related to washwater runoff or direct dumping to the basin. Vehicle washing, pressure washing, and emptying of mop buckets are common sources of methylene blue active detergents in stormwater drainage systems. We recommend that the Water Department inspect this catchbasin periodically to check for detergent suds, odors, or other signs of contamination, and, if found, to advise neighboring residents and business owners not to allow washwater and other contaminated flows to enter the town's stormwater drainage system.

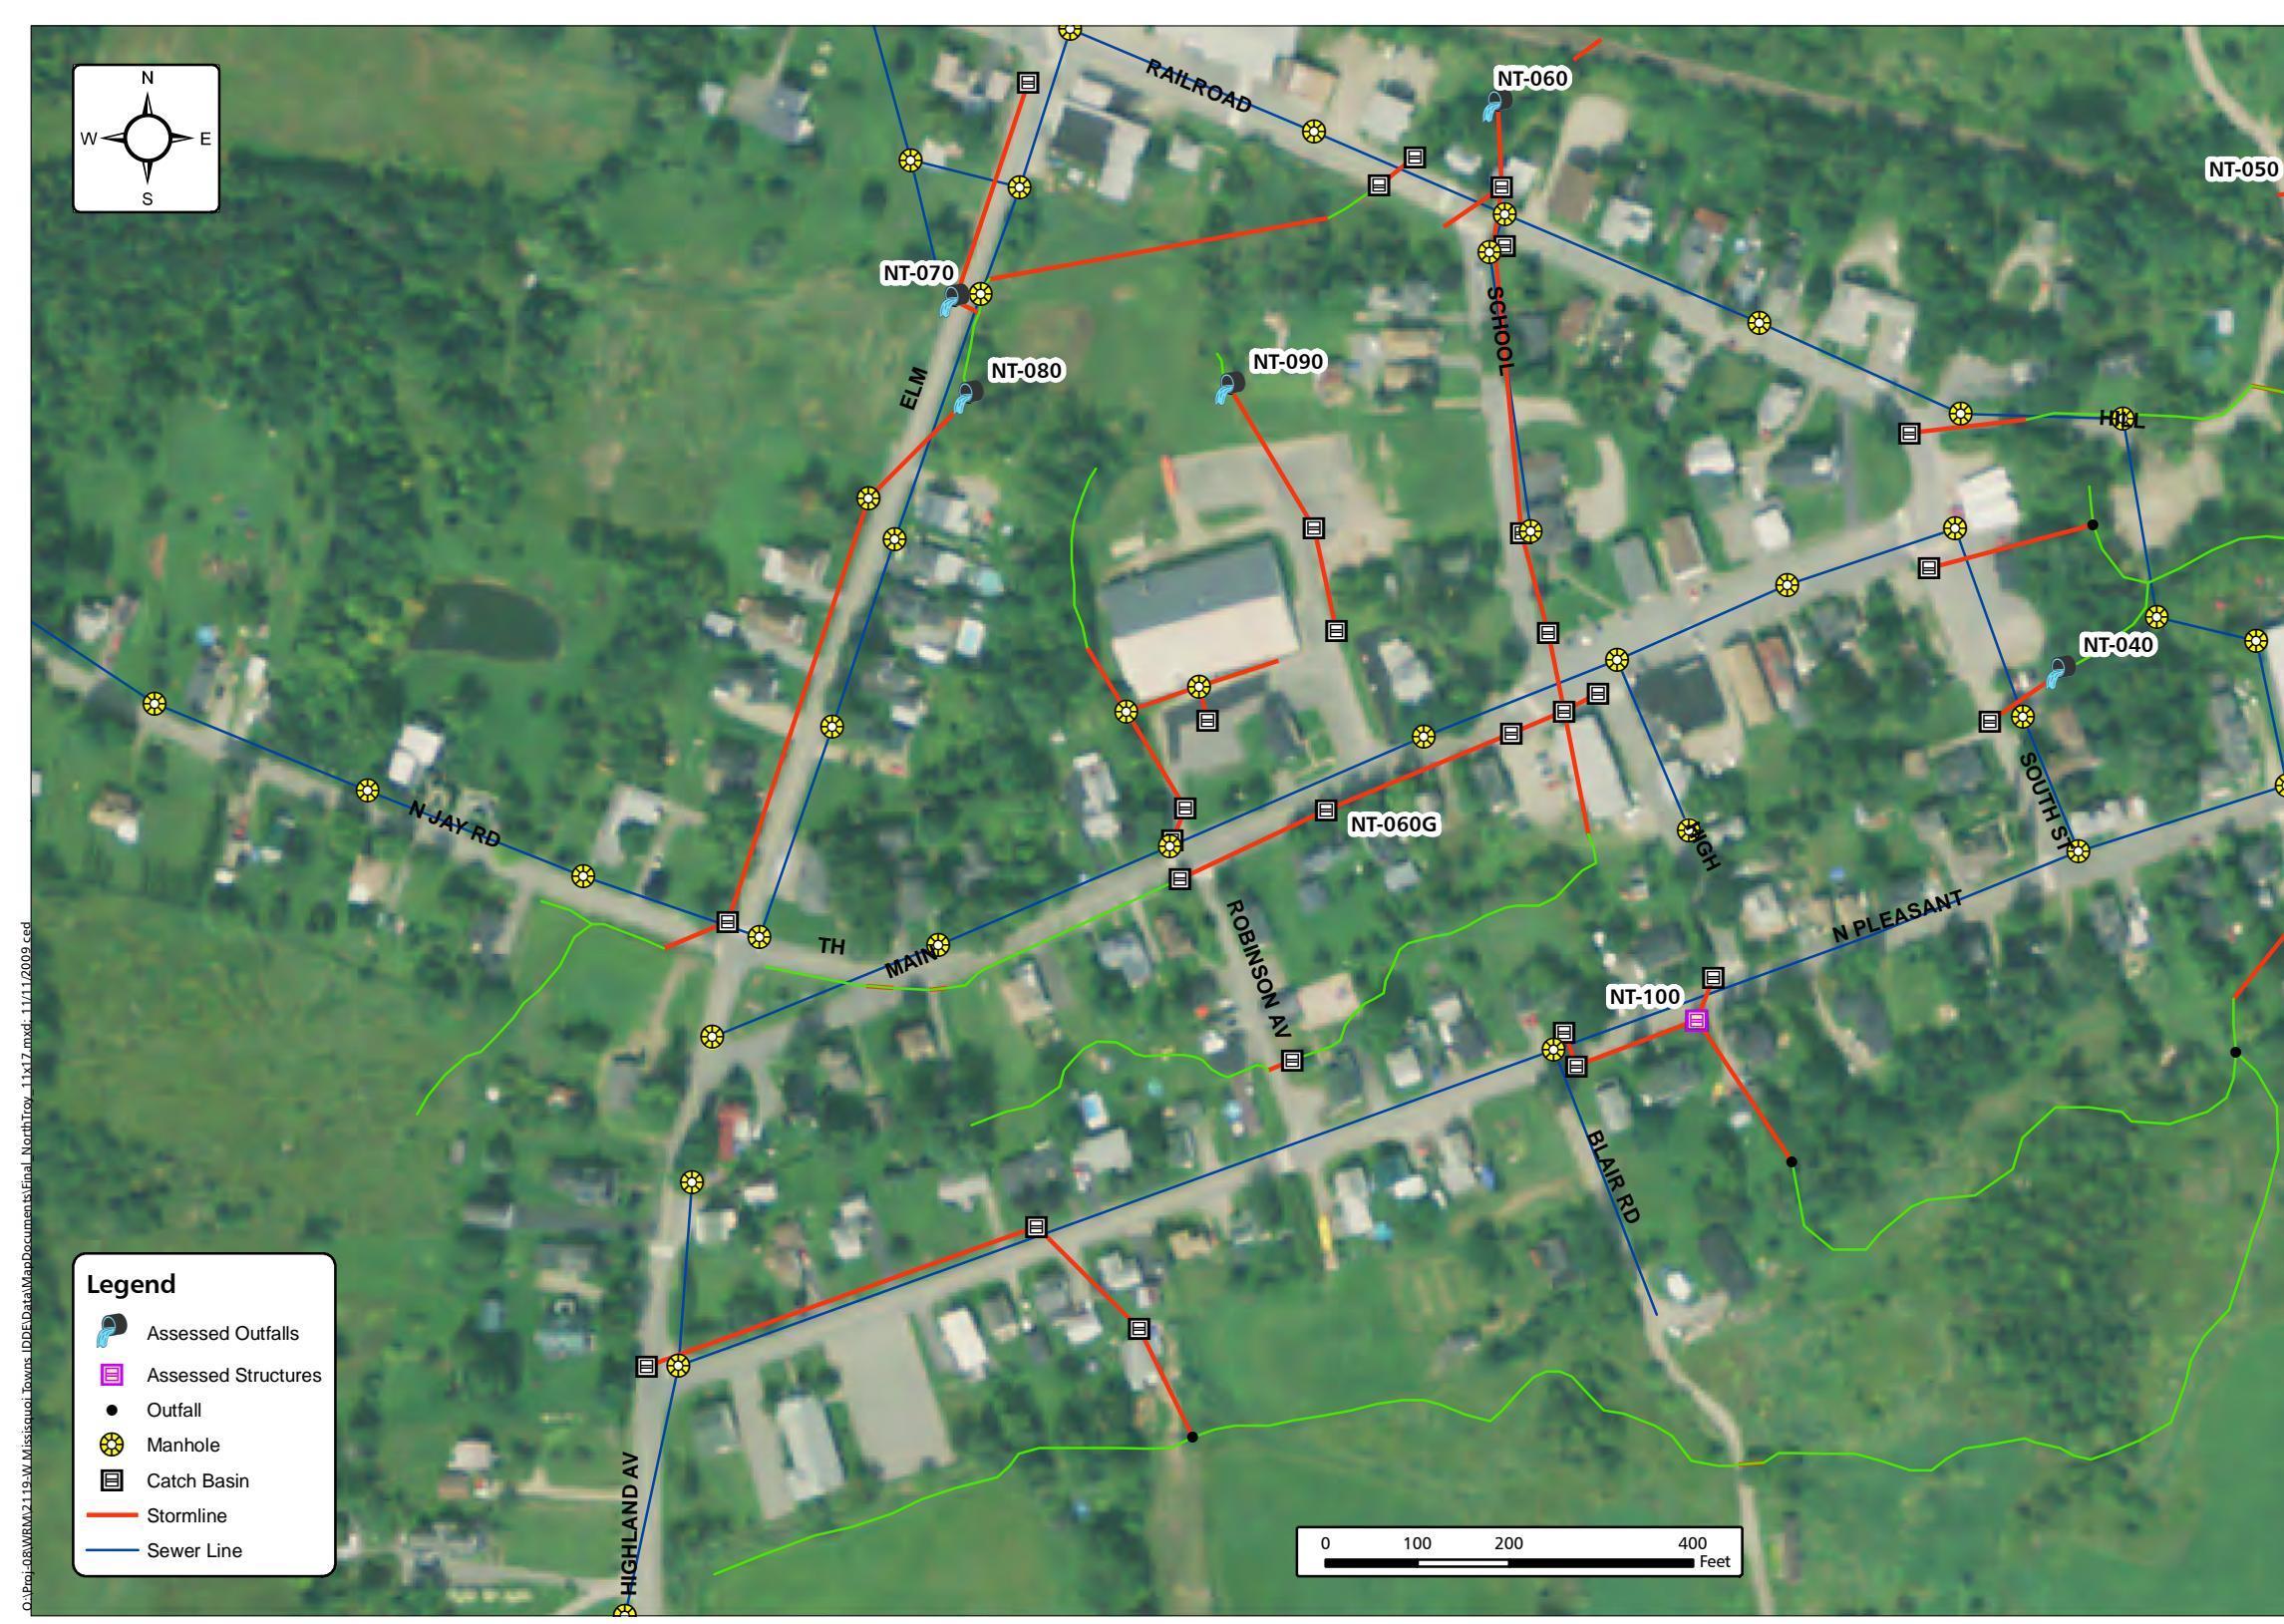
Figure 1: Illicit Discharge, Detection, & Elimination Assessment Points North Troy, Vermont - Summer 2009

On June 24, 2009, we assessed 10 stormwater structures in North Troy (see Figure 1) during dryweather conditions. Five stormwater outfalls were dry when visited. Water quality tests were conducted at the five flowing structures, which included three outfalls (labeled NT-010, NT-060, and NT-080), a stream culvert (NT-050), and a catchbasin (NT-100). We sampled flow at catchbasin NT-100 because we could not locate the outfall for this stormsewer, which we expect is buried; catchbasin NT-100 was the final structure we could access on this stormline. At the flowing structures, we tested for ammonia, detergents (specifically, methylene blue active substances), specific conductance (electrical conductivity), and optical brighteners, which are fluorescent dyes contained in most laundry detergents. Results from the initial assessment are summarized in Table 1 below.

In summary, we suspect illicit discharges are occurring in the storm drainage systems discharging at NT-010 (Nason Terrace) and NT-060 (Railroad St.). The likely source of the contamination documented at outfall NT-010 is inflow of sanitary wastewater to the stormline between the catchbasin on Nason Terrace and the next catchbasin up the line on North Pleasant Street. We recommend the Town of North Troy inspect this stormline and, if necessary, the sanitary sewer using a closed circuit television camera. The likely source of contamination in the stormsewer discharging at NT-060 is a sanitary wastewater or washwater connection to the stormline from a house on Main St. We recommend inspection and correction of the plumbing connections, including laundry facilities, in #129 Main St. If this doesn't lead to resolution of the problem, then we recommend inspection of neighboring houses.

catchbasin. We therefore recommend inspecting this pipe, and possibly also the sanitary sewer line in this area, using a closed circuit television camera. Wayne Graham of the Vermont Rural Water Association may be of assistance with the pipe inspection.

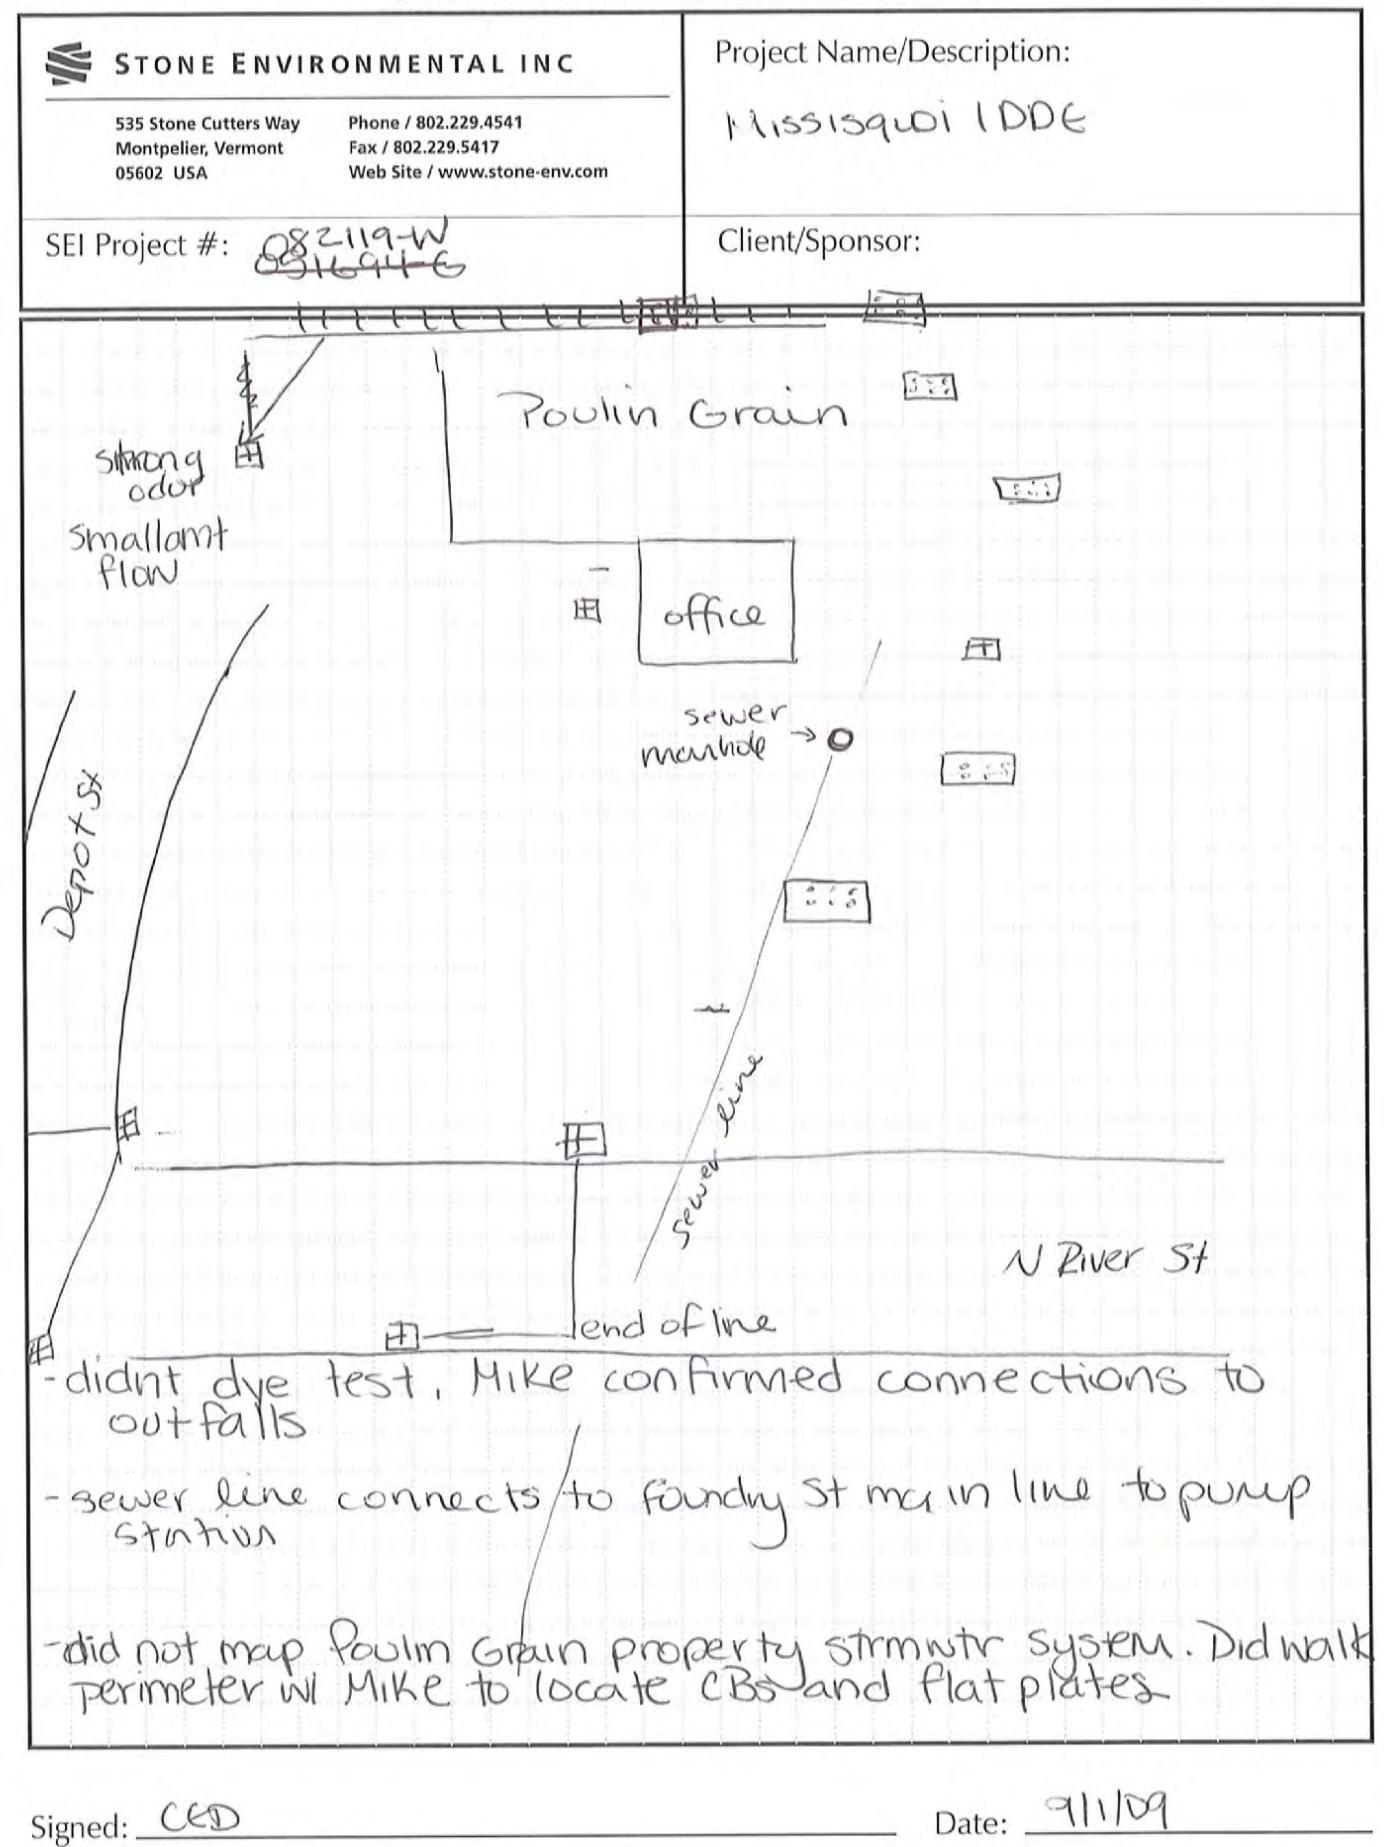
STONE ENVIRONMENTAL INC	Project Name/Description:
535 Stone Cutters WayPhone / 802.229.4541Montpelier, VermontFax / 802.229.541705602 USAWeb Site / www.stone-env.com	Missisquoi IDDE
SEI Project #: 08 2119-W	Client/Sponsor:
SW296 CB below Po	whin Grain
Ammonia = 1ppm	
Detergents = 0.2	
igned: CED	Date: 9/24/09
squares = 1 inch	Page: of
