# Final Report: Contract #35956 Statewide IDDE

March 2021

**Andres Torizzo**

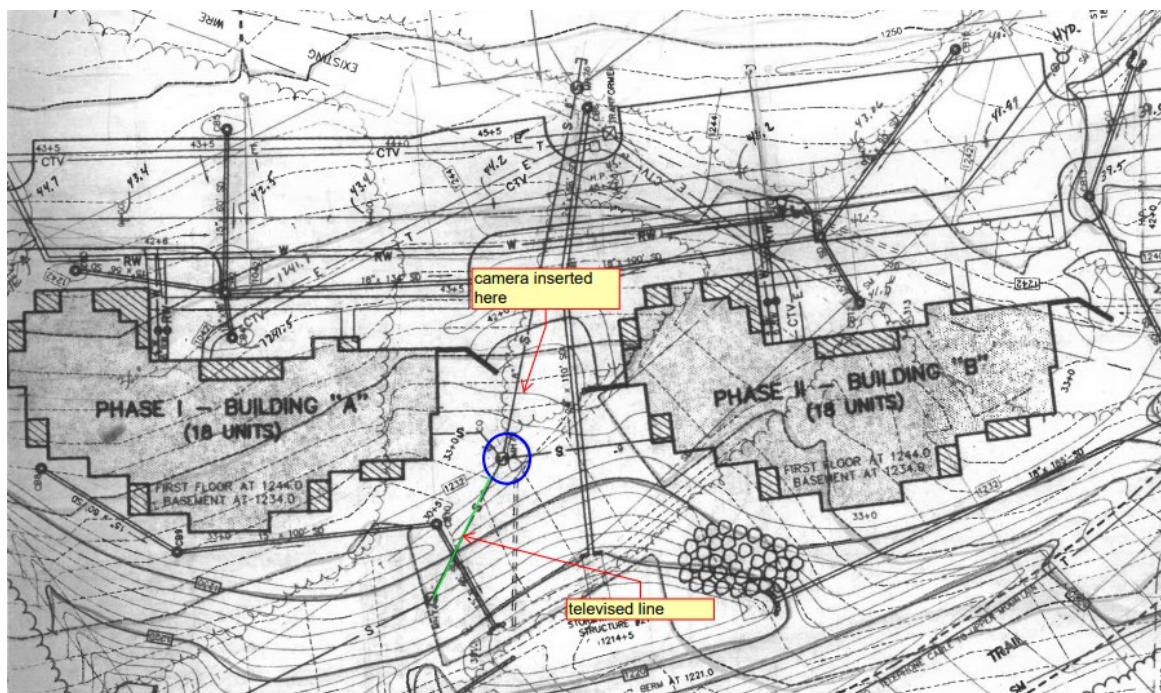
Figure 2. Map depicting location of push camera.

Watershed followed up on this work and on August 20, 2020, a televised survey of the sewer system was completed to further evaluate CAMB\_7. A push camera was installed into the sewer manhole as indicated on the plan in Figure 2. The camera was extended through the sewer line beyond the crossing with the subject stormwater line to the next sewer manhole structure as seen in Figure 1. The pipe was observed to be in good condition with no evidence of bends or cracks. The outfall was observed to be dry at the time of the inspection with no visual evidence of contamination.
