Detecting and Eliminating Illicit Discharges in St. Johnsbury to Improve Water Quality

Final Report

August 14, 2015

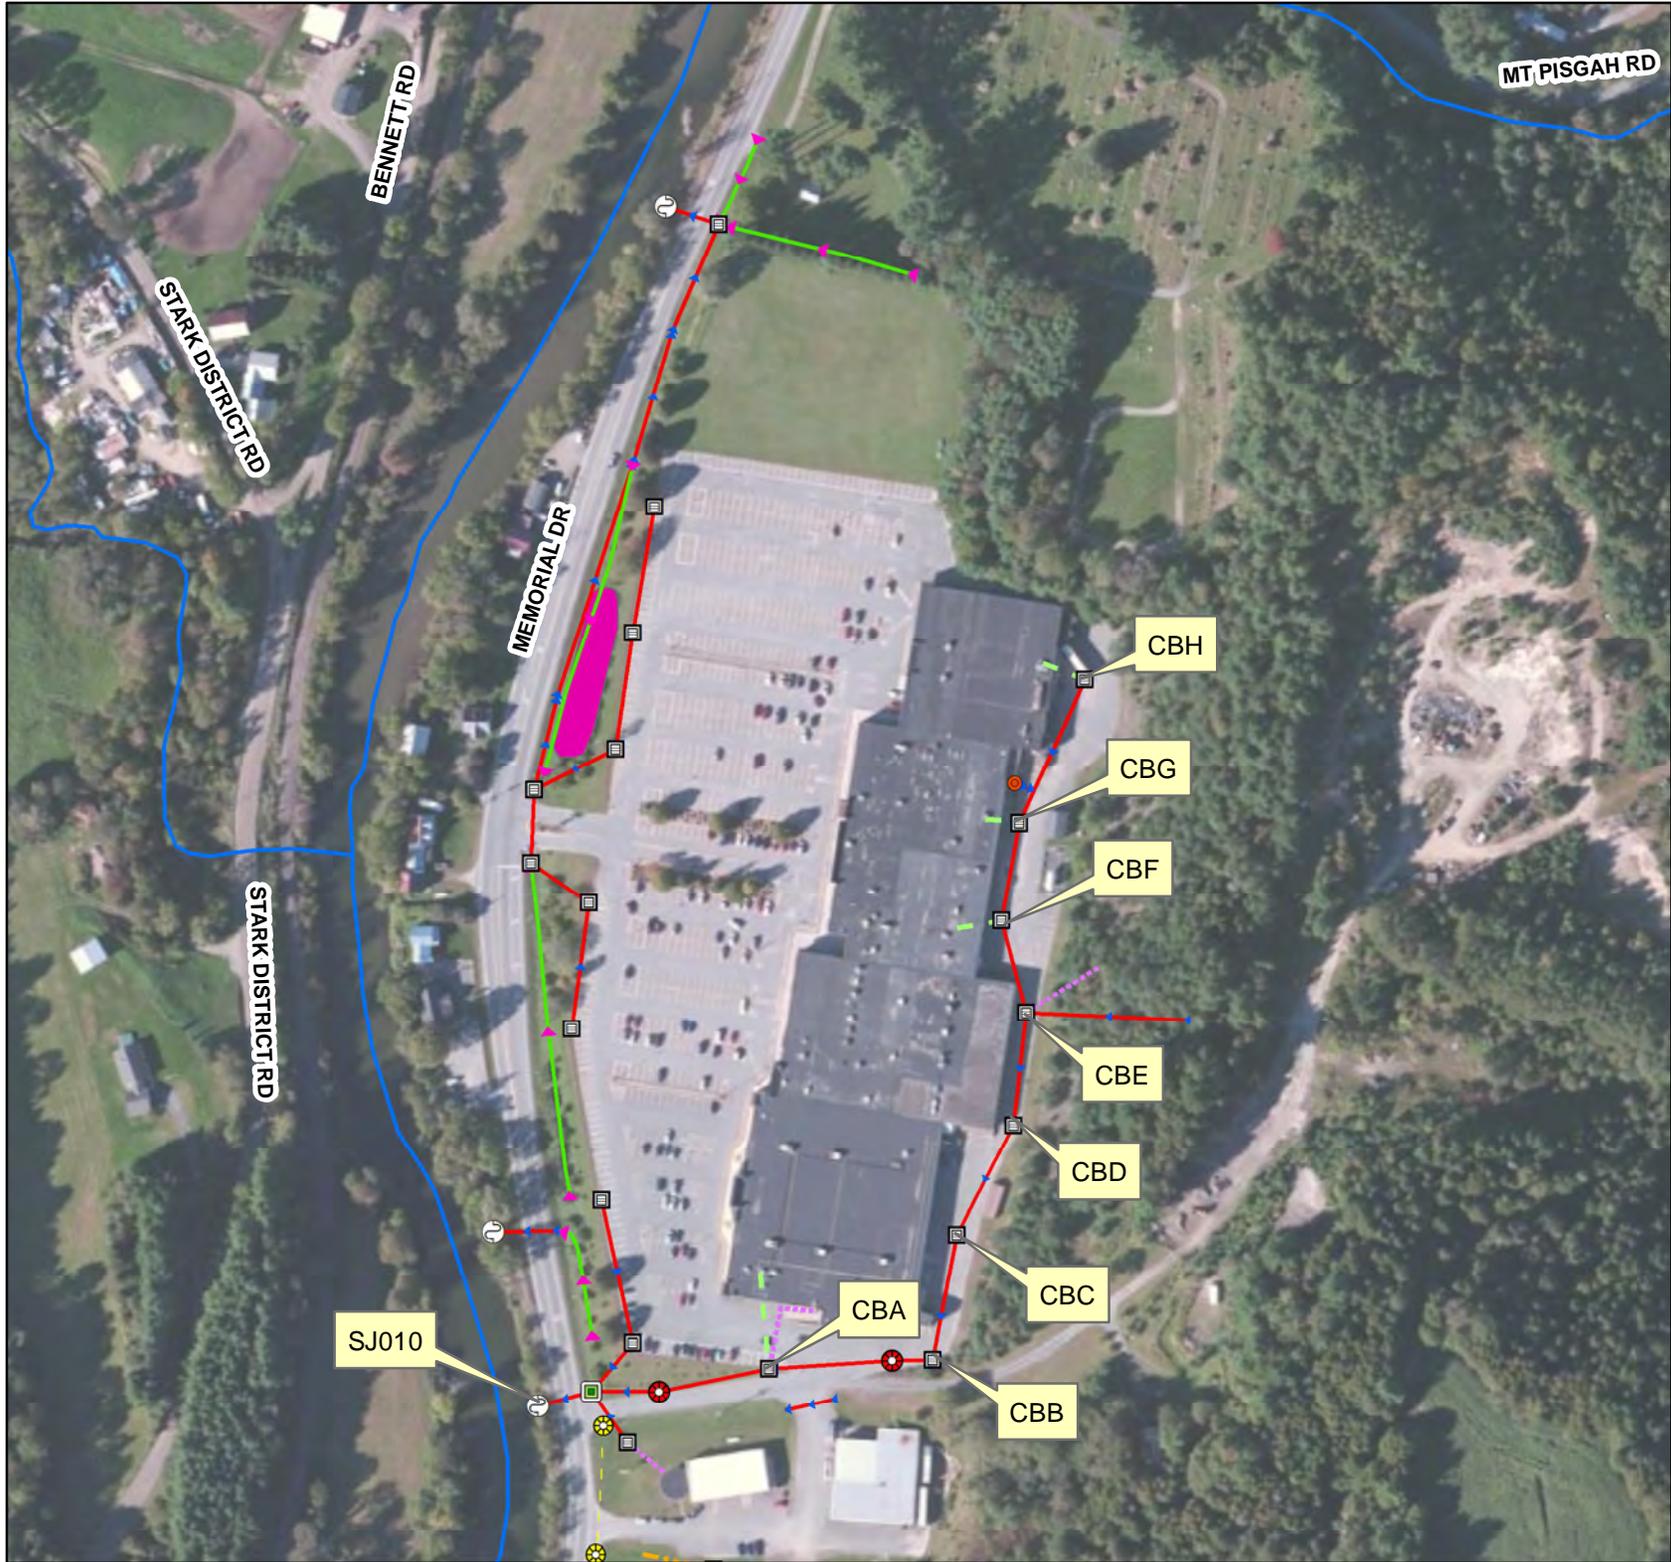
Map SJ-1
System SJ010
St. Johnsbury, VT

Conclusion: We suspect that the slop sink or another interior drain in the Green Mountain Mall is connected to the stormdrain on the backside of the property and that washwater is routinely discharged to this sink or drain. Another possibility is that cleaning of roof vents or air conditioning units introduces detergent and ammonia to the stormdrain. Regardless of the source, it is clear that contaminated water has been discharged to the stormdrain on the mall property in violation of the mall's stormwater permit.

Resolution: At this time, Stone recommends that this issue be referred to enforcement by the DEC project manager.

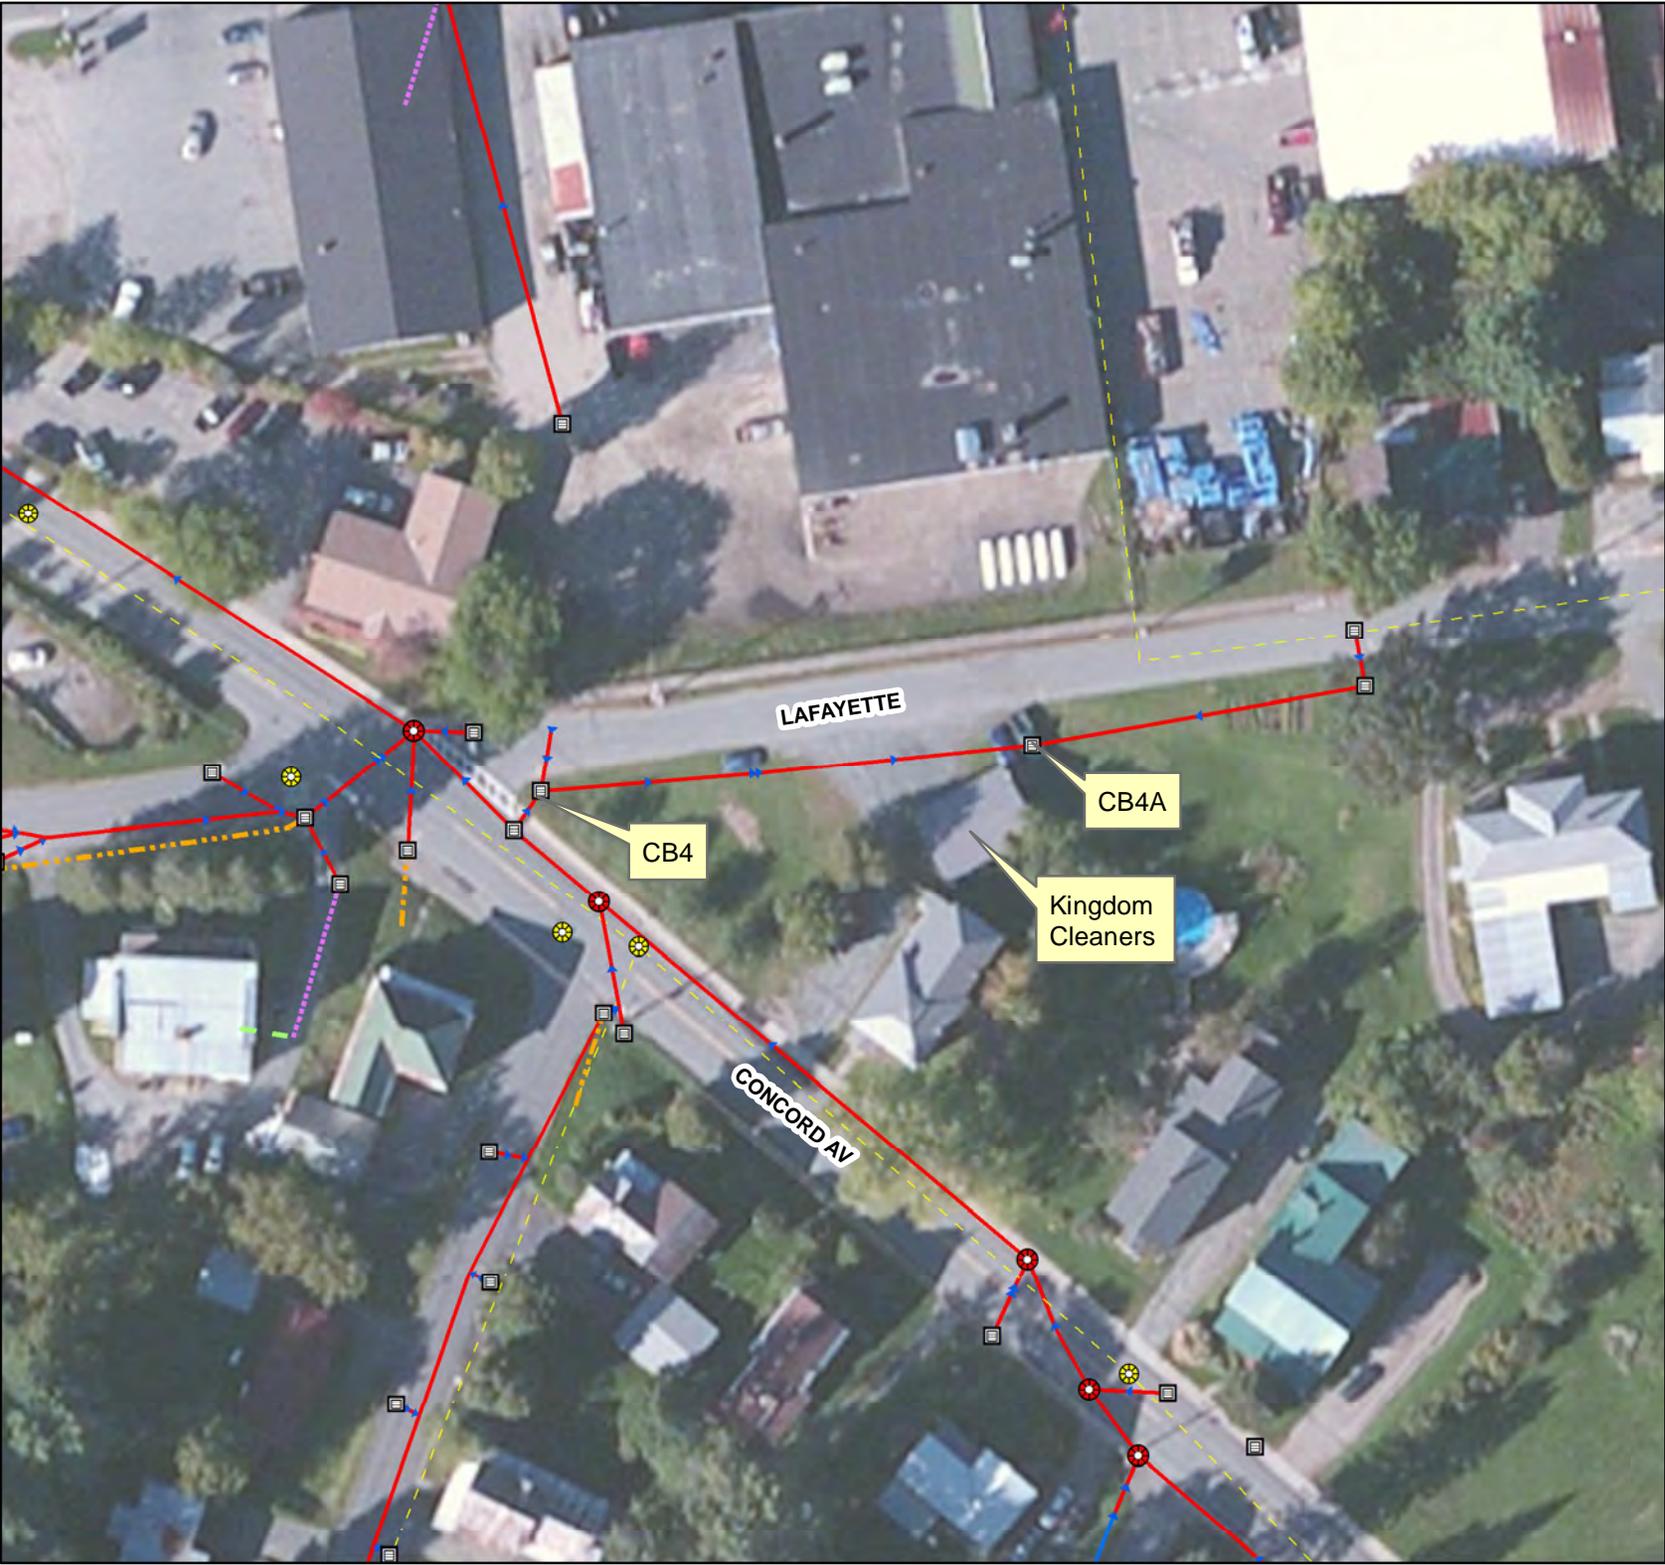
Map SJ-8
System SJ440
St. Johnsbury, VT

SJ440	During wet weather, sanitary wastewater can discharge to the separate stormwater system on Concord Avenue. Two possible routes of entry are 1) discharge to the street under surcharged conditions followed by drainage to a catchbasin, and 2) sewage backing up and flowing to a connected basement floor drain. There are reports of sewer backups in certain houses on Concord Avenue due to surcharging of the municipal sewer. These observations should inform future investigations by the Town of St. Johnsbury.
SJ450	No chronic illicit discharge.
SJ470	No chronic illicit discharge.
SJ480	No chronic illicit discharge.
SJ500	No chronic illicit discharge.
SJ510, CB4 Pipe B branch	Suspected washwater dumping to catchbasin CB4A by Kingdom Cleaners. The Town of St. Johnsbury sent Kingdom Cleaners a letter on August 14, 2015 notifying them that dumping washwater to the catchbasin is illegal and they must stop.

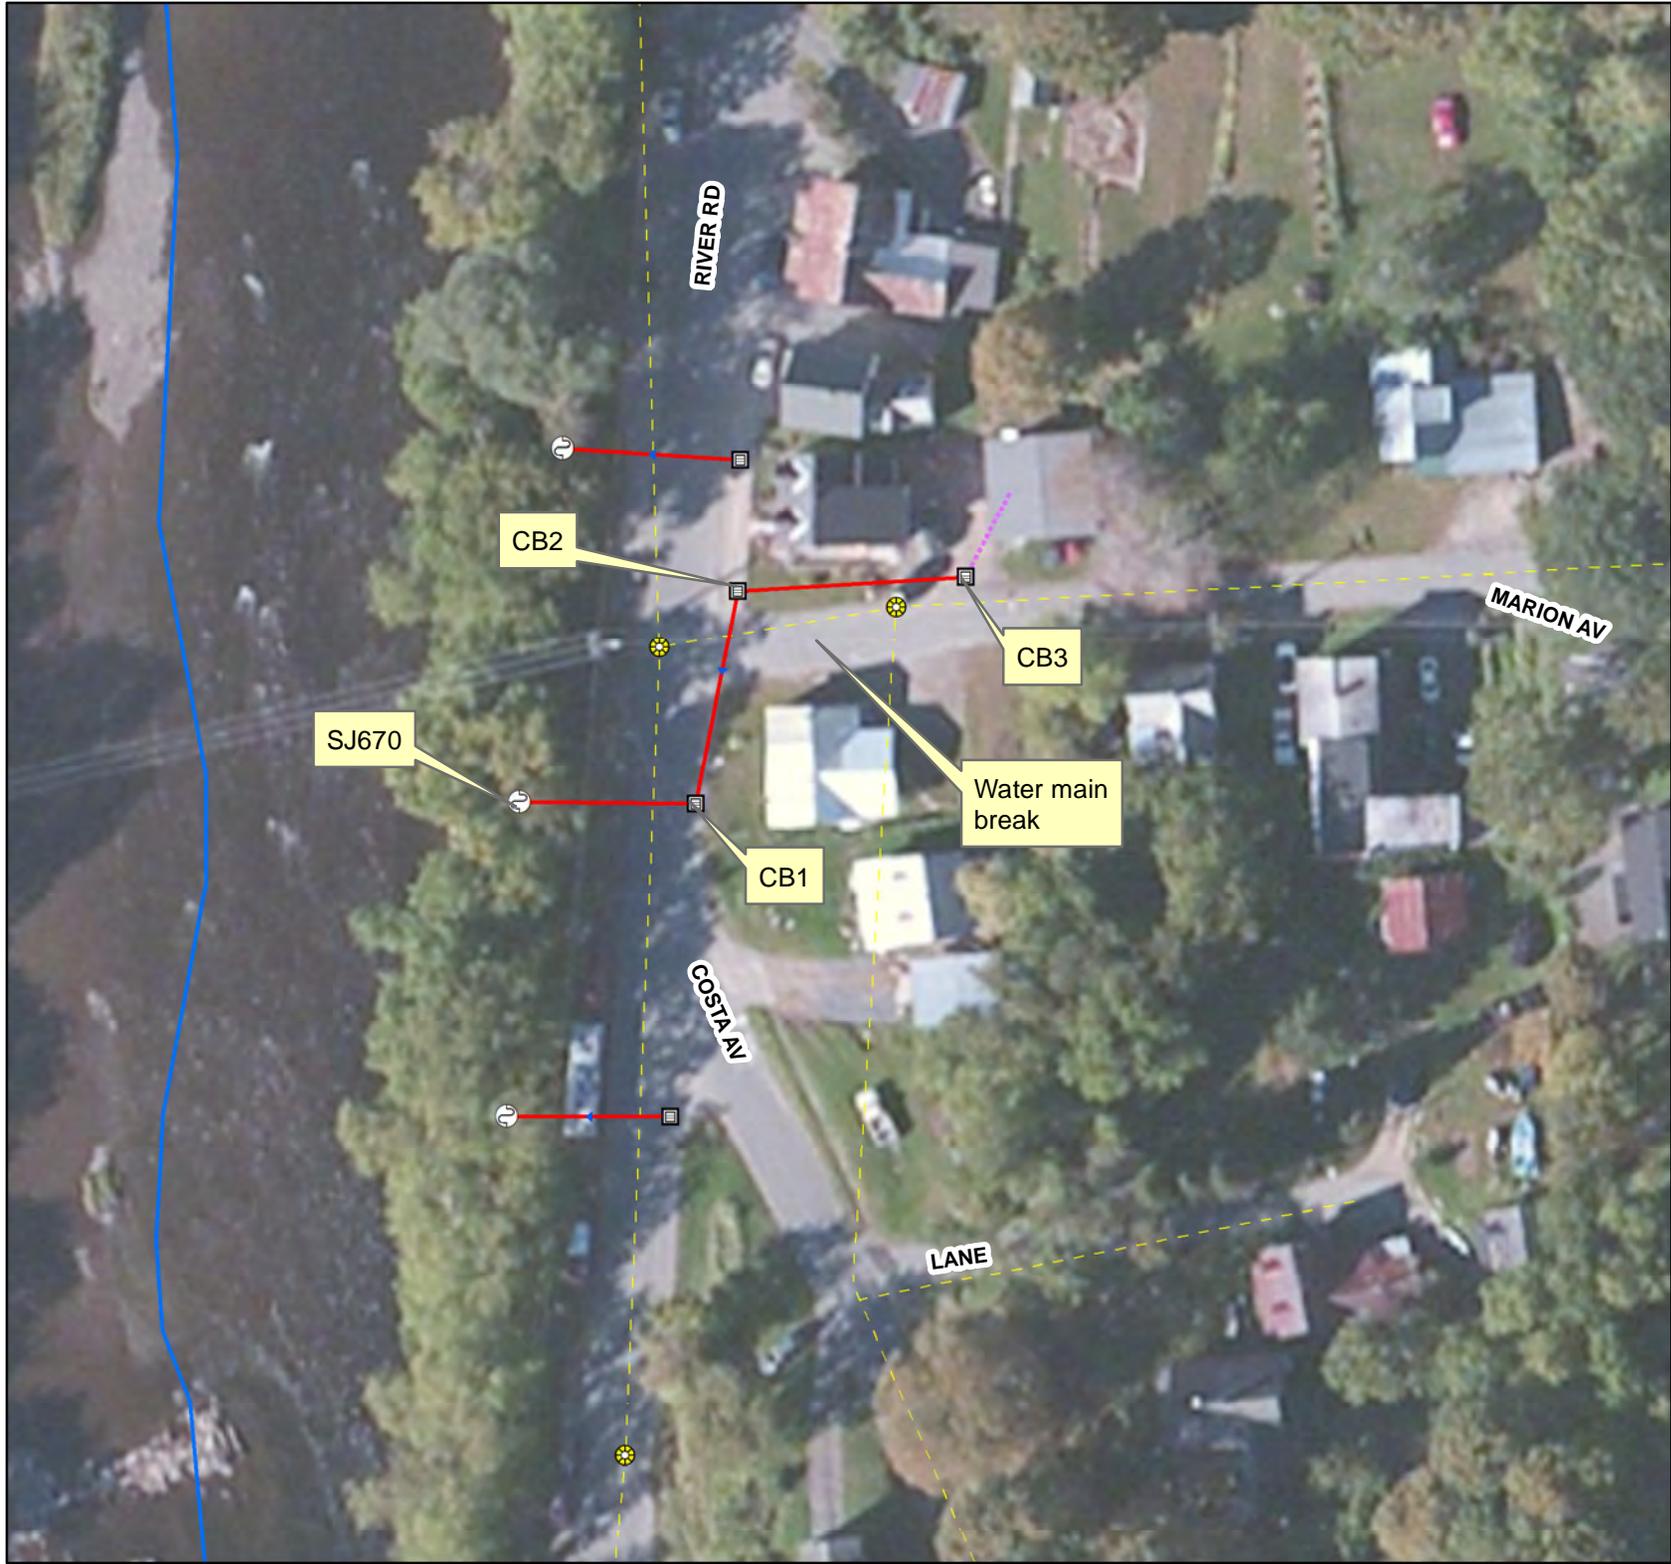
Map SJ-10, System SJ510,
CB9 Pipe B Branch
St. Johnsbury, VT

Structure ID	Status
SJ510 CB9	The source of optical brightener at catchbasin CB9 may be a plugged and leaking sewer lateral at 17 Parker Avenue. This lateral was cleaned out on June 29, 2015. This maintenance may eliminate the suspected wastewater discharge. However, it is also possible that the sewer lateral is in poor condition and will continue to leak into the stormdrain unless replaced.
SJ620	No chronic illicit discharge.
SJ640	No chronic illicit discharge.
SJ670	Leaks in the water distribution system were fixed and chlorine has not been detected in the system since.
SJ780	No chronic illicit discharge.
SJ820	No chronic illicit discharge.
SJ840	Despite poor water quality, there appears to be no current illicit discharge in this system.
SJ880	No chronic illicit discharge. Contaminants detected during the summer of 2014 appear to have resulted from construction.
SJ920	During dry weather, there is a slow drip from this CSO outfall. This appears insignificant from a water quality perspective.

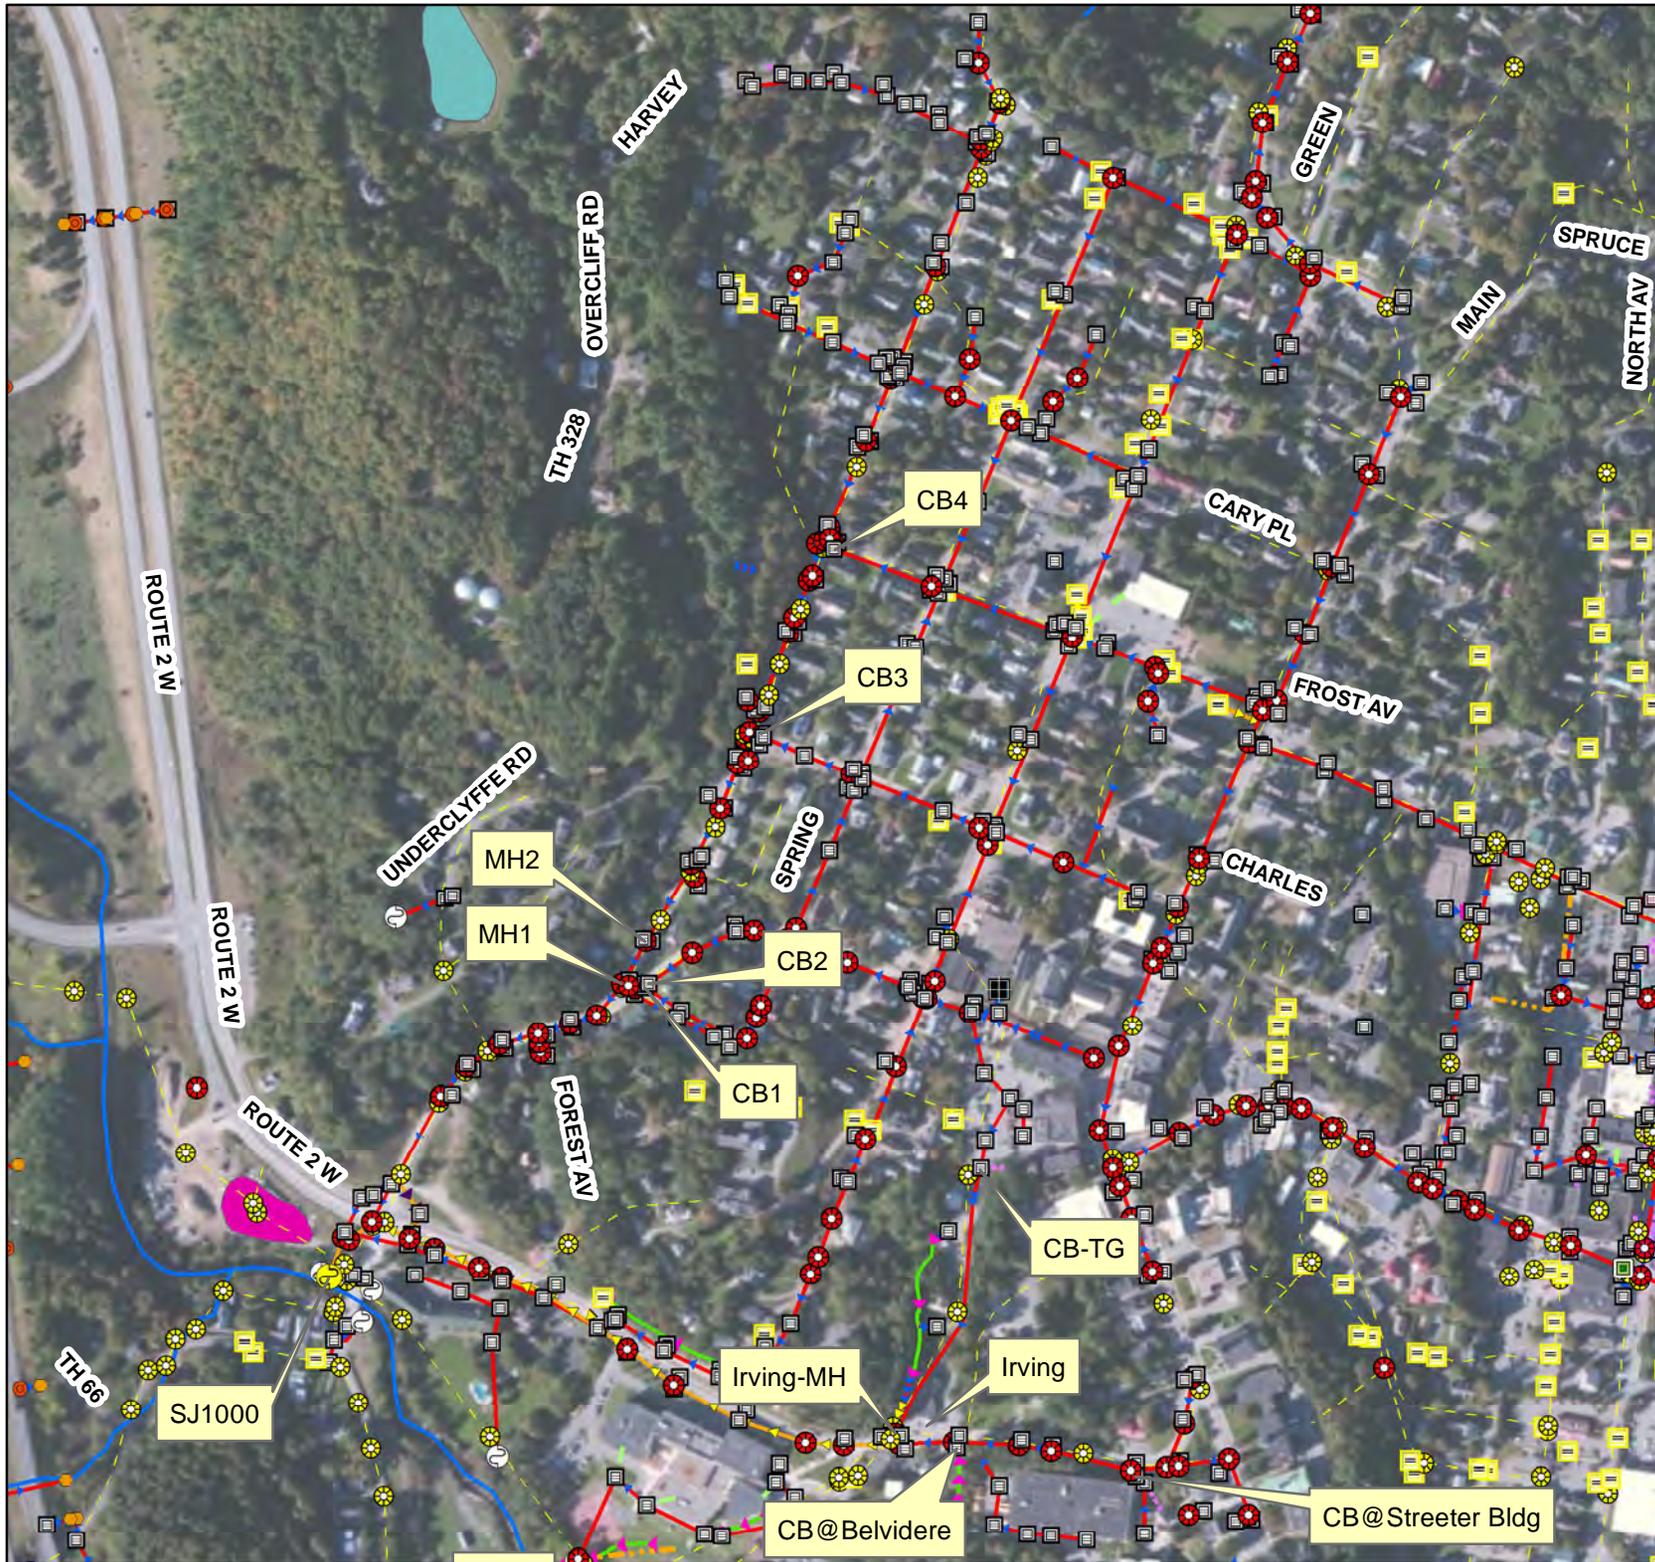
Map SJ-16
System SJ950
St. Johnsbury, VT

SJ950	Partially renovated wastewater from the septic system at 240 High Street appears to infiltrate a small stream passing through a deep culvert under the property. Because effluent does not surface, the system is not considered to have failed. Therefore, it appears that neither the Town of St. Johnsbury nor DEC could compel the property owner to replace the system.
SJ960	The chlorinated dry weather flow detected in this system on June 26, 2015 suggests a municipal water leak is present on lower Mt. Vernon Street. This issue was referred to the Town of St. Johnsbury.
SJ1000, CB1 branch	No chronic illicit discharge. Contaminants detected during the summer of 2014 appear to have resulted from construction.
SJ1000, CB3 branch	No chronic illicit discharge. Contaminants detected during the summer of 2014 appear to have resulted from construction.
SJ1000, CB4 branch	No chronic illicit discharge. Contaminants detected during the summer of 2014 appear to have resulted from construction.

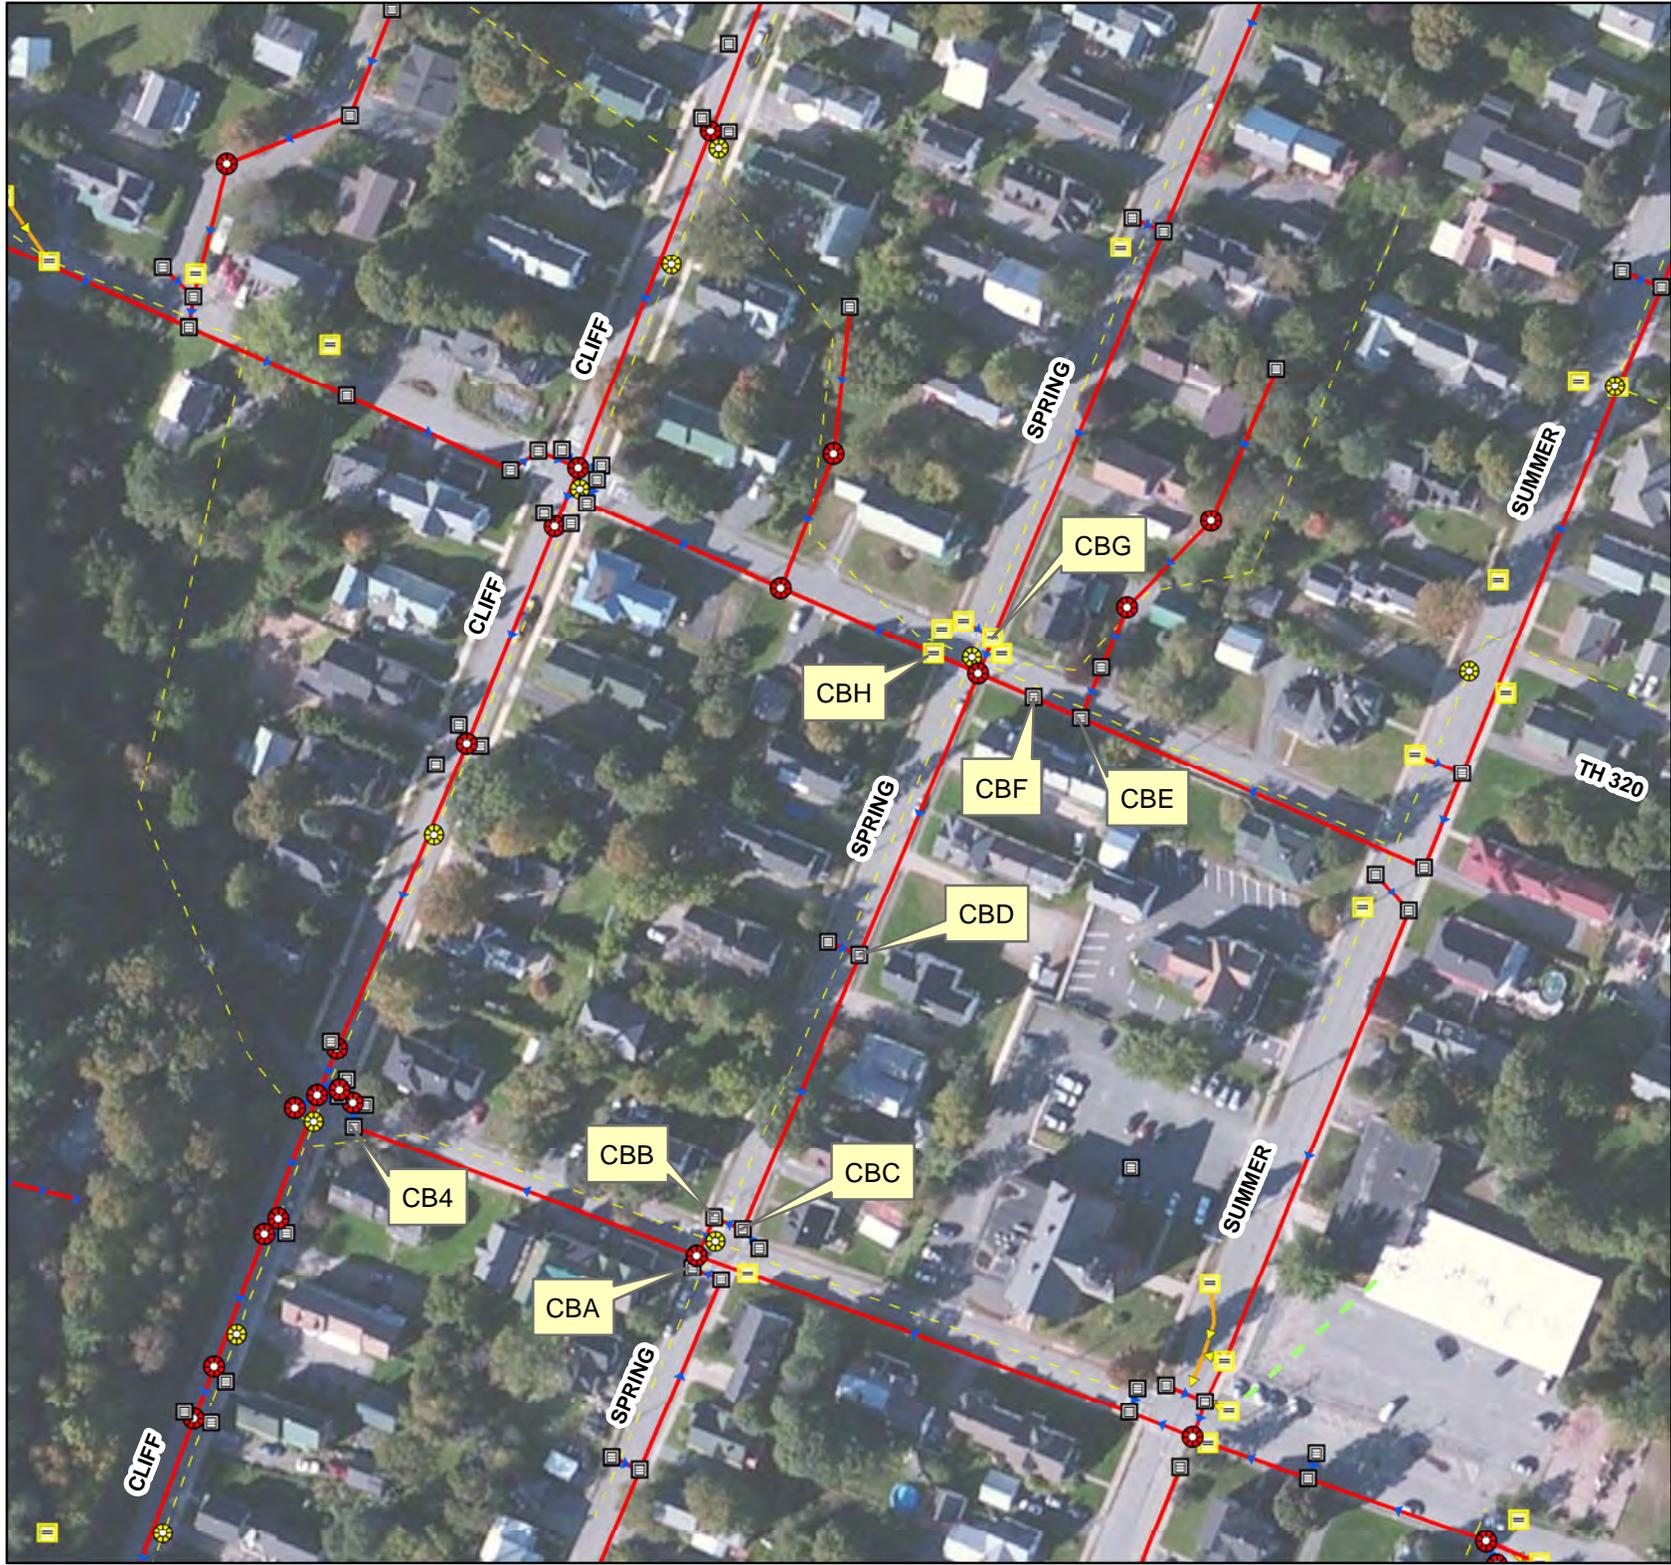
Map SJ-20 - Branch CB3
Systems SJ1000
St. Johnsbury, VT

Conclusion: A pipe entering catchbasin CB3 from the Cancer Center on Hospital Drive is the likely source of contaminants believed to be entering this system. The discharge may include air conditioning condensate, washwater, or both.

Resolution: Air conditioning condensation is generally considered an allowable discharge. However, these data suggest that washwater is also present in the flow. We recommend DEC contact the Cancer Center to notify them of these findings and to request information concerning any activities that might discharge washwater to this stormdrain.
