Illicit Discharge Detection and Elimination Statewide Project #4

19-128

Illicit Discharge Detection and Elimination Statewide Project

#4: Final Report

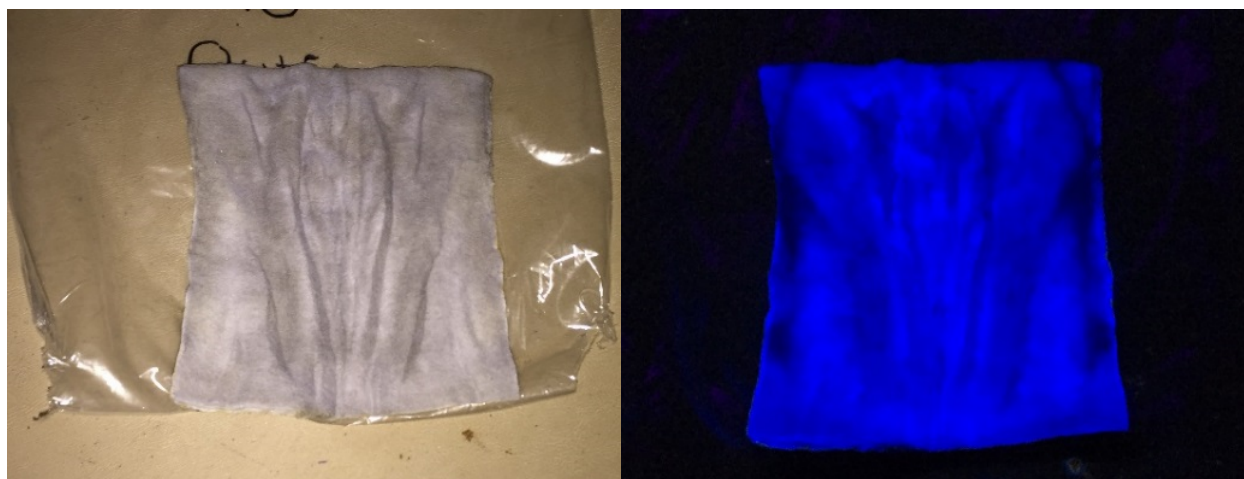
OB monitoring was performed at outfalls and selected catchbasins and manholes that were flowing at the time of inspection, in accordance with Stone Environmental SOP SEI-5.52.2 (Appendix A). To test for OB, a cotton pad was placed in the flow stream for a period of 4–10 days, after which the pad was rinsed, dried, and viewed under a long-wave ultraviolet light (“black light”). Fluorescence of the pad (see example in Figure 1) indicates the presence of OB. Pads were held in a sleeve of fiberglass window screen, affixed to the rim of the outfall pipe or secured with fishing line to a rock or other anchor. At catchbasins and manholes located at junctions in the storm sewer, pads were deployed in incoming pipes, if possible, but were often hung from the catchbasin grate or manhole rung into the sump. An advantage of OB monitoring is that some intermittent or dilute wastewater discharges can be detected due to the multiple-day exposure of the pad, whereas the contaminant may not be detected in tests performed on grab samples.

Figure 1. Positive OB pad under fluorescent (left) and UV (right) lamps

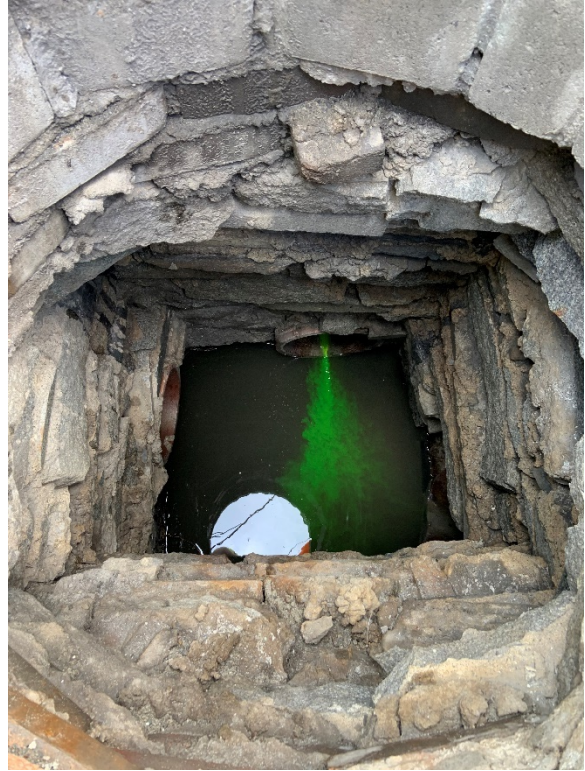
-
- MH11, indicating presence of wastewater (Figure 3). A high concentration of ammonia (4.0 mg/L) was also measured.
- Dye added in the sanitary manhole at 204 Hill Street (adjacent to storm manhole MH12) appeared in storm manhole MH11 (Figure 4), demonstrating a sanitary connection above MH11 on Nelson Street.

- The distance between storm manhole MH11 and the sanitary manhole at 204 Hill Street is 330 feet. Therefore, the uninspected length of the stormdrain was approximately 50 feet. The crossover point into the stormdrain must be within this 50-ft. segment (between 98 and 148 feet up the pipe from MH11).

Figure 4. Dye entering stormwater manhole MH11

Conclusion: High concentrations of ammonia, MBAS detergents, PPCPs, *E. coli*, and TP and a strong wastewater odor all indicate there is an ongoing illicit wastewater discharge to this system. Through dye and smoke testing and camera inspection we isolated the crossover point of sanitary sewage to the stormdrain between 98 and 148 feet up the pipe from MH11.

Resolution: Working with the City DPW, Stone has demonstrated there is a fourth, substantial leak in the Hill Street sanitary sewer. We recommend the City of Barre reconstruct the sanitary sewer between Nelson Street and the sanitary sewer manhole at 204 Hill Street.

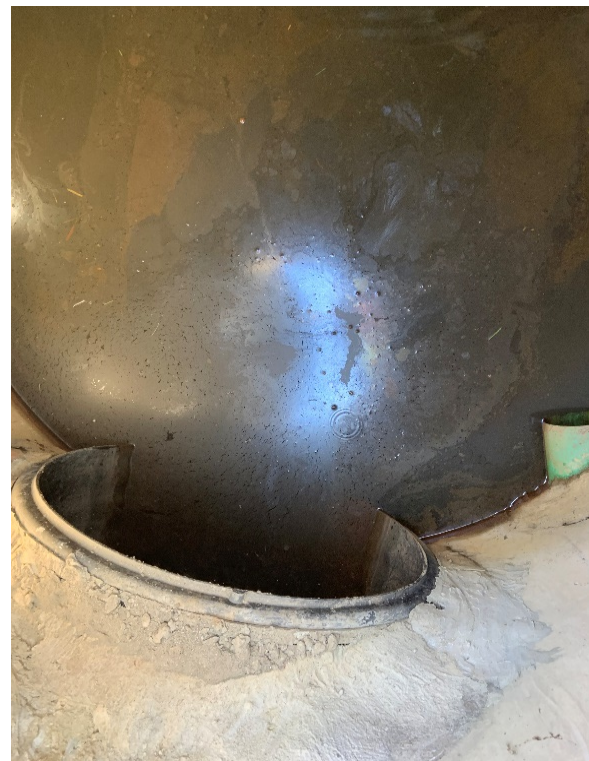
- On November 17, 2020, samples collected at the outfall had low concentrations of *E. coli* (31.3 MPN/100 mL) and TP (35.1 µg/L) (Table 31).
- Stone assessed the HRT446 drainage system on May 20, 2021.
 - There was no discernable connection from the onsite wastewater treatment system to the HRT446 stormdrain. Catchbasin CB1, which is closest to the wastewater system, had no outflow.
 - Flow at the outfall and in manhole MH1 (Figure 7) had an orange (iron) hue and a metallic sheen and odor.
 - All flow through the HRT446 system appeared to originate on the tree nursery property immediately south of the sports

Figure 7. Stormwater manhole MH1

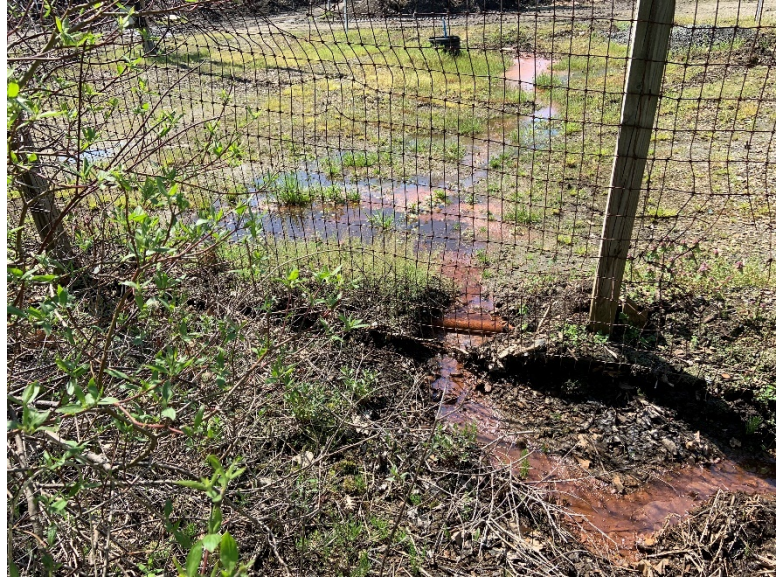
complex. Surface runoff and shallow groundwater were flowing off the nursery property in at least two areas (Figures 8 and 9). In the location labelled “drain outlets” on Map 8, the outlets of multiple drainage pipes were visible in a shallow gully (Figure 9). Flow from the nursery enters the HRT446 stormdrain at the culvert inlet labelled CI1 (Figure 10). The water flowing into CI1 had the same orange (iron) hue and metallic odor as the water in manhole MH1 and at the outfall.

Figure 8. Runoff from tree nursery property

Conclusion: We found no evidence of an illicit discharge on the property of the sports complex. The poor water quality in the HRT446 stormdrain flows into the stormdrain from the tree nursery south of the sports complex.

Resolution: It is unclear what, if any, recourse DEC or the Town of Hartford may have to reduce flow and transport of iron floc from the nursery property onto the sports complex property.

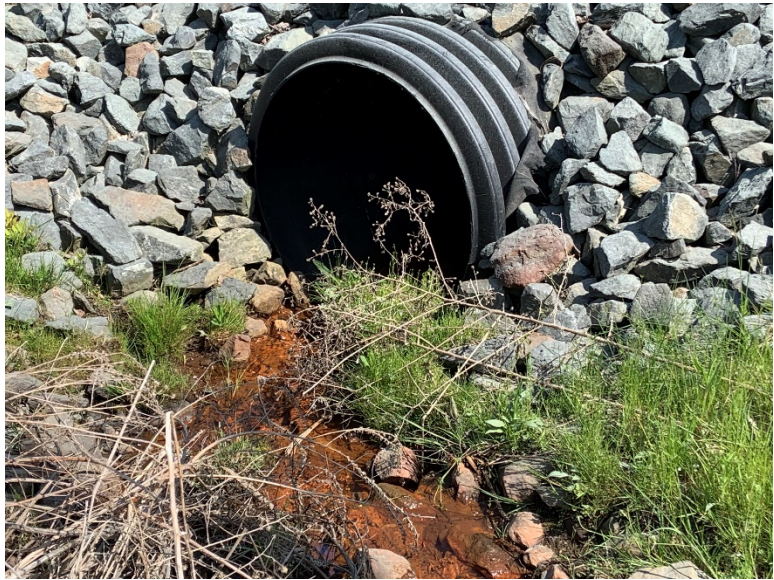
Figure 10. Culvert inlet (CI1) to the HRT446 stormdrain

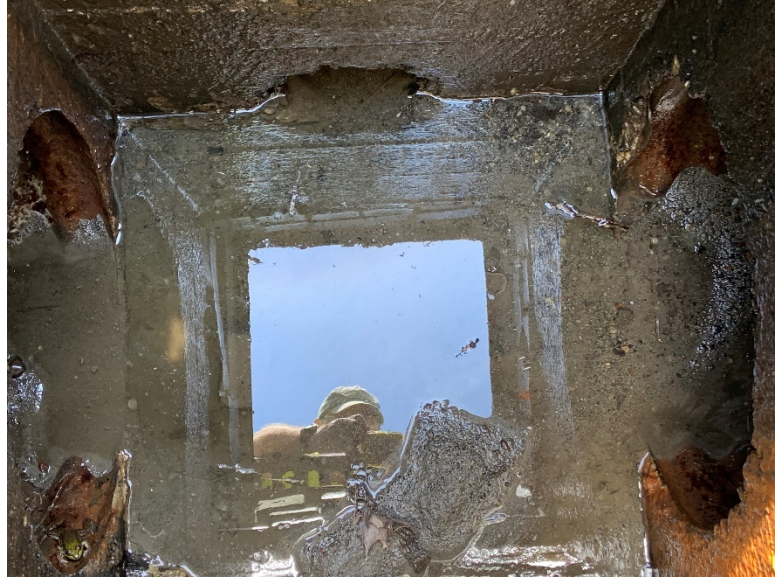
- Stone began advanced investigation of this stormdrain on July 1, 2020. In catchbasin CB1, an unmapped 6-in diameter pipe (Figure 11) was noted entering the sump from the direction of the childcare center. It was mostly plugged with sediment.
 - The MBAS concentration at the outfall and at CB1 was slightly elevated, 0.3 mg/L.

- During a third visit to the site on August 31, 2020, the ammonia concentration in catchbasins CB1, CB2, and CB4 were below detection.
- VTrans cleaned catchbasin CB1 during the summer of 2021, enabling camera inspection. On September 18, 2021, Dave Braun and Jim Pease inspected catchbasin CB1 with a push camera. The camera was inserted into pipe B (Figure 11), the unmapped pipe aligned with the Childcare Center. Beyond the concrete wall of the catchbasin, the pipe changes to corrugated metal. Only 2-3 feet into

Figure 11. Pipe junctions in catchbasin CB01

the pipe the camera was stopped by a solid plug of wet sediment. The sediment was stained orange with iron.

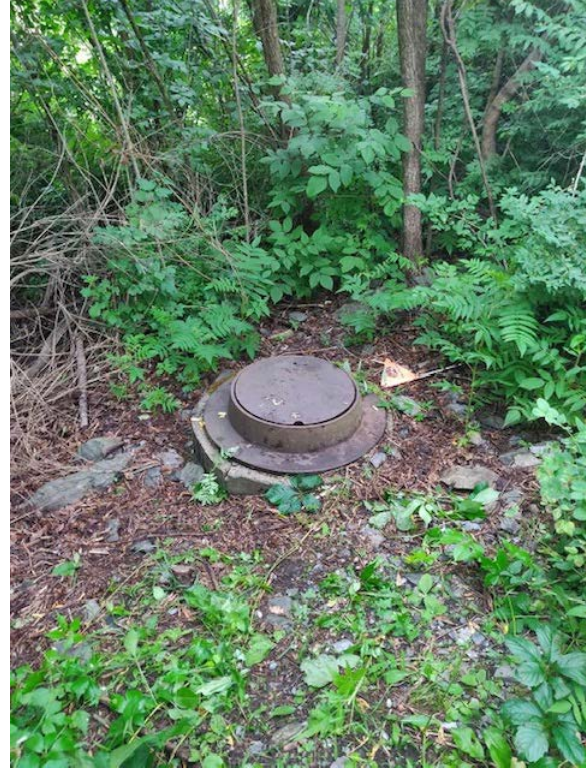
- There are no known stormwater inlets to this system. At this time, the entire system appears to have been abandoned, with no recognized purpose. The MO01 stormdrain outfall could not be located. It is likely buried. Therefore, all testing was performed at the first storm manhole up the line, MO01-MH1 (Figure 17).

- MH1 was retested for OB on June 10, 2021, and was positive.
- Dye testing and camera inspection were performed on September 18, 2021, by Dave Braun and Jim Pease. In MH1, the inlet pipe was dry, and the outlet pipe was entirely buried in sediment. A camera was pushed as far up the inlet pipe as possible. The first ~7 feet of pipe is broken vitrified clay pipe. At 7 feet up the line, the pipe turns left and changes to a short section of

Figure 17. Manhole MH1

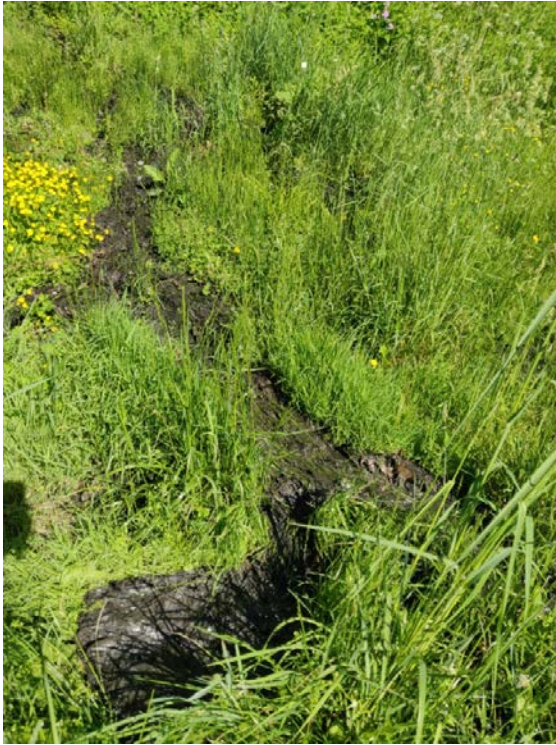
- The NF15 outfall was first visited on June 12, 2020. A problem was immediately apparent, as the discharge contained dark, malodorous sediment (Figures 19 and 20). Samples were taken and OB pads set at the outfall and at catchbasins CB01 and CB02, which contained the same dark, malodorous sediment. Ammonia, chlorine, and MBAS concentrations were elevated at the outfall and

at catchbasin CB02. However, since these three tests are colorimetric and the water samples were extremely turbid, these may not be valid results. OB was not detected at the outfall.

Figure 19. Muddy effluent flowing over the grass below the NF15 outfall, June 12, 2020

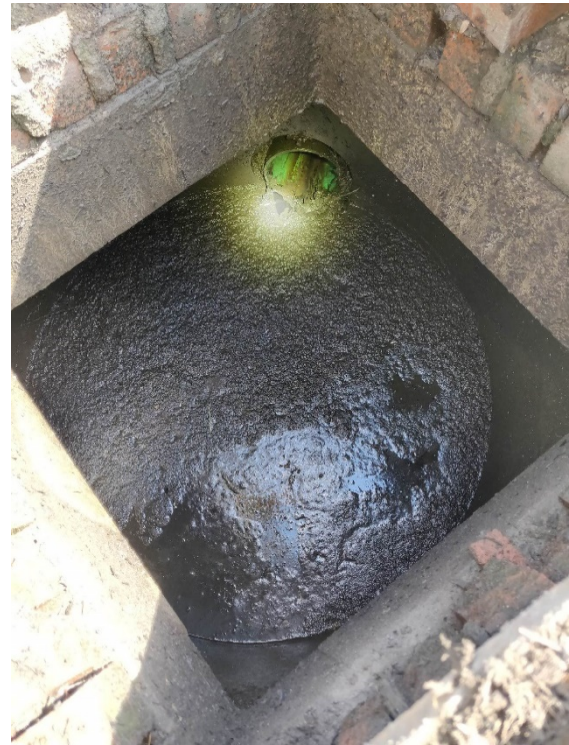
Figure 20. Dark, muddy water in catchbasin CB02

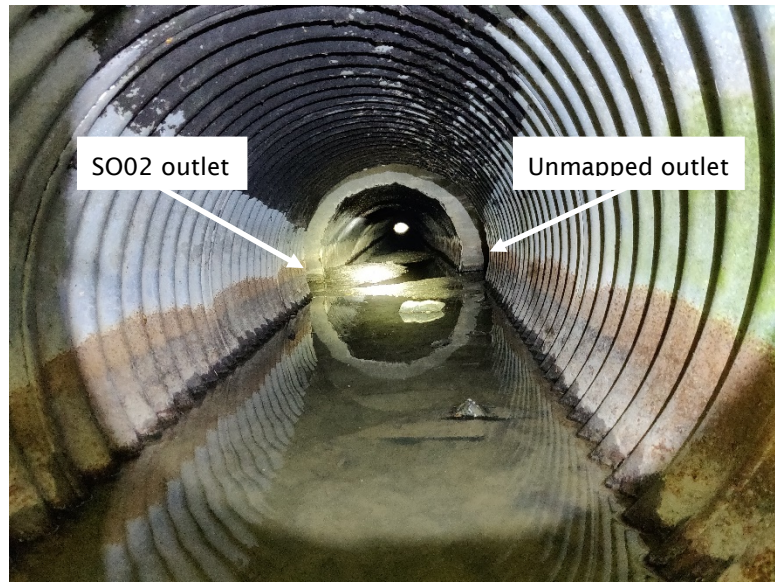
Conclusion: The presence of OB at the outlet of the US Route 2 cross-culvert was consistent and obvious. However, there was no evidence of an illicit discharge in the SO02 stormdrain. Rather, a sanitary wastewater connection was identified from 255 US-2 to a different (unmapped) stormdrain that also discharges to the US Route 2 cross-culvert. Given the odors and discoloration observed in CB1, and the fact that the flow rate increased when the toilet was flushed, this is almost certainly a sanitary connection. However, the absence of wastewater solids suggests the connection is a septic tank overflow pipe rather than a straight pipe.

Figure 22. View down US Route 2 cross-culvert

Resolution: With this report, we are notifying the Town of South Hero and DEC's Regional Wastewater Engineer of this finding.

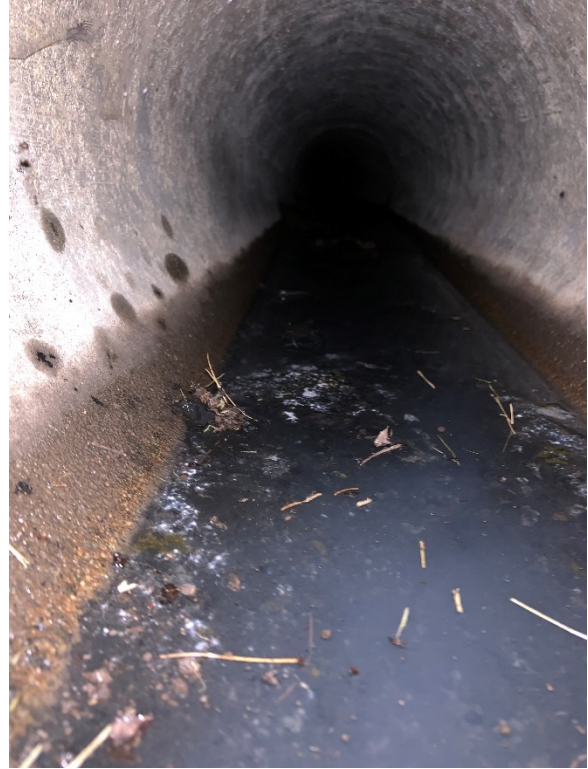
- On June 1, 2021, we opened catchbasins on the SO05 stormdrain and noted wastewater odors and water with a blue-grey cast (Figure 23). We also observed an unmapped pipe outlet within the stormdrain between CB04 and CB05.

Figure 23. View up SO05 stormdrain from catchbasin CB04, June 1, 2021
