Detecting and Eliminating Illicit Discharges in the Upper and Middle Connecticut River Basin: Final Report

15-090

Jim Pease / *Environmental Scientist*
VT Department of Environmental Conservation
1 National Life Drive, Main Building, 2nd Floor
Montpelier, VT 05620-3522
Jim.Pease@vermont.gov
802.490.6116

David Braun / *Senior Water Resources Scientist*
Stone Environmental, Inc.
535 Stone Cutters Way
Montpelier, VT 05602
dbraun@stone-env.com
802.229.5379

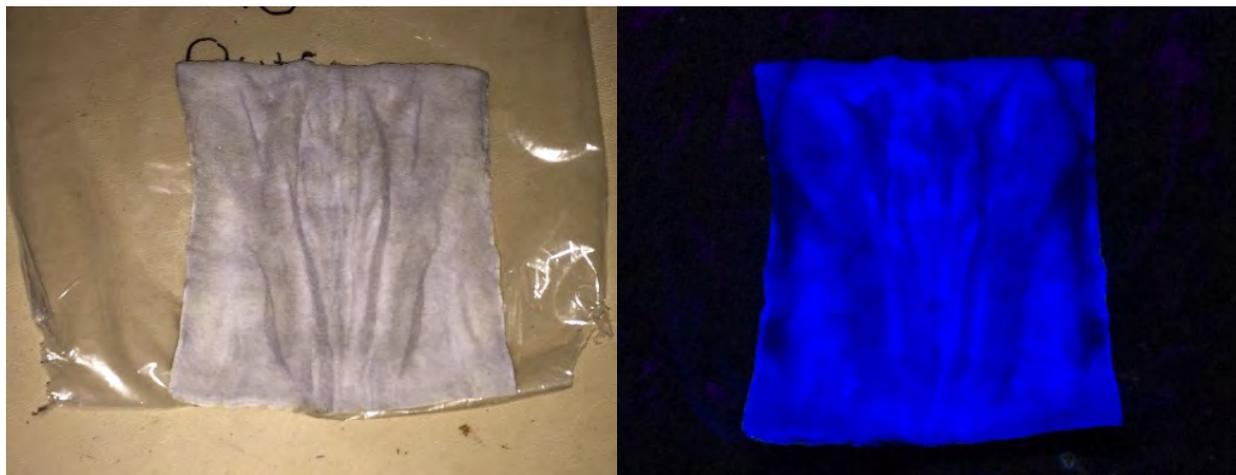
Figure 1. Positive optical brightener monitoring pad under fluorescent (left) and UV (right) lamps.

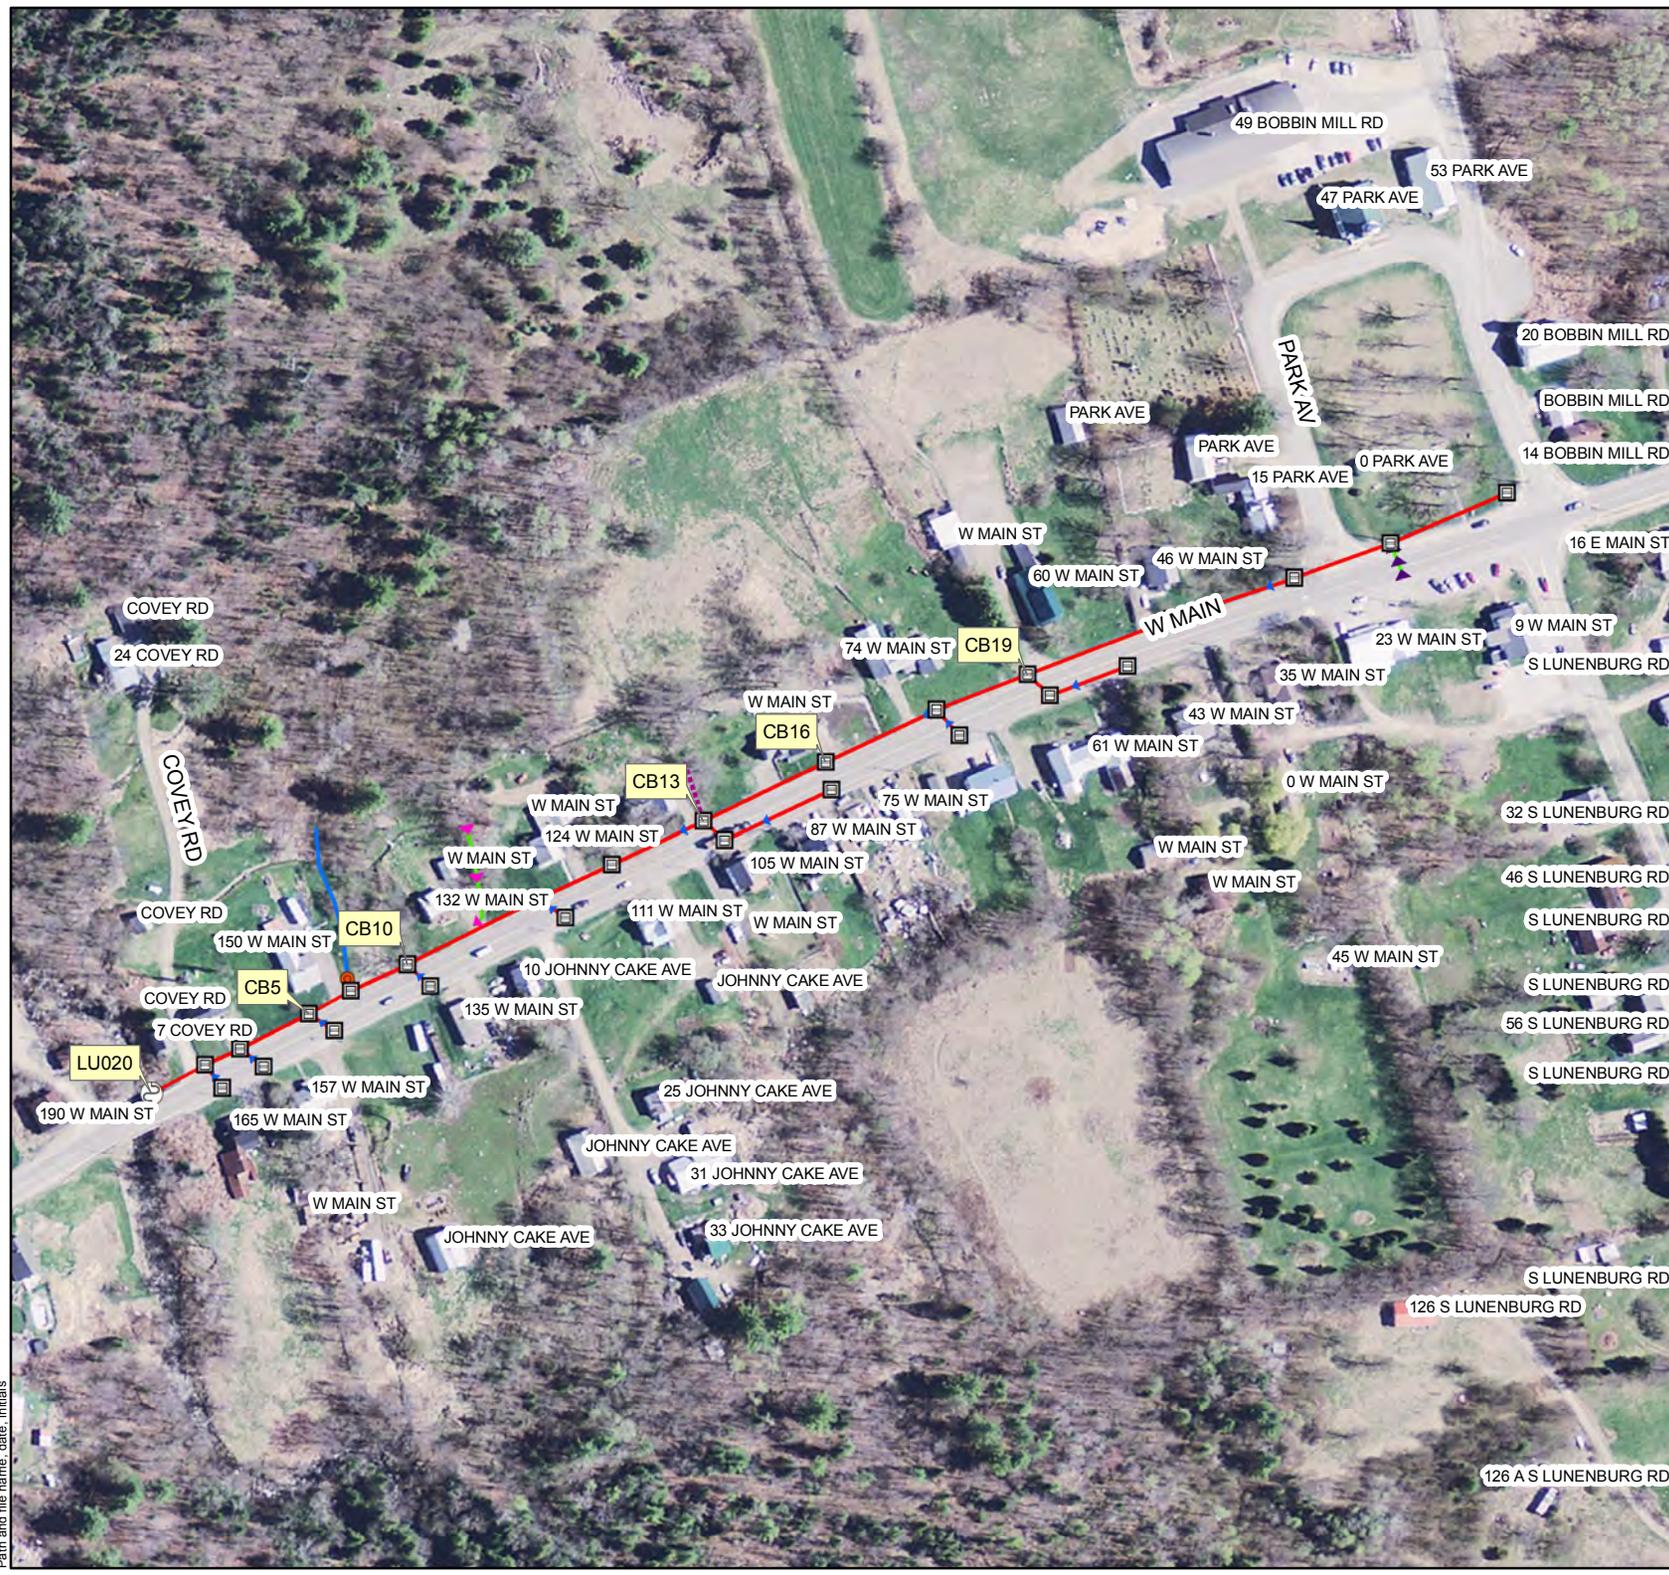
System LU020

- A septic odor was noted when the LU020 outfall was first sampled on October 7, 2015. However, the concentrations of ammonia and MBAS were below detection and optical brightener was not present.
