FINAL REPORT – WHITE RIVER BASIN ILLICIT DISCHARGE DETECTION AND ELIMINATION STUDY

BARNARD, BETHEL, CHELSEA,
GRANVILLE, HANCOCK, HARTFORD,
PITTSFIELD, QUEECHEE, RANDOLPH,
ROCHESTER, ROYALTON, SHARON, AND
TUNBRIDGE,

FINAL REPORT

9-26-2018

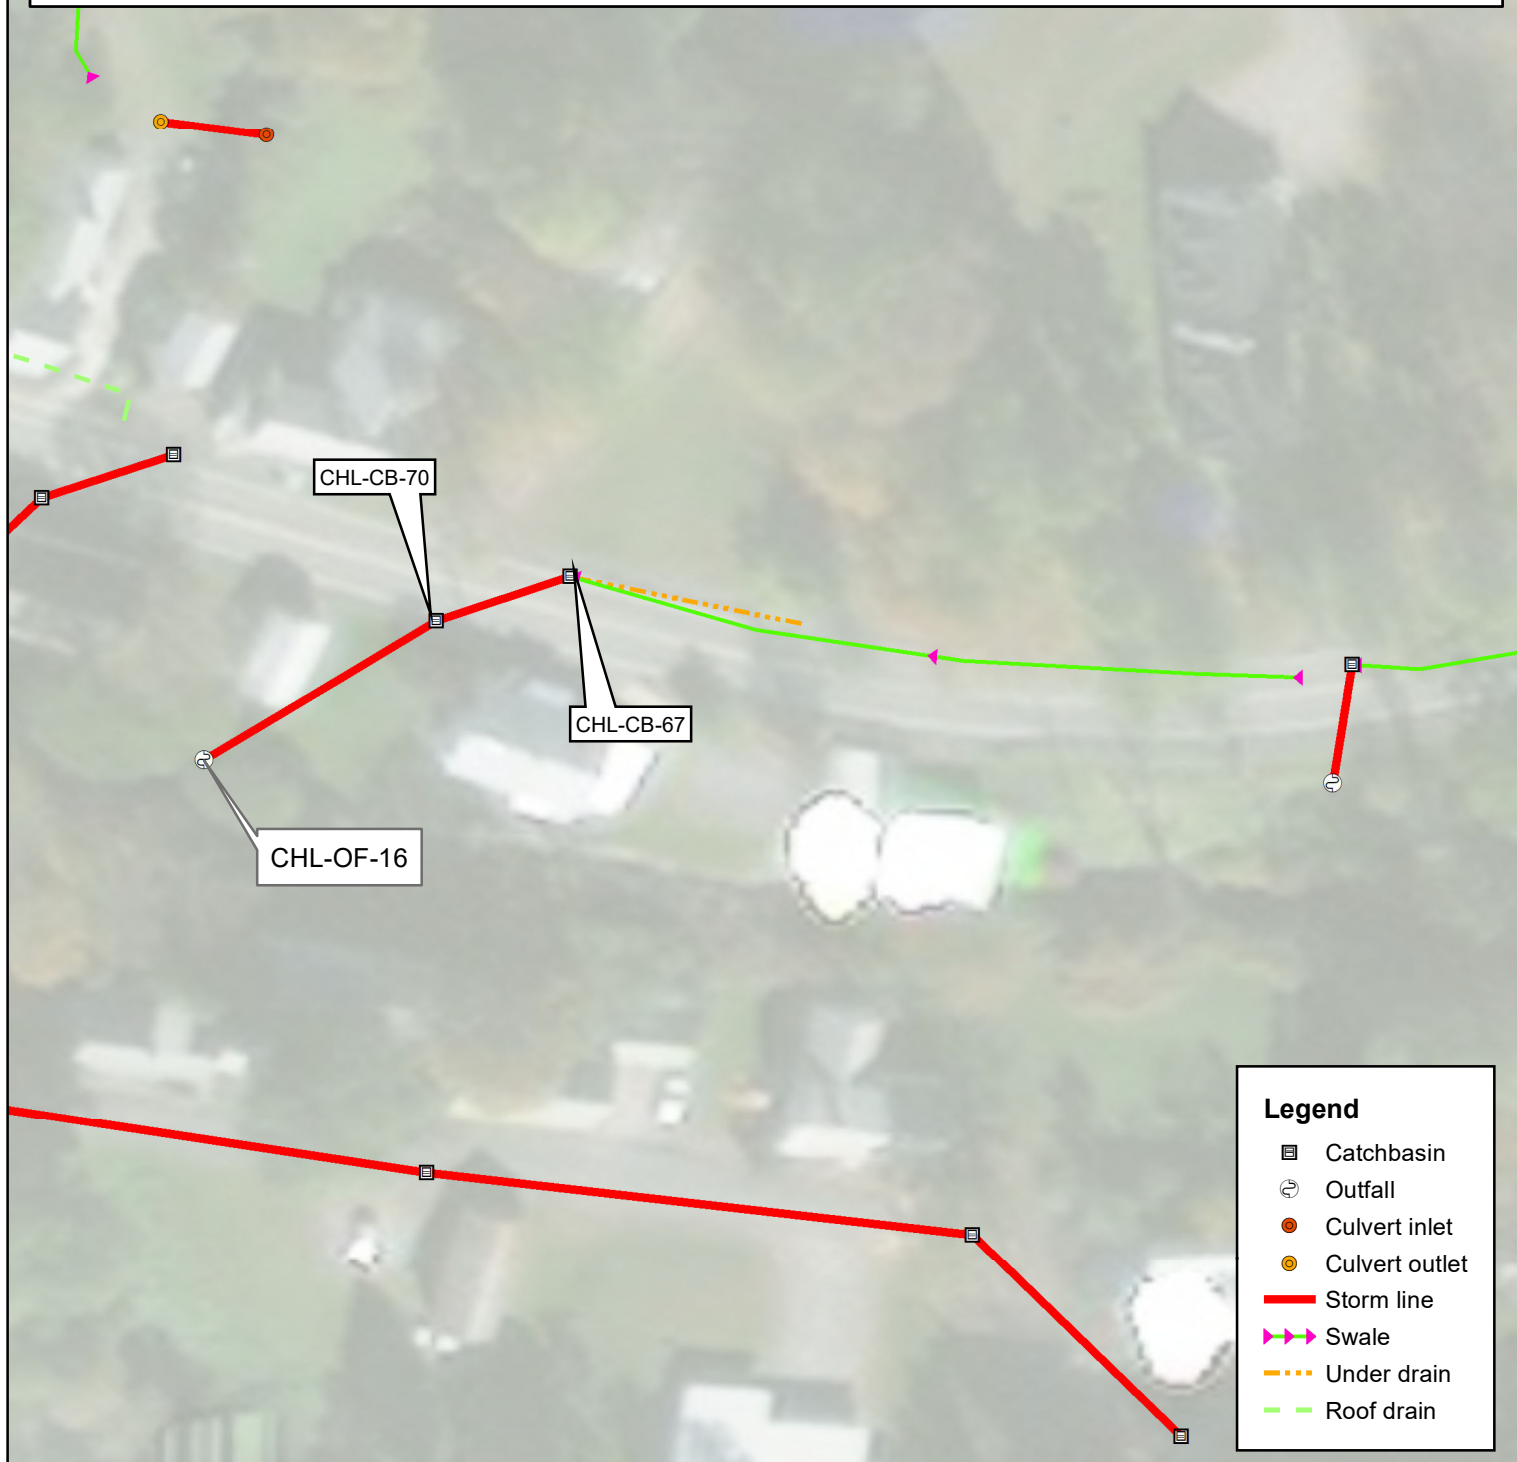
Initial water quality testing revealed a relatively elevated pH of 9.6 and conductivity of 2055 uS/cm. Connected to an underdrain, upstream catchbasins were flowing but infrastructure restricted sampling. Smoke was injected into CHL-CB-70 and no smoke was observed from any non-stormwater related infrastructure. Illicit discharge unlikely.

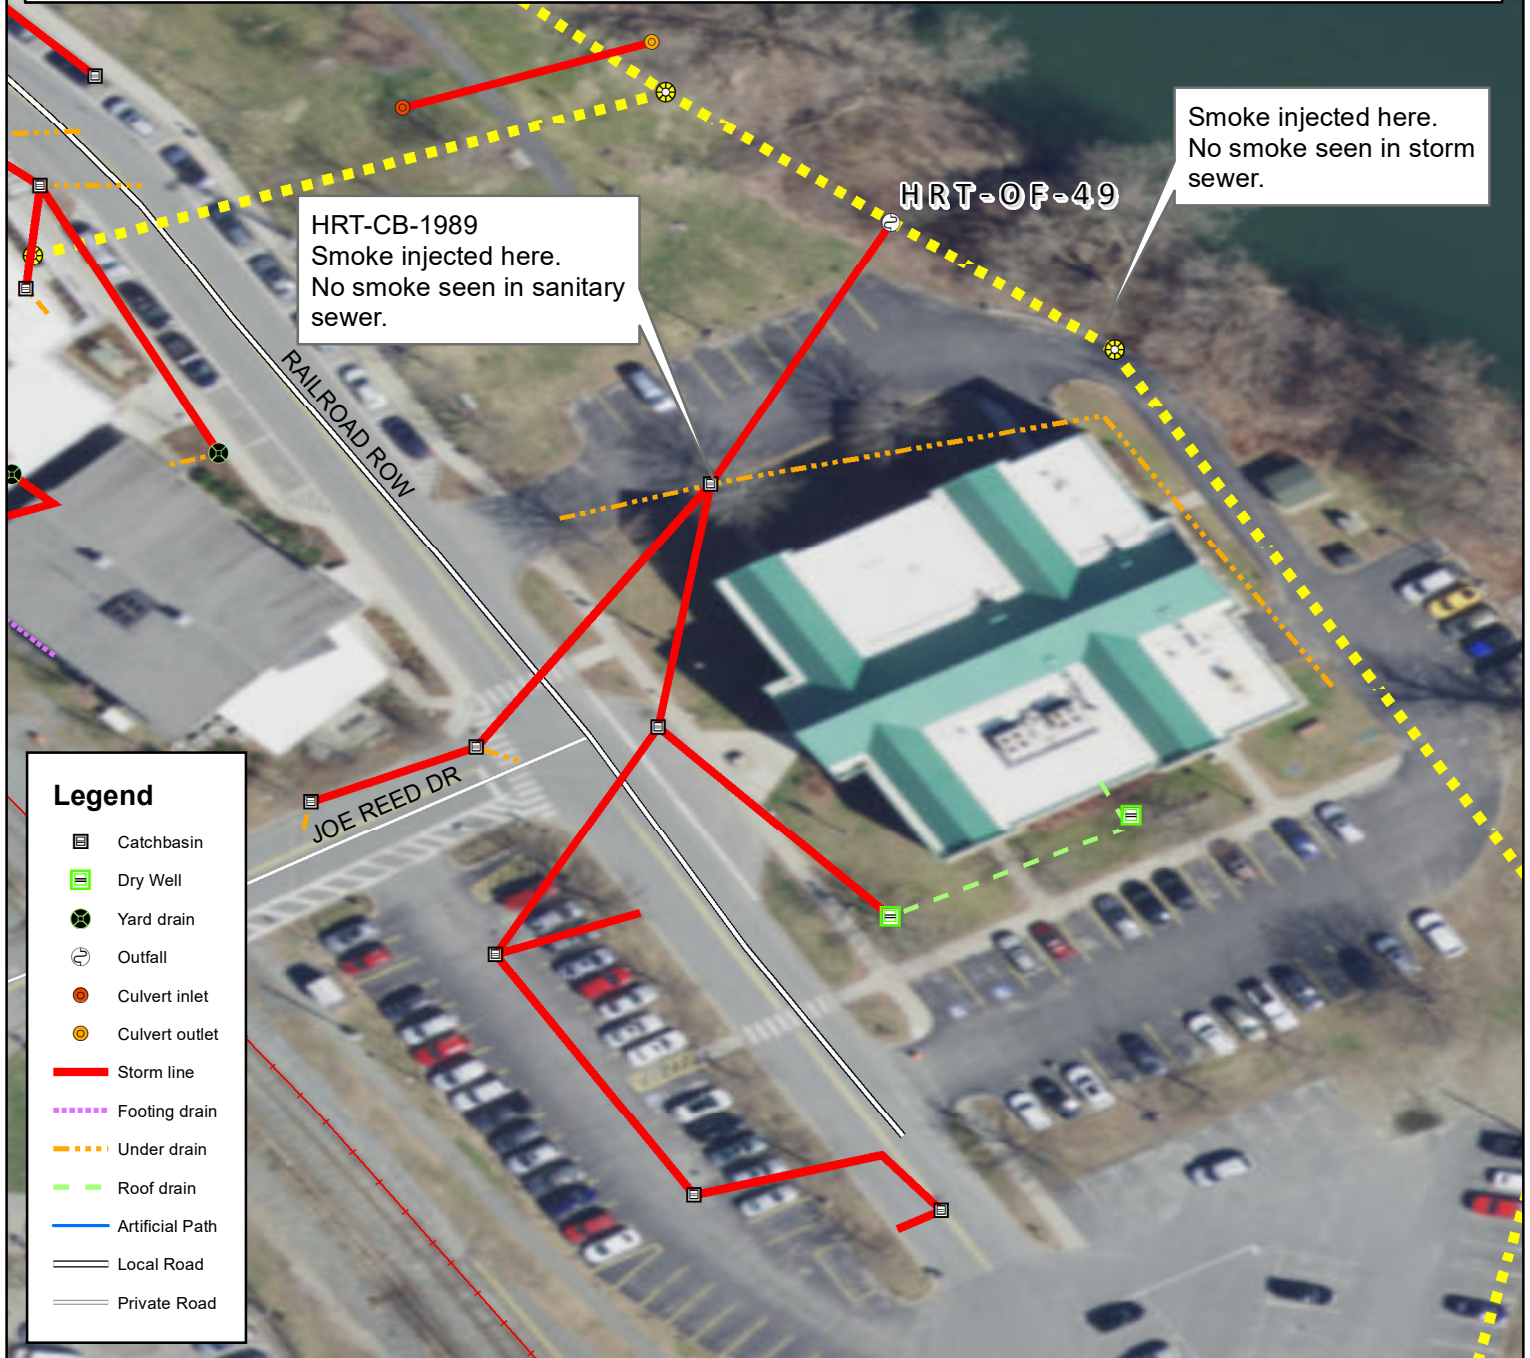
Initial investigation revealed a very small amount of flow but with elevated concentrations of ammonia, chlorine, and detergents. The source of the flow was a pipe discharging to nearest upstream catchbasin. Based on the results of smoke testing it is unlikely there is an illicit discharge to this

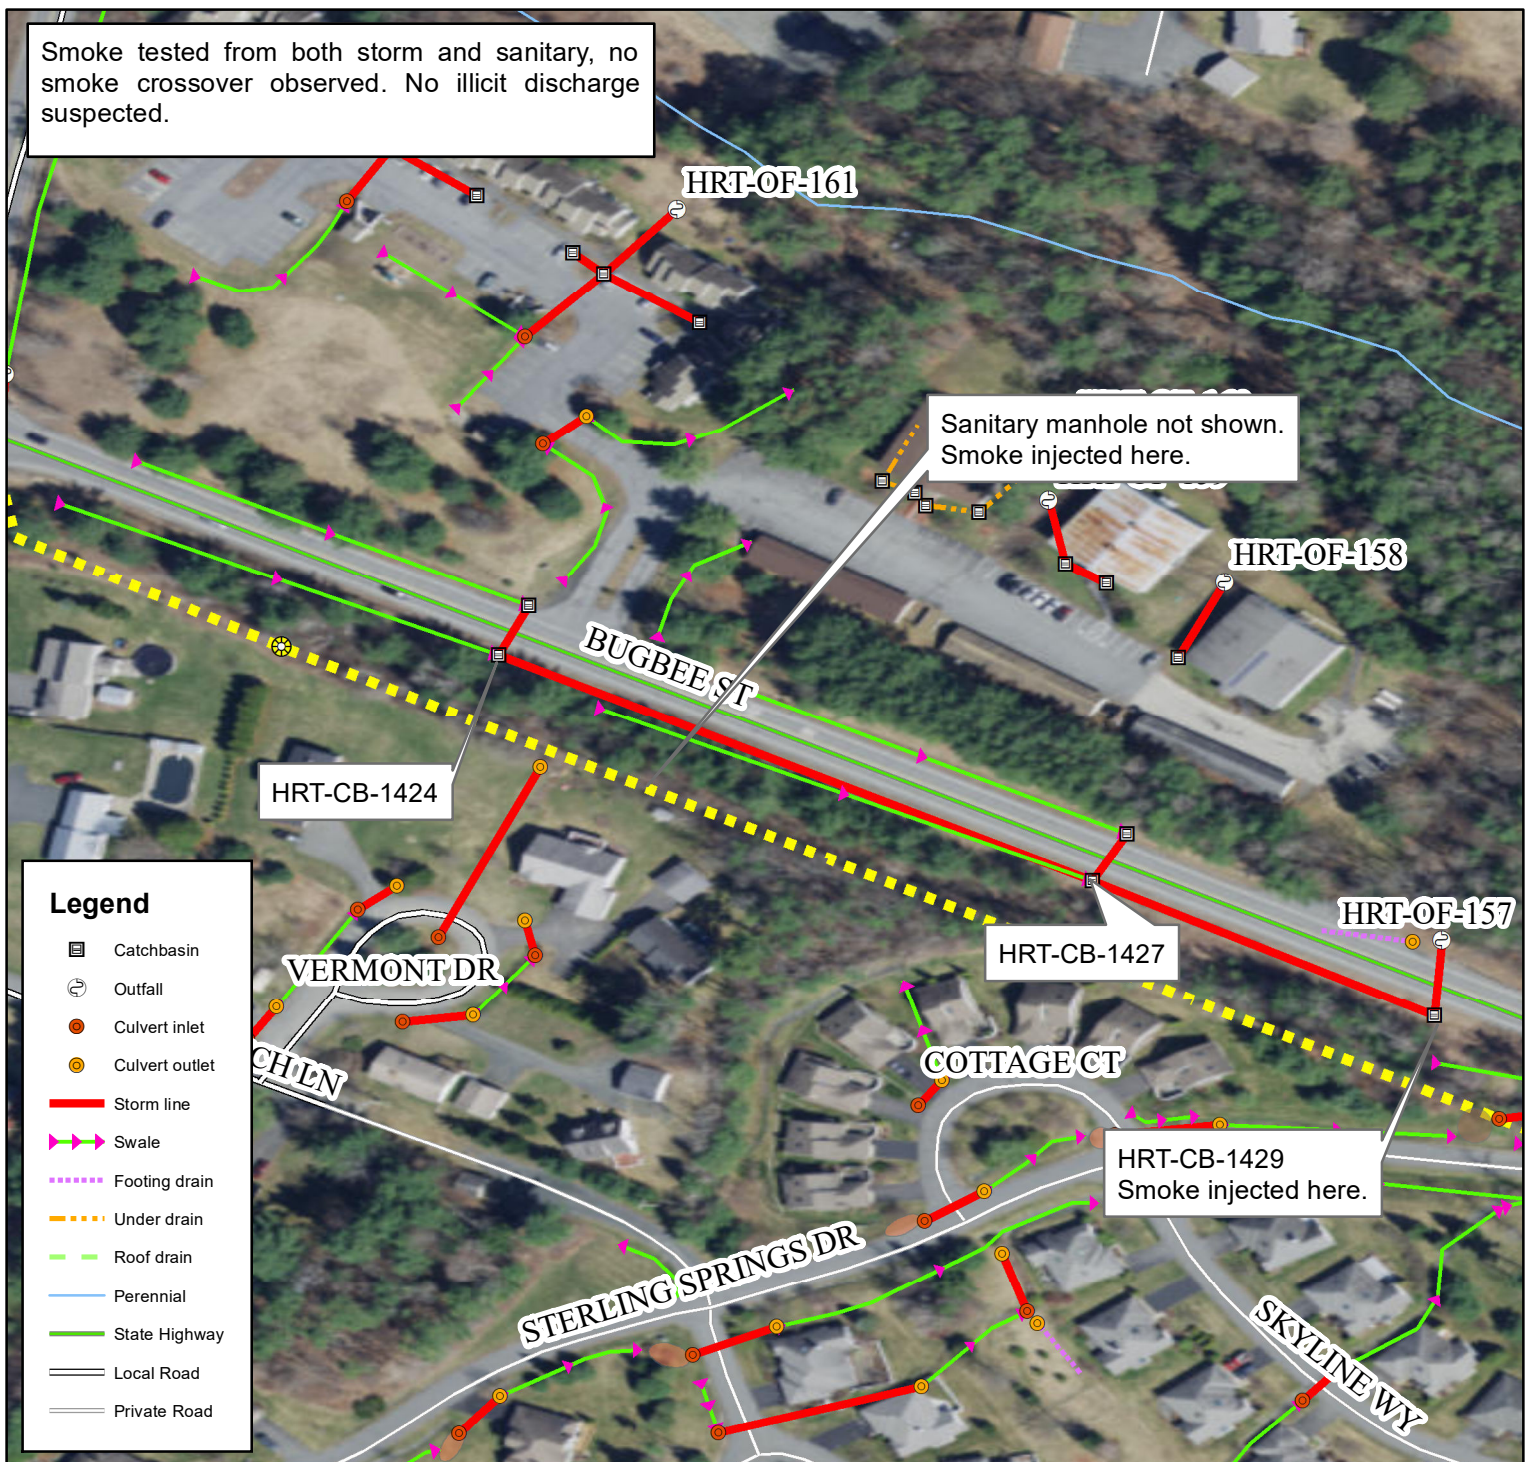
Smoke tested from both storm and sanitary, no smoke crossover observed. No illicit discharge suspected.

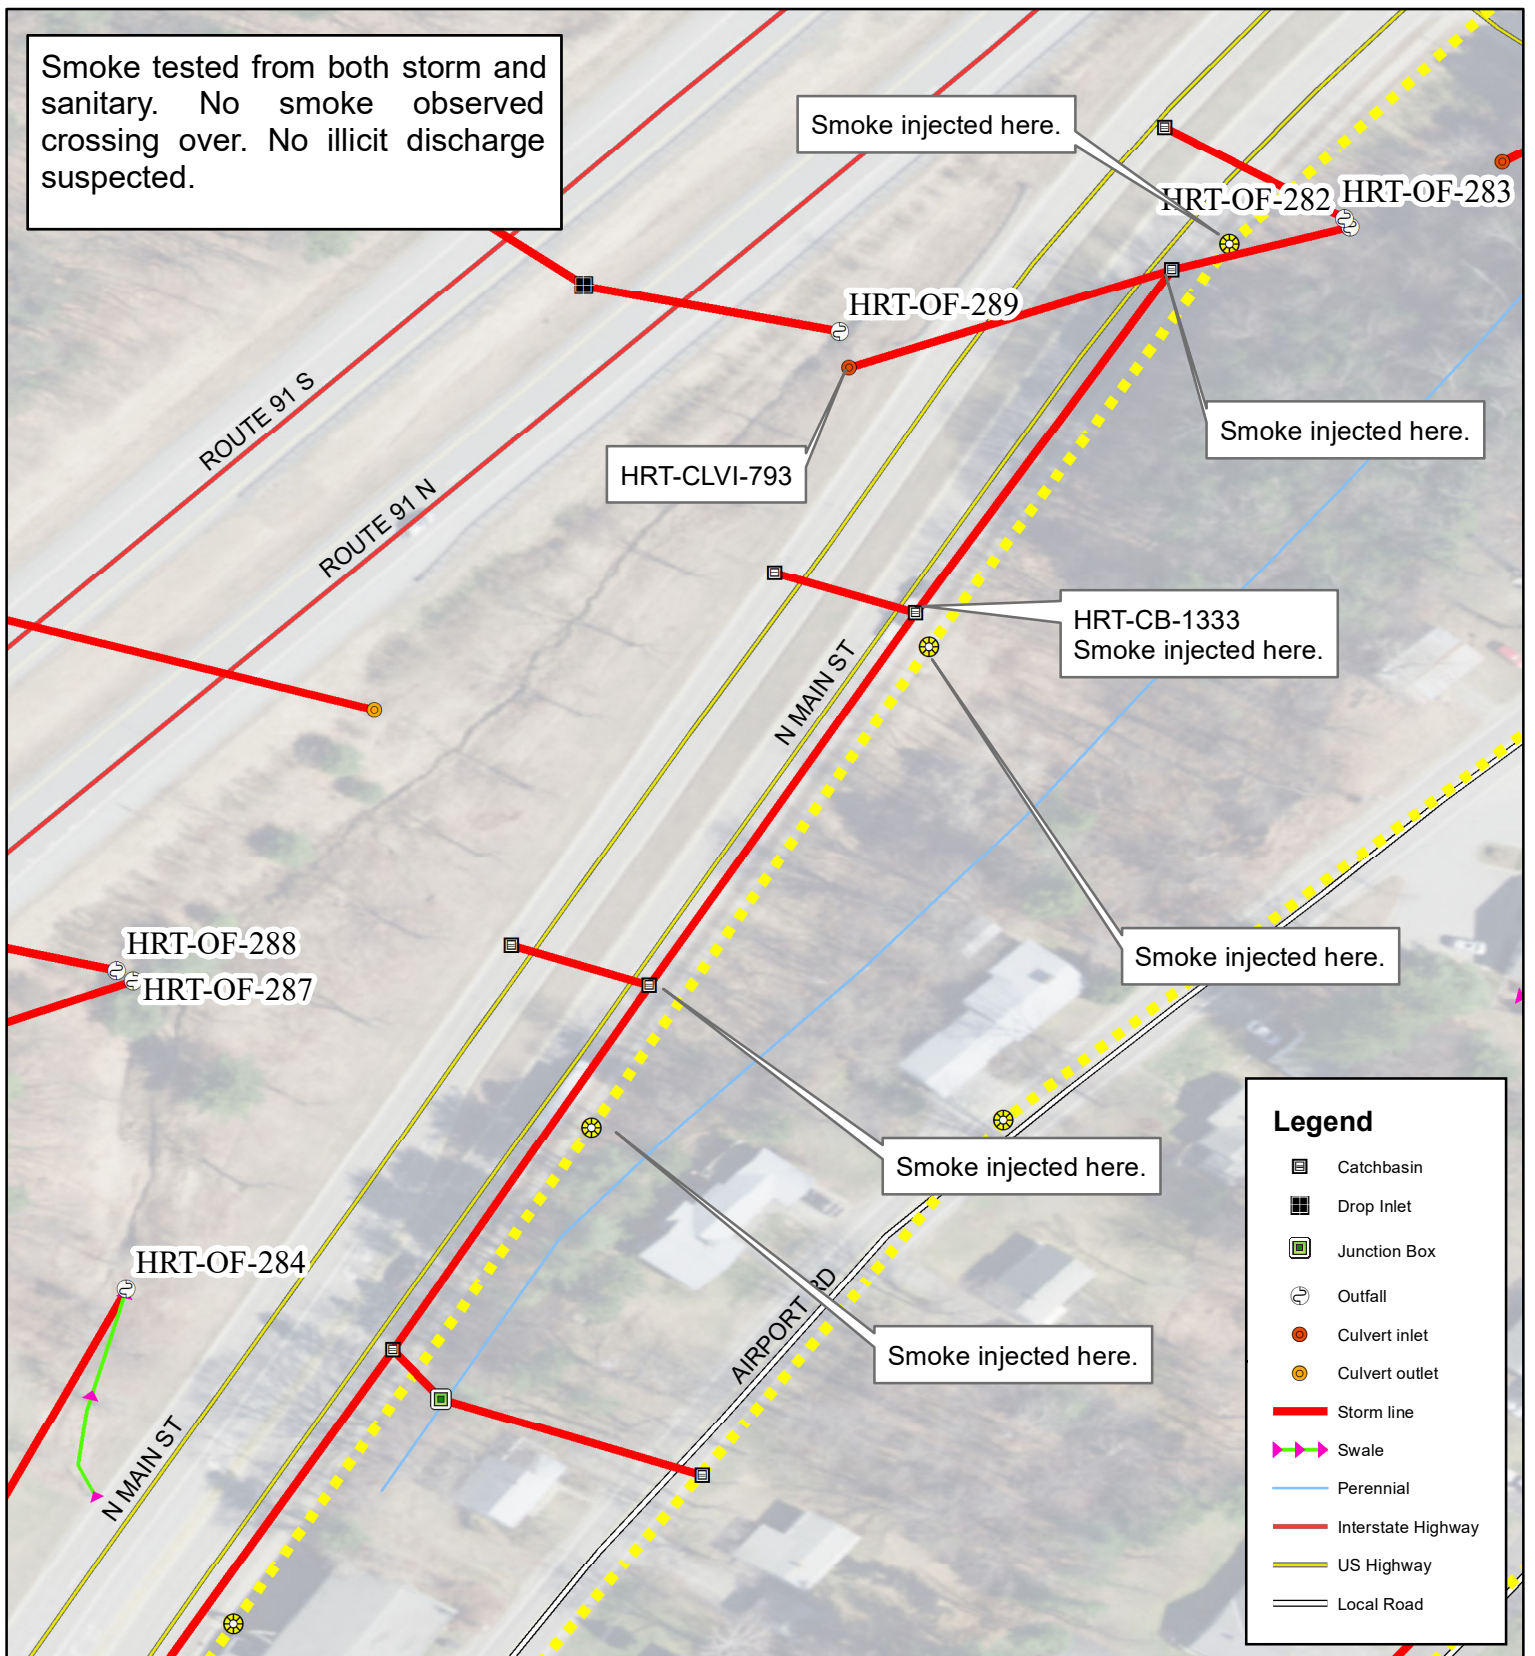
Smoke tested from both storm and sanitary. No smoke observed crossing over. No illicit discharge suspected.

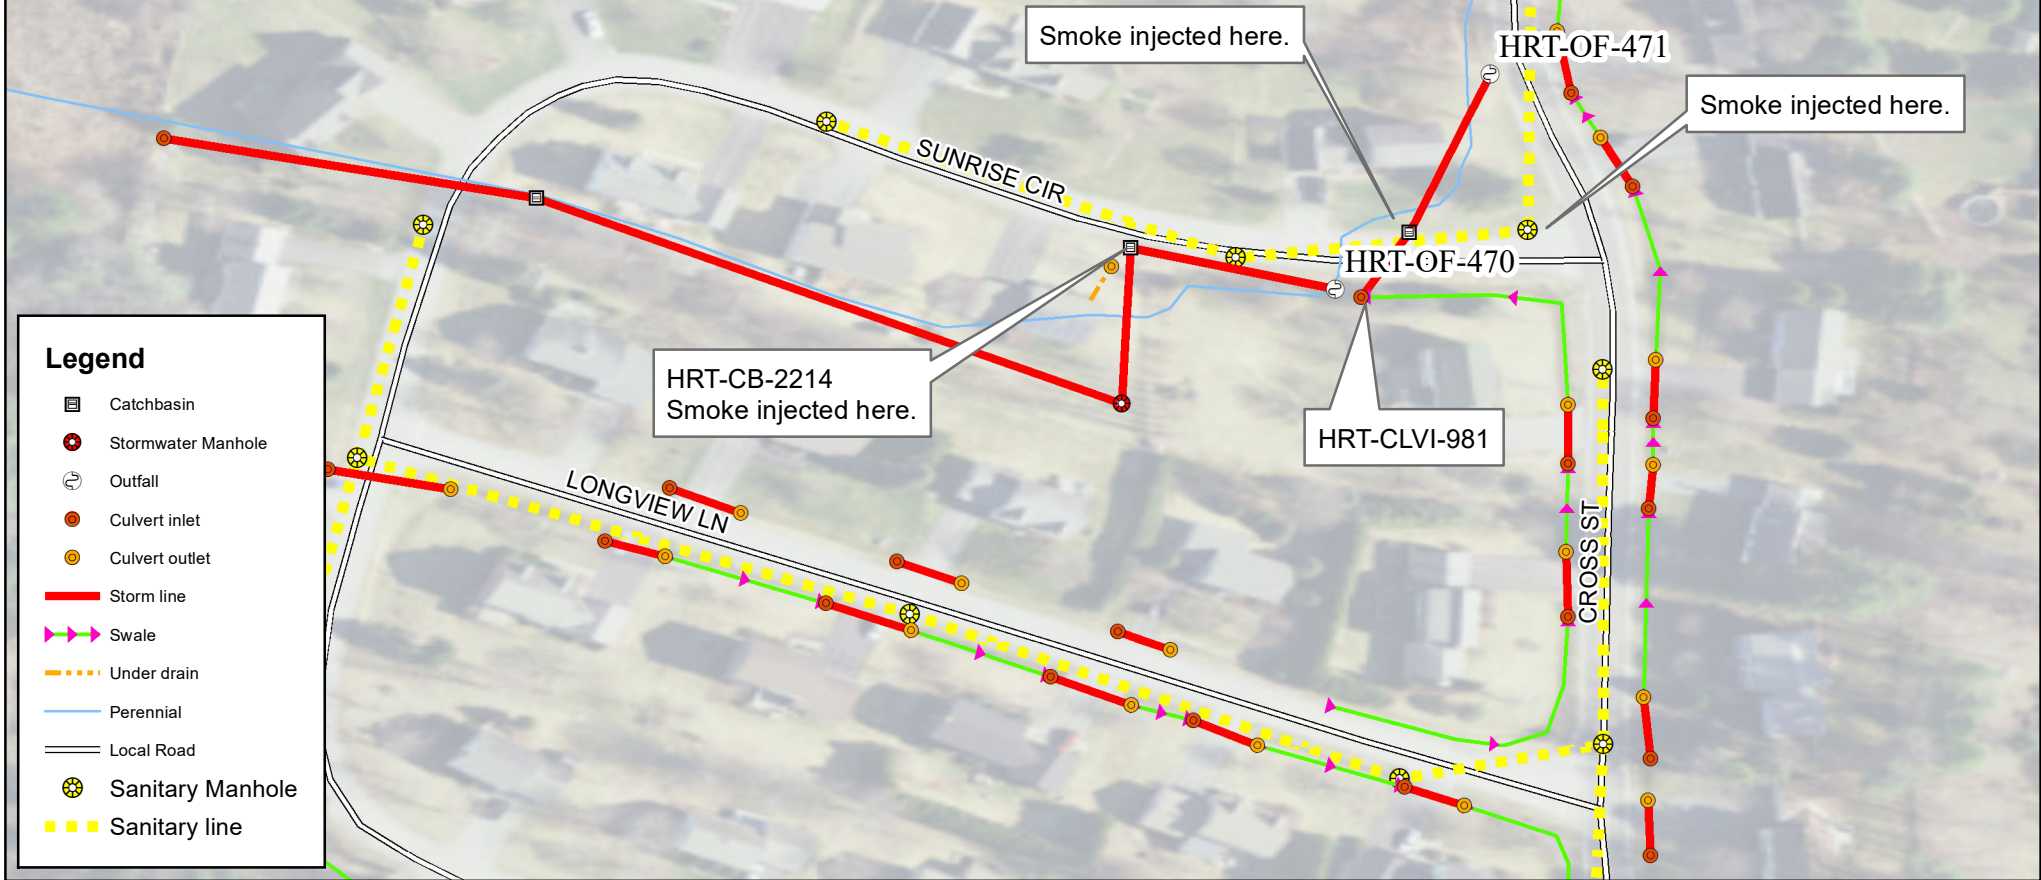
Smoke tested from both storm and sanitary. No smoke observed crossing over. No illicit discharge suspected.

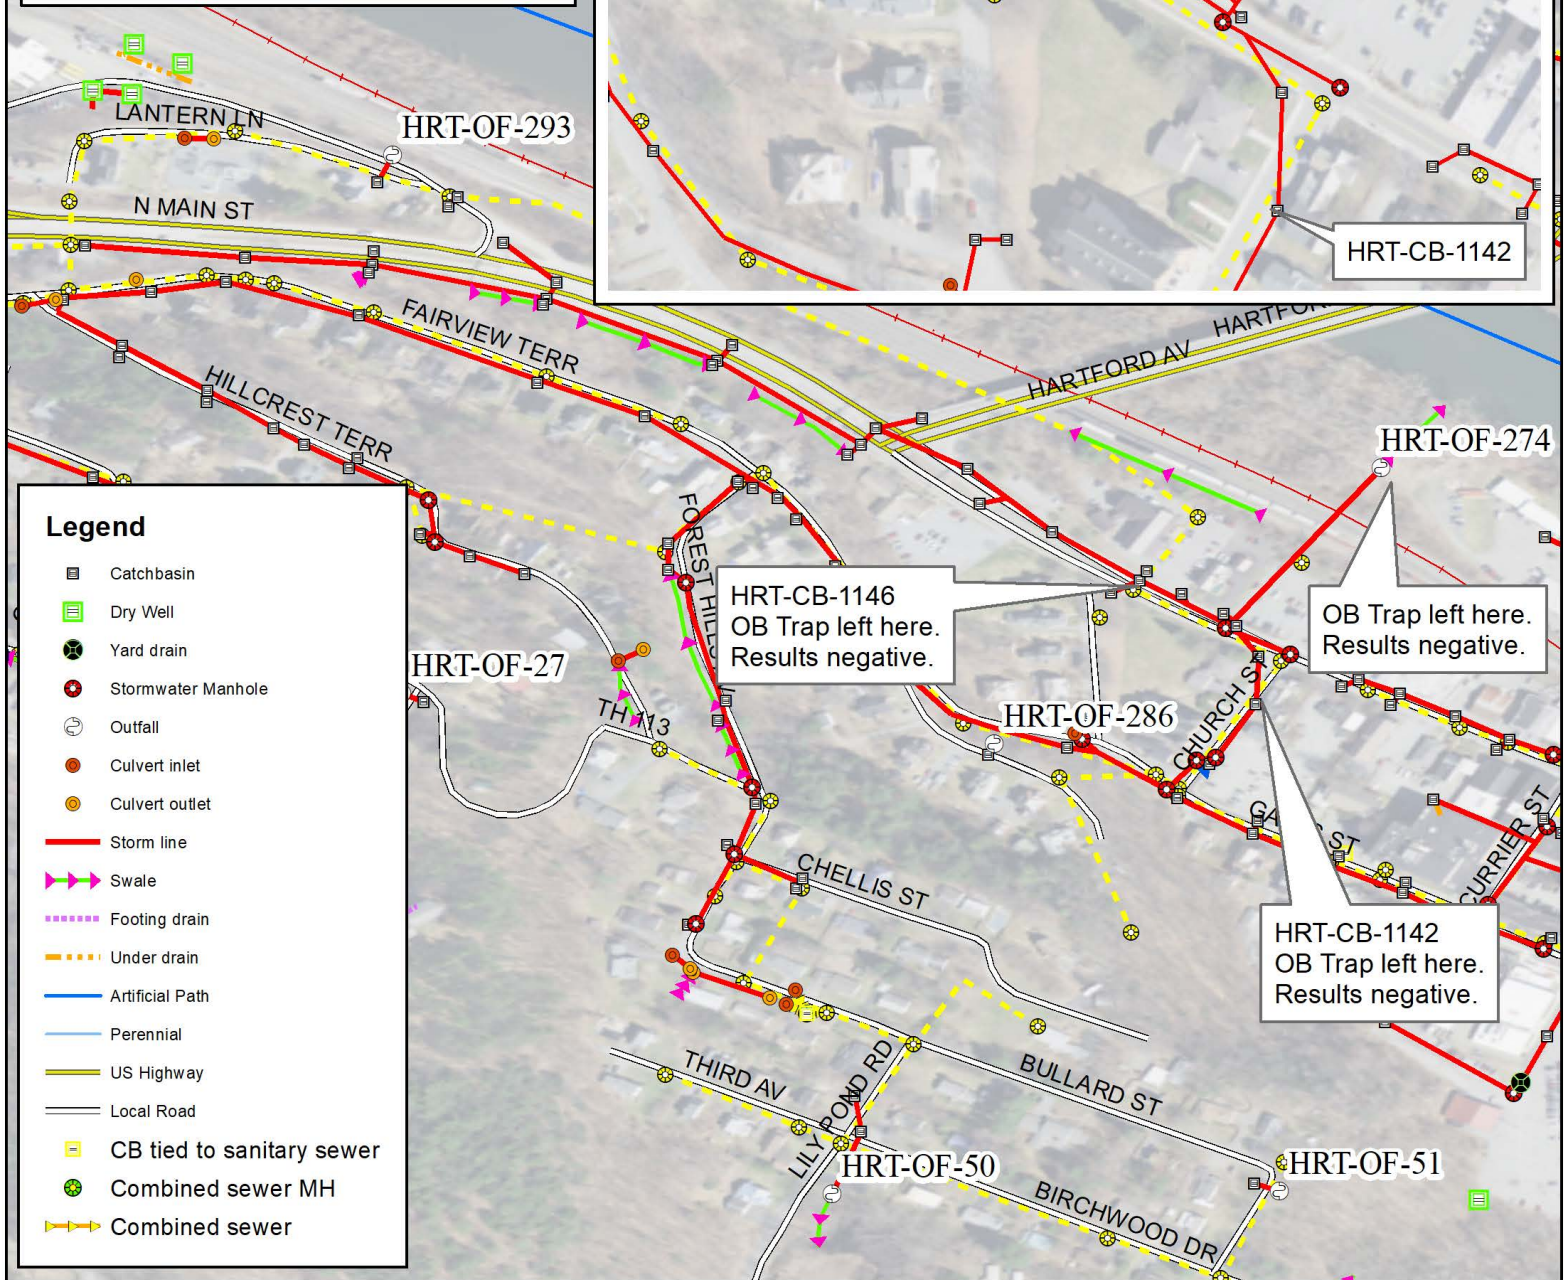
Samples taken from upstream catchbasin for Environmental Canine Services Ship and Sniff. No alert on any samples. No illicit discharge suspected.

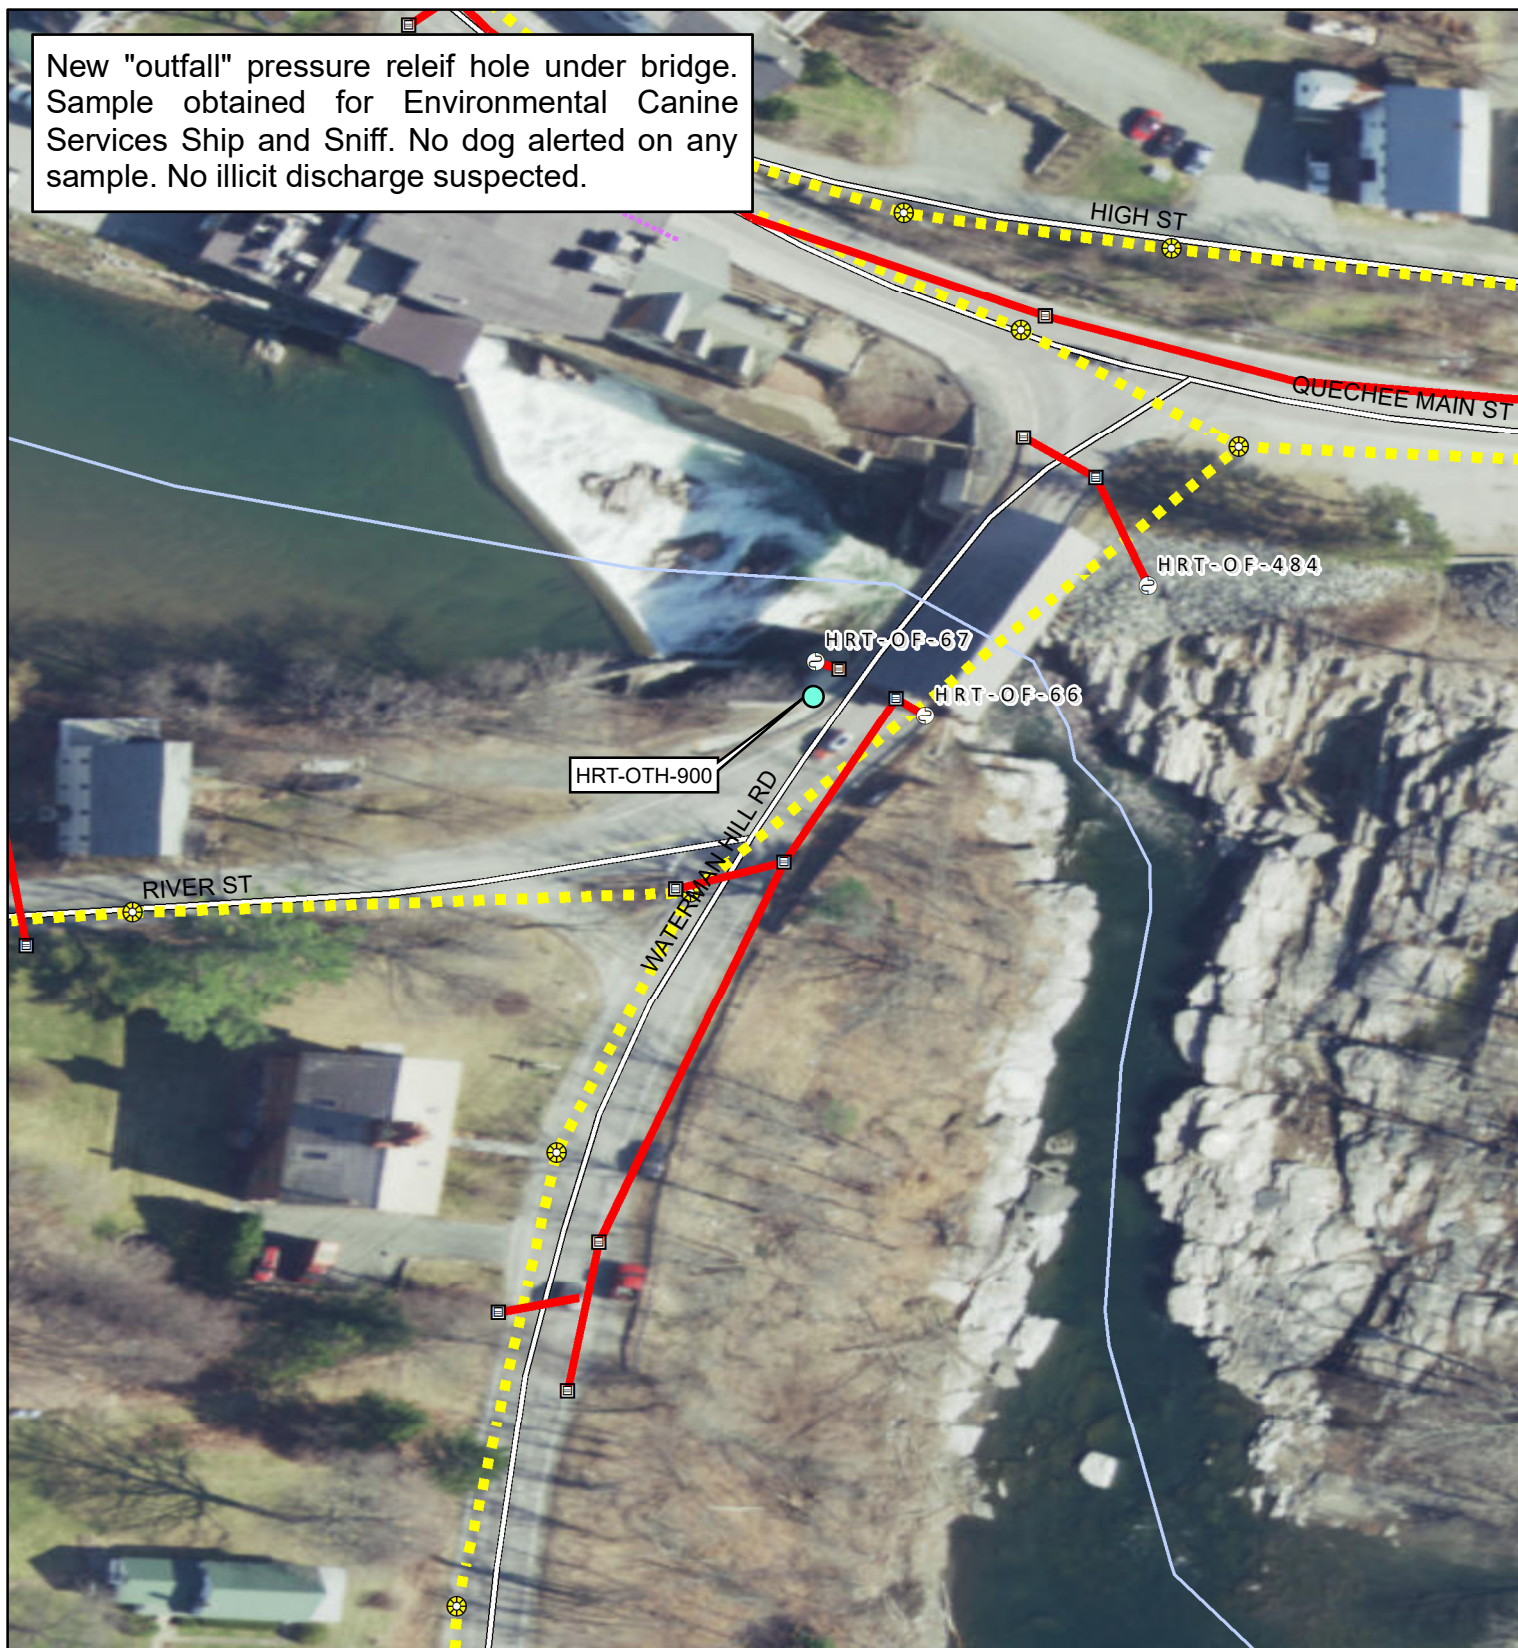
New "outfall" pressure relief hole under bridge. Sample obtained for Environmental Canine Services Ship and Sniff. No dog alerted on any sample. No illicit discharge suspected.

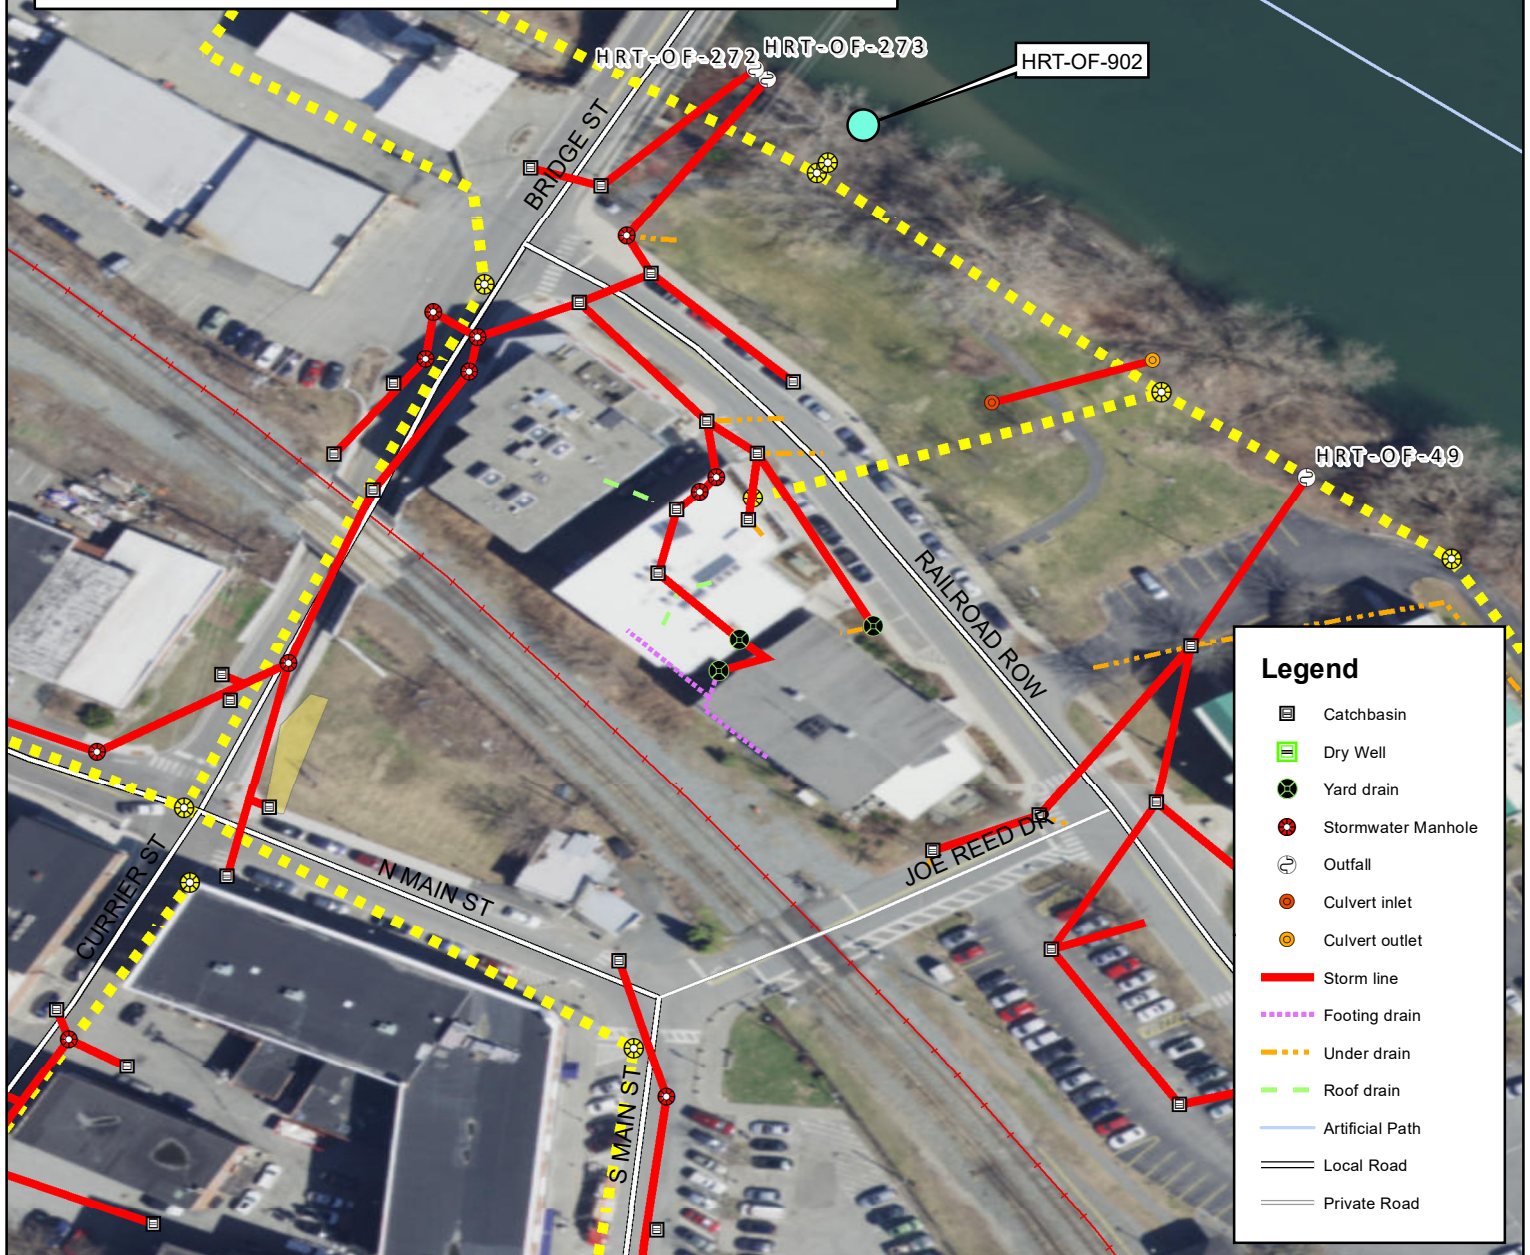
Outfall found near downtown area. Formerly CSO but supposedly shut off. Evidence of human fecal matter found, linked to cracking in adjacent sanitary sump. Crack was fixed and the issue is considered resolved.

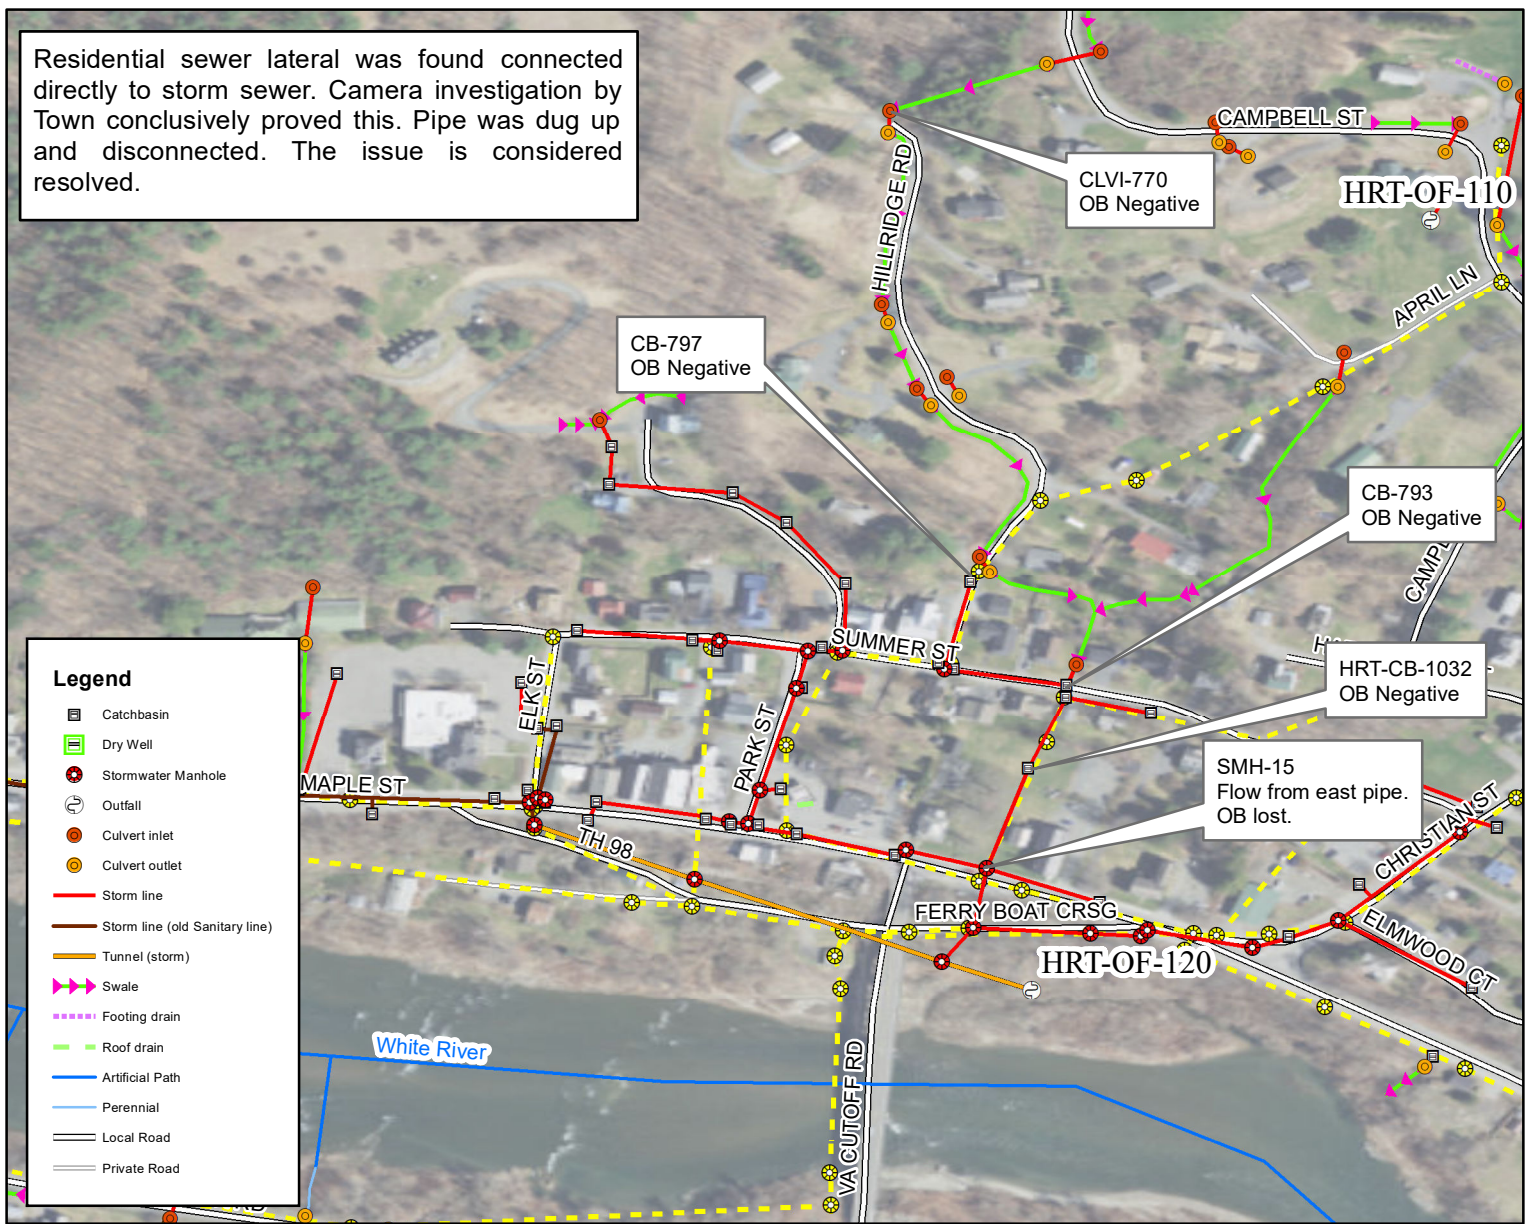
Residential sewer lateral was found connected directly to storm sewer. Camera investigation by Town conclusively proved this. Pipe was dug up and disconnected. The issue is considered resolved.

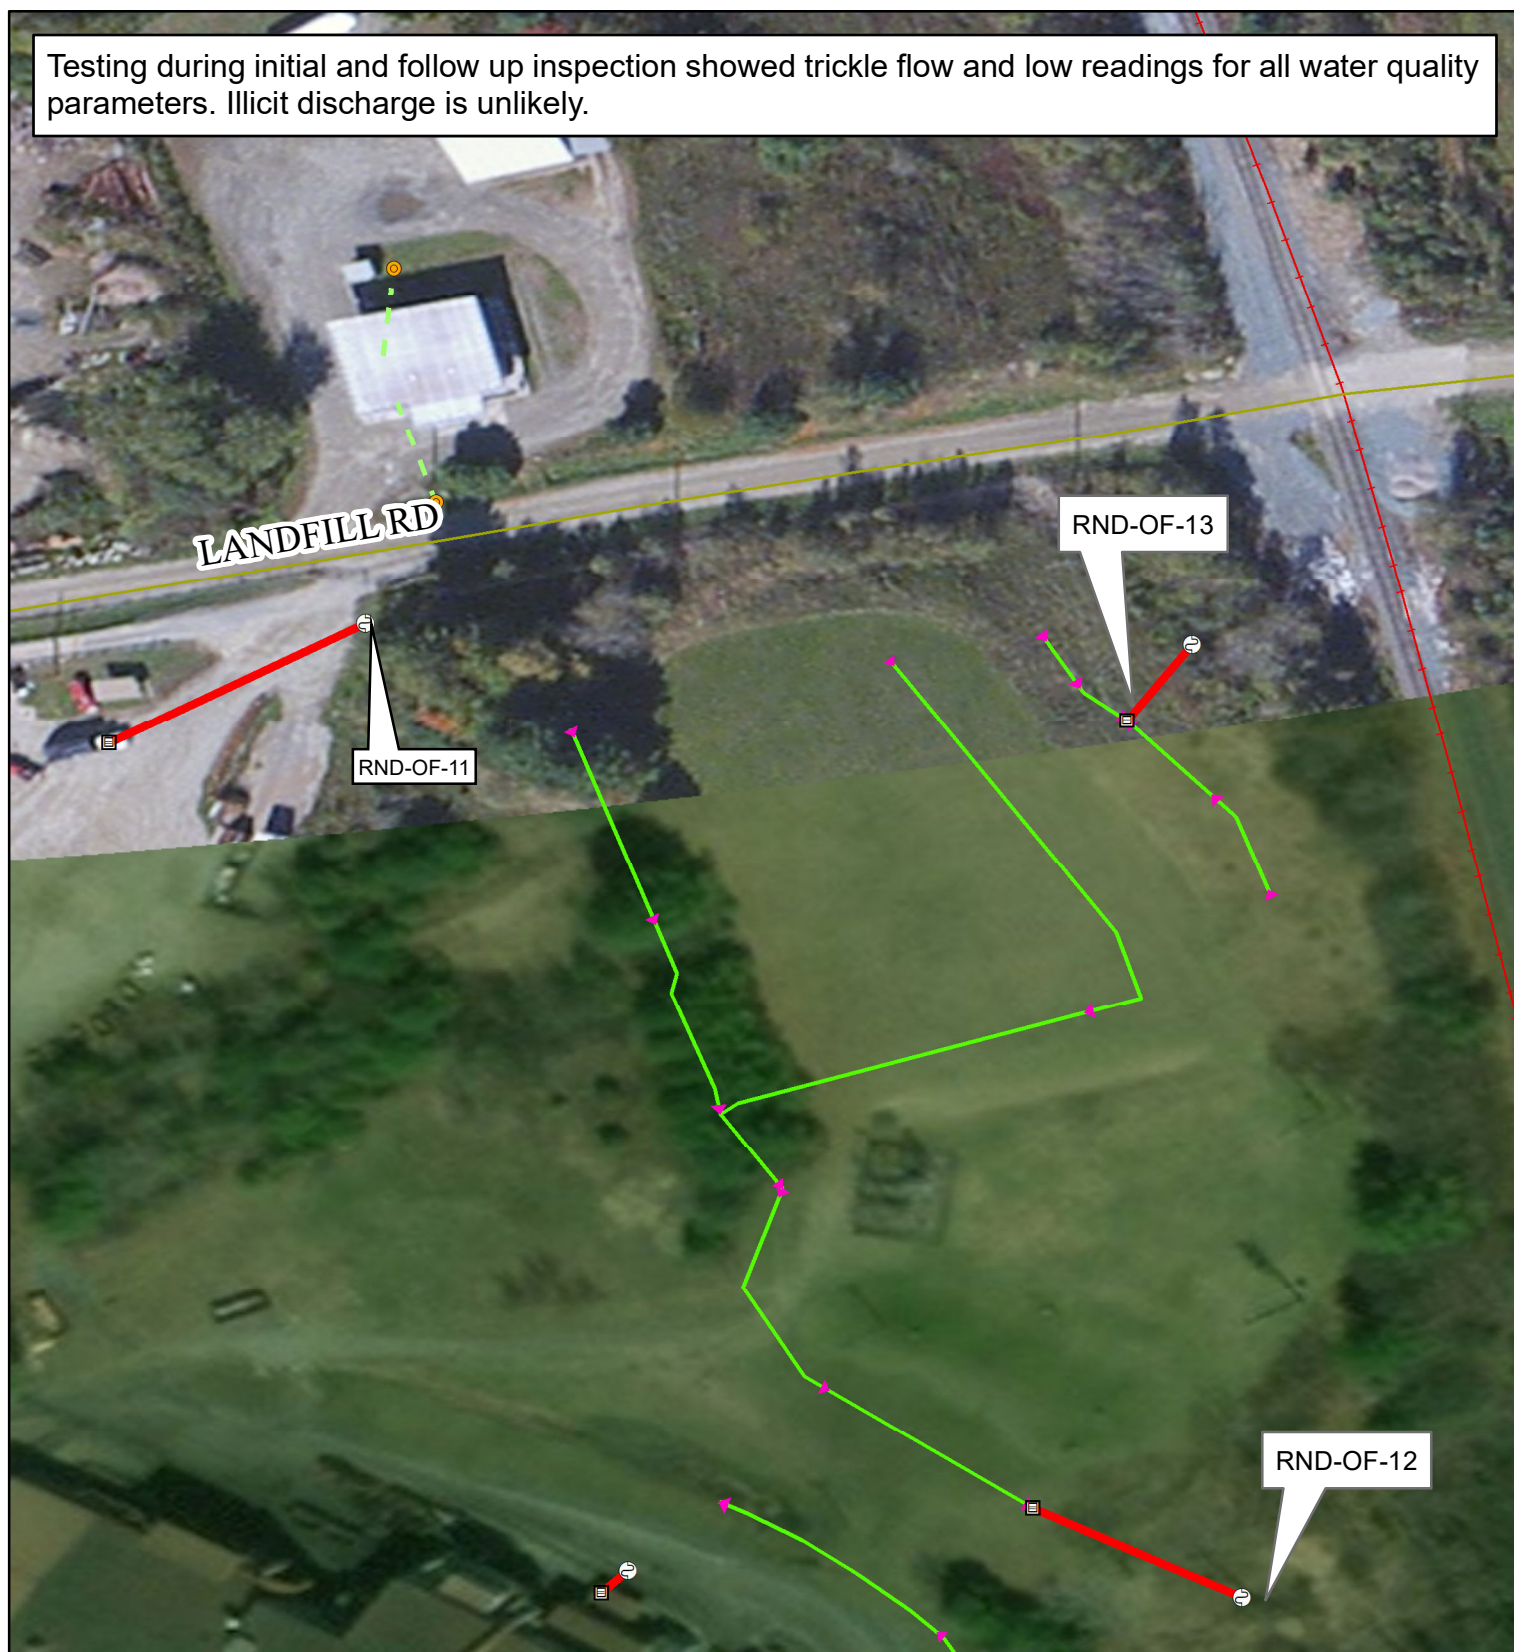
Testing during initial and follow up inspection showed trickle flow and low readings for all water quality parameters. Illicit discharge is unlikely.
