FINAL REPORT – WHITE RIVER BASIN ILLICIT DISCHARGE DETECTION AND ELIMINATION STUDY

BARNARD, BETHEL, CHELSEA,
GRANVILLE, HANCOCK, HARTFORD,
PITTSFIELD, QUEECHEE, RANDOLPH,
ROCHESTER, ROYALTON, SHARON, AND
TUNBRIDGE,

FINAL REPORT

9-26-2018

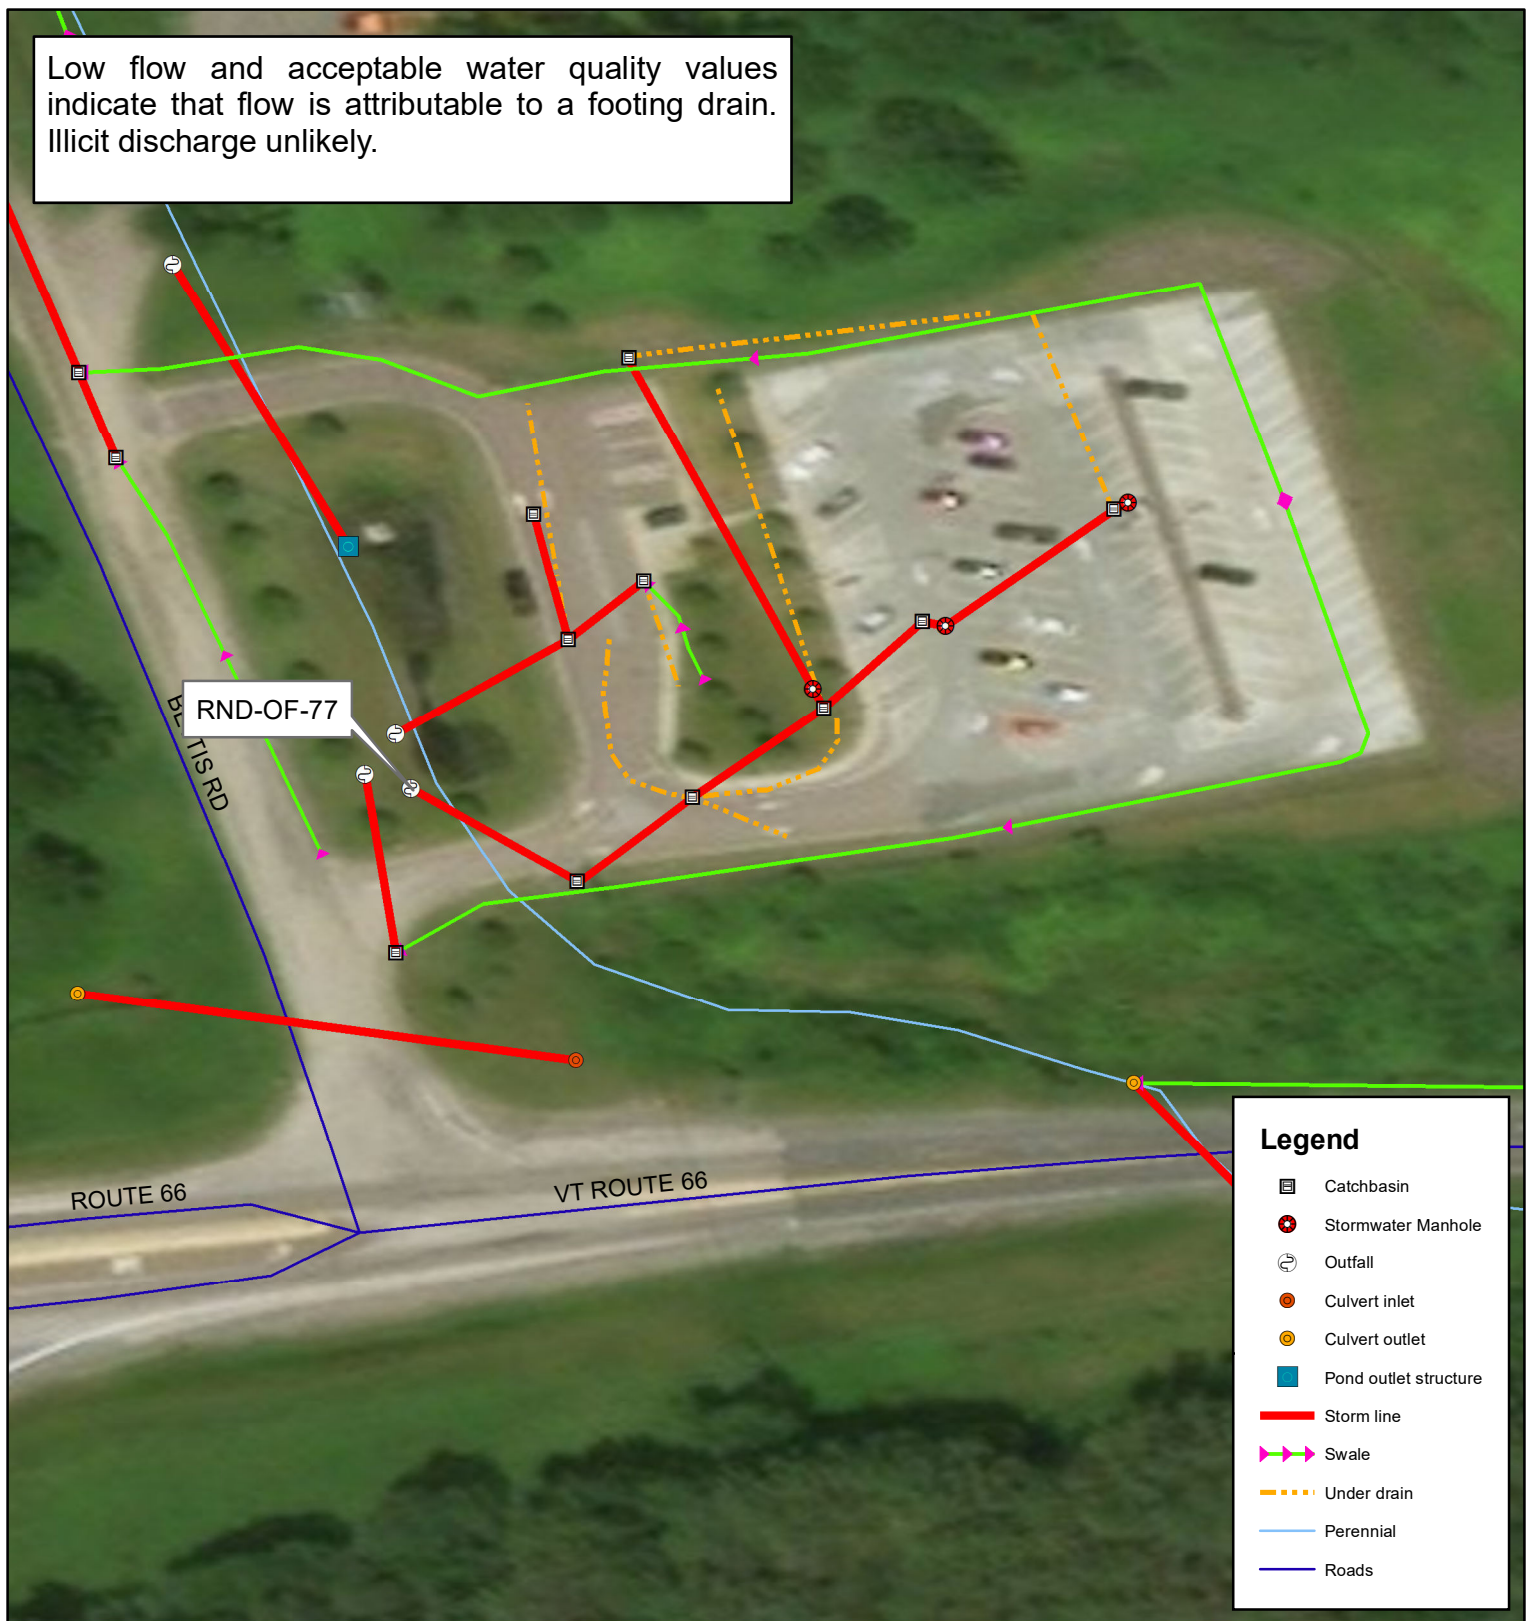
Low flow and acceptable water quality values indicate that flow is attributable to a footing drain. Illicit discharge unlikely.

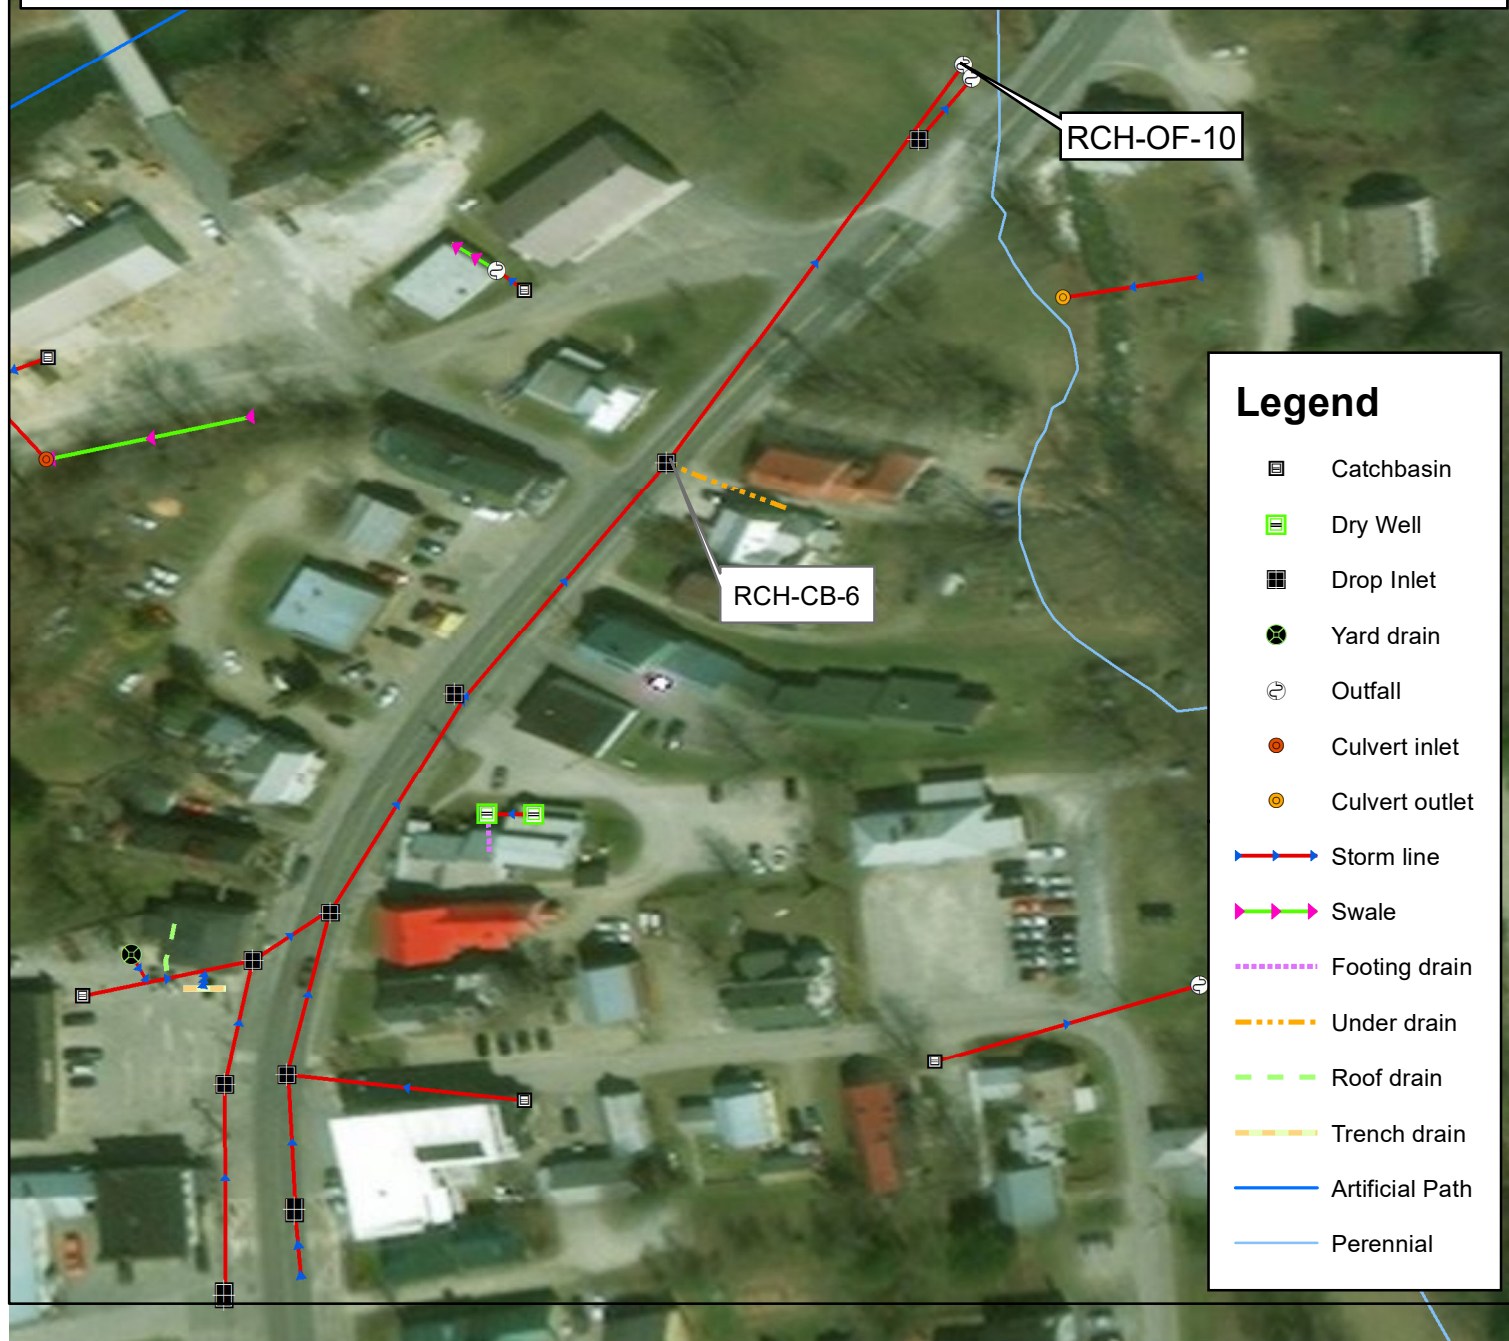
Upon initial investigation the outfall was not found as it was buried under rip rap. The upstream catchbasin, RCH-CB-6 was tested as proxy and revealed slightly elevated values for multiple water quality parameters. After a second visit revealed no flow present in upstream catchbasins smoke testing was deemed most effective. No smoke was seen discharging from any non-stormwater related infrastructure. Illicit discharge at the outfall is unlikely.

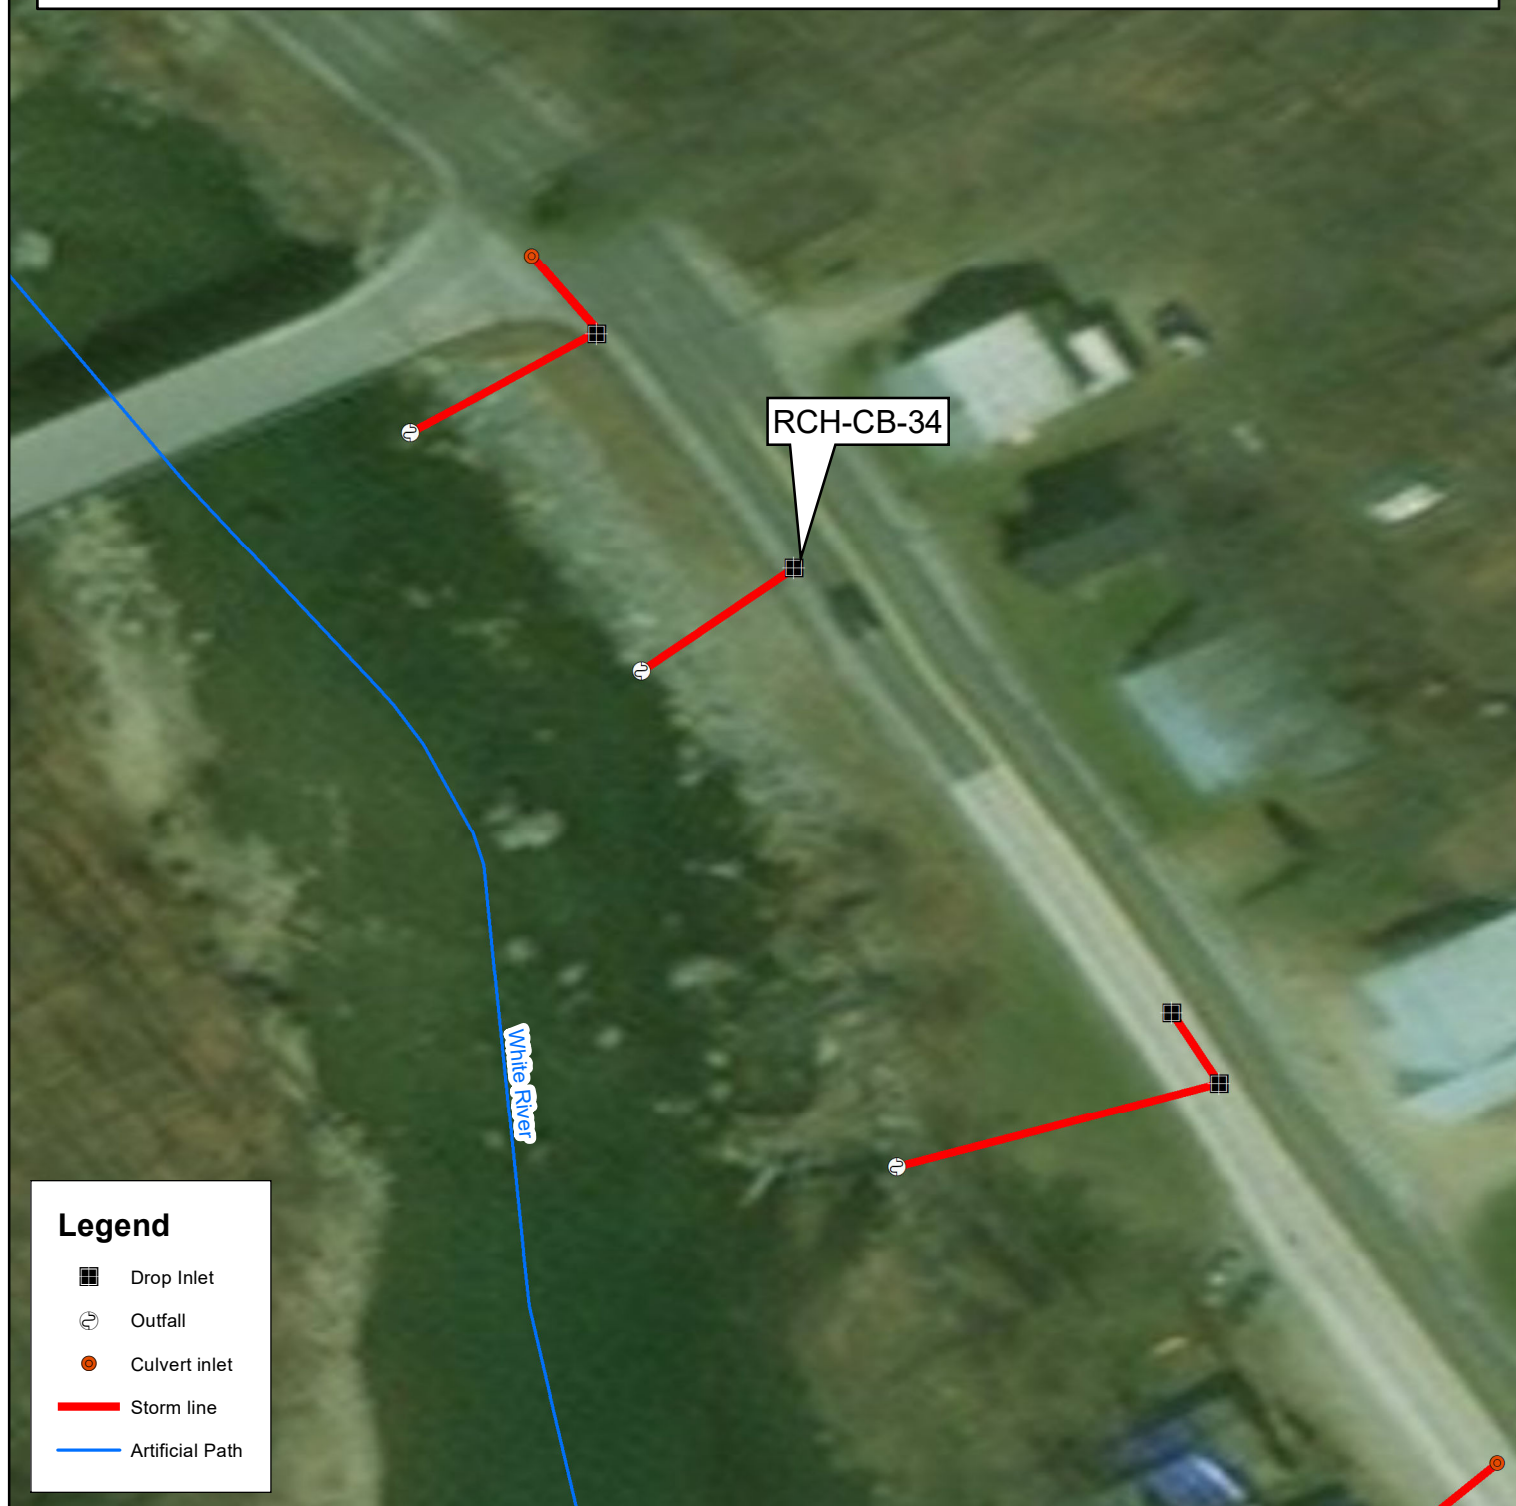
Initial inspection had small amount of flow with non-alarming water quality parameter readings. A second visit contained no flow at outfall and only upstream catchbasin. Given the small size of the system and low initial readings, illicit discharge is deemed unlikely.

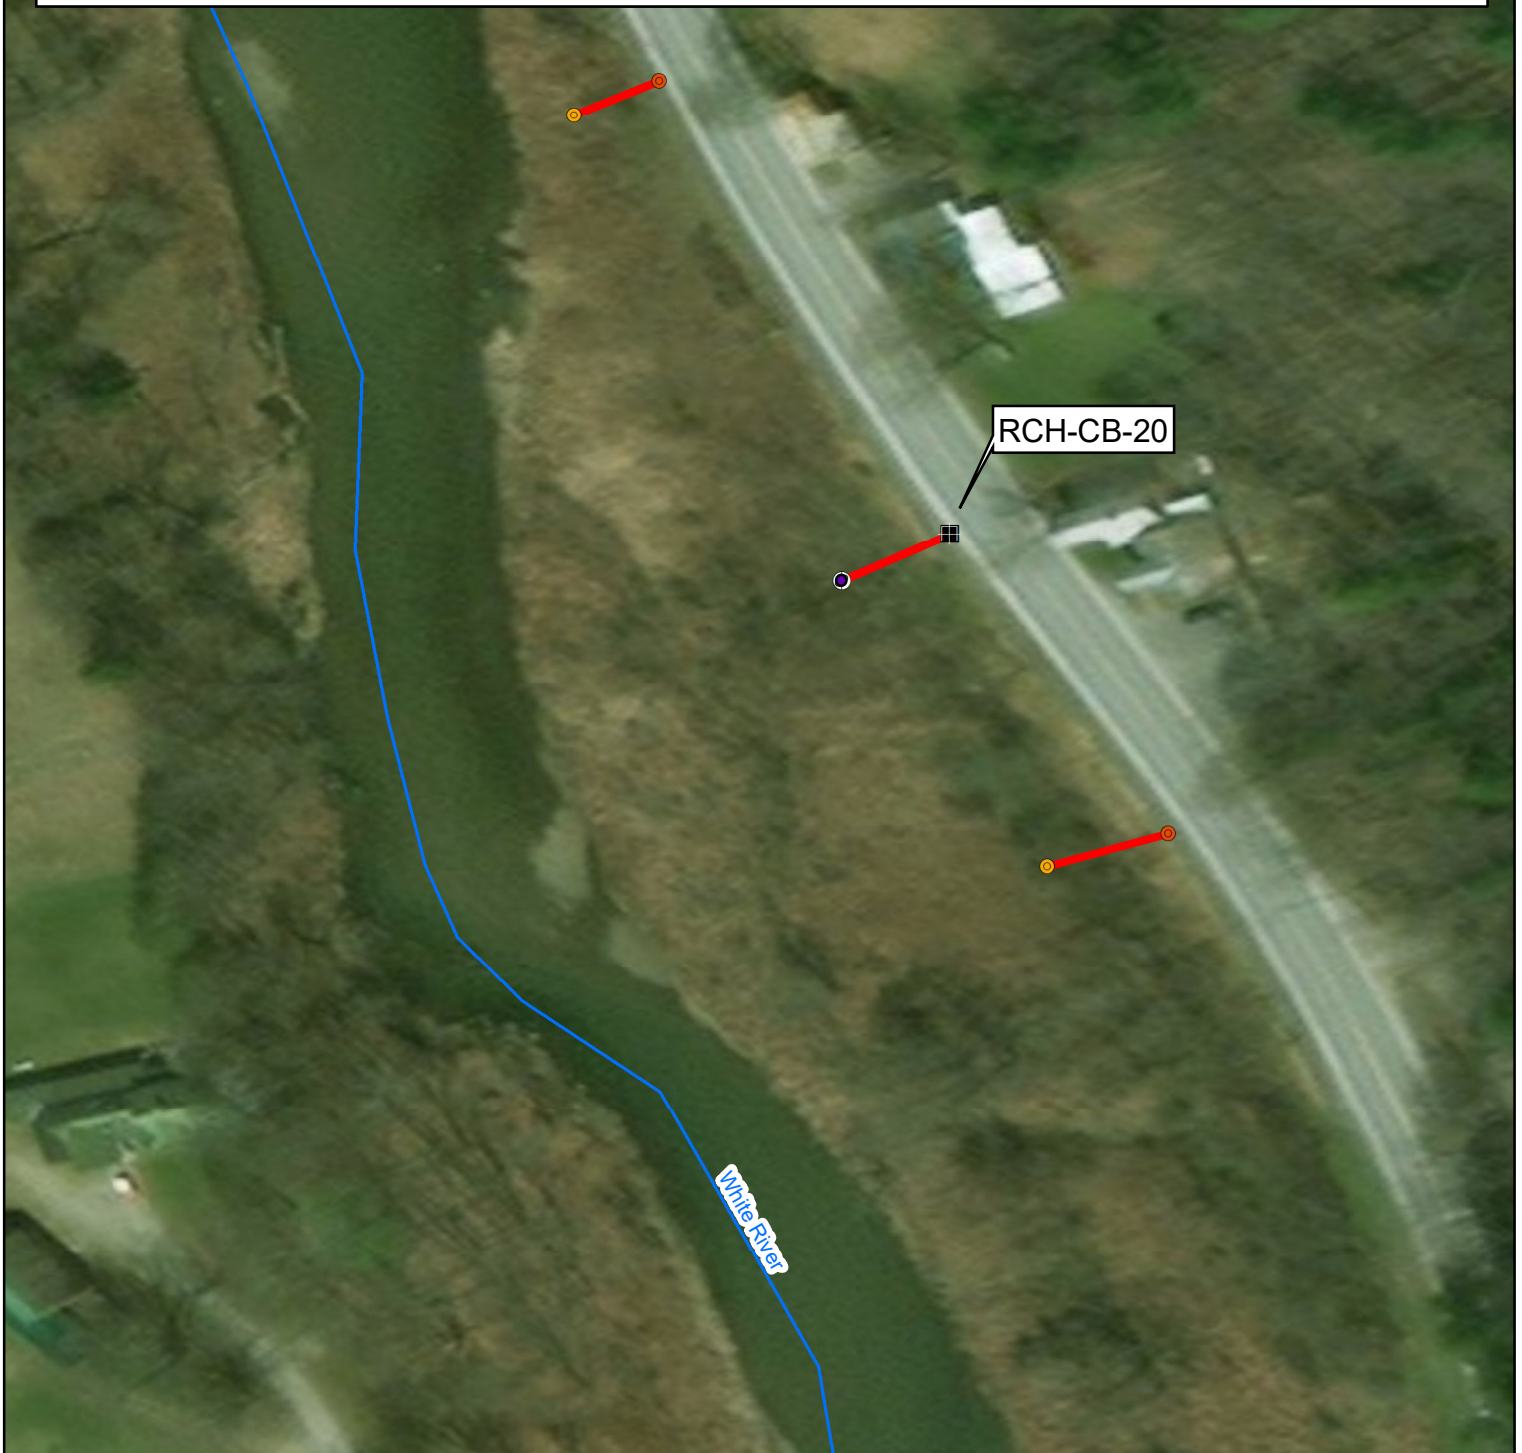
Initial inspection had a small amount of flow with non-alarming water quality parameter readings. A second visit contained no flow at the outfall and only upstream catchbasin. Given the small size of the system and low initial readings, illicit discharge is deemed unlikely.

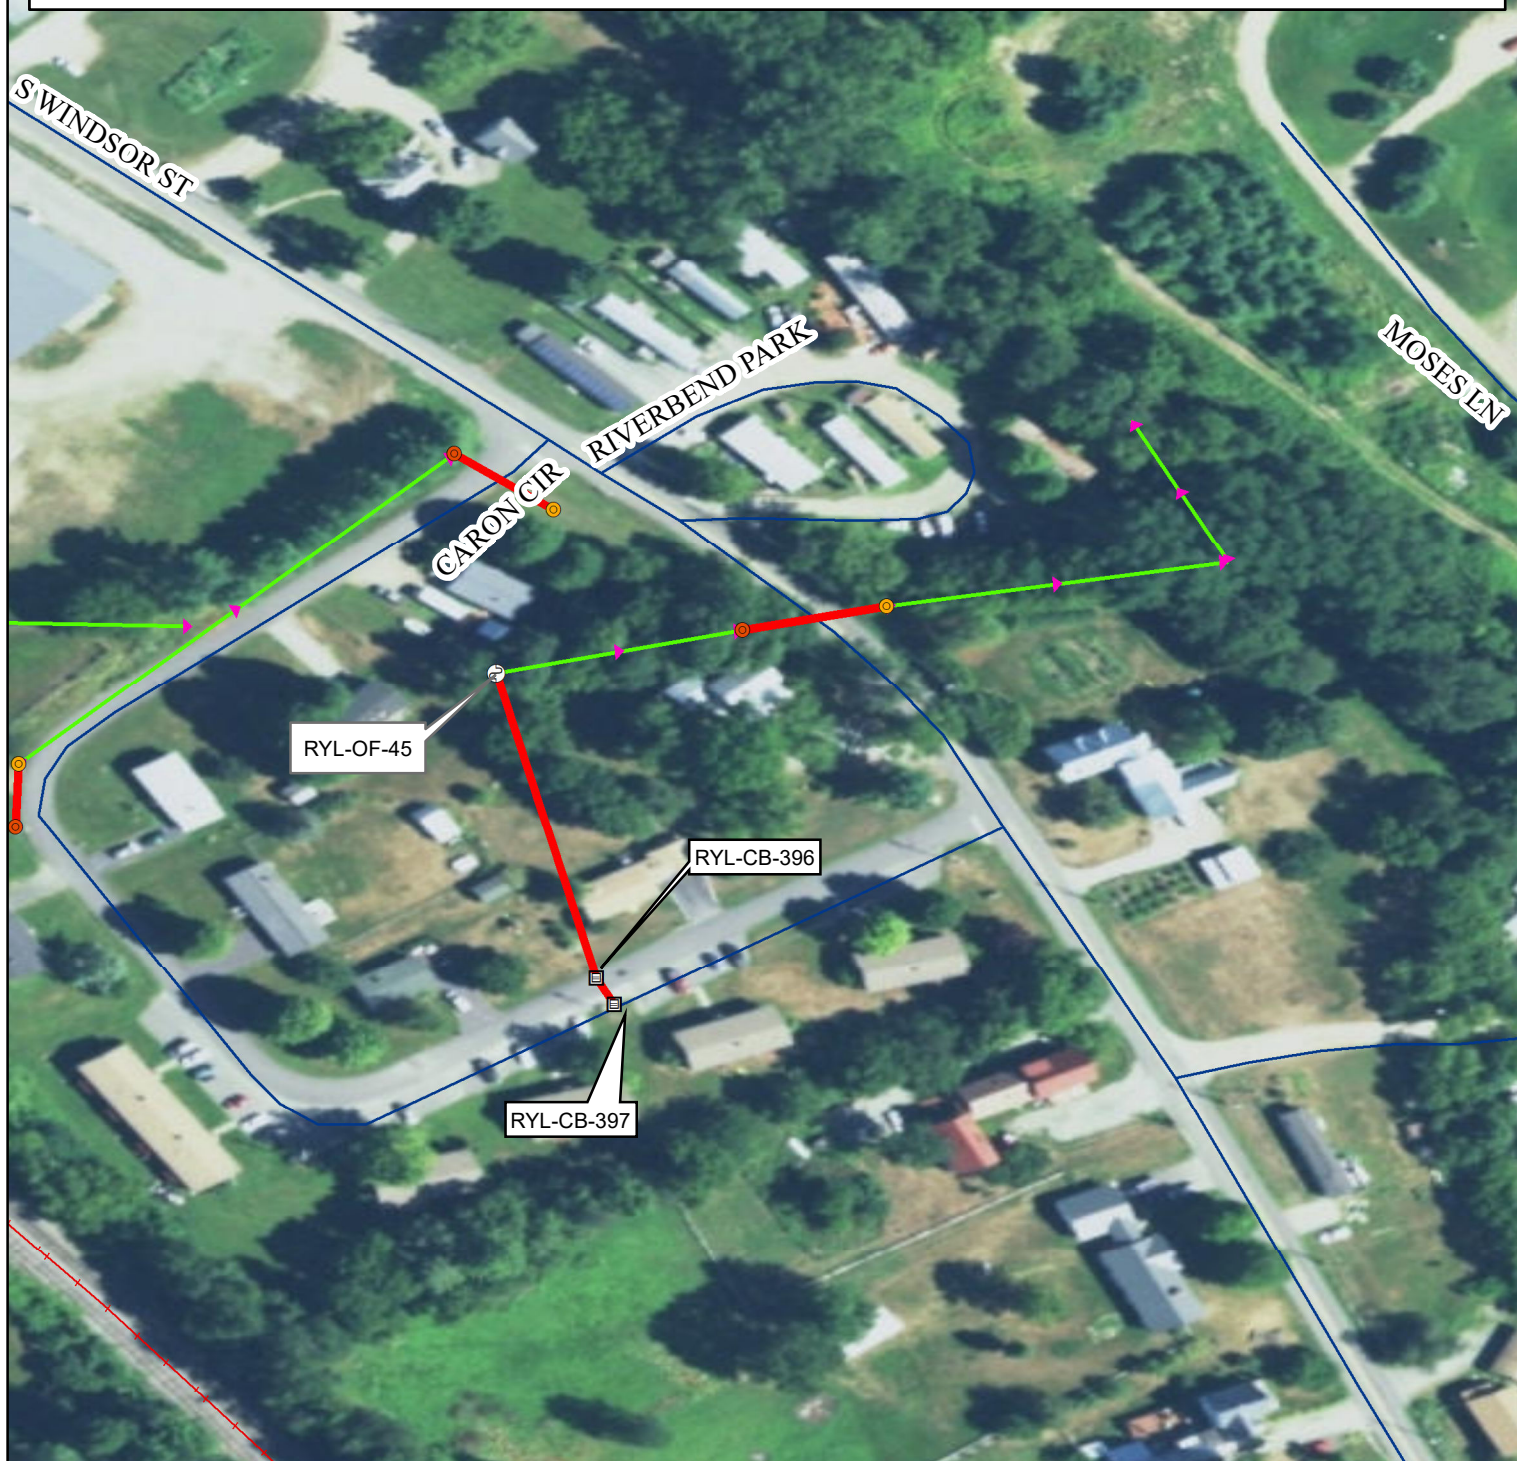
Slightly elevated water quality parameters at the outfall and RYL-CB-397 were cause for concern and smoke testing was performed in August of 2017. No smoke was seen discharging from any non-stormwater related infrastructure. Conversely, smoke was injected into the sanitary sewer line and no smoke was seen discharging from any stormwater related infrastructure. Illicit discharge unlikely.

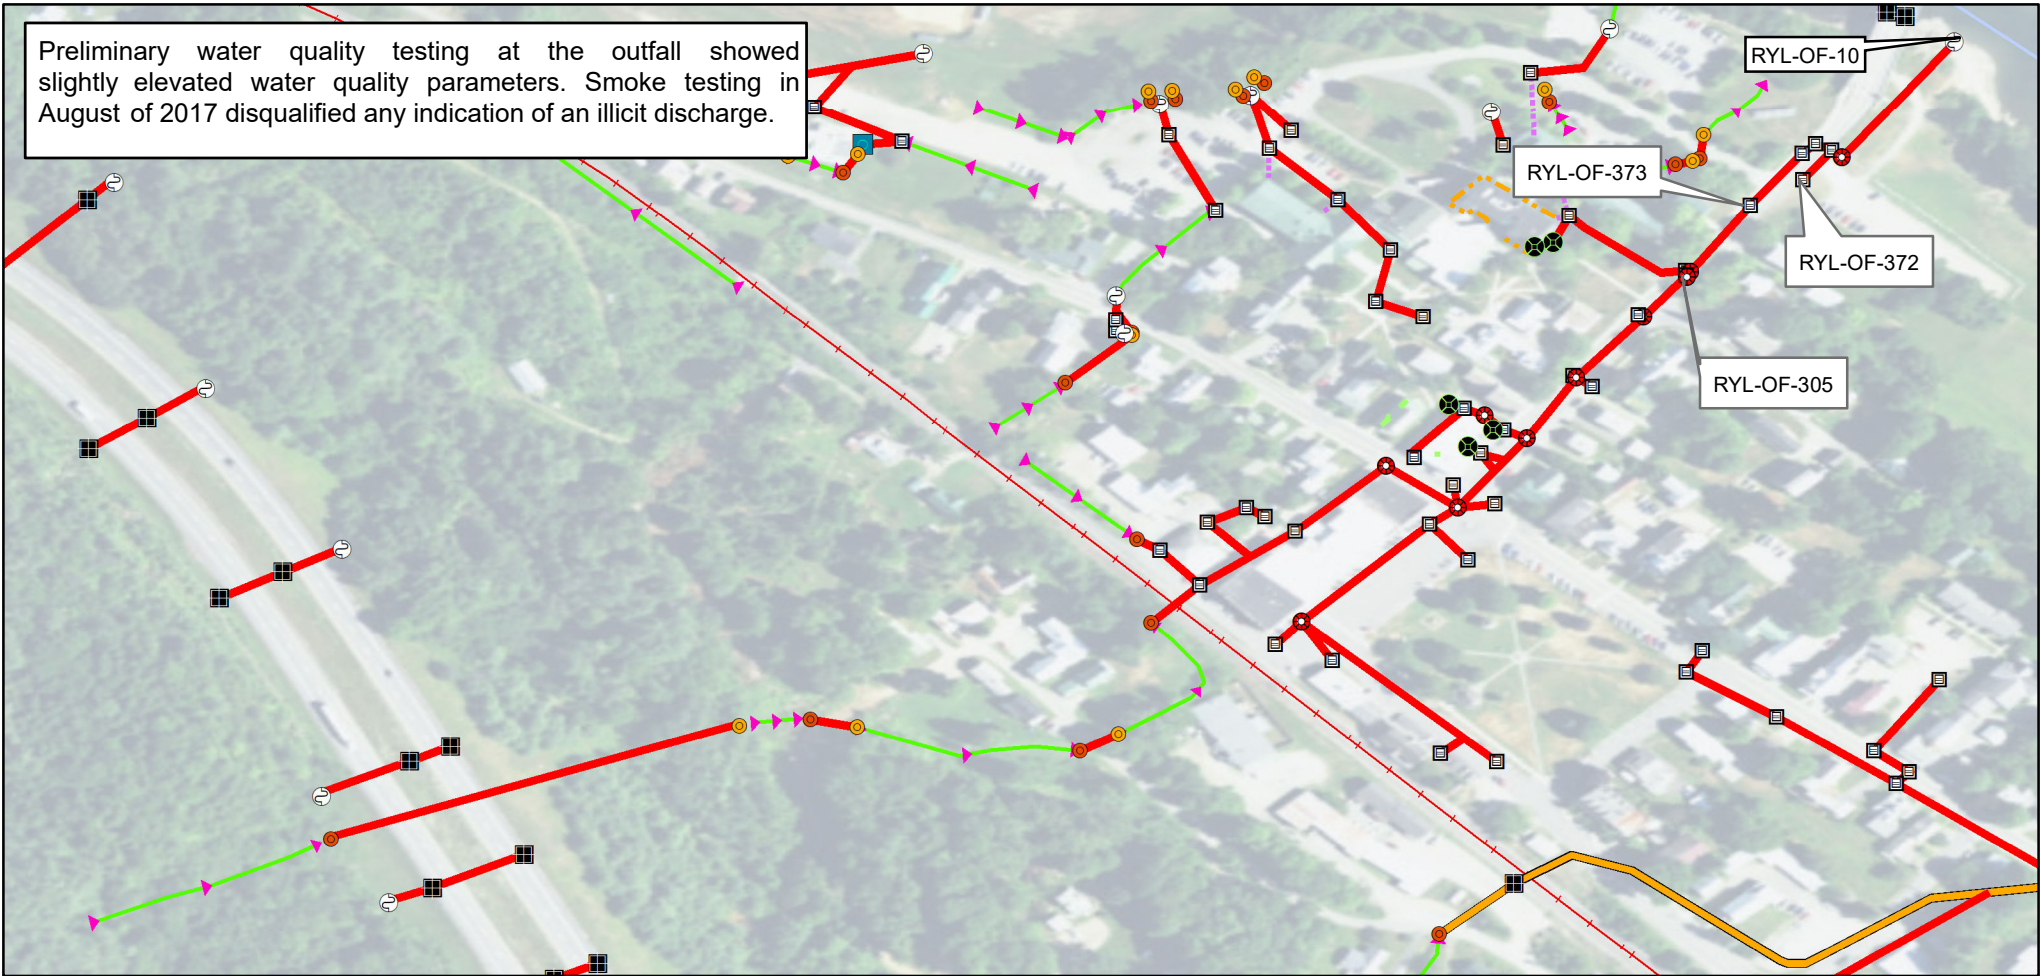
Preliminary water quality testing at the outfall showed slightly elevated water quality parameters. Smoke testing in August of 2017 disqualified any indication of an illicit discharge.

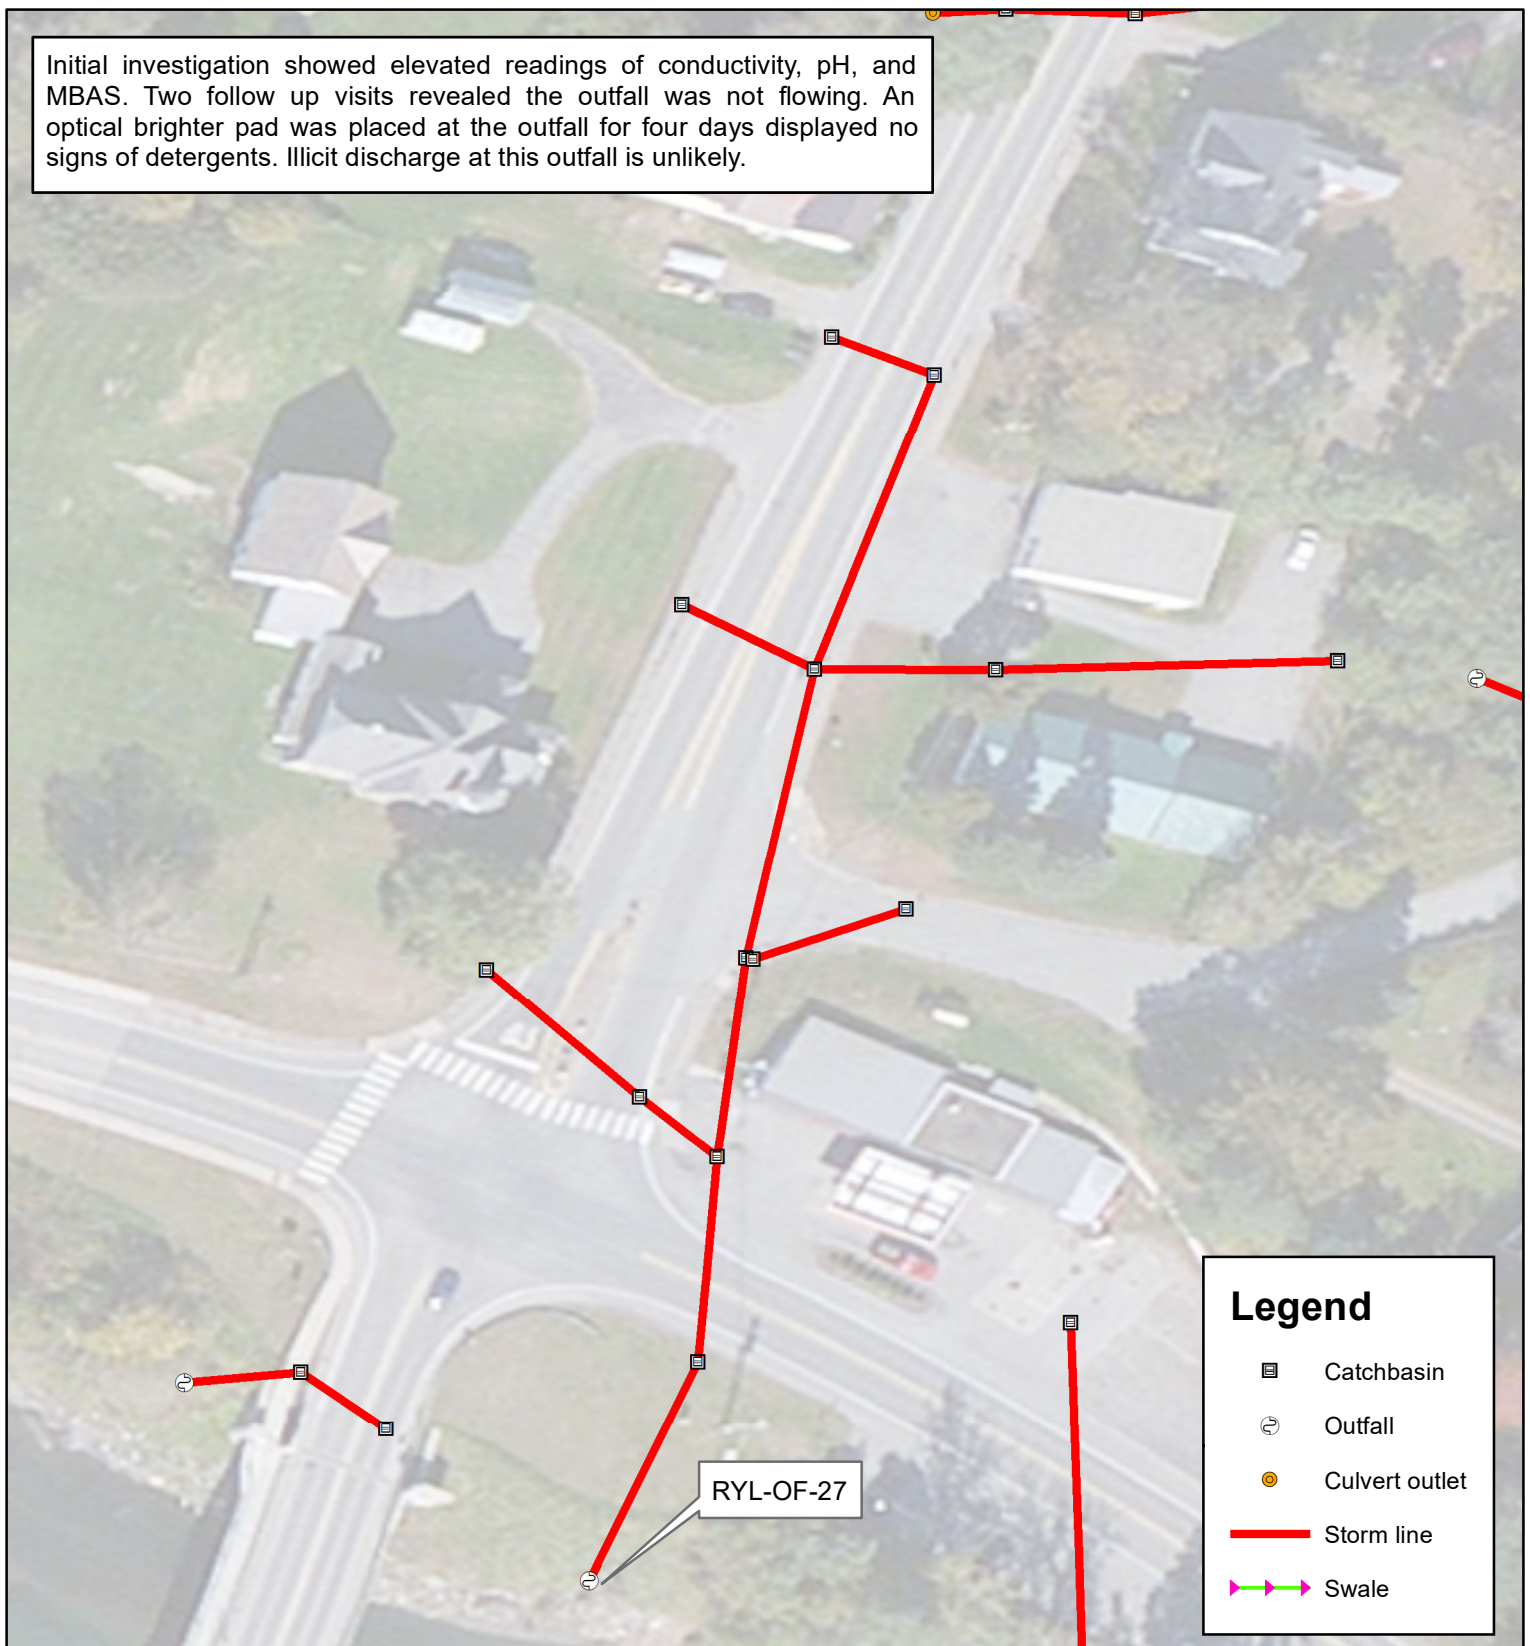
Initial investigation showed elevated readings of conductivity, pH, and MBAS. Two follow up visits revealed the outfall was not flowing. An optical brighter pad was placed at the outfall for four days displayed no signs of detergents. Illicit discharge at this outfall is unlikely.

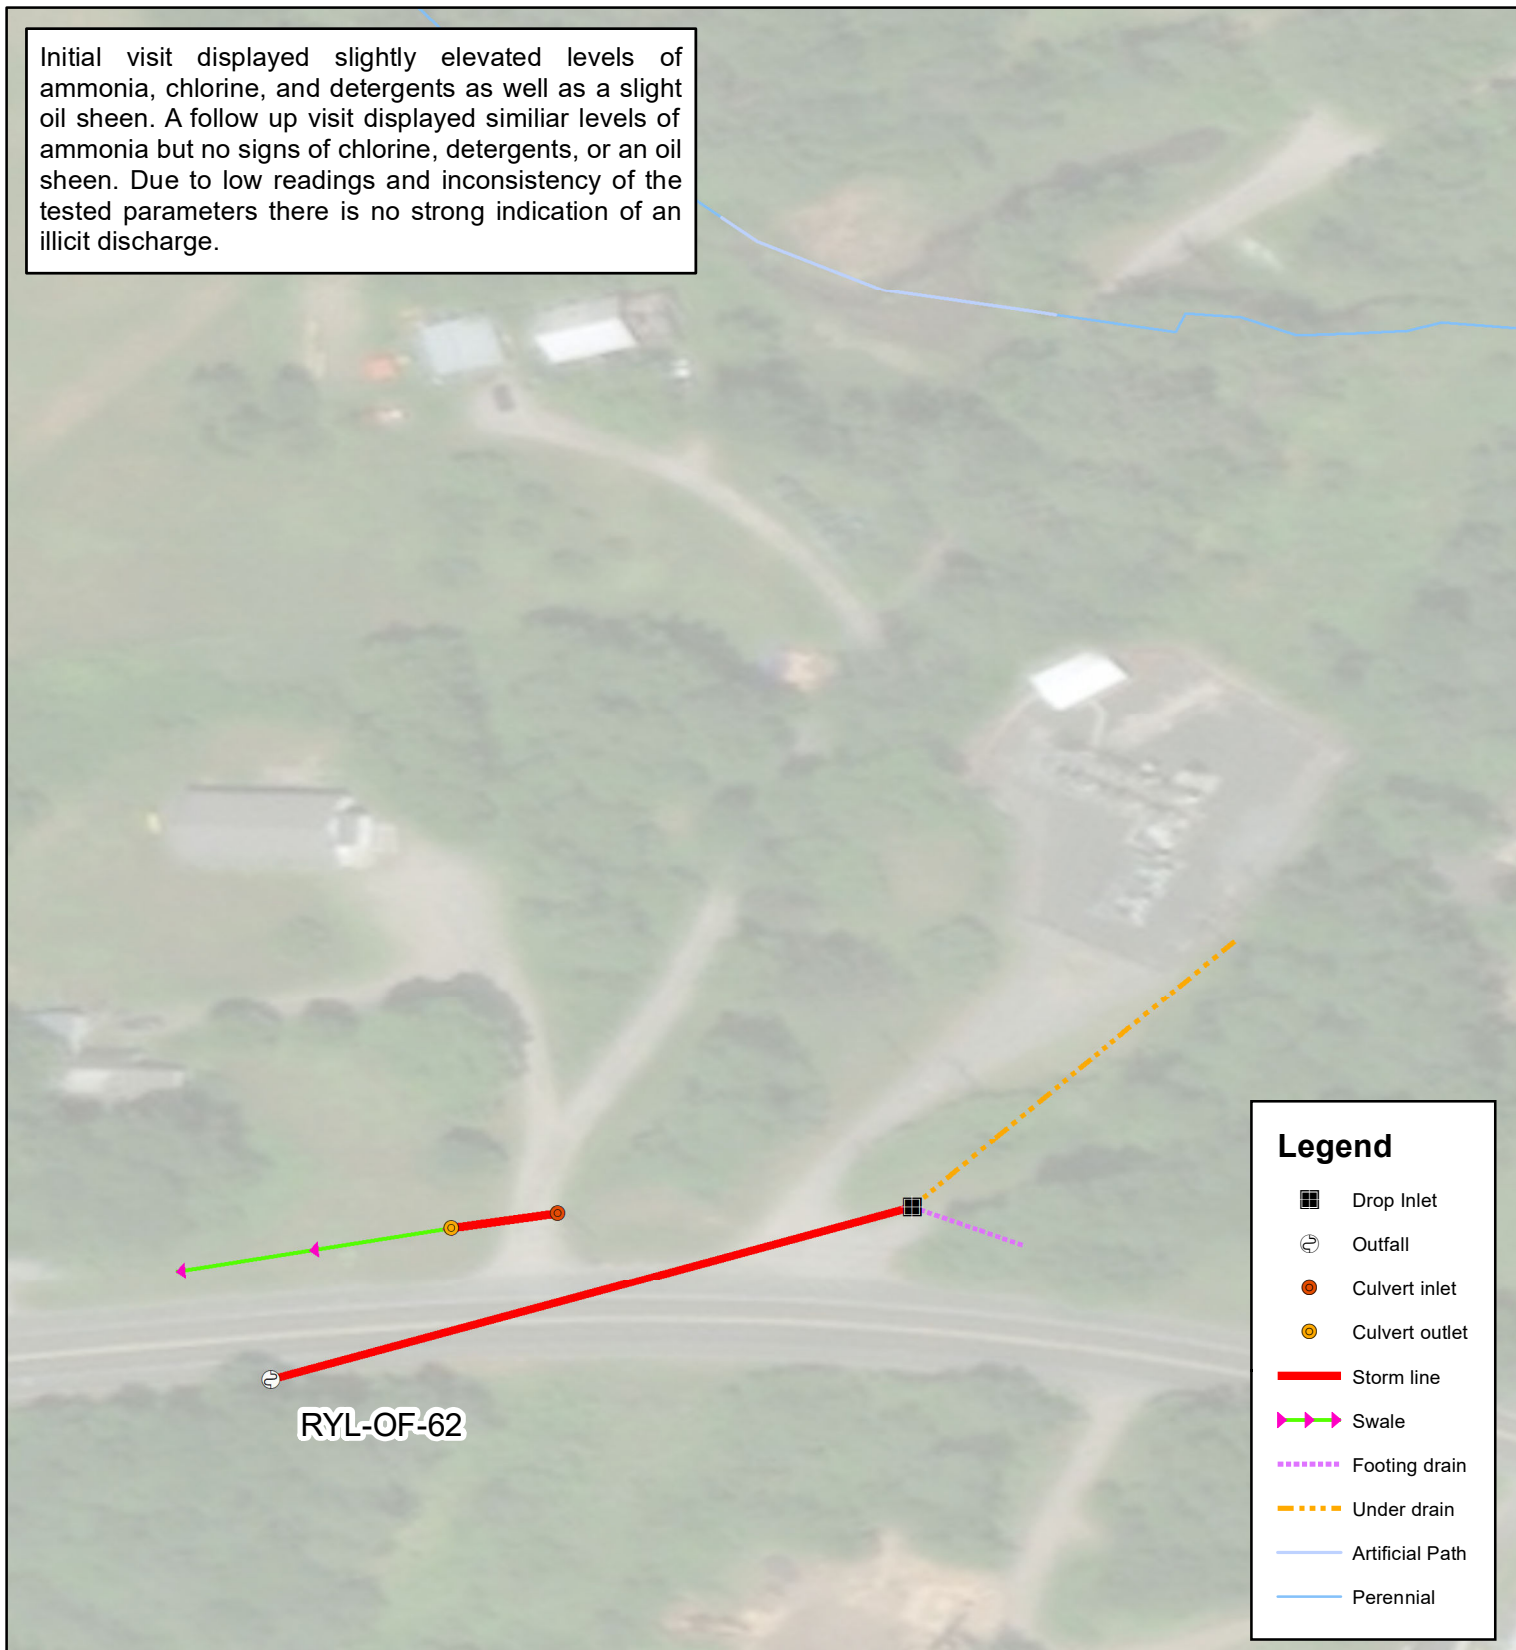
Initial visit displayed slightly elevated levels of ammonia, chlorine, and detergents as well as a slight oil sheen. A follow up visit displayed similar levels of ammonia but no signs of chlorine, detergents, or an oil sheen. Due to low readings and inconsistency of the tested parameters there is no strong indication of an illicit discharge.

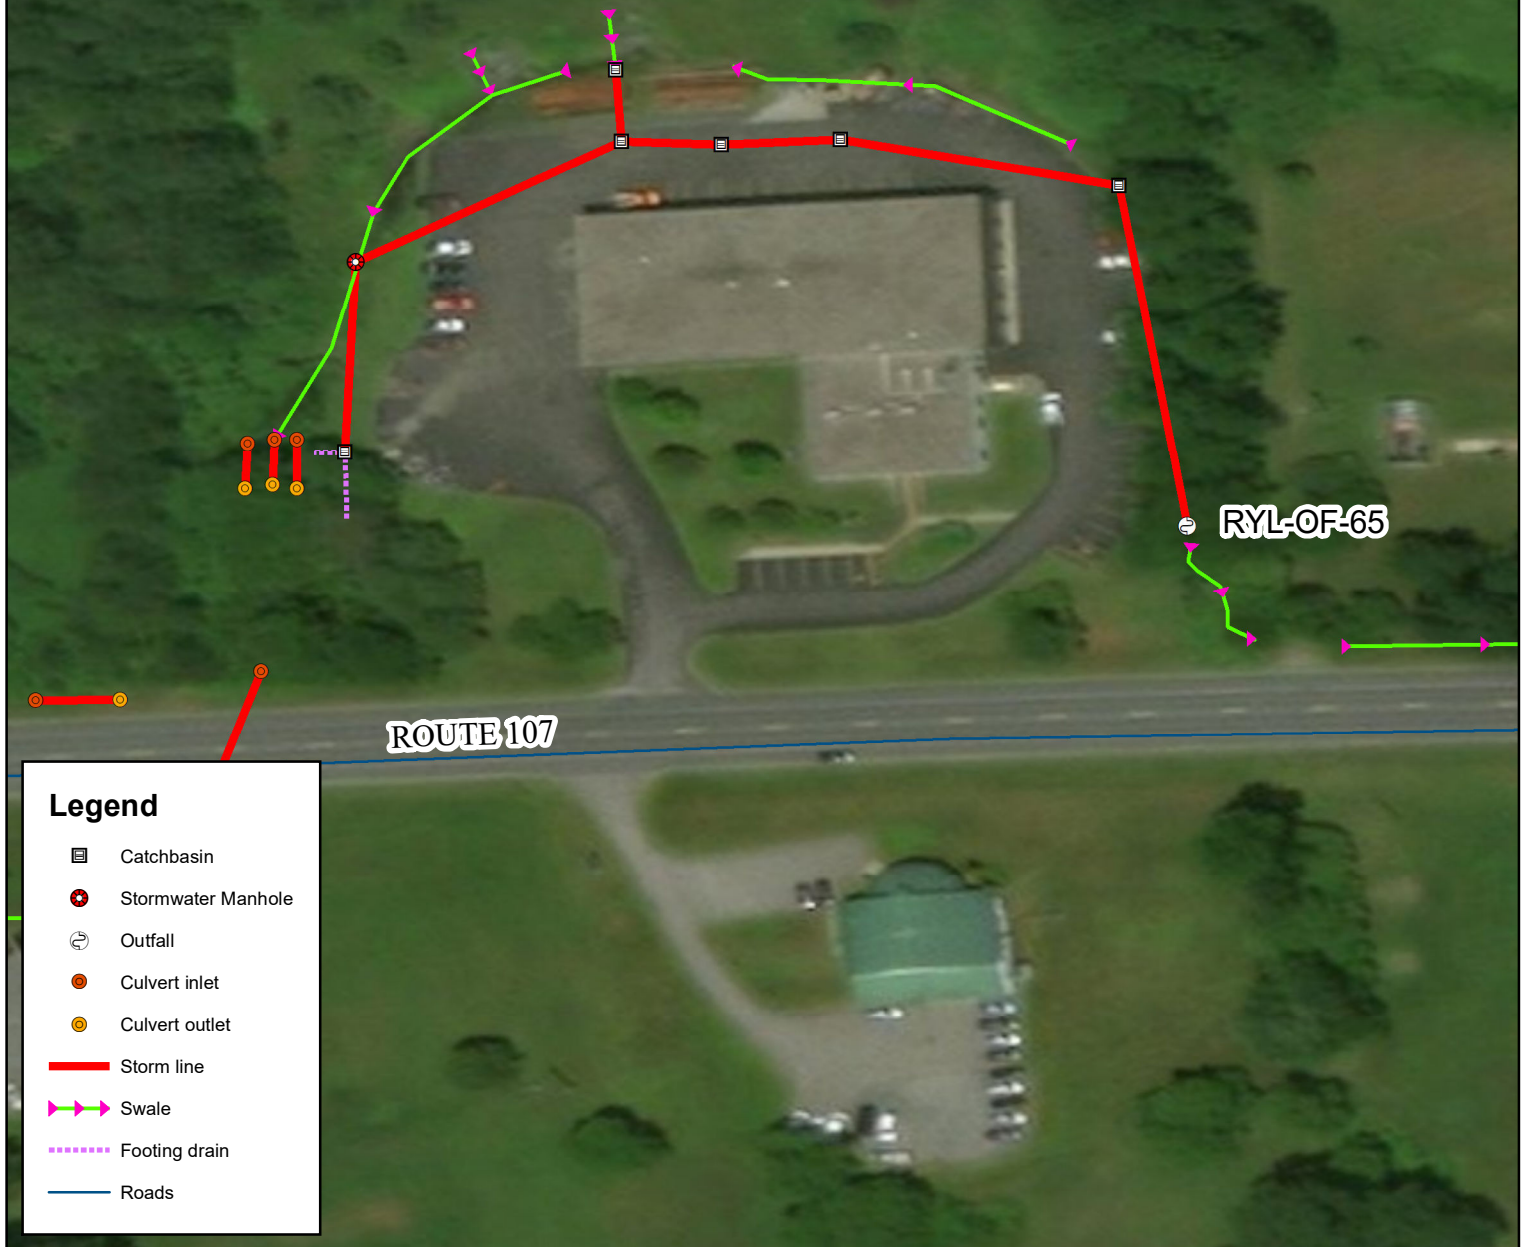
Due to slightly elevated ammonia readings during the initial investigation a follow up visit took place the following week. Flow was attributed to a swale which lines the back parking lot of Green Mountain Power. Suds were observed and staff was informed to wash vehicles inside where wash water could drain to the sanitary sewer. No other illicit discharge is suspected.
