Otter Creek Basin Illicit Discharge Detection and Elimination Project

FINAL REPORT

May 31, 2014

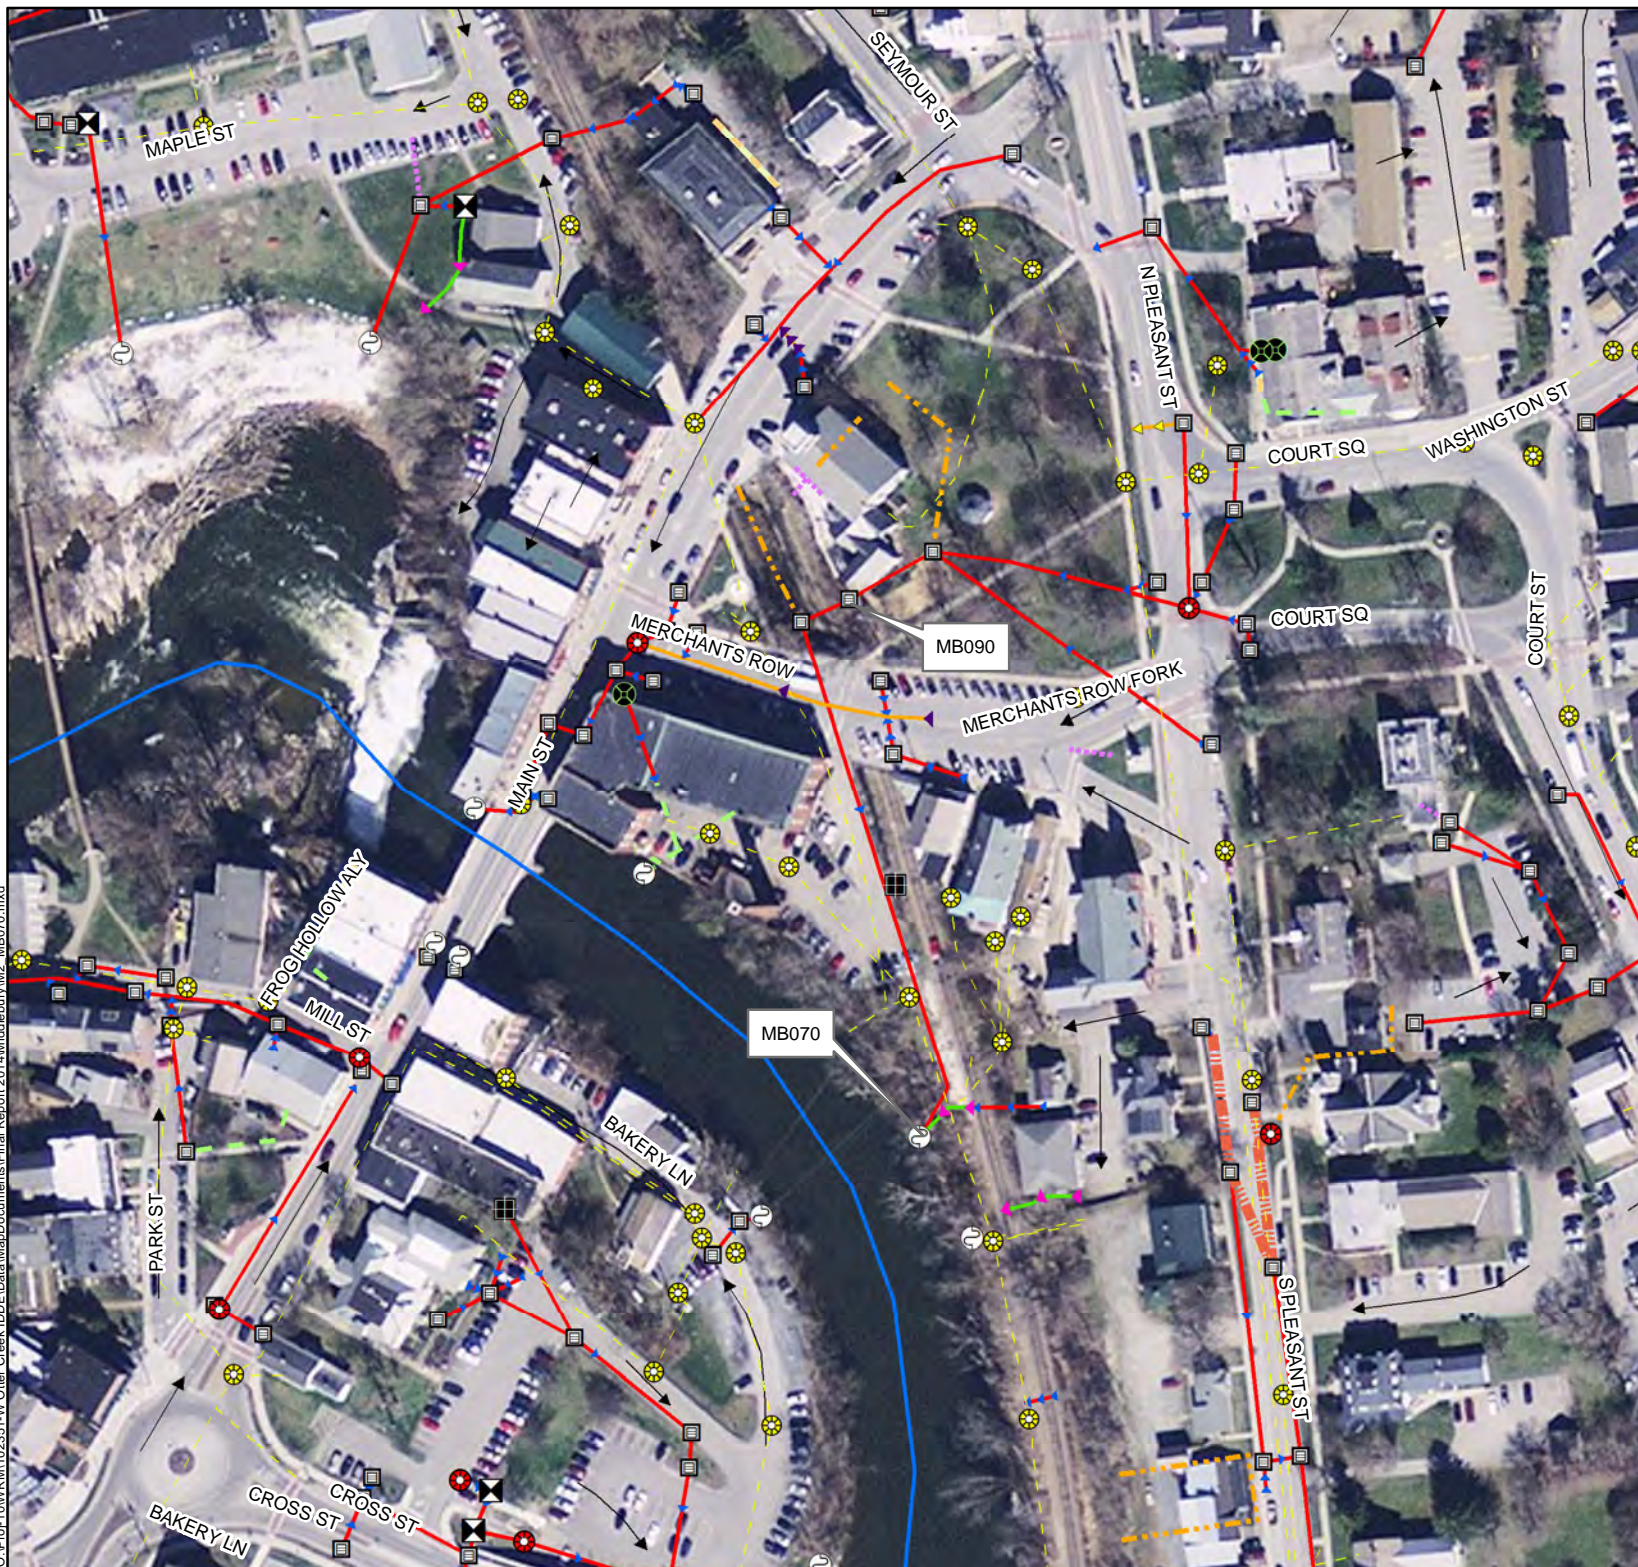
Map M1

System ID	Assessment Findings	Map
MB030	<p>Description: Outfall MB030 discharges to Otter Creek on the east side of the Storm Café on Mill Street. The system drains the eastern length of Mill Street and a short section of Main Street. During sampling on October 28, 2011, the field crew noted turbid water and a distinct swimming pool odor in the structure (catchbasin MB050) immediately up-pipe from the outfall. A sample collected from the catchbasin had an exceedingly high total chlorine concentration (2.20 mg/L) and elevated ammonia (0.5 mg/L). The MBAS detergent test was invalid, possibly because the concentration exceeded the analytical range. While samples were being processed, a Storm Café employee was witnessed dumping mop water into catchbasin MB050.</p> <p>Status: The employee and restaurant manager agreed to stop dumping to the storm sewer. During a follow up visit on December 8, 2011, ammonia and chlorine concentrations were below the limit of detection at the outfall and the restaurant manager confirmed that wastes were no longer discharged to the catchbasin. Therefore, we consider this discharge to have been eliminated.</p>	M1

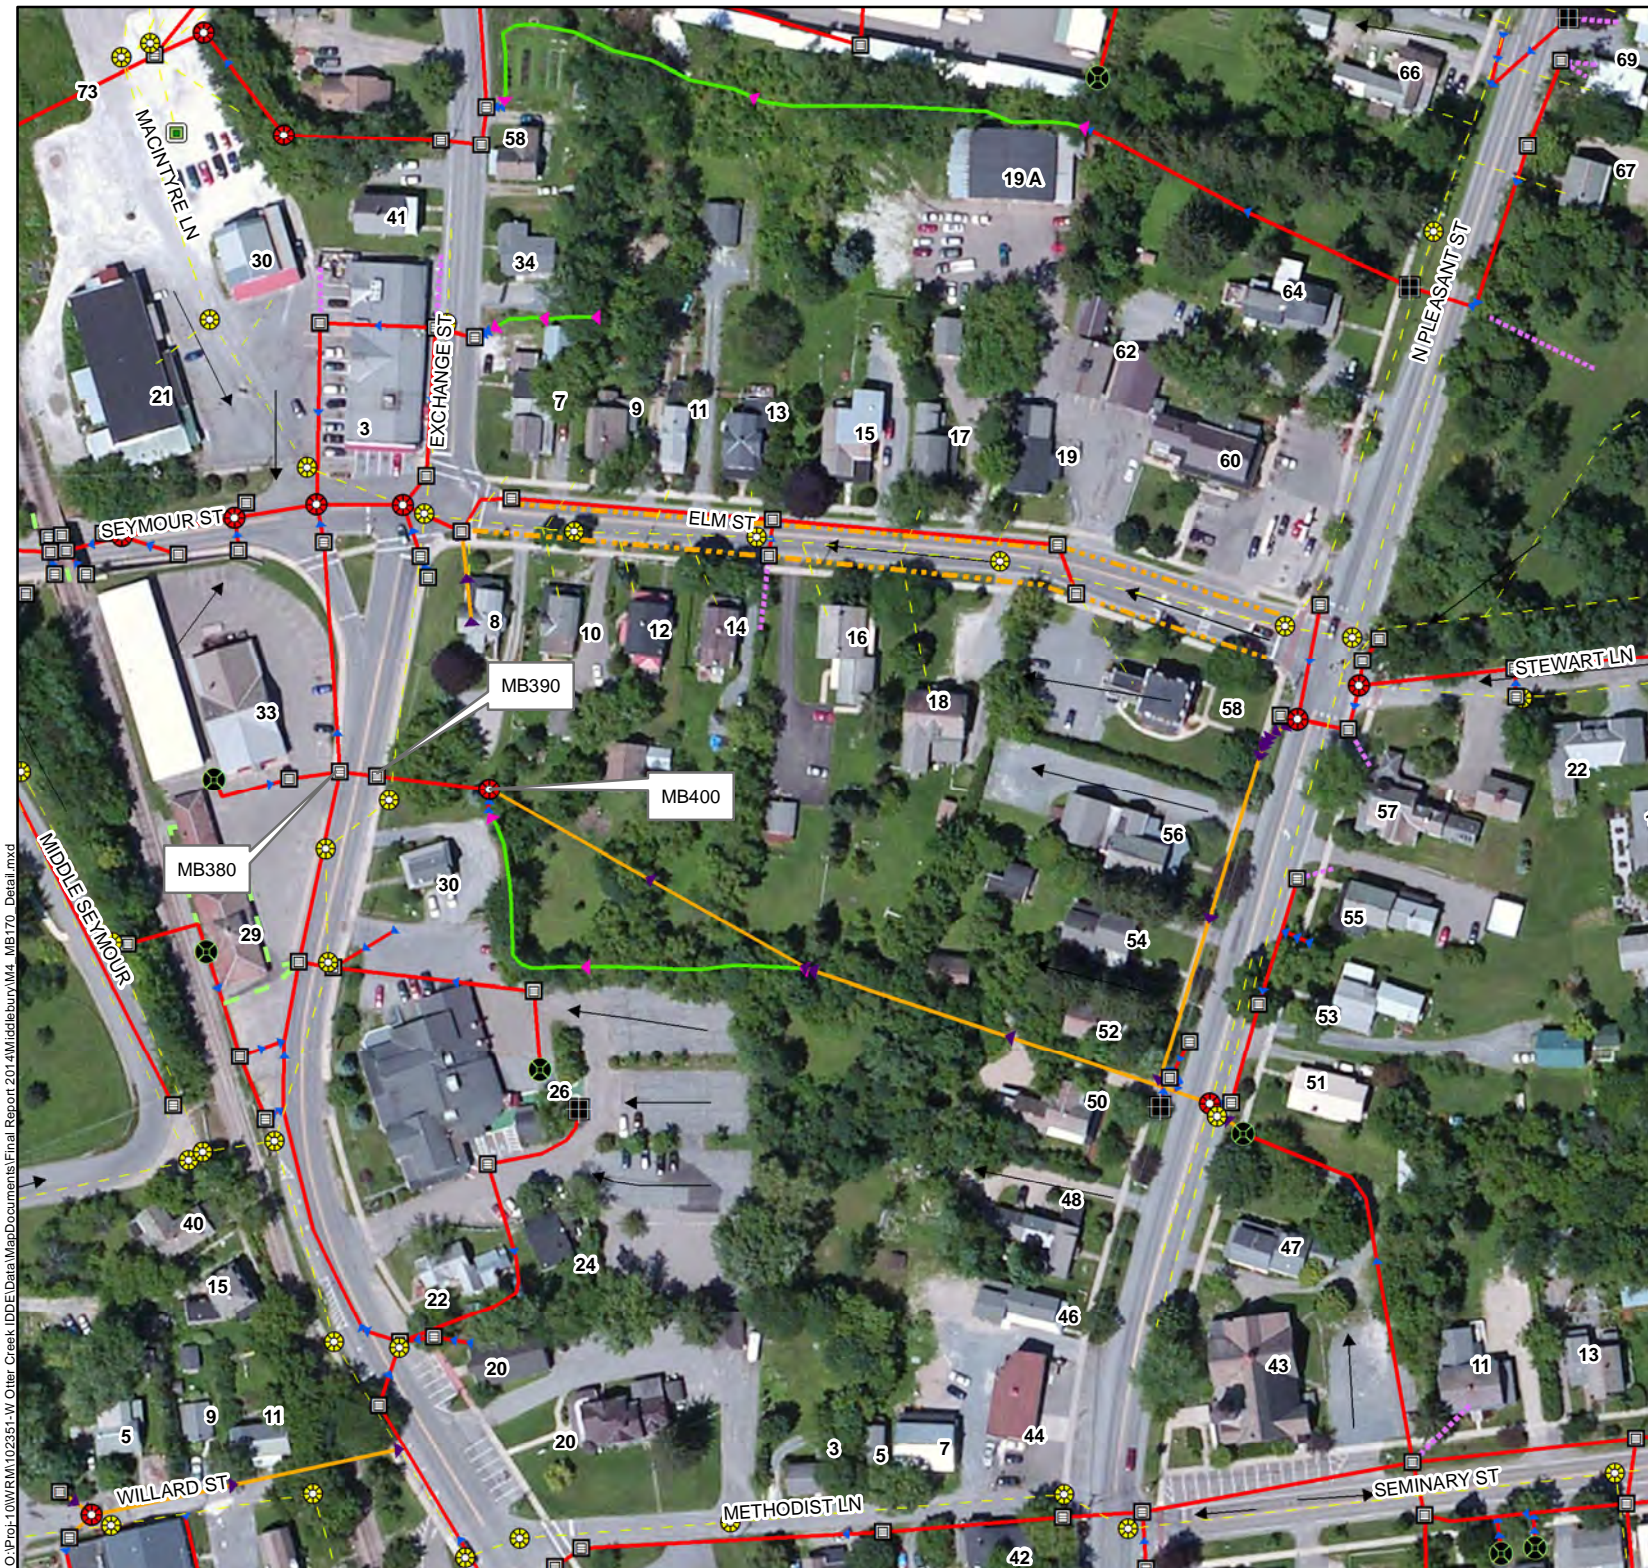
Map M3

System ID	Assessment Findings	Map
	Superintendent, Bob Wells, this stormwater system is scheduled to be replaced with a modern system as part of a major train tunnel construction project scheduled to begin in the fall of 2014. The sanitary sewer will be reconstructed or realigned as well. Direct connections to the system from floor drains should be eliminated during reconstruction. Therefore, no other action is recommended.	
MB170 system	<p>Description: Manhole MB170 is a manhole on Lucius Shaw Lane at the former wastewater treatment plant (now a pump station). This extensive drainage system discharges to Otter Creek at an outfall identified as Middlebury CSO #10. MB170 is the first structure up-pipe from the outfall, which is inaccessible.</p> <p>It appears there are contaminated non-stormwater flows entering in three segments within the contributing drainage system, identified as #1 to #3 below.</p>	M3

<p>#2: Catchbasin MB360 is located on the north side of Seminary Street in the grass next to the church parking lot. On two dates chlorine was detected in Pipe C, which crosses Seminary Street: 0.20 mg/L was measured on November 1, 2011 and 0.16 mg/L was measured on December 13, 2011. A tapwater leak is suspected in the vicinity that infiltrates the Pipe C stormline between catchbasin MB360 and the next up-pipe structure.</p> <p>Status: Small potable water leaks are essentially a municipal concern rather than sources of priority pollutants. We recommend acoustic leak detection be performed to locate the apparent leak.</p>	M3
	<p>#3: Catchbasin MB370 is located at the intersection of Seymour Street and Methodist Lane. The system in question drains the southern section of Seymour Street. During the assessment on November 2, 2011, there was small flow into the catchbasin from pipes A and B and suds in the sump. On two dates chlorine was detected in flow from Pipe B: 0.5 mg/L on November 2 and 0.09 mg/L on December 14, 2011. A tapwater leak is suspected in this vicinity that infiltrates the Pipe B stormline between catchbasin MB370 and the next up-pipe structure.</p> <p>Status: Small potable water leaks are essentially a municipal concern rather than sources of priority pollutants. We recommend acoustic leak detection be performed to locate the apparent leak.</p>	M3

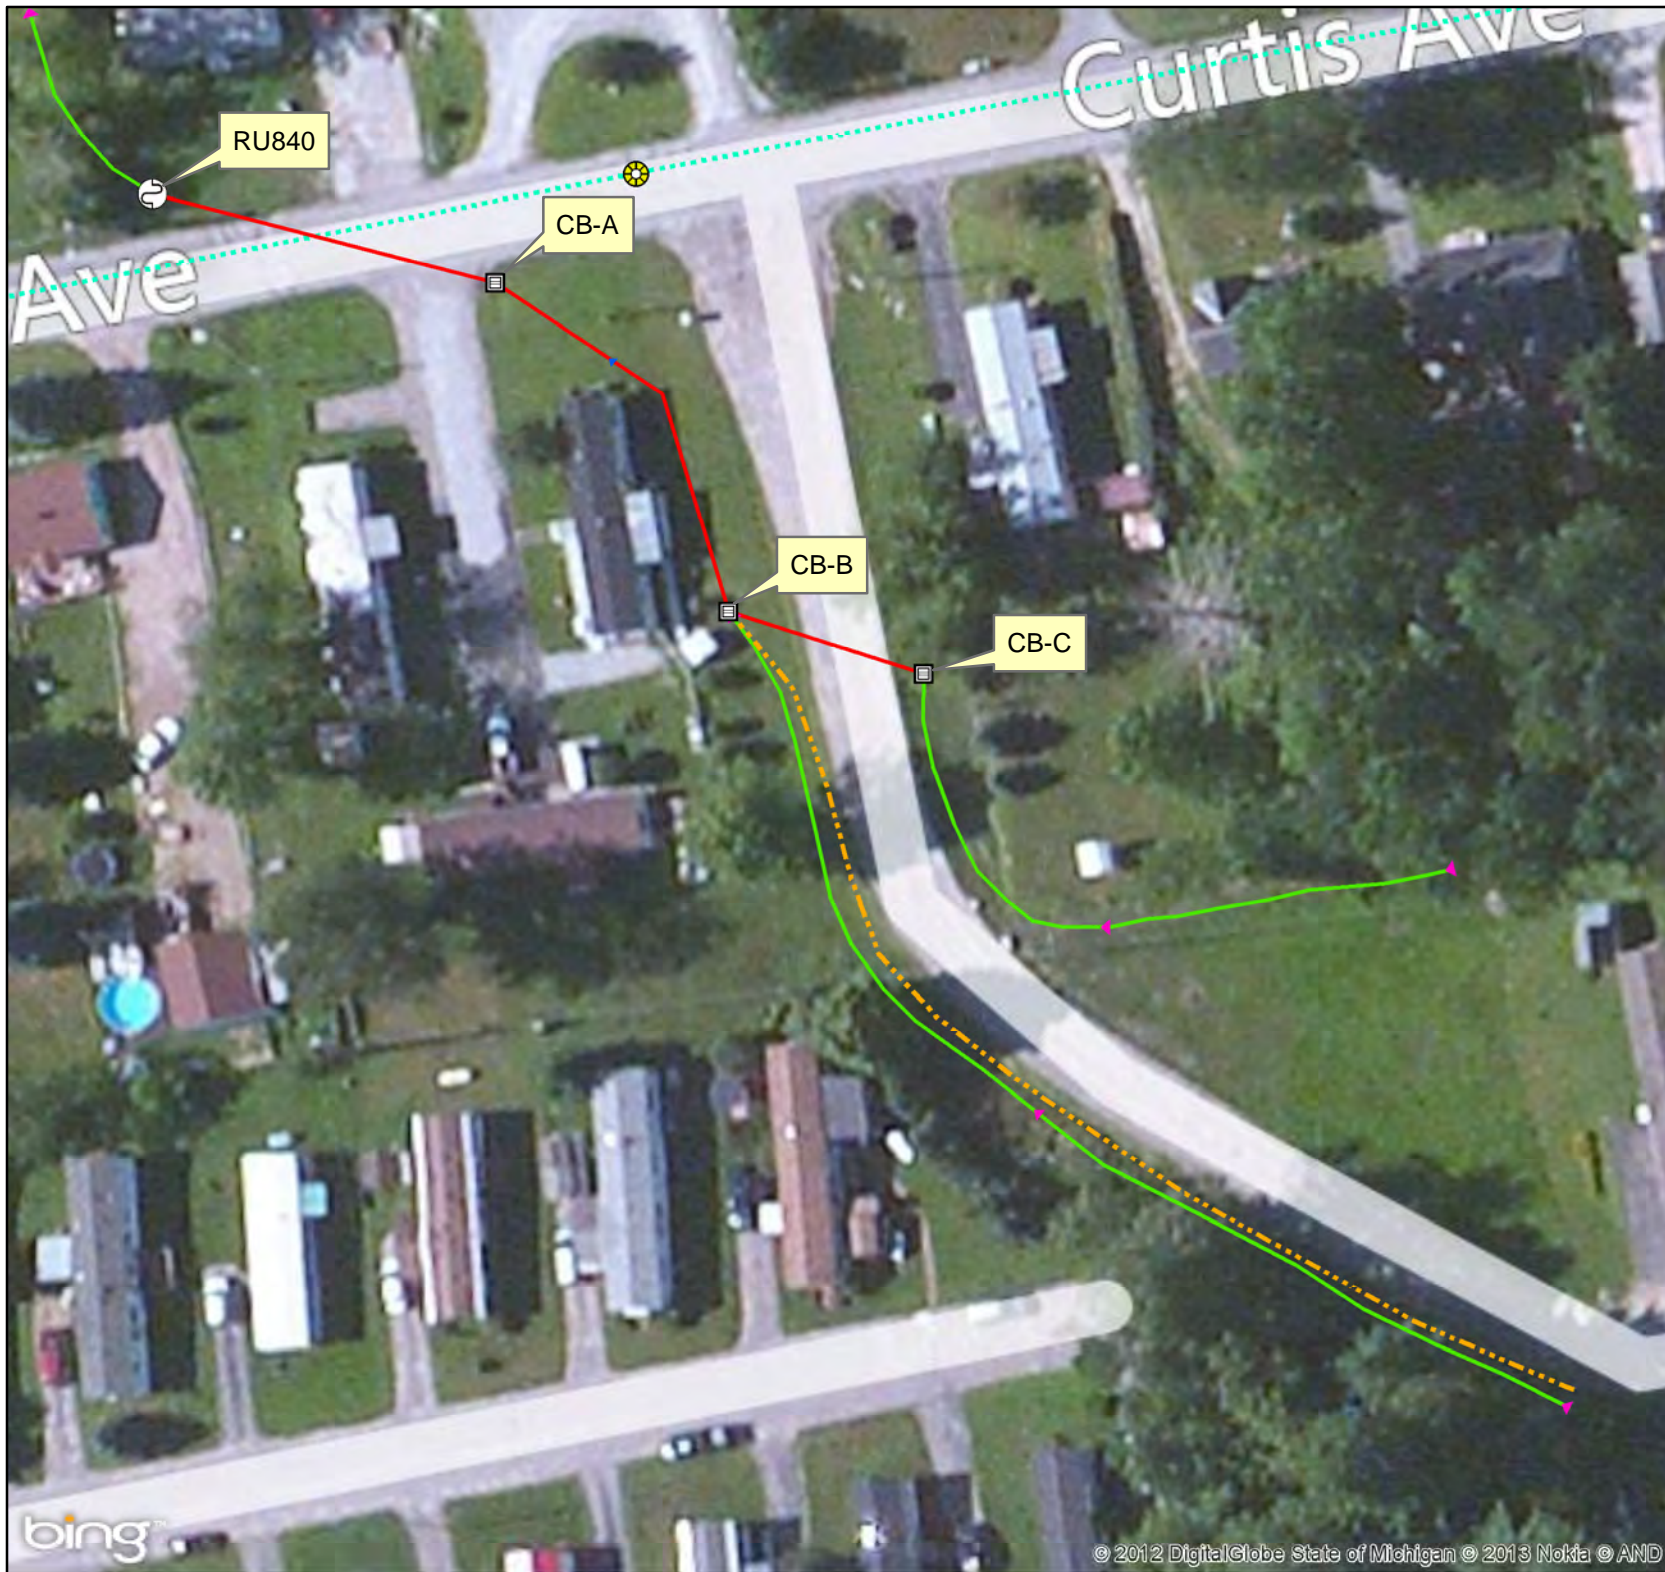
Map RC4

RU380	<p>Description: Outfall RU380 is a 15-inch diameter corrugated black plastic pipe located on the southeast corner of Moon Brook Drive. The outfall was dripping when assessed on June 21, 2012. The total chlorine concentration (0.06 mg/L) was low and the specific conductance (3,360 μS/cm) was high. No optical brightener was detected.</p> <p>No flow was observed on October 30, 2013 and there appear to be no illicit connections. The high specific conductance may be characteristic of groundwater in this area of Rutland.</p> <p>Status: An illicit discharge in this system was not demonstrated; therefore, no action is recommended.</p>	NA
RU410	<p>Description: Outfall RU410 was mapped at the intersection of Catherine Drive and Dogwood Lane. The outfall could not be located; therefore the first up-pipe catchbasin (CB-A) was assessed. Very low levels of chlorine (0.05 mg/L) and MBAS (0.25 mg/L) were measured. The outfall was located on August 2, 2013 and very low <i>E. coli</i> (10 MPN/100 mL) and total phosphorus (53.6 μg/L) concentrations were measured. On October 23, 2013, a moderate total chlorine concentration (0.11 mg/L) was measured. Similar results (0.08 mg/L) were obtained testing flow from a 4-inch pipe discharging to catchbasin CB-H, near houses #22 and #24 on Catherine Drive, suggesting this pipe is the source of the chlorine. We suspect there is a water line leak in the vicinity of #24 Catherine Drive.</p> <p>Status: Small potable water leaks are essentially a municipal concern rather than sources of priority pollutants. We recommended that the City of Rutland perform leak detection on the water line in the vicinity of #24 Catherine Drive.</p>	RC4

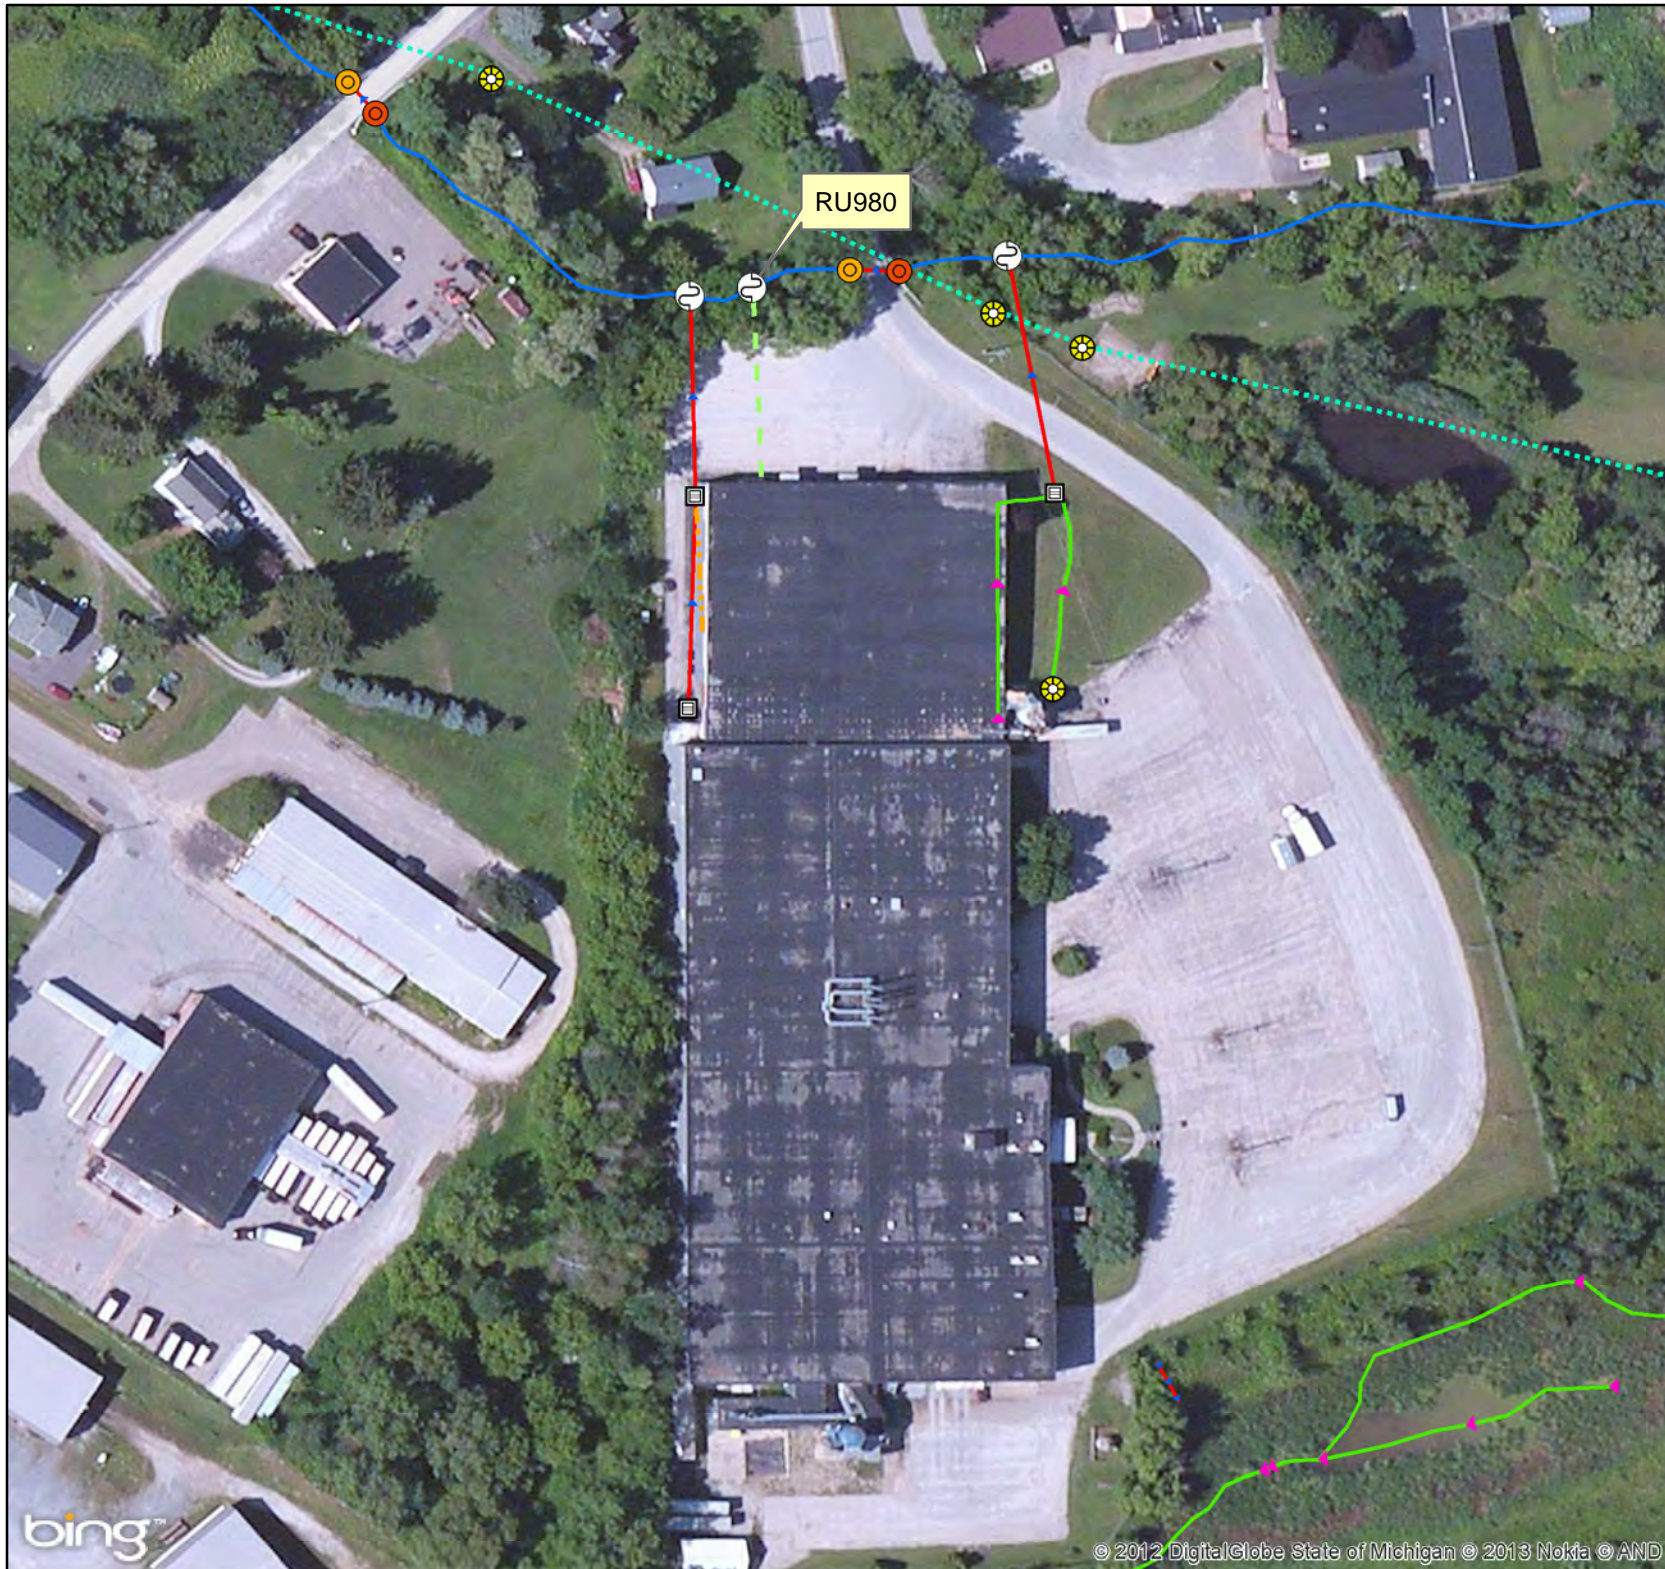
Map RC5

System ID	Assessment Findings	Map
RU840	<p>Description: Outfall RU840 is a 12-inch diameter corrugated black plastic pipe located on Curtis Avenue west of the intersection with Preston Park. The chlorine concentration at the outfall was 0.11 mg/L on July 3, 2012. Suds and iron staining were observed. The source of flow and contamination is believed to be a 4-inch diameter underdrain flowing from the south into catchbasin CB-B. The chlorine concentration from this underdrain was high, 0.55 mg/L.</p> <p>On October 23, 2013 a low total chlorine concentration (0.05 mg/L) was measured at CB-C. As in 2012, a high total chlorine concentration (0.47 mg/L) was measured in flow from the 4-inch diameter underdrain entering CB-B. We could not identify the origin of the flow. According to the City Engineer, there has been a history of leaking pipelines in the Preston/Billings neighborhood.</p> <p>Status: Small potable water leaks are essentially a municipal concern rather than sources of priority pollutants. We suspect a water leak in this vicinity is infiltrating the underdrain discharging at catchbasin CB-B. As this system is privately owned, our recommendation is simply that the City Engineer informs the property owner of this finding.</p>	RC5

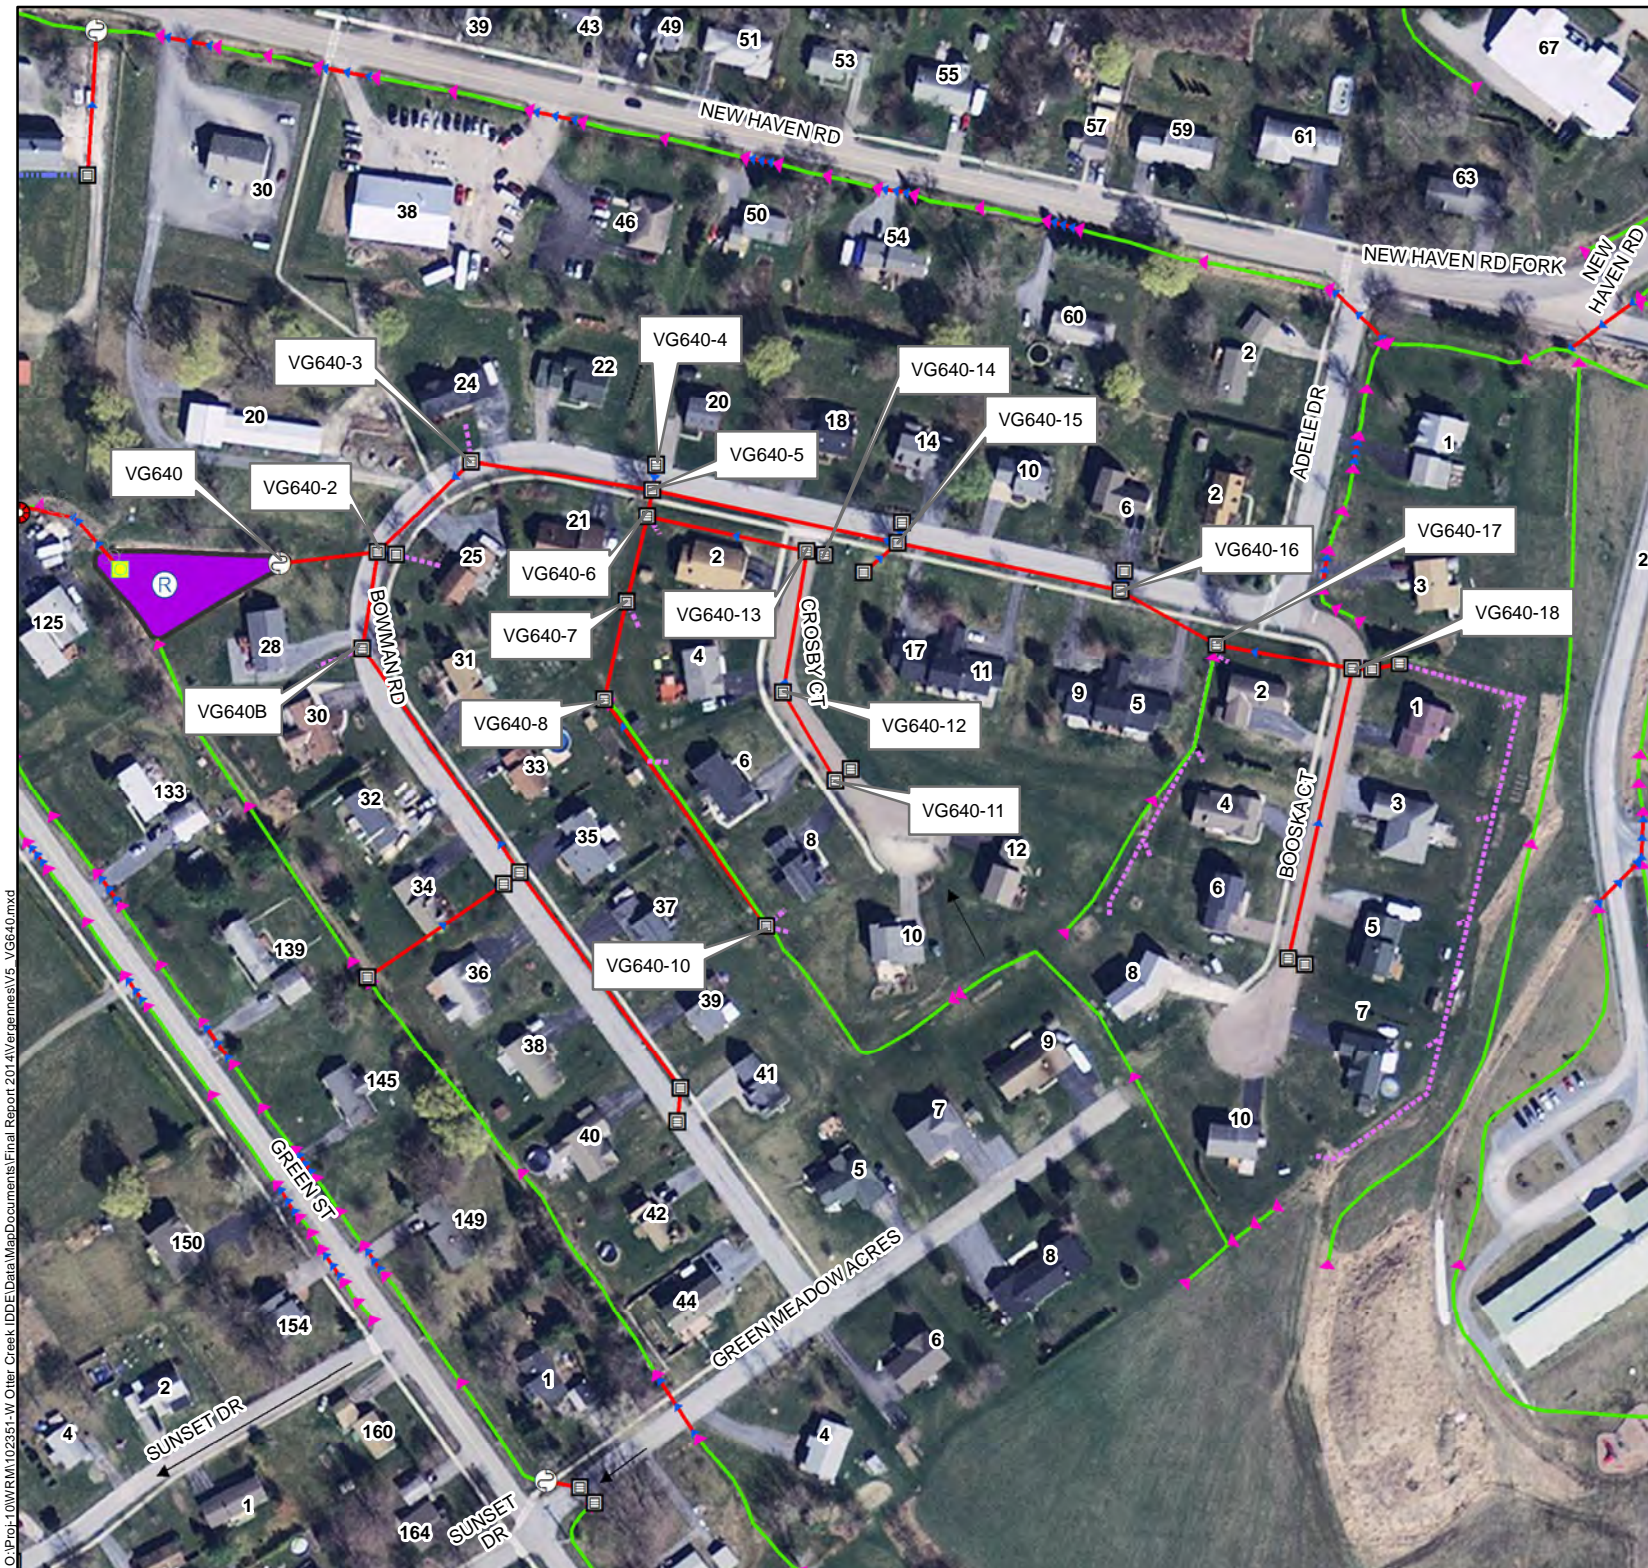
Map V4

System ID	Assessment Findings	Map
	<p>the outfall and at catchbasin VG480. On December 14, 2011 optical brightener monitoring pads were deployed throughout the system to bracket the source of the optical brightener. The source was effectively narrowed to the catchbasin VG470-6 at the intersection of South Maple Street and Roberts Street.</p> <p>Status: We recommend that the Vergennes Department of Public Works Dye test several houses on South Maple Street: #45, #46, #48, #51, #53, and #54.</p>	
VG570	<p>Description: Outfall VG570 is a 15-inch smooth plastic pipe located behind #12 Sunset Drive. The system drains all of Sunset Drive and discharges to a rip-rapped gully leading to a swampy area. Dry weather flow sampled on November 28, 2011 had no detectable ammonia, chlorine, or MBAS detergent; however, optical brightener was detected at the outfall. On December 14, 2011, the tests were repeated and an optical brightener monitoring pad was placed in every accessible structure in the system. Optical brightener was detected at the outfall and at the second catchbasin up-pipe from the outfall labeled VG570-3. The pad placed in the first catchbasin up-pipe from the outfall labeled VG570-2 (a drain in the backyard) was negative, which is an inconsistency with the detection in catchbasin VG570-3. Outfall VG570 is a 15-inch diameter smooth plastic pipe located behind a house on Sunset Drive. Optical brightener was detected at the outfall and at the second catchbasins up-pipe from the outfall.</p> <p>Status: The source of the optical brightener has been bracketed as closely as possible using monitoring pads. We recommend that the Town of Vergennes inspect, and dye test if necessary, the houses (#12, #14, and #16 Sunset Drive) surrounding the second catchbasin in order to identify any direct connections. If no direct connections are found, then there is probably a leak in the sanitary sewer system in this vicinity.</p>	V4
