Detecting and Eliminating Illicit Discharges in Rutland County to Improve Water Quality

Final Report

March 31, 2014

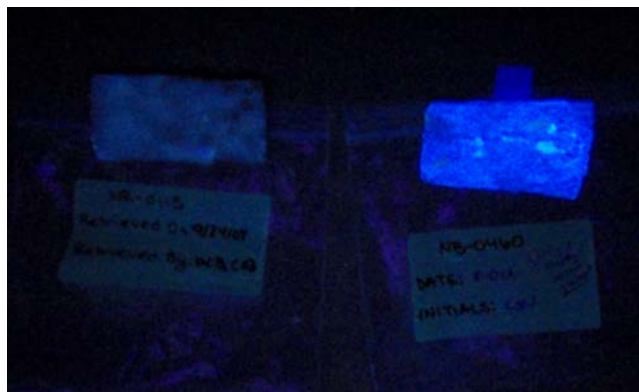
Figure 1. Optical brightener monitoring pads under UV light

Optical brightener monitoring was performed at outfalls and selected catchbasins and manholes that were flowing at the time of inspection, according to Stone Environmental SOP 6.38.0 (Appendix B). To test for optical brightener, a cotton pad is placed in the flow stream for a period of 4-10 days, after which the pad is rinsed, dried, and viewed under a long-wave ultraviolet light (“black light”). Fluorescence of the pad (seen on the right pad in Figure 1) indicates the presence of optical brightener. Pads are held in a sleeve of fiberglass window screen, clipped to the rim of the outfall pipe or secured with fishing line to a rock or other anchor. At catchbasins and manholes located at junctions in the storm sewer, pads are deployed in incoming pipes if possible, but are more often hung from the catchbasin grate or manhole rung into the sump. An advantage of optical brightener monitoring is that some intermittent or dilute wastewater discharges may be detected due to the multiple-day exposure of the pad, whereas the contaminant may not be detected in tests performed on grab samples.

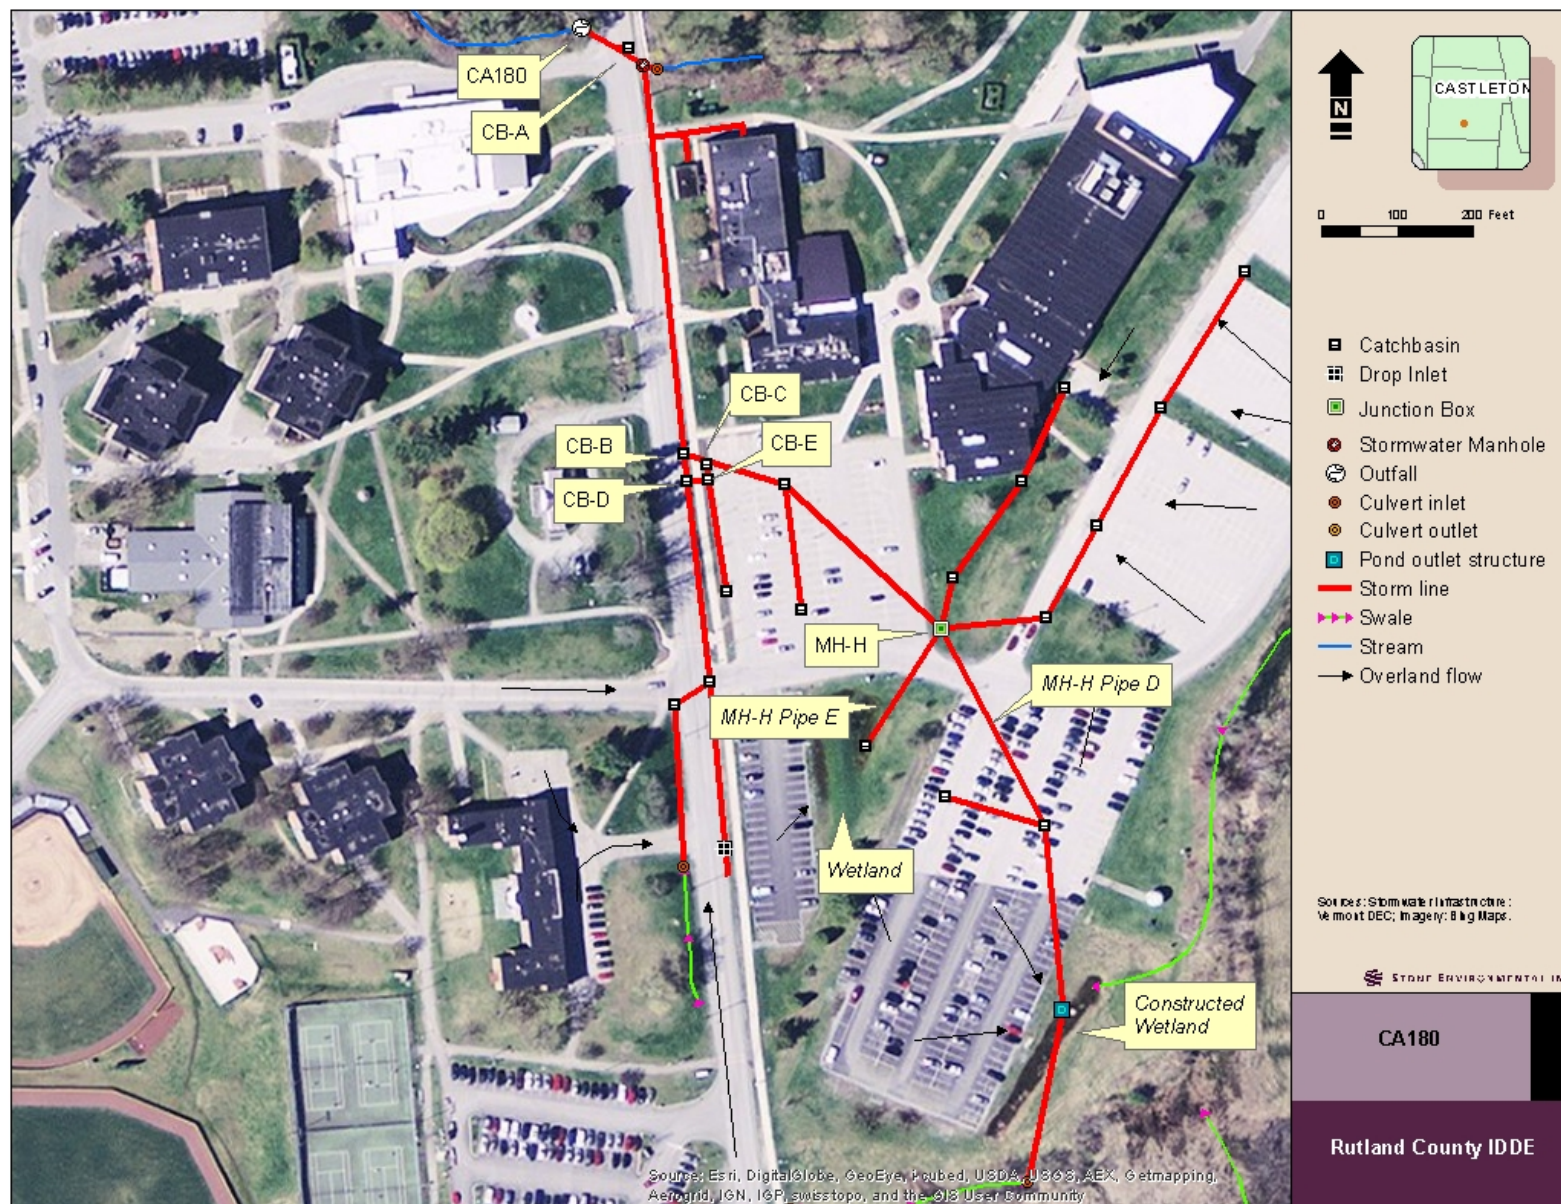
Map 2. System CA180

Of the 26 stormwater drainage systems assessed in Castleton, an illicit discharge was suspected in only one, system CA180 (see description below). Through extensive bracket sampling, the apparent contamination (ammonia) in this system was determined to be of natural origin. Therefore, we found no confirmed illicit discharges in Castleton.

The CA180 outfall is a 36-in. diameter corrugated black plastic pipe. This system drains a series of catchbasins along South Street and an adjoining Castleton State College parking lot to the east (Appendix C, Map 2). Water quality data for this system are presented in Table 5. The outfall was flowing and discharge was clear with a musty odor when inspected on June 20, 2013. A low ammonia concentration (0.5 mg/L) was measured. The outfall pipe and the streambed below the pipe had substantial iron staining. Optical brightener was not detected at the outfall or catchbasin-CB-D, but a pad placed in catchbasin CB-E in the Castleton State College parking lot was indeterminate. Monitoring pads set on July 25, 2013 indicated no optical brightener at CB-E or at the outfall.
