TOWN OF SPRINGFIELD, VERMONT

Illicit Discharge Detection and Elimination Study

January 2013

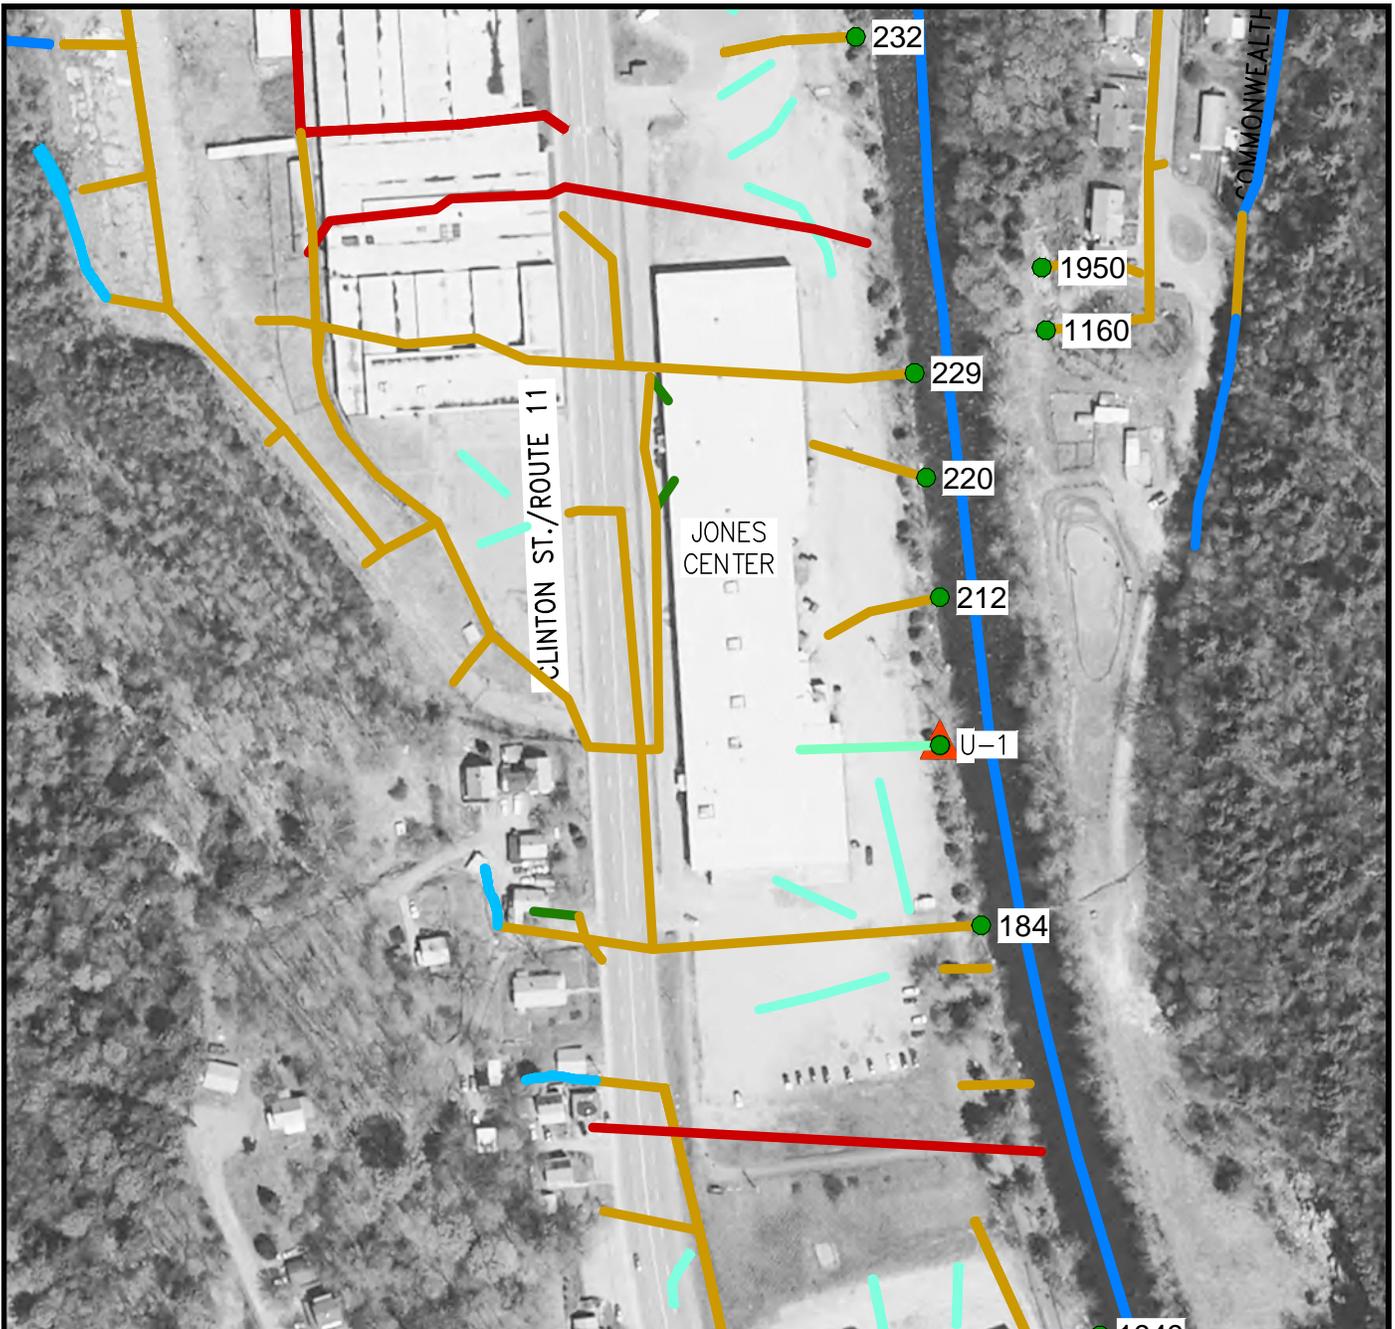
OUTFALL #U-1	DESIGNED NAP	PROJECT NO. 12049
	DRAWN JEB	
SPRINGFIELD IDDE STUDY	CHECKED (PM) ADL	FIGURE NO. 3
TOWN OF SPRINGFIELD	CHECKED (PE) JJD	
SPRINGFIELD	SCALE AS NOTED	DATE NOV. 2012
VERMONT

Outfall U-1 is an 8-inch diameter corrugated metal pipe discharging at the west bank of the Black River directly behind the Jones Center Building on Route 11, also known as Clinton Street. The outfall was labeled as U-1, since the outfall was not identified on the DEC stormwater mapping. During the initial investigation, the pipe was found to be dripping with an odor of sewage present and paper products located below the outfall. An OB pad was tested in the outfall with positive results. Table 3.2 shows the water quality results from the initial assessment.

Flow (gpm)	Deposits/Staining	Conductivity(uS/cm)	OB Pad
0.04	Iron/Grey Water	355	Positive

The Town of Springfield dye tested within the Jones Center Building to confirm the source of the illicit discharge. Through the dye testing, it was determined that a sink, seen in Figure 3.1 and a floor drain were connected to this outfall. The Town, informed the property owner of the identified problem. The property owner subsequently had the drain pipe rerouted to the building sewer to eliminate the illicit connection. This repair was made by the property owner at a cost of \$1,200.

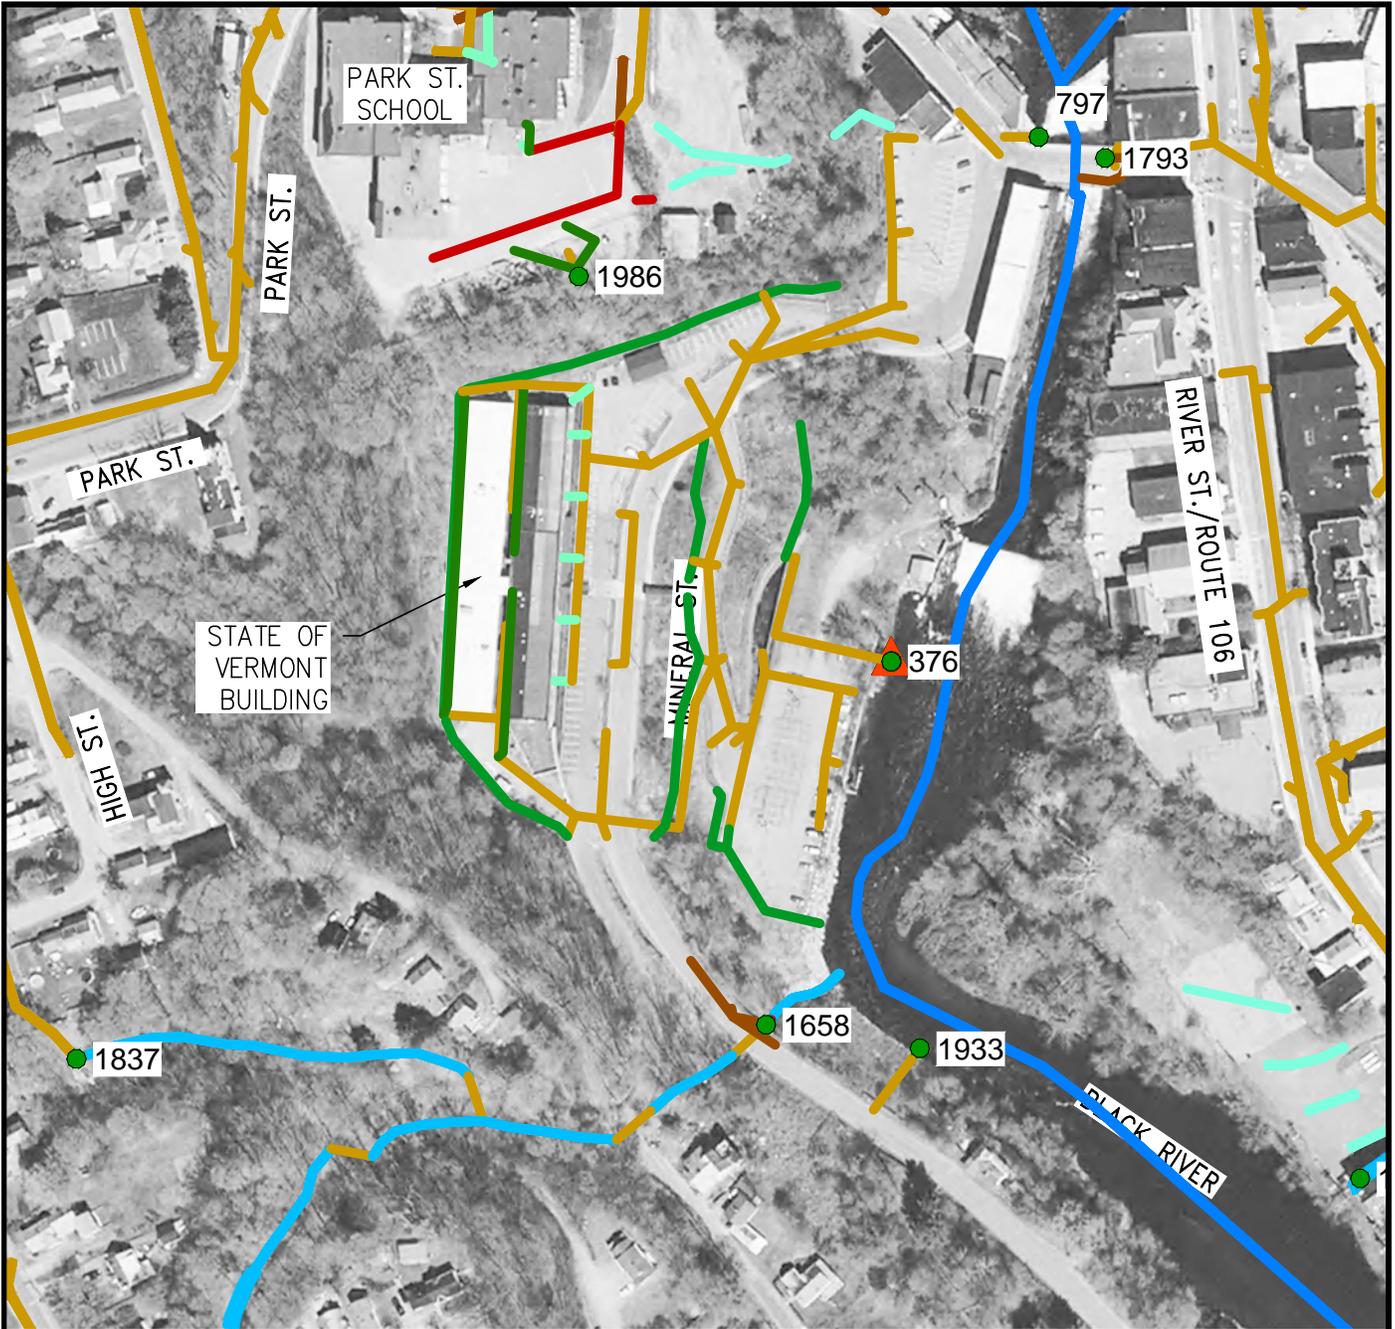
OUTFALL #376	DESIGNED MAP	PROJECT NO. 12049
	DRAWN JEB	
SPRINGFIELD IDDE STUDY	CHECKED (PM) ADL	FIGURE NO. 4
TOWN OF SPRINGFIELD	CHECKED (PE) JJD	
SPRINGFIELD	SCALE AS NOTED	DATE NOV. 2012
VERMONT

Flow (gpm)	Deposits/Staining	Conductivity(uS/cm)	OB Pad
0.5	---	483	Positive

A+E completed a survey to verify that the building sewer could be rerouted into the sewer line on Park Street. A preliminary design for the new sewer service was completed and shown on Figure No. 12 in Appendix A. In Spring 2013, the Town is planning to coordinate with the property owner to construct the new sewer building service from the Park Street sewer main. The cost to construct the new service is estimated at \$11,000. The Town needs to confirm prior to the repair that the roof drains are not tied into the sewer service. After the repair, it is recommended that the Town resample the sluiceway to confirm that the illicit discharge has been eliminated.

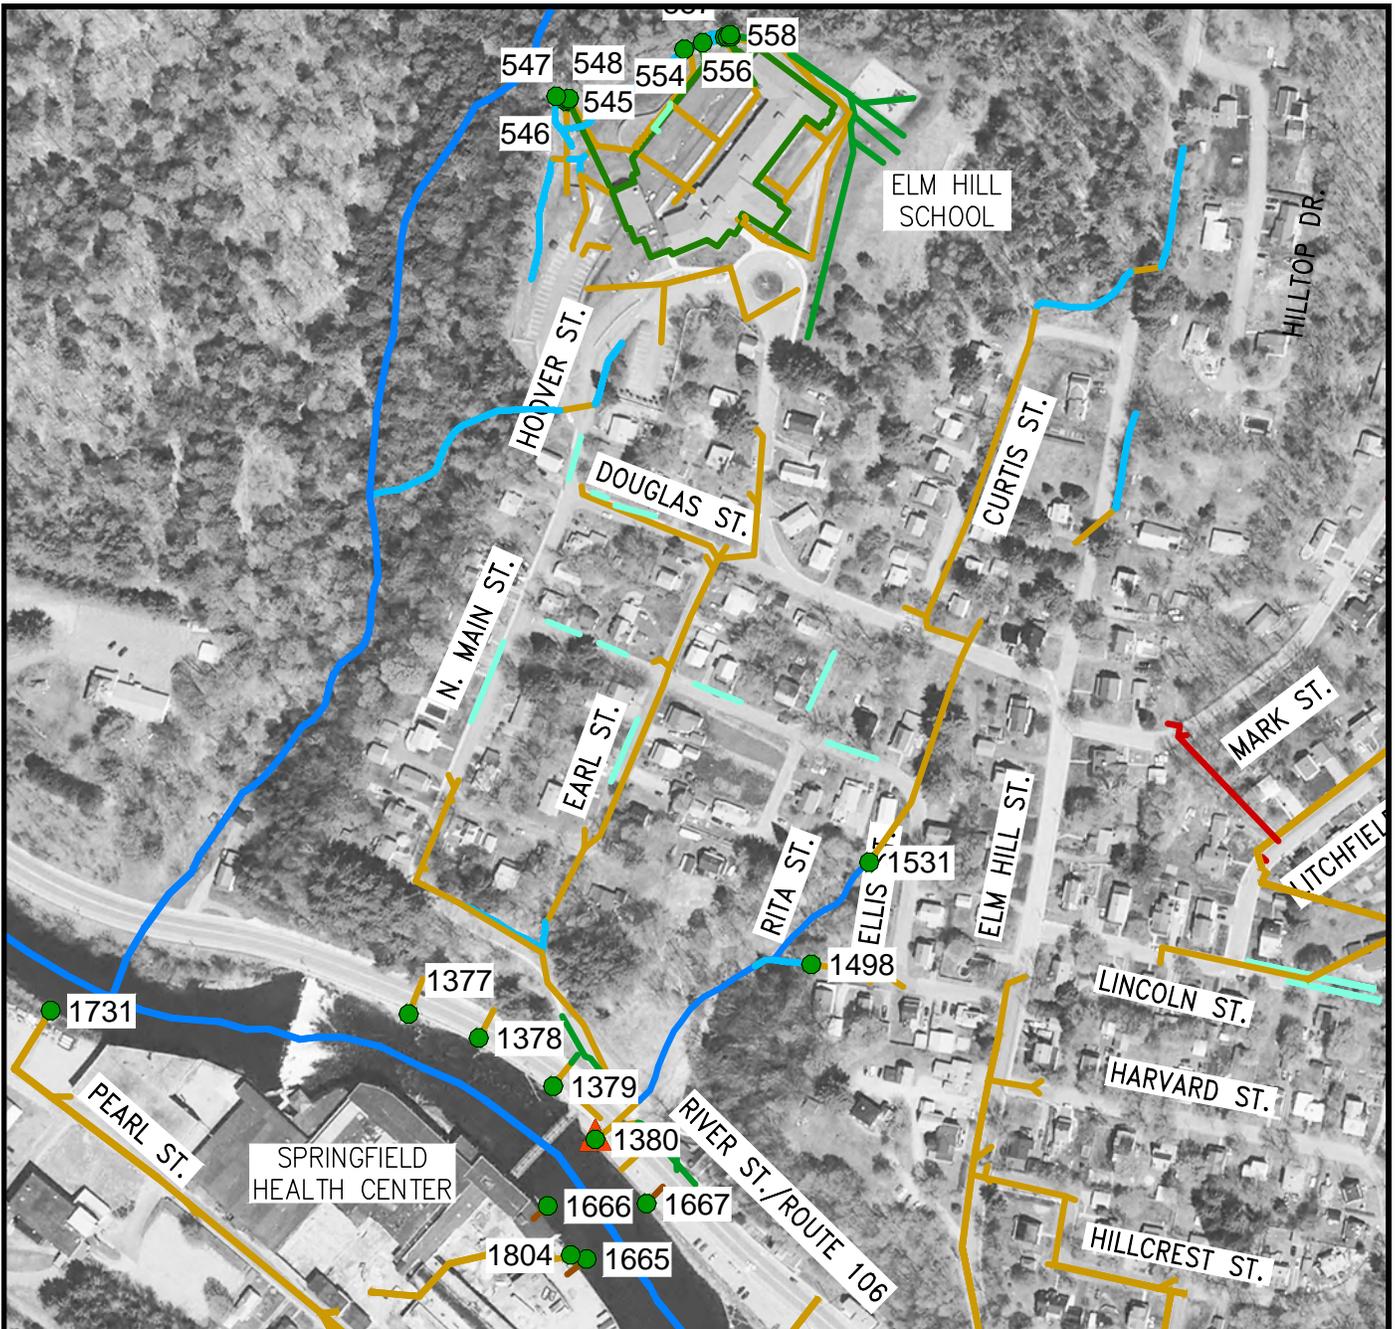
DESIGNED NAP	PROJECT NO. 12049
DRAWN JEB	
CHECKED (PM) ADL	FIGURE NO. 6
CHECKED (PE) JJD	
SCALE AS NOTED	
DATE NOV. 2012

Flow (gpm)	Deposits/Staining	Conductivity(uS/cm)	OB Pad
3.0	---	1150	Positive

An *E. Coli* test sample was taken at Outfall 1380. The result was 8 MPN/100mL, which is insignificant and rules out the influence of wastewater cross connection. The lab results can be found in Appendix D.

The Town of Springfield pushed a remote camera down the Mary Street catch basin to Outfall 1531 to see if any connections occurred between the two points. No connections were found during the inspection. The storm sewer upstream from catch basin 1531 was also inspected with a remote camera and no connections were found. An OB pad was left in the catch basin upstream of Outfall 1490 and the result was negative.

The Mary Street ravine was walked to locate any possible sources of illicit discharges and none were found. One possible intermittent source for the positive OB test may be car washing in this residential neighborhood near the Mary Street catch basin above Outfall 1531.

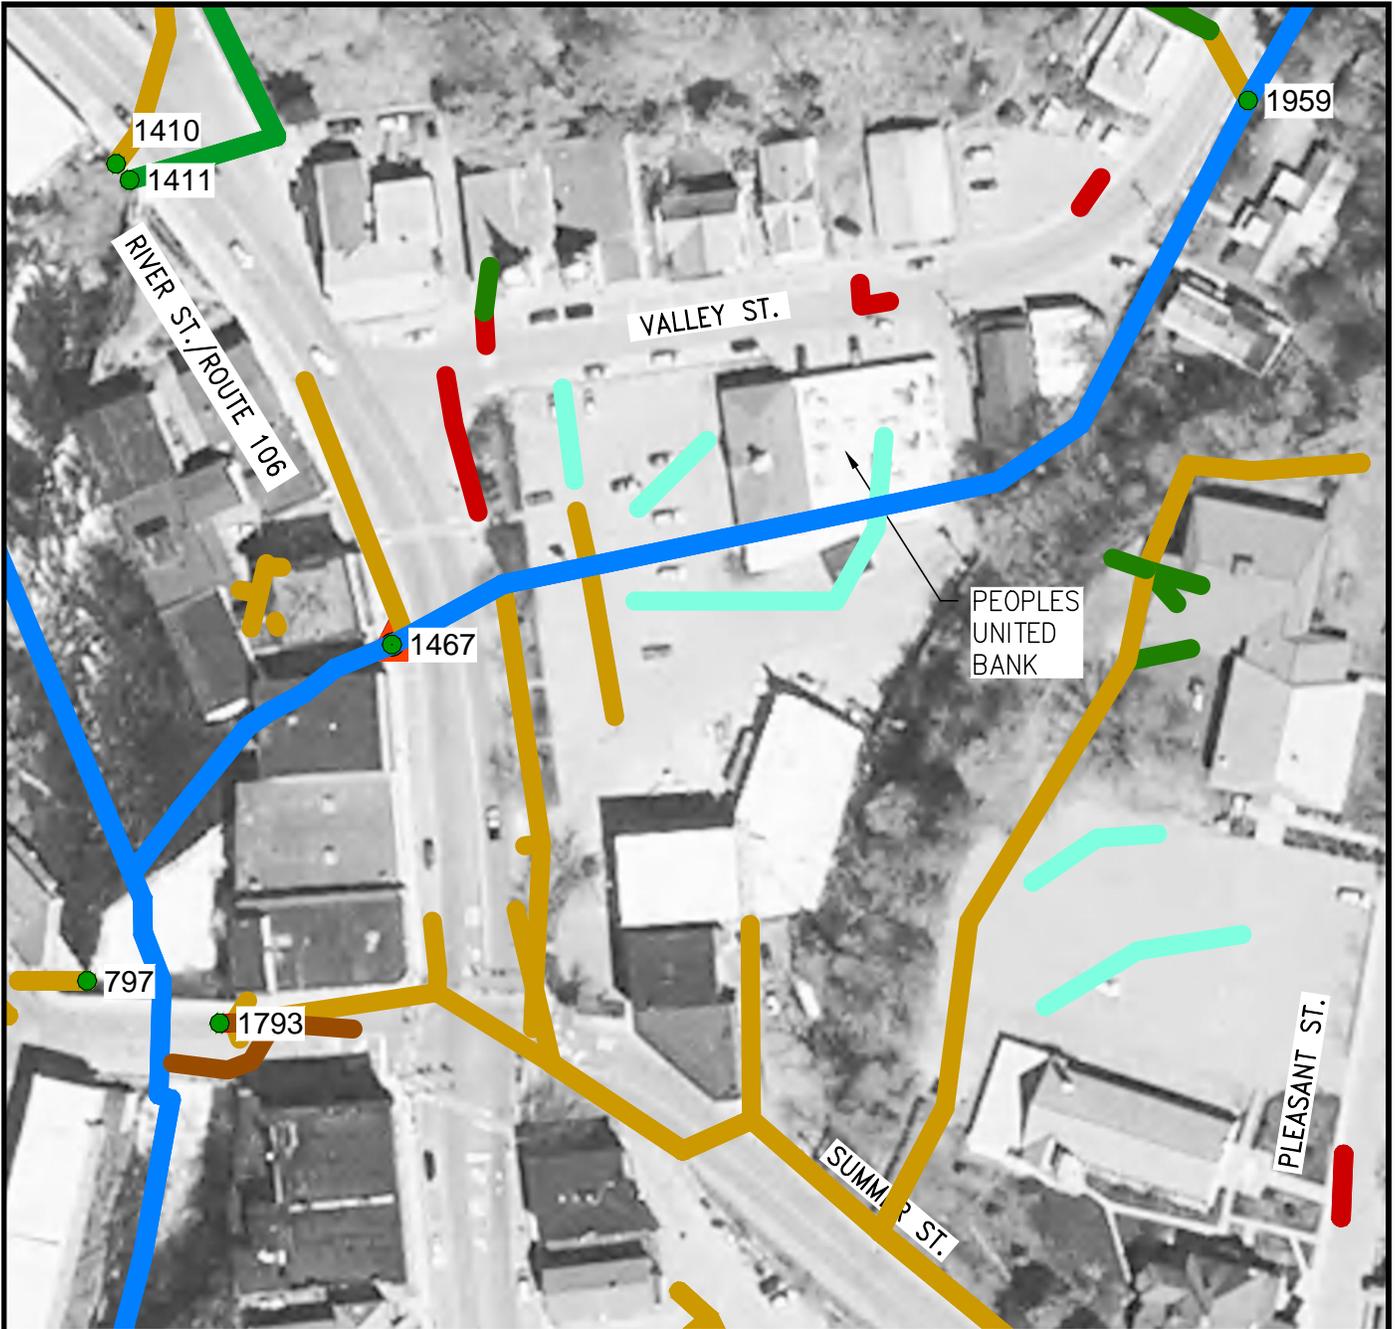
DESIGNED NAP	PROJECT NO. 12049
DRAWN JEB	
CHECKED (PM) ADL	FIGURE NO. 7
CHECKED (PE) JJD	
SCALE AS NOTED	
DATE NOV. 2012

1467	Chlorine	6-inch corrugated metal pipe from River St. stormwater system discharging into Valley St. Brook. Chlorine test confirmed water was Town water supply.
Near 749	Chlorine	Water leak in floor of building near Outfall 749. Chlorine test confirmed water was Town water supply.
1467	Odor/Visible Sheen (Petroleum)	Petroleum odor and sheen found in the Valley Street Brook sluiceway.
313	Odor/Visible Sheen (Petroleum)	24-inch corrugated metal pipe from Clinton St. stormwater discharging to the Black River. Petroleum odor including visible petroleum sheen.
2004	Odor/Visible Sheen (Petroleum)	12-inch corrugated HDPE pipe from the Riverside School stormwater that discharges to the Black River. Heating oil found in upstream manhole. Petroleum odor at outfall including presence of petroleum sheen in Black River.
376	Visual (Latex Paint)	18-inch corrugated HDPE from the State Building drainage system that discharges into the Black River. Cloudy water present in retention pond.

stop that had not been shut off and was releasing approximately 50 gpm of treated Town water. The other leak was a small crack found in the water main at the intersection of Main Street and Valley Street. Both leaks were promptly fixed by the Town of Springfield Public Works Department. The cost for this repair was approximately \$1,700.

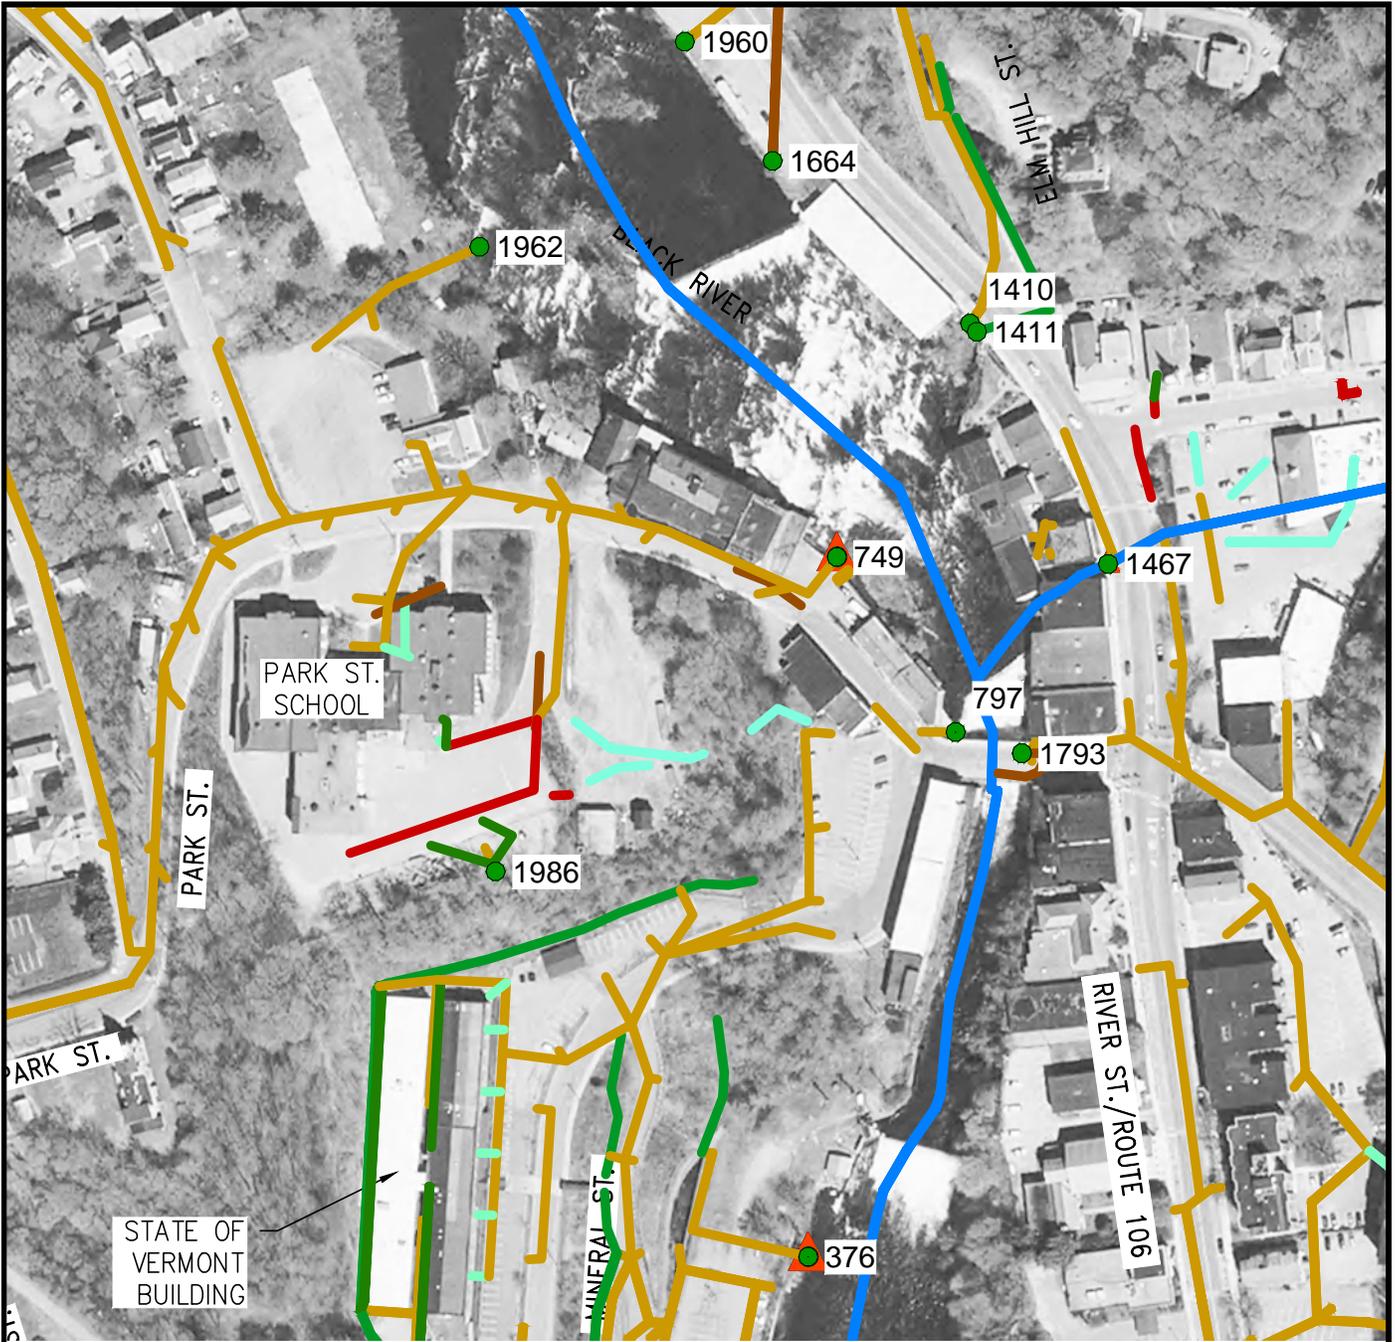
OUTFALL #749	DESIGNED NAP	PROJECT NO. 12049
	DRAWN JEB	
SPRINGFIELD IDDE STUDY	CHECKED (PM) ADL	FIGURE NO. 8
TOWN OF SPRINGFIELD	CHECKED (PE) JJD	
SPRINGFIELD	SCALE AS NOTED	
VERMONT	DATE NOV. 2012

The building to the west of Outfall 749 had a steady flow of water discharging into the Black River. Chlorine testing determined that the water leak was from the Town water supply. The property owner was informed of this leak by the Town. Underneath the building, visible petroleum stains were seen on the bottom of the floor slab. The property owner was present during the on-site inspection and informed of the findings and his responsibility to take corrective actions.

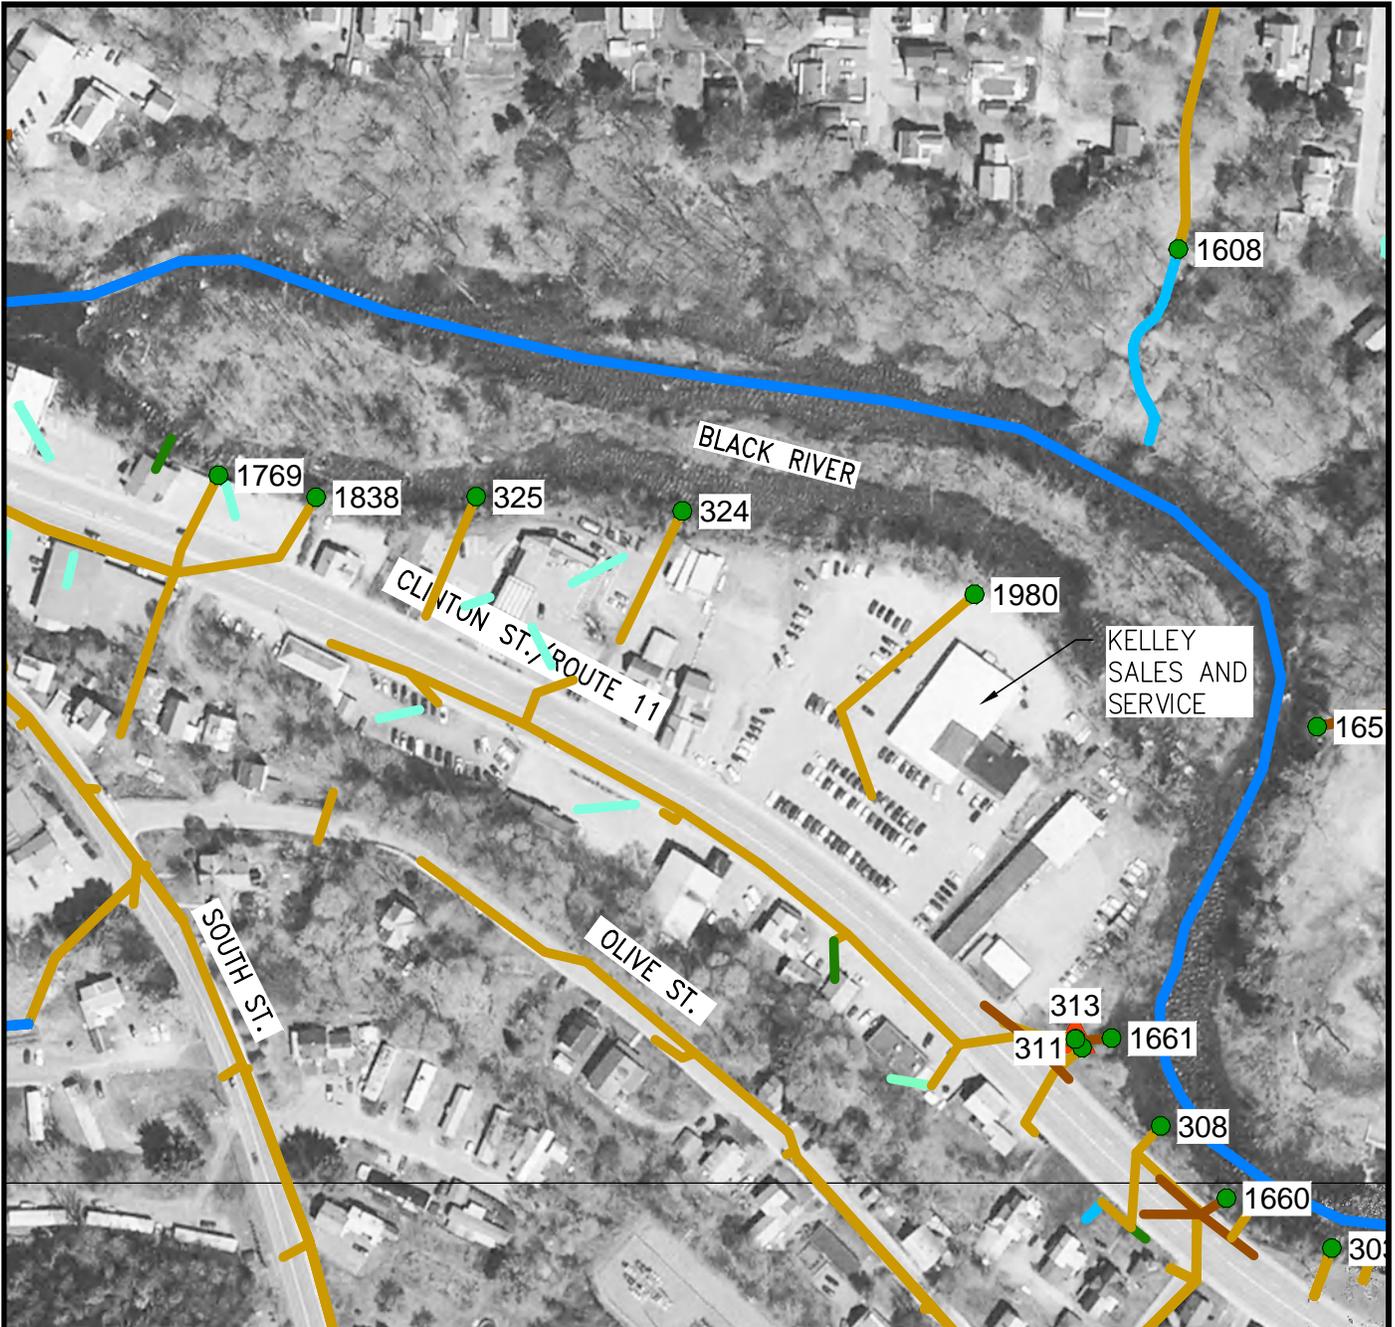
OUTFALL #313	DESIGNED MAP	PROJECT NO. 12049
	DRAWN JEB	
SPRINGFIELD IDDE STUDY	CHECKED (PM) ADL	FIGURE NO. 9
	CHECKED (PE) JJD	
TOWN OF SPRINGFIELD VERMONT	SCALE AS NOTED	
	DATE NOV. 2012

Flow (gpm)	Deposits/Staining	Conductivity(uS/cm)	OB Pad
0.5	Iron/Petroleum Sheen	1257	Negative

Figure 3.7 shows the collection system for Outfall 313. It extends up Clinton Street past numerous existing and past gas stations. Based on information provided from the ANR Environmental Interest Locator, there are several sites that have had petroleum spills and site cases along this area previously. During the advanced investigation, all catch basins connected to this outfall were inspected to identify any sources of contamination. No additional evidence of petroleum leaks was found during this investigation. The outfall was referred to DEC Site Manager for further investigation.
