Illicit Discharge Detection  
and Elimination in  
Richmond, Waterbury,  
Moretown, and Waitsfield

FINAL REPORT

February 25, 2011

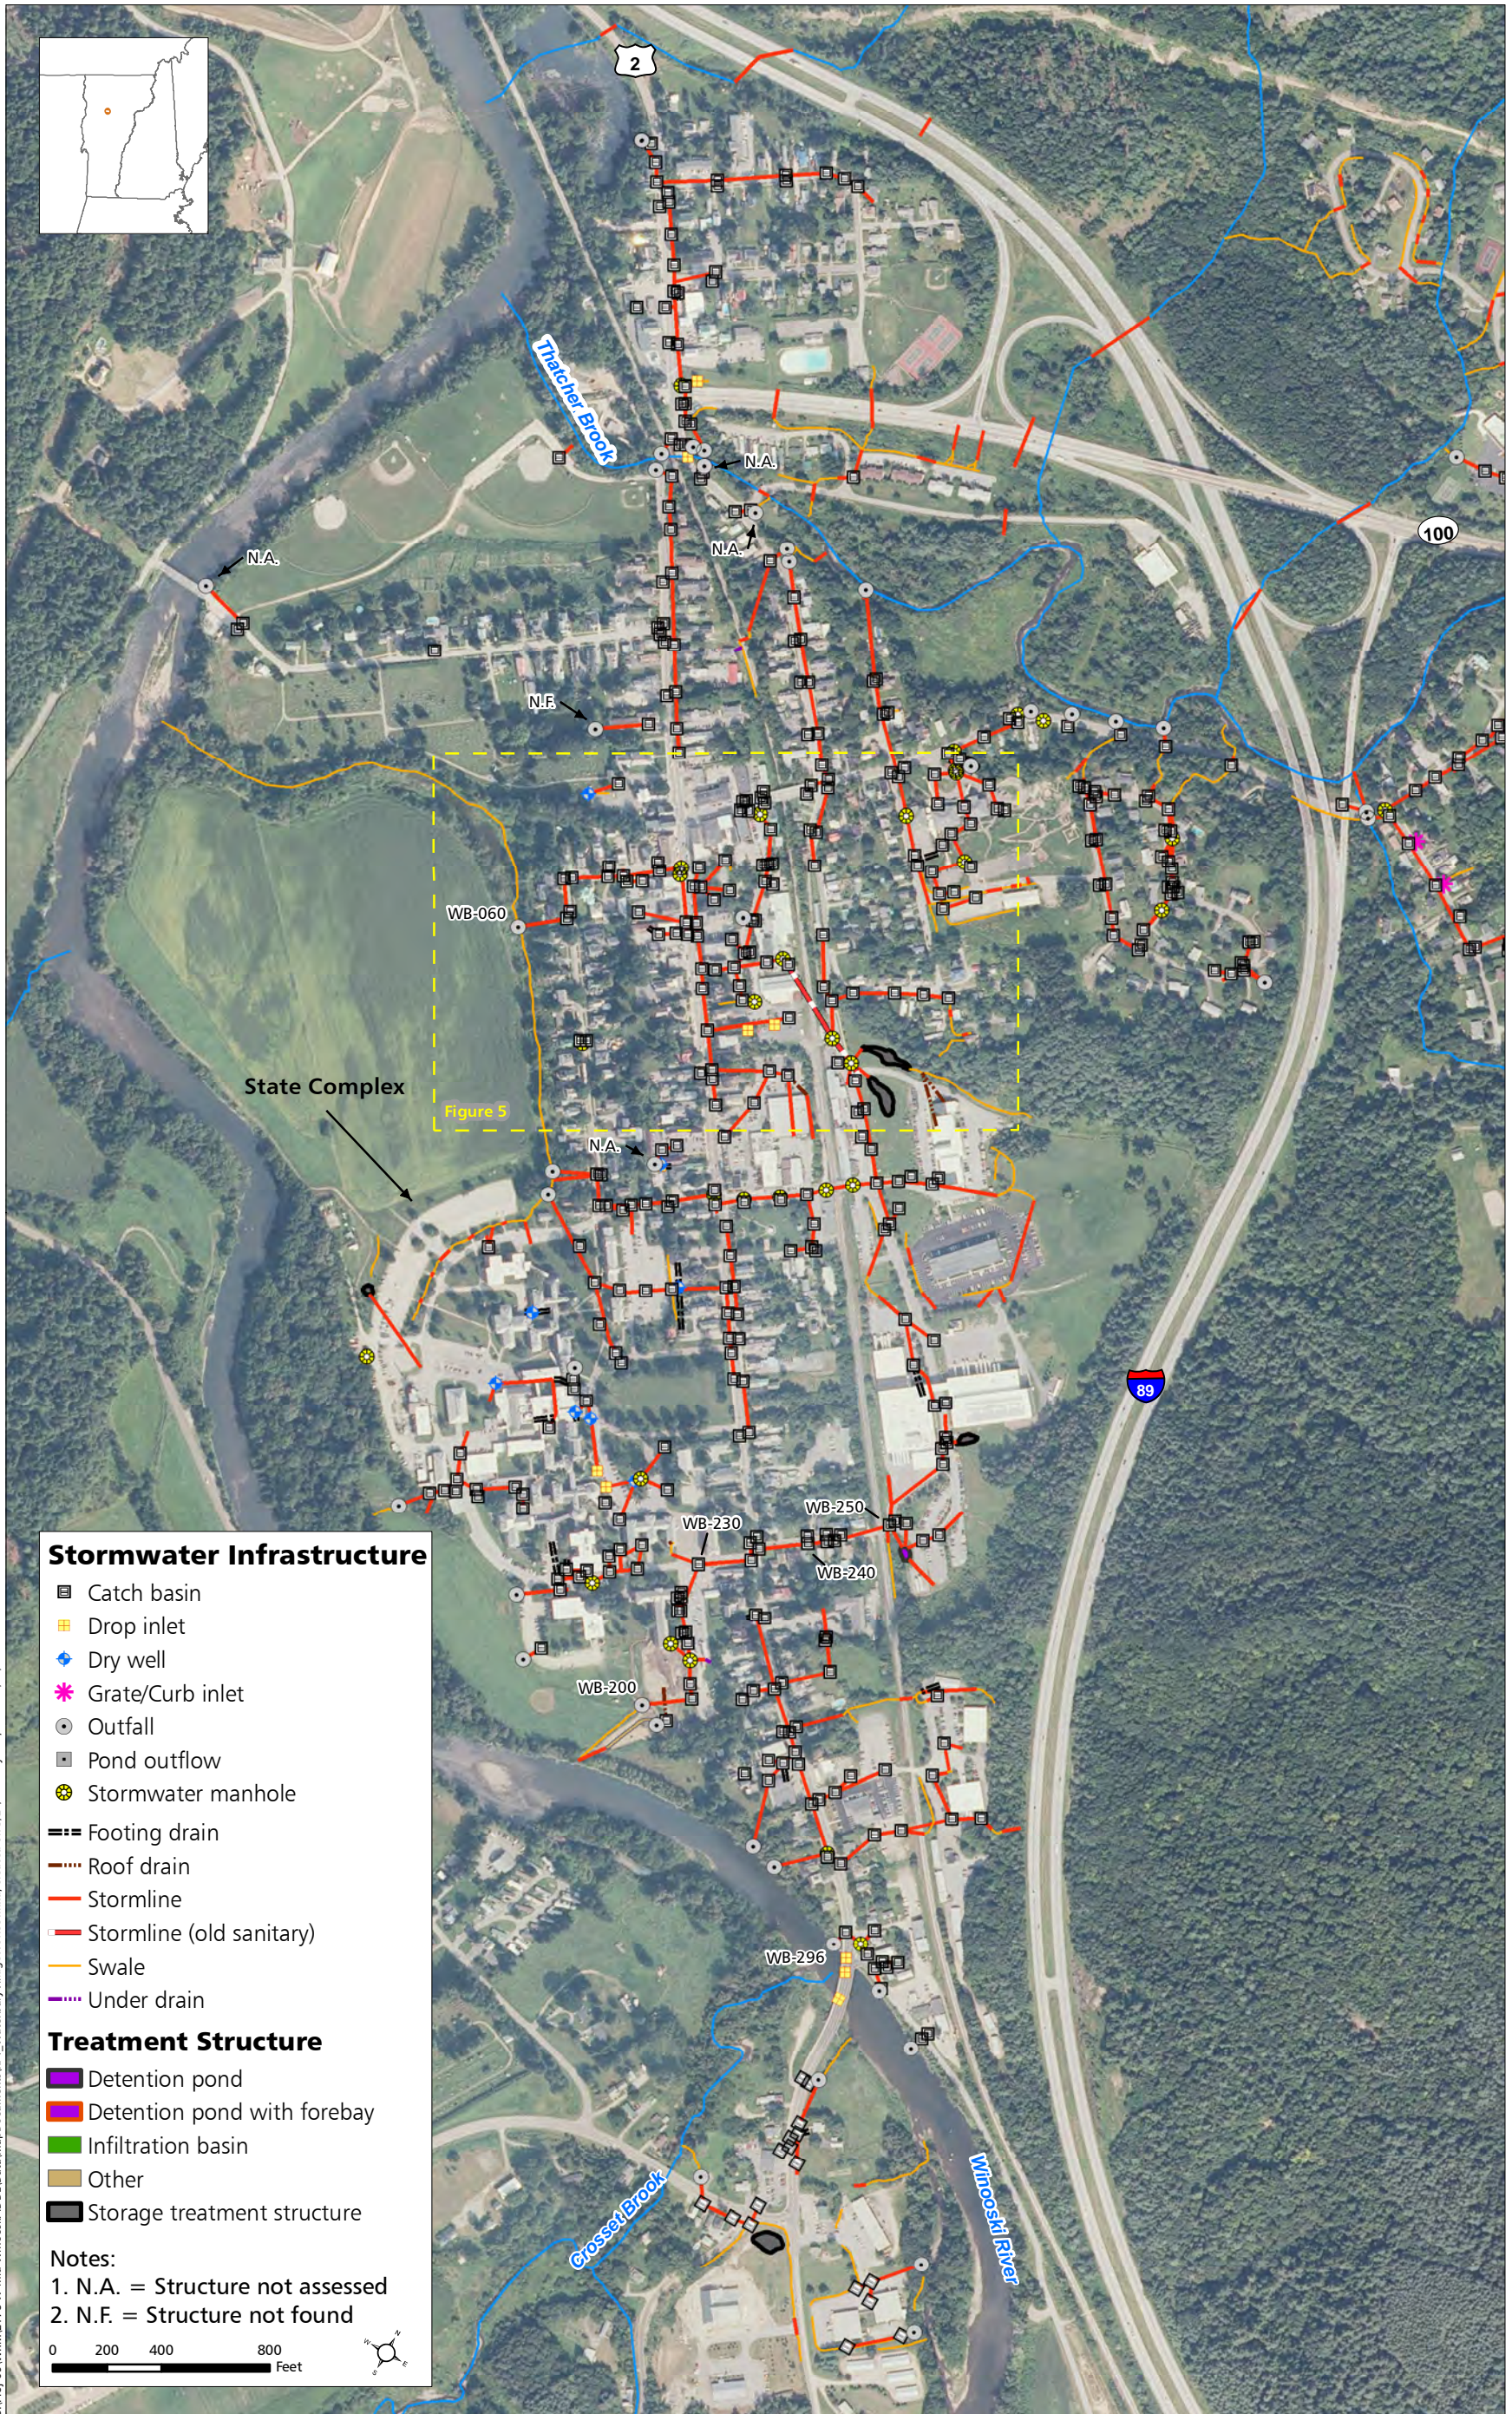
**Figure 3. Waterbury (West of I-89) Illicit Discharge Assessment**  
Mid-Winooski IDDE

Outfall WB-296 is the discharge point for a small storm sewer located immediately north of the Route 2 bridge over the Winooski River (see Figure 3). The outfall was dripping when assessed on July 7, 2010 and had a low, but detectable, ammonia concentration of 0.25 mg/L. Optical brightener was not detected. The outfall was revisited on July 13 and July 28, 2010 and was dry on both occasions. Based on these results, we concluded that there is no illicit discharge to this system.

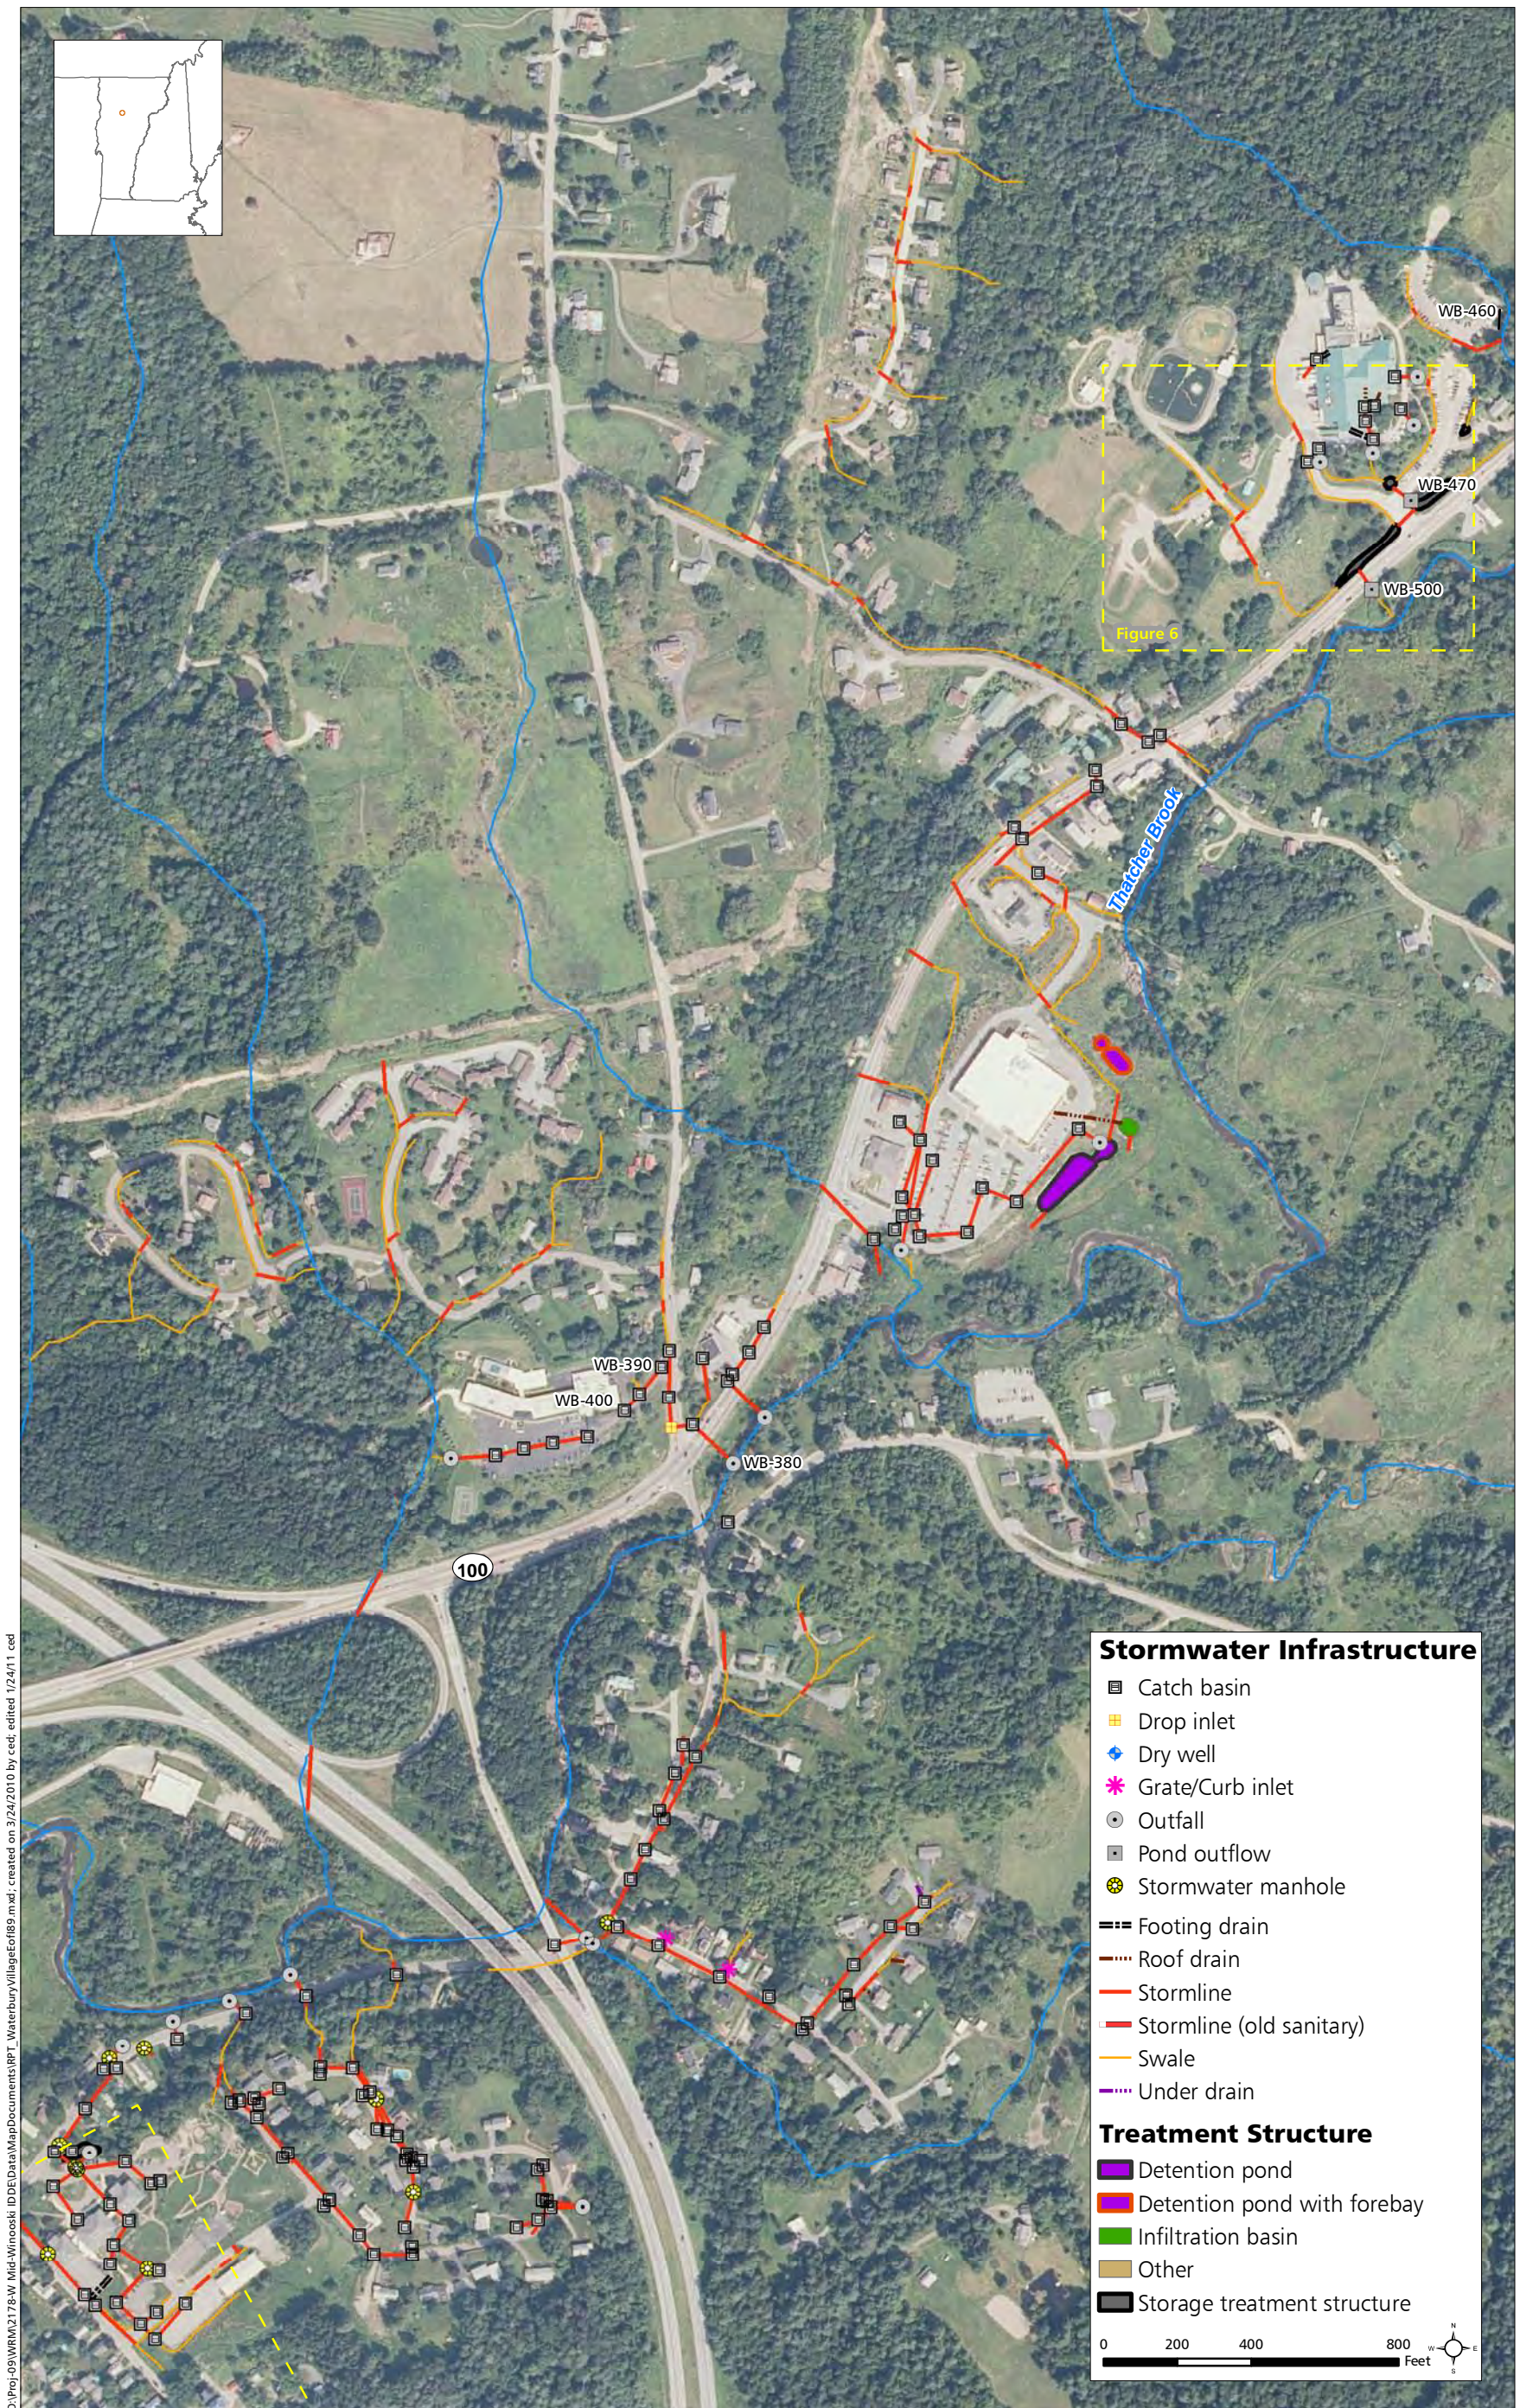
**Figure 4. Waterbury (East of I-89) Illicit Discharge Assessment**  
Mid-Winooski IDDE

Outfall WB-380 discharges to Thatcher Brook near the intersection of Route 100 and Blush Hill Road (see Figure 4). Assessment data for this outfall are presented in Appendix B and are summarized in Table 8. A trickle of flow was present on each occasion this outfall was visited. Samples collected from this outfall on July 8, 2010 had high specific conductance and a moderate fluoride concentration. No ammonia was detected and the optical brightener test was negative. Follow-up samples collected on July 28, 2010 had very low total phosphorus but moderately high *E. coli* concentration (690 MPN/100 mL). Results of a final set of samples collected on September 15, 2010 had a similar fluoride concentration and specific conductance to the July 8 samples, but *E. coli* was low compared with the July 28 sampling.

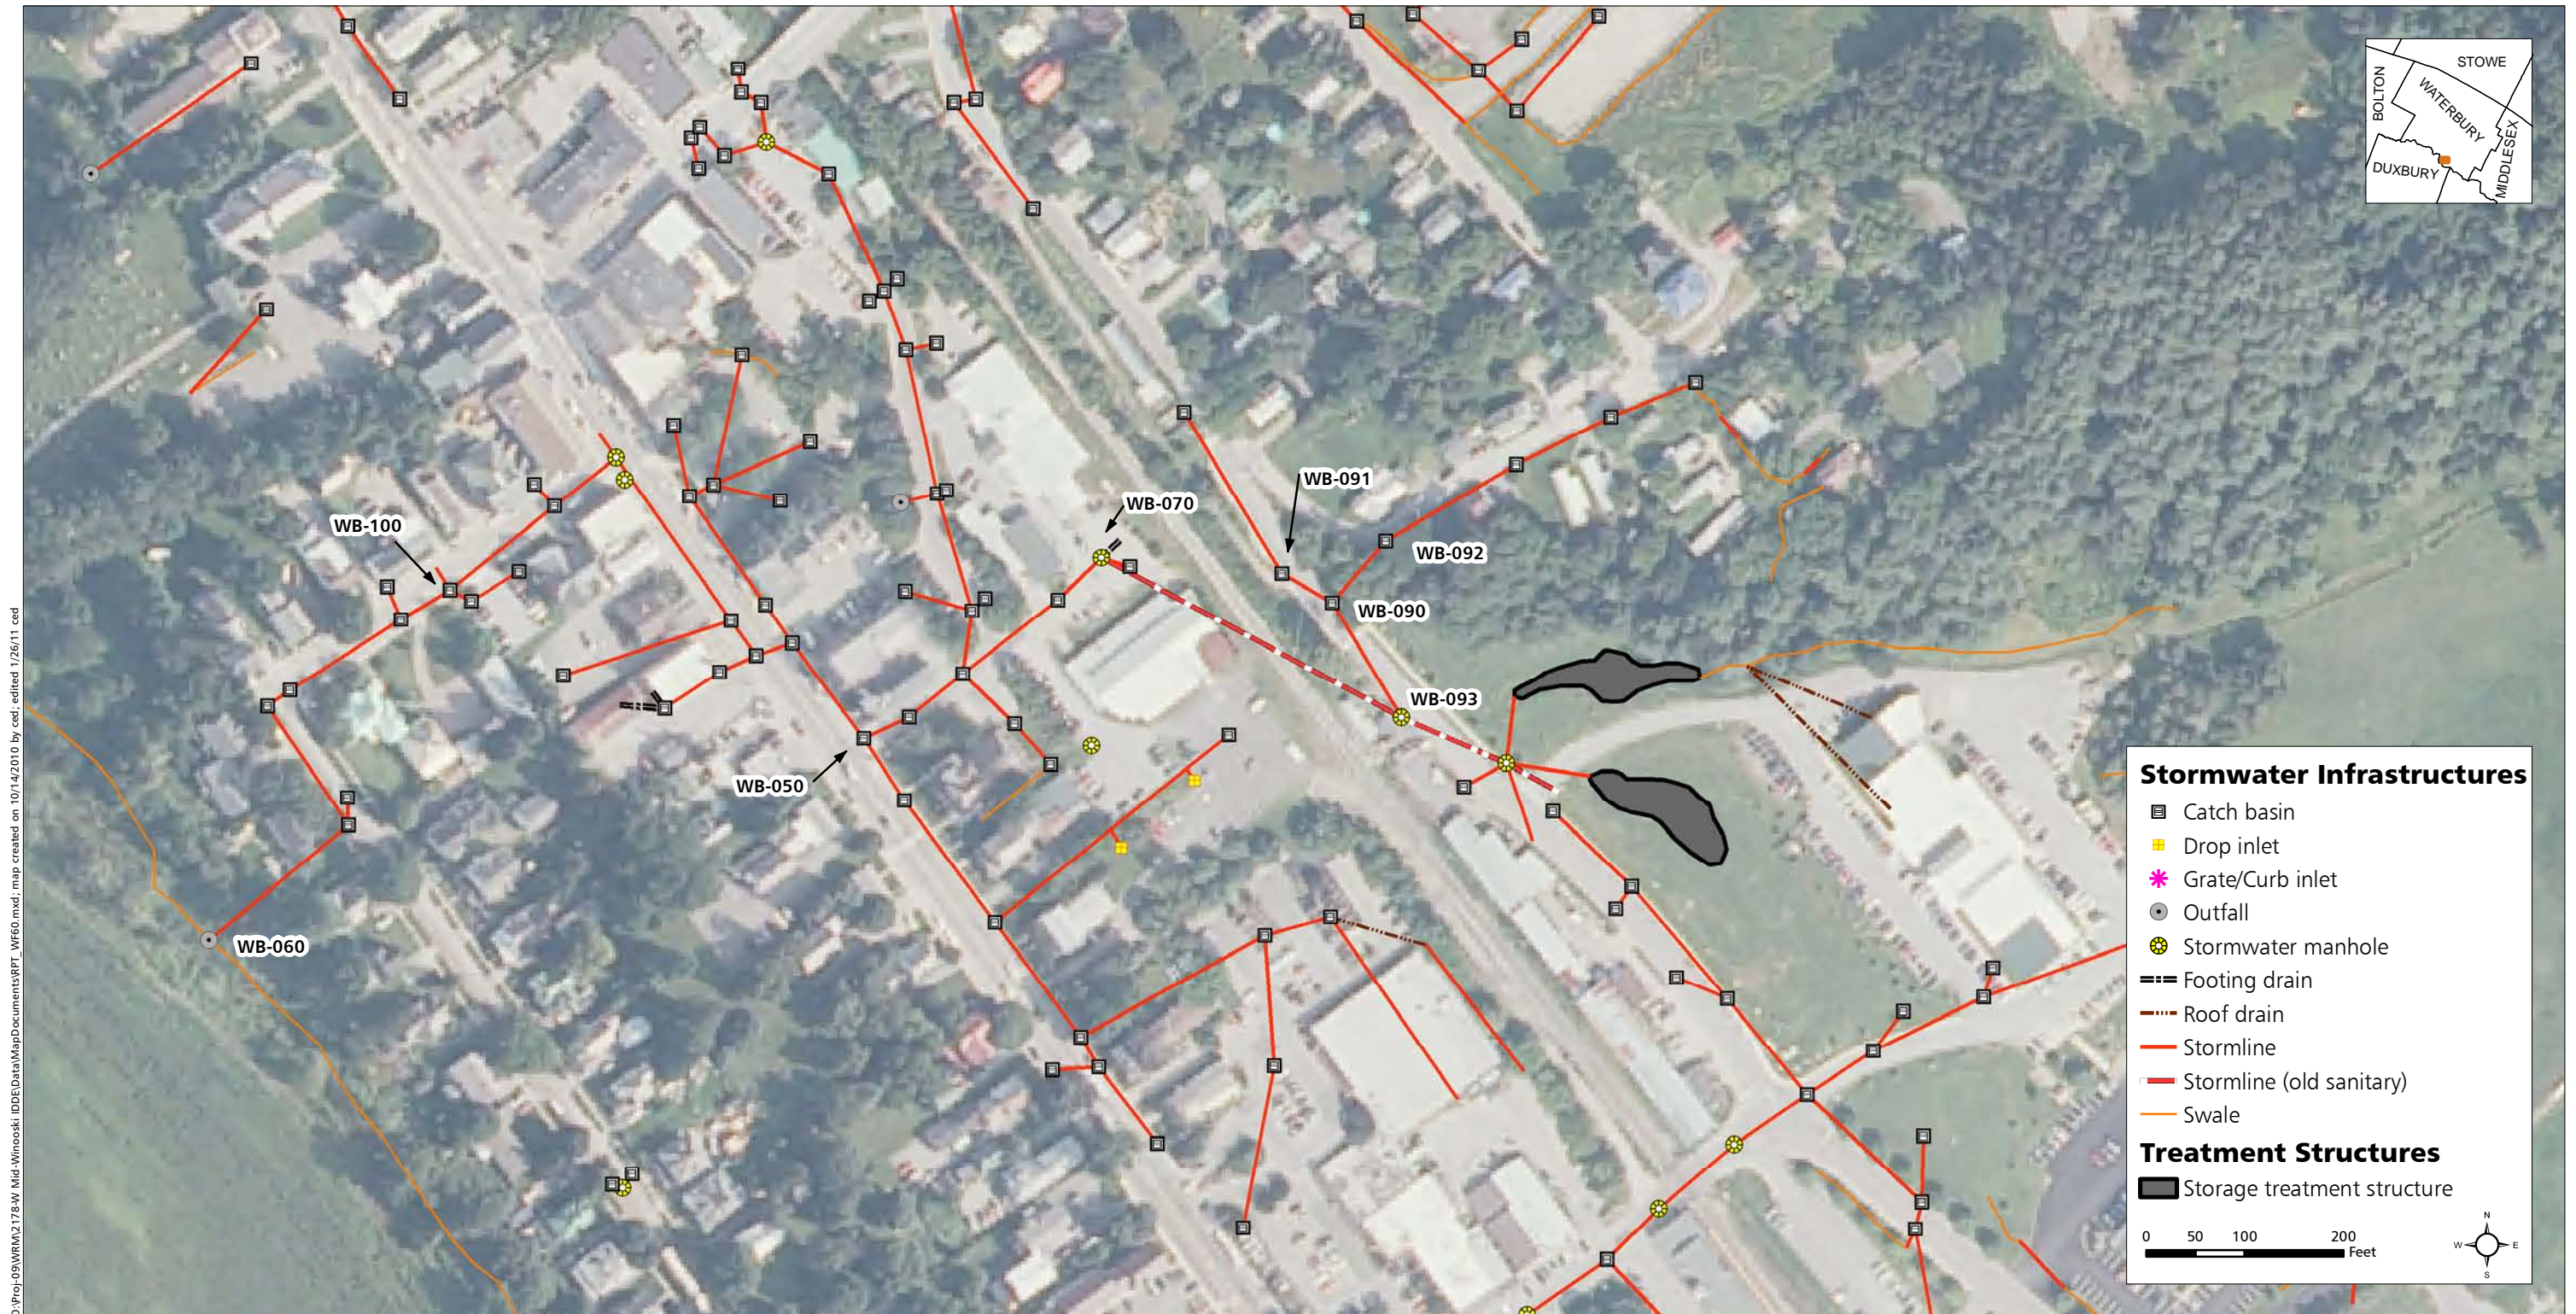
**Figure 5. Waterbury WB-060 System Illicit Discharge Assessment**  
Mid-Winooski IDDE

Outfall WB-060 is the discharge point for the most extensive storm sewer in Waterbury (Figure 5). It discharges to a swale on the backside of Randall Street. During the initial assessment, the optical brightener monitoring test was negative. However, water samples collected on July 6 had slightly elevated specific conductance and ammonia and fluoride concentrations. These data are presented in Table 7. In addition to the outfall, seven other structures in the WB-060 system were assessed on July 6 (manholes WB-070 and WB-093 and catchbasins WB-050, WB-090, WB-091, WB-092, and WB-100). There was negligible flow at WB-093 and the flow rate increased to WB-070. Specific conductance and ammonia and fluoride concentrations at WB-070 were similar to levels at the outfall. No structures were identified that had substantially higher concentrations of these constituents.

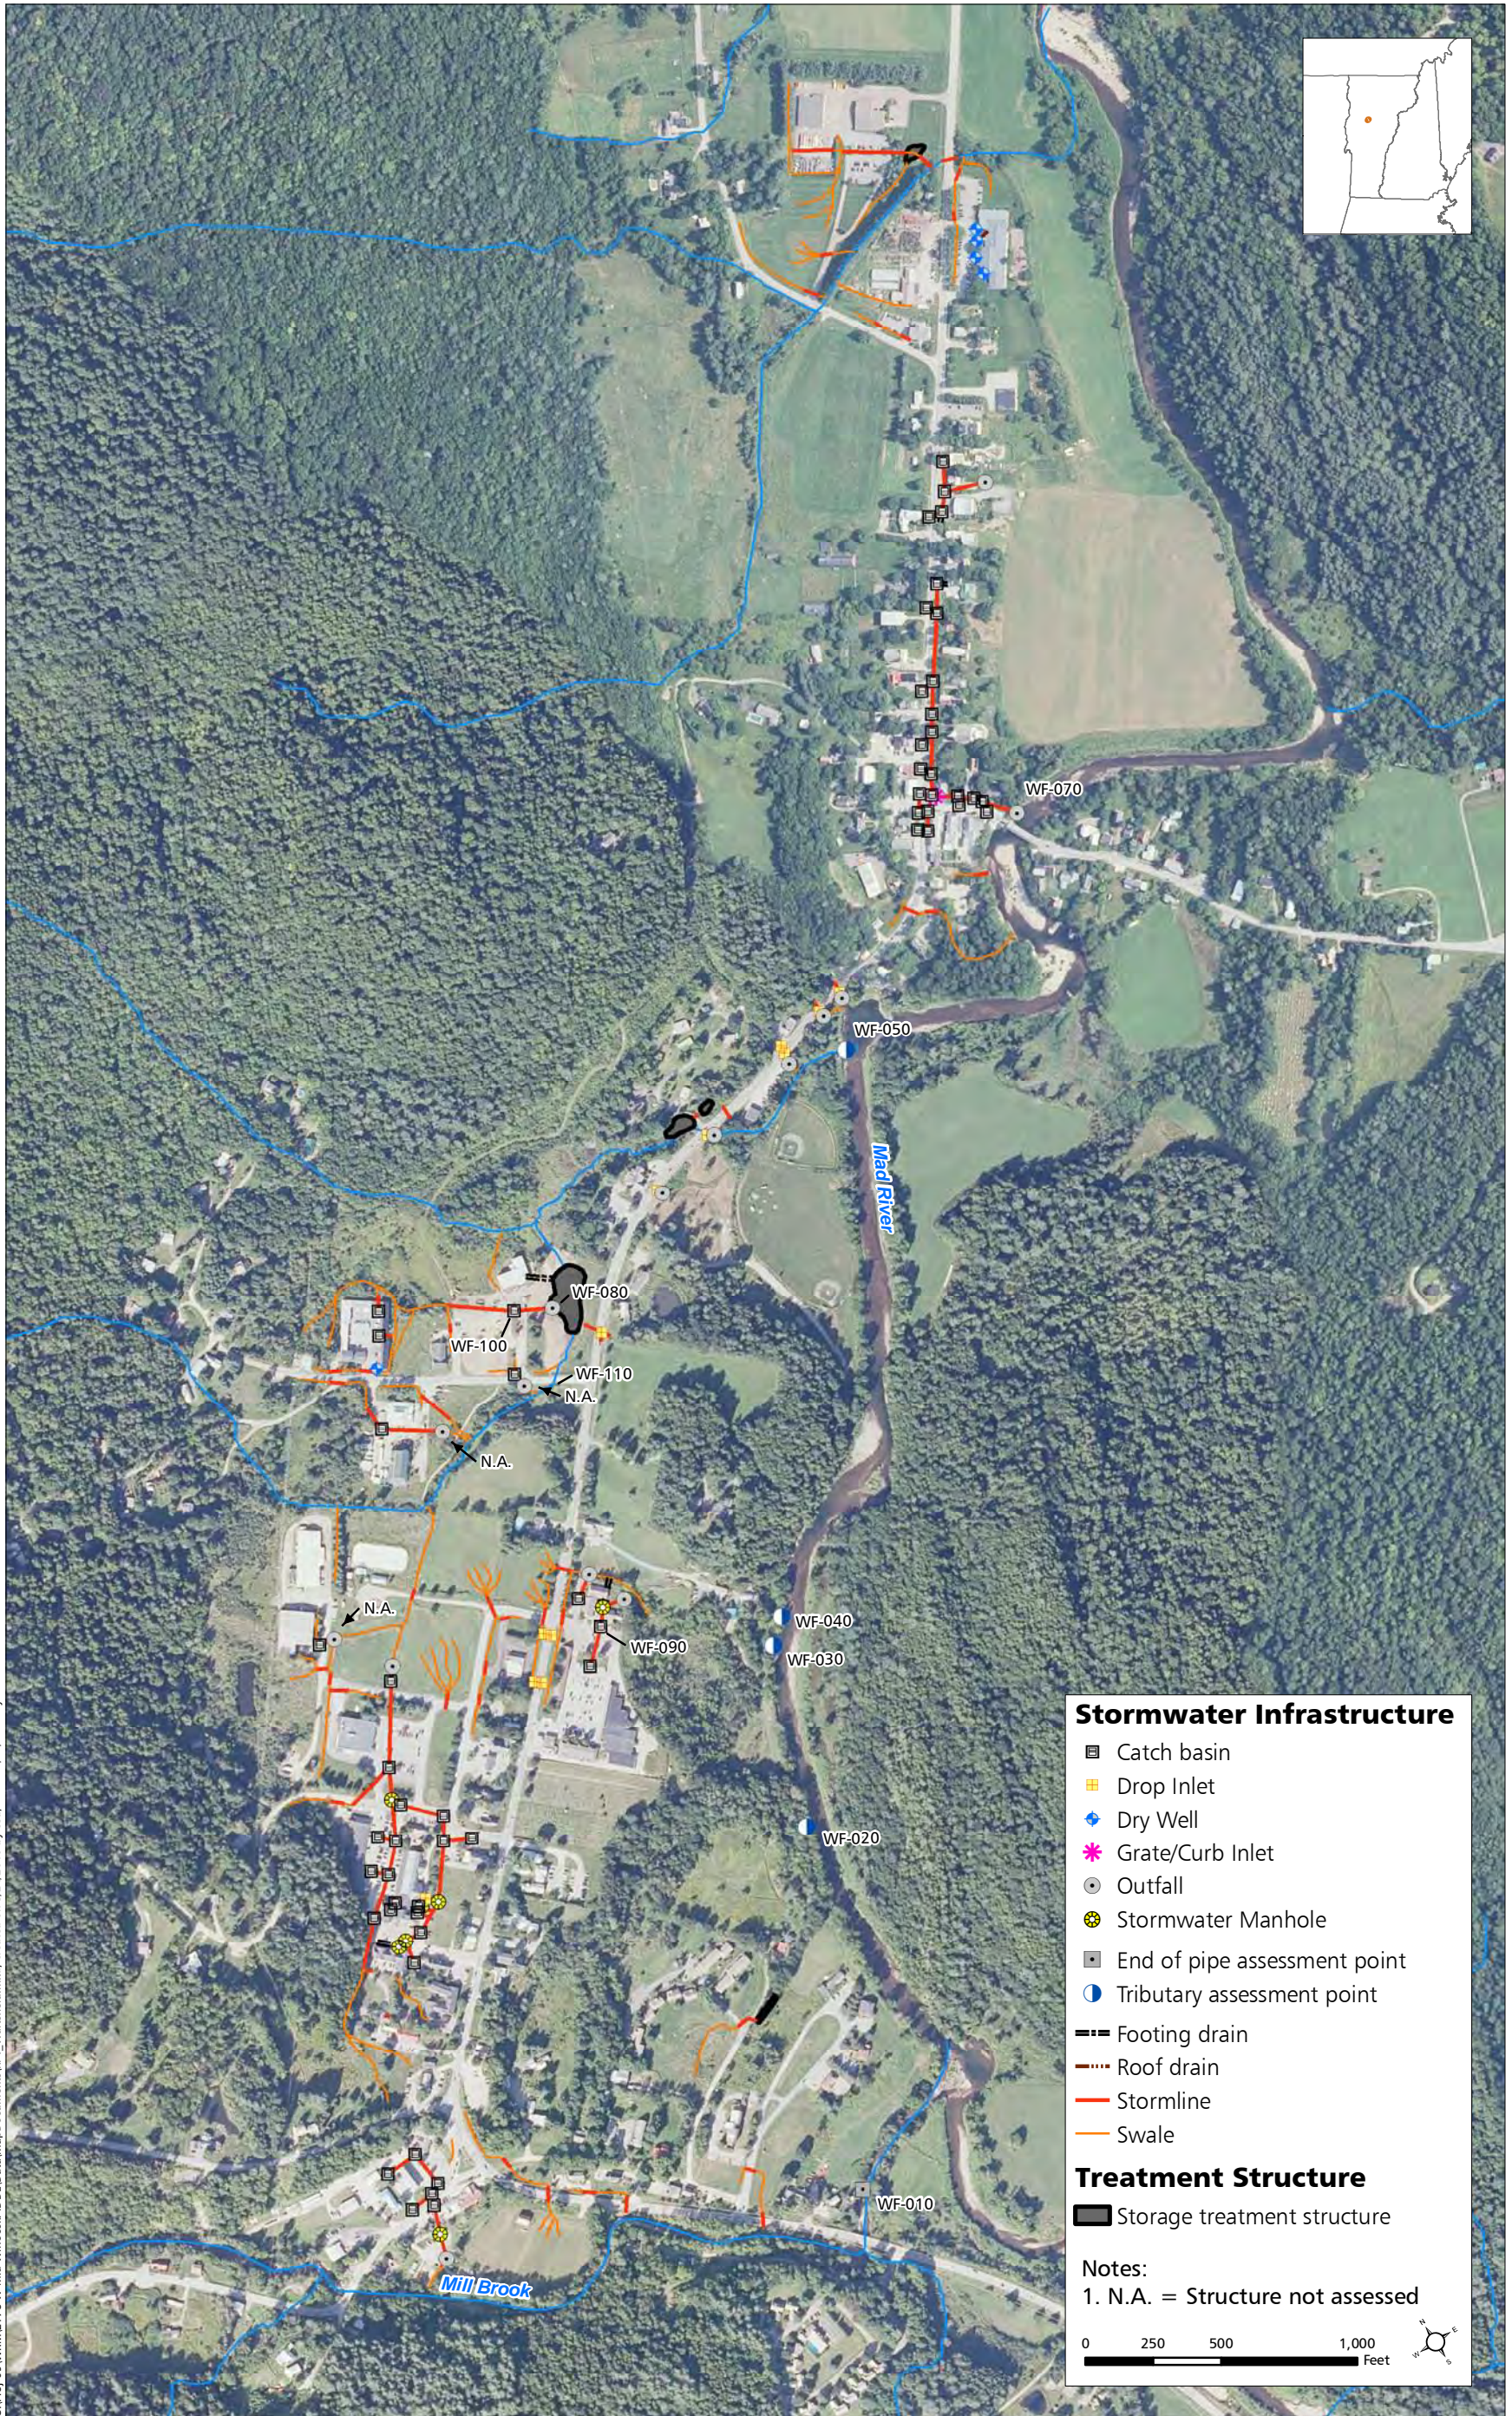
**Figure 8. Waitsfield Illicit Discharge Assessment**  
Mid-Winooski IDDE

Stormwater infrastructure mapped by DEC in Waitsfield is shown on Figure 8. On June 4, 2010 the municipal stormwater outfalls were assessed. Only two outfalls were identified as flowing during dry weather: WF-010, a 4-inch diameter pipe found to be dripping, and WF-080, an 18-inch diameter pipe flowing at a depth of approximately 1 inch. Iron staining was present at both WF-010 and WF-080, but there were no definite indications of contamination in water samples collected at either pipe and optical brightener tests were negative. Iron staining can be associated with contamination, but very often it is simply an indication of groundwater seepage. The storm sewer outfall on the left bank of the Mad River immediately downstream of the Bridge Street covered bridge (WF-070) was dry. The storm sewer discharging to the right bank of the Mad River immediately upstream of the covered bridge (this system is not mapped) was also dry. All catchbasins inspected were dry except for a catchbasin (WF-100) in the parking lot of the Big Picture Theater that drains to outfall WF-080 and a series of catchbasins in the Mad River Green area. A dripping, iron stained pipe was observed discharging to catchbasin WF-100. Beyond documenting whether certain structures were flowing, assessment in these areas was complicated by the fact that most of the structures are on private property. After the June 4 assessment, repeated attempts were made by the Friends of the Mad River to contact property owners for permission to sample at WF-100 and stormwater structures in the Mad River Green area.
