Illicit Discharge Detection and Elimination in Six Missisquoi River Basin Communities

FINAL REPORT

Project ID 082219-W

March 20, 2011

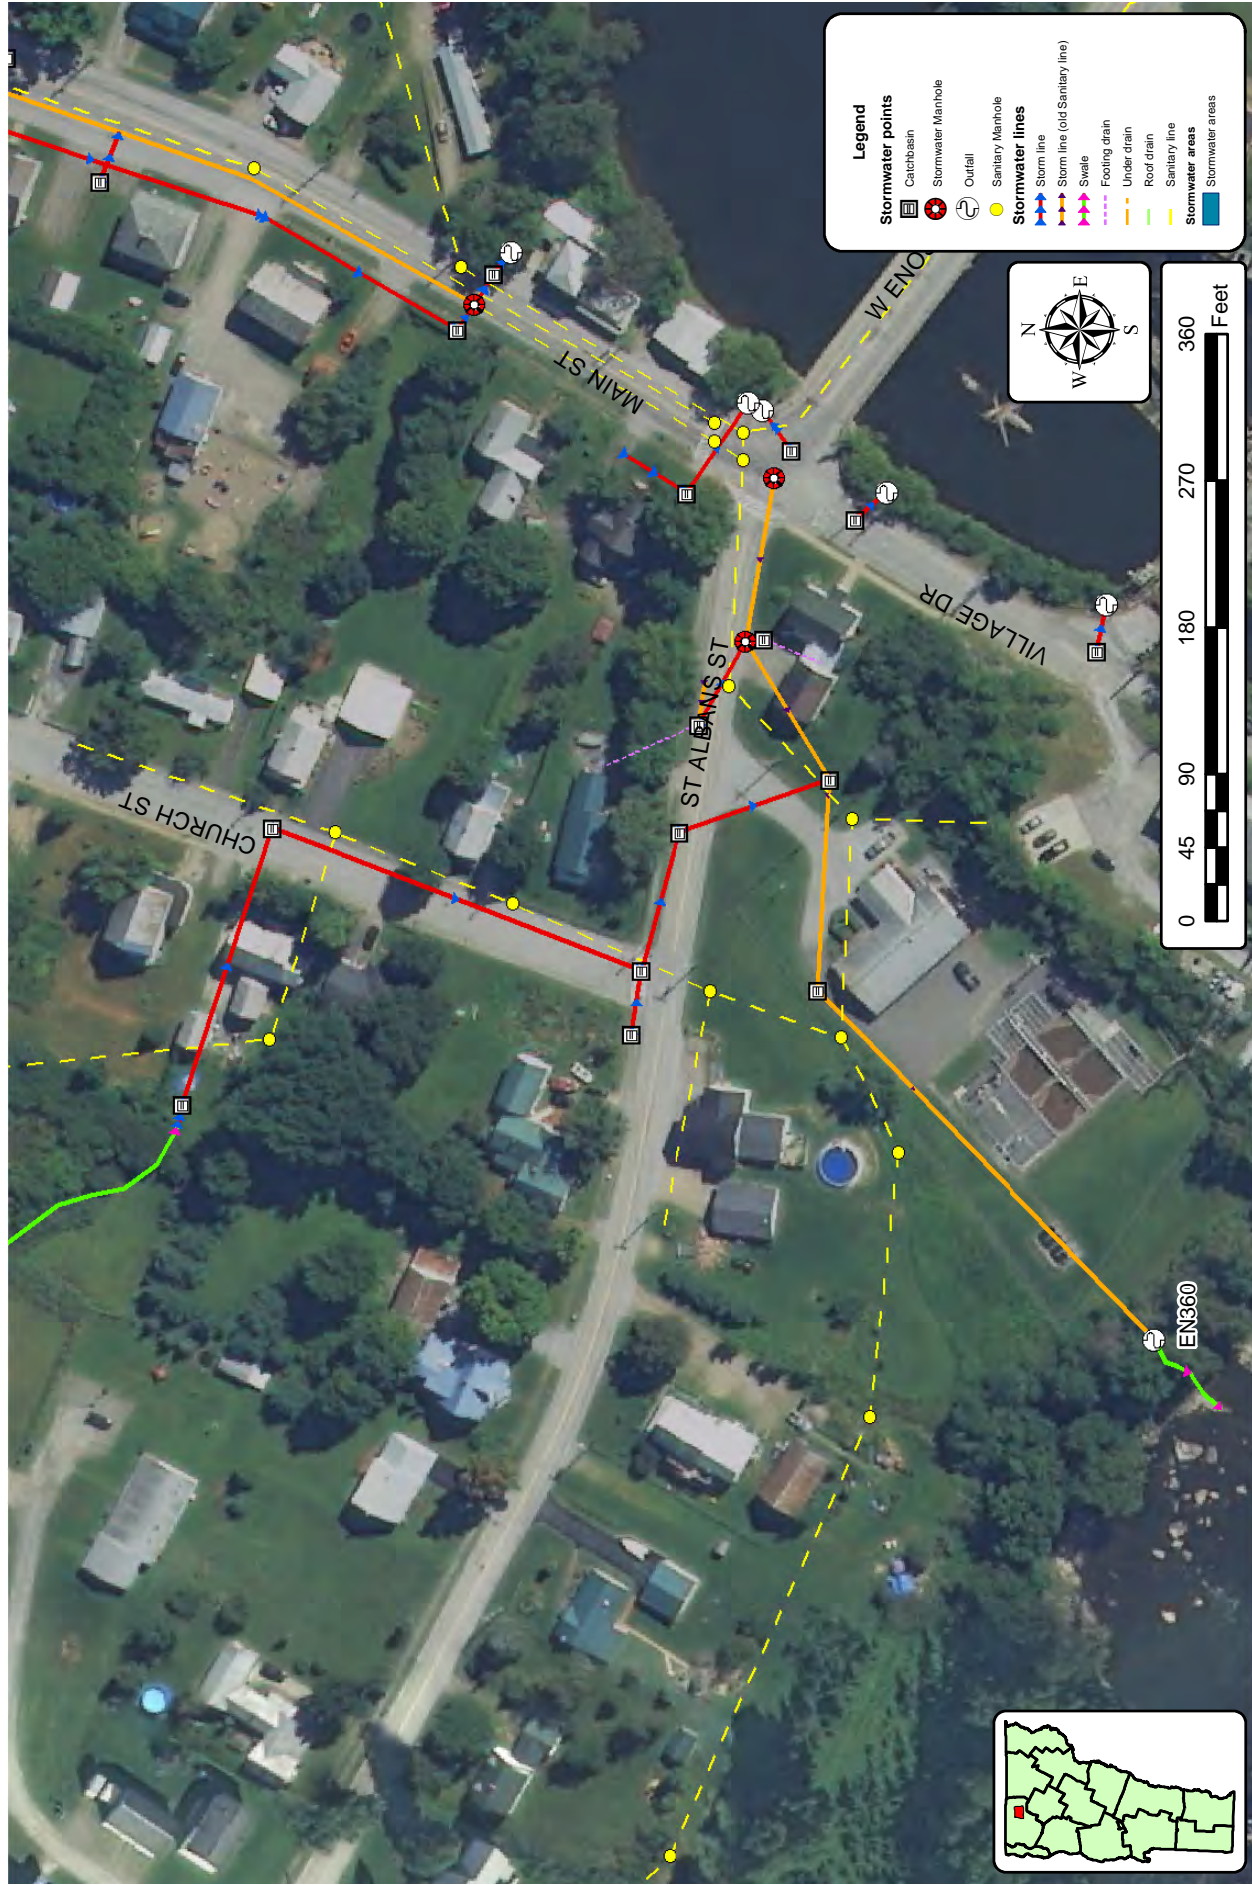
Figure 3. Stormwater drainage system discharging at outfall EN-360
Enosburg Falls, VT

Outfall EN-360 is located behind the wastewater treatment plant (Figure 3). When this outfall was first sampled on June 22, 2009, a low ammonia concentration was detected (0.25 mg/L) and optical brightener was present, although the fluorescence was weak.

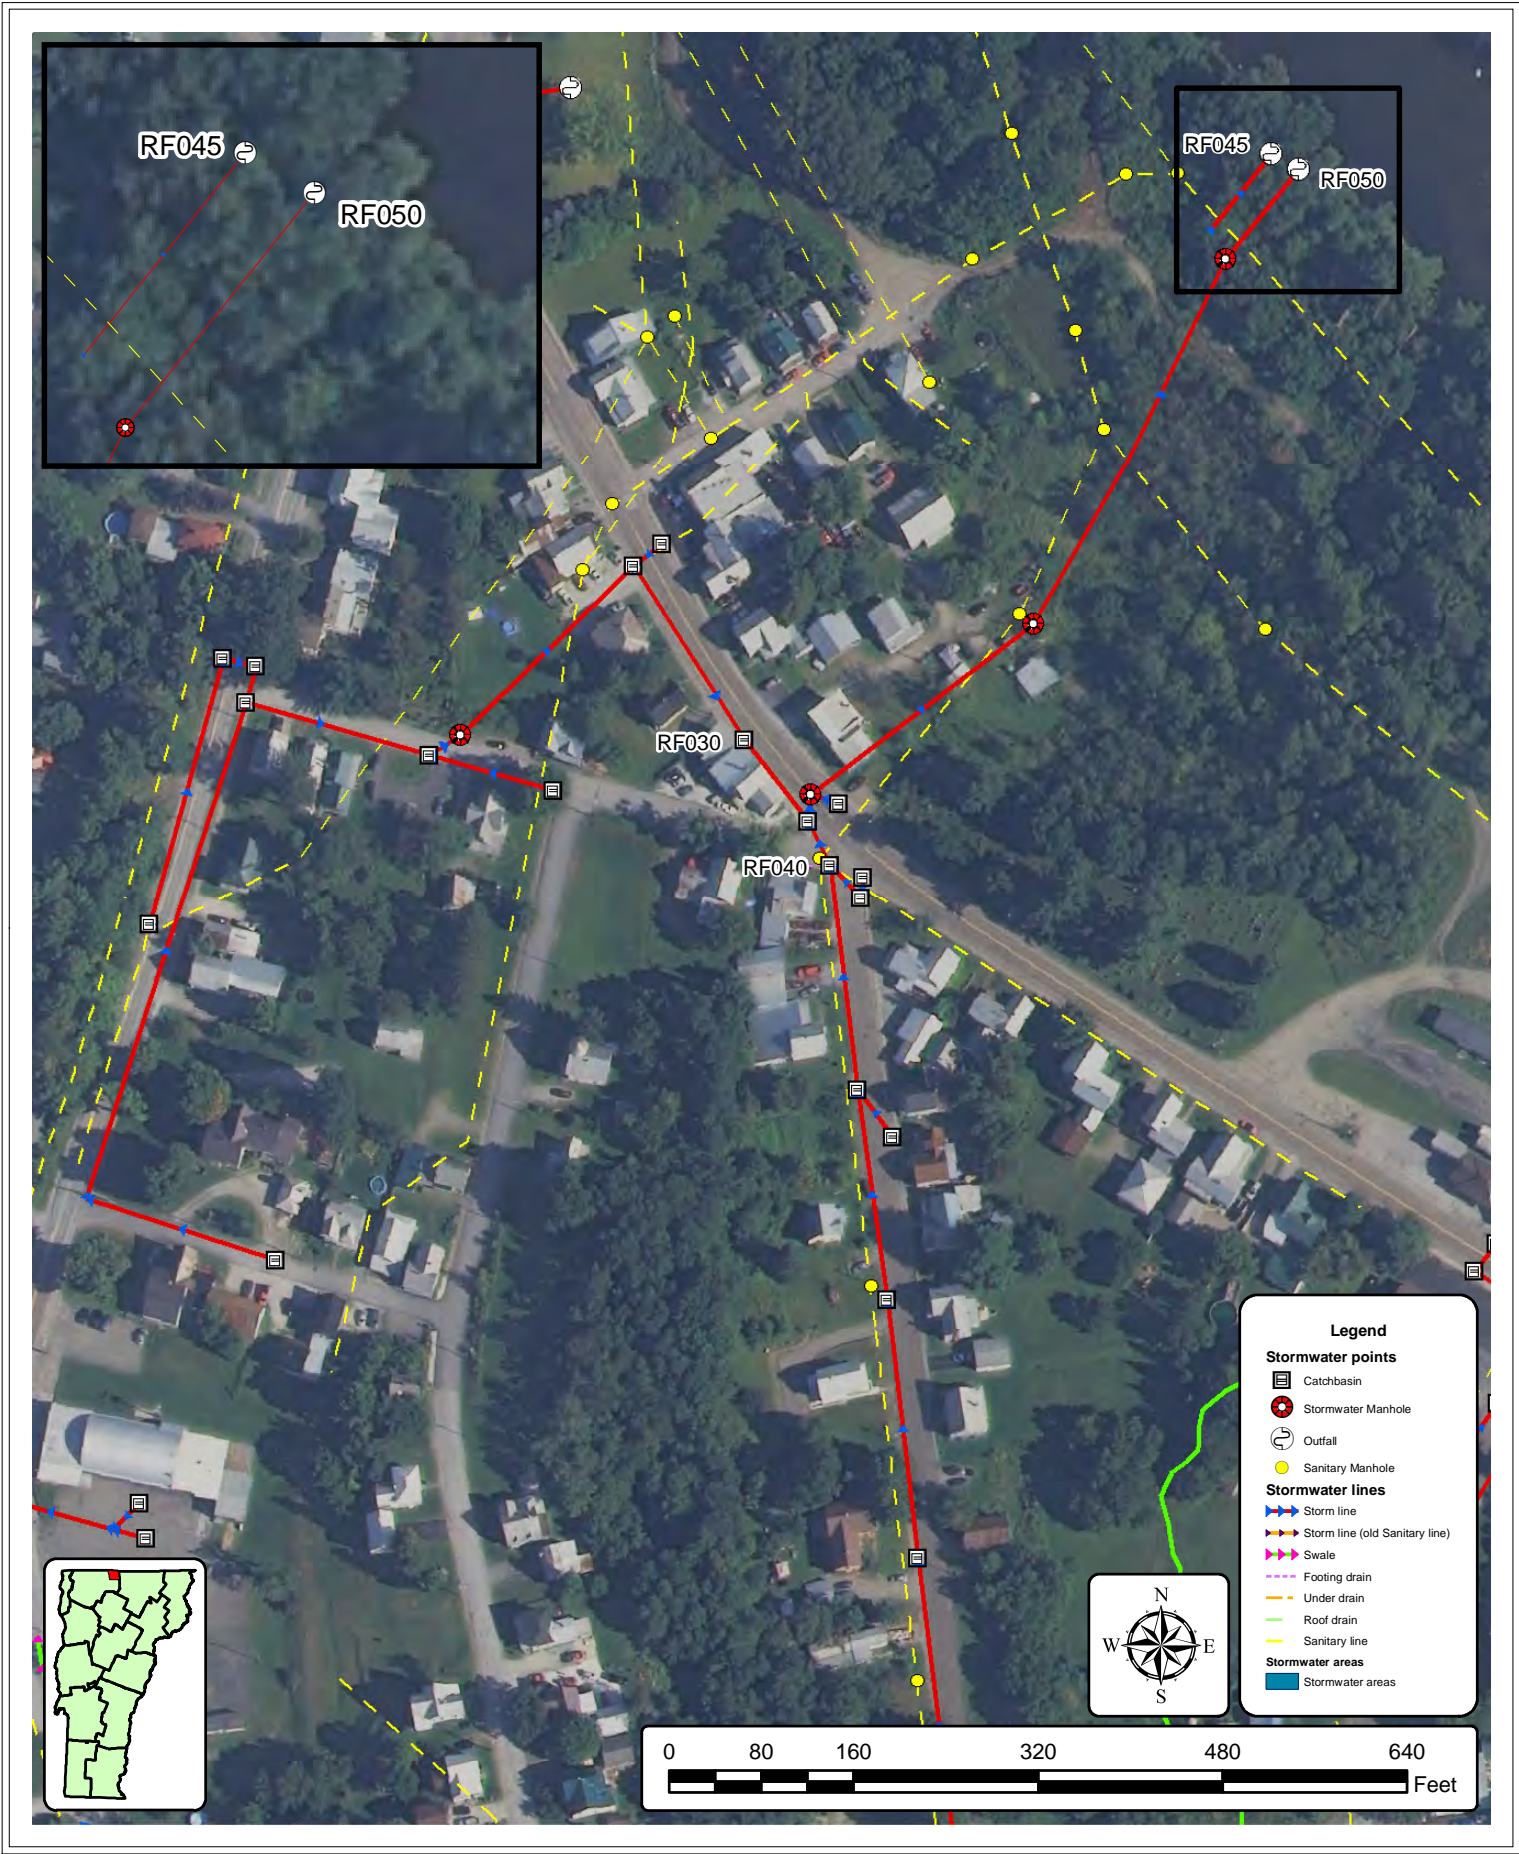
Figure 8. Stormwater drainage systems discharging at outfalls RF-045 and RF-050 Richford, VT

Pipes RF-045 and RF-050 discharge to the Missisquoi River from a low bank south of the wastewater pumping station (Figure 8). These pipes are accessible via a dirt track extending from the end of Willow Street. RF-050 is a 12-inch diameter corrugated metal stormwater outfall draining a section of Route 105 south of Main Street. RF-045 is a 24-inch diameter pipe located approximately 10 feet downstream from RF-050. RF-045 has a crushed end and no apparent connection to any stormwater inlet.

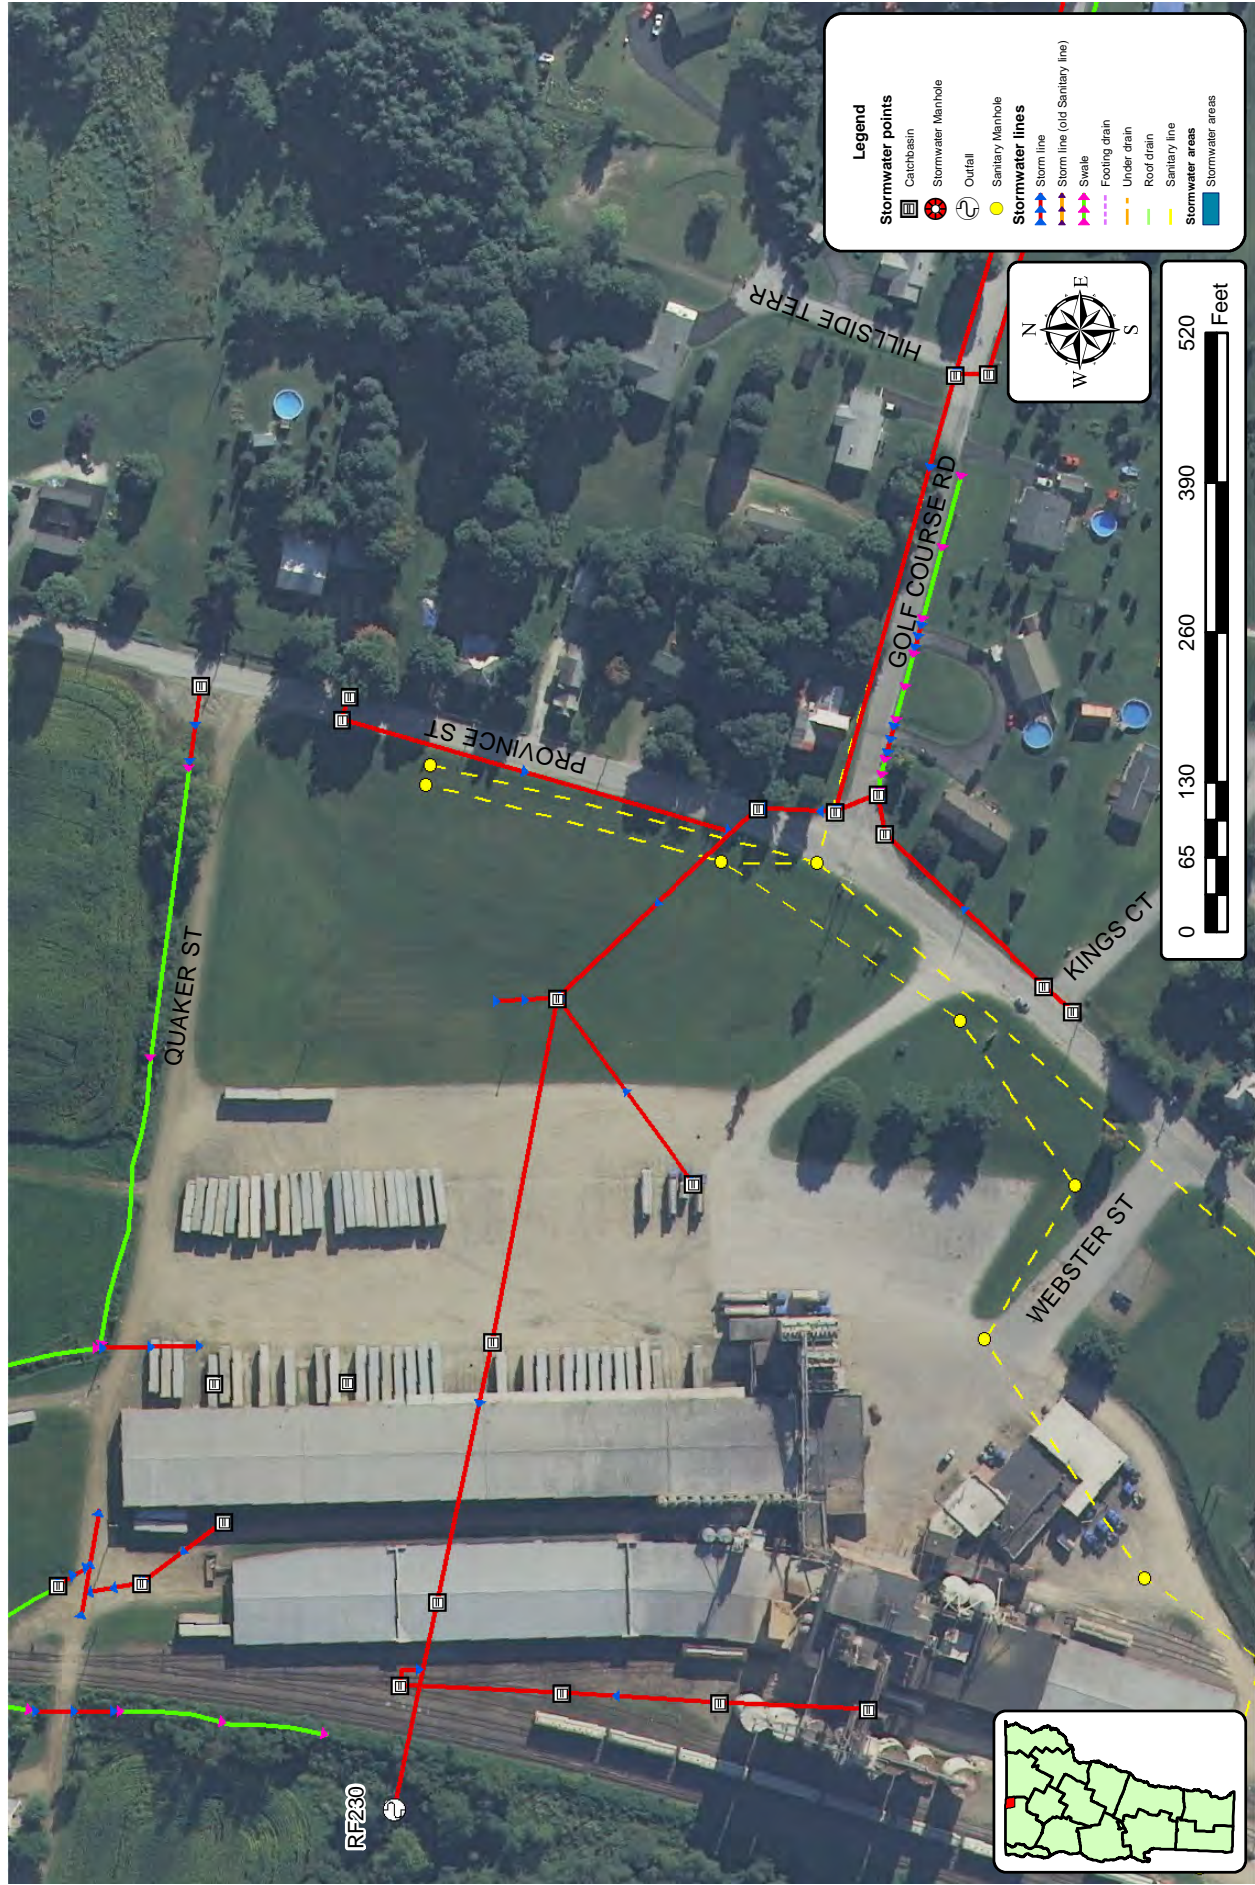
Figure 12. Stormwater drainage system discharging at outfall RF-230
 Richford, VT

RF-230 is a 30-inch diameter corrugated steel outfall pipe located across railroad tracks behind the Blue Seal Feeds factory (Figure 12). It discharges to a small stream. The municipal storm sewer on Province Street is connected to a network of catch basins, roof leaders, and culverts on the Blue Seal property, all of which discharge at RF-230.

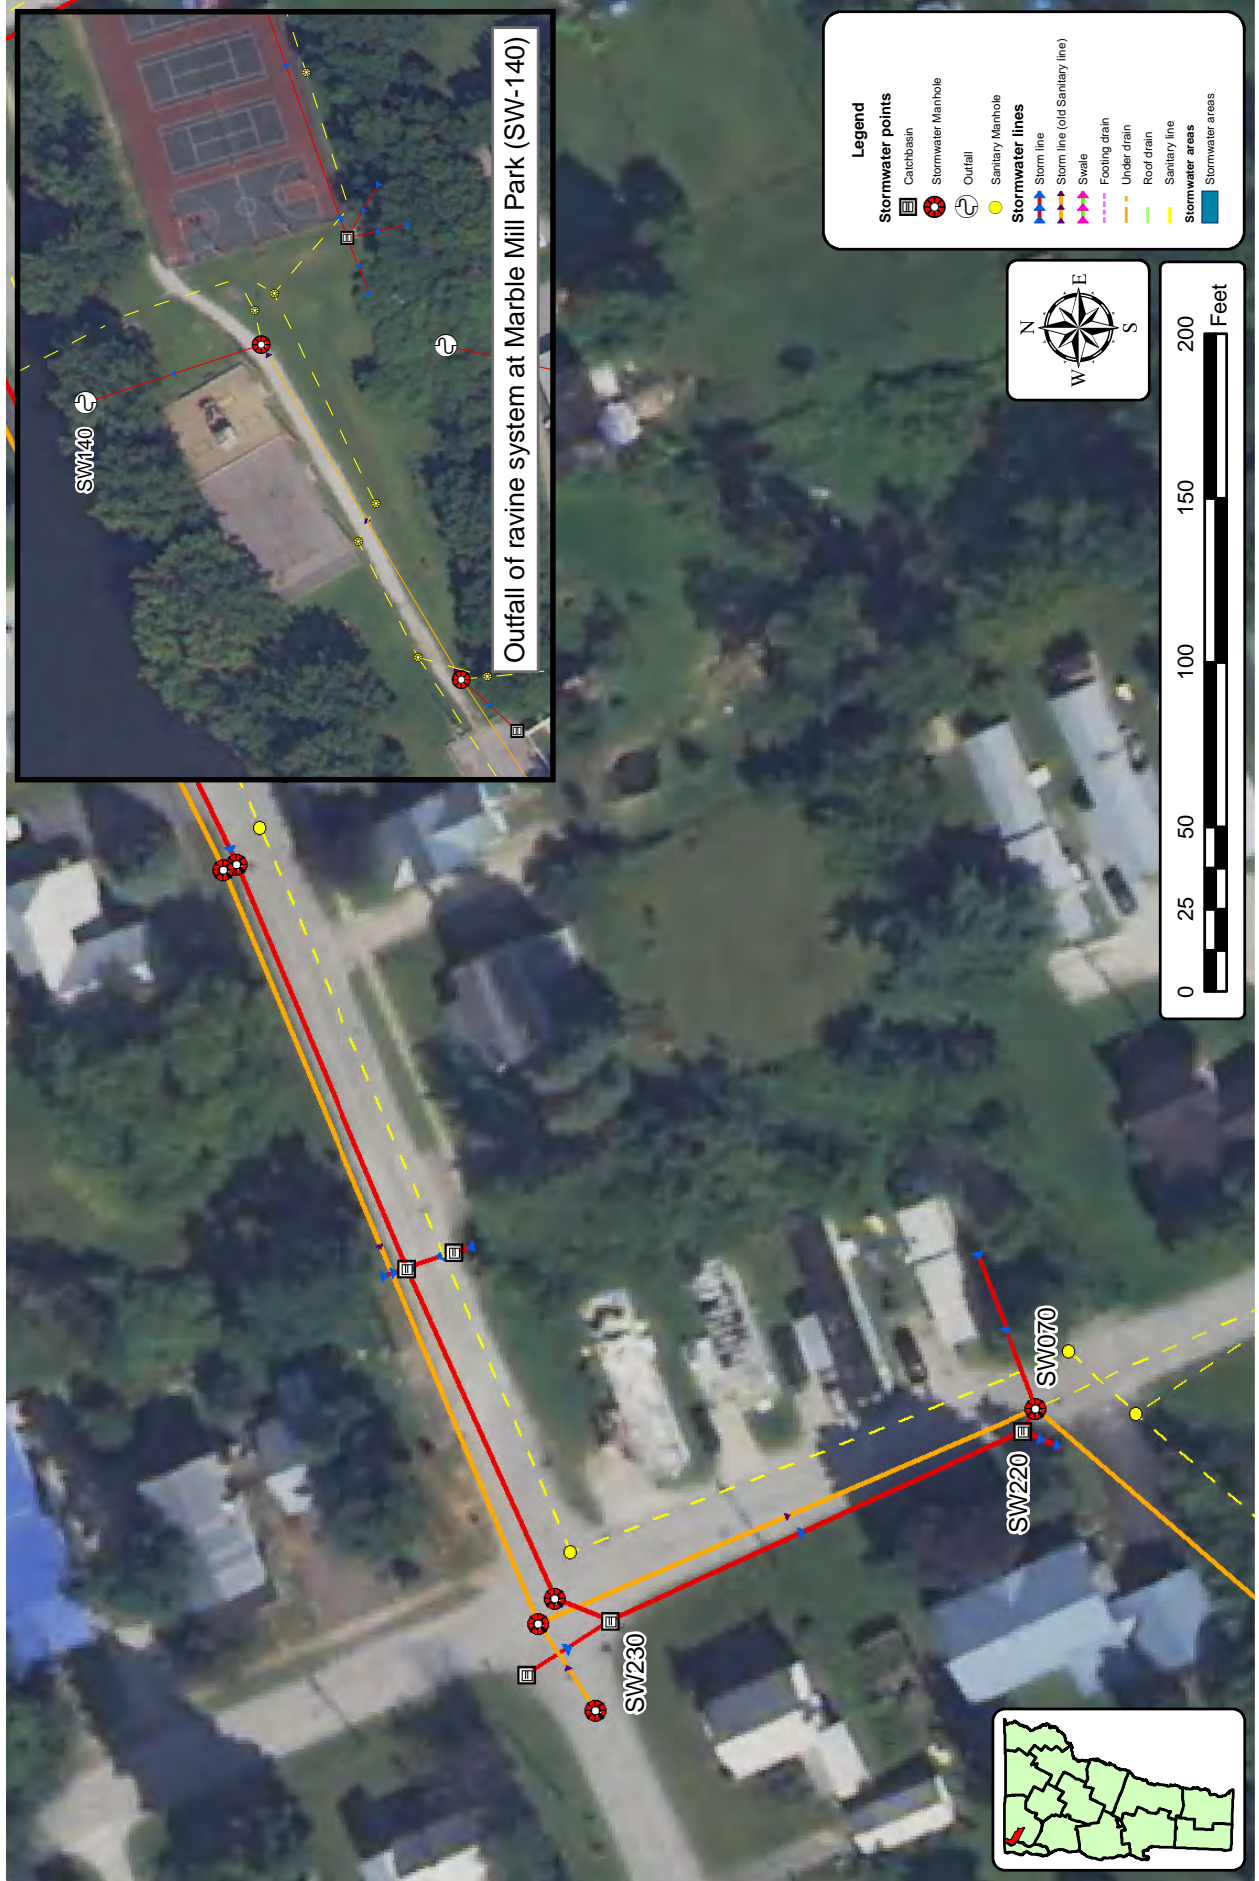
Figure 13. Section of stormwater drainage ravine system discharging at outfall SW-140 Swanton, VT

SW-140 is a 24-inch diameter metal outfall pipe in Marble Mill Park from the storm sewer draining most of the south side of the Village of Swanton. This system will be referred to as the “ravine” system. The main storm sewer lines in this system were formerly used as sanitary sewer. Table 8 describes water quality testing and investigation throughout this storm sewer. A section of the system including manhole SW-070 on New Street is presented in Figure 13.

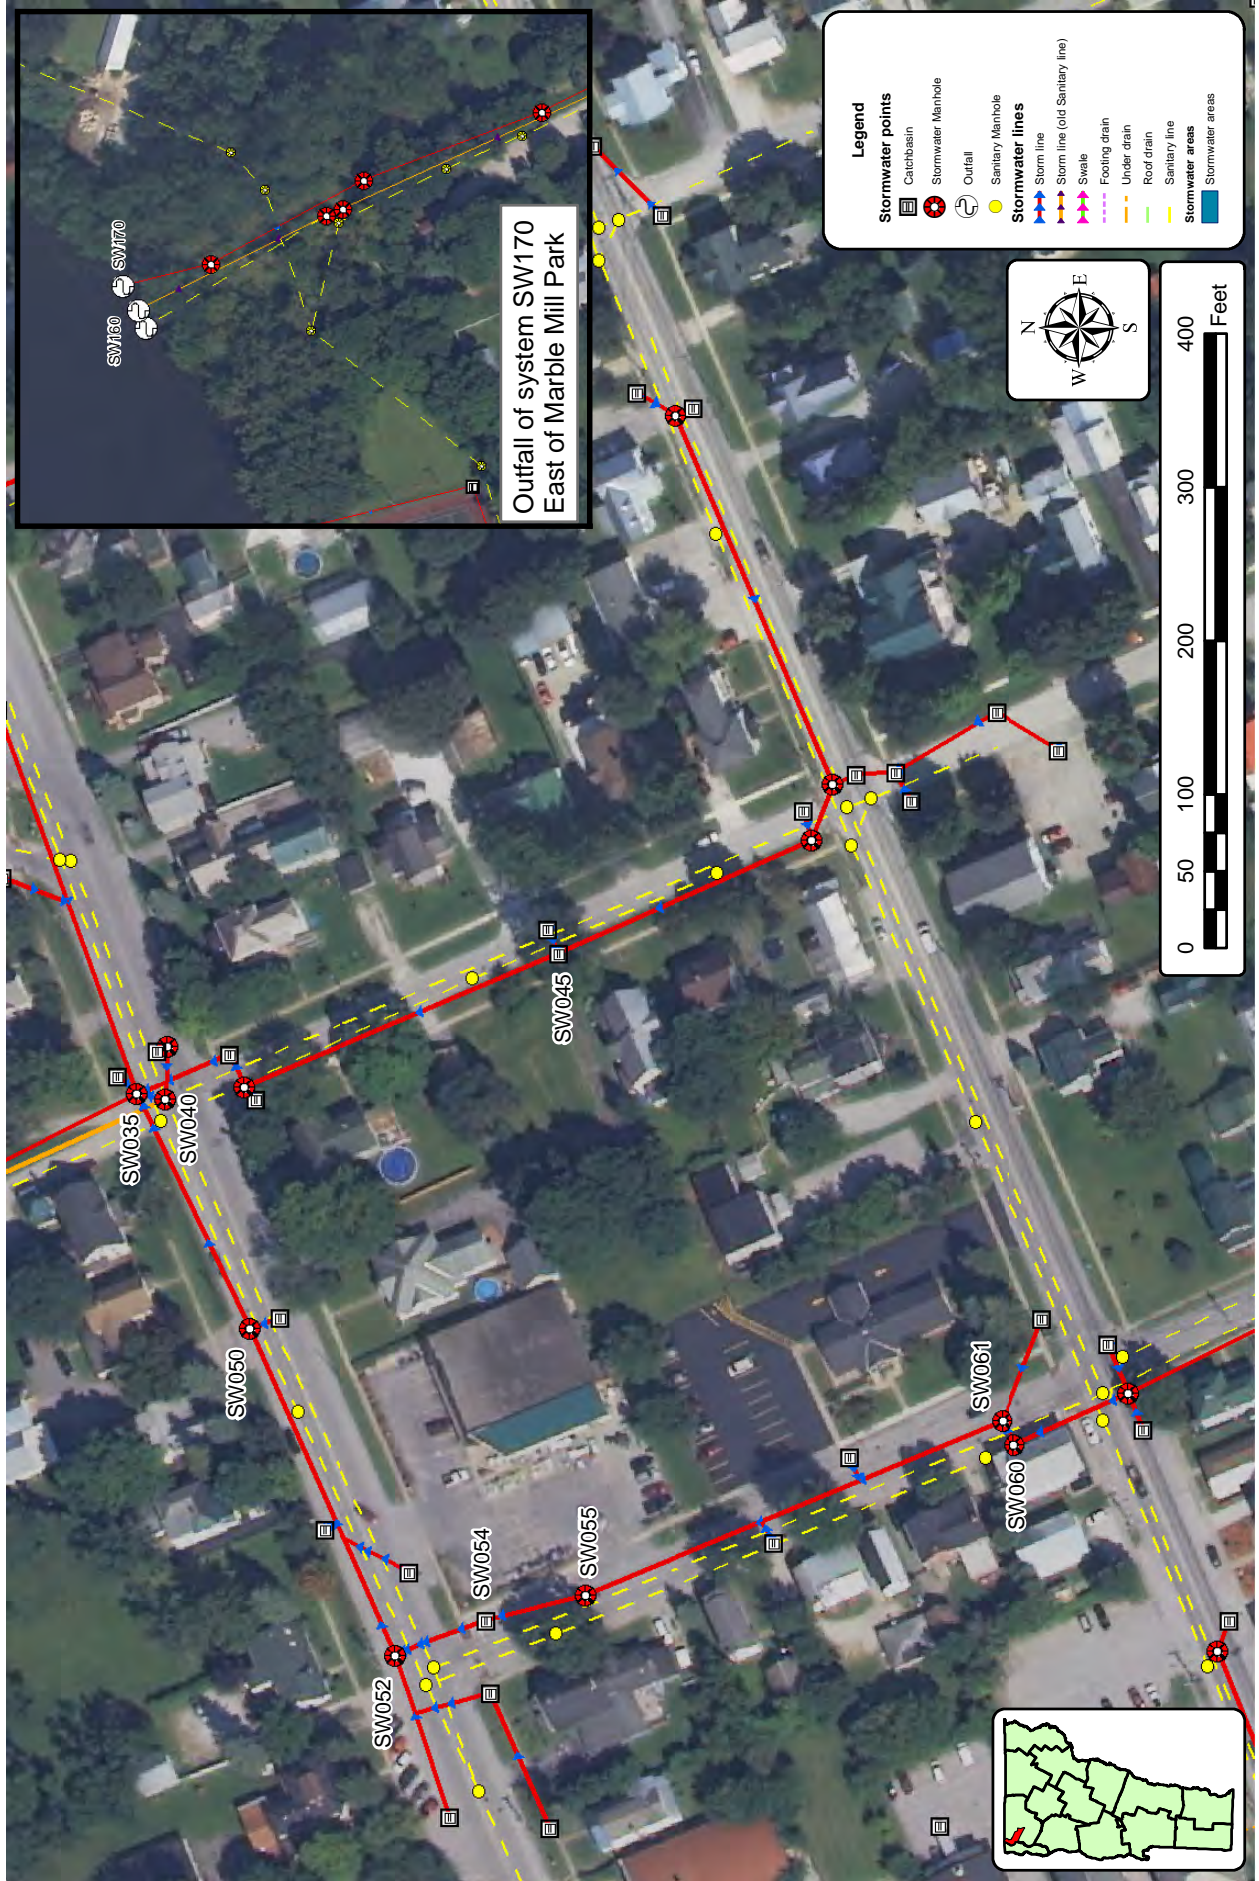
Figure 15. Section of stormwater drainage system discharging at outfall SW-170 Swanton, VT

At the intersection of Canada Street and Broadway Street, there are two connected manholes (SW-035 and SW-040) into which multiple storm and old sewer lines flow (Figure 15). SW-035 discharges to the stormline which outfalls at the Missisquoi River in Marble Mill Park via a 24-inch diameter concrete pipe. This outfall is SW-170. The incoming pipes to manhole SW-035 include the line from manhole SW-040, two new stormlines draining eastern and western Canada Street, and the stormline from a single catch basin located at the corner of Webster Terrace. The incoming pipes to manhole SW-040 are three old sewer lines (one from the west and two from the east) plus the storm sewer draining Broadway Street. The old sewer lines discharging to manhole SW-040 do not appear to have any connection to surface drains.

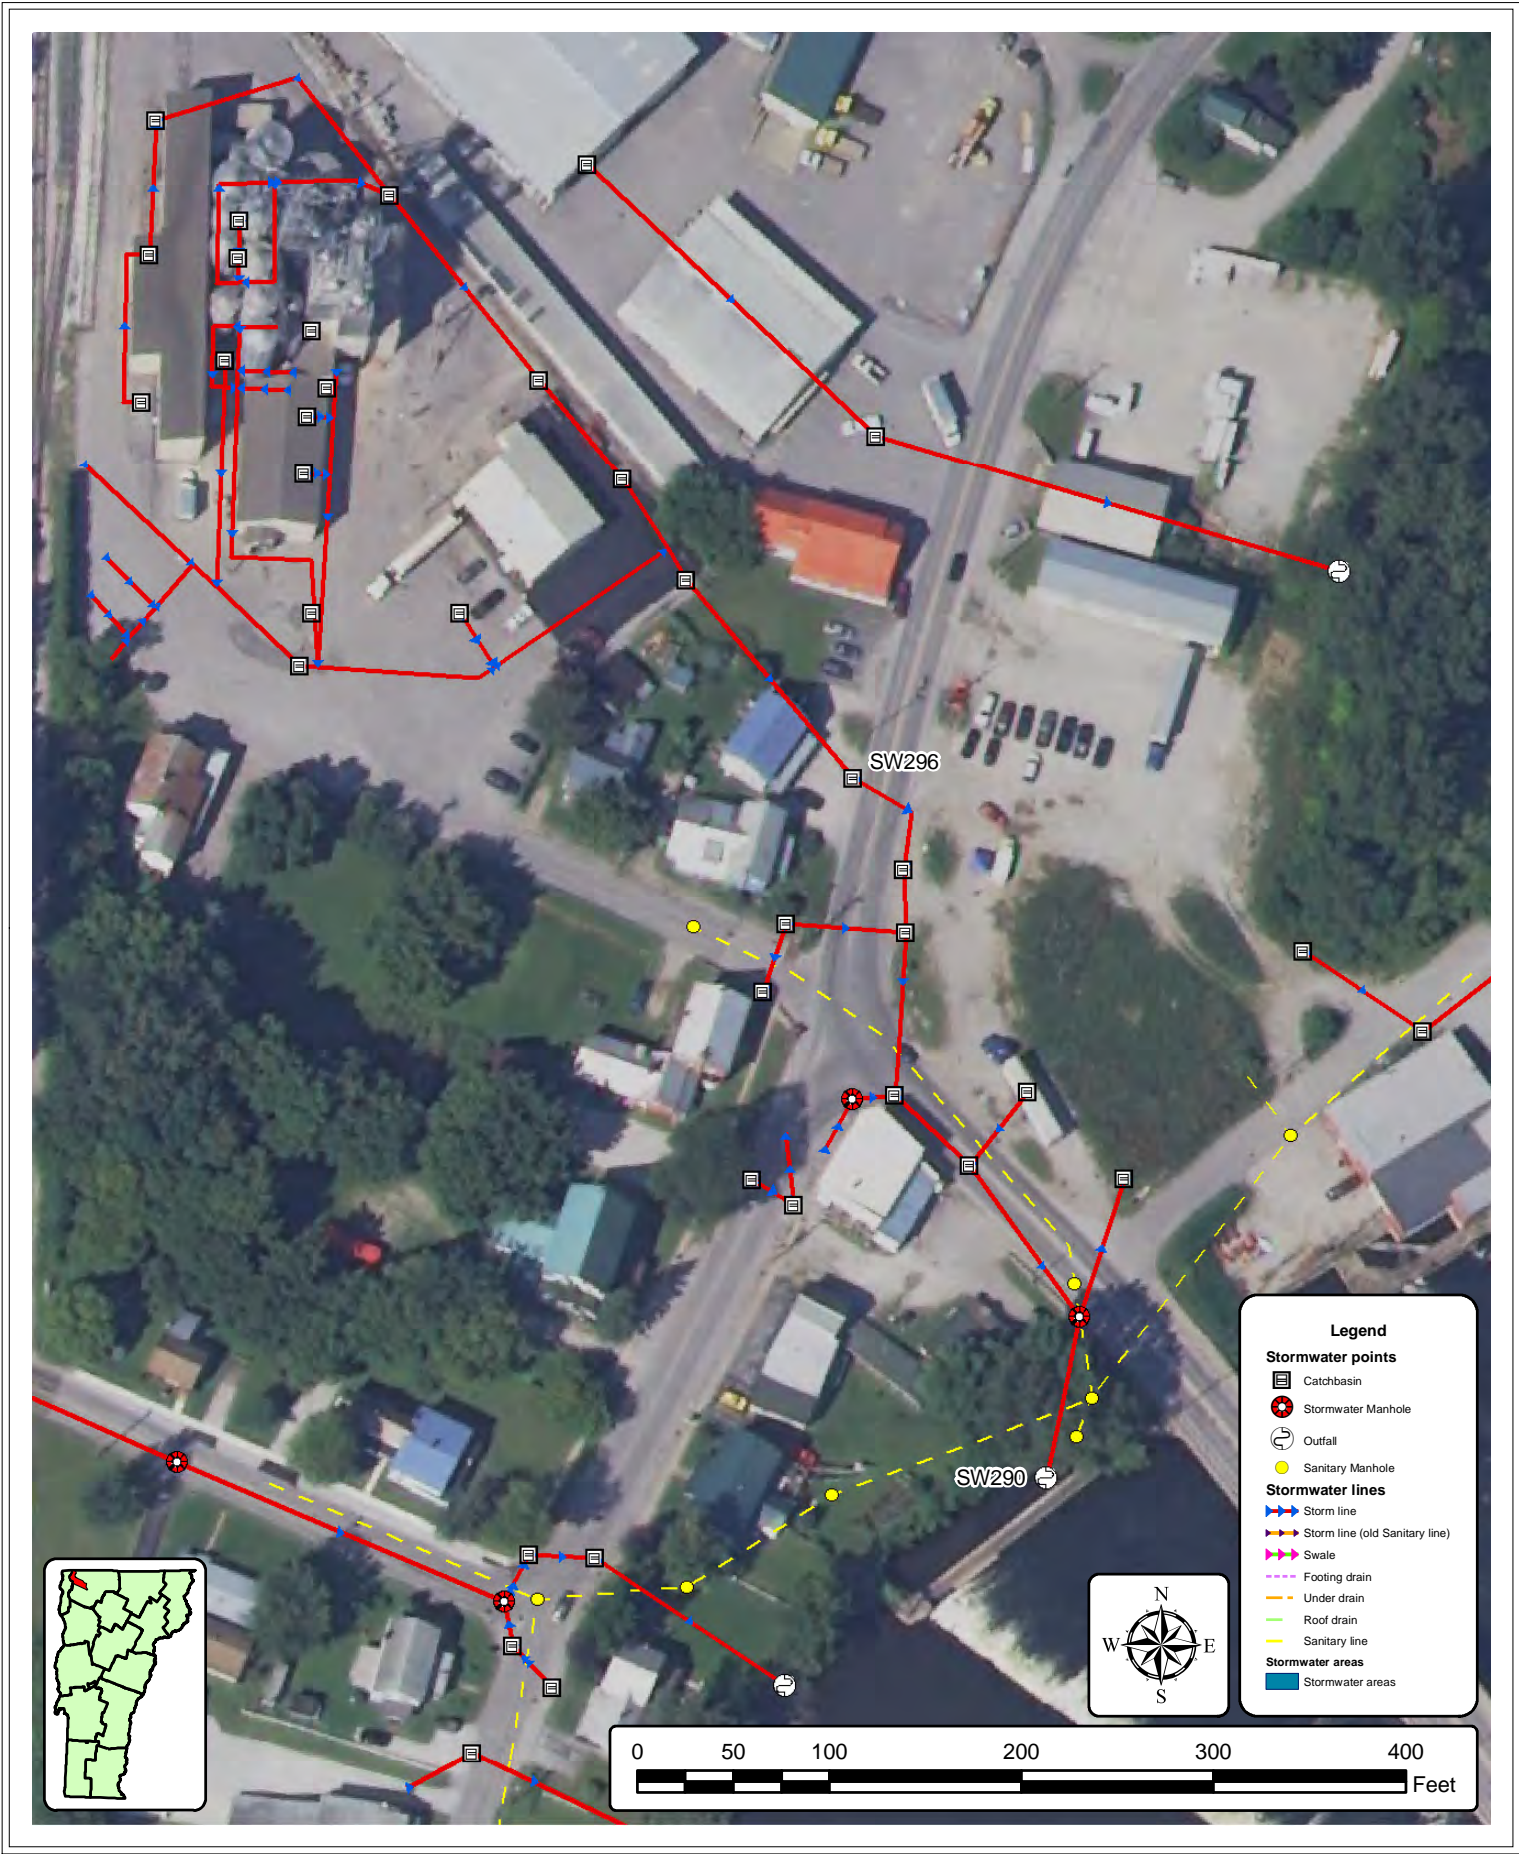
Figure 16. Stormwater drainage system discharging at outfall SW-290 Swanton, VT

SW-290 is an 18-inch diameter outfall pipe discharging to the Missisquoi River, on the left bank, immediately upstream of the Depot Street Bridge (Figure 16). Elevated ammonia and phosphorus concentrations and high *E. coli* levels in this storm sewer were determined to be coming from the Poulin Grain plant property. Table 11 summarizes the water quality data available for this storm sewer.
