Lake Morey

Lake and Watershed Action Plan (LWAP)

Fairlee, Vermont

March 19, 2024

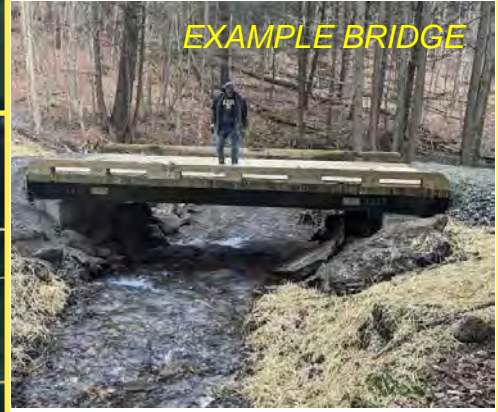
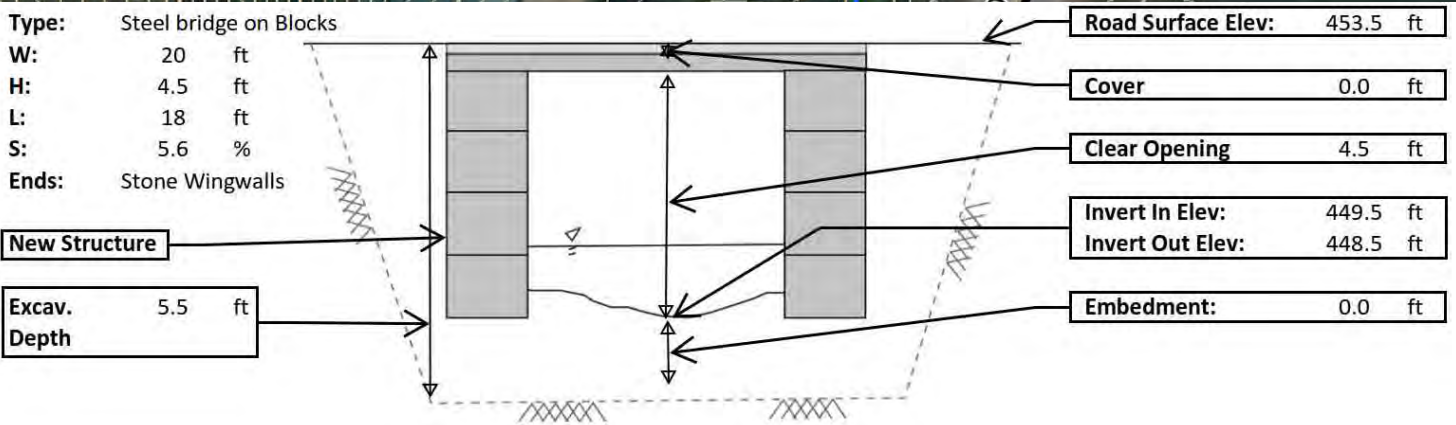
Project 1-3: Twin Culvert on Big Brook Stream Crossing Structure Replacement

| Site Description: Replace twin culverts that are perched 1.2 feet to increase geomorphic compatibility and improve fish passage. Drainage area of Big Brook at this location is 1.4 square miles. | |

NEW 20' BRIDGE

- * Concrete block abutments
- * Steel beams
- * Wooden deck
- * 1.5-lane (17' travel-way)

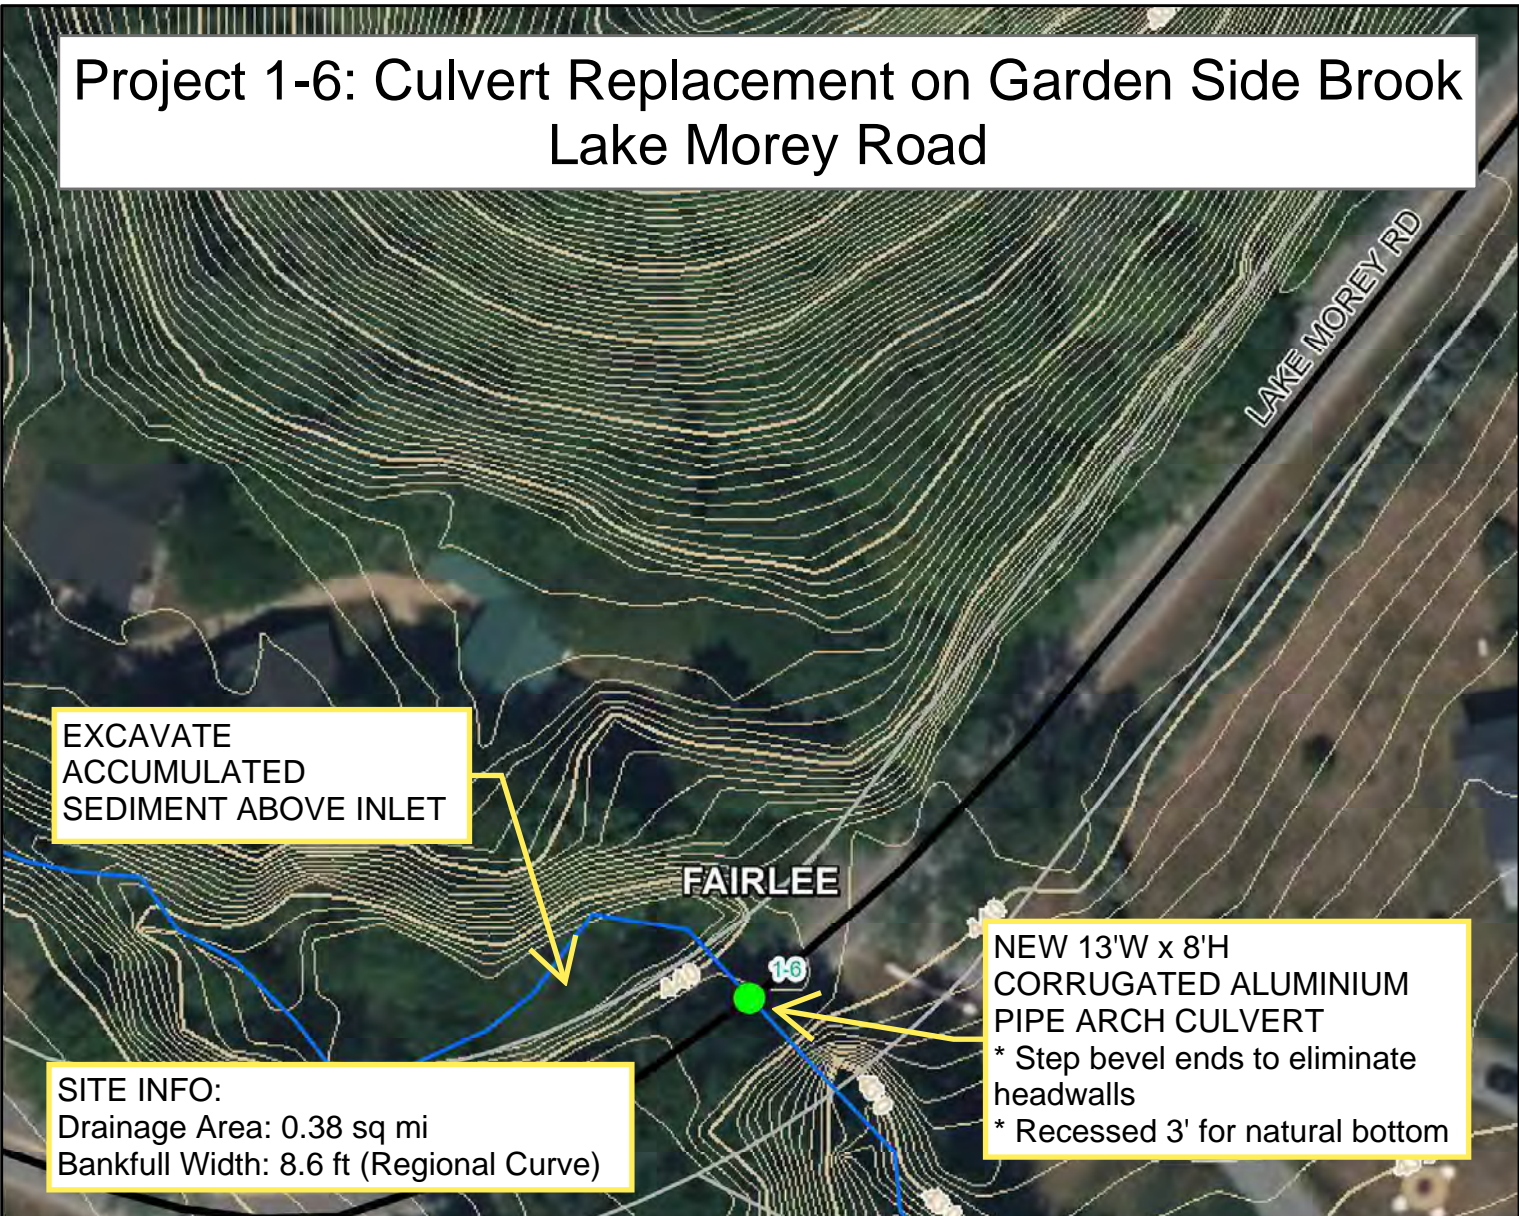
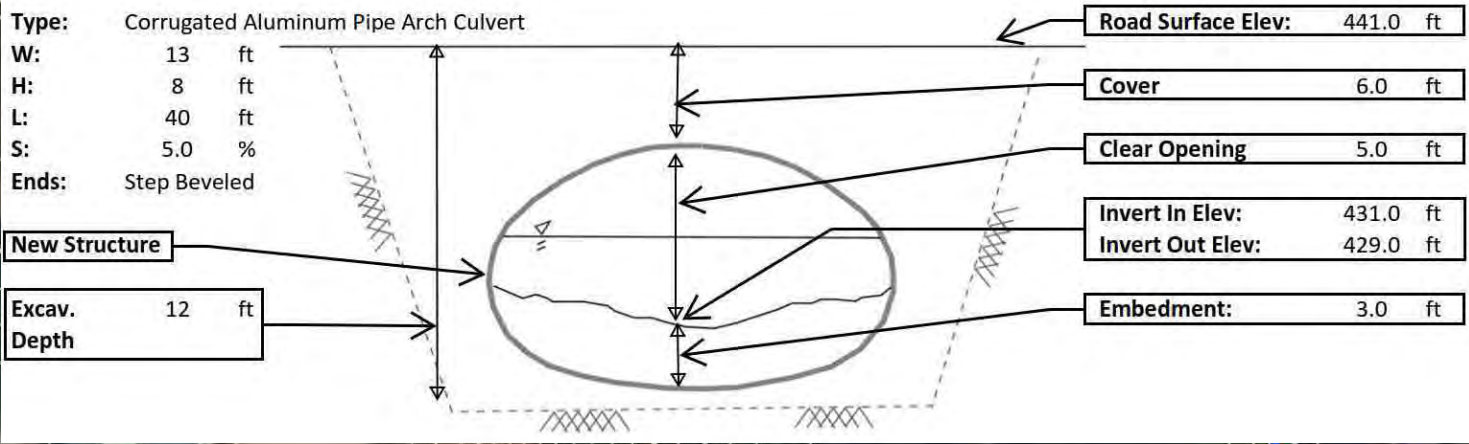
Project 1-6: Culvert Replacement on Garden Side Brook Lake Morey Road

| <p>Site Description: Replace culvert that is perched 3.9 feet on the outlet side and mostly buried at the inlet. This will increase geomorphic compatibility and potentially improve fish passage. Drainage area of Garden Side Brook at this area is 0.38 square miles.</p> | |

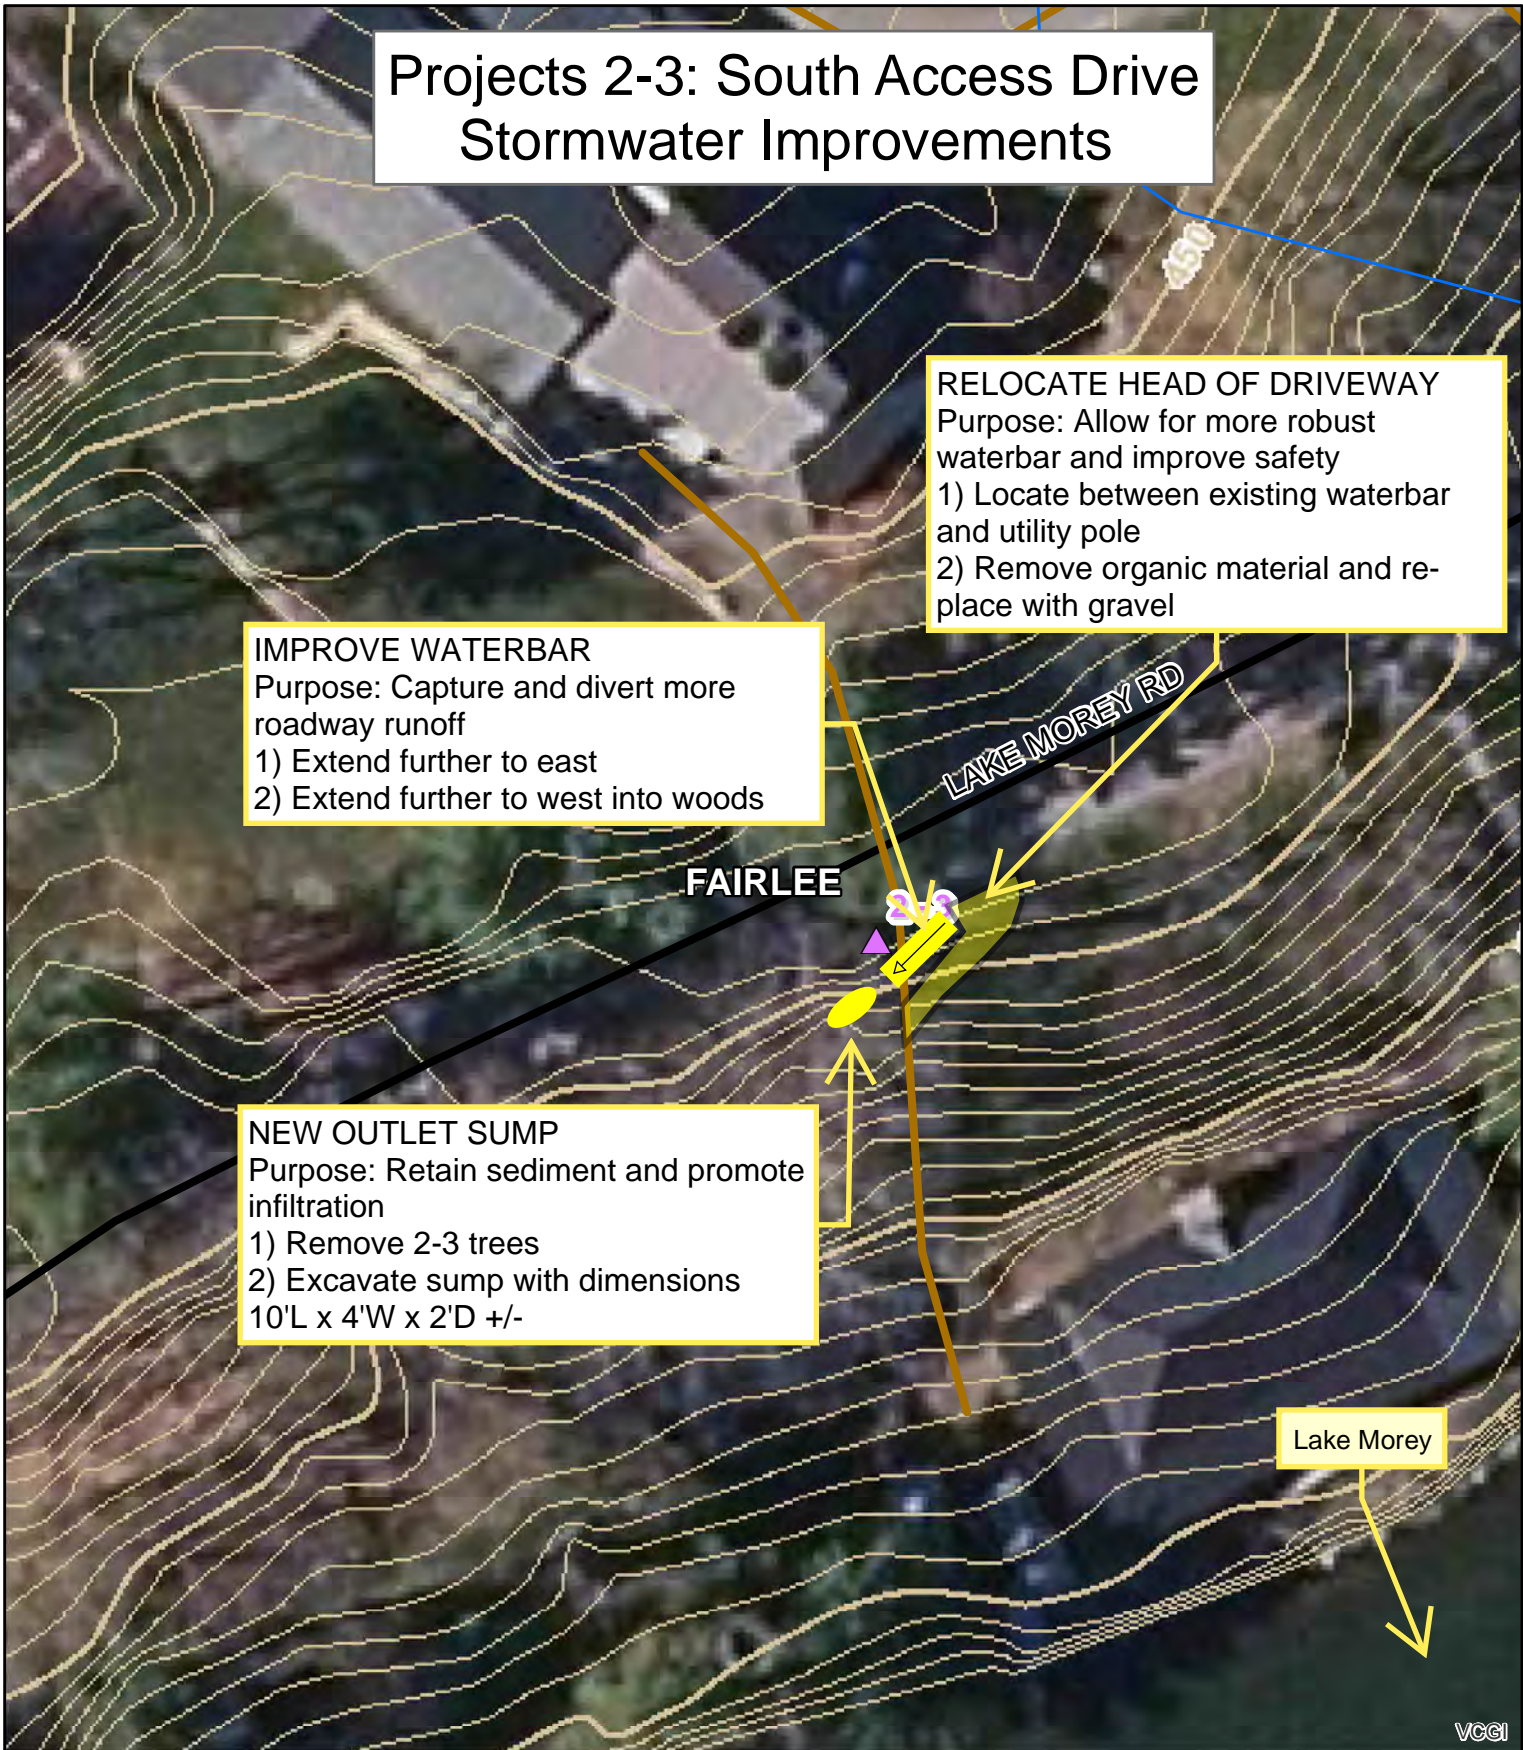
Projects 2-3: South Access Drive Stormwater Improvements

| Project Number Segment | Project Category | Project Type | Project Location | Town | Ownership | Project Description | Environmental Benefits | Degree of Landowner Commitment |
|---|---|---|---|---|---|--|---|---|
| 2-3 | Road | Stormwater Improvement | South Access Drive at Aloha Camp | Fairlee | Aloha Foundation | Stormwater runoff is causing erosion of steep access road, which is in close proximity to Lake Fairlee. Reduce erosion by extending the water bar down slope and creating a small sedimentation basin at the outlet. Move top of access road slightly to east. | 1, 2 | High |

| Site Design Considerations: The south access drive is steep and is in close proximity to Lake Fairlee. In an effort to reduce erosion and sedimentation, extend the water bar down slope and create a small sedimentation basin. It is also recommended that the top of the access road be moved slightly to the east. | |

RELOCATE HEAD OF DRIVEWAY
 Purpose: Allow for more robust waterbar and improve safety
 1) Locate between existing waterbar and utility pole
 2) Remove organic material and replace with gravel

IMPROVE WATERBAR
 Purpose: Capture and divert more roadway runoff
 1) Extend further to east
 2) Extend further to west into woods

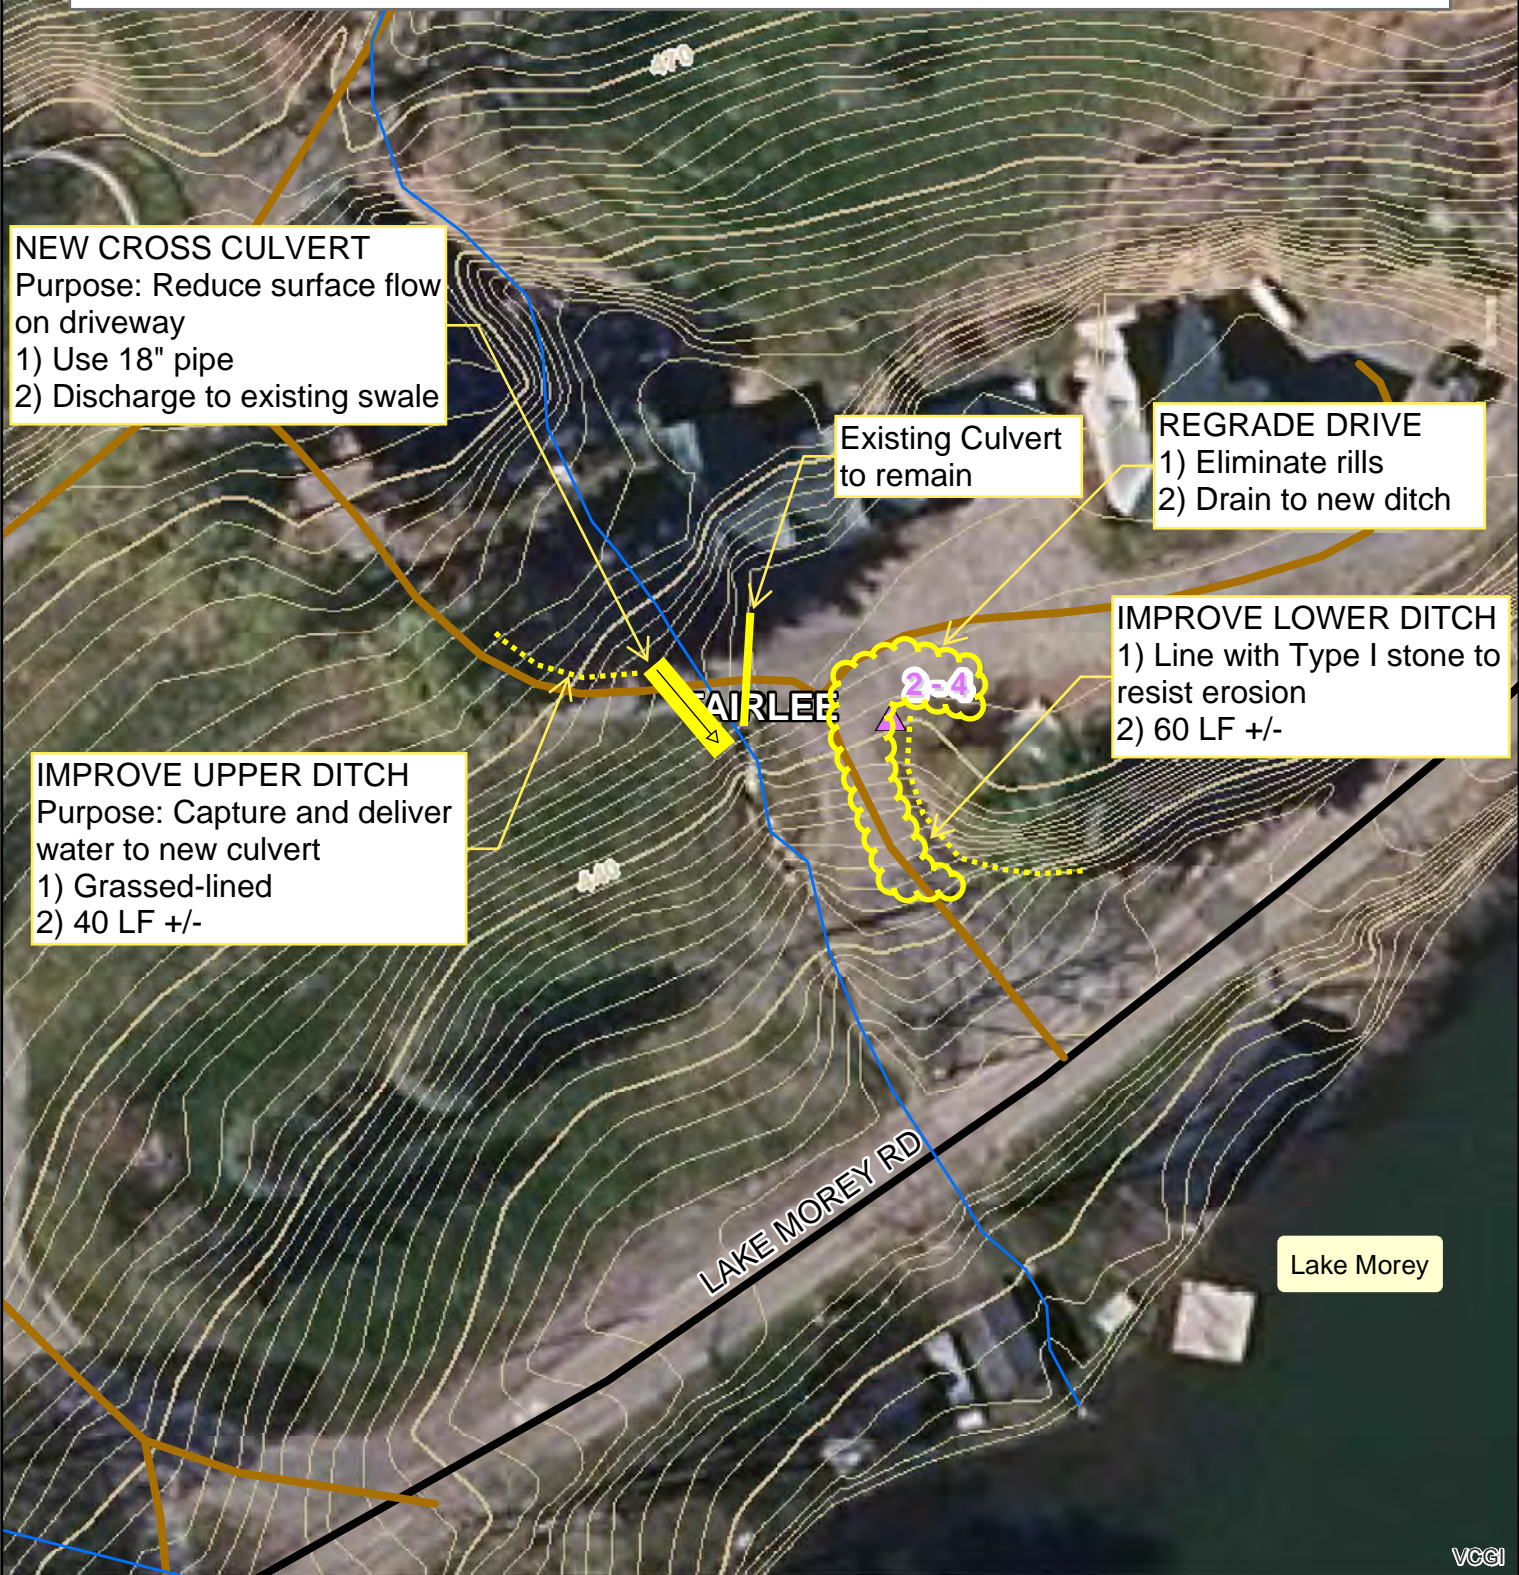
Project 2-4: Northwestern Access Drive at Aloha Camp Stormwater Improvements

| Project Number Segment | Project Category | Project Type | Project Location | Town | Ownership | Project Description | Environmental Benefits | Degree of Landowner Commitment |
|---|---|---|---|---|---|--|---|---|
| 2-4 | Road | Stormwater Improvement | Northeastern Access Drive at Aloha Camp | Fairlee | Aloha Foundation | Stormwater runoff is causing erosion of northeastern access drive of the Aloha Camp. Add a cross culvert at the upper end of drive to reduce concentration of stormwater runoff. Rock line the ditch along the drive and regrade the parking lot. | 1, 2 | High |
