Lake Watershed Action Plan Phase 1 at Shadow Lake in Glover, Vermont Final Report

March 2024

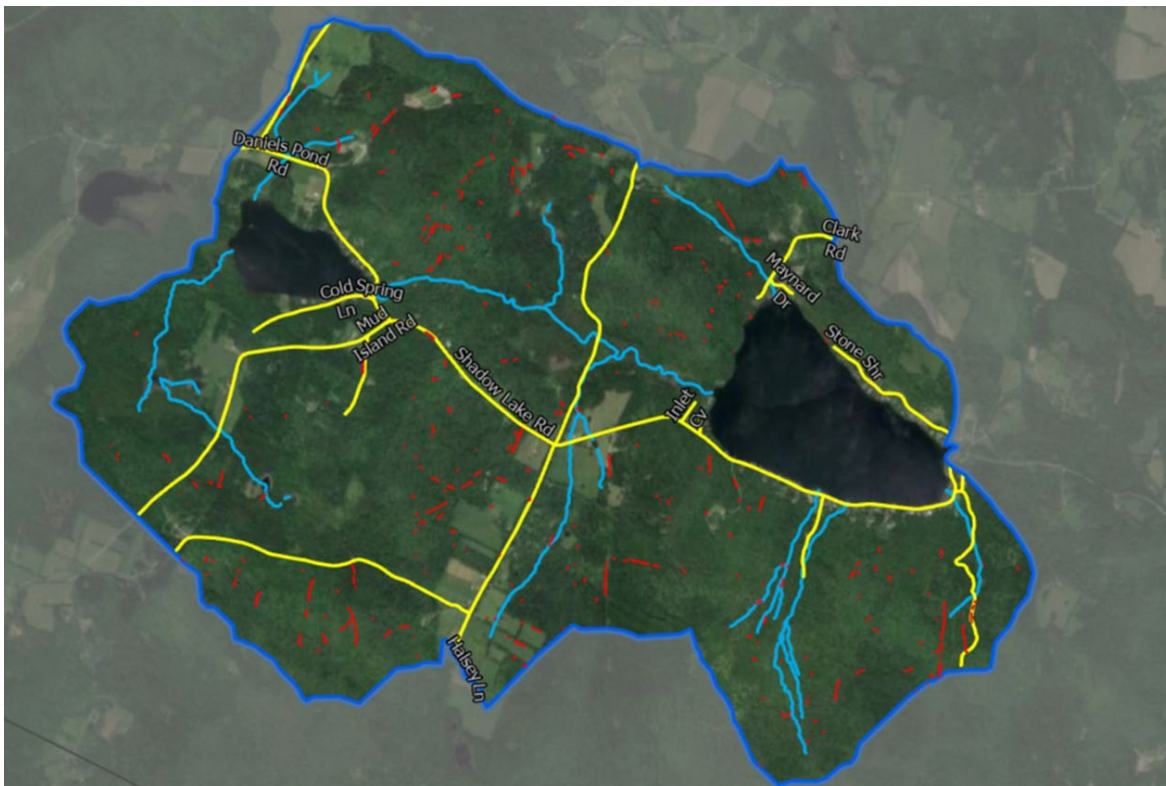
Figure 4. 393 Potentially Erosive Features were mapped in the watershed (see areas in red), totaling six acres (data generated by UVM Spatial Analysis lab, 2021).

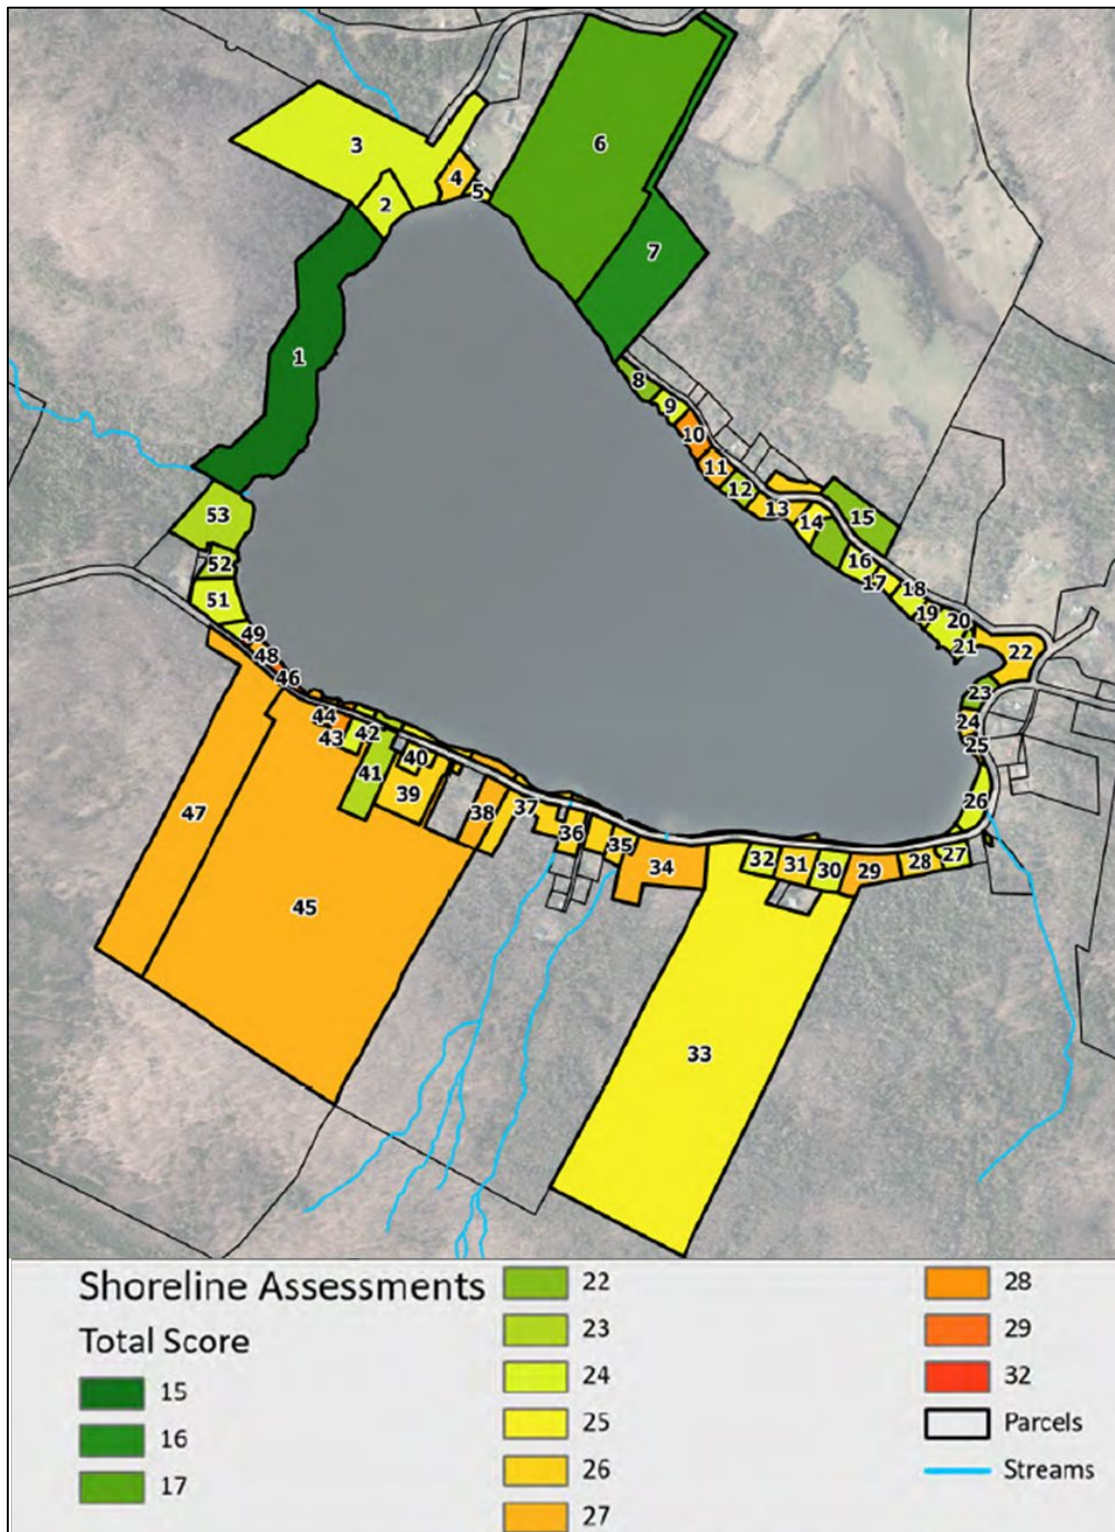
Figure 13. Shoreline assessment scores with the higher scores indicating a higher risk of poor water quality. Note that the numbers displayed on the map are ID numbers that correlate to the ranking tables and summary sheets provided in Appendix D.

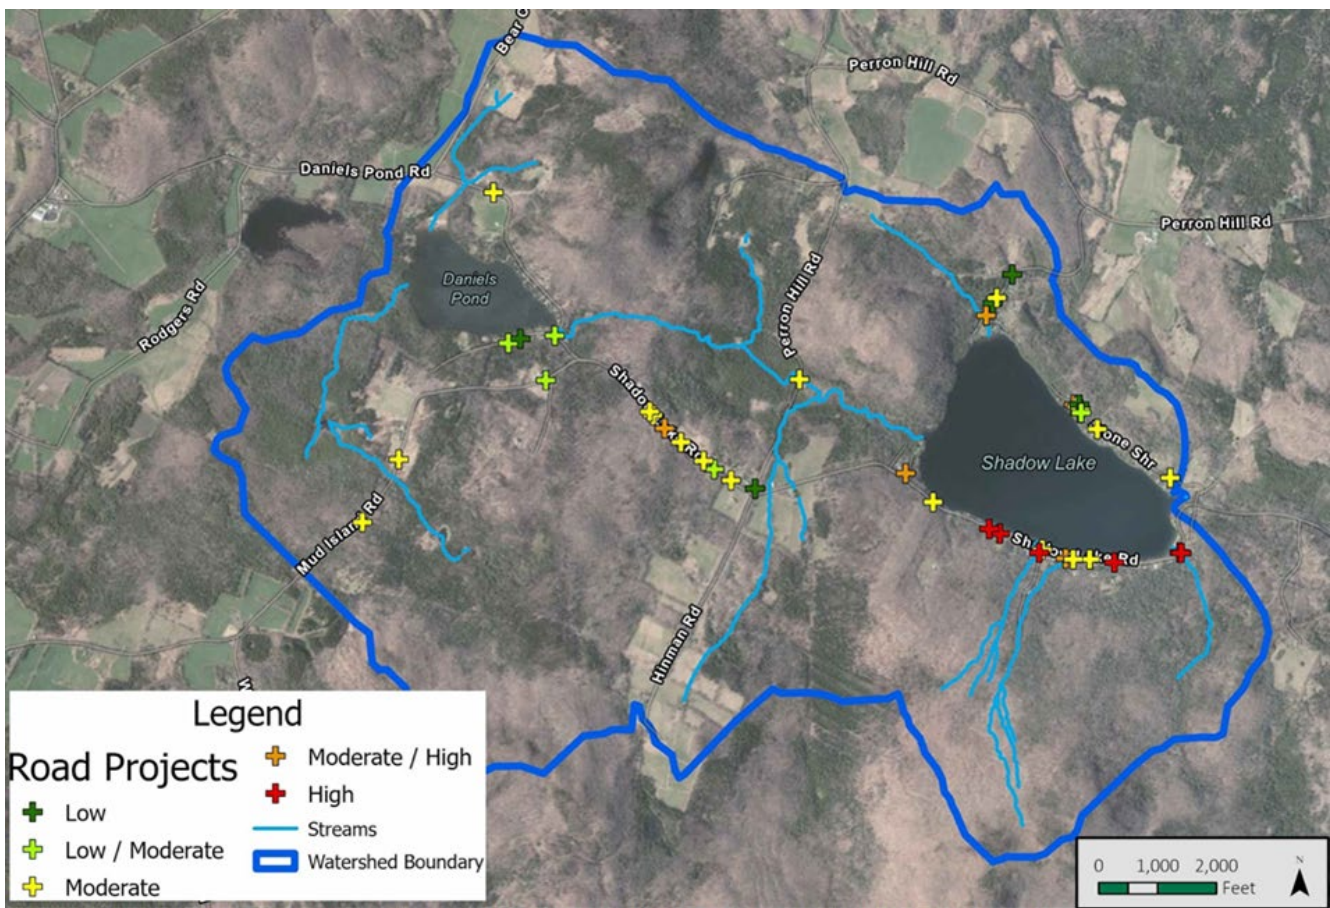
Figure 19. Road projects are shown by priority with those higher priority projects shown in red and lower priority projects shown in green.

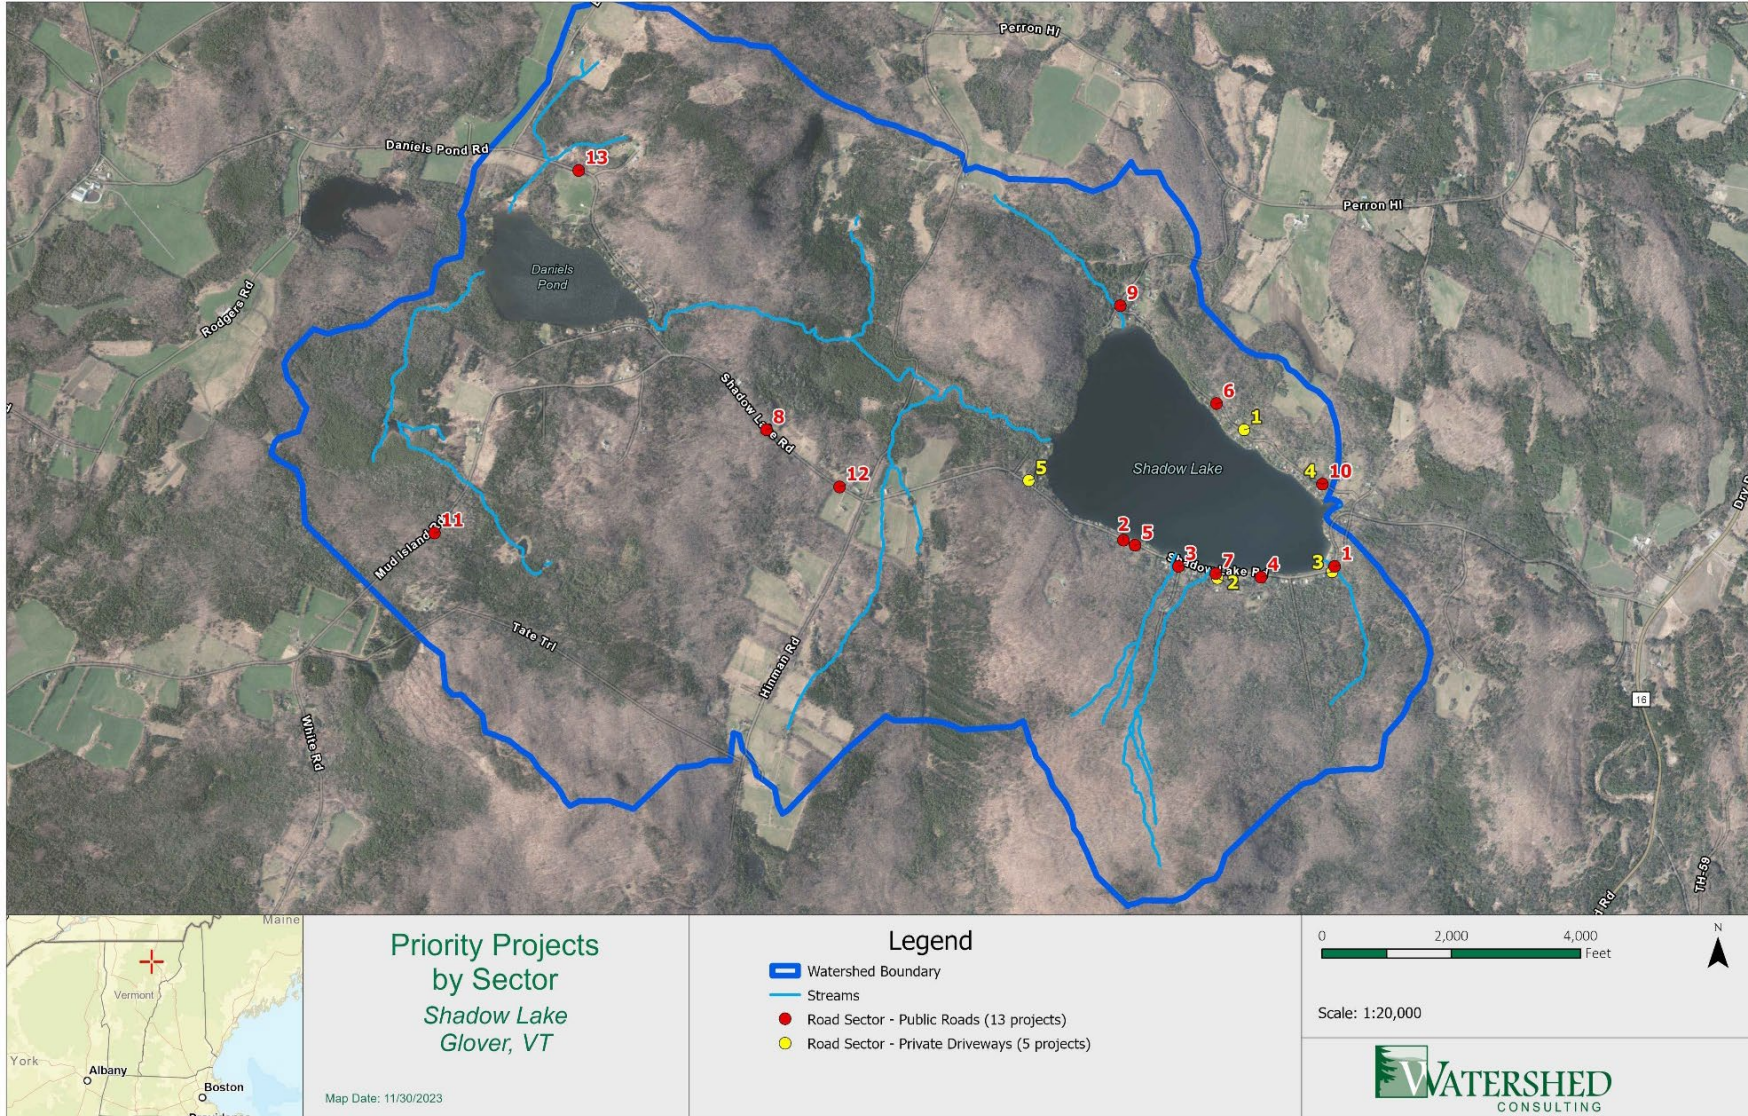
Figure 25. The selected priority road (and driveway) projects are shown within the watershed. The numbers correspond to the project rank within the sector.

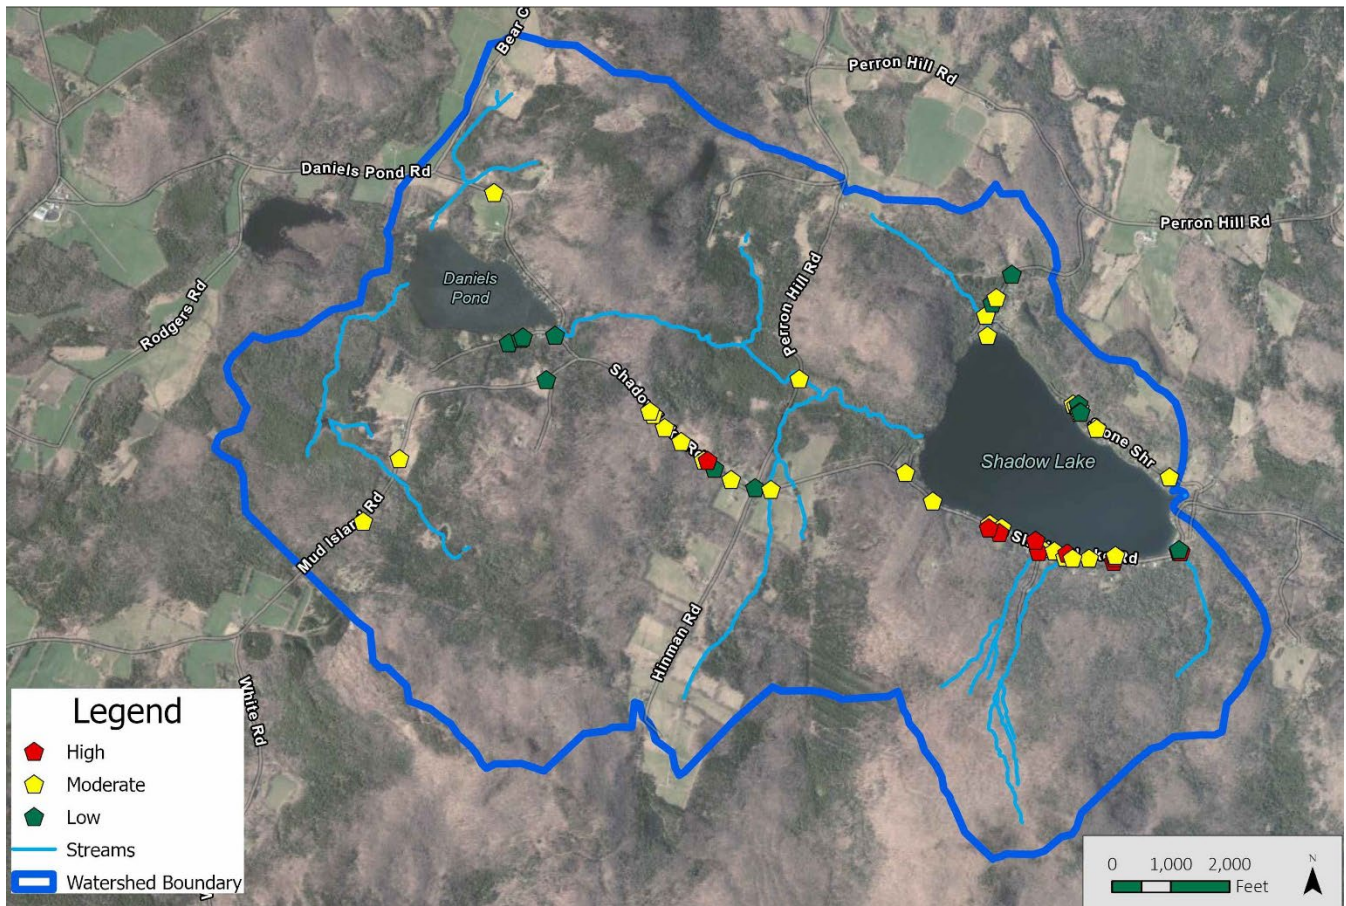
Figure 33. Identified projects within the stream sector were preliminarily ranked into high, moderate, and low priority.
