Re: Jay Peak Resort
Revised 2014 Water Quality Remediation Plan ("WQRP")

**Water Quality Remediation Plan
2014 Update**

JAY PEAK RESORT
Jay, Vermont

Revised: January 16, 2015

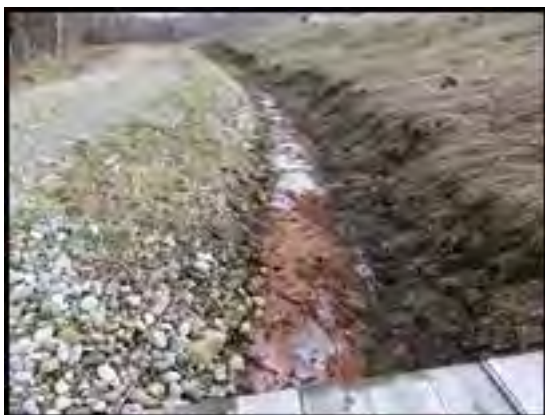
Unique ID	1001		
Subwatershed	Jay Branch		
Geographic Coordinates	-72.511; 44.941		
Location Description	Toe of slope at snowmaking pond		
Type of Problem	Iron Seep		
Remedial Action Description	Iron seep into ditch at toe of slope. Install limestone cutoff trench to treat seep.		
Discharges to Stormwater BMP	No	Associated Stormwater BMP	
Seasonal Discharge	All		
Reduction Potential (est.)	Lower		
Remediation Cost (est.)	Moderate		
Identification Date	04/24/2012		
Proposed Implementation	November 1, 2015		
Implementation Completed			
Follow-up Inspection Date(s)	05/22/2014		
Follow-up Inspection Notes

Work road ditch at toe of slope (04/24/2012)

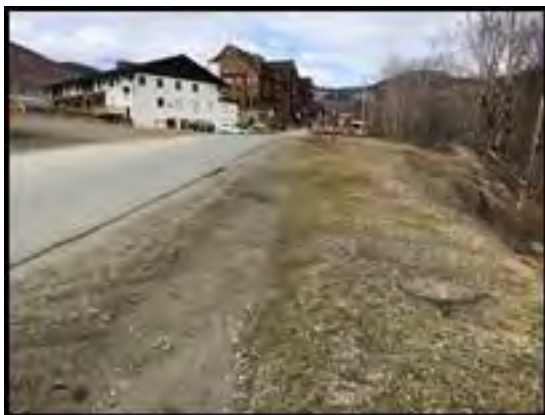
Unique ID	1002		
Subwatershed	Jay Branch		
Geographic Coordinates	-72.505; 44.939		
Location Description	Hotel Jay / Jay Peak Access Road		
Type of Problem	Untreated Impervious		
Remedial Action Description	Vegetate informal parking spaces that occur adjacent to the roadway and parking lots. Install wattles to capture sediment each fall. Remove sand, mulch and reseed as necessary each spring.		
Discharges to Stormwater BMP	Yes	Associated Stormwater BMP	Hotel Jay Basin
Seasonal Discharge	All		
Reduction Potential (est.)	Lower		
Remediation Cost (est.)	Lower		
Identification Date	04/28/2014		
Proposed Implementation	2014		
Implementation Completed	2014 (complete); Provide maintenance annually as needed.		
Follow-up Inspection Date(s)	05/22/2014		
Follow-up Inspection Notes	Sand removed and area mulched as of 5/22/2014. Disturbed areas vegetated as of 08/20/2014.

Ad hoc parking adjacent to Jay Peak Road (04/28/2014)

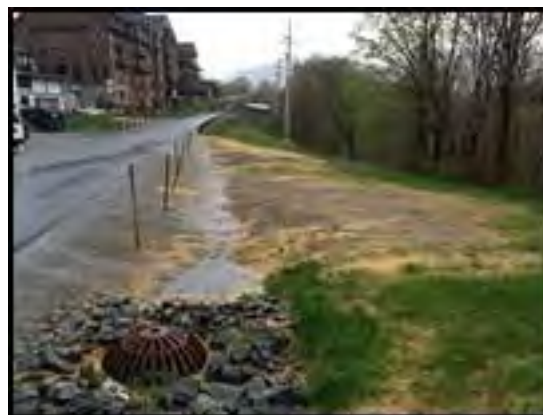
Area following application of mulch (05/22/2014)

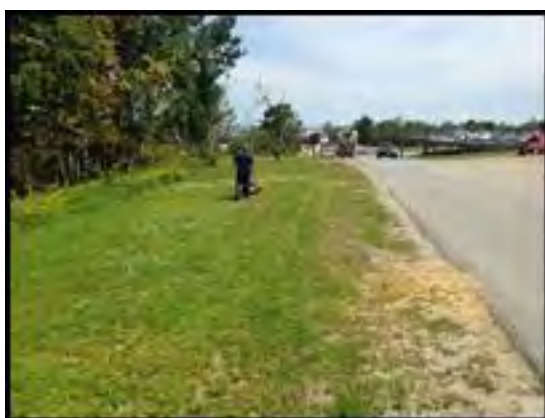
Re-established vegetation along roadside (08/20/2014)

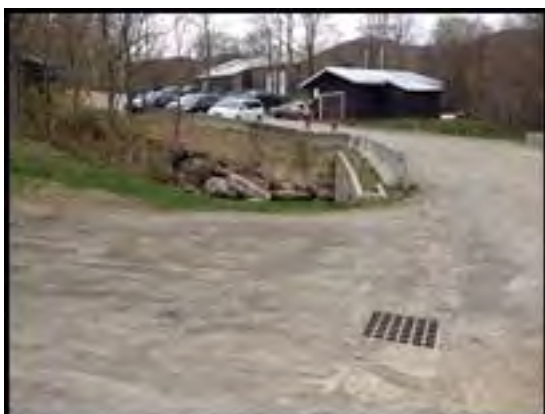
Unique ID	1003		
Subwatershed	Jay Branch		
Geographic Coordinates	-72.507; 44.939		
Location Description	Tram Haus Lodge		
Type of Problem	Untreated Impervious		
Remedial Action Description	Revegetate edge of roadway and prevent vehicles from parking in this area. Plant shrubs and trees to restore riparian buffer of the tributary to Jay Branch.		
Discharges to Stormwater BMP	No	Associated Stormwater BMP	
Seasonal Discharge	All		
Reduction Potential (est.)	Lower		
Remediation Cost (est.)	Lower		
Identification Date	04/28/2014		
Proposed Implementation	November 1, 2015		
Implementation Completed	Initial stabilization completed 2014; Additional plantings to be installed by November 1, 2015.		
Follow-up Inspection Date(s)	05/22/2014		
Follow-up Inspection Notes	Disturbed area seeded & stabilized as of 07/30/2014. Additional plantings scheduled for fall 2014.

Ad hoc parking adjacent to Tram Haus Lodge (04/28/2014)

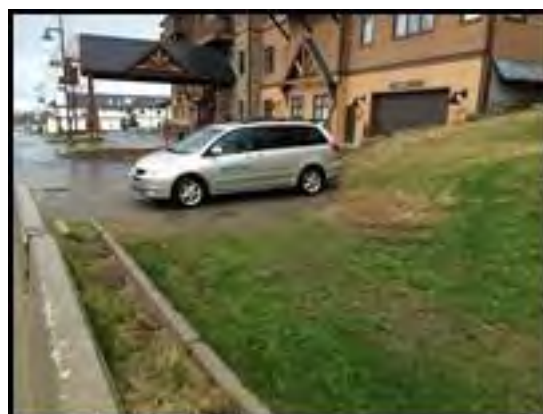
Shuttle van parked in area of concern (05/22/2014)

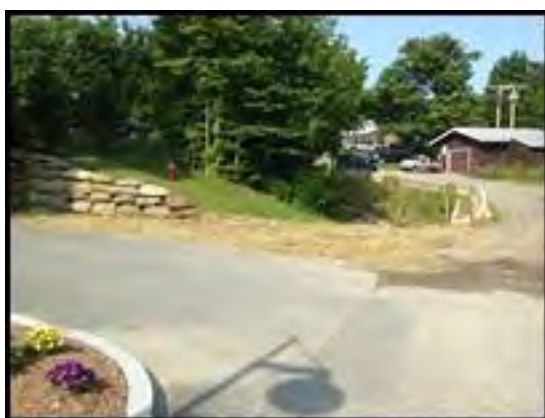
Additional stabilization of area (07/30/2014)

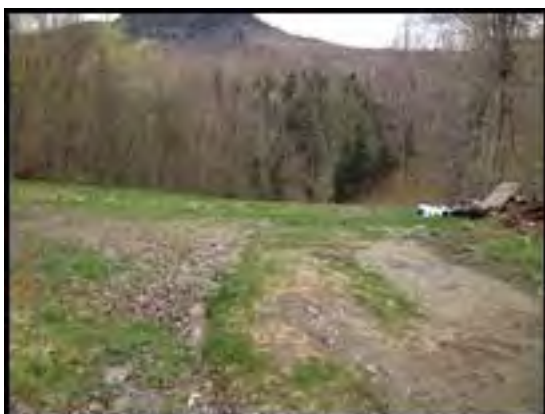
Unique ID	1004		
Subwatershed	Jay Branch		
Geographic Coordinates	-72.508; 44.940		
Location Description	Snowmaking / Chair Barn Parking Lot		
Type of Problem	Plowing Practices		
Remedial Action Description	Improve and armor existing swale and construct a settling basin.		
Discharges to Stormwater BMP	No	Associated Stormwater BMP	
Seasonal Discharge	Winter		
Reduction Potential (est.)	Moderate		
Remediation Cost (est.)	Moderate		
Identification Date	04/28/2014		
Proposed Implementation	2014		
Implementation Completed	2014		
Follow-up Inspection Date(s)	07/09/2014		
Follow-up Inspection Notes	Existing vegetated open area could be used for snow storage; swale lined with stone and disturbed area mulched as of 08/06/2014.

Potential enhanced snow storage area (04/28/2014)

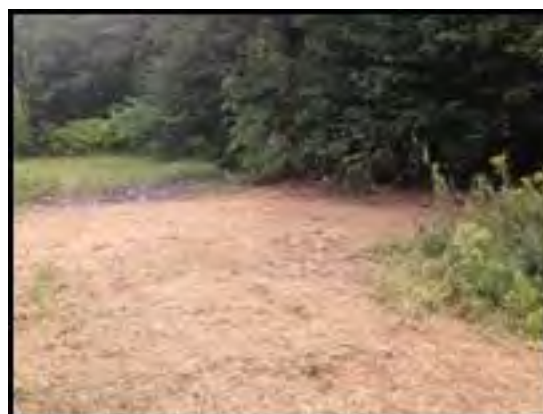
Area stabilized and pipeline removed (08/06/2014)

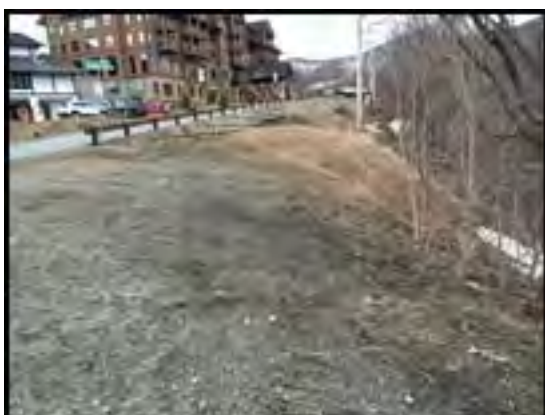
Unique ID	1005		
Subwatershed	Jay Branch		
Geographic Coordinates	-72.506; 44.939		
Location Description	Jay Peak Road opposite Tram Base Lodge		
Type of Problem	Untreated Impervious		
Remedial Action Description	Vegetate informal parking spaces that appear adjacent to the roadway and other parking lots in this area.		
Discharges to Stormwater BMP	Yes	Associated Stormwater BMP	Hotel Jay Basin
Seasonal Discharge	All		
Reduction Potential (est.)	Lower		
Remediation Cost (est.)	Lower		
Identification Date	04/28/2014		
Proposed Implementation	2014		
Implementation Completed	Completed 2014; Provide maintenance annually as needed.		
Follow-up Inspection Date(s)	05/22/2014		
Follow-up Inspection Notes	Some areas of informal parking eliminated by installing split rail fence. Disturbed areas vegetated as of 08/20/2014.

Typical example of parking off Jay Peak Rd (04/28/2014)

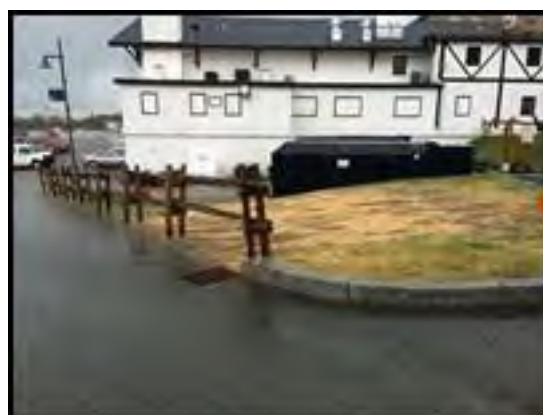
New fence installed and mulch applied (05/22/2014)

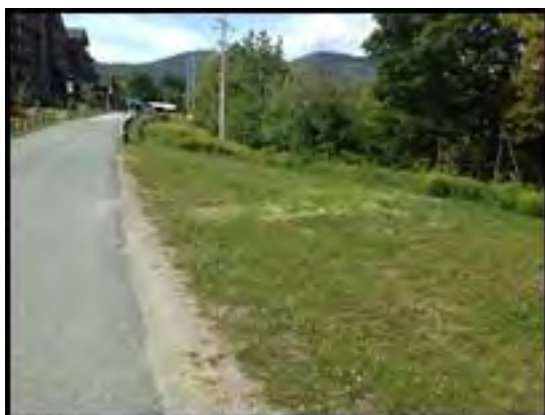
Re-established vegetation along roadside (08/20/2014)

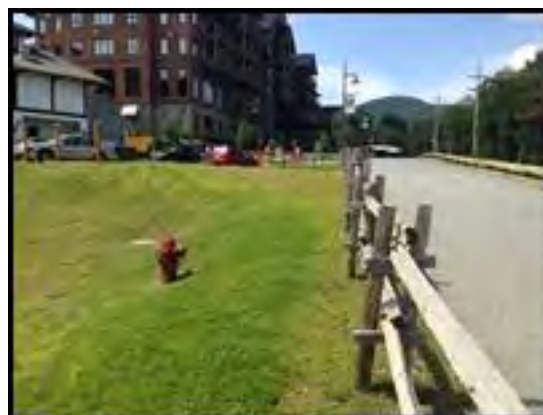
Re-established vegetation in fenced area (08/20/2014)

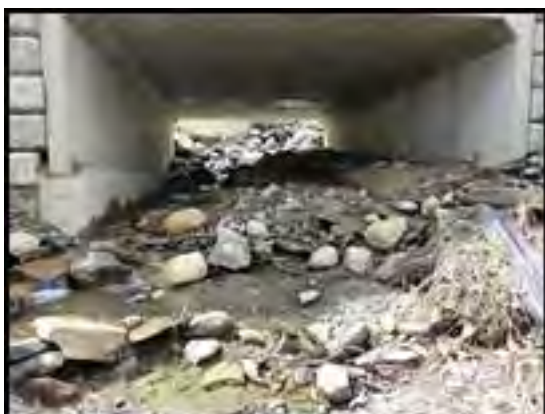
Unique ID	1006		
Subwatershed	Jay Branch		
Geographic Coordinates	-72.507; 44.940		
Location Description	West Bowl Road at Tram Haus Lodge		
Type of Problem	Bank Stabilization		
Remedial Action Description	Stream channel under bridge near Tram Haus Lodge has eroded in-stream material; is flowing against bridge abutment but footing is not exposed.		
Discharges to Stormwater BMP	No	Associated Stormwater BMP	
Seasonal Discharge	All		
Reduction Potential (est.)	Lower		
Remediation Cost (est.)	Moderate		
Identification Date	04/24/2012		
Proposed Implementation	Monitor and assess		
Implementation Completed			
Follow-up Inspection Date(s)	04/28/2014		
Follow-up Inspection Notes	Channel appears stable but is flowing against abutment as of 04/28/2014.

Stream at West Bowl Road bridge (04/24/2012)

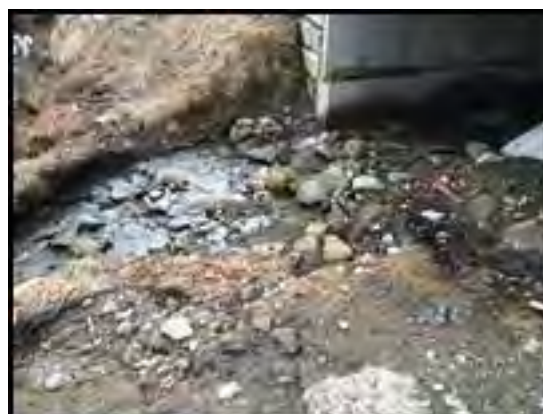
Stream as viewed from above (04/28/2014)

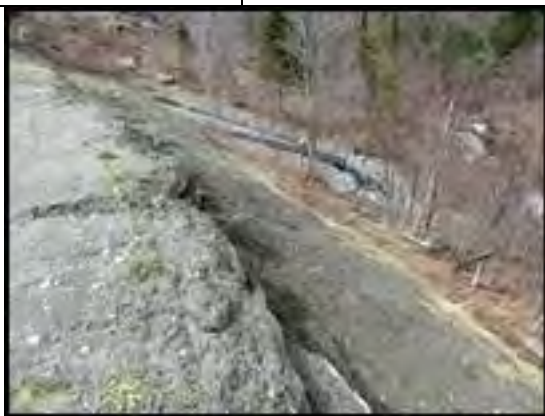
Unique ID	1012		
Subwatershed	Jay Branch		
Geographic Coordinates	-72.504; 44.939		
Location Description	Jay Peak Road opposite Hotel Jay		
Type of Problem	Plowing Practices		
Remedial Action Description	Prevent sediment from plowing activity from directly entering streams.		
Discharges to Stormwater BMP	No	Associated Stormwater BMP	
Seasonal Discharge	Winter		
Reduction Potential (est.)	Moderate		
Remediation Cost (est.)	Lower		
Identification Date	04/28/2014		
Proposed Implementation	2014 and on-going winter operations		
Implementation Completed	Snow Management Plan implemented 2014		
Follow-up Inspection Date(s)	05/22/2014		
Follow-up Inspection Notes	Straw mulch applied, excess sediment removed. Good vegetative growth as of 08/20/2014.

Snow storage near Jay Peak Road (04/28/2014)

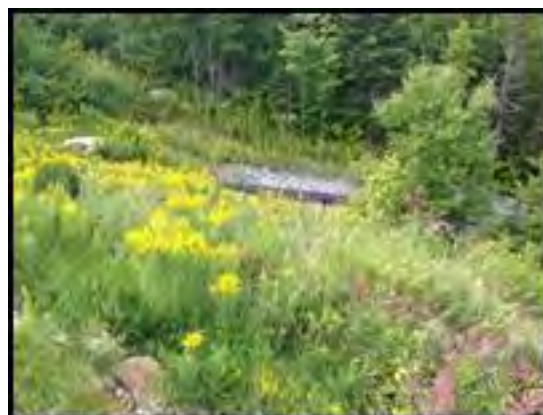
Well-vegetated slope during summer (08/19/2014)

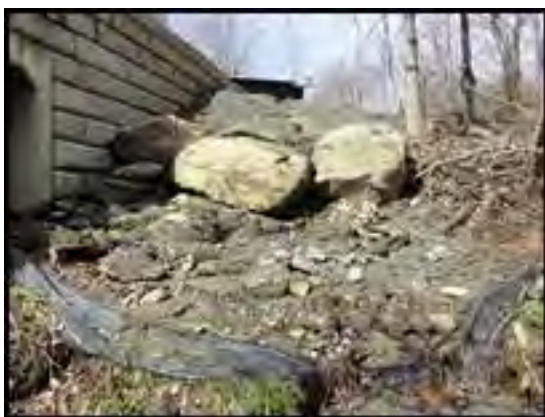
Unique ID	1013		
Subwatershed	Jay Branch		
Geographic Coordinates	-72.507; 44.940		
Location Description	Tram Haus Lodge		
Type of Problem	Plowing Practices		
Remedial Action Description	Eliminate snow storage area adjacent to the West Bowl Road bridge. Plant woody species in riparian buffer. Install straw wattles on slope each fall to capture sediment.		
Discharges to Stormwater BMP	No	Associated Stormwater BMP	
Seasonal Discharge	Winter		
Reduction Potential (est.)	Moderate		
Remediation Cost (est.)	Lower		
Identification Date	04/24/2012		
Proposed Implementation	2014		
Implementation Completed	2014 (complete)		
Follow-up Inspection Date(s)	04/28/2014; 05/22/2014		
Follow-up Inspection Notes	Similar conditions present as of 04/28/2014. Some sediment removed and area mulched (05/22/2014)

Snow storage near West Bowl Road Bridge (04/24/2012)

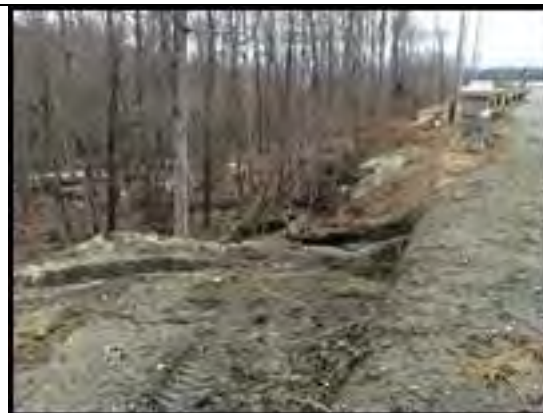
Snow storage near West Bowl Road Bridge (04/28/2014)

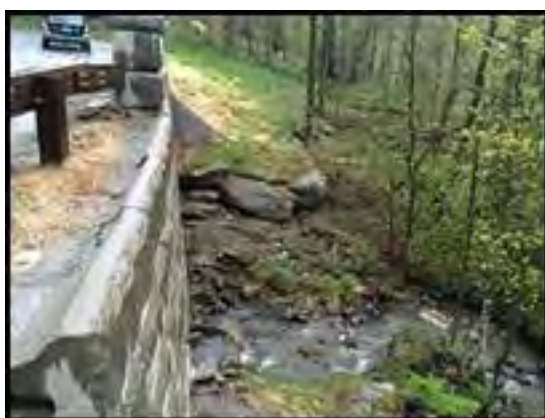
Area after straw mulch application (05/22/2014)

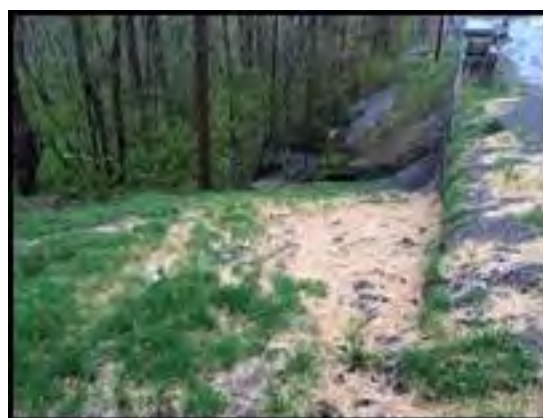
Area after straw mulch application (05/22/2014)

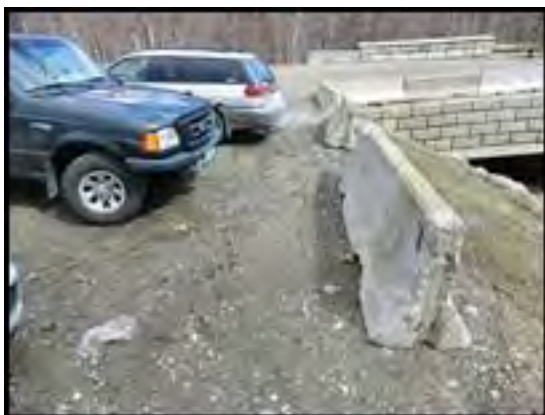
Unique ID	1014		
Subwatershed	Jay Branch		
Geographic Coordinates	-72.507; 44.939		
Location Description	Snowmaking / Chair Barn Parking Lot		
Type of Problem	Untreated Impervious		
Remedial Action Description	Regrade and pave parking area; provide stormwater management; restore riparian buffer vegetation		
Discharges to Stormwater BMP	No	Associated Stormwater BMP	
Seasonal Discharge	All		
Reduction Potential (est.)	Higher		
Remediation Cost (est.)	Moderate		
Identification Date	04/24/2012		
Proposed Implementation	November 1, 2015		
Implementation Completed	Paving completed 2014; Additional plantings to be installed by November 1, 2015.		
Follow-up Inspection Date(s)	07/09/2014		
Follow-up Inspection Notes	Area will be improved with paving project scheduled for fall 2014.

Unpaved parking area adjacent to stream (04/24/2012)

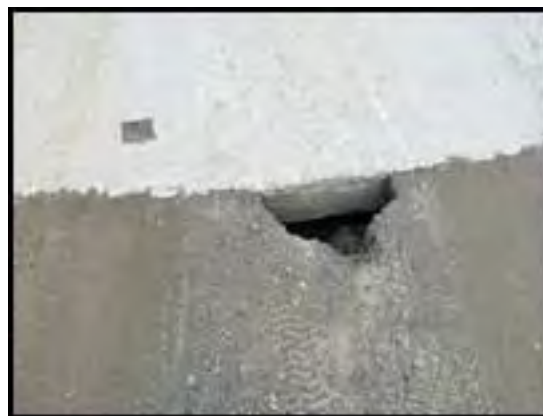
Unique ID	1019		
Subwatershed	Jay Branch		
Geographic Coordinates	-72.502; 44.940		
Location Description	Golf Course		
Type of Problem	Untreated Impervious		
Remedial Action Description	Repair cart path erosion at Golf Course Bridge over Jay Branch; stabilize approaches to reduce erosion and sediment discharge. Repair erosion at Hole 18 Bridge over Jay Branch; pave approaches to reduce sediment		
Discharges to Stormwater BMP	No	Associated Stormwater BMP	
Seasonal Discharge	All		
Reduction Potential (est.)	Lower		
Remediation Cost (est.)	Lower		
Identification Date	04/28/2014		
Proposed Implementation	2014		
Implementation Completed	2014 (complete)		
Follow-up Inspection Date(s)	04/28/2014		
Follow-up Inspection Notes	Cartpath regraded and shoulders vegetated as of 08/08/2014.

Eroded bridge approaches over Jay Branch (4/28/2014)

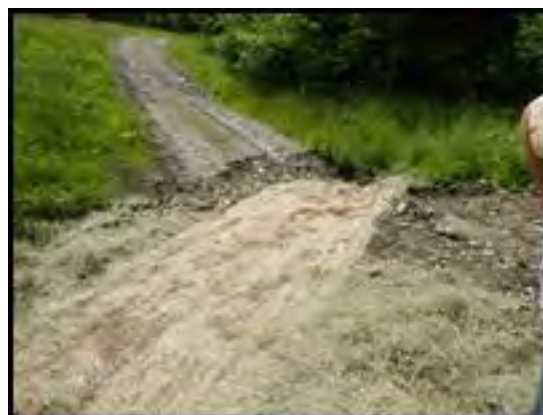
Removal of work road crossing underway (07/09/2014)

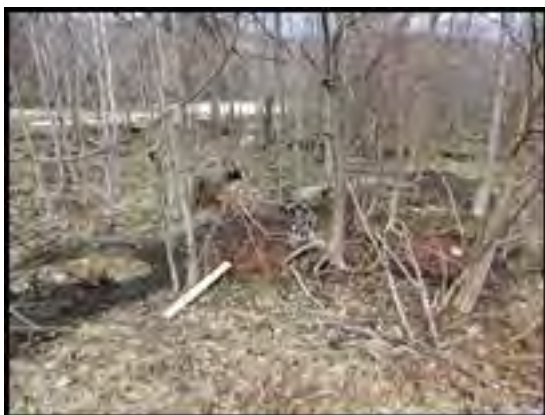
Unique ID	2002		
Subwatershed	Tributary 9		
Geographic Coordinates	-72.508; 44.933		
Location Description	Raccoon Run Ski Trail		
Type of Problem	Iron Seep		
Remedial Action Description	Iron seep from underdrain into wetland. Install treatment measures upgradient from wetland to intercept flow.		
Discharges to Stormwater BMP	No	Associated Stormwater BMP	
Seasonal Discharge	All		
Reduction Potential (est.)	Lower		
Remediation Cost (est.)	Moderate		
Identification Date	04/24/2012		
Proposed Implementation	November 1, 2015		
Implementation Completed			
Follow-up Inspection Date(s)	05/22/2014		
Follow-up Inspection Notes	Similar conditions observed as of 05/22/2014.

Iron seep into wetland near Raccoon Run (04/24/2012)

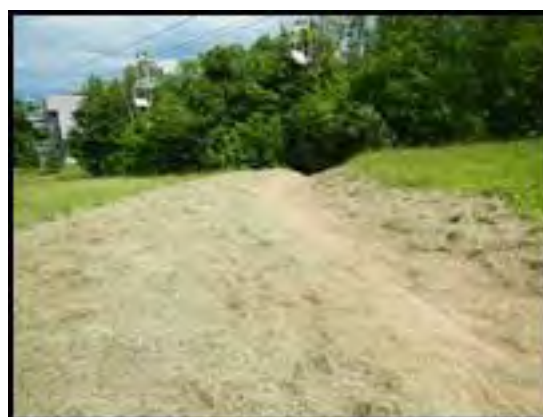
Regraded and stabilized water bar crossing (07/09/2014)

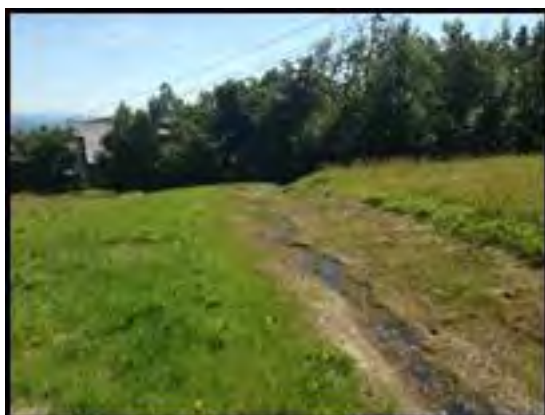
Vegetation establishment on waterbar (08/20/2014)

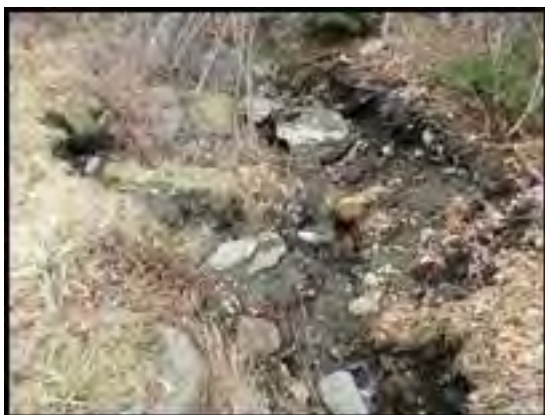
Unique ID	2004		
Subwatershed	Tributary 9		
Geographic Coordinates	-72.507; 44.933		
Location Description	Phase II Tributary at Racoon Run		
Type of Problem	Bank Stabilization		
Remedial Action Description	Regrade and stabilize waterbar and transition area between ski trail and natural channel at edge of ski trail.		
Discharges to Stormwater BMP	No	Associated Stormwater BMP	
Seasonal Discharge	All		
Reduction Potential (est.)	Moderate		
Remediation Cost (est.)	Moderate		
Identification Date	04/24/2012		
Proposed Implementation	2014		
Implementation Completed	2014 (complete)		
Follow-up Inspection Date(s)	05/22/2014		
Follow-up Inspection Notes	Waterbar and headcut stabilized as of 07/17/2014.

Phase II Tributary erosion (04/24/2012)

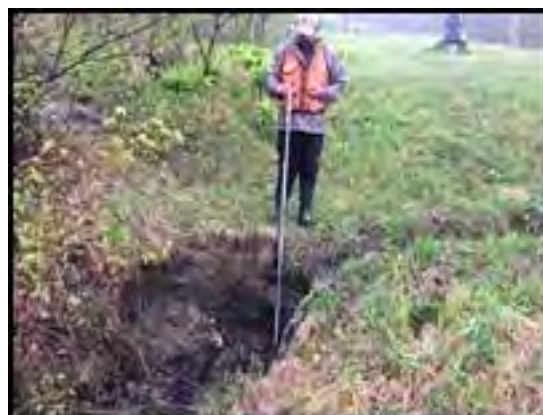
3-ft deep headcut has developed (05/22/2014)

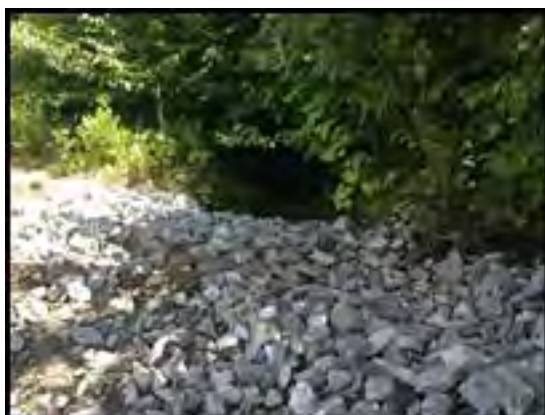
Channel regraded and transition stabilized (07/17/2014)

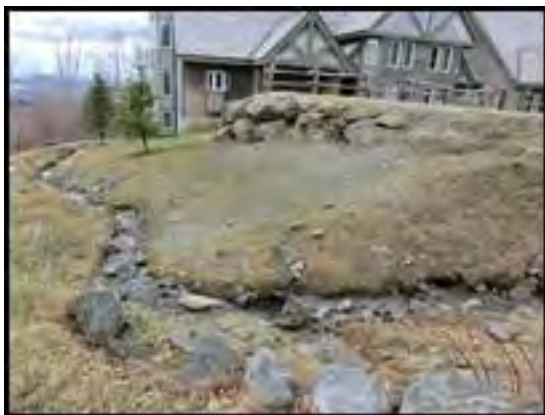
Unique ID	2005		
Subwatershed	Tributary 9		
Geographic Coordinates	-72.506; 44.933		
Location Description	South Village Road		
Type of Problem	Plowing Practices / Riparian Buffer Management		
Remedial Action Description	Prevent sediment from plowing activity from directly entering streams. Protect buffer vegetation (no mow signage) and install straw wattles each fall.		
Discharges to Stormwater BMP	No	Associated Stormwater BMP	
Seasonal Discharge	Winter		
Reduction Potential (est.)	Lower		
Remediation Cost (est.)	Lower		
Identification Date	04/24/2012		
Proposed Implementation	2014		
Implementation Completed	No mow zone established 2014; additional plantings to be installed by November 1, 2015.		
Follow-up Inspection Date(s)	07/17/2014		
Follow-up Inspection Notes	Straw wattle present, less sediment visible. No mow signage added 07/17/2014. Additional plantings to be added fall 2014.

Sediment from snow storage area (04/24/2012)

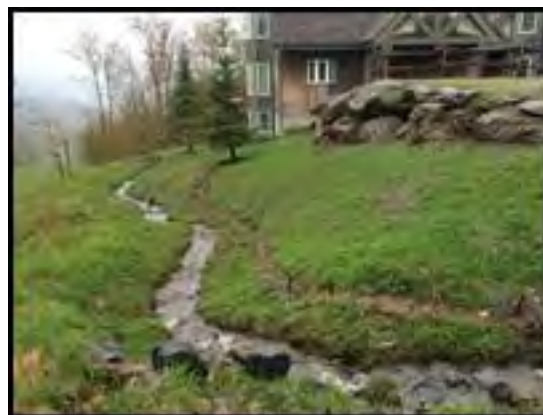
Straw wattle used to trap sediment (05/22/2014)

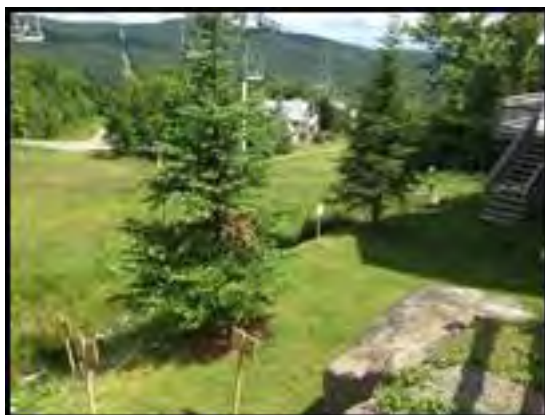
No mow area signage added (07/17/2014)

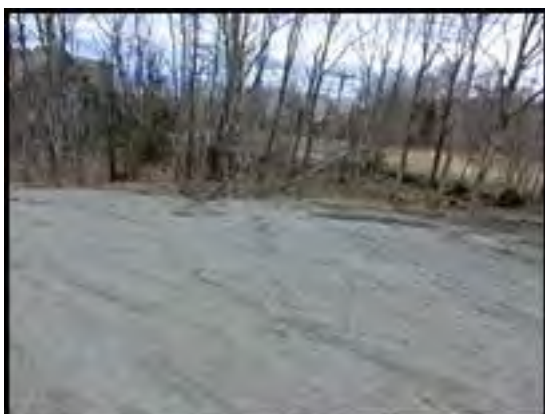
Unique ID	2006		
Subwatershed	Tributary 9		
Geographic Coordinates	-72.506; 44.934		
Location Description	North Village Road		
Type of Problem	Plowing Practices		
Remedial Action Description	Prevent sediment from plowing activity from directly entering streams. Create snow dump with settling pond to retain winter sand, per Snow Management Plan Area #3.		
Discharges to Stormwater BMP	No	Associated Stormwater BMP	
Seasonal Discharge	Winter		
Reduction Potential (est.)	Lower		
Remediation Cost (est.)	Lower		
Identification Date	04/24/2012		
Proposed Implementation	2014		
Implementation Completed	2014 (complete)		
Follow-up Inspection Date(s)	05/22/2014		
Follow-up Inspection Notes	Sediment basin constructed and straw mulch spread over area as of 08/20/2014.

Sediment from snow storage area (04/24/2012)

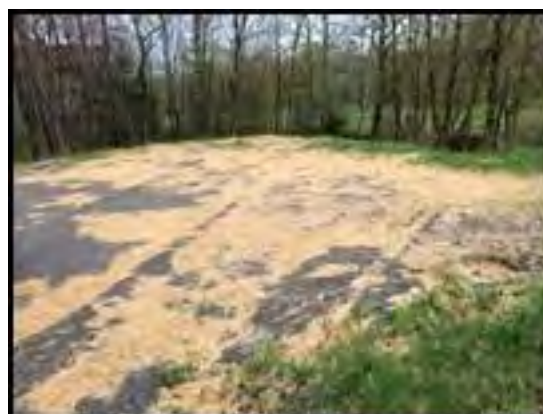
Area following application of mulch (05/22/2014)

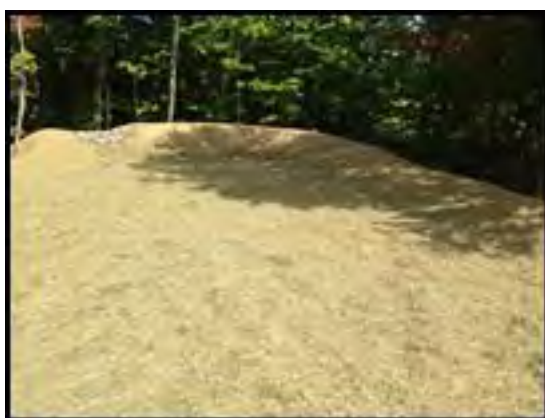
Snow storage area with rip rap outlet (08/20/2014)

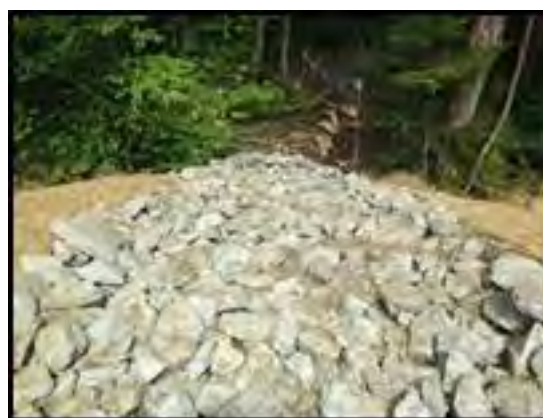
Rip rap outlet spillway (08/20/2014)

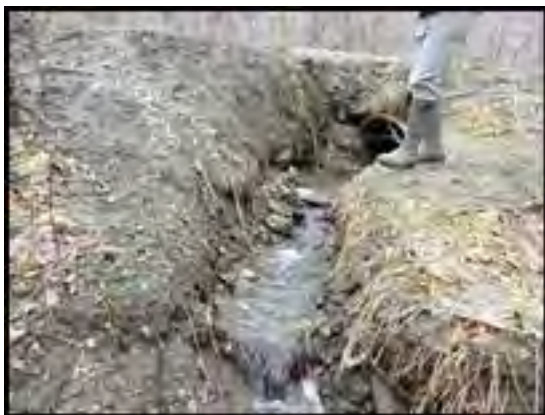
Unique ID	2007		
Subwatershed	Tributary 9		
Geographic Coordinates	-72.506; 44.935		
Location Description	Phase I Tributary at North Village Road		
Type of Problem	Plowing Practices		
Remedial Action Description	Prevent sediment from plowing activity from directly entering streams. Create snow dump with settling pond to retain winter sand, per Snow Management Plan Area #4.		
Discharges to Stormwater BMP	No	Associated Stormwater BMP	
Seasonal Discharge	Winter		
Reduction Potential (est.)	Moderate		
Remediation Cost (est.)	Lower		
Identification Date	04/24/2012		
Proposed Implementation	2014		
Implementation Completed	2014 (complete)		
Follow-up Inspection Date(s)	04/24/2012		
Follow-up Inspection Notes	Good vegetation growth observed as of 08/20/2014, minimal sediment contribution during summer months.

Sediment from road plowing operations (04/24/2012)

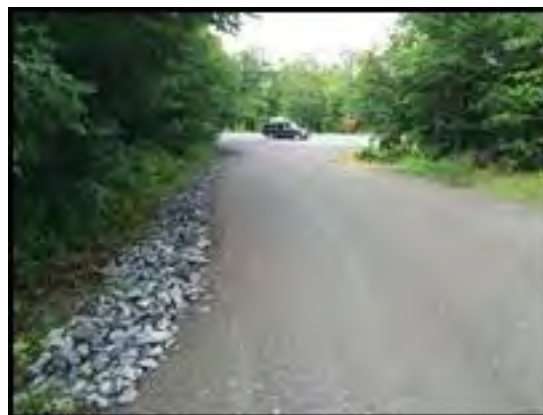
Regraded road with stone edging (08/07/2014)

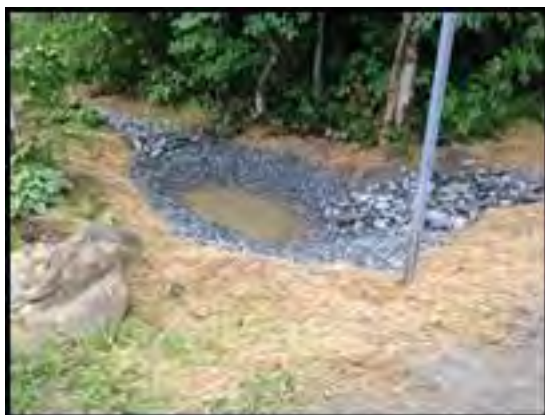
Sedimentation basin adjacent to roadway (08/06/2014)

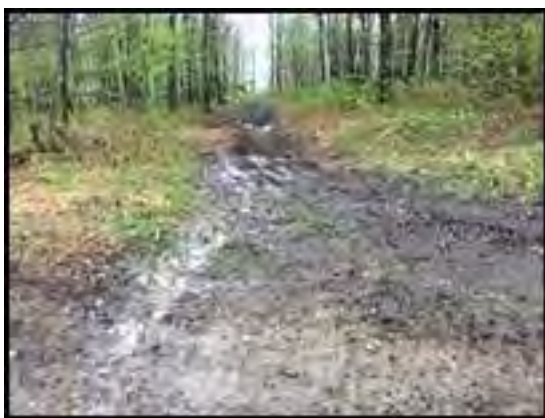
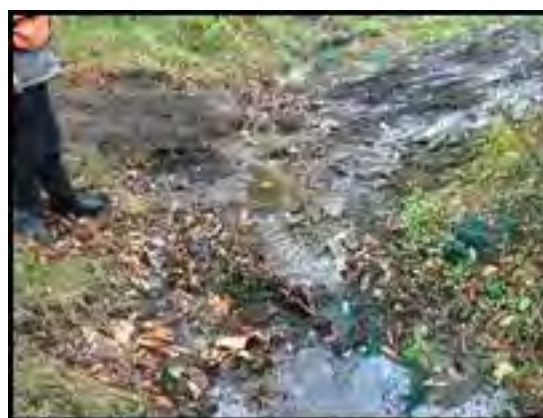
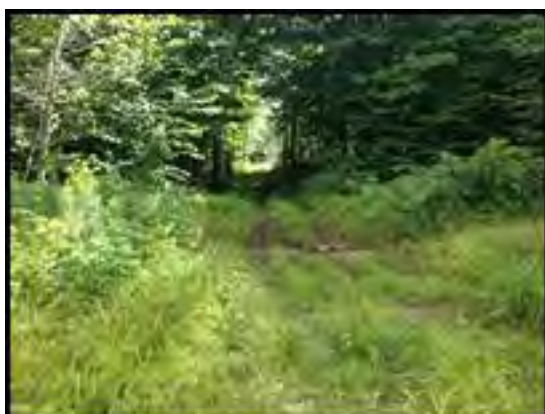
Unique ID	2016		
Subwatershed	Tributary 9		
Geographic Coordinates	-72.506; 44.932		
Location Description	Unnamed Trib. along Grammy Jay		
Type of Problem	Bank Stabilization		
Remedial Action Description	Improve work road crossing and stabilize surface		
Discharges to Stormwater BMP	no	Associated Stormwater BMP	
Seasonal Discharge	All		
Reduction Potential (est.)	Lower		
Remediation Cost (est.)	Lower		
Identification Date	05/22/2014		
Proposed Implementation	2014		
Implementation Completed	2014		
Follow-up Inspection Date(s)	05/22/2014		
Follow-up Inspection Notes	Good vegetation growth observed as of 08/20/2014.

Work Road crossing near Grammy Jay (05/22/2014)

Close-up of work road crossing (05/22/2014)

Same area with established vegetation (08/19/2014)

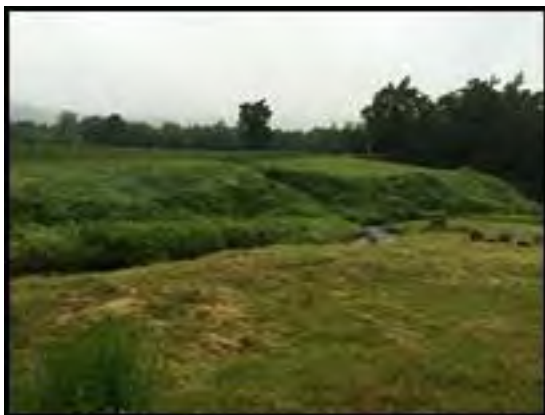
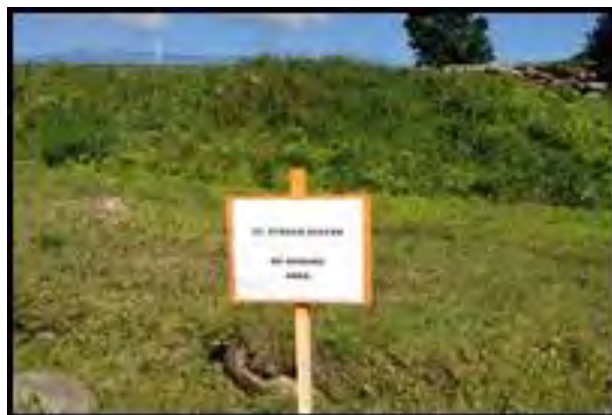
Unique ID	2017		
Subwatershed	Tributary 9		
Geographic Coordinates	-72.497; 44.939		
Location Description	Tributary 9 along Driving Range slope		
Type of Problem	Riparian Buffer Management		
Remedial Action Description	Discontinue intensive vegetation management in riparian buffer. Install additional plant materials to restore stream shading and habitat functions.		
Discharges to Stormwater BMP	No	Associated Stormwater BMP	
Seasonal Discharge	Summer		
Reduction Potential (est.)	Lower		
Remediation Cost (est.)	Lower		
Identification Date	06/23/2014		
Proposed Implementation	2014		
Implementation Completed	2014 (complete)		
Follow-up Inspection Date(s)	06/25/2014		
Follow-up Inspection Notes	No mow zone signage installed as of 07/18/2014. Additional plant materials installed fall 2014.

Mowed area within riparian buffer zone (06/25/2014)

"No Mow" signage installed (7/17/2014)

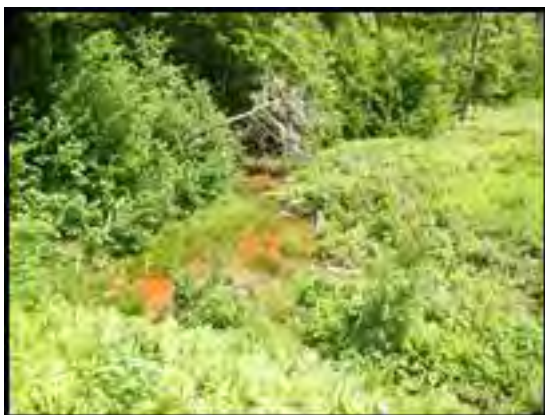
Unique ID	2018		
Subwatershed	Tributary 9		
Geographic Coordinates	-72.497; 44.939		
Location Description	Wetland adjacent to Tributary 9 near Driving Range slope		
Type of Problem	Iron Seep		
Remedial Action Description	Provide treatment for iron seep without encroachment into wetland.		
Discharges to Stormwater BMP	No	Associated Stormwater BMP	
Seasonal Discharge	All		
Reduction Potential (est.)	Lower		
Remediation Cost (est.)	Moderate		
Identification Date	07/09/2014		
Proposed Implementation	November 1, 2015		
Implementation Completed			
Follow-up Inspection Date(s)	07/09/2014		
Follow-up Inspection Notes

Iron seep within wetland at toe of slope (07/09/2014)

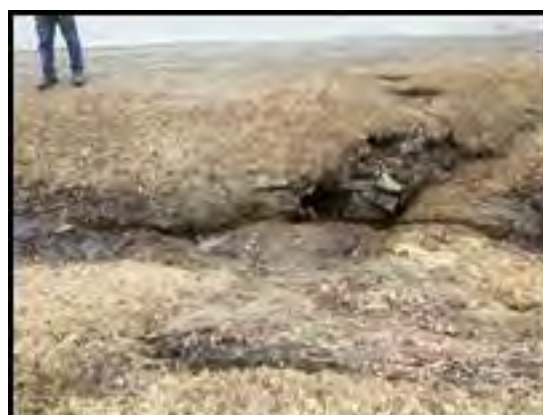
Unique ID	3002		
Subwatershed	South Mtn Branch		
Geographic Coordinates	-72.500; 44.929		
Location Description	Stateside Road Culvert at Route 242		
Type of Problem	Bank Stabilization		
Remedial Action Description	Improve drainage, and prevent road side slope erosion, through repair of ditch.		
Discharges to Stormwater BMP	No	Associated Stormwater BMP	
Seasonal Discharge	All		
Reduction Potential (est.)	Lower		
Remediation Cost (est.)	Lower		
Identification Date	05/02/2012		
Proposed Implementation	2014		
Implementation Completed	2014 (complete)		
Follow-up Inspection Date(s)	04/28/2014; 05/22/2014		
Follow-up Inspection Notes	Slope and ditchline regraded and stabilized as of 08/14/2014.

Slumped banks and clogged culvert inlet (04/28/2014)

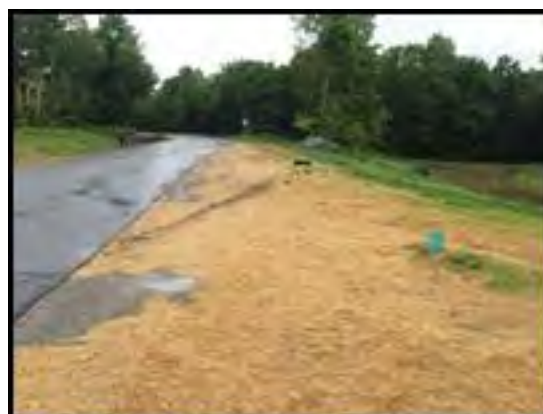
Mulched area along Stateside Road (06/25/2014)

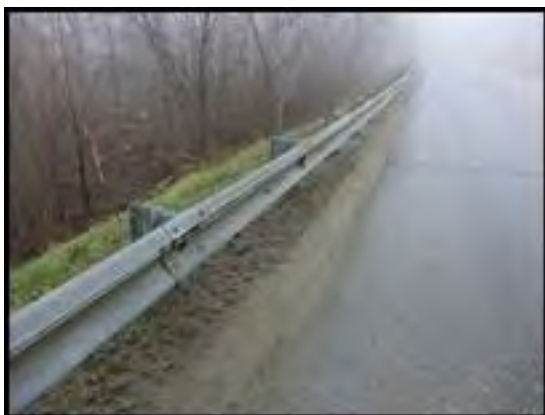
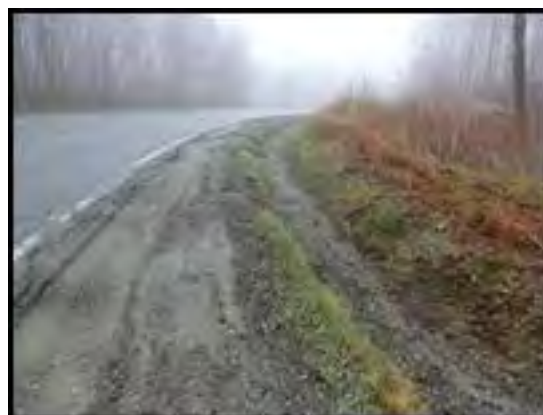
Unique ID	3006		
Subwatershed	South Mtn Branch		
Geographic Coordinates	-72.501; 44.929		
Location Description	Route 242 Ditches		
Type of Problem	Plowing Practices / Untreated Impervious		
Remedial Action Description	Route 242 improvements anticipated 2015; changes to Lower Rt. 242 lot will reduce sediment discharge to roadway.		
Discharges to Stormwater BMP	No	Associated Stormwater BMP	
Seasonal Discharge	All		
Reduction Potential (est.)	Lower		
Remediation Cost (est.)	Lower		
Identification Date	05/02/2012		
Proposed Implementation	November 1, 2015		
Implementation Completed	Stateside Road intersection partially reconfigured 2014; complete improvements with paving by November 1, 2015.		
Follow-up Inspection Date(s)	05/02/2012		
Follow-up Inspection Notes

Sand along road near Rt. 242 Parking Lot (05/02/2012)

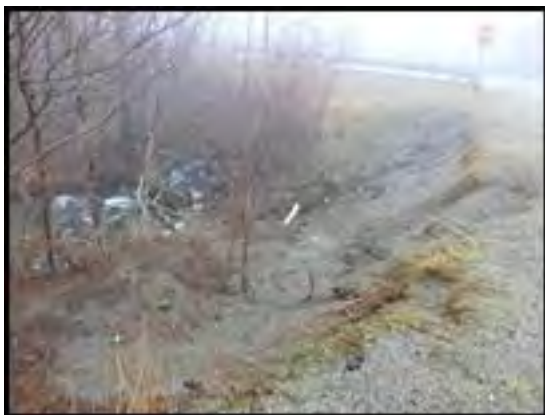
Unique ID	3007		
Subwatershed	South Mtn Branch		
Geographic Coordinates	-72.502; 44.928		
Location Description	Stateside Road		
Type of Problem	Plowing Practices		
Remedial Action Description	Snow Management Plan Area #2. Manage snow from roadway and parking lot in areas away from stream. Promote woody revegetation on stream side slopes and at the top of bank.		
Discharges to Stormwater BMP	No	Associated Stormwater BMP	
Seasonal Discharge	Winter		
Reduction Potential (est.)	Moderate		
Remediation Cost (est.)	Moderate		
Identification Date	05/02/2012		
Proposed Implementation	2014 and on-going winter operations		
Implementation Completed	Snow Management Plan implemented 2014		
Follow-up Inspection Date(s)	05/02/2012; 04/28/2014;		
Follow-up Inspection Notes	Similar conditions present as of 04/28/2014; continue to monitor; improvements expected when Route 242 lot regraded.

Sediment entering Trib. 3 near Rt. 242 (05/02/2012)

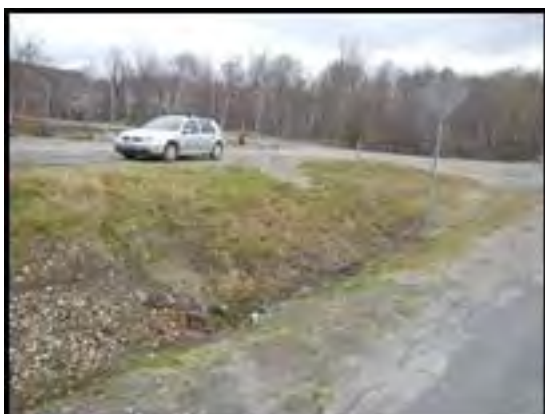
Unique ID	3009		
Subwatershed	South Mtn Branch		
Geographic Coordinates	-72.502; 44.928		
Location Description	VT-242 Parking Lot		
Type of Problem	Bank Stabilization		
Remedial Action Description	Sediment is being routed directly to swale without treatment. Improve parking lot grading and stormwater management.		
Discharges to Stormwater BMP	No	Associated Stormwater BMP	
Seasonal Discharge	All		
Reduction Potential (est.)	Moderate		
Remediation Cost (est.)	Moderate		
Identification Date	11/01/2012		
Proposed Implementation	November 1, 2015		
Implementation Completed			
Follow-up Inspection Date(s)	11/01/2012; 07/09/2014		
Follow-up Inspection Notes	Summer conditions show significant vegetation improvement.continue to monitor. Additional improvements expected when Route 242 lot regraded and Stateside Road intersection reconfigured.

Untreated runoff from Rt. 242 Parking Lot (11/01/2012)

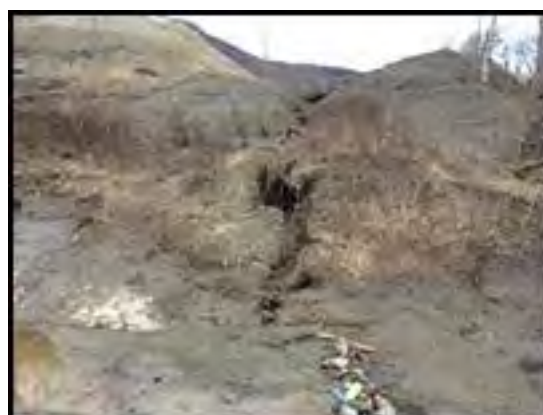
Unique ID	3010		
Subwatershed	South Mtn Branch		
Geographic Coordinates	-72.502; 44.928		
Location Description	Stateside Road		
Type of Problem	STP Issues/Concerns		
Remedial Action Description	Slope failure above treatment swale, receiving runoff from sand pile and clogging outlet.		
Discharges to Stormwater BMP	No	Associated Stormwater BMP	
Seasonal Discharge	All		
Reduction Potential (est.)	Higher		
Remediation Cost (est.)	Lower		
Identification Date	11/01/2012		
Proposed Implementation	2014		
Implementation Completed	2014 (complete)		
Follow-up Inspection Date(s)	05/22/2014		
Follow-up Inspection Notes	Swale stabilized as of 05/22/2014; Route 242 lot regraded October 2014

Slope erosion at Rt. 242 Parking Lot (04/28/2014)

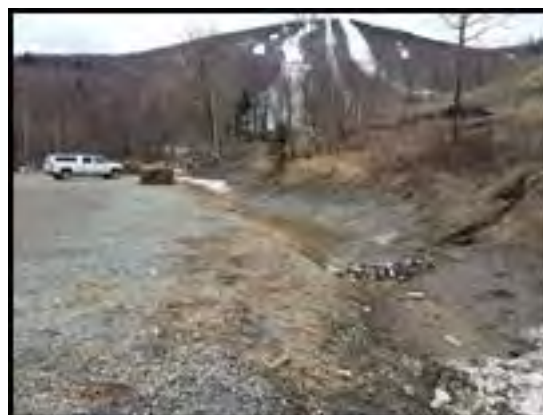
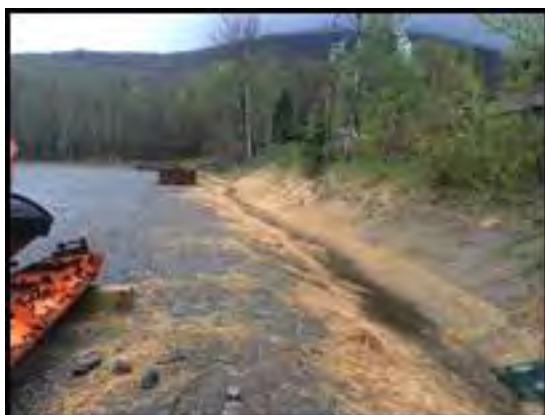
Drainage swale at Rt. 242 Parking Lot (04/28/2014)

Improved stabilization of drainage swale (05/22/2014)

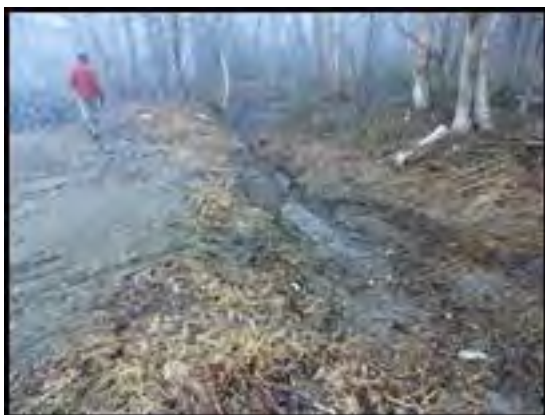
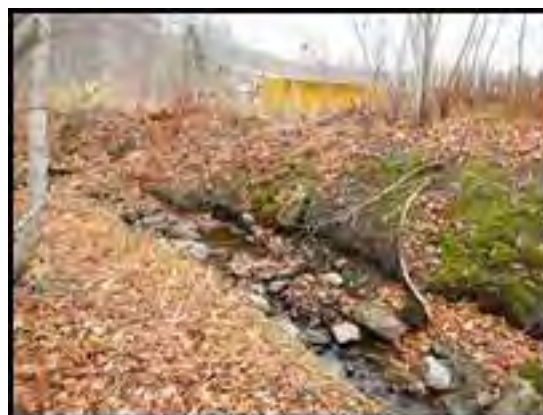
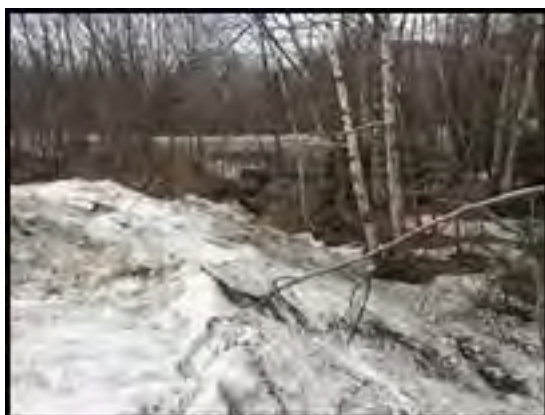
Unique ID	3012		
Subwatershed	South Mtn Branch		
Geographic Coordinates	-72.502; 44.928		
Location Description	VT-242 Parking Lot		
Type of Problem	Plowing Practices		
Remedial Action Description	Install barriers to prevent vehicle and snow piles from entering the riparian buffer. Snow Management Plan Area #1.		
Discharges to Stormwater BMP	No	Associated Stormwater BMP	
Seasonal Discharge	All		
Reduction Potential (est.)	Lower		
Remediation Cost (est.)	Lower		
Identification Date	05/02/2012		
Proposed Implementation	2014 and on-going winter operations		
Implementation Completed	Snow Management Plan implemented 2014		
Follow-up Inspection Date(s)	05/02/2012; 11/01/2012; 04/28/2014		
Follow-up Inspection Notes	Similar conditions present as of 04/28/2014.

Sediment from snow storage near stream (05/02/2012)

Equipment storage within riparian corridor (11/01/2012)

Snow storage in riparian corridor (04/28/2014)

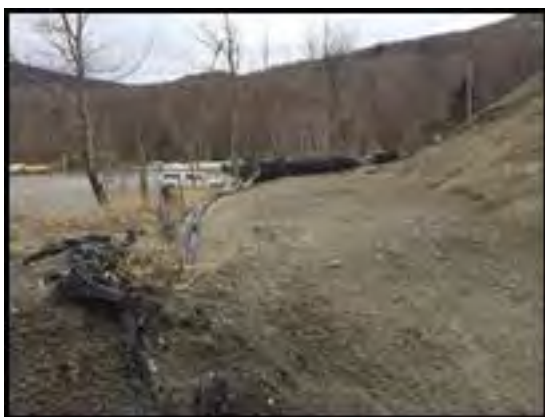
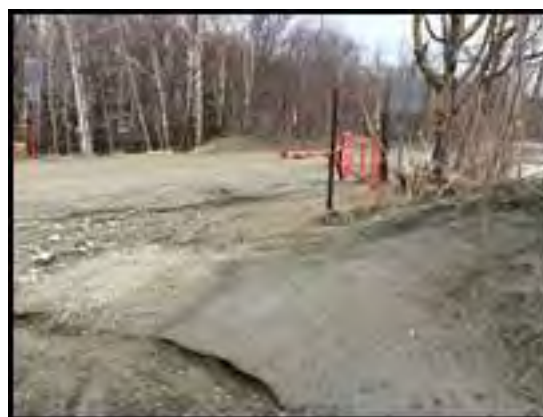
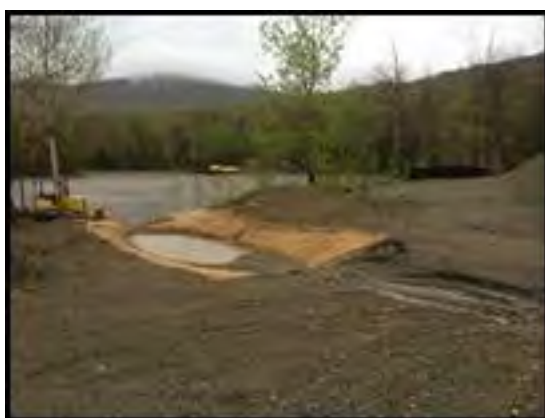
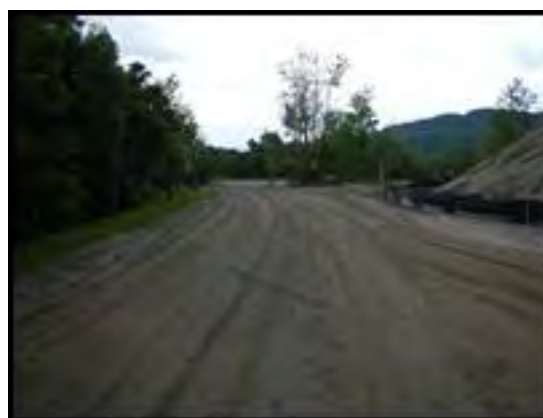
Unique ID	3013		
Subwatershed	South Mtn Branch		
Geographic Coordinates	-72.503; 44.928		
Location Description	Stateside Maintenance Area		
Type of Problem	Untreated Impervious		
Remedial Action Description	Restore sediment controls surrounding Sand Pile and prevent runoff from entering this area.		
Discharges to Stormwater BMP	No	Associated Stormwater BMP	
Seasonal Discharge	All		
Reduction Potential (est.)	Higher		
Remediation Cost (est.)	Lower		
Identification Date	04/28/2014		
Proposed Implementation	2014		
Implementation Completed	2014 (complete)		
Follow-up Inspection Date(s)	05/22/2014; 07/09/2014		
Follow-up Inspection Notes	Temporary sedimentation basin installed and silt fence restored as of 07/11/2014. Continue to monitor during winter operations.

Overtopped silt fence at sand pile (04/28/2014)

Erosion and fugitive sand from sand pile (04/28/2014)

Temporary sedimentation basin at sand pile (05/22/2014)

Sand pile surrounded by silt fence (07/09/2014)

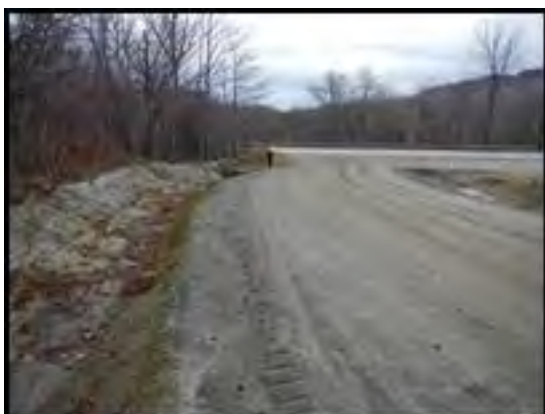
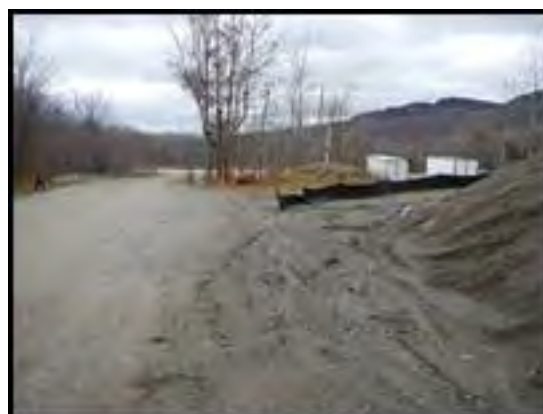
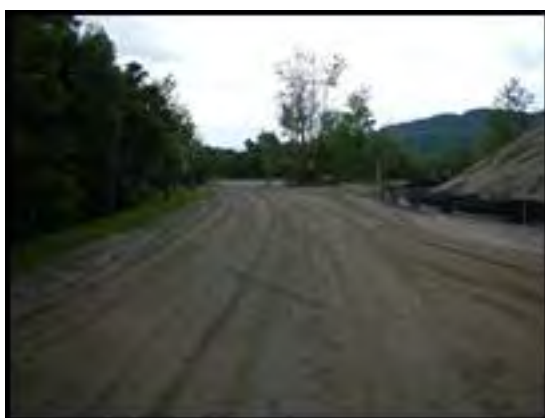
Unique ID	3014		
Subwatershed	South Mtn Branch		
Geographic Coordinates	-72.503; 44.928		
Location Description	Stateside Road at VT-242 Parking Lot		
Type of Problem	Bank Stabilization		
Remedial Action Description	Improve stormwater management along Stateside Road, vegetate swales and stabilize / pave roadway surface to minimize sediment discharge to Trib. 3.		
Discharges to Stormwater BMP	No	Associated Stormwater BMP	
Seasonal Discharge	All		
Reduction Potential (est.)	Higher		
Remediation Cost (est.)	Higher		
Identification Date	11/01/2012		
Proposed Implementation	November 1, 2015		
Implementation Completed			
Follow-up Inspection Date(s)	11/01/2012; 04/28/2014; 07/09/2014		
Follow-up Inspection Notes

Stateside Road sediment and swales (11/01/2012)

Stateside Road at sand pile (11/01/2012)

Stateside Road near sand pile (07/09/2014)

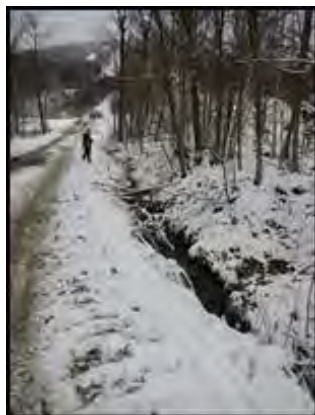
Unique ID	3015		
Subwatershed	South Mtn Branch		
Geographic Coordinates	-72.503; 44.928		
Location Description	Jet Triple Lift access road		
Type of Problem	Untreated Impervious / Plowing Practices		
Remedial Action Description	Stream in close proximity to road. Snow plowing operations will cease to push snow onto this stream, per Snow Management Plan Area #11.		
Discharges to Stormwater BMP	No	Associated Stormwater BMP	
Seasonal Discharge	All		
Reduction Potential (est.)	Moderate		
Remediation Cost (est.)	Moderate		
Identification Date	11/08/2012		
Proposed Implementation	2014 and on-going winter operations		
Implementation Completed	Snow Management Plan implemented 2014		
Follow-up Inspection Date(s)	11/08/2012		
Follow-up Inspection Notes	Good vegetation growth observed as of 08/20/2014, minimal sediment contribution during summer months.

Stream near Jet Triple Lift access road (11/08/2012)

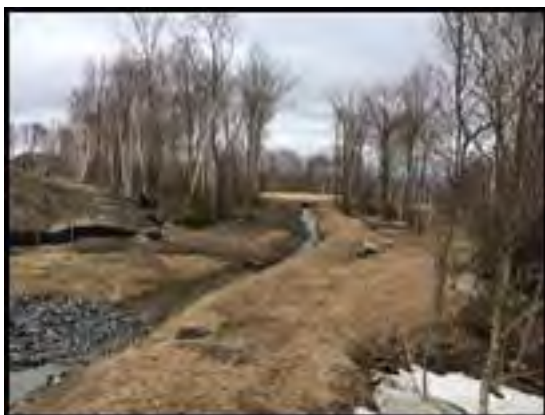
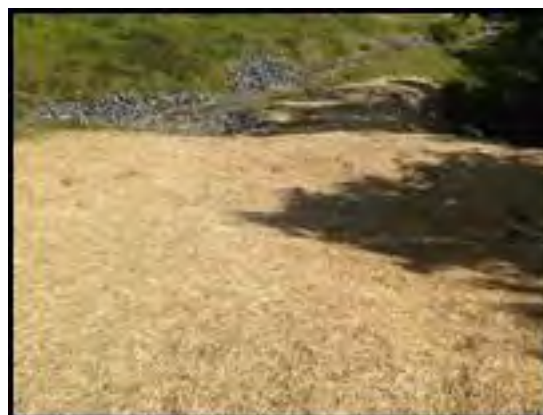
Unique ID	3018		
Subwatershed	South Mtn Branch		
Geographic Coordinates	-72.503; 44.929		
Location Description	Stateside Maintenance Area		
Type of Problem	Plowing Practices		
Remedial Action Description	Create berm/terrace to direct snow melt into the Stateside Hotel treatment system.		
Discharges to Stormwater BMP	Yes	Associated Stormwater BMP	Stateside Hotel Basin
Seasonal Discharge	All		
Reduction Potential (est.)	Moderate		
Remediation Cost (est.)	Lower		
Identification Date	04/28/2014		
Proposed Implementation	2014		
Implementation Completed	2014 (complete); Snow Management Plan implemented 2014		
Follow-up Inspection Date(s)	04/28/2014		
Follow-up Inspection Notes	Area regraded and stabilized as of 08/20/2014.

Swale to basin behind maintenance area (04/28/2014)

Area graded to direct snow to swale (08/19/2014)
