Re: Jay Peak Resort
Revised 2014 Water Quality Remediation Plan ("WQRP")

**Water Quality Remediation Plan
2014 Update**

JAY PEAK RESORT
Jay, Vermont

Revised: January 16, 2015

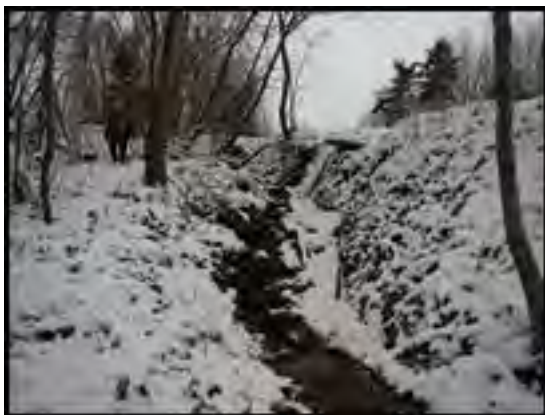
Unique ID	3020		
Subwatershed	South Mtn Branch		
Geographic Coordinates	-72.504; 44.928		
Location Description	Stateside Road ditch upgradient from Tributary 3 culvert		
Type of Problem	Bank Stabilization		
Remedial Action Description	Poorly vegetated banks and channel, erosion and sediment delivery to Tributary 3. Install rip-rap to protect channel from erosion.		
Discharges to Stormwater BMP	No	Associated Stormwater BMP	
Seasonal Discharge	All		
Reduction Potential (est.)	Lower		
Remediation Cost (est.)	Lower		
Identification Date	11/08/2012		
Proposed Implementation	2014		
Implementation Completed	2014 (complete)		
Follow-up Inspection Date(s)	11/08/2012		
Follow-up Inspection Notes	Similar conditions present as of 07/09/2014. Rock rip rap installed to stabilize ditchline as of 08/20/2014.

Ditch adjacent to Stateside Road (11/08/2012)

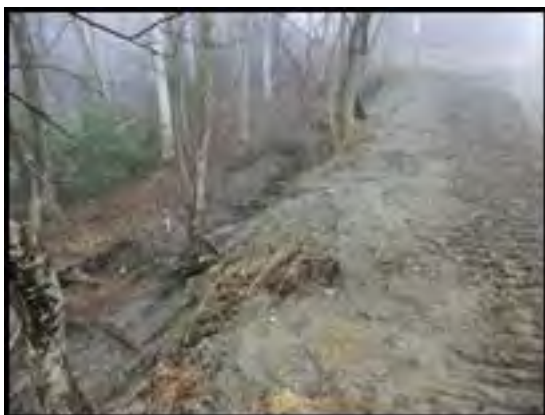
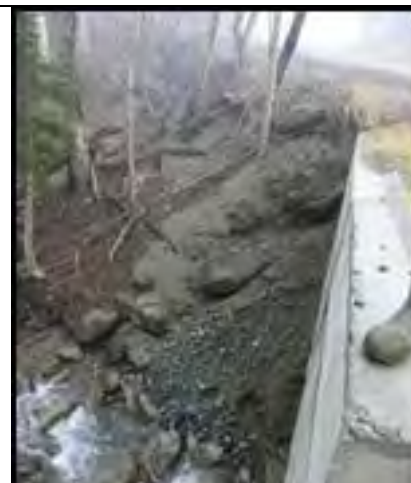
Unique ID	3021		
Subwatershed	South Mtn Branch		
Geographic Coordinates	-72.504; 44.928		
Location Description	Stateside Road Trib 3 Culvert		
Type of Problem	Bank Stabilization		
Remedial Action Description	Stabilize banks and headwall on upstream end of Tributary 3 culvert to prevent further erosion.		
Discharges to Stormwater BMP	No	Associated Stormwater BMP	
Seasonal Discharge	All		
Reduction Potential (est.)	Moderate		
Remediation Cost (est.)	Lower		
Identification Date	05/02/2012		
Proposed Implementation	2014		
Implementation Completed	2014 (complete)		
Follow-up Inspection Date(s)	05/02/2012		
Follow-up Inspection Notes	Some improvement due to road work and new guardrails. Additional stabilization recommended.

Stateside Road at Trib. 3 culvert crossing (05/02/2012)

Stateside Road at Tributary 3 culvert (07/09/2014)

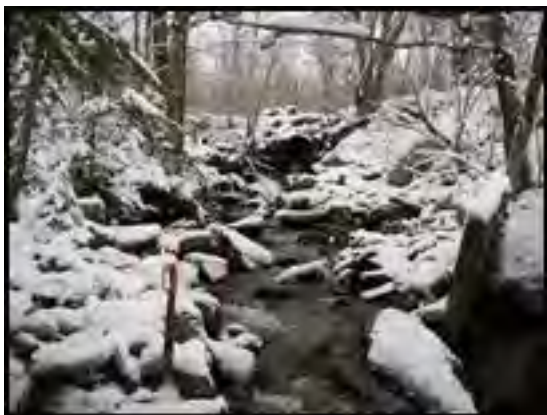
Unique ID	3023		
Subwatershed	South Mtn Branch		
Geographic Coordinates	-72.506; 44.929		
Location Description	Hell's Crossing Tributary 3 culvert		
Type of Problem	Culvert / Bridge Improvement		
Remedial Action Description	Culvert is skewed with respect to channel, has perched outlet, and scoured banks downstream. Coordinate with River Management Engineer.		
Discharges to Stormwater BMP	No	Associated Stormwater BMP	
Seasonal Discharge	All		
Reduction Potential (est.)	Moderate		
Remediation Cost (est.)	Moderate		
Identification Date	11/08/2012		
Proposed Implementation	Monitor and assess		
Implementation Completed			
Follow-up Inspection Date(s)	11/08/2012		
Follow-up Inspection Notes	Chris Brunelle, VT DEC River Management Engineer, conducted site visit in October 2014

Tributary 3 at Hell's Crossing culvert (11/08/2012)

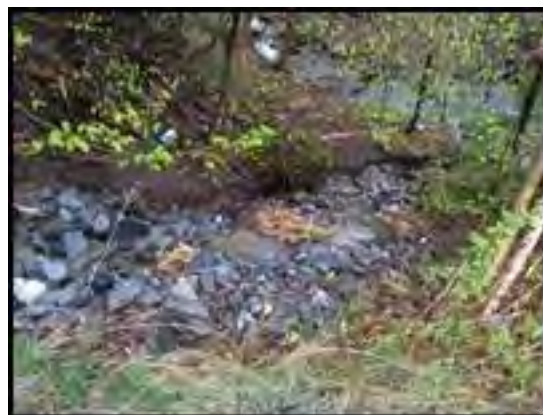
Unique ID	3026		
Subwatershed	South Mtn Branch		
Geographic Coordinates	-72.502; 44.928		
Location Description	VT-242 Parking Lot		
Type of Problem	Culvert / Bridge Improvement		
Remedial Action Description	Culvert outfall partially blocked, potentially causing localized flooding in Rt. 242 parking lot. Culvert will be replaced in conjunction with Rt. 242 lot improvements.		
Discharges to Stormwater BMP	No	Associated Stormwater BMP	
Seasonal Discharge	All		
Reduction Potential (est.)	Lower		
Remediation Cost (est.)	Lower		
Identification Date	11/01/2012		
Proposed Implementation	2014		
Implementation Completed	2014 (complete)		
Follow-up Inspection Date(s)	11/01/2012; 05/22/2014		
Follow-up Inspection Notes	On-going improvements at parking lot have reduced impact to culvert outfall. Outfall channel is stable. Continue to monitor.

View from the outfall toward Tributary 3 (05/22/2014)

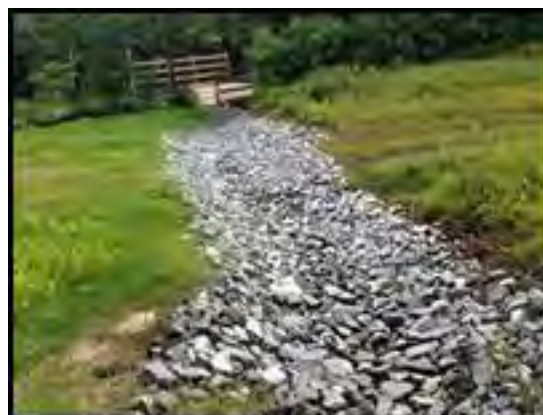
Stabilized waterbar looking downhill (08/19/2014)

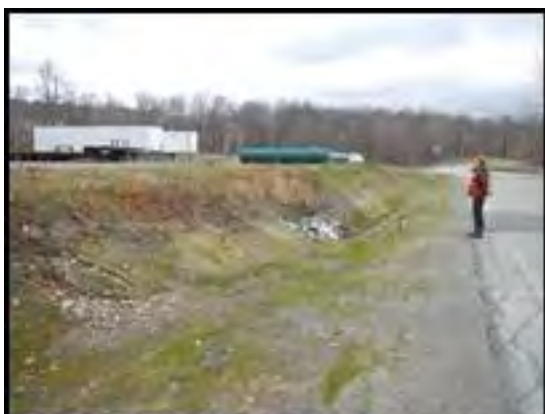
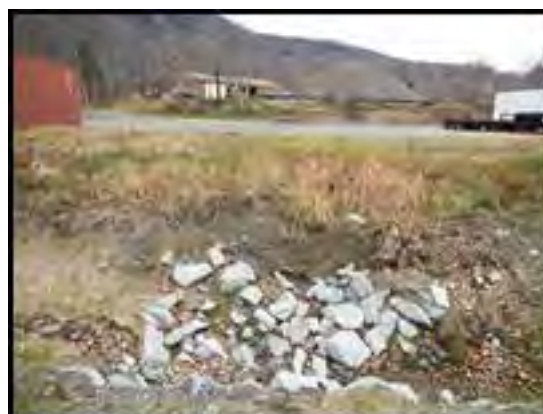
Unique ID	3028		
Subwatershed	South Mtn Branch		
Geographic Coordinates	-72.502; 44.928		
Location Description	VT-242		
Type of Problem	VTrans Outreach / Untreated Impervious		
Remedial Action Description	Poorly stabilized roadside ditches and embankments on VT Rt. 242 are actively eroding.		
Discharges to Stormwater BMP	No	Associated Stormwater BMP	
Seasonal Discharge	All		
Reduction Potential (est.)	Moderate		
Remediation Cost (est.)	Moderate		
Identification Date	11/01/2012		
Proposed Implementation	November 1, 2015		
Implementation Completed	Parking lot regarded and swales added 2014. VTrans expected to conduct Route 242 work in 2015.		
Follow-up Inspection Date(s)	11/01/2012		
Follow-up Inspection Notes	Summer conditions show significant vegetation improvement; additional improvements expected with Route 242 improvement.

Rt. 242 drainage at Rt. 242 Parking Lot (11/01/2012)

Rt. 242 ditch at Rt. 242 Parking Lot (11/01/2012)

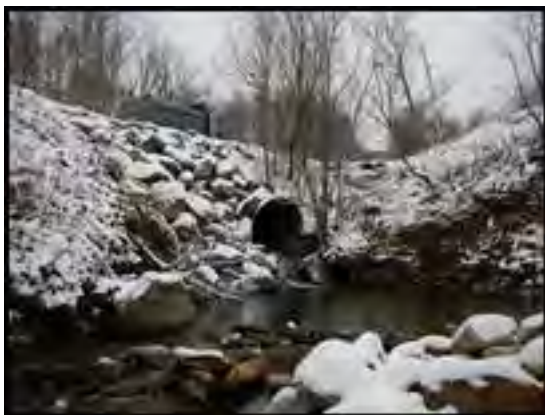
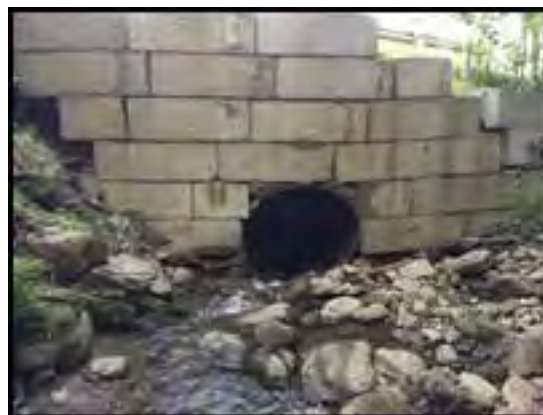
Unique ID	3029		
Subwatershed	South Mtn Branch		
Geographic Coordinates	-72.503; 44.928		
Location Description	Stateside Road Tributary 3 Culvert		
Type of Problem	Culvert / Bridge Improvement		
Remedial Action Description	Reestablish sediment transport, decrease flood flow velocity and scour, and reestablish aquatic organism passage (AOP). Note - AOP goal constrained by perched culvert at VT-242.		
Discharges to Stormwater BMP	No	Associated Stormwater BMP	
Seasonal Discharge	All		
Reduction Potential (est.)	Moderate		
Remediation Cost (est.)	Higher		
Identification Date	11/08/2012		
Proposed Implementation	Monitor and assess		
Implementation Completed			
Follow-up Inspection Date(s)	11/08/2012		
Follow-up Inspection Notes	Similar conditions present (04/28/2014).

Undersized culvert at Stateside Road (11/08/2012)

Upstream face of Tributary 3 culvert (07/09/2014)

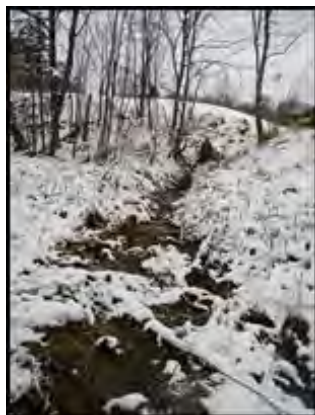
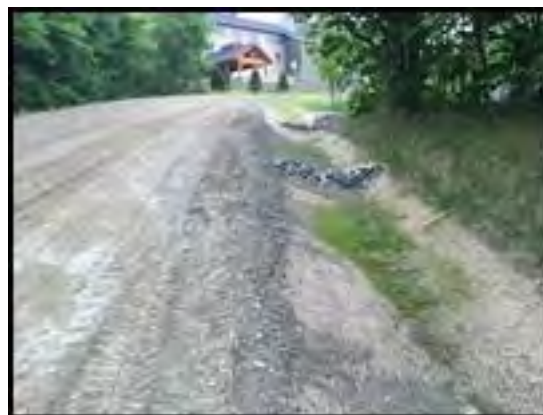
Unique ID	3030		
Subwatershed	South Mtn Branch		
Geographic Coordinates	-72.504; 44.929		
Location Description	Stateside Road Ditches		
Type of Problem	Bank Stabilization		
Remedial Action Description	Poorly vegetated banks and channel, erosion and sediment delivery to Tributary 3. Rip-rap ditch sections where required.		
Discharges to Stormwater BMP	No	Associated Stormwater BMP	Stateside Hotel Basin (partial)
Seasonal Discharge	All		
Reduction Potential (est.)	Lower		
Remediation Cost (est.)	Lower		
Identification Date	11/08/2012		
Proposed Implementation	2014		
Implementation Completed	2014 (complete)		
Follow-up Inspection Date(s)	11/08/2012; 07/09/2014		
Follow-up Inspection Notes	Ditches reworked and lined with RECP with Stateside Road improvements. Area is now treated in Stateside Hotel Basin. Continue to monitor for vegetation establishment.

Former ditch near Stateside Lodge (11/08/2012)

Stabilized ditch along Stateside Road (07/09/2014)

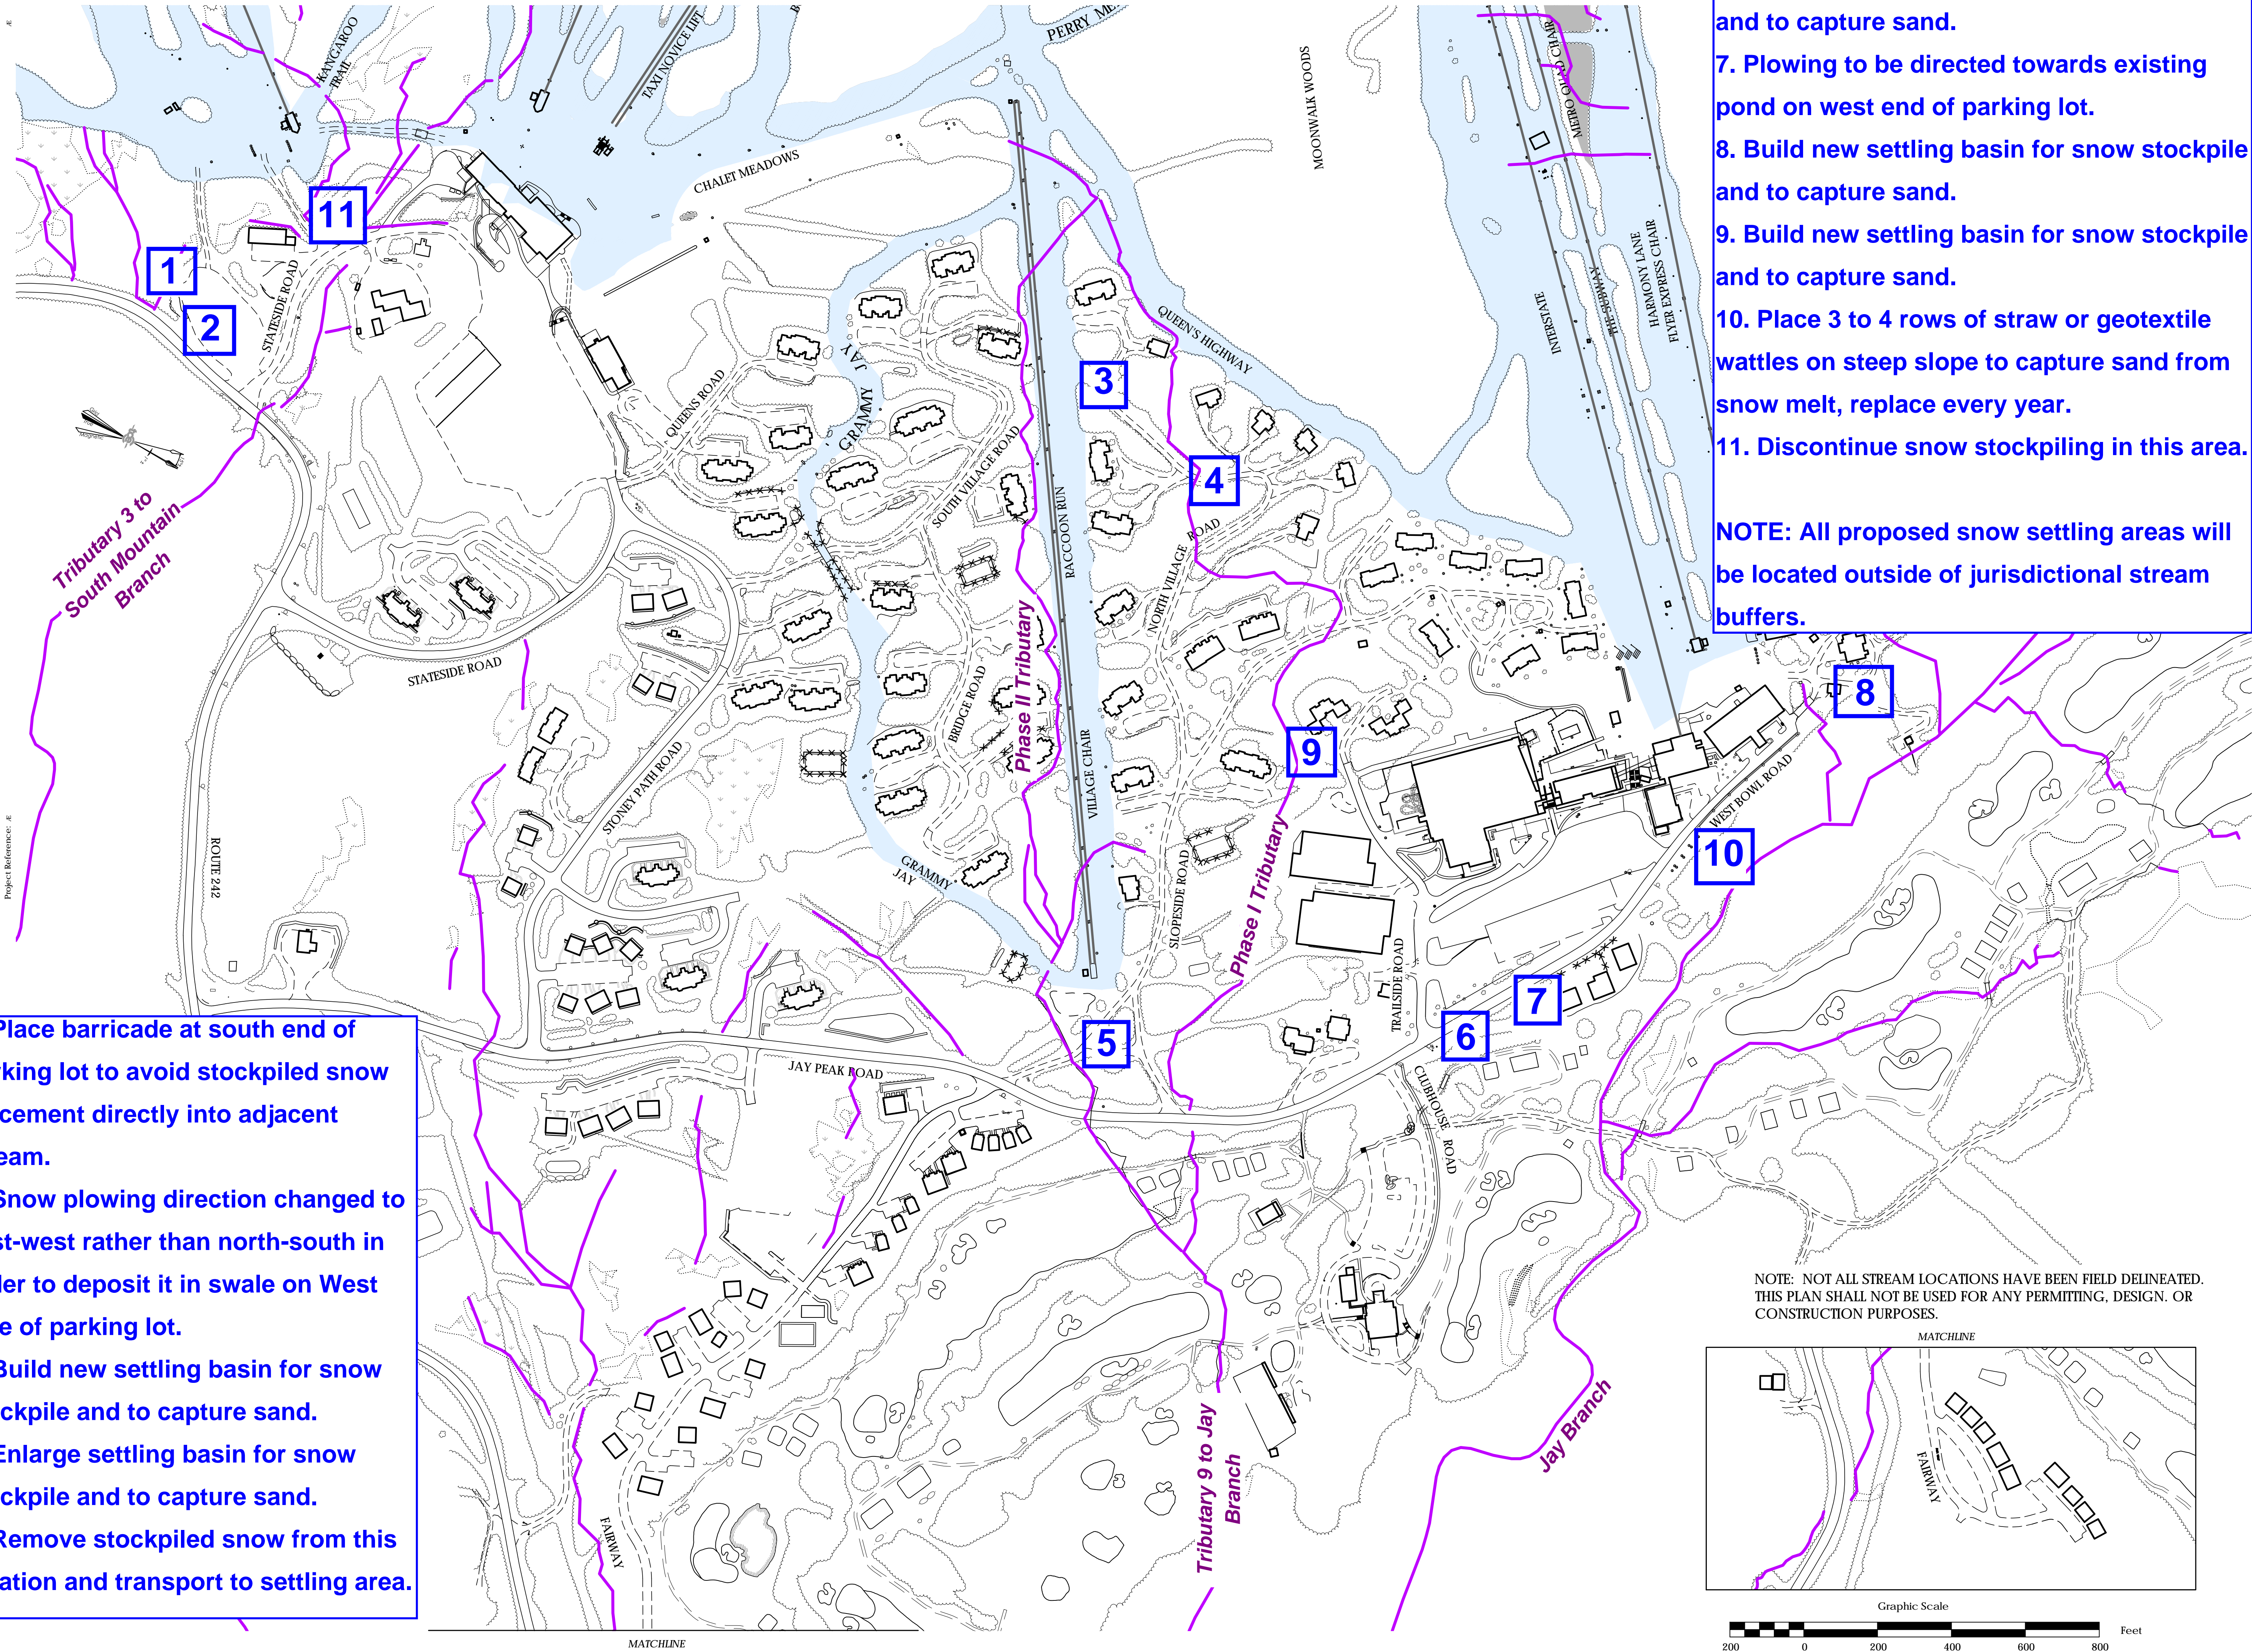
- In 2012 JPR had its road sand tested to verify that it met VT AOT standards for road sand and does not have excessive fines. The attached sieve analysis shows the results. The solid line is Jay Peak winter sand and the shaded area is the range of acceptable gradations for winter sand

according to VT AOT. The reader should note that the Jay Peak sand has fewer fines (the lower right side of the solid line) than the acceptable VT AOT standard. JPR continues to buy the same type of winter sand each year.

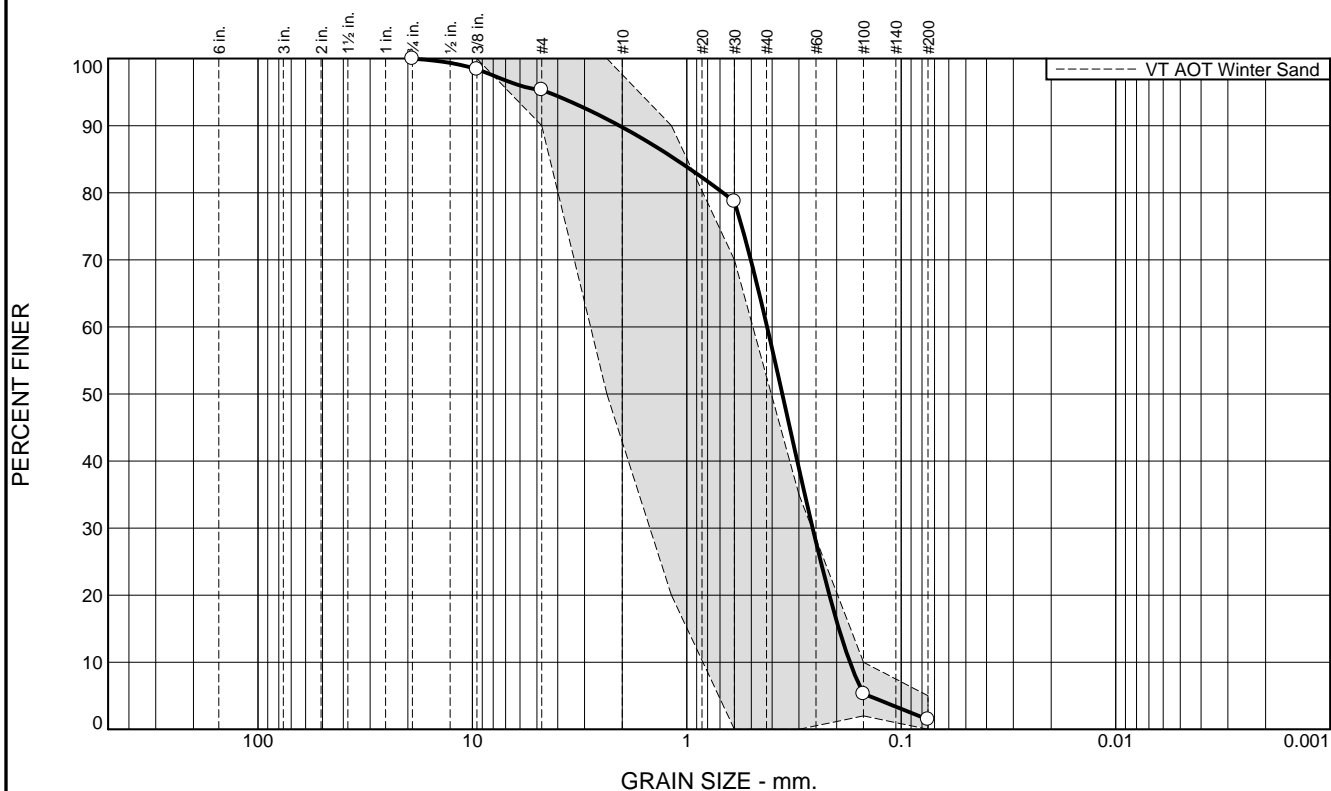
Particle Size Distribution Report

% +3"	% Gravel		% Sand			% Fines	
	Coarse	Fine	Coarse	Medium	Fine	Silt	Clay
0.0	0.0	4.7	5.5	29.4	58.9	1.5

SIEVE SIZE	PERCENT FINER	SPEC.* PERCENT	PASS? (X=NO)
3/4"	100.0		
3/8"	98.4	100.0	X
#4	95.3	90.0 - 100.0	
#30	78.7	0.0 - 70.0	X
#100	5.3	2.0 - 10.0	
#200	1.5	0.0 - 5.0
