Re: FERC project #P-14308-001—VT  
Vermont Tissue Mill Dam Hydroelectric Project  
Carbon Zero, LLC

*Re: Vermont Tissue Project-FERC# P-14308-001*  
*1. Amendment to prescribed bypass flows*

## VT Tissue Hydro – Secondary Channel Flow Assessment and Report

Rod Wentworth, December 9, 2015

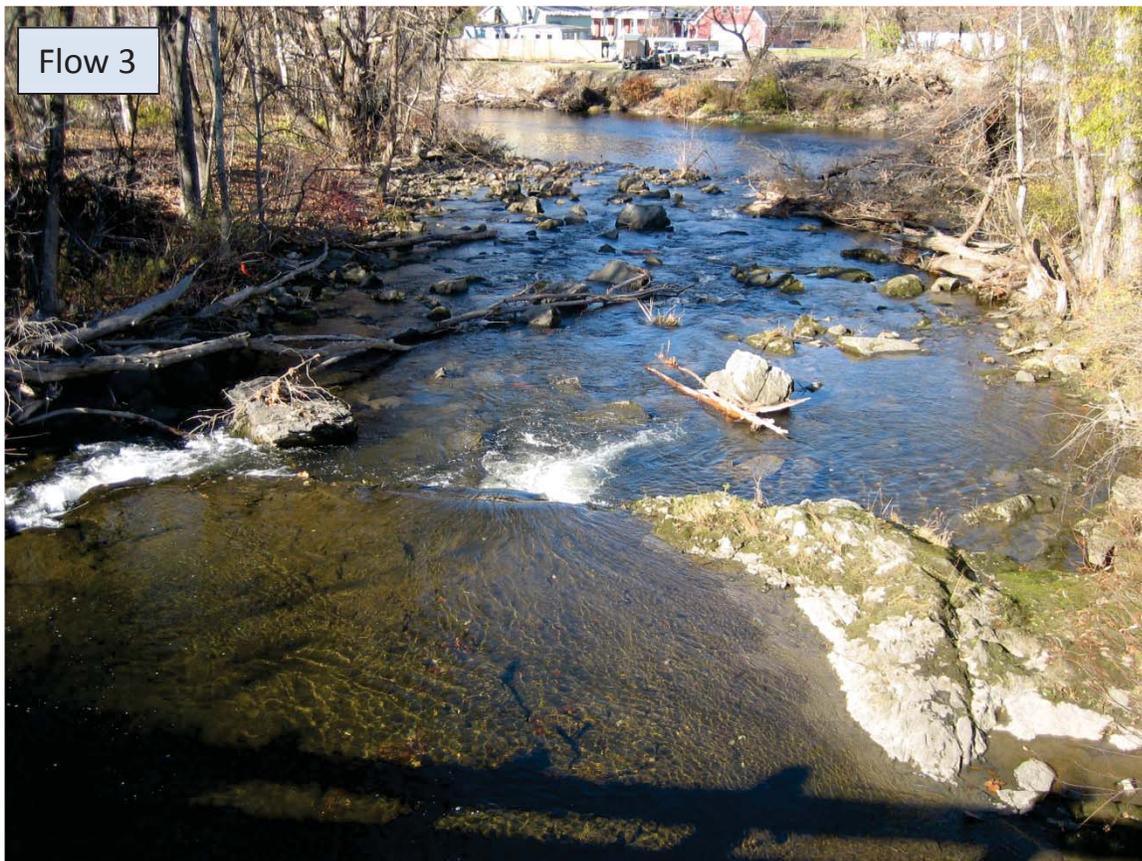
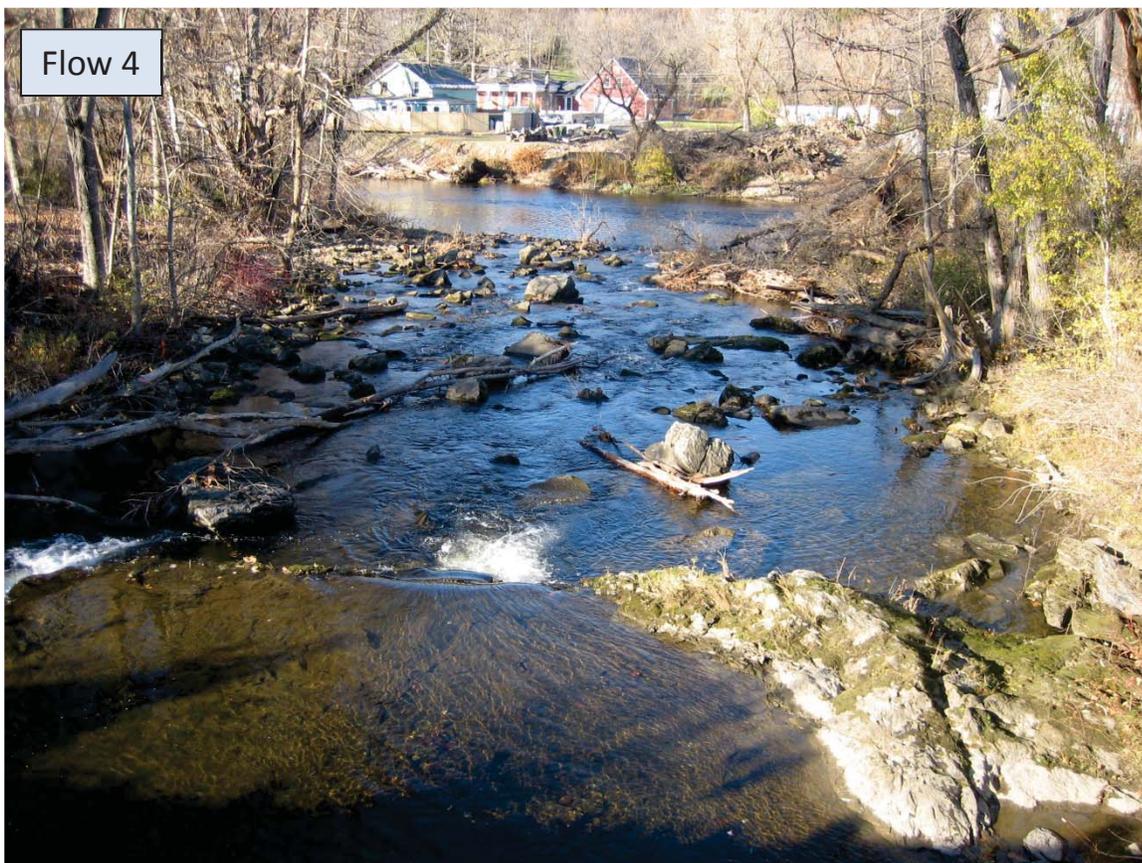
Flow 5

The water exiting the pool provided an attractive tongue of water that was too diminished at Flow #5. A similar condition exists where water passes over ledge near transect 2.

In summary, Flows #1 and #2 looked very good. Both Flow #3 and #4 looked good; Flow #4 was shallower but still met the assessment criteria. Flow #5 exhibited several unacceptable conditions as described. The flow requirement for the secondary bypass channel can be revised to 15 cfs.
