AUTHORIZATION TO CONDUCT NEXT FLOOD MEASURES

Project Number: NFM-06-23-2016

1. This project authorizes scour protection repairs to the Randell Road crossing of Shepard Brook; to be completed as described in the documents submitted to this office on 11/16/2016; prepared by J.A. McDonald Inc.

Bridge Repair

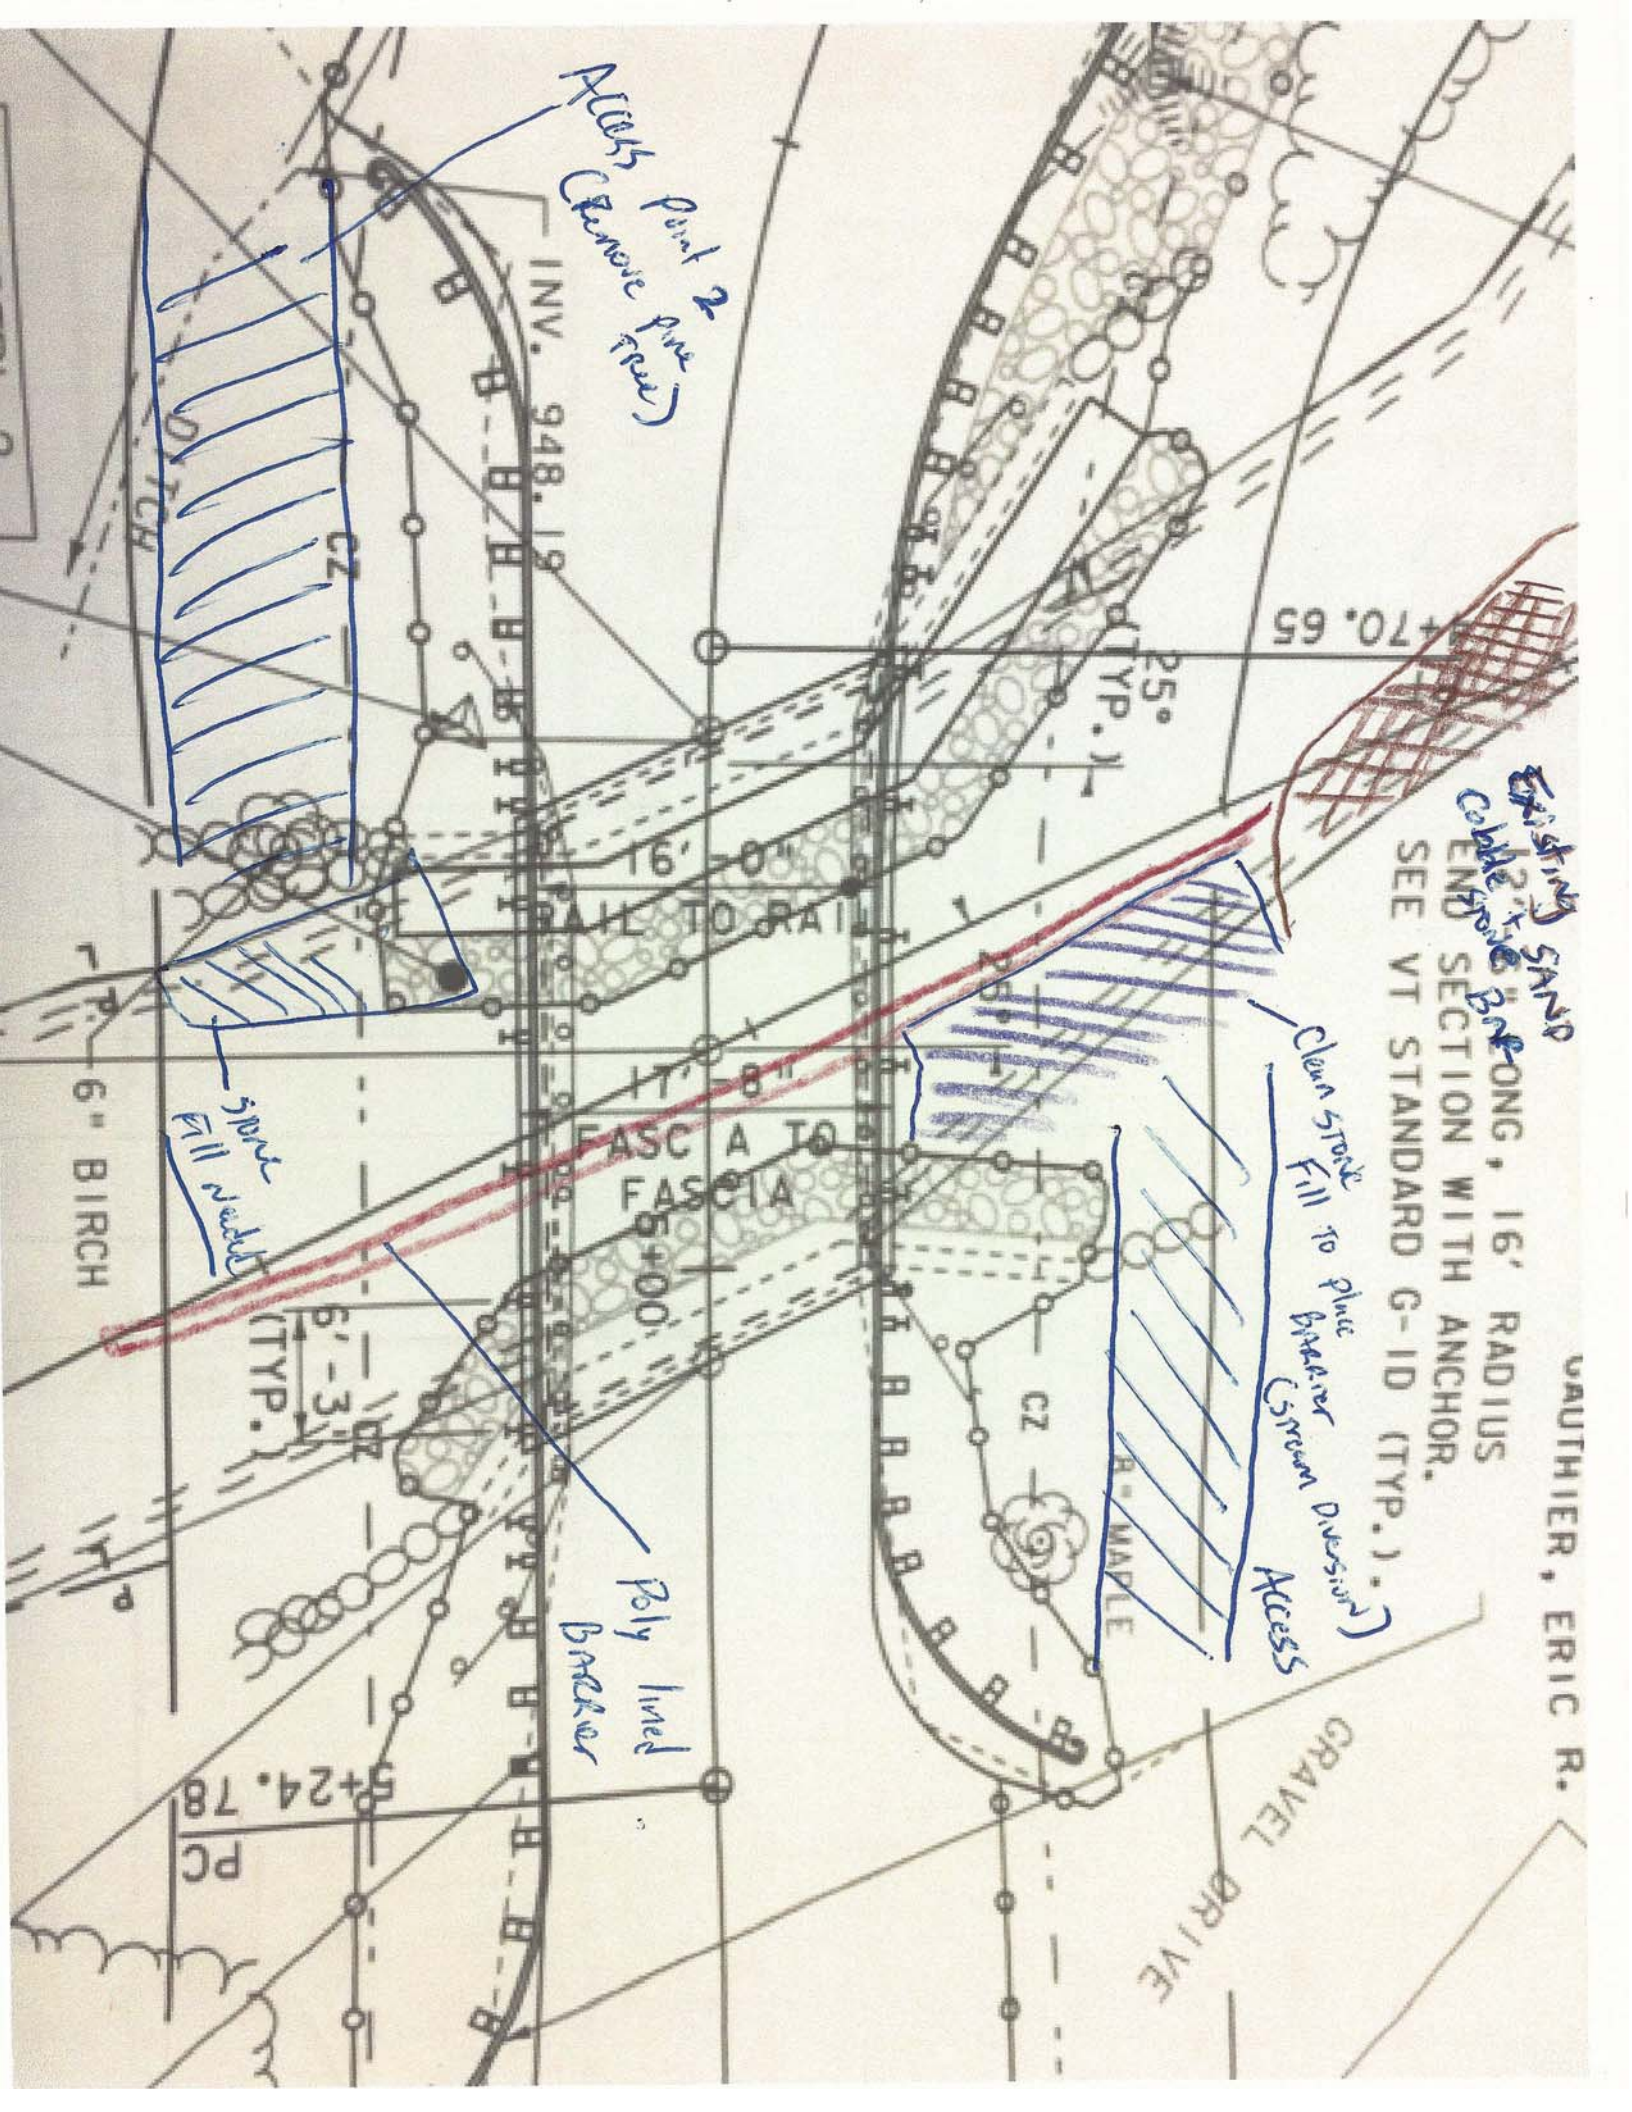
Access Point 2
(Remove Pine Tree)

Clean Stone
Fill to place
Barrier Division

Poly lined
Barriers

Stone
Fill needed

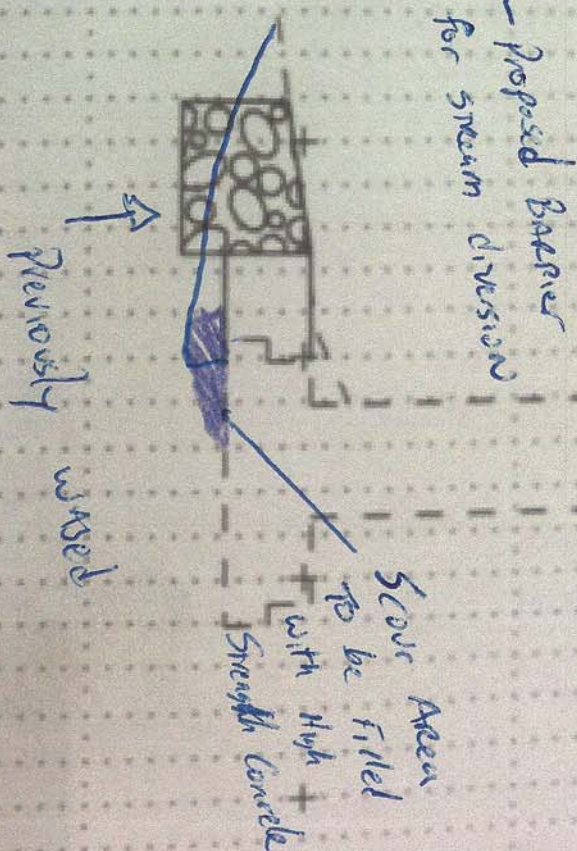
I stopped by the bridge this morning, and inspected it for high water damage, and have attached some photos.

The recent water flow did cause some erosion along and behind the downstream end of abut. #1(south), which extends up the side slope, and has exposed a precast concrete block laying now, at the toe of slope. This abutment was noted as having a forward list for a number of years, which increased slowly up to 3" of rotation in 4' noted in 2012. I checked this today and noted 2-3/4" to 2-7/8" in 4', so no indication that this recent flow has caused any further displacement. Some cracking in the upper corners of the abutment are noted, but have been present, and look like thermal cracking, as the wing, and curtains were poured integral. No bending anchor bolts, or seat/curtain displacement either, though a slight drop in 4' horizontally.

Some scour has occurred along the north abutment which has had chronic undermining issues in the past. The abutment has been repaired at least twice over the years, with narrow knee walls, and riprap added to correct undermining. The water now is 5' deep along the abutment, still murky making visibility limited, but there is now undermining that extends along the upstream wing for approximately 6', and along the footing below the stem for approximately 10'. The voiding is at least 10" deep, and extends in 6' or more in some spots. The added narrow knee walls are cracked thru at the downstream end, but the abutment which was noted as having 3/4" of forward list in 4' remains the same; with no additional movement.

I would recommend, that abutment #2(north) be repaired with concrete flowed in under, to fill the voids, and jagged stone protection added again. The Town could get a better estimate on the void dimensions for quantities, once the water level, and clarity have improve.

Consideration should also be given to adding a larger and deeper knee wall along this abutment, as was done to the south abutment during the recon. project. Stone fill material needs to be added to correct the southern slope erosion. No loading restrictions are necessary at this time, though the undermining repair should be made this fall. Further scour and undermining could certainly destabilize the abutment.
