**Stream Corridor Plan
LaPlatte River and Tributaries
Town of Hinesburg, Vermont**

Prepared by the LaPlatte Watershed Partnership

June 2007

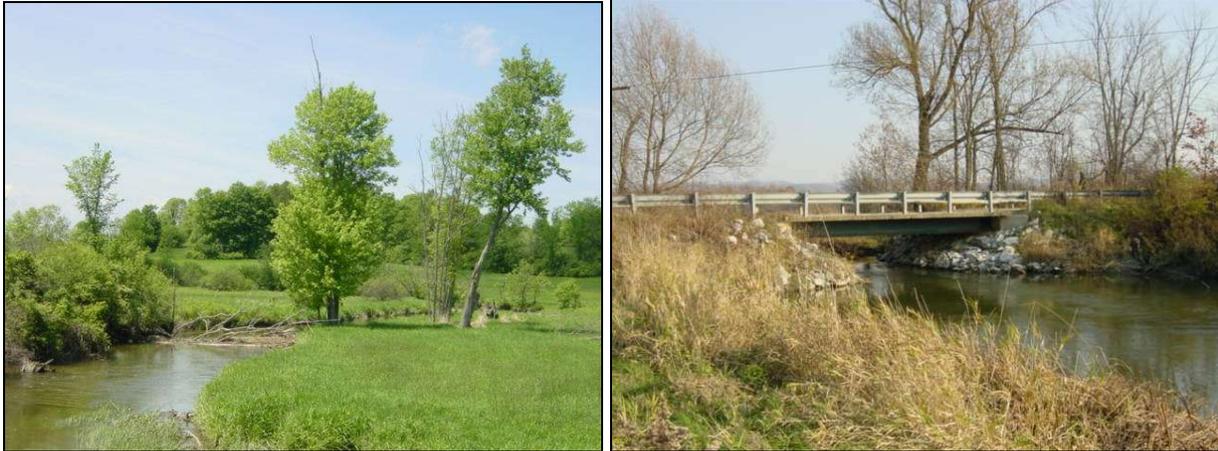
The river corridor was largely undeveloped and the channel appeared in regime, so protecting the corridor along the reach is recommended and a high priority to alleviate pressures from upstream. Also, perennial vegetation was lacking in some parts of the buffer, so planting the stream buffer with native woody vegetation is recommended. This can also act to stabilize the stream banks. Additional bank stabilization not recommended because bank erosion is minor and not endangering buildings.

An undersized bridge is in the reach at Leavensworth Rd. Flooding problems have been identified here by the landowner, who has noticed increased flooding of fields. The bridge and road were apparently designed to have flood flows run over the road, so even though the bridge constricts the bankfull width, pressure is low because of the opportunity for flood flows to access the floodplain and flow over the road. Development past the river on Leavensworth Road now makes road closure due to flooding inconvenient. A series of culverts under the road and adjacent to the bridge to pass flood flows has been proposed. If the culverts are put in and the road therefore raised, more pressure would likely be placed on the bridge (which brings problems there) because the floodplain would be constricted as well.

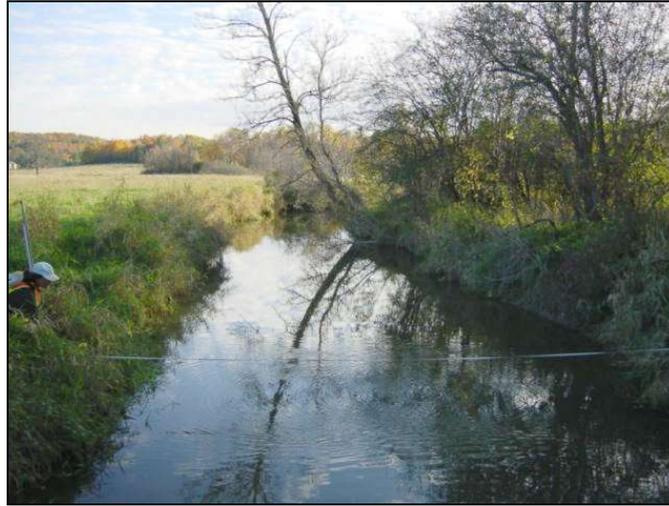
The river corridor was largely undeveloped and channel in regime, so protecting the corridor for the reach is recommended and a high priority to alleviate pressures from upstream. Perennial riparian vegetation was lacking in areas, especially on the left bank. Planting the stream buffer with native woody vegetation is recommended, some planting was observed at the time of assessment.

Bank erosion was observed with moderate changes in channel planform. Planting buffer vegetation can also act to stabilize the stream banks. Additional bank stabilization is not recommended because bank erosion is minor and not endangering buildings.

1 - Protect River Corridor

2 - Plant Stream Buffers

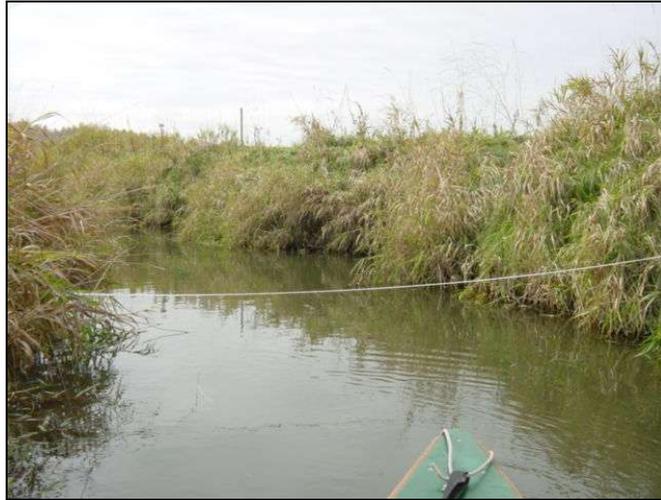
Reach: M14

The river corridor is undeveloped at this time. The channel appeared to be in stage III of the F-stage evolution process, with minor planform and aggradation observed and an incision ratio of 1.3. If the channel were not actively managed in the near term, it may adjust to equilibrium conditions, depending on ongoing channel management and adjustments upstream. So protecting the corridor along the reach is recommended to provide for passive geomorphic restoration of floodplain and meanders, although continued adjustment and/or changes in watershed stressors may require ongoing monitoring of conditions and adjustment here.

Perennial woody riparian vegetation was lacking, so planting the stream buffer with native woody vegetation is recommended, although planting away from actively migrating or unstable banks and toward the outer edges of the corridor is advised. This can also act to stabilize the stream banks. Additional bank stabilization not recommended because bank erosion is minor and not endangering buildings.

1 - Protect River Corridor

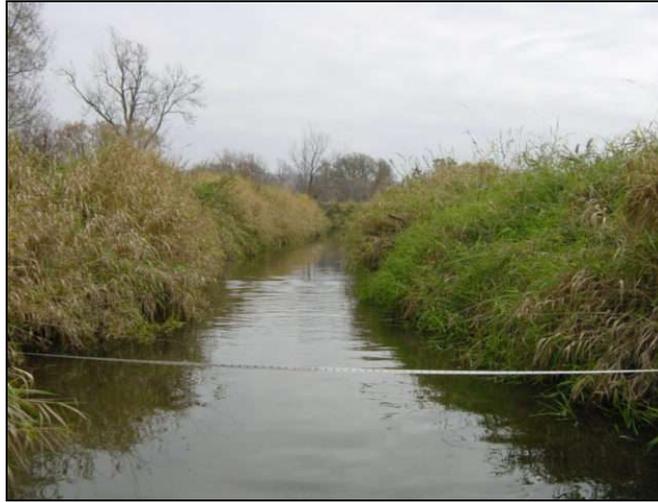
The channel appeared incised (incision ratio of 1.7), likely due to historical channel management activities and possibly some historical watershed deforestation (although the lesser of the stressors), resulting in greater stream power and sediment transport capacity (active bed degradation not observed). No recently abandoned channels were observed to capture as a restoration tool. No permanent constraints exist within the corridor of this segment, although the Hinesburg Sewage Treatment Plant is within the corridor of the upstream segment, M15B. Current corridor land use was pasture, although the landowner was working to fence the pasture and plant a small buffer (35 feet) In terms of flow and sediment load alterations, upstream reaches have been significantly straightened, so stream power would be higher, but no alterations appeared to inhibit active geomorphic restoration of floodplain or meanders here.

The stream is not likely to quickly equilibrate as significant clay in the bed and banks has limited channel movement. Therefore, if adjacent landowners are willing, an active restoration of floodplain with respect to the current channel bed elevation is recommended. Protect the river corridor and plant perennial native vegetation as part of the overall restoration plan to ensure long-term viability.

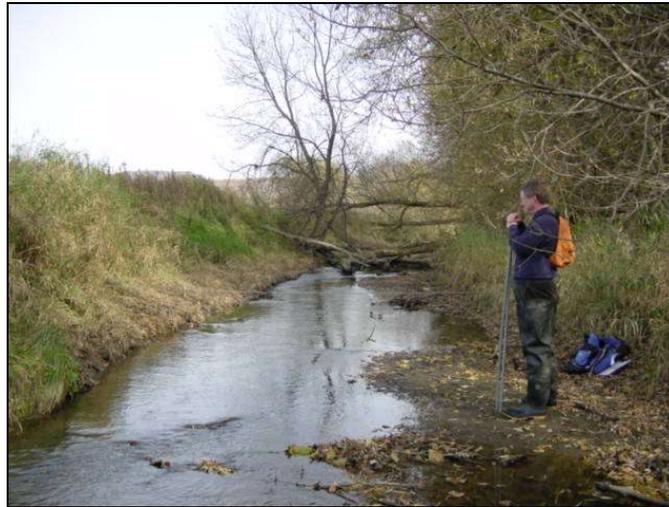
The river corridor is undeveloped except for the Hinesburg Sewage Treatment Plant (STP) on the left bank. If the channel were not actively managed, it may adjust to equilibrium conditions, although the 20-30 year “near-term” time line may not be realistic due to the clay present in the bed and banks, which has limited movement. Therefore, protecting the river corridor and planting stream buffers should be part of an overall restoration plan. Current beaver activity could help by trapping sediment.

The channel was straightened and incised, resulting in greater stream power and increased sediment transport capacity. No recently abandoned channels were observed to capture as a restoration tool. The Hinesburg Sewage Treatment Plant is a permanent constraint within the corridor on the left bank. The LWP has been working with the Town of Hinesburg to plan future Plant expansions out of the stream corridor. Other than that, adjacent land use appeared to be fallow field and flow and sediment load alterations do not appear to be significant enough to inhibit the active geomorphic restoration of floodplain and meanders.

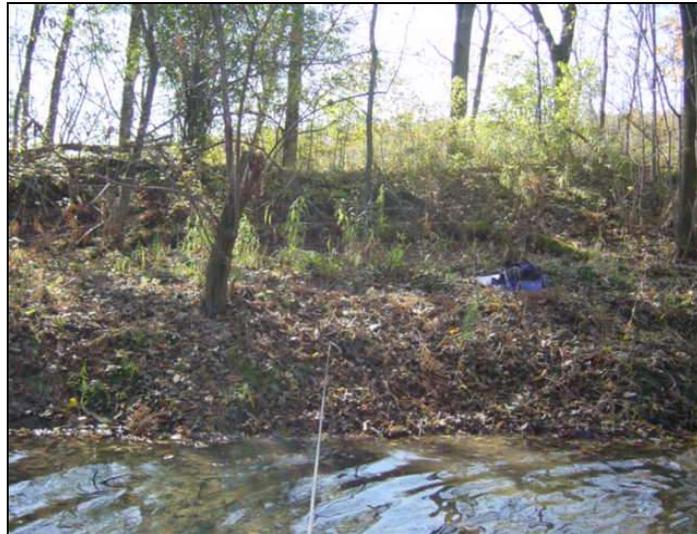
The river corridor is largely undeveloped, however the channel is not likely to adjust to equilibrium conditions in the near term due to the presence of berms and clay soils. Buffer width was 25-50 feet with some areas of about 5 feet or less. Bank erosion and lateral movement were observed. Since the channel was not at or near equilibrium conditions, it is recommended to protect the river corridor and plant perennial native vegetation as part of the overall restoration plan to ensure long-term viability.

Replace structures with appropriately sized structures as they come up for replacement. The culvert at Charlotte Road did not appear to have problems, but does back up water during high flows. The bridge at Silver Street constricted floodprone width, but not bankfull width. Reach is straightened (incision 1.17) resulting in an increase in stream power. No recently abandoned channels were observed to capture as a restoration tool. Very little development (300 feet) exists within the corridor. Current corridor land use was pasture and hay with some crop, although the area adjacent to the stream appears wet much of the year and might be of limited use for agriculture. The parking lot for the Hinesburg Community School, lagoons at the cheese factory, and one house encroached into the corridor. Berms were present in areas along both banks, limiting floodplain access.

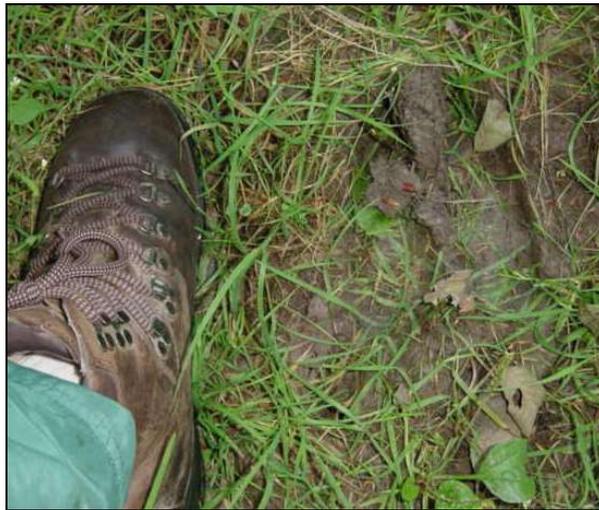
The river corridor is undeveloped and the channel is likely to adjust to equilibrium conditions in time. So protecting the river corridor is recommended. The segment appeared to be aggrading, but not due to significantly increased sediment supply or decreased peak flows. The stream has access to floodplain, but sediment is being generated in the upstream reach. Protecting the river corridor and addressing upstream issues is recommended.

Moose track to the right of boot. Moose seen in the area as well as bear, deer, turkey, coyote, fox, and others.

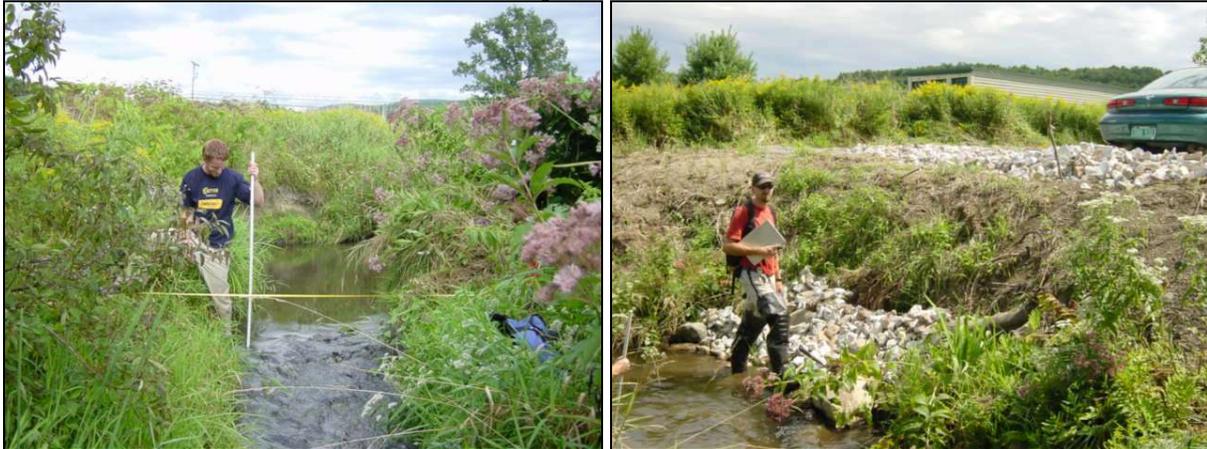
The river corridor is largely undeveloped except for the left bank along Commerce Park. Diversion of water from this reach into “The Canal” has altered flow historically. In recent years, a failing dam behind Nestech has allowed more water to return to this reach. It is likely that this reach would adjust to equilibrium conditions in the near term if conditions were constant. However with uncertainty in the stream flow and in how “The Canal” will be managed in the future, it is recommended that the stream corridor be protected to prevent further investments from encroaching on the area the stream needs to regain equilibrium. Additionally, restoring flow to this reach and finding alternative ways to fill “The Canal” (such as stormwater) are recommended further actions as Potential Restoration/Protection Projects (to also include planting a stream buffer).

A culvert constricts the channel at Route 116, with scour at the downstream end. No upstream sediment deposition was observed. Replacing the structure with one of appropriate size is recommended, especially if flow is restored to this reach from the Canal diversion.

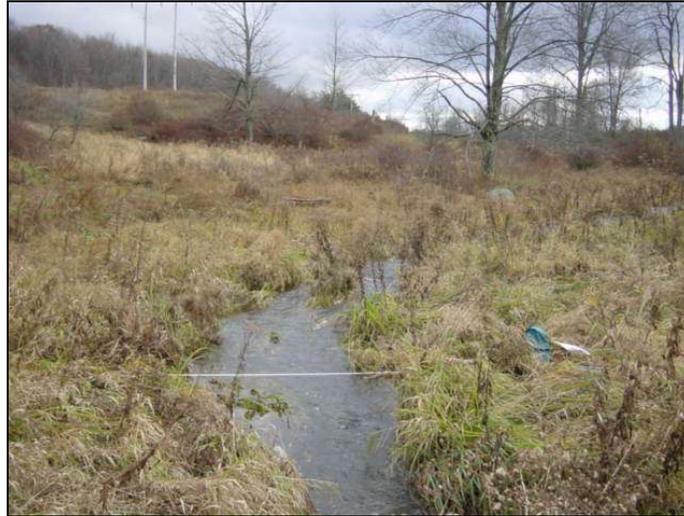
The river corridor is undeveloped and used for pasture. A large beaver dam and pond were located at the upstream end of the reach and beaver activity was observed in the reach. Bank vegetation consisted of herbaceous species with some shrub-saplings. Banks were moderately stable and assessed in “good” condition. Riparian buffer widths were 50-100 feet on each bank with some areas of 5-25 feet. Buffer vegetation was herbaceous with shrubs-saplings. Riparian corridor land use was pasture. Many wetland areas and seeps were noted along the reach. Historical straightening was noted along the reach. The channel is likely to adjust to equilibrium conditions if the corridor is protected and livestock fenced out of the channel. Plant stream buffers in areas where grazing and trampling have disturbed buffer, or allow vegetation to regenerate through corridor protection.

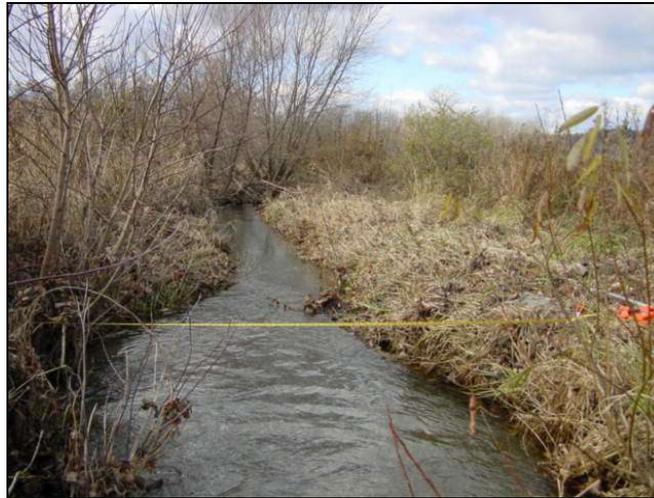
The river corridor is undeveloped, except for a house on the right bank near Route 116. Sediment supply is high and the channel is likely to adjust to equilibrium conditions, although it has been moved over to increase field area. Protecting the river corridor is recommended. The channel has been windrowed downstream of Route 116, with slight sediment buildup along the tops of the banks. This could be removed, or opened up in areas to allow more frequent floodplain access. Planting buffer vegetation away from where the channel is likely to actively migrate can help with long-term bank stability and habitat value.

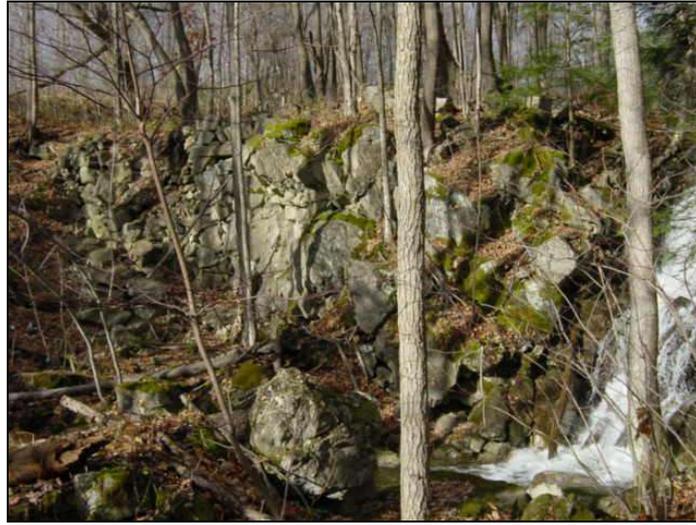
Reach: T5.01C

Milldam to left, falls to right.

This area had multiple ledges and a waterfall and a wooded corridor. Protect the corridor to avoid future encroachment.
