SURVEY OF HIGHWAY CONSTRUCTION MATERIALS IN THE TOWN OF MIDDLEBURY, ADDISON COUNTY, VERMONT

Engineering Geology Section, Materials Division

Vermont Department of Highways

Montpelier, Vermont
March, 1977

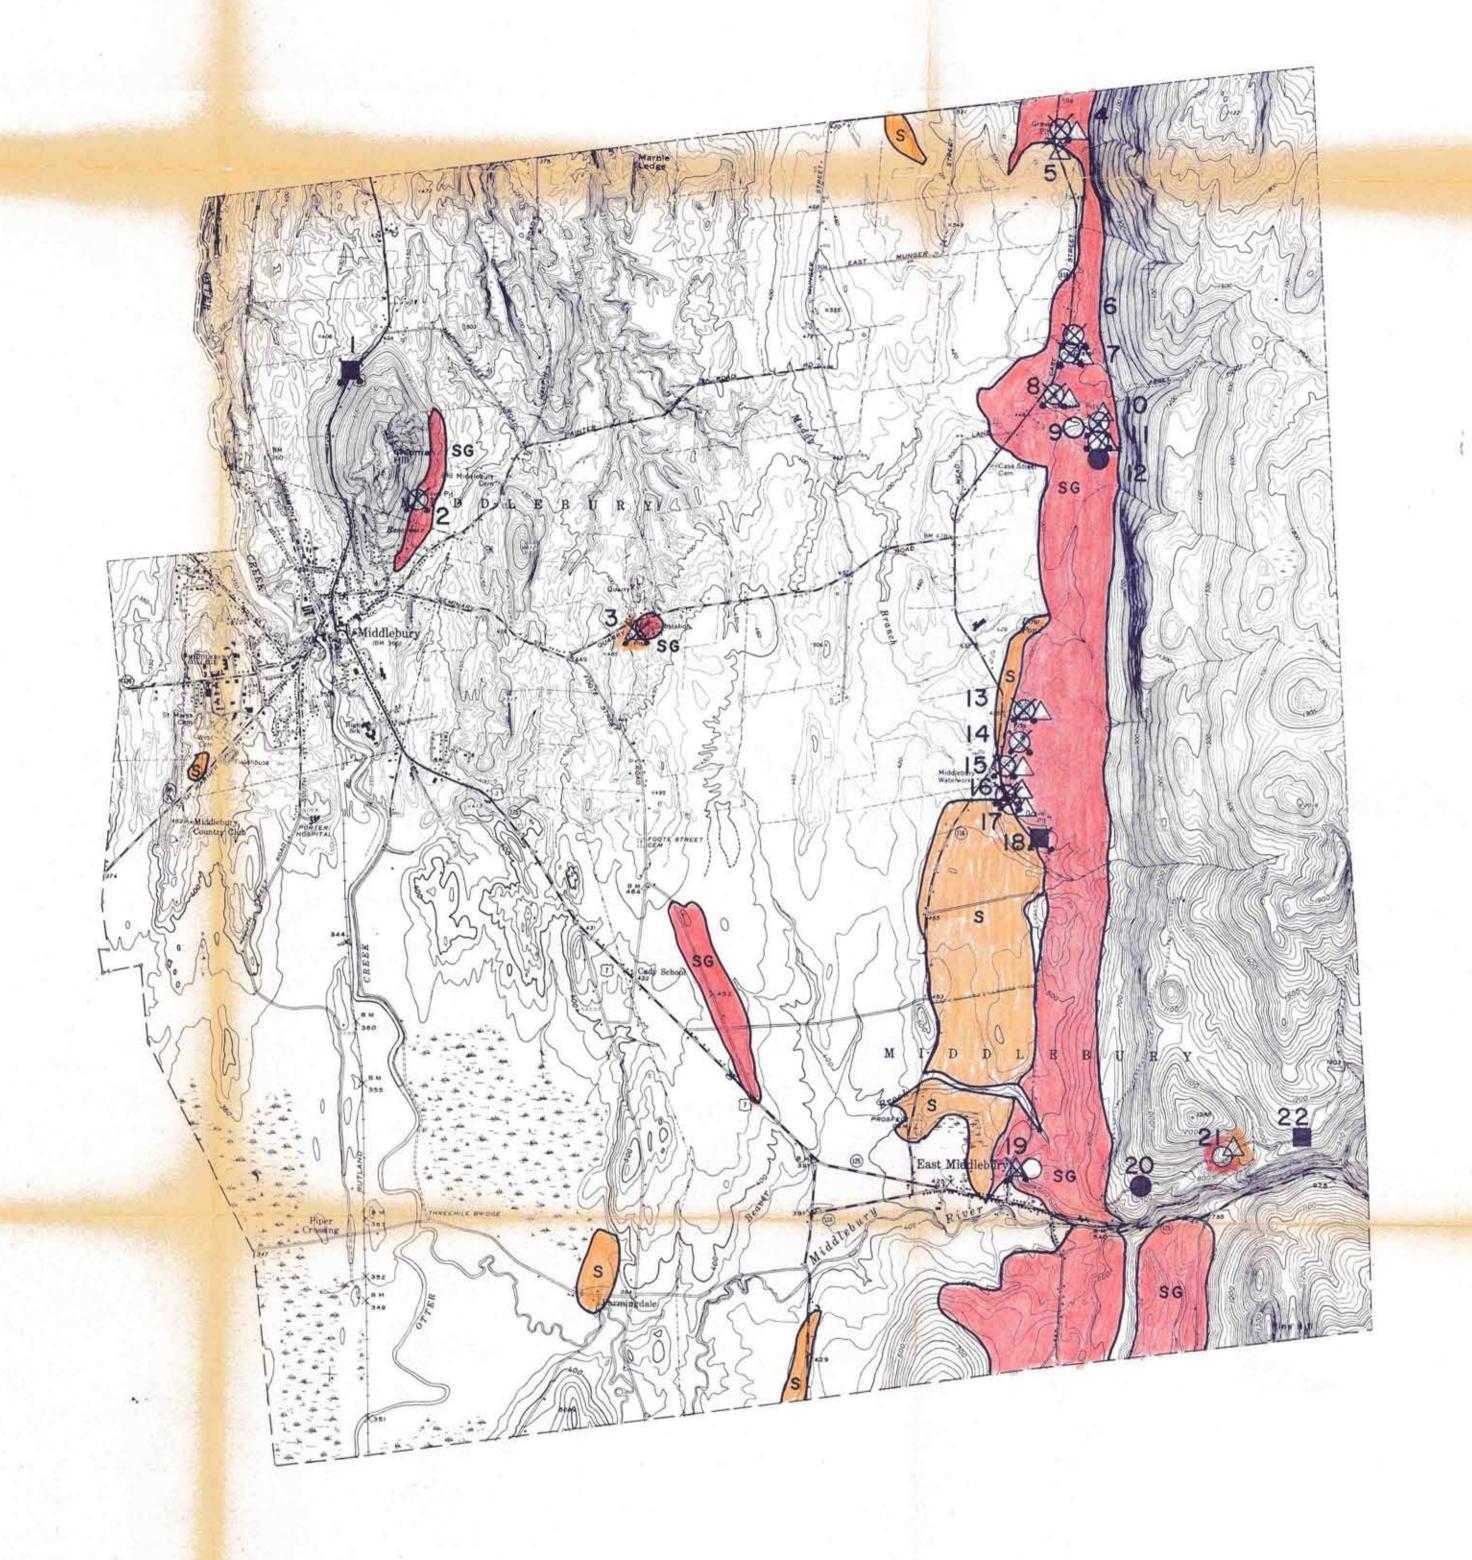
- GRAVEL, ACCEPTABLE FOR ITEM 704.05 (gravel for sub-base)
- GRAVEL, DEPLETED OR NOT ACCEPTABLE FOR ITEM 704.05
- SAND, ACCEPTABLE FOR ITEM 703.03 (sand borrow and cushion)
- SAND, DEPLETED OR NOT ACCEPTABLE FOR ITEM 703.03
- GRANULAR BORROW, ITEM 703.05
- MATERIAL NOT ACCEPTABLE FOR ITEM 703.05
- EXISTING PIT
- SAND & GRAVEL DEPOSIT
- SAND DEPOSIT
- IDENTIFICATION NUMBER (refer to data sheets)

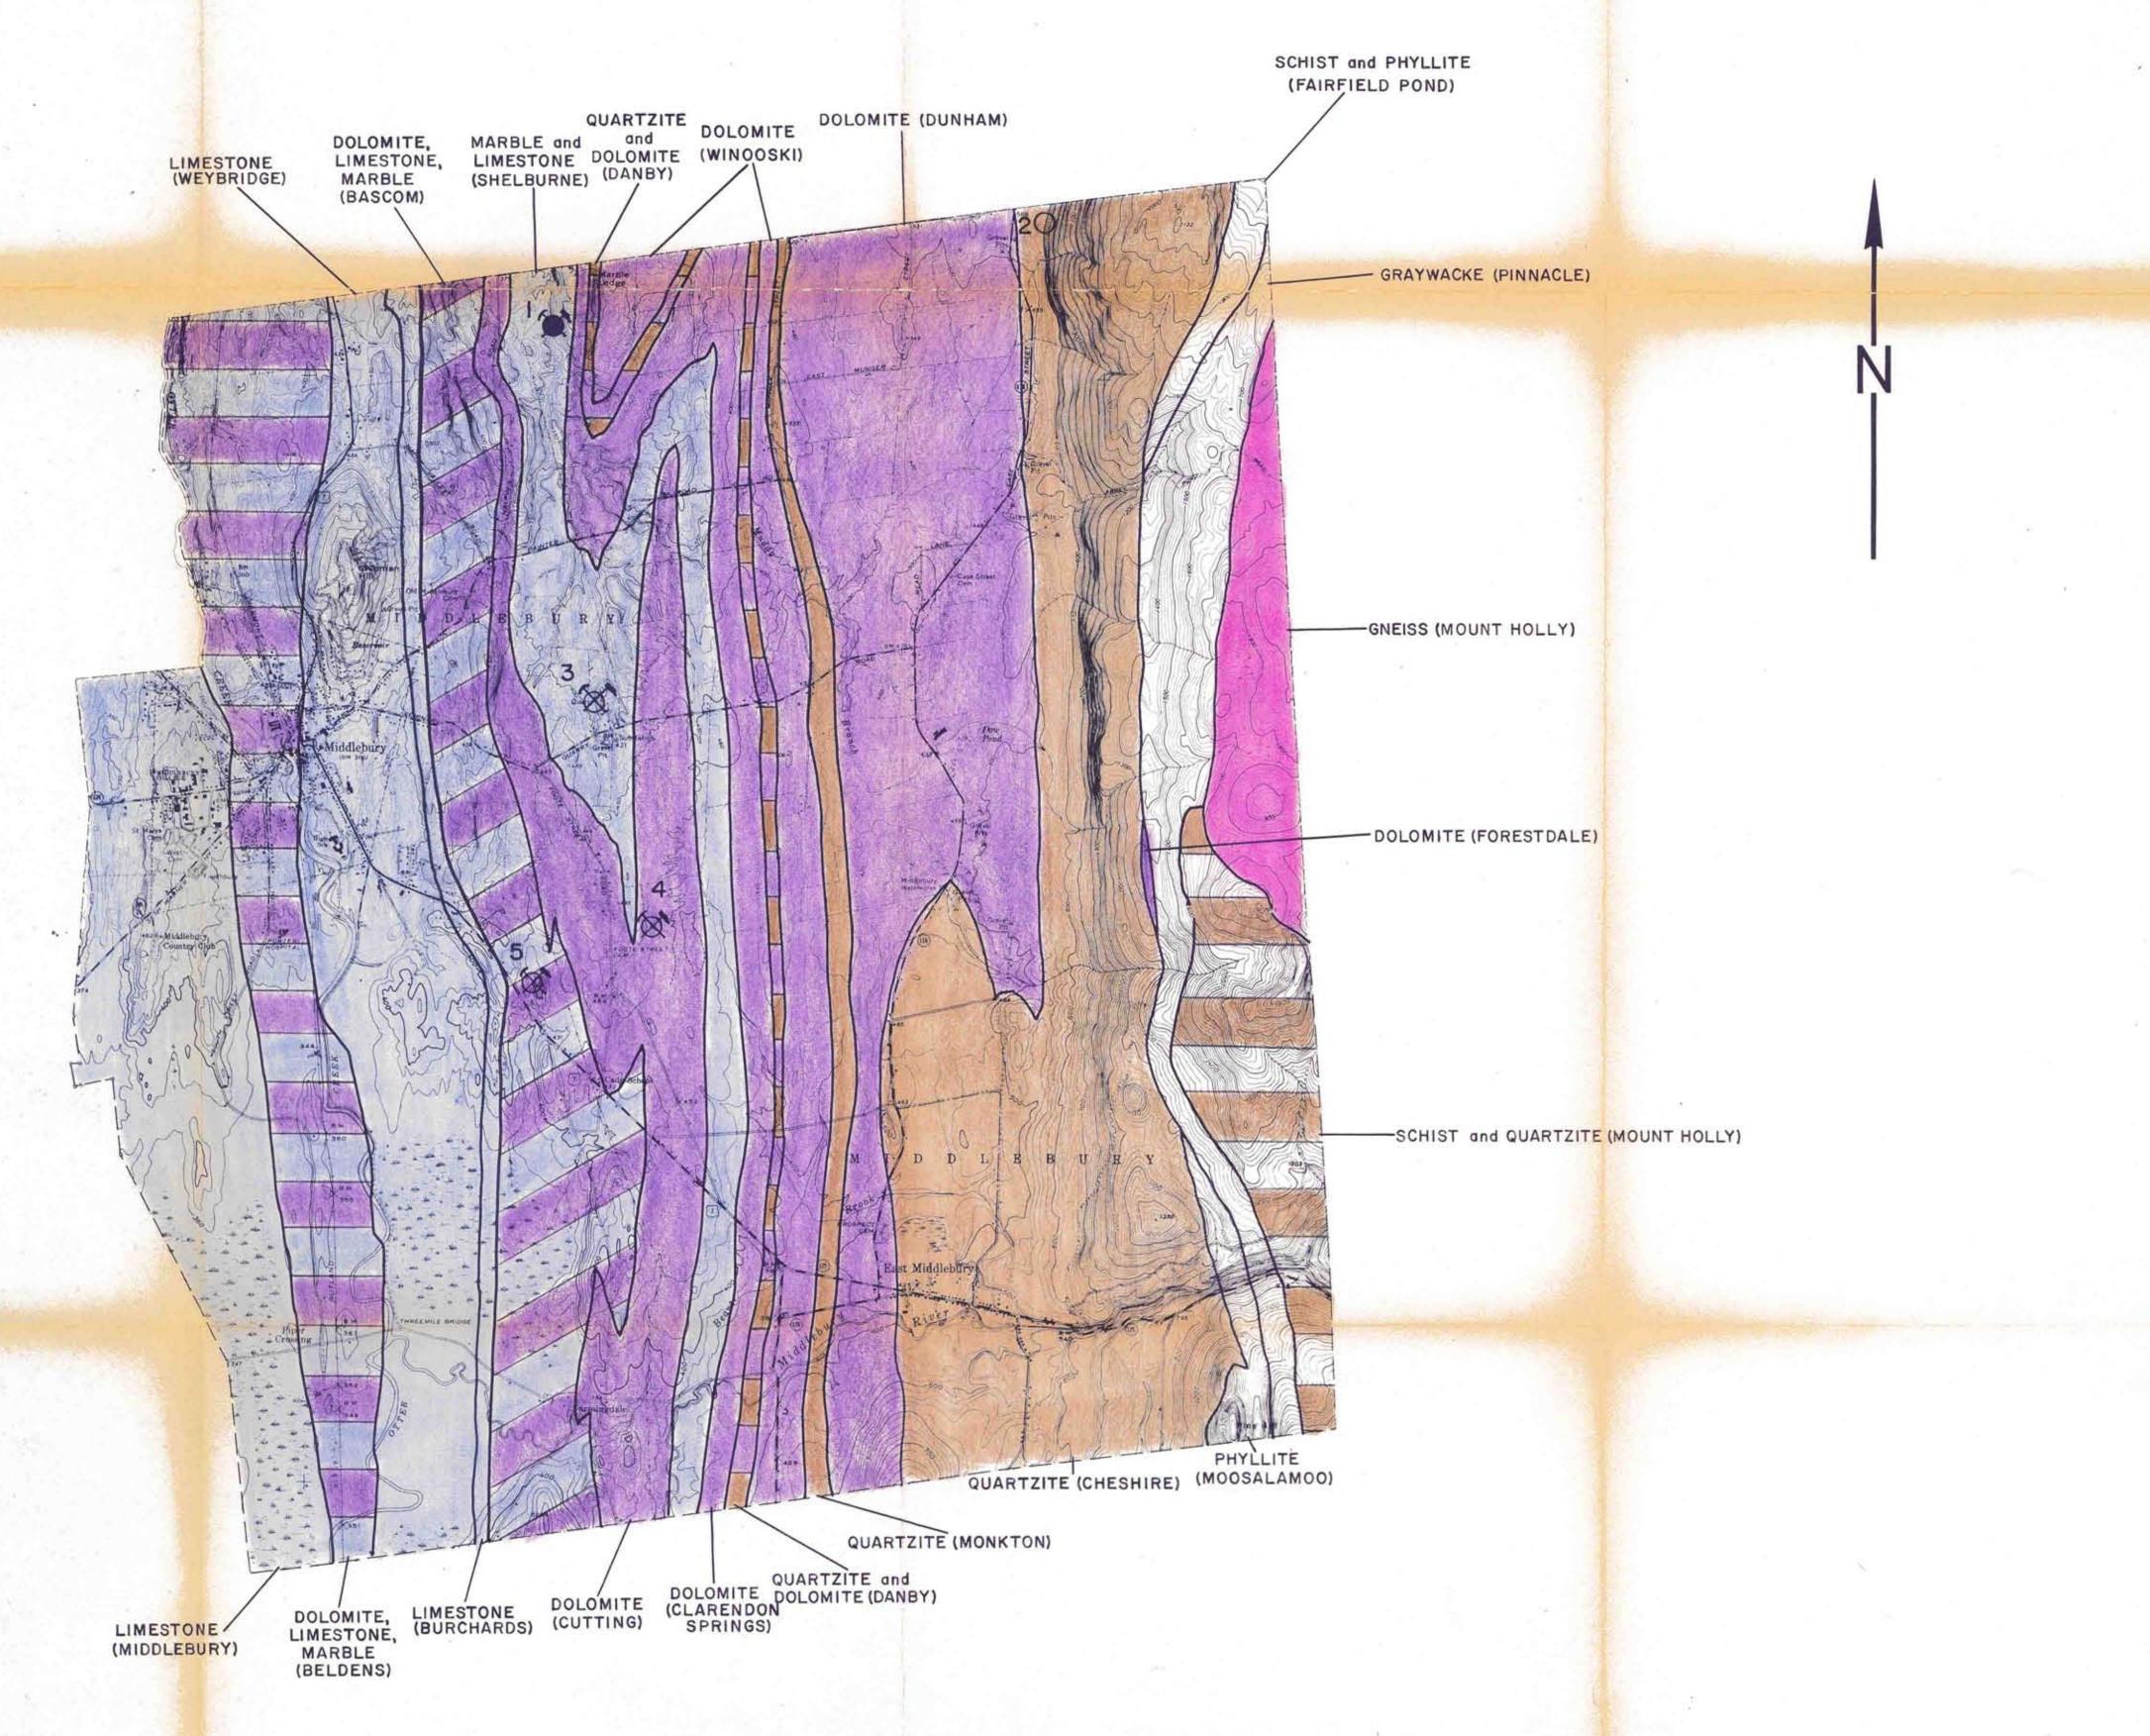
ROCK, ACCEPTABLE FOR ITEM 704.06 (crushed stone for sub-base) ROCK, NOT ACCEPTABLE FOR ITEM 704.06 EXISTING QUARRY
