Report on Streambank Stability Assessment Techniques

Vermont Geological Survey Technical Report VGTR2007-1

Executive Summary

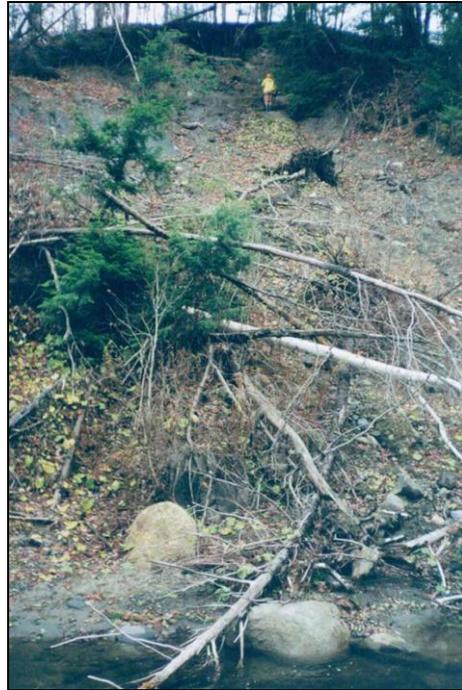
Figure 2.2. Large landslide in dense till on Great Brook, Plainfield. Site GB-179. Photo by Lori Barg.

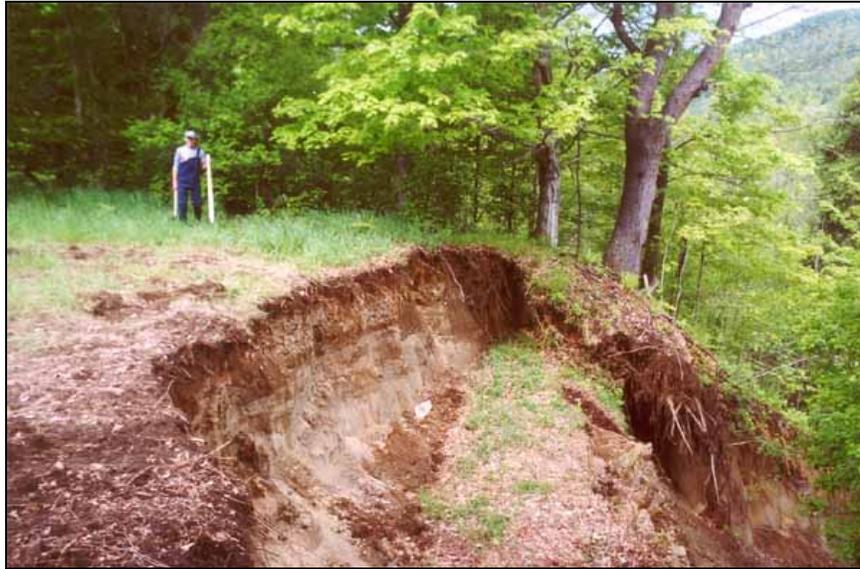
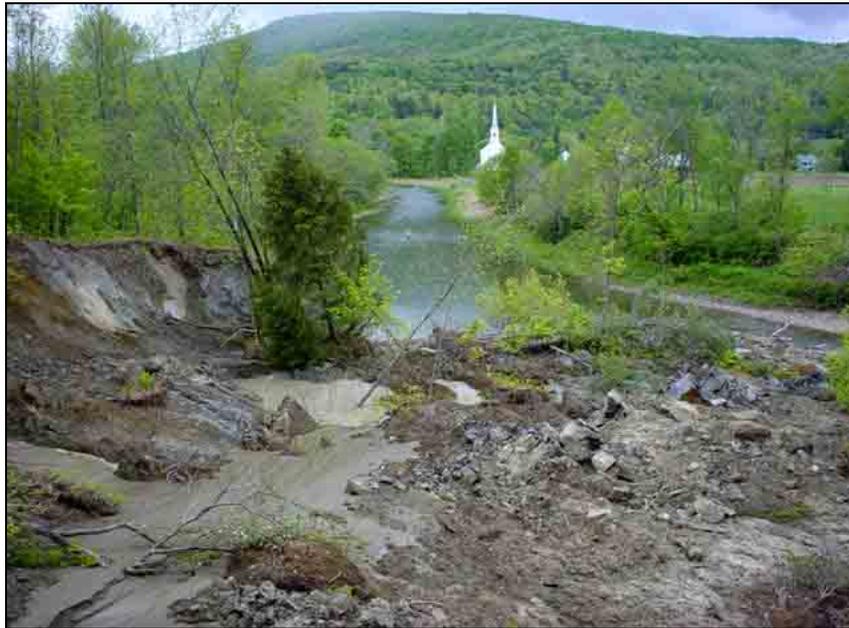
Figure 3.4. Complex rotational earth slide and flow in lacustrine sediments on the Mad River in Waitsfield. a) Top scarp. Note down-dropped block with grass. Mike Blazewicz for scale. May, 2003. b) The complex form of a fresh landslide deposit. View from main scarp of landslide shown in previous figure, looking down onto the displaced material at the foot of the complex rotational earth slide and flow. A fresh earth flow is seen at lower left. The trees out on the surface rode down as blocks on top of the flow--some a few days after the main failure had occurred. Most of the foot is a jumble of blocks of varved silt and silty clay in a matrix of remoulded silt and silty clay. The toe is being rapidly eroded away by the river. May, 2003.

A typical example of a rotational slide is shown in Figure 3.4. The slide does not have the simple form shown in Figure 3.2. Instead, there are multiple blocks and scarps, formed as the slide retrogressed away from the stream. Some of the displaced blocks have deformed in a plastic fashion while others have fractured into smaller blocks. As much of the material is highly disturbed has lost much of its strength, flows are widespread (such slides commonly break up into flows in their lower portions).

Flow-type slope failures are found in two main settings in Vermont. The displaced material of translational and rotational slides is commonly disaggregated into small- or medium-scale earth or debris flows as shown in Figure 3.4b and channelized debris flows on steep mountainsides can move large quantities of boulders, cobbles, and finer material. The debris flow shown in Figure 3.8 is a typical example of this second type.

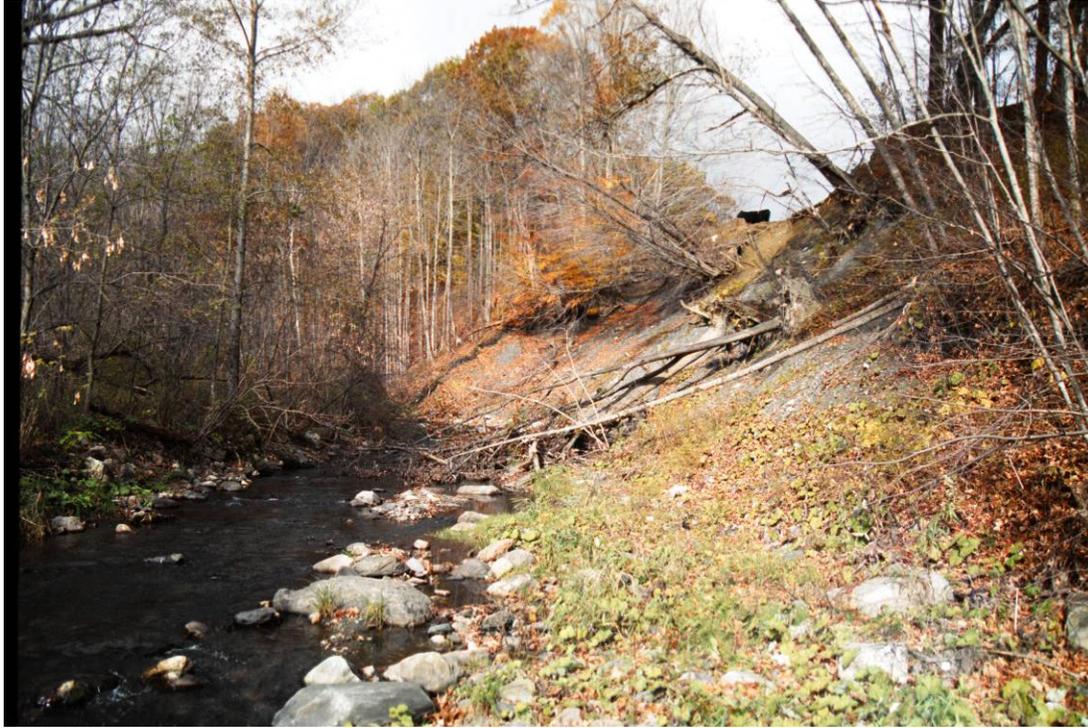
Figure 3.5. Ira Brook landslide. Shallow translational slide in till. Looking upstream. Cow for scale at top of bank. Note slabs of soil with trees falling down the bank, 10/24/2003.

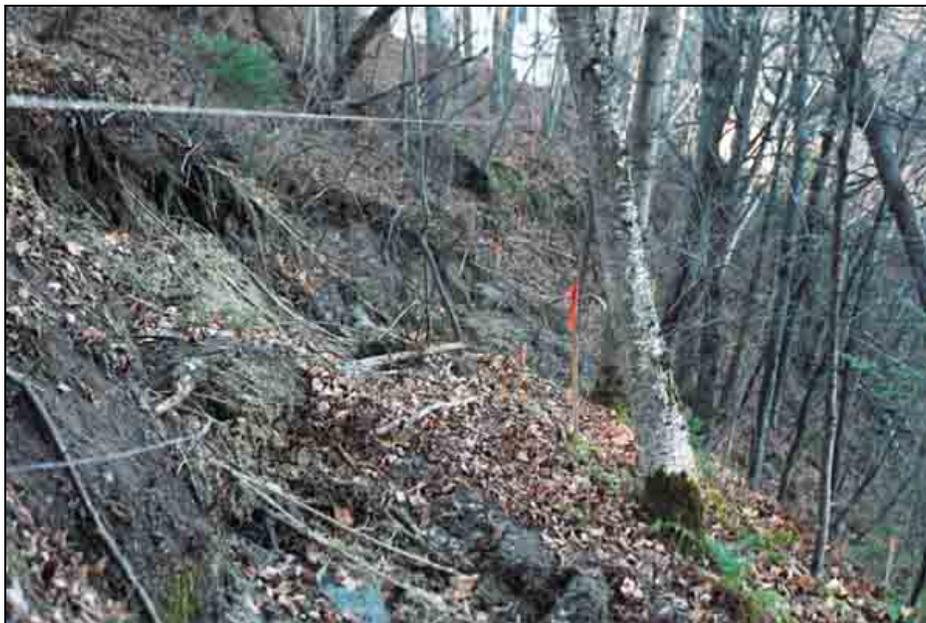
Figure 3.6. Shallow translational slide on weathered till and lacustrine silty clay on a wooded slope in Hardwick. Soil block in center with birch tree has slid down to the right. November, 2003.

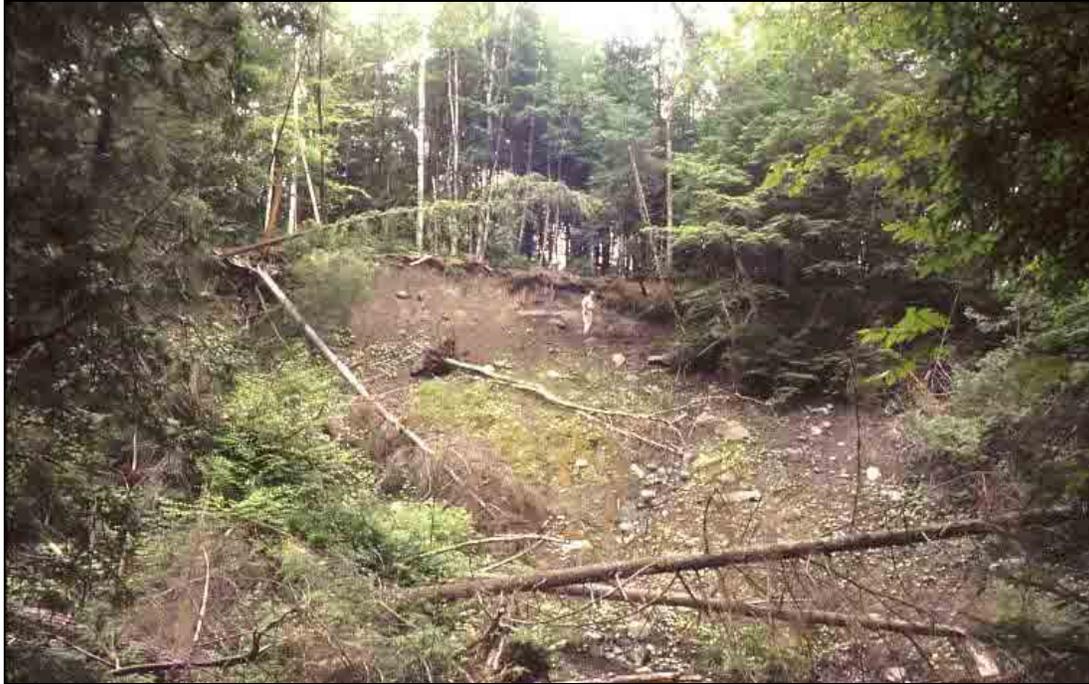
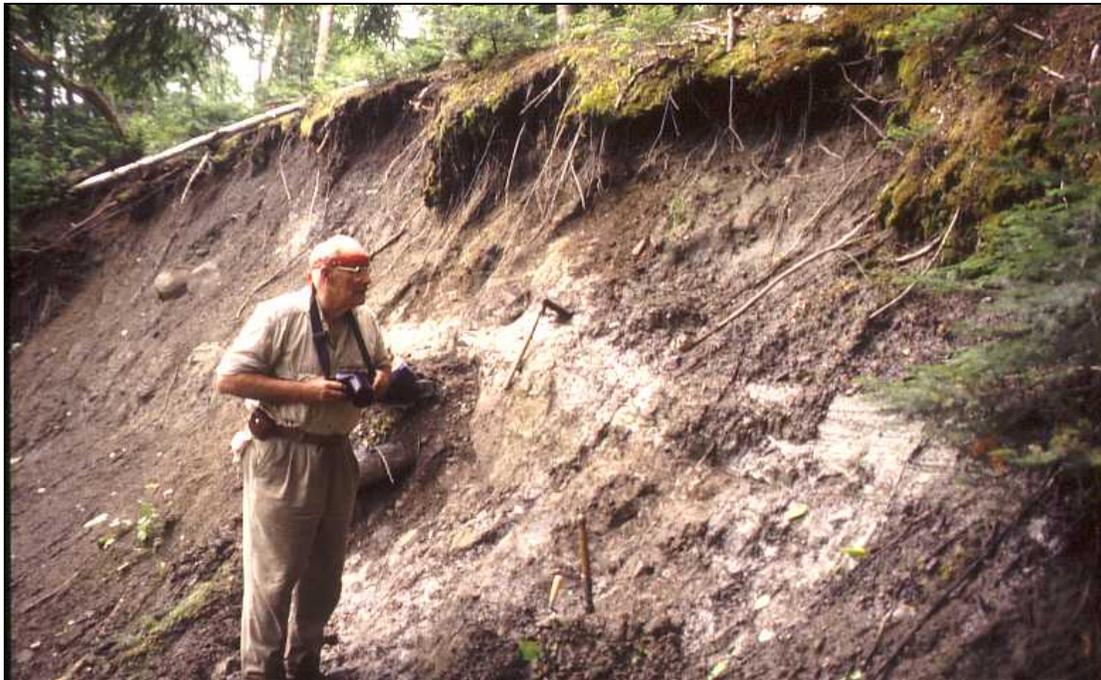
Figure 3.7. Slope failure on Water Andric, Danville. a) The overall form of movement here is a translational earth slide and earth flow. Continued toe erosion has enlarged the slide, leading to toppling of trees out onto the water-saturated flow surface. b) Closeup of upper part of the slope. George Haselton examines a thin layer of varved lacustrine sediments: Although the majority of the slope is till, in the uppermost few meters the till is overlain by varved lacustrine clay, sandy diamict, and a final layer of varved lacustrine clayey silt. The overall slope failure here is dominated by the till. Note the thin root zone.

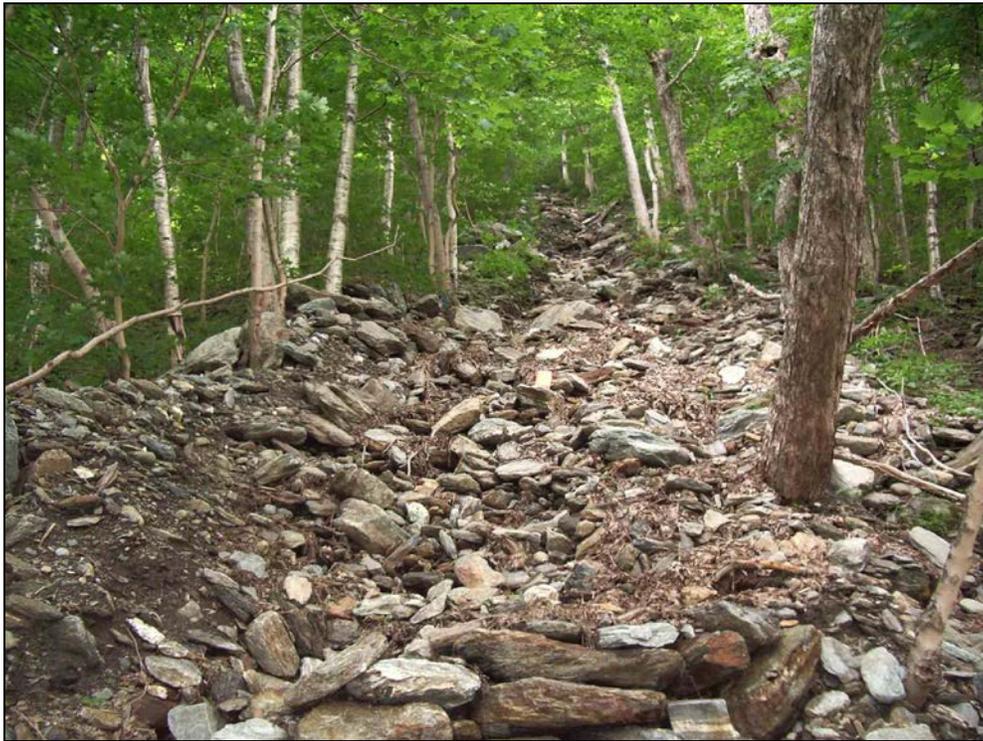
Figure 3.8. Looking up a recently active debris flow path on the west side of Smugglers Notch, Cambridge. A heavy rainstorm mobilized material up to three feet across over the entire length of the channel, which is about 900 feet long. Orange notebook in center of channel for scale. Note levees of coarse debris on both sides. July, 2006.

The channelized debris flows may originate from slope failures on the slope or be initiated by rock fall from a cliff. The source material for the flow in Figure 3.8 appears to have been the channel and sides of the gully. Although there were signs of recent

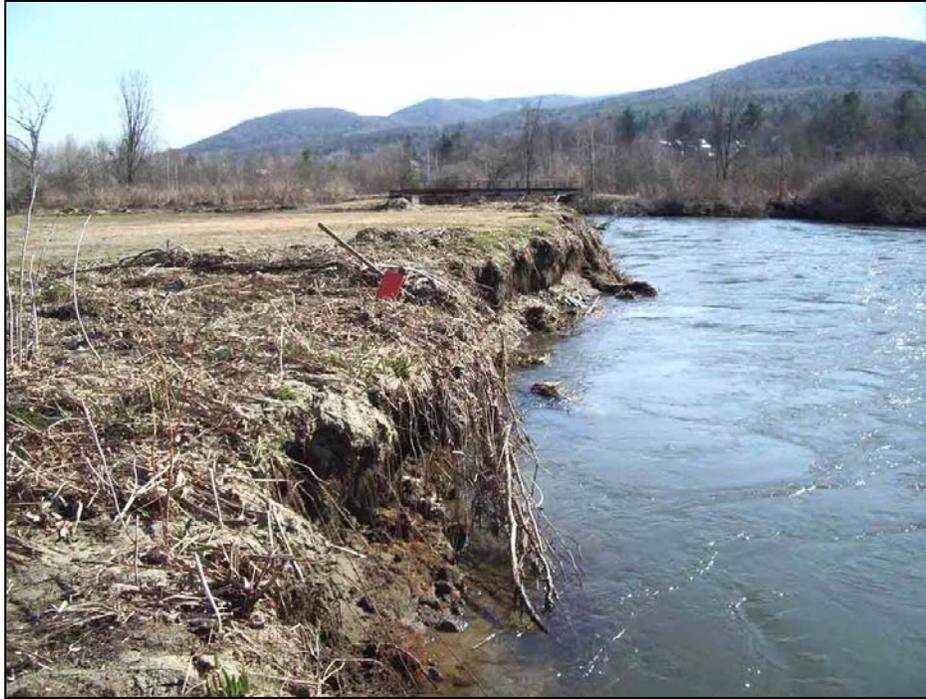
Figure 3.10. Cantilever failures on the west bank of the Dog River, Norwich University, Northfield, Vermont. Shovel and notebook for scale. Flow is away from observer. Sandy alluvium has been undercut during recent high flows and is in the process of collapsing. Note collapsed sod temporarily protecting base of bank in distance. April, 2007.

In Vermont, wedge slides are sometimes encountered on failing stream banks composed of silty to sandy alluvium, although they typically have steeper failure surfaces than shown in Figure 3.9a. Cantilever failures on an eroding bank of the Dog River are shown in Figure 3.10.

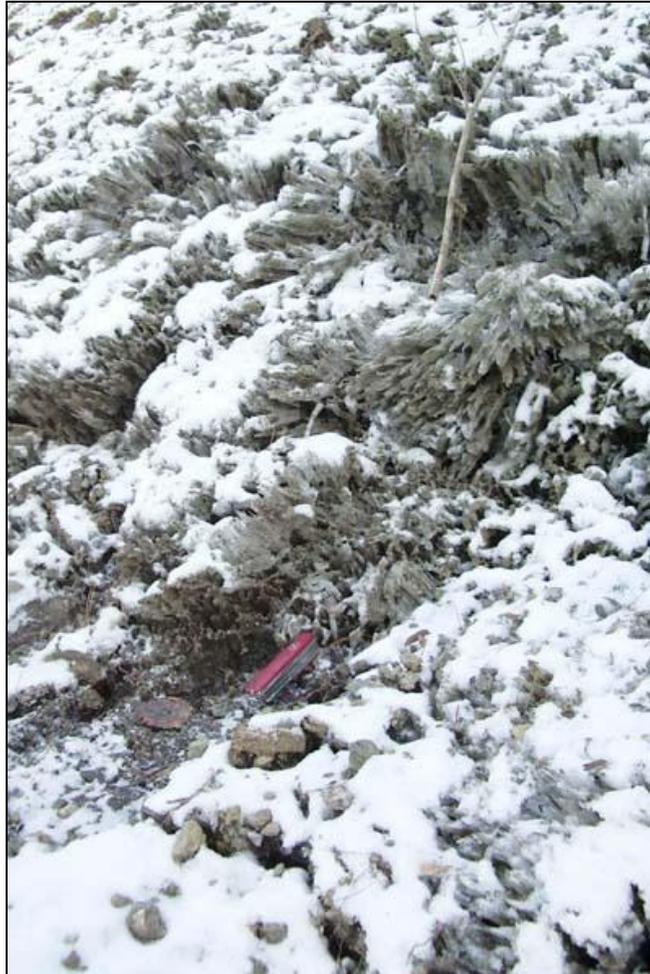
Figure 4.1. Needle ice formed on a recently excavated silt-matrix till, Woodstock. The needle ice appears to form in frost-susceptible soils in late fall or early winter if soils are sufficiently moist while temperatures dip will below freezing without snow cover. This is an important process for softening fresh exposures in dense fine-grained soils. Knife for scale.

In late fall and early winter, as the frost first begins to penetrate deeply into the ground, some raw exposures of silt or clayey silt become coated with spectacular needles of ice that have grown out of the soil surface, pushing grains and small aggregates of soil ahead of them (Figure 4.1). Lawler (1993) has discussed the influence of this needle ice formation on bank erosion at a site in Scotland. Needle ice formation typically occurs in late fall and early winter and results in a "fluffed" soil surface with lower cohesion upon thawing. The result is increased likelihood of erosion. Gatto and others (2001) review the effects of freeze-thaw processes on soil erosion and point out that there is a rough annual cycle of soil strength in the frost-susceptible soils (soils with silt or clayey silt matrices): Soils have high strength in the winter while frozen, are weakest in the spring when recently thawed and still saturated, and subsequently recover strength over the summer and fall as drainage takes place and particle cohesion returns. Thus newly thawed soils can be quite susceptible to slope failures. The depth of this cycle of strength is dependent on the amount of frost penetration. Field observations by the author indicate that over

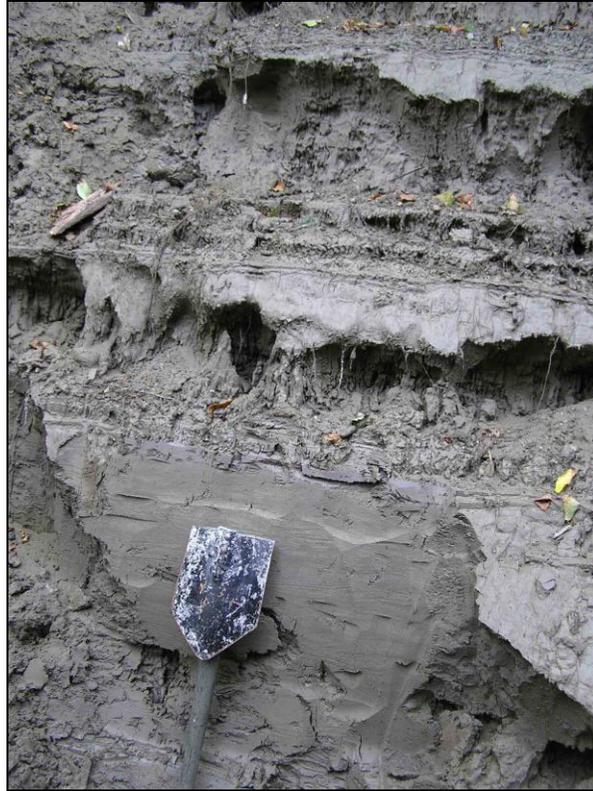
Figure 4.2. Sapping at interfaces of varved sand over silty clay. Each varve consists of a "summer" layer composed of very fine sand overlain by a silty clay "winter" layer above. This silty clay serves as a barrier to easy vertical movement of water and thus water in the next season's summer layer seeps out onto the face. Water was observed to be seeping out from the lower several centimeters of each of these summer layers. The two lines of dark hollows on the slope above the shovel head are areas where sand has been sapped (eroded out) by the water, leaving the winter layer above cantilevered out over the hollow. At the back of an active landslide scarp above the Brewster River, Jeffersonville. Photo by Jonathan Kim, Vermont Geological Survey.

An example of slope degradation due to sapping is shown in Figure 4.2. This site is at the back of an active landslide in varved lacustrine deposits in Jeffersonville. Water is seeping out from sandy layers overlying silty clay layers. The silty clay layers acts as confining layers that prevent or at least inhibit vertical movement of ground water. As the water seeps out from the sands, it carries grains of sand with it, hollowing out each sandy layer and leaving behind an overhang of silty clay.

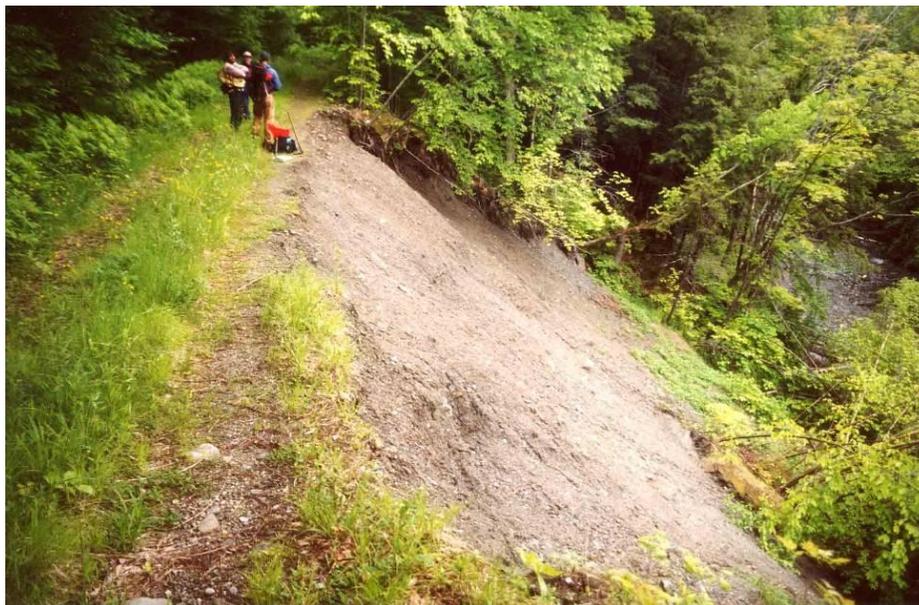
Figure 6.5. Stetson Brook, Warren. Shallow translational slide in till on the north side of the brook. Looking downstream at the slide cutting into a Forest Service road, 6/13/2003. Note the constant slope and shallow depth. This is characteristic of slides on dense till.

The Stetson Brook study site is a shallow translational landslide in dense till. The brook is a tributary of the Mad River located in the southwestern corner of Warren in Washington County (Figure 6.4). The watershed of the site is forested and is entirely within the Green Mountain National Forest. The site is on the north side of the brook, on the downstream half of an outside bend of the stream. The slope is about 35 feet high and the slide surface has an angle of 38° (78%) where not mantled with slide deposits (Figure 6.5). The upper portions of the slope are underlain by a typical dense, clast-rich, silt-matrix till. Near the base of the slope the till has a higher clay content and contains few large clasts. This clayey silt-matrix till at the base may have formed from a readvance of a glacier over earlier clay-rich lacustrine deposits. Although an old Forest Service road is located at the top of the slide, the presence of the road does not appear to be the primary cause of instability at this site. Instead, this and other landslides in the watershed were activated (or at least reactivated) by severe flooding in June of 1998 (Kathy Donna, U.S. Forest Service, personal communication, 2003). It appears that toe erosion and high ground water levels led to the failure. The Forest Service attempted to revegetate the slope in the fall of 2001 but the stream still impinges on the toe of the slope and as the fresh till has softened, flows and slides have continued. With the sliding off of the soil and trees, incision into the unweathered till is rather slow, perhaps largely occurring gradually as the material weathers. If the stream shifts its position at the base it is expected that new sections of soil and trees on the bank will be destabilized.

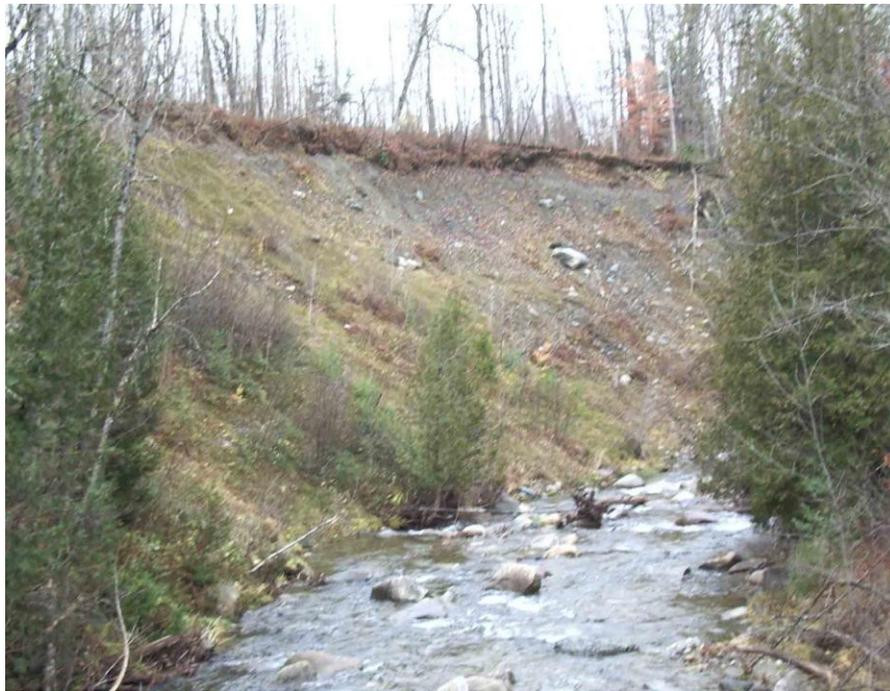
Figure 6.7. Landslide in dense till at Site GB-3, Plainfield.

The final dense till site is located on Great Brook in Plainfield in Washington County (Figure 6.6). This is one of many large landslides along the brook and is representative of many slides in dense till throughout the state. The till has a silt-rich matrix and has abundant clasts. When fresh it is very dense and almost impossible to dig with a shovel. At this site a mantle of weathered till is accumulating on the lower portions of the slide (Figure 6.7). Although most of this may be debris flow material, some may be till exposed by landsliding that has subsequently weathered in place. The stability analysis

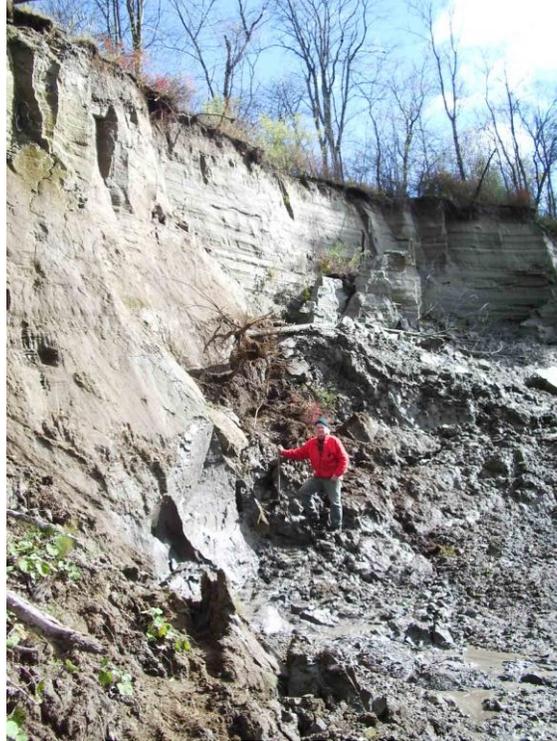
Figure 6.10. Landslide in varved lacustrine deposits, Winooski River, Plainfield. Note steep main scarp in rear, towers of silty material above and behind Allen Clark of the Plainfield Conservation Commission, and disaggregated slide deposits at his feet and to his right. October 20, 2005.

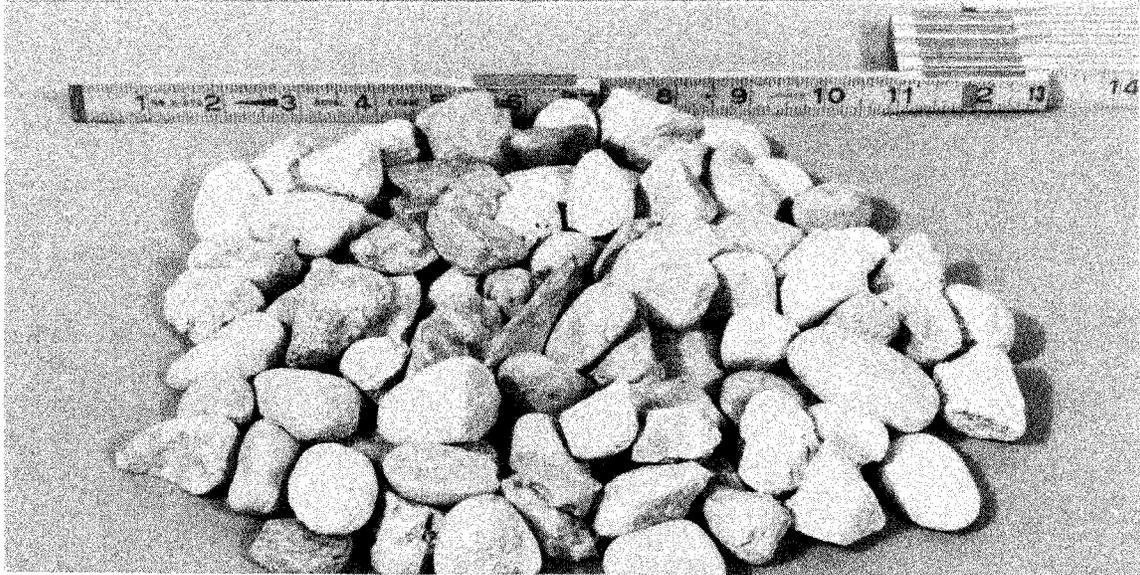
a. Coarse gravel

b. Fine gravel

Figure E-1. Photographs of several soils to aid in selecting terms for describing the grain size of soil (Sheet 1 of 3)

c. Coarse sand

d. Fine sand

e. Silt or clay

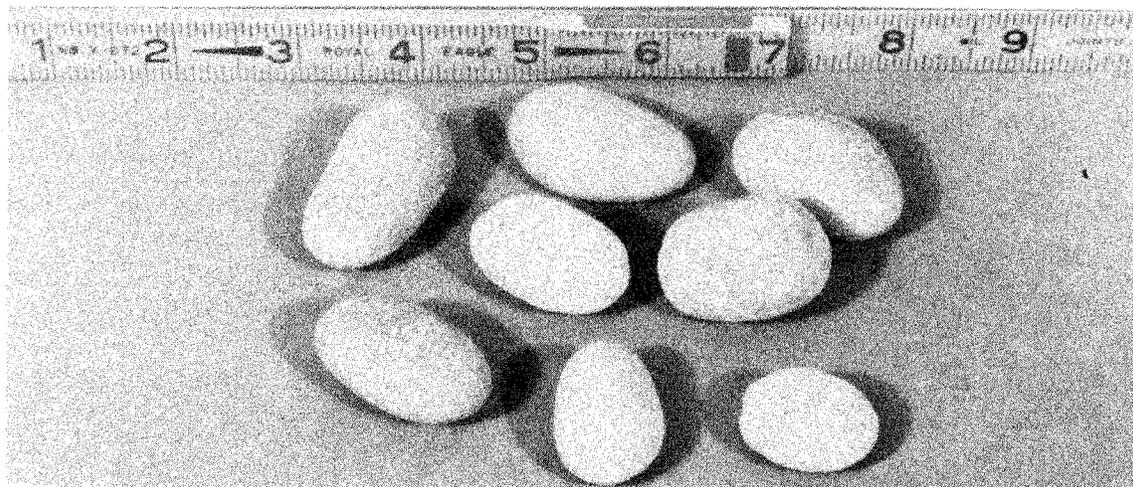
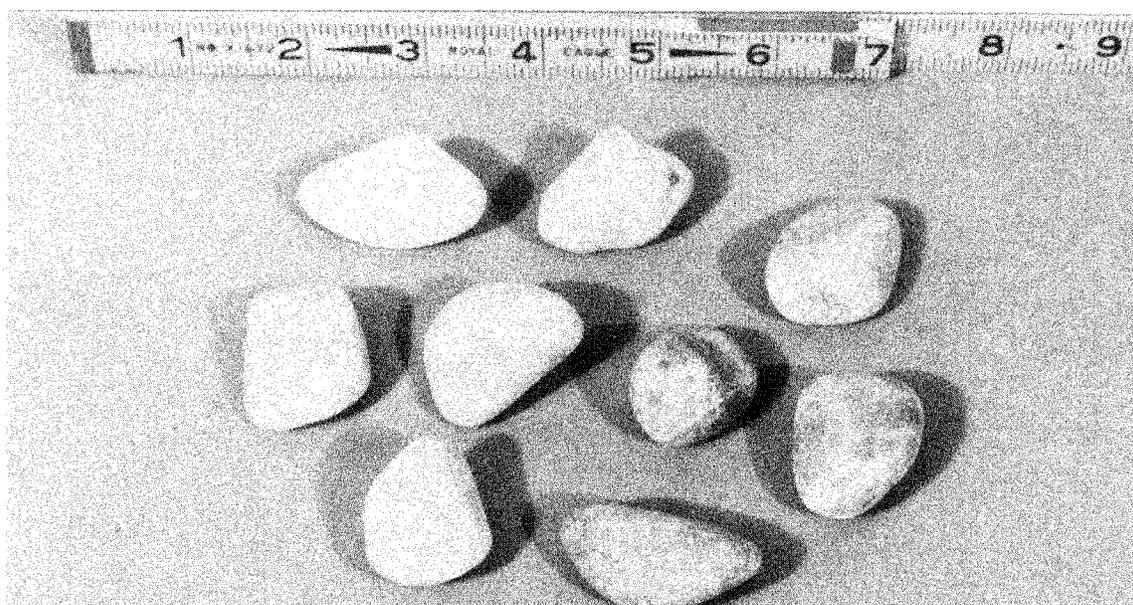
a. Rounded

b. Subrounded

Figure E-3. Photographs of several soils to aid in selecting terms for describing the grain shape of coarse-grained soils (Continued)

c. Subangular

d. Angular

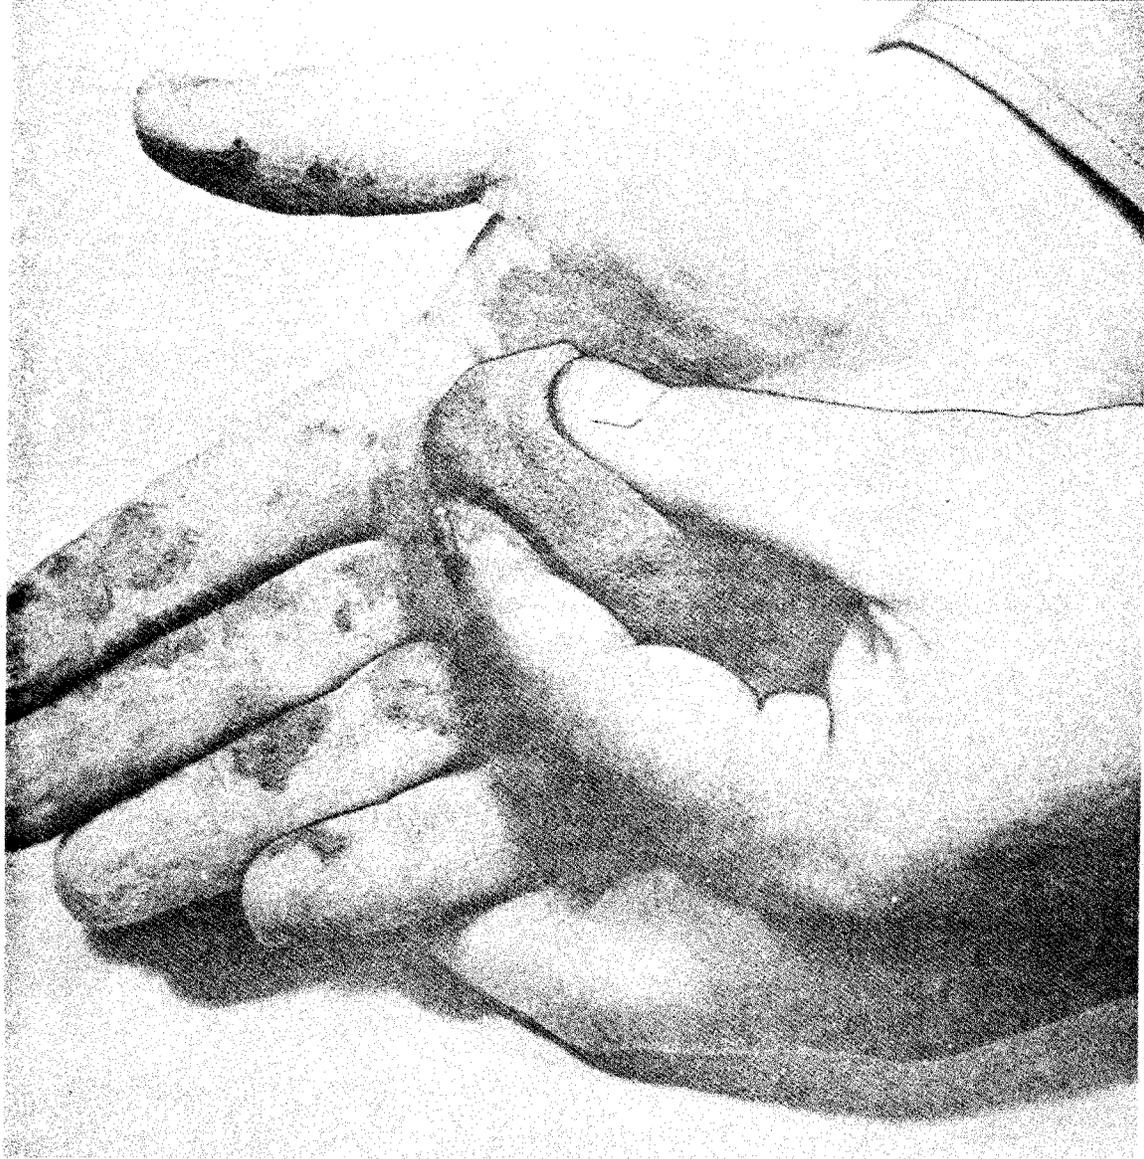
Figure E-6. Photograph of a sample of a moist, fine-grained soil being squeezed during the dilatancy test

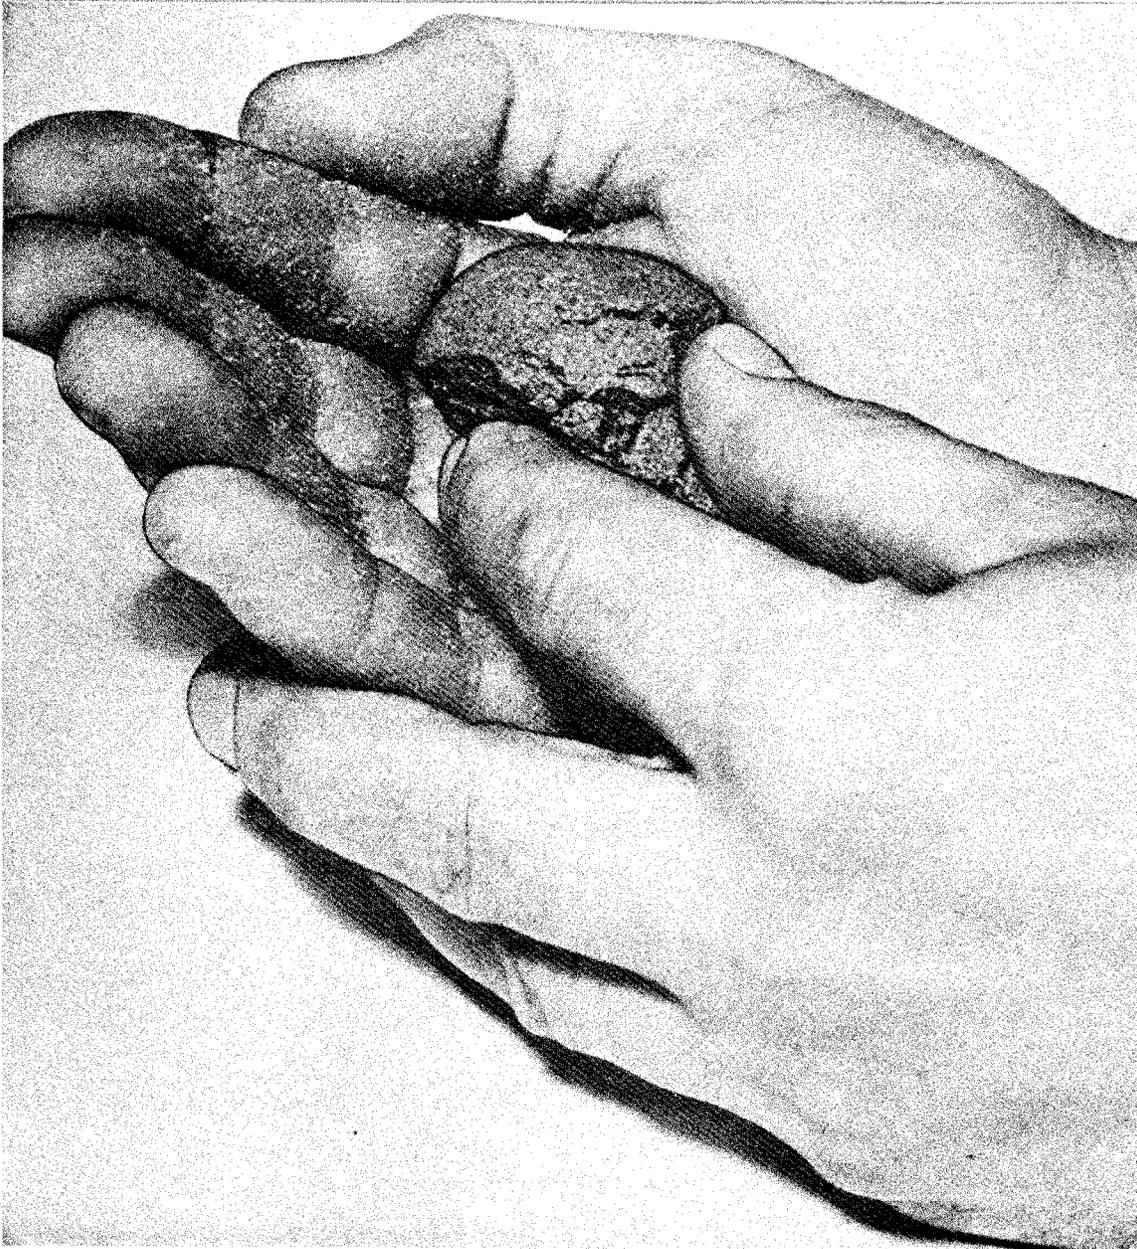
Figure E-7. A sample of a moist, fine-grained soil cracking and crumbling during the dilatancy test
