# Landslides in Vermont

**George Springston**

**Norwich University Dept. of Geology and Environmental Science  
Northfield, VT, October, 2010**

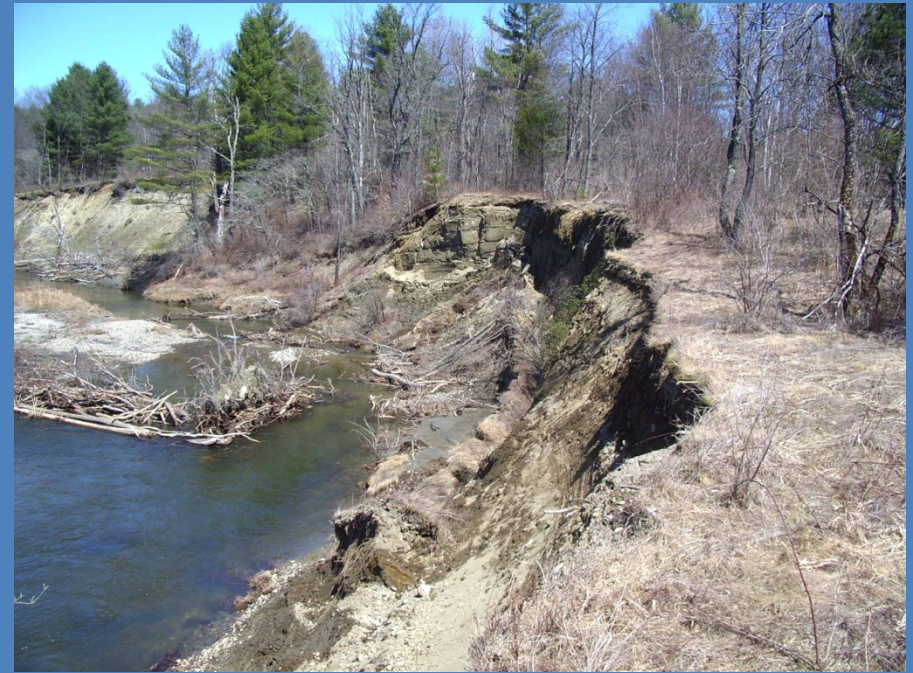
Figure from USGS Fact Sheet 2004-3072  
<http://pubs.usgs.gov/fs/2004/3072/fs-2004-3072.html>

Landslide on Winooski River,  
 Cate Farm, Plainfield, 2009

- “The downslope movement of soil, rock and organic materials under the influence of gravity and also the landform that results from such a movement” (The Landslide Handbook, USGS Circular 1325, p. 4).

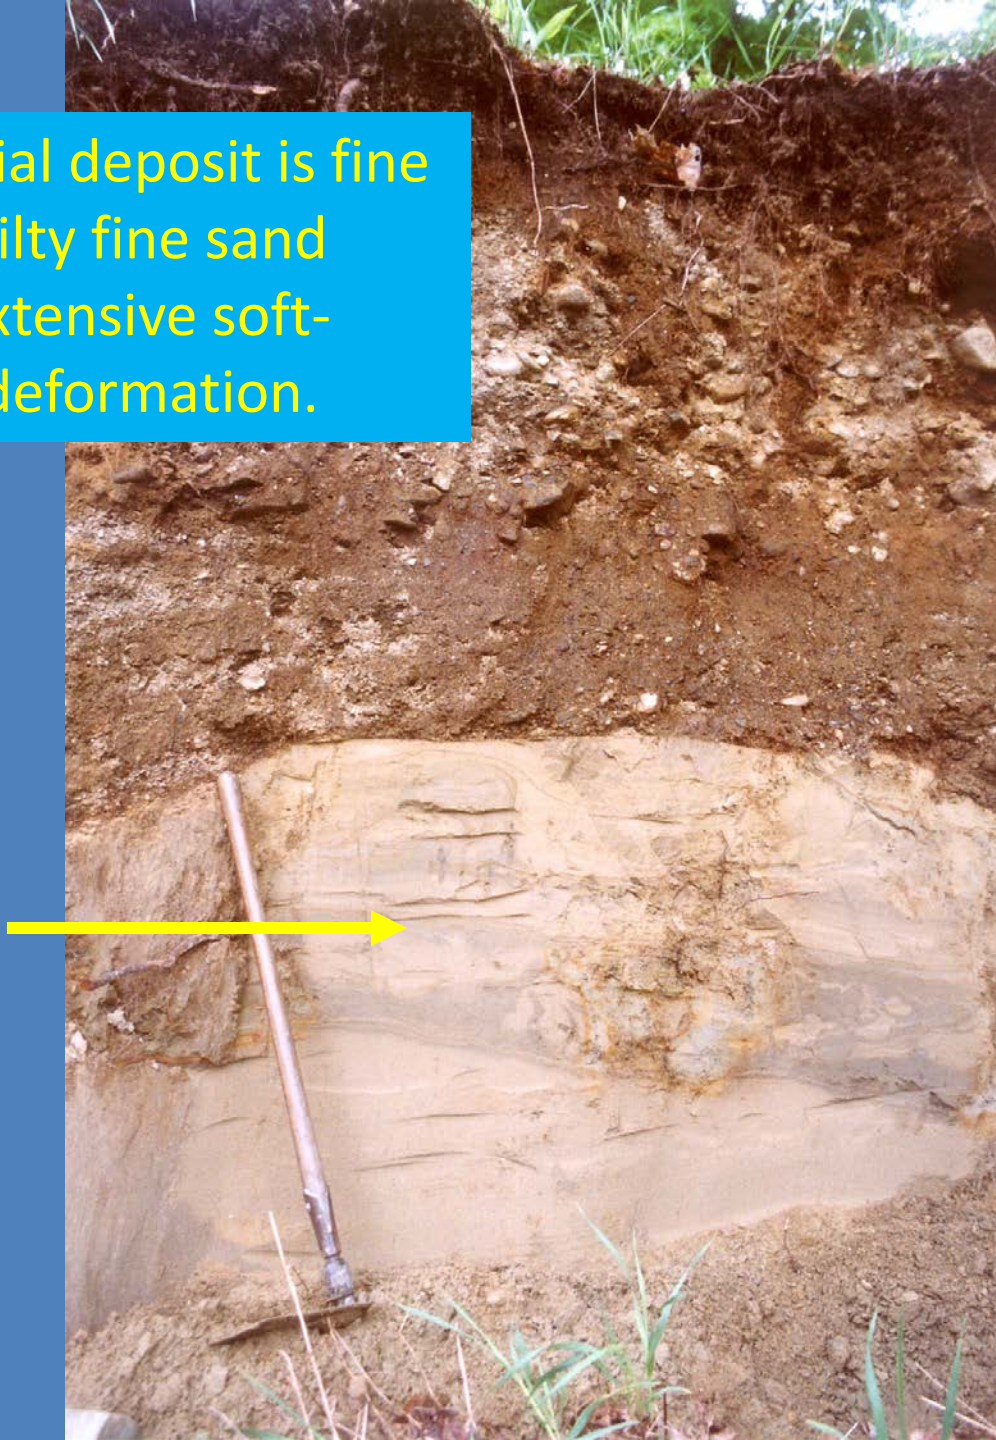
Below fluvial deposit is fine sand and silty fine sand showing extensive soft-sediment deformation.

- 0.7 - 1.2 m pebbly medium sand (fluvial).
- 12.2 m fine sand and silty fine sand with layers of massive silty clay (lacustrine).
- 9.1 m varved silt, silty clay and clay with 2-4 cm couplets (lacustrine).

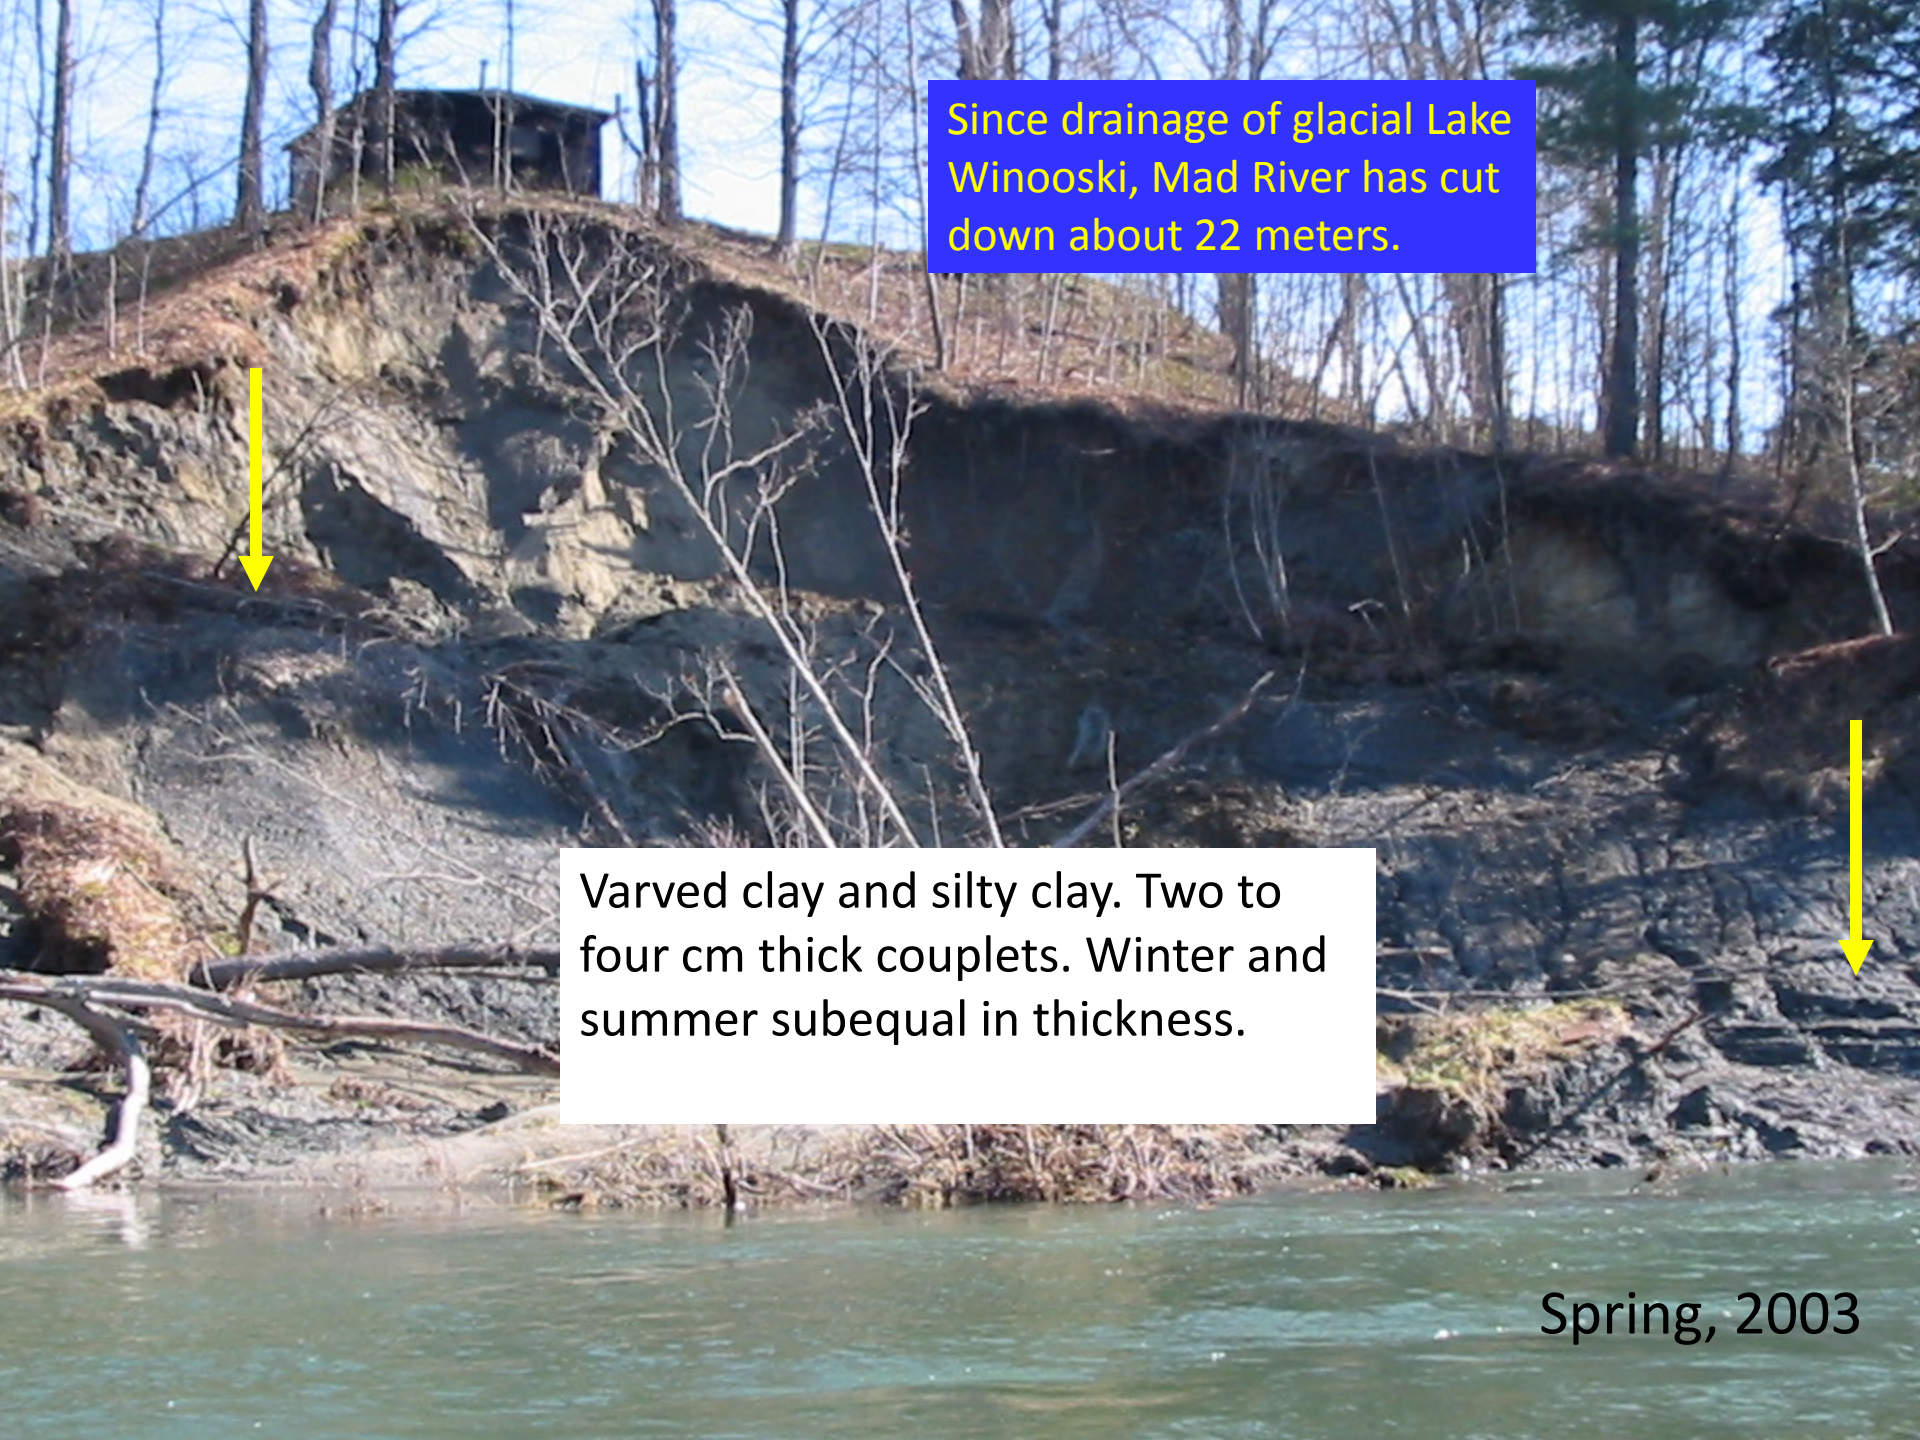
Spring, 2003

Since drainage of glacial Lake Winooski, Mad River has cut down about 22 meters.

Varved clay and silty clay. Two to four cm thick couplets. Winter and summer subequal in thickness.

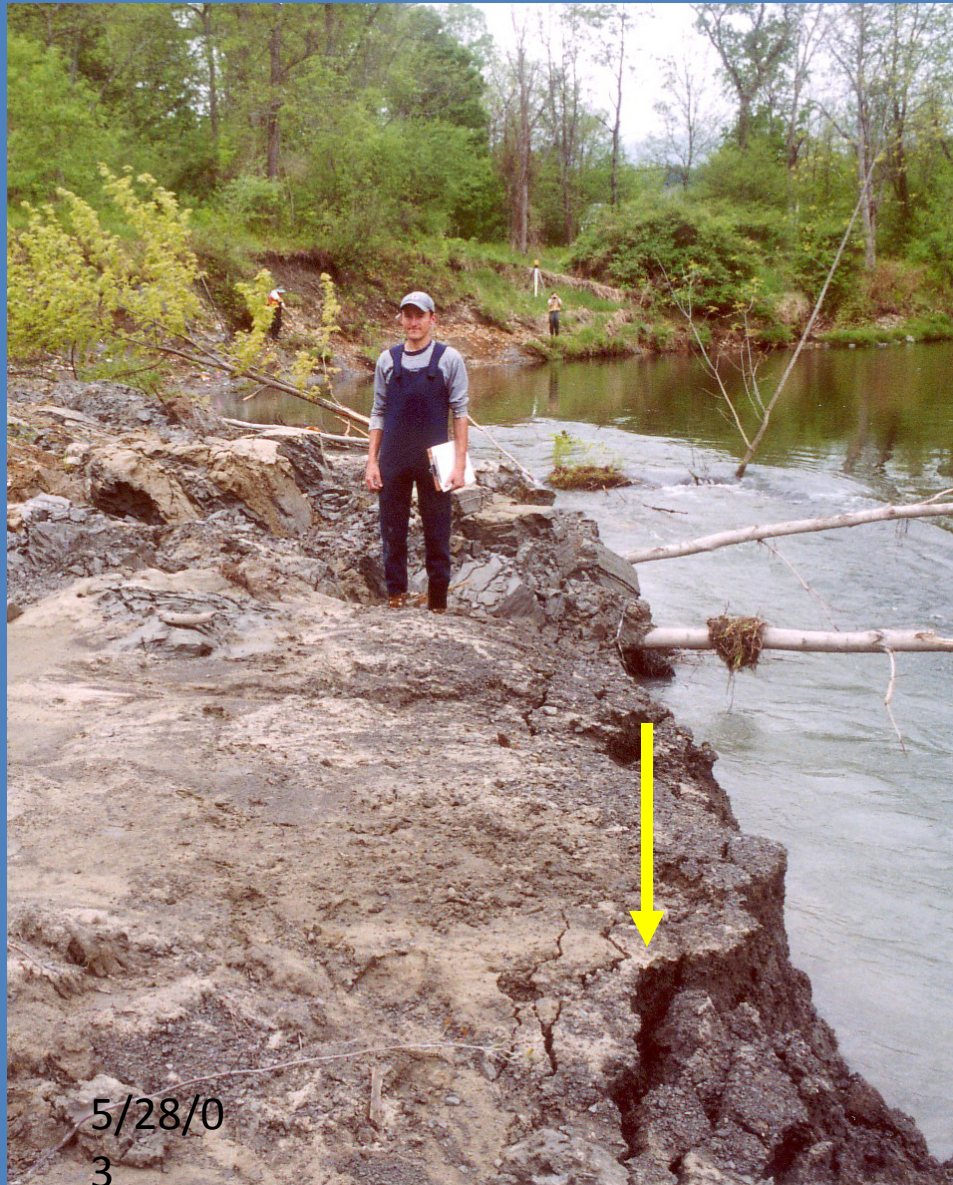
# Erosion of Toe

- >10 m (33 ft) eroded since 5/28/03
- >700 m<sup>3</sup> (900 yards<sup>3</sup>) carried away by river
- Turbidity visible at least to Waterbury -26 km downstream

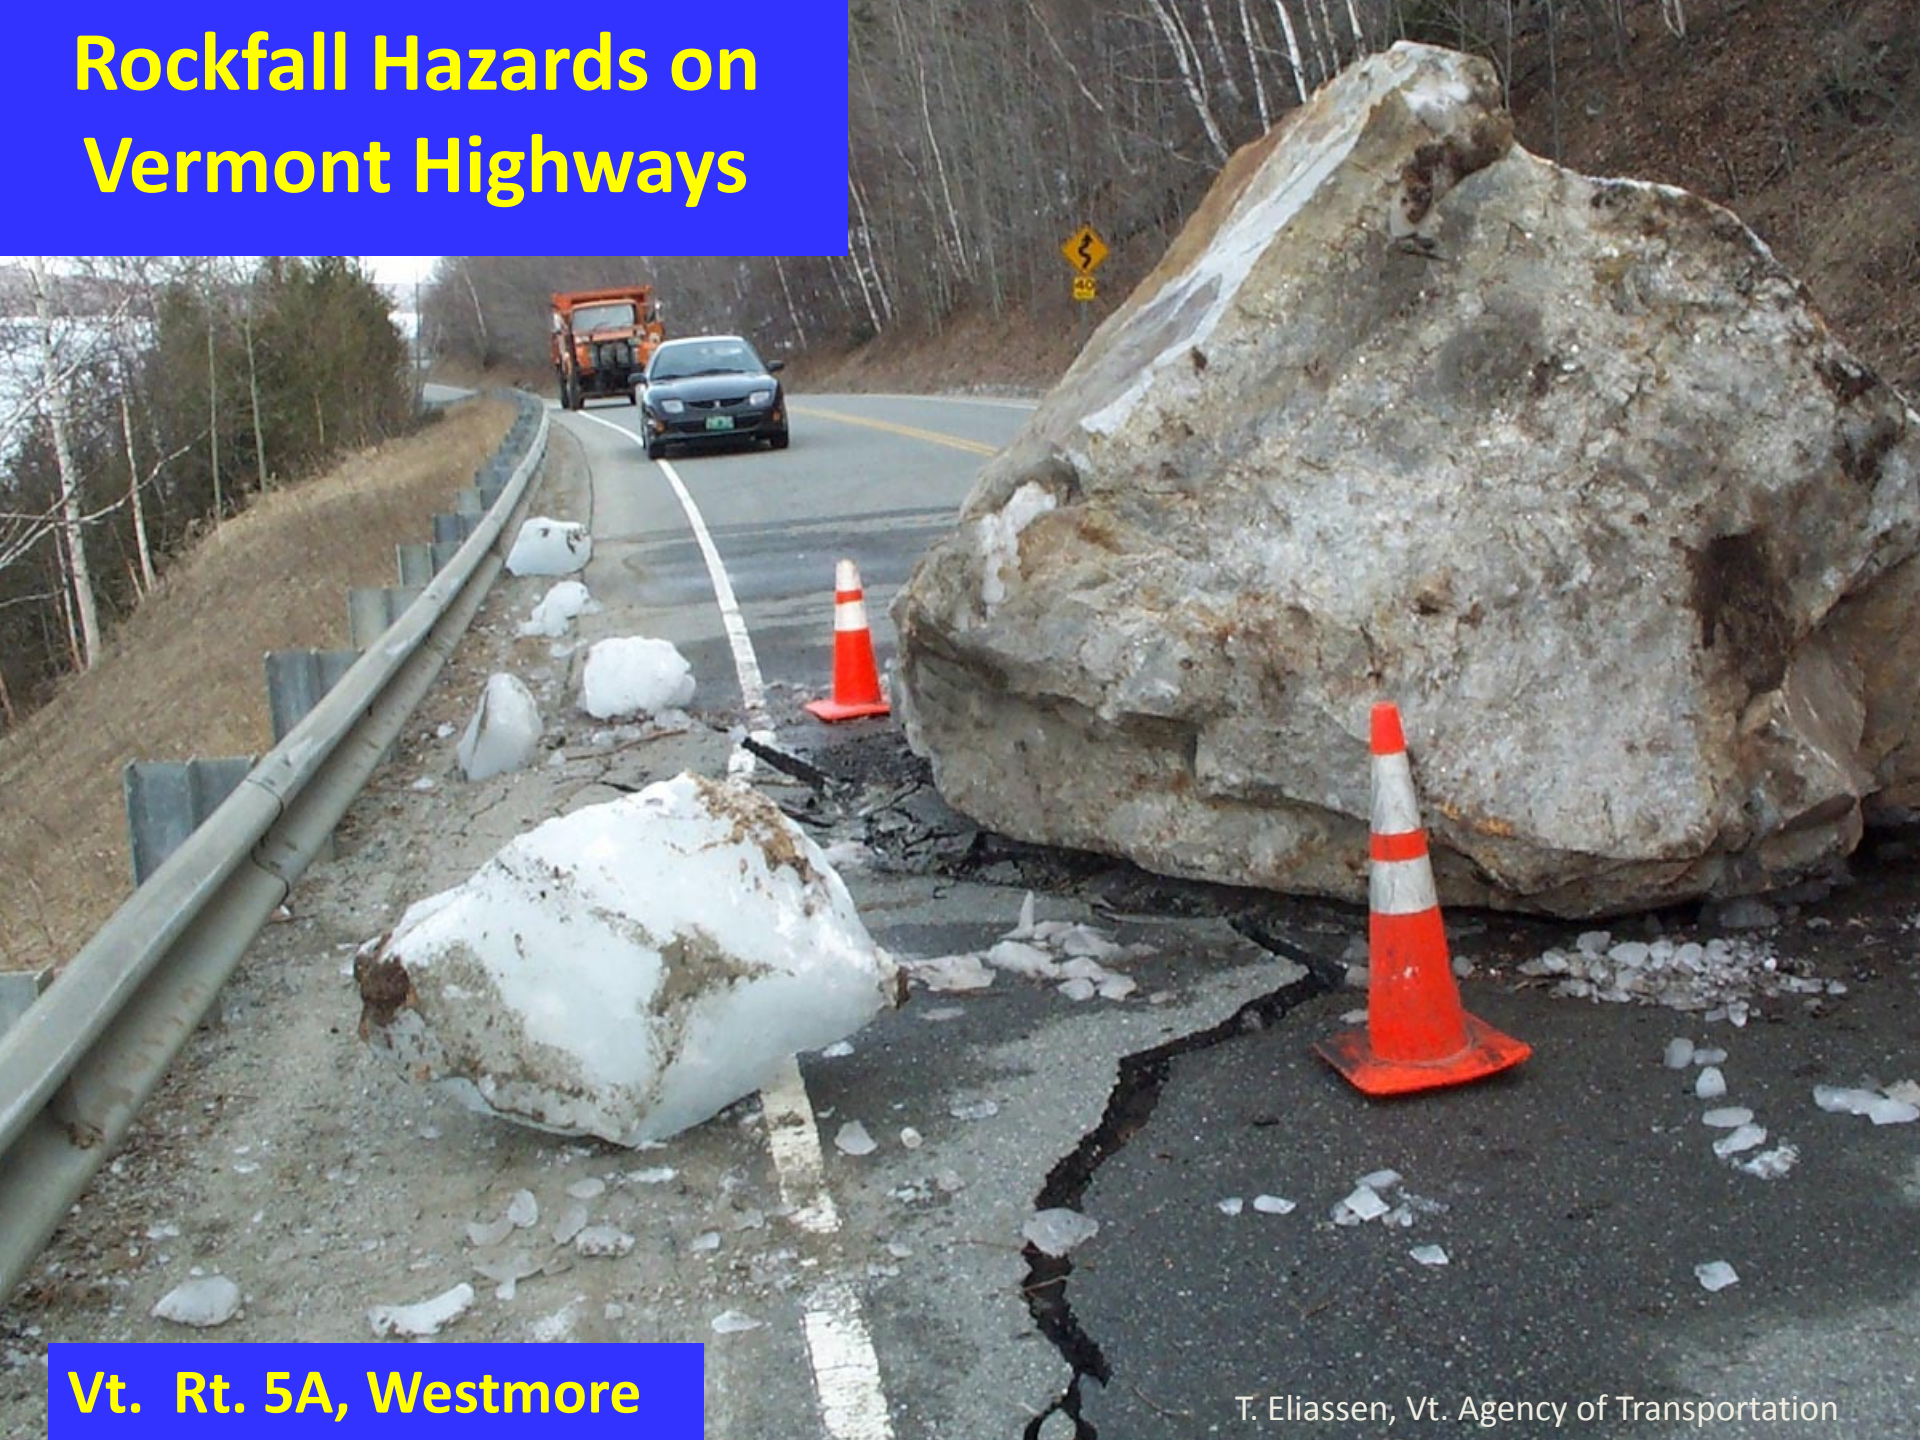
**Vt. Rt. 5A, Westmore**

Plane failure:  
slabs dipping  
toward road.

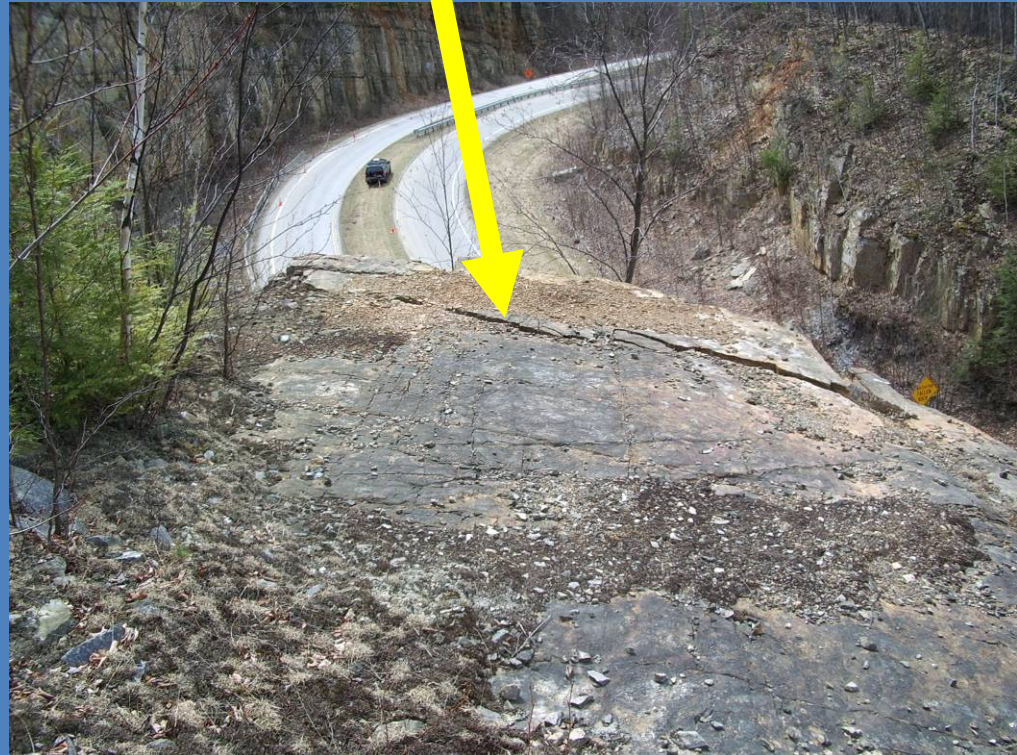
U.S. Rt. 7, Exit 2, Bennington,  
G. Springston, Norwich U. Dept. Geology

Fracture-bounded  
Column

Tension Crack
