SURVEY OF HIGHWAY CONSTRUCTION MATERIALS
IN THE TOWN OF BELVIDERE, LAMOILLE COUNTY, VERMONT

Engineering Geology Section, Materials Division
Vermont Department of Highways

January, 1974

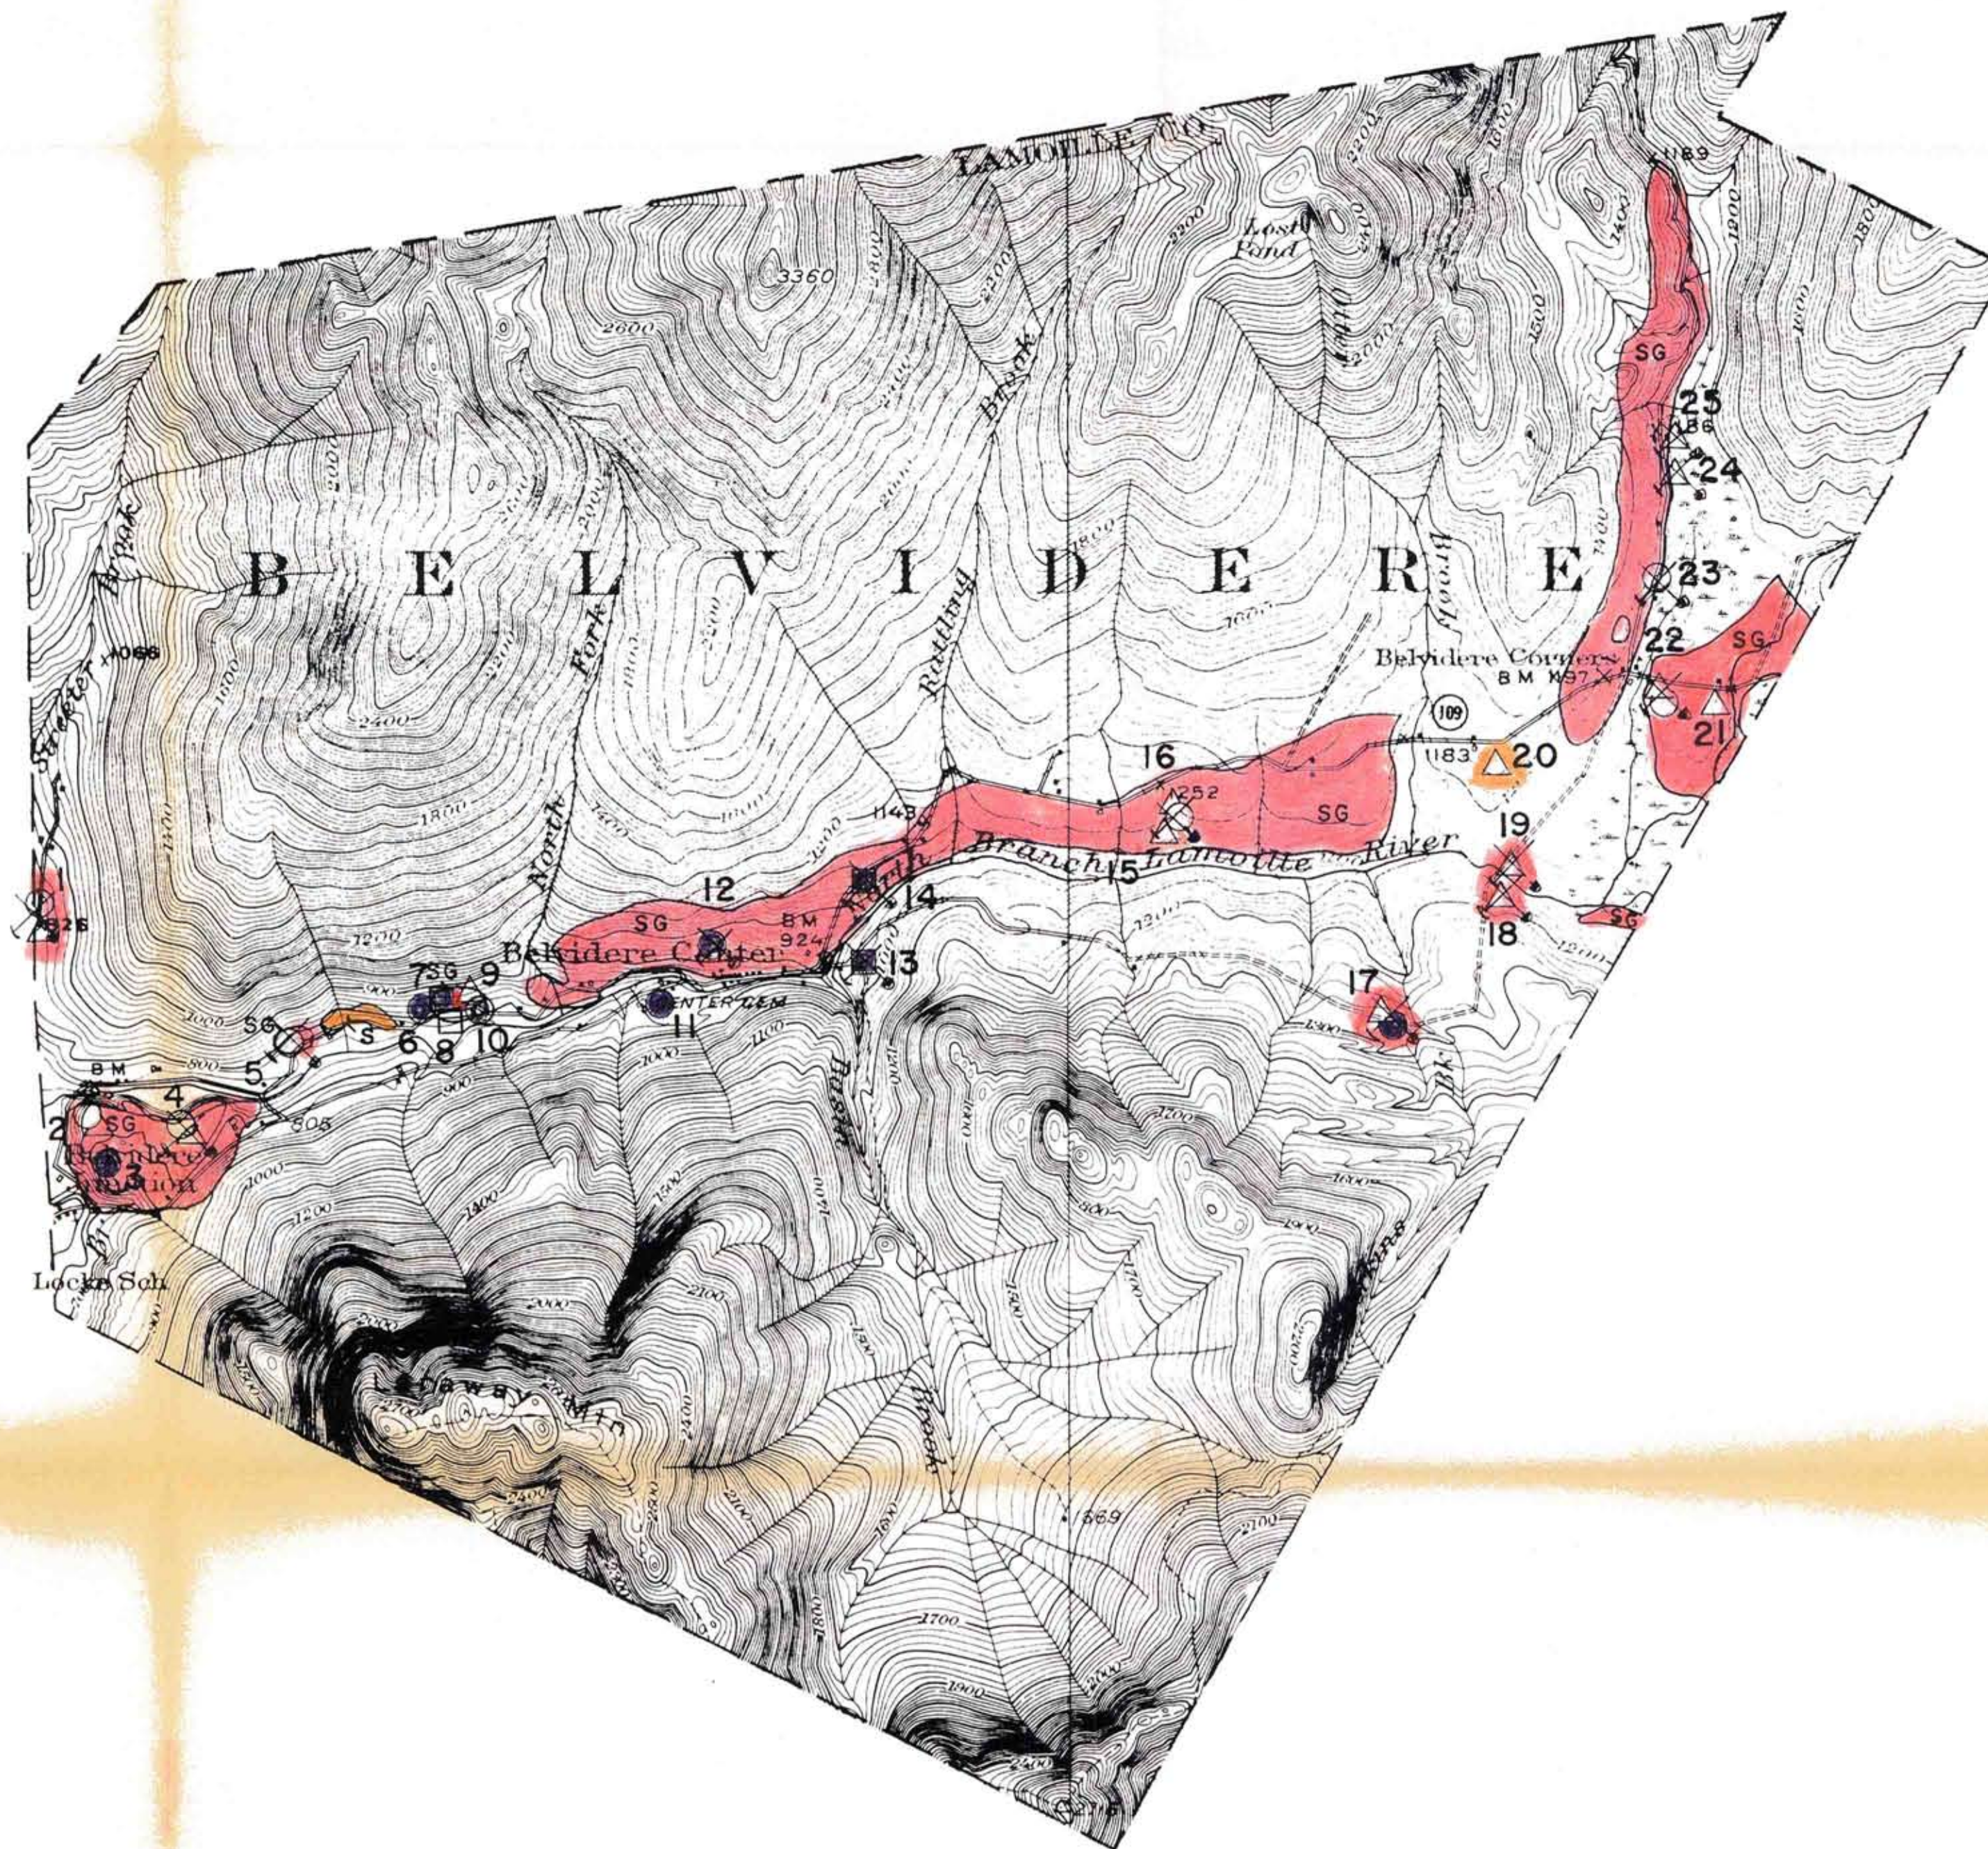
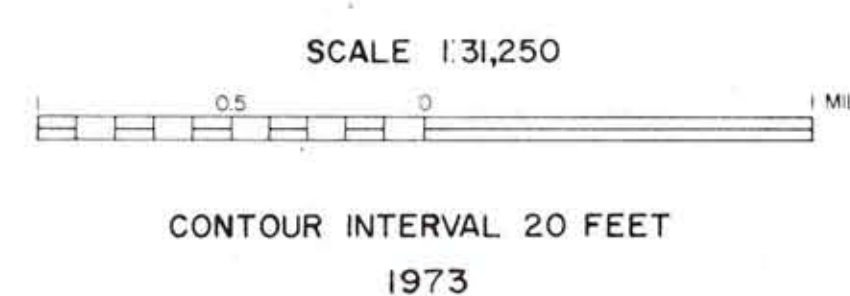
GRANULAR
MATERIALS MAP
BY
VERMONT DEPARTMENT OF HIGHWAYS
IN COOPERATION WITH
U.S. BUREAU OF PUBLIC ROADS

- GRAVEL, ACCEPTABLE FOR SEC. 704.05 (gravel for sub-base)
- GRAVEL, DEPLETED OR NOT ACCEPTABLE FOR SEC. 704.05
- △ SAND, ACCEPTABLE FOR SEC. 703.03 (sand borrow and cushion)
- ▲ SAND, DEPLETED OR NOT ACCEPTABLE FOR SEC. 703.03
- GRANULAR BORROW, SEC. 703.05
- MATERIAL NOT ACCEPTABLE FOR SEC. 703.05
- × EXISTING PIT
- SG SAND & GRAVEL DEPOSIT
- S SAND DEPOSIT
- 3 IDENTIFICATION NUMBER (refer to data sheets)

The glaciolacustrine deposits are lake sand, pebbly sands, and beach gravel emplaced in a high-level, shoaling lake that was dammed between the receding continental glacier and highlands southeast of it. Beach gravels may be found at Map Identification Numbers 1, 2, 3, 4, 18 and 19. At Map Identification Number 20 is a pebbly sand source probably deposited after the high-level lake was nearly filled with sediments.

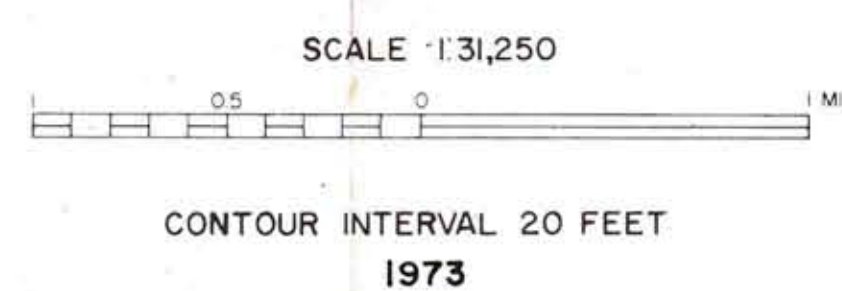
ROCK
MATERIALS MAP
 BY
 VERMONT DEPARTMENT OF HIGHWAYS
 IN COOPERATION WITH
 U.S. BUREAU OF PUBLIC ROADS

- ROCK, ACCEPTABLE FOR SEC. 704.06 (crushed stone for sub-base)
- ROCK, NOT ACCEPTABLE FOR SEC. 704.06
- EXISTING QUARRY
- GRANITE TO DIORITE (light to intermediate igneous rocks)
- AMPHIBOLITE, GABBRO, DIABASE METADIABASE, GREENSTONE, TRAP DIKES (basic or dark igneous rocks)
- PERIDOTITE, PYROXENITE, SERPENTINITE (ultra basic igneous rocks)
- GNEISS
- QUARTZITE
- DOLOMITE
- MARBLE, LIMESTONE
- SCHISTS, SLATES, PHYLLITES, SHALES, CONGLOMERATES
- IDENTIFICATION NUMBER (refer to data sheets)

It should be noted that information appearing on the Rock Materials Map is somewhat simplified. (For a more detailed description of the rock formations see the Summary of Rock Formations included in this report.) Complex metamorphic rocks comprise most of the lithology within the town of Belvidere.

All the bedrock outcrops accessible from Vermont Route 118 and Town Highway No. 8 were phyllitic schist of the Hazen Notch Formation. These outcrops were thin- ($\frac{1}{2}$ "-1") bedded; and, since no pieces of rock large enough for abrasion tests could be found, no samples were taken.
