# Basin 5

## St. Albans Bay Streams

Update June 2013

An assessment of the St. Albans Bay streams was last summarized in December 2003 in a Basin 5 Upper Lake Champlain Direct Drainage Assessment Report. A plan for this basin was published in February 2009 and that plan included some updated river and stream, lake and pond water quality information. This document constitutes the update for St. Albans Bay streams.

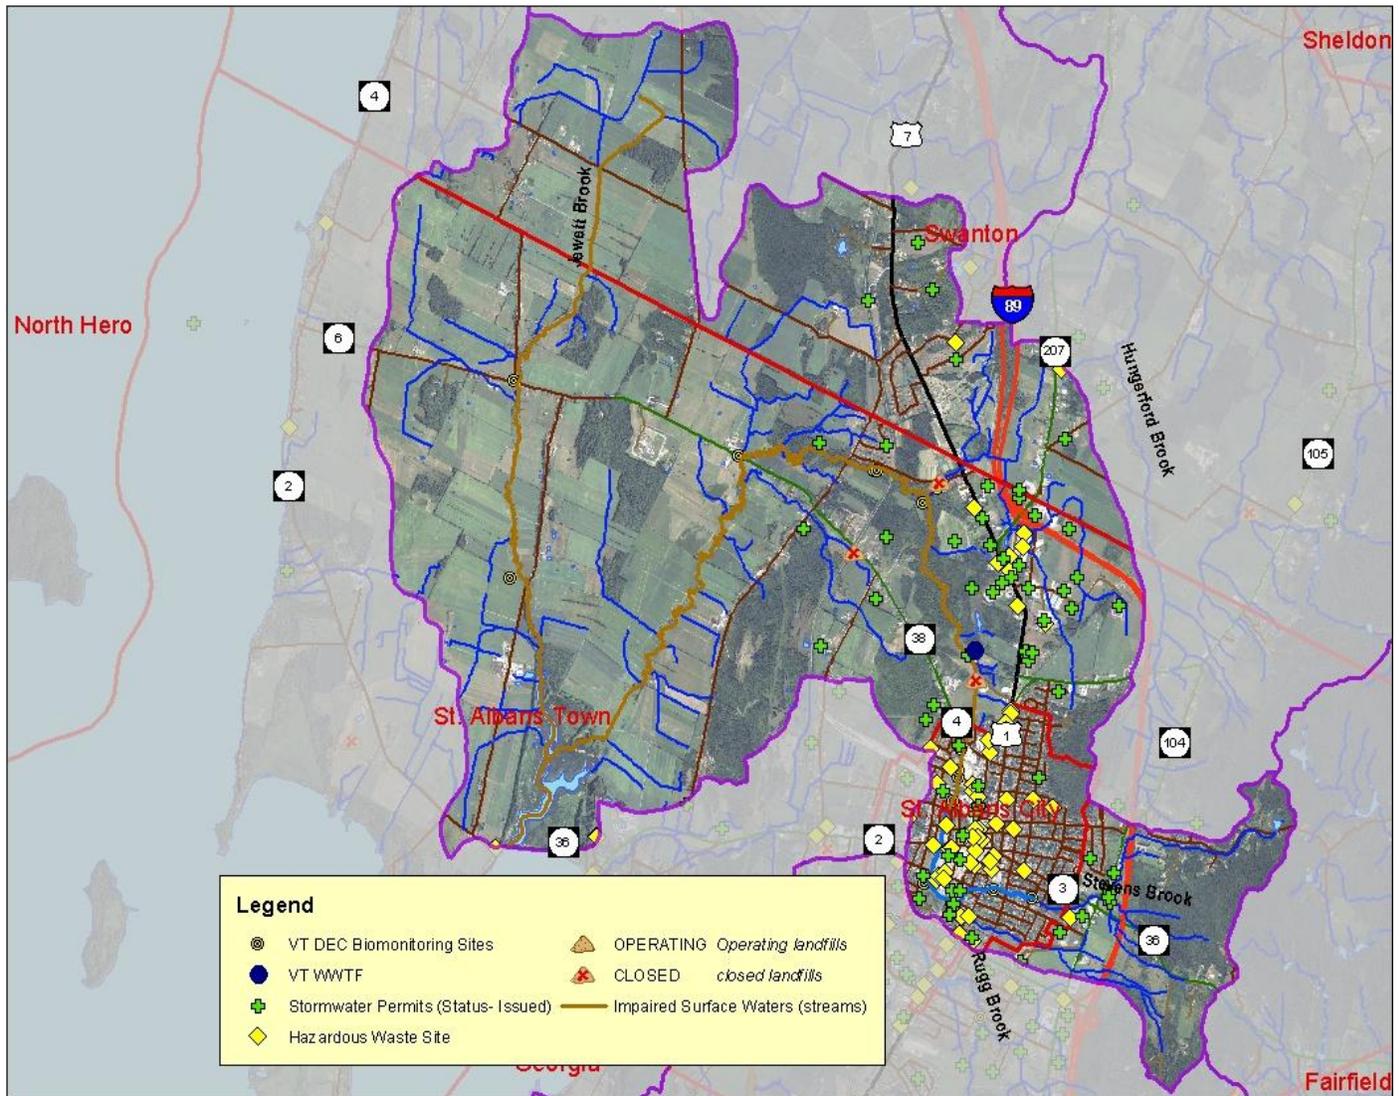
The headwaters of Stevens Brook originate along the ridgeline east of Interstate 89. West of the interstate, Stevens Brook jogs southerly and then flows first west through the southern part of St. Albans City. It turns north after the floodwater diversion structure that was built in the late 1970s and shunts floodwaters from Stevens Brook into Rugg Brook at certain flows.

Stevens Brook then flows north along the western side of St. Albans City past the Central Vermont Railroad lands and facilities and then under Lower Newton Road and out of St. Albans City. Once out of the city, the brook continues north past the St. Albans WWTF and then through more rural and agricultural land than previously. Near Jewett Road, the Stevens Brook begins a westerly flow and then after approximately a mile, the stream turns south and continues in a southwesterly direction for approximately three miles until it reaches the large wetland complex at the confluence of Stevens and Jewett Brooks.

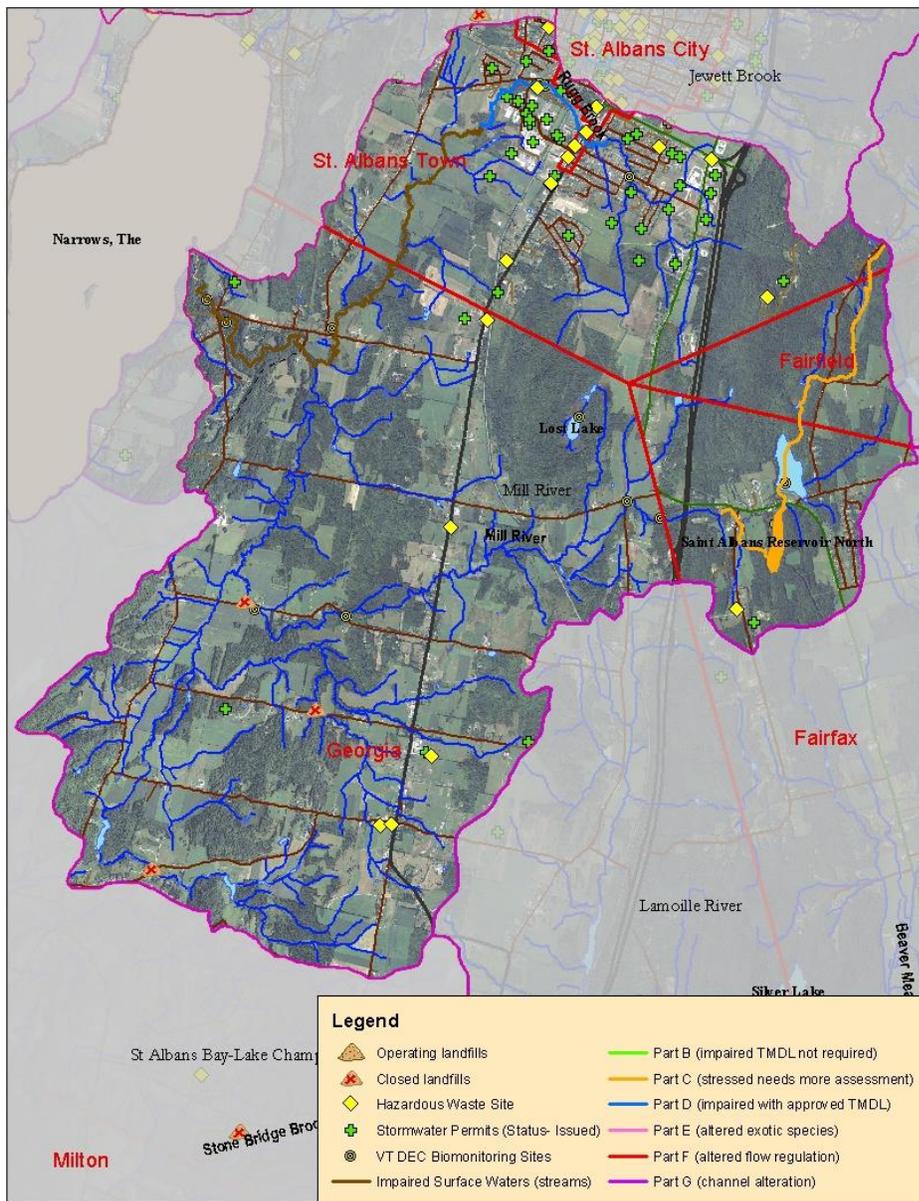
The Mill River originates at the St. Albans Reservoir and flows west under Interstate 89 then southwesterly passing under Route 7. About a mile and a half west of Route 7, the river flows abruptly north turning west again towards Lake Champlain after Rugg Brook enters. It flows through a lakeside floodplain forest community west of Georgia Shore Road before entering St. Albans Bay of Lake Champlain.

Rugg Brook's headwaters originate from east of Interstate 89 and from the south between St. Albans Hill and Bellevue Hill. The two main branches of this brook flow together near Clyde Allen Drive in St. Albans. The brook flows northwest through suburban and urban areas then west along Nason Street in St. Albans City. It then flows southwest through primarily agricultural land until it joins the Mill River.
