## The Passumpsic Watershed Water Quality Assessment Report 2018

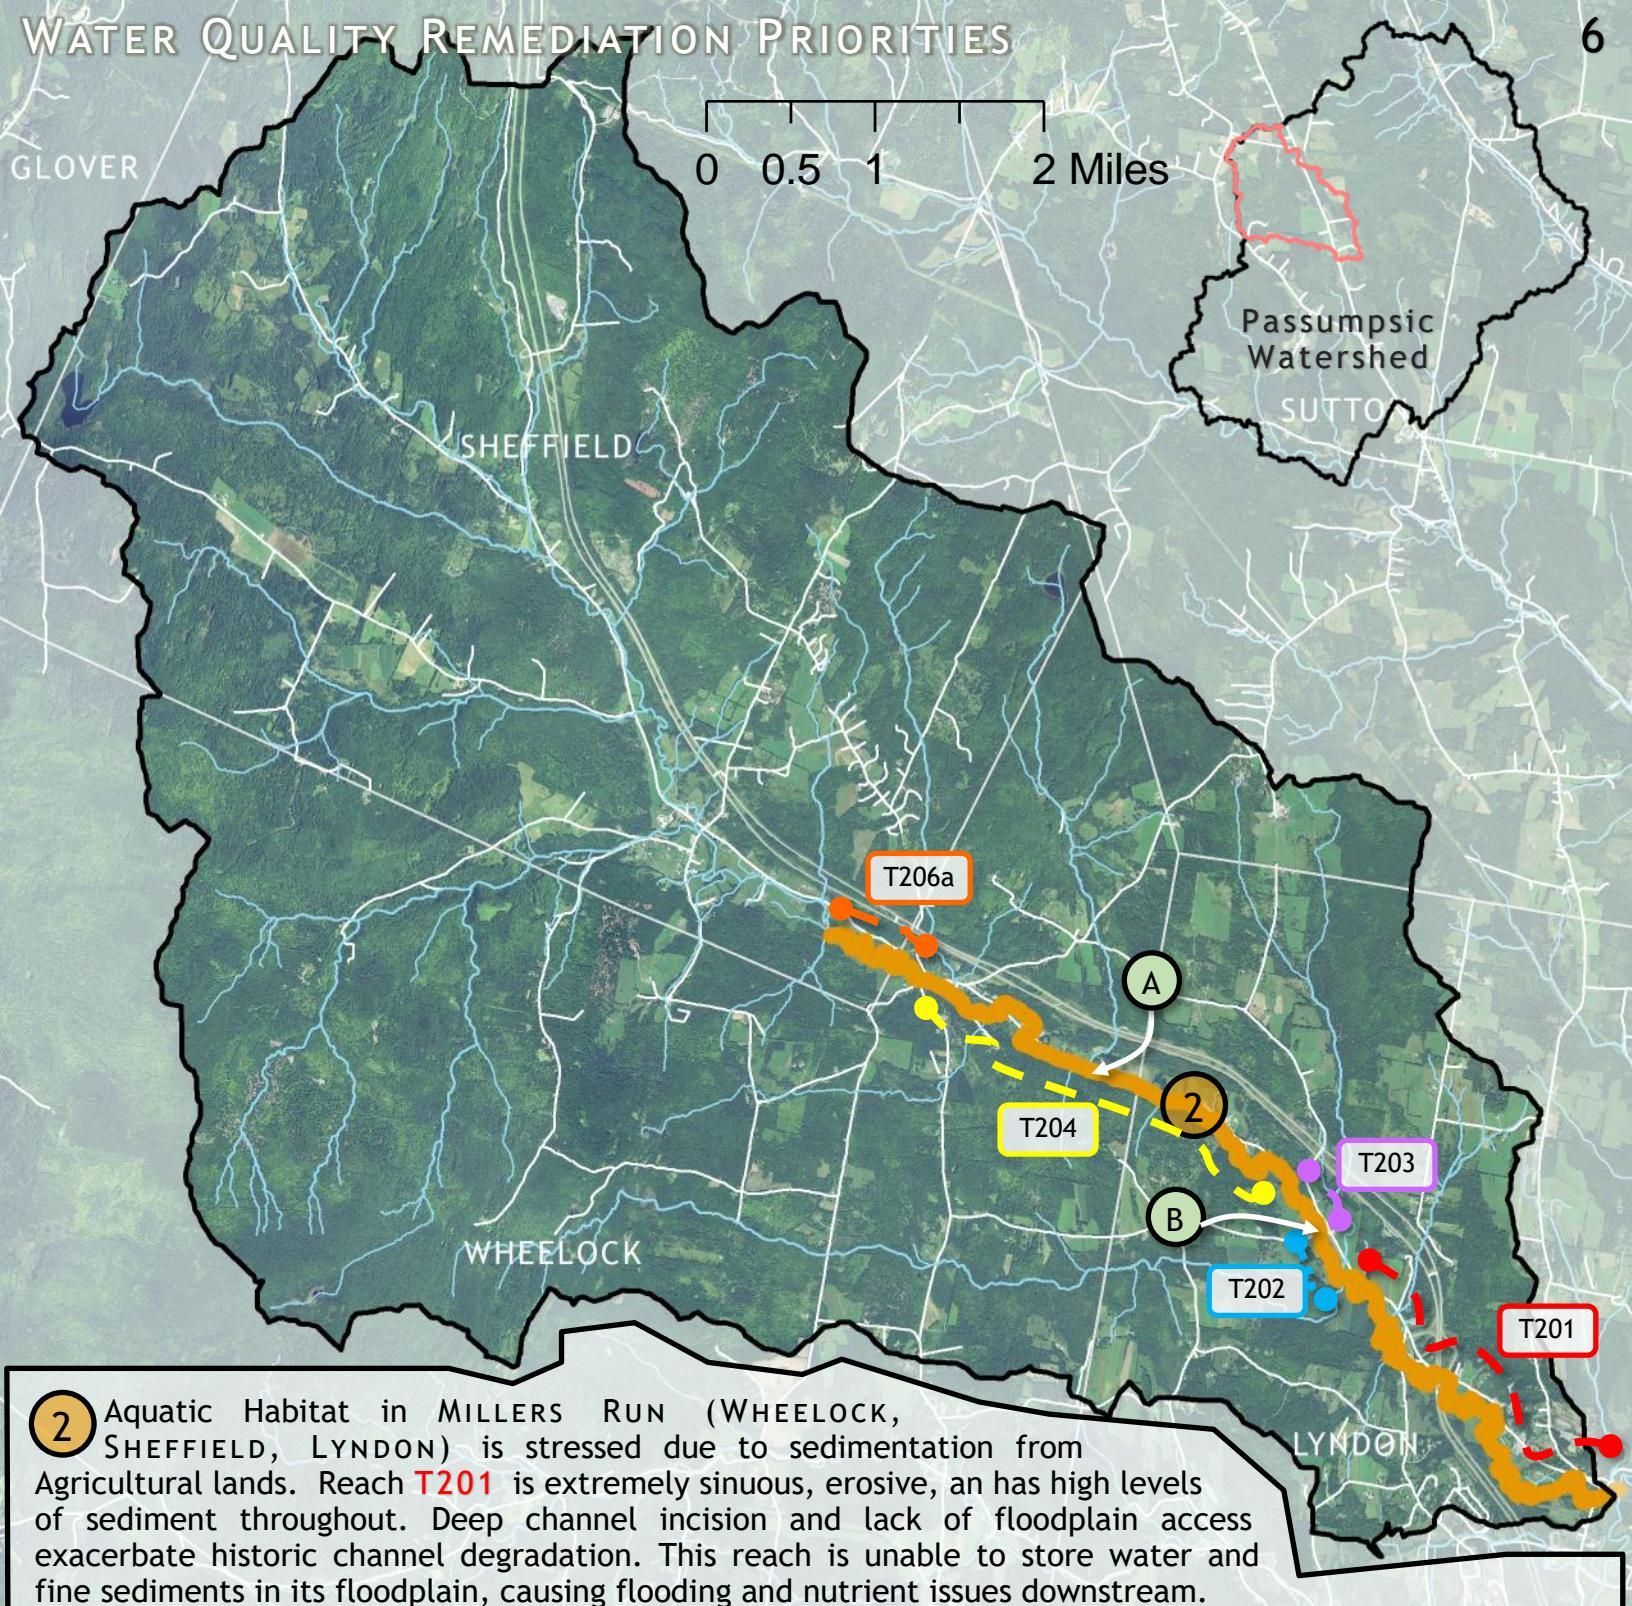
Reach T202 is entirely straightened, shows evidence of dredging, and has no vegetated buffer. This reach is unable to access its floodplain due to a berm on its right bank. Hubbard Hill Bridge is undersized, causing

scour downstream. T203 is well buffered except the upstream left bank.

**T204** in its upper reach is pinned along a valley wall on the right bank by route 122. This reach is largely entrenched except for a few points of access to the floodplain. Development along the river banks has straightened the river, removing reference riffle pool form habitats, leaving a plane bed. The bridges on this reach are significantly undersized, causing major geomorphic conflicts. Erosion is common throughout **T206a** most evidently in meander bends. Vegetated buffers are minimal and bank armoring is failing. Deposition is significant and has embedded riffle habitat. Habitat in Millers Run is poorest in this reach. For more information see Millers Run Corridor Plan.

Macroinvertebrate communities have been monitored at two locations, Map ID A and B in 2004 and 2005 respectively. Both samples passed biocriteria.

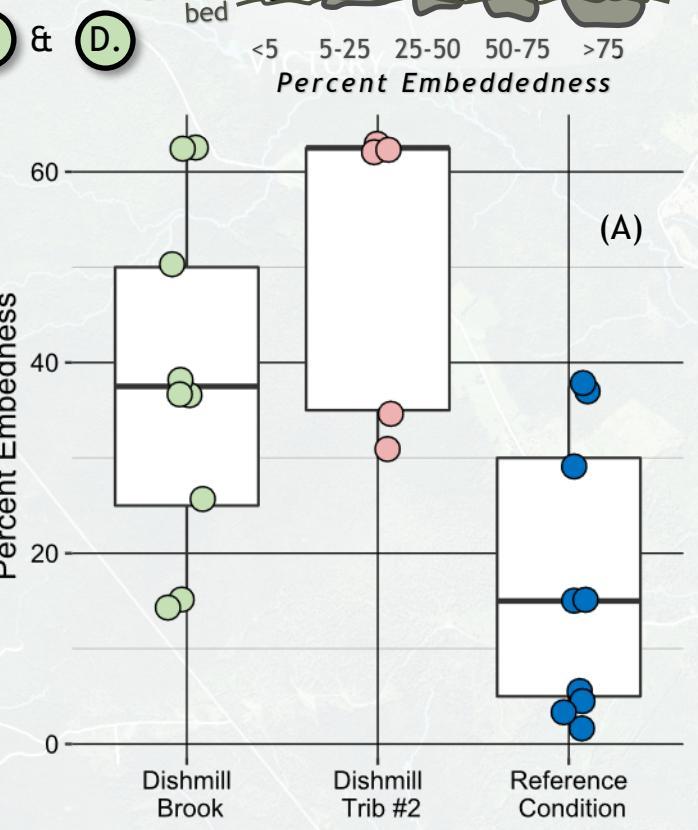
Aquatic Life in DISHMILL BROOK (BURKE) is stressed from its mouth upstream 1.3 miles due to sedimentation from upstream development and backwater intrusion from the East Burke Dam. embedding Sedimentation is instream

habitat, compromising its riffle-pool system (A). Elevated peak flows from upstream flow regime modifications and other stormwater inputs are also scouring stream banks. The impacts of scour are enhanced in portions of the reach where woody riparian vegetation is lacking. For more information on the Water's geomorphological conditions of DISHMILL BROOK, see the Dishmill Brook Watershed River Corridor Plan.

Aquatic life has been monitored at map ID (C Macroinvertebrates have failed biocriteria four out of five monitoring events, passing most recently at map ID 3 in 2015. The fish community in Dishmill Brook has performed exceedingly well, scoring near reference condition four out of four monitoring events; the earliest monitoring event occurred in 1989 and the most recent event occurred in 2015.

Aquatic Life in DISHMILL BROOK TRIB #2 (BURKE) is stressed due to sedimentation from upstream development. Habitat embeddedness is greater in trib #2 than mainstem Dishmill (A).

Aquatic life has been monitored at map ID(A)&(B) since 1988. The macroinvertebrates have failed three out of six times, passing most recently at both sites during 2006, 2010, and 2015. Similarly to the fish community in the mainstem, the fish in trib #2 have performed exceedingly well, scoring near reference condition two out of two monitoring events in 2010 &

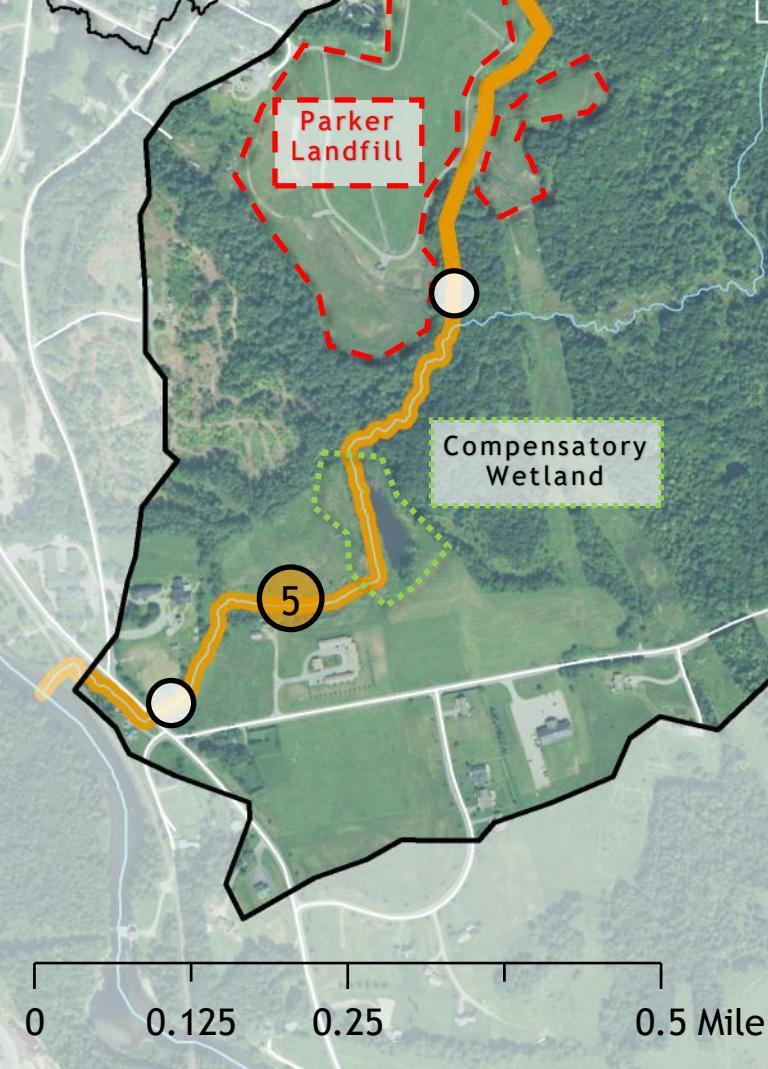
Prior to 1983, 1 million gallons of liquid waste and 760 tons of semi-solid wastes containing metal plating wash waters, waste oils, electroplating sludges, paint sludges, chlorinated solvent sludges, caustic cleaners and metallic salts were disposed of directly on the ground or in lagoons. To remediate the site, construction of a multi-layer cap, industrial waste site areas, gas collection sites, a permeable reactive barrier, and bio-enhanced natural attenuation area was completed in 2005. Maintenance and monitoring has continued since. A compensatory wetland was constructed to offset wetland loss due to construction at the Parker Landfill.

From 2014 EPA Re	eview Rep	<u>port</u>		
(ug/l)	1990-1994 Max	2001-2004 Max	2005-2008 Max	2009-2013 Max
Acetone	15	10	ND	7.03
Trichloroethene	21	920	50	30.6
Vinyl Chloride	1	5.2	0.513	0.359
Cis-1,2-Dichloroethene	42	350	17.8	25.3
Trans-1,2-Dichloroethene	42	2.4	ND	0.277
Aluminum	116	34100	199	3320
Antimony	56.5	7.9	ND	ND
Barium	291.5	258	31.7	112
Cadmium	NS	0.8	ND	ND
Calcium	79400	36700	59700	73200
Chromium	11.2	52.3	ND	ND
Cobalt	NS	19.9	13.4	3.22
Iron	33750	51400	945	16100
Lead	NS	61.4	13.4	13.3
Magnesium	9375	11300	6050	7060
Manganese	3350	6990	249	2060
Nickel	38.8	32.3	ND	ND
Pottasium	10040	4780	3060	3920
Selenium	NS	8.3	ND	ND
Silver	14.4	4.7	ND	ND
Sodium	23550	15100	15100	ND
Thallium	1.6	18	ND	ND
Zinc	NS	238	9.77	64.7
O Surface Wa Monitoring	Black shading exceed criteria
